MEMORANDUM FOR: RECORD

March 10, 2010

SUBJECT: DMMP DETERMINATION ON THE SEDIMENT QUALITY OF THE EXPOSED SEDIMENT SURFACE AFTER UNPERMITTED DREDGING TO VERIFY COMPLIANCE WITH THE WASHINGTON STATE ANTIDegradation POLICY FOR THE CAMAS SLOUGH, CAMAS, WASHINGTON DREDGING PROJECT (2003-01135)

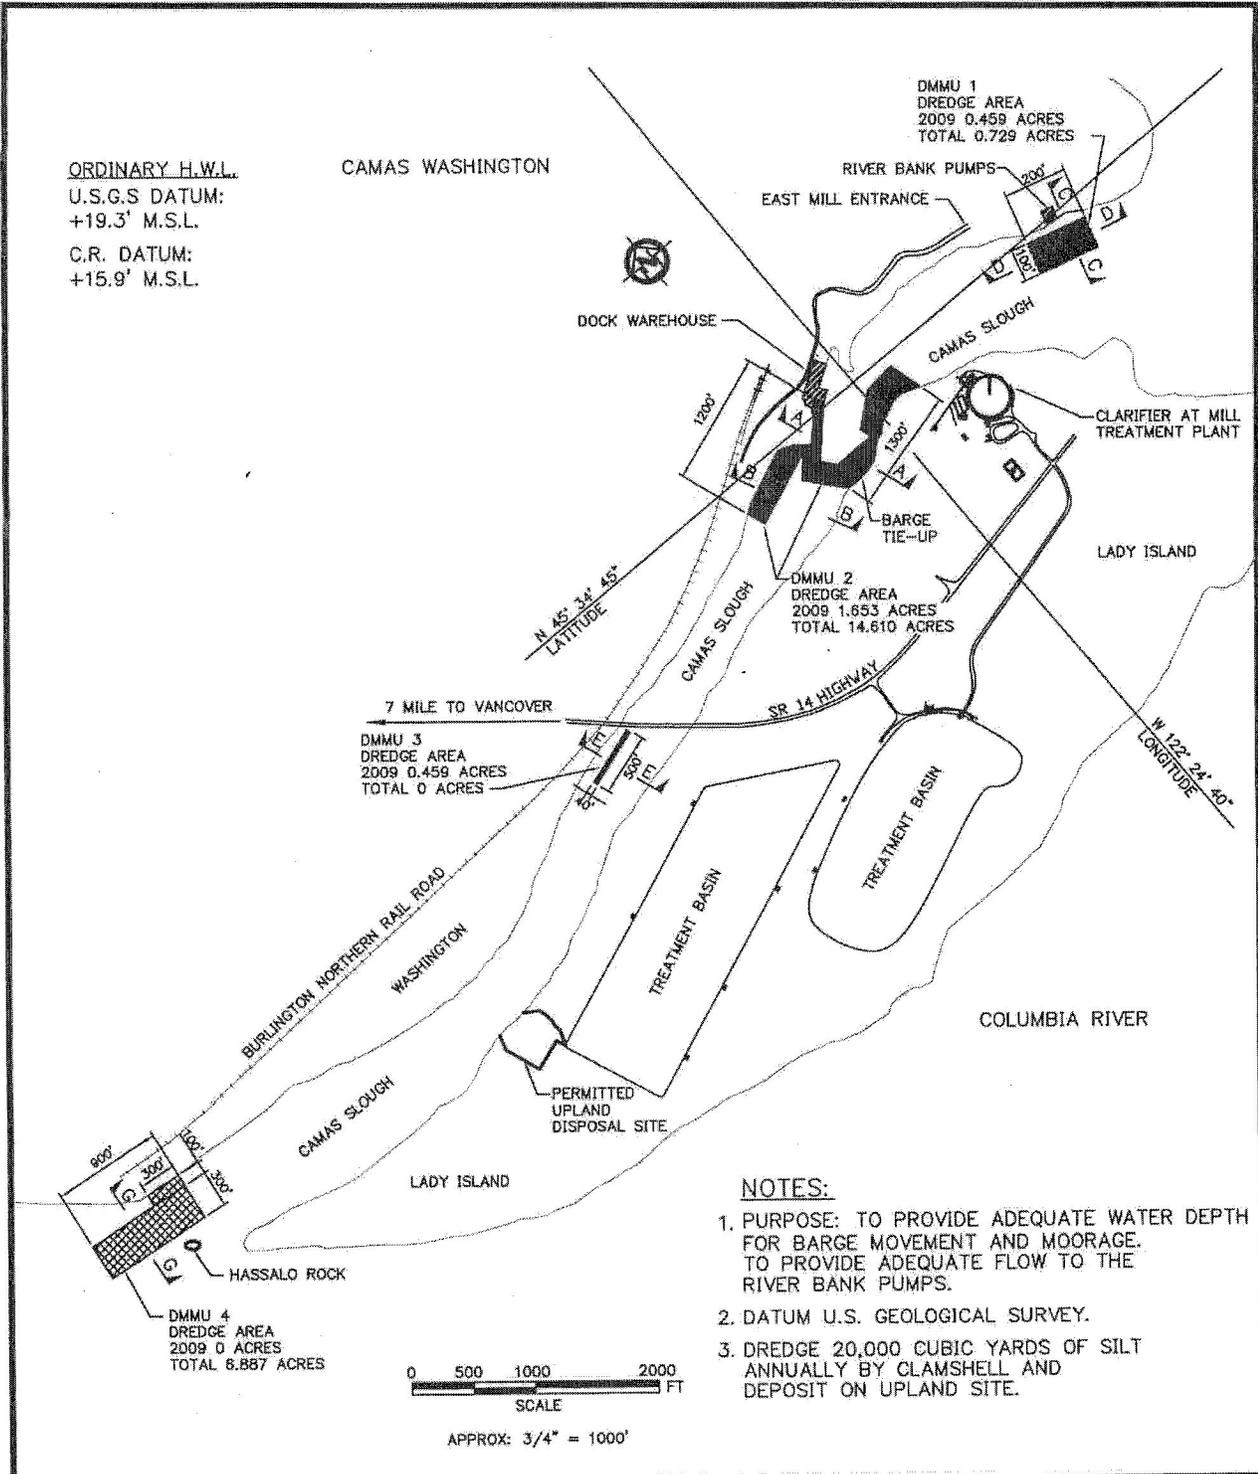
Figure 1. Project dredging areas. Non-permitted dredging occurred in DMMU 3.

In a letter dated March 11, 2009, the permittee (Georgia-Pacific Consumer Products LLC in Camas) reported that 3,217 cy in DMMU 3 had been dredged in violation of the permit. The unapproved dredging occurred on January 12-14, 2009 (Figure 1). As part of the response to this violation, GP was required to conduct a post-dredge survey of the exposed surface to determine whether anti-degradation had actually occurred. A Sampling and Analysis Plan (SAP) was prepared by GP and approved by the agencies (Table1).

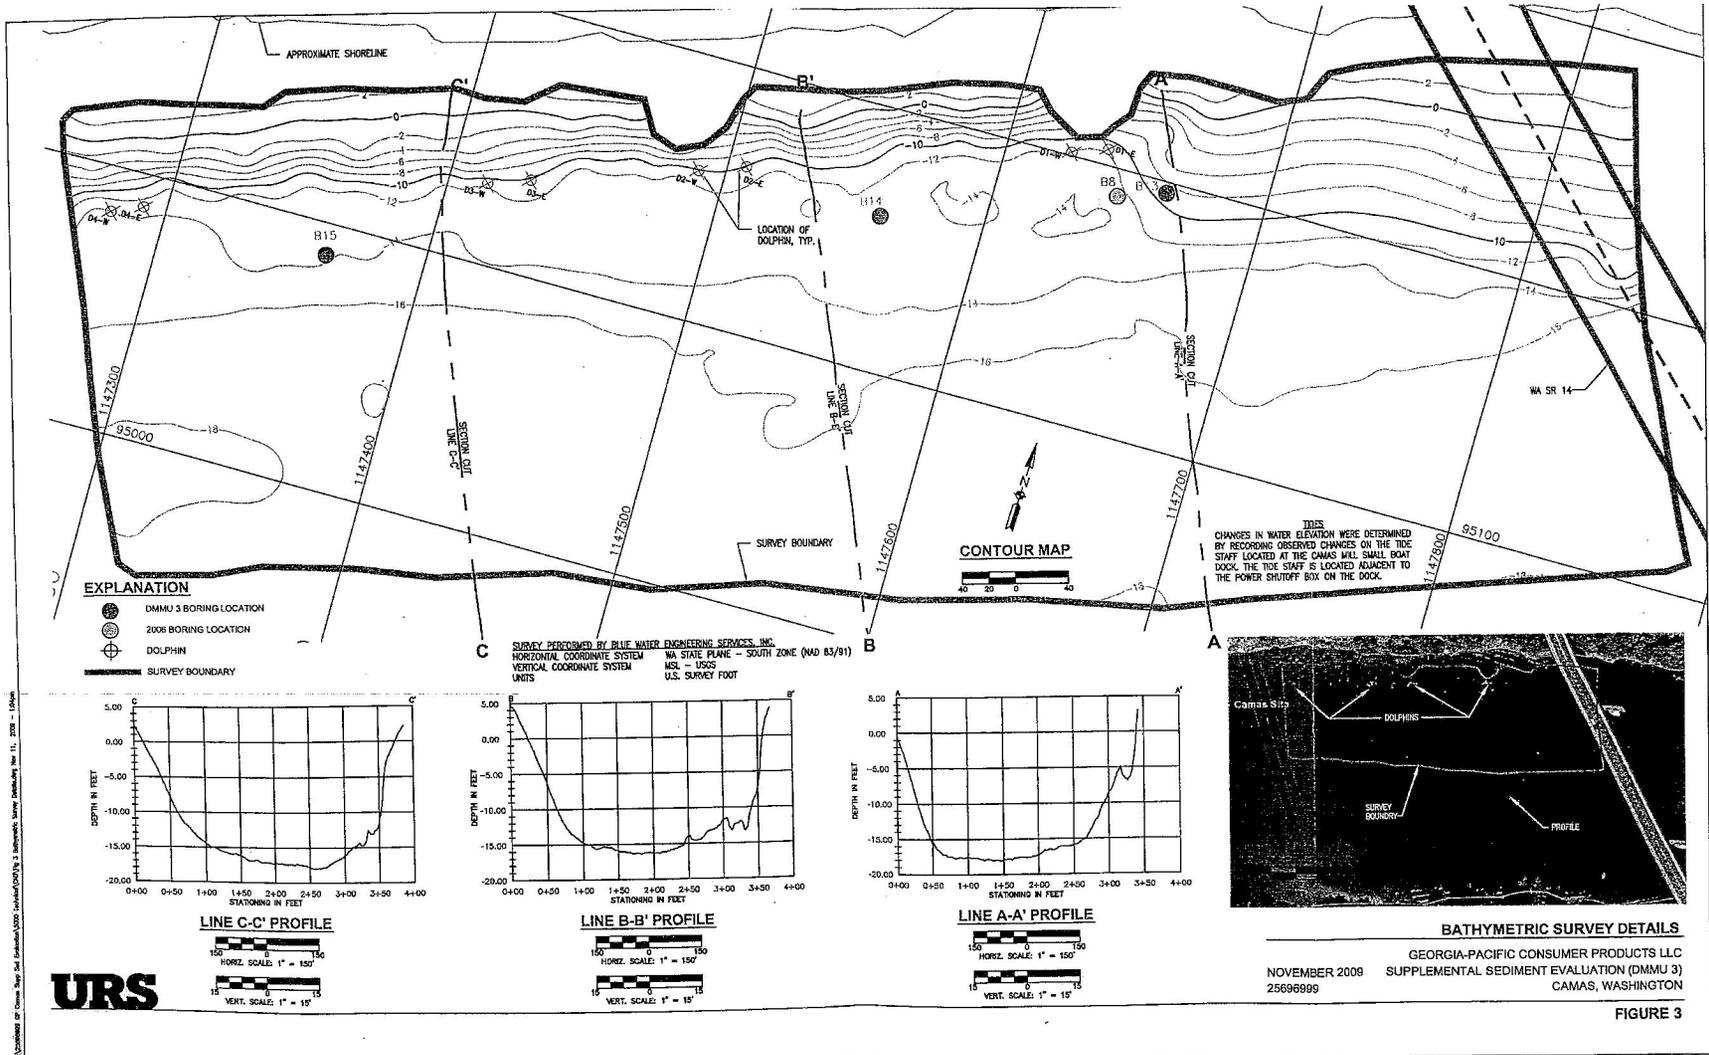
Figure 2. DMMU 3 post dredge sampling locations and bathymetry.

3. Project Sampling. The required bathymetric survey was conducted prior to sediment sampling. Core sediment samples were collected with a direct push Vibracore from three locations within DMMU 3 (Figure 2). Sediment samples were collected from each core at the 0-1 ft. interval, 2-3 ft. interval, and 4-5 ft. interval to determine not only the exposed surface but, if further remediation should be necessary, to determine whether contamination continued to increase with depth below the exposed sediment surface.

Samples were placed along the length of the DMMU. Sample B13 was positioned near the 2006 sampling station (B8) but not directly on it, as the bathymetry at station B8 would not allow for the desired sample.

5. **Evaluation.** Since the top foot of each of 3 separate Z-samples showed no exceedances of target chemicals, there is no evidence of degradation to the surface occurring subsequent to dredging at DMMU

6. **Recommendations.** No further action is necessary to bring the exposed sediment surface into compliance with the state antidegradation standards. Further penalties for the permit violation are not within the purview of the DMMP program.
