**LOWER DUNGENESS RIVER
SECTION 544
ECOSYSTEM RESTORATION**

**APPENDIX F
HAZARDOUS, TOXIC AND RADIOACTIVE
WASTE**

**DUNGENESS RIVER
ECOSYSTEM RESTORATION PROJECT**

**ENVIRONMENTAL SITE ASSESSMENT
PHASE I**

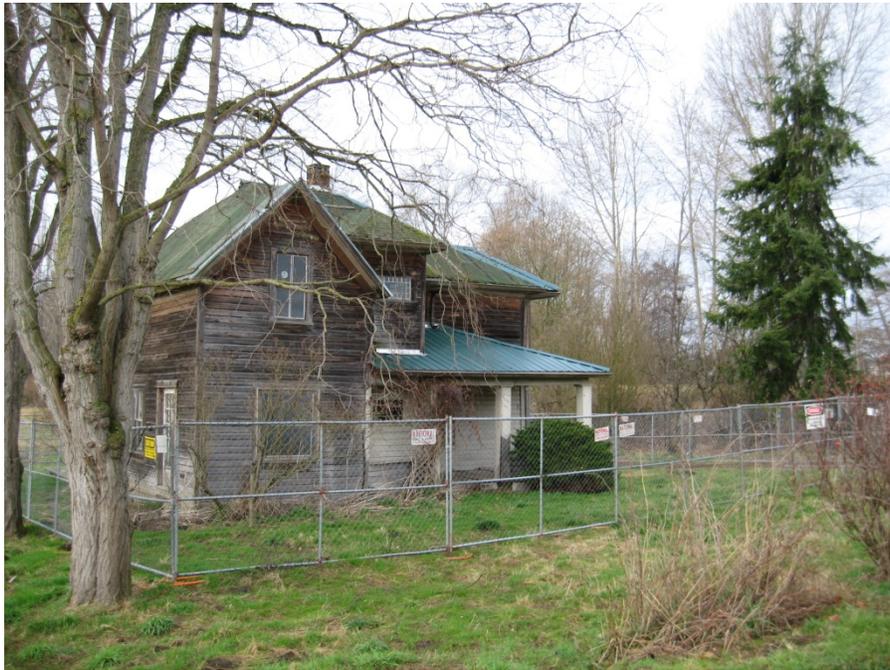
Figure 2 shows the locations of the pictures that follow in this section. Picture 1 (Figure 3) shows the Chang House currently abandoned. Asphalt shingles can be seen along with white paint on some of the boards. An attempt to enter the house was not made but asbestos and lead is suspected.

Figure 3 - Photo 1, looking towards the Historic House

No visibly stained soil, stressed vegetation, or other evidence of surface contamination indicating disposal of hazardous substances, or improper use or storage of hazardous materials was observed on the ground along the edges of the property. The following observations of hazardous or potentially hazardous substances were found exterior from the historic house shown in photo 1 (Figure 3):

- Asphalt Shingle covering part of the roof showing renovations / improvements have been made. This could have introduced asbestos and lead containing materials to the structure.
- Paint on the exterior most likely contains lead. Reason for this is it is likely the house was updated during the period house hold paints commonly contained lead. Other renovations that cannot be seen from the exterior will also likely contain lead and or asbestos but no determination can be made at this point.

This structure is to be demolished and materials reclaimed according to a MOA authored by USACE dated 28 June, 2012. It is suggested that a Hazardous Material Survey that includes sampling of the drip line around the structure for lead contamination. This will allow for appropriate debris separation for disposal. This would be at the discretion of the current property owner and should be completed before the Seattle District starts the construction phase.

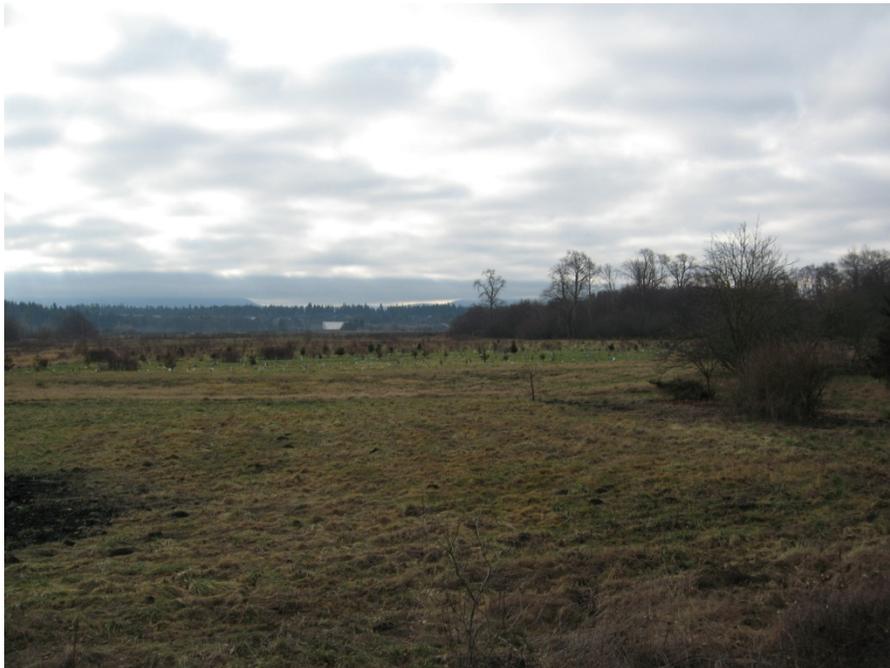
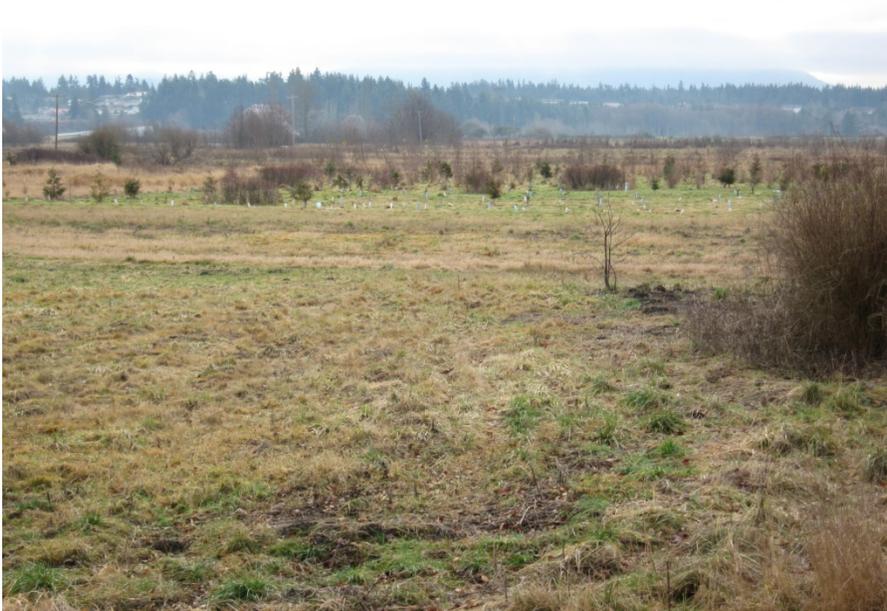
From the house the levee was walked and no significant findings were observed. Pictures 2 and 3 (Figures 4 and 5) show newly planted trees looking south west and south east respectively. White cones at the base of the trees are to protect from deer / grazing animals.

Figure 4 - Photo 2 looking south from levee

Figure 5 - Photo 3 looking south from levee

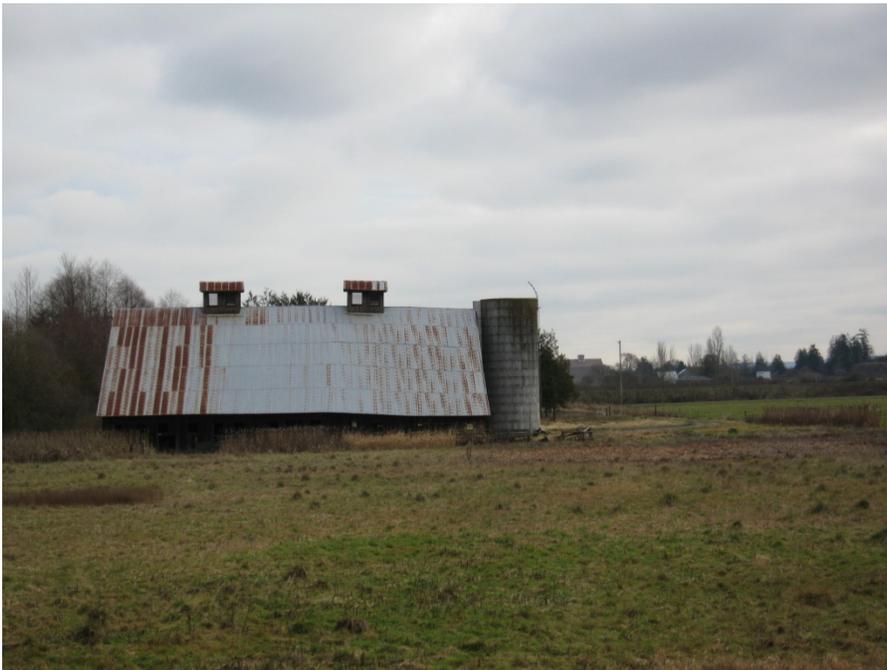
Figure 6 - Photo 4, Looking east towards the old barn

On the south side of the project area is the old barn, named the Schneider Barn, with grain silo (Figure 6). In photo 4 shows red marks on the roof. Before the 1970's, lead was often an additive in red pain and would suggest characterizing if the barn is to be demolished.

- Interior is clean; however, some white paint is present on the lower interior walls extending up to 15 feet in places. Paint could contain lead.
- Roof looks like it was painted at one time with red paint and could be a source of lead contamination.

Additionally, if the paint contains lead then the soil around the barns foundation parameter should also be sampled.

From the age of the structure and the paint on both the roof and interior walls, a Hazardous Material Survey is recommended to survey the interior and exterior of the structure. This will be a relatively simple survey since the building has relatively few differing surfaces. Similar to historic house recommendation, soil samples around the drip line of the structure would determine the extent, if any, of lead soil contamination. This would be at the discretion of the current property owner and should be completed before the Seattle District starts the construction phase.

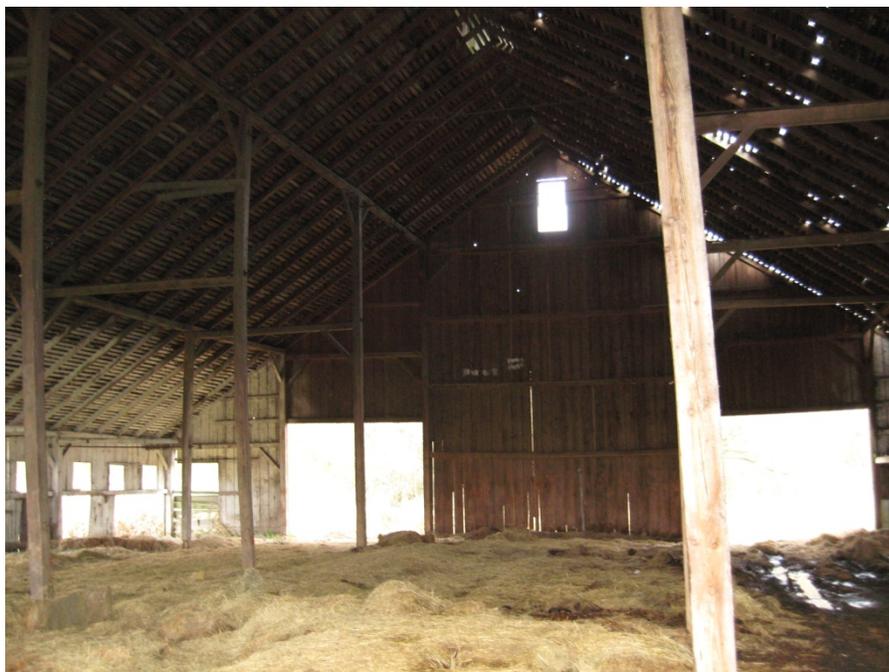
Figure 8 - Photo 6, inside the barn. Notice the white paint on the lower interior slats

Inside the barn (Figure 8) white paint can be seen on the lower portion of the wooden slats. This could also contain lead and should be characterized if building is being demolished.

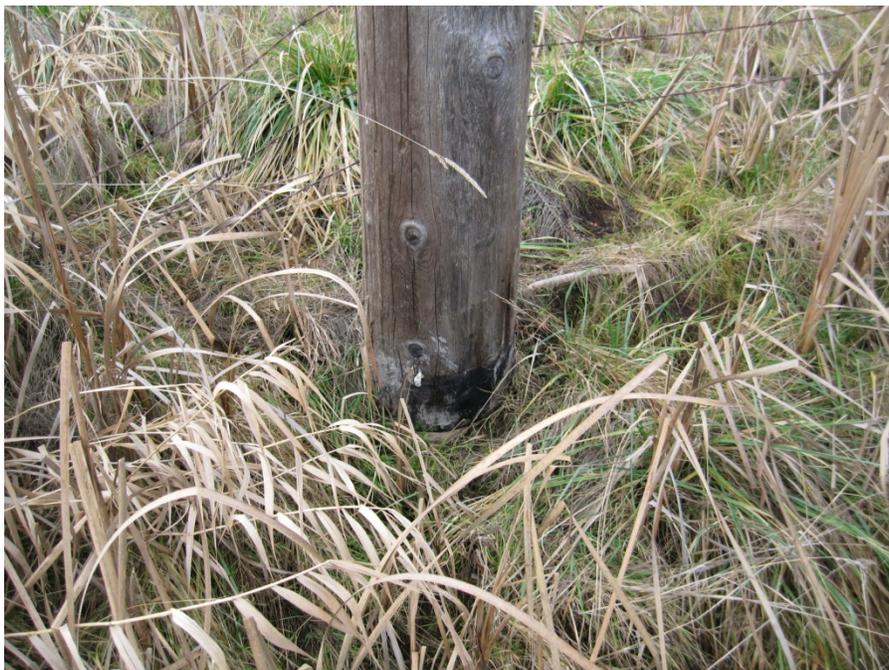
Figure 10 - Photo 8, base of telephone pole, notice the black creosote staining.

Figure 12 - Photo 10, Old corral fencing along Town Road, Black Creosote staining over many of the surfaces
Many of the wooden timbers (Figures 10 – 12) have evidence of creosote treatment as was the standard practice to weatherize outdoor timbers for most of the last century. Creosote is a known carcinogen and will continue to leach into the soil. While the effects of this contamination is most likely localized around the timbers themselves, it is suggested that all treated timbers be removed within the restoration boundaries.

Telephone poles shown in pictures 8 and 9 are found in the project area along Town Road. Of significance is the creosote staining found on the bottoms of the poles and the treated timbers of the corral shown in picture 10. Creosote can leach from the treated timbers and could be a detriment to the immediate local ecology if left as is .

It is recommended for the telephone poles located within the final project area to be removed completely from the ground and properly disposed of. If the project area includes restoration of the corral fence area, the fence timbers should also need to be removed. Since this is not a true HTRW issue, but more of proper housekeeping for the project site, it will be the responsibility of the Seattle District to coordinate the removal and disposal of the creosote timbers during the construction phase.

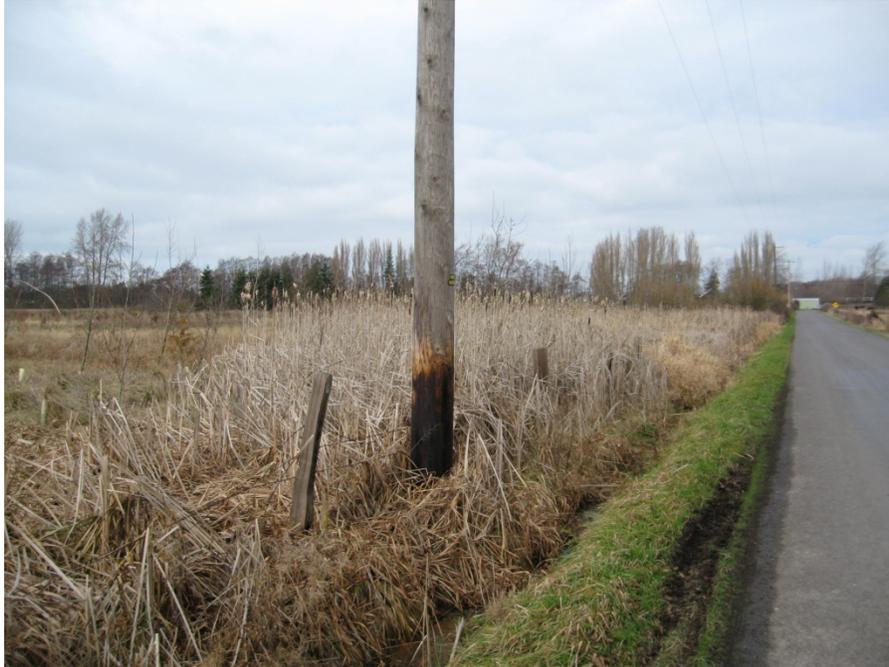
Figure 11 - Photo 9, Telephone Pole along Town Road, notice the black creosote staining at the base
