ENVIRONMENTAL ASSESSMENT

SKAGIT RIVER – DIKING DISTRICTS 1, 3, 12, 17, AND 22 LEVEES REHABILITATION OF FLOOD CONTROL WORKS SKAGIT COUNTY, WASHINGTON

May 2011

**US Army Corps
of Engineers®**
Seattle District

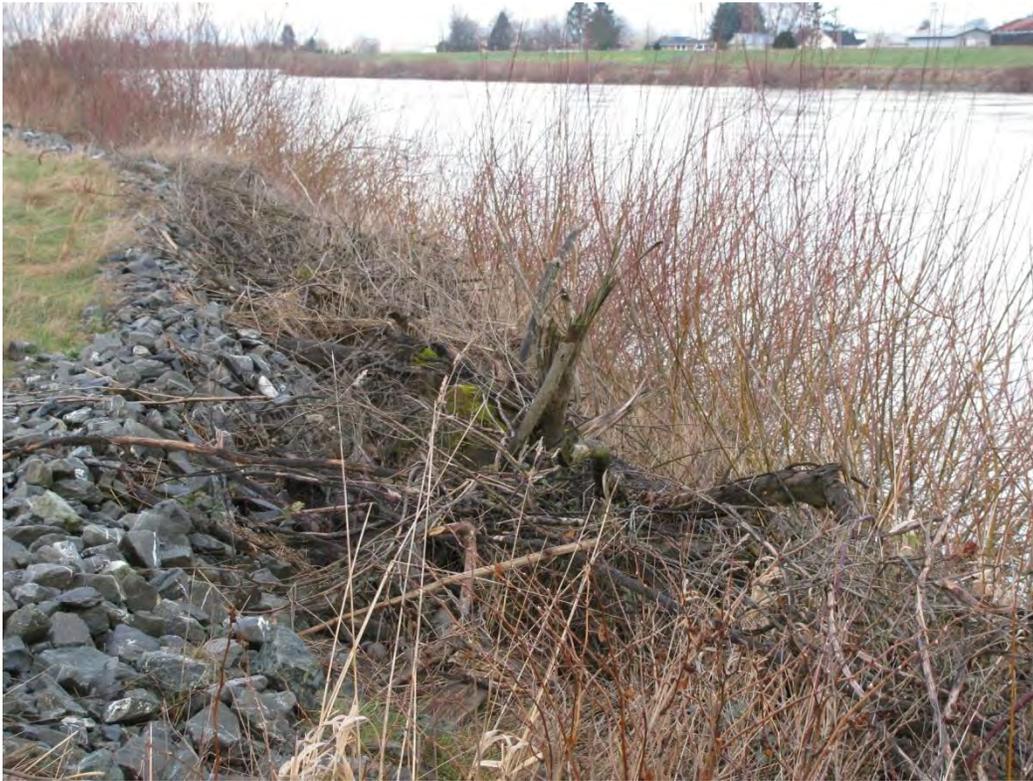
Figure 5: Willow growth at repaired Site 1-2, photo taken February 2011.

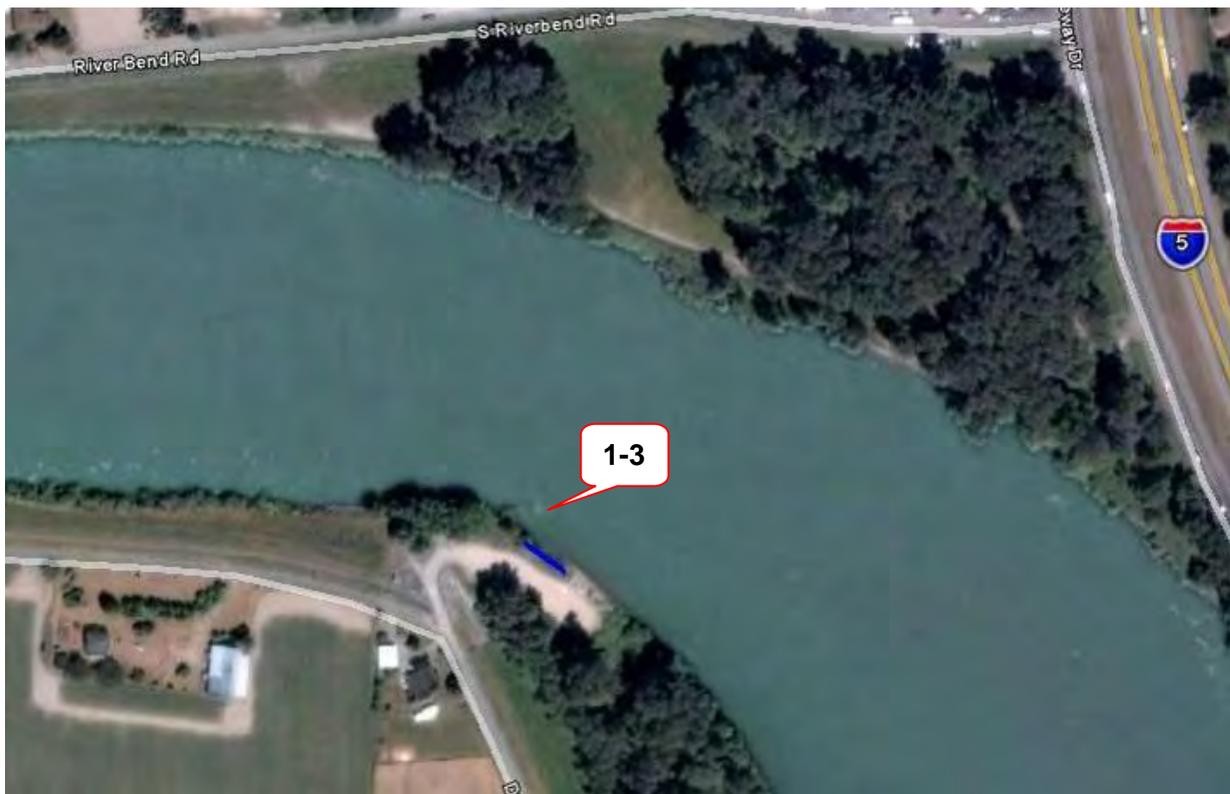
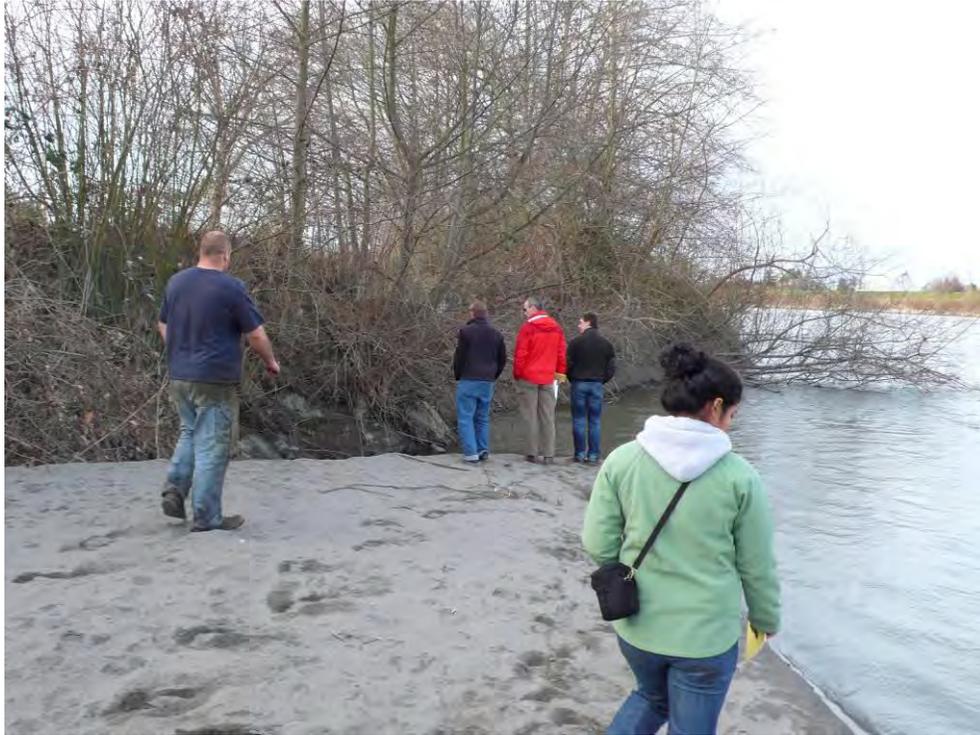
Figure 6: Site 1-3 Length of Repair: 75ft, 2011 Construction

Figure 7: Site 1-3 Before Construction, December 2009

- Site 1-3: This site is scheduled for repair in 2011. The damaged section of levee is 75 LF long on an inside bend of the river, adjacent to an armored section. The downstream end of the armored area is experiencing erosion that could continue behind the armor and unravel the levee. Continued erosion would lead to levee failure and loss of access to Young's Bar. Engineers recommend that the repair include re-grading and armoring the slope to tie in the armored revetment to high ground. Vegetation that will be removed from the revetment face consists of a few alders four to eight inches dbh, with willows, blackberry, and dogwoods in the understory. Mitigation options included in the design for this repair include a double willow lift starting at OHW, anchored rootwads off the levee toe, and placement of soil and hydroseed over the top of the riverward face and the bench.

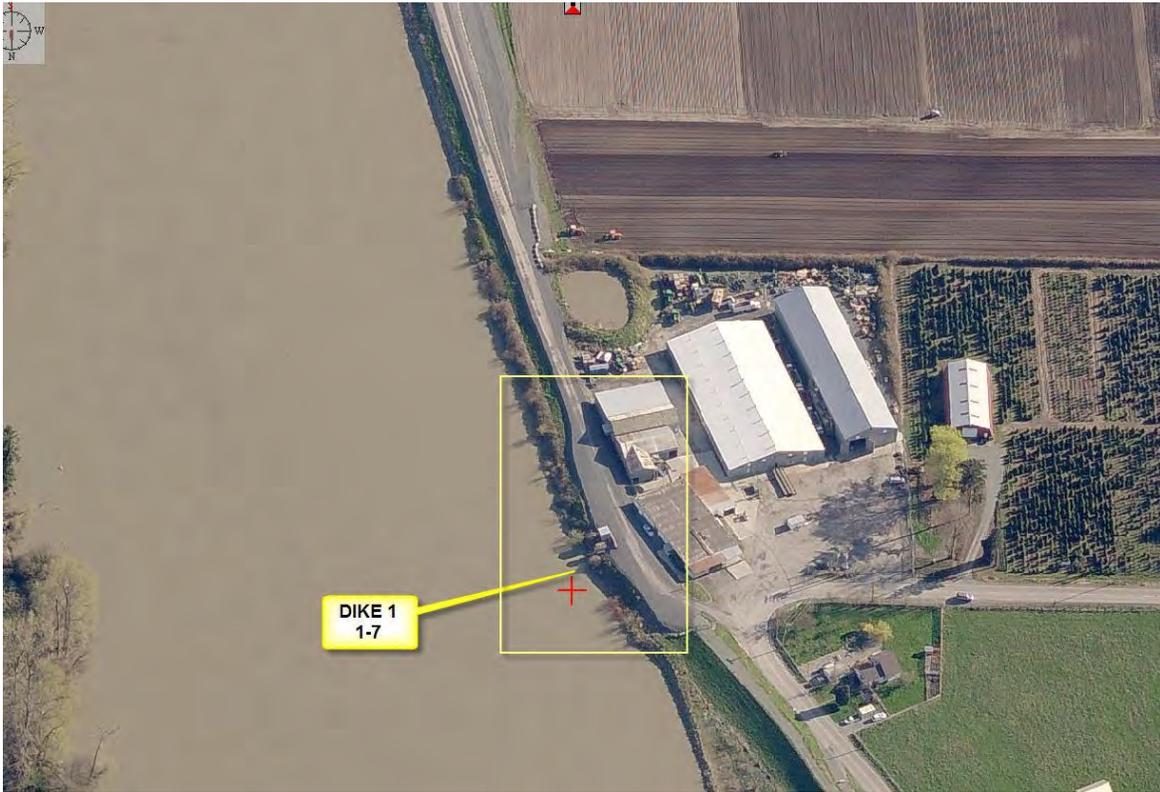
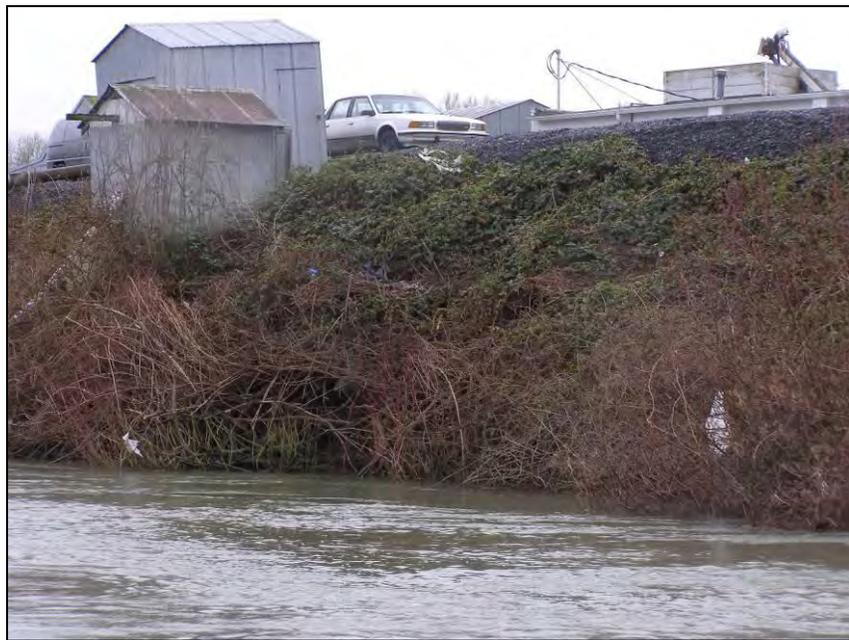
Figure 9: Site 1-7 Length of Repair: 257ft

Figure 10: Site 1-7 Before Construction

- Site 1-7: The Corps repaired 257 LF of levee in 2007. The riverward slope of 2H:1V was reshaped and armored with a three-foot blanket of class IV riprap. The piles at the toe were not disturbed. Vegetation removed from the revetment face consisted of one locust tree less than four inches dbh, five small brushy alders, and a dense blackberry understory. The mitigation option installed at this site in 2007 include one willow lift (400 willows) spanning 153 LF was installed 8.6 feet below the levee top, approximately six feet above OHW. In 2011, 100 LF of woody debris will be placed as further mitigation along the toe intertwined in the piles.

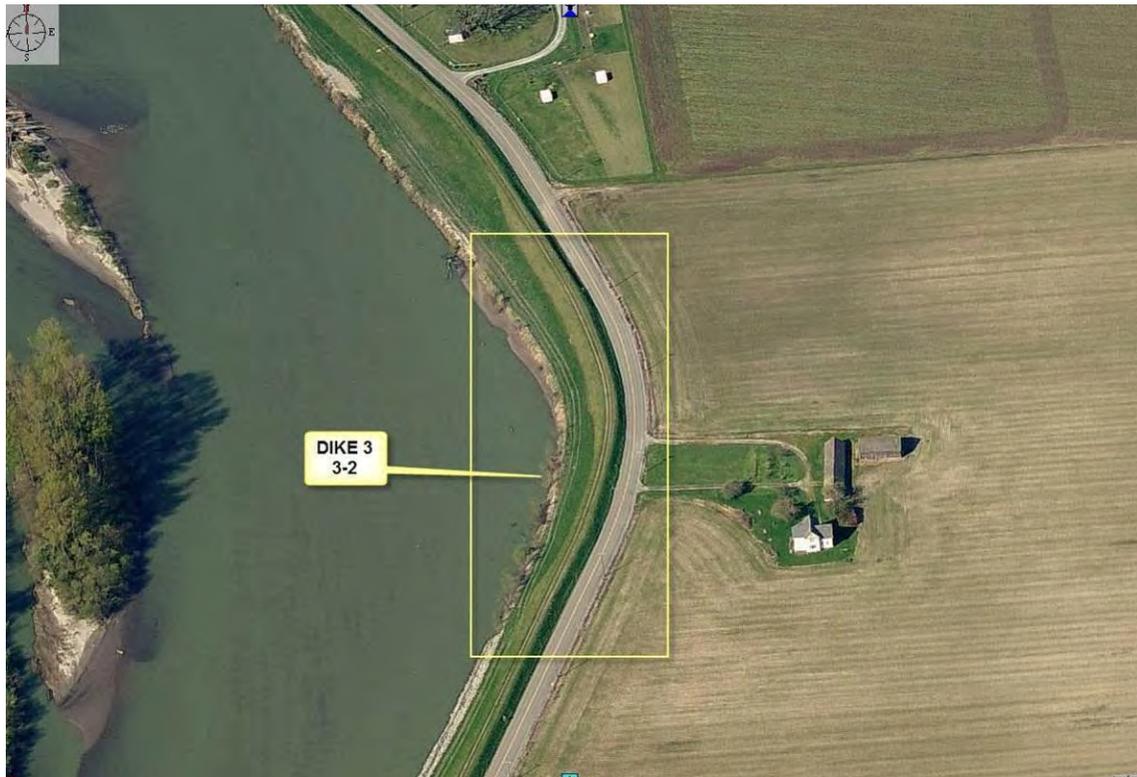
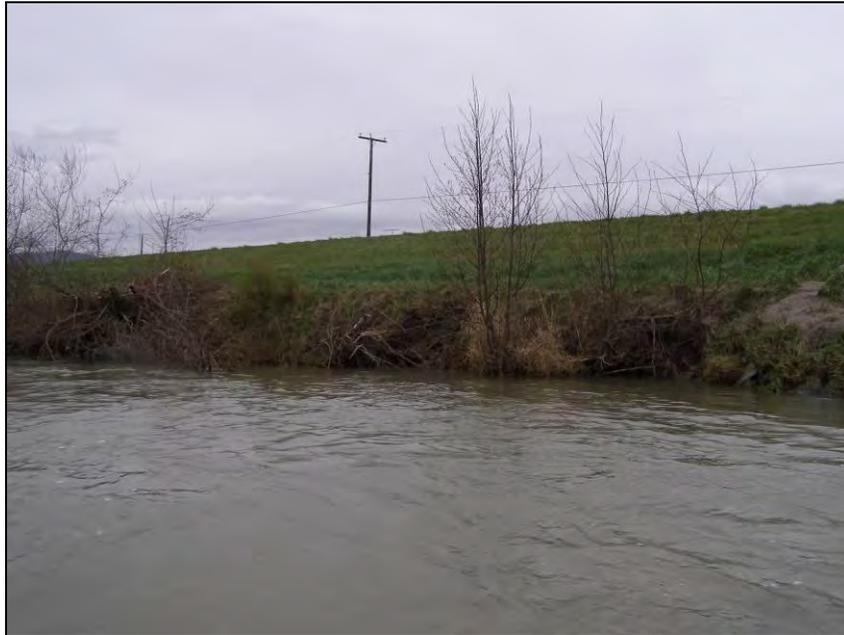
Figure 16: Site 3-2 Length of Repair: 436ft

Figure 17: Site 3-2 Before Construction

- Site 3-2: The Corps repaired 436 LF of levee in 2007 on the South Fork Skagit River. The riverward slope was reshaped, covered with spall rock, and armored with a three-foot blanket of class IV riprap. The levee crown was topped with crushed gravel, providing a driving surface. Vegetation removed from the site was grass, blackberries, and seven alders smaller than four inches dbh that were growing along the river. Mitigation at this site included one willow lift (~238 willows) installed throughout the project area. The willow lift elevation changes through the repair area with 391 LF at 3.6 feet below the levee crown (3 feet above OHW) and 45 LF at 6.6 feet below the levee crown (at OHW).

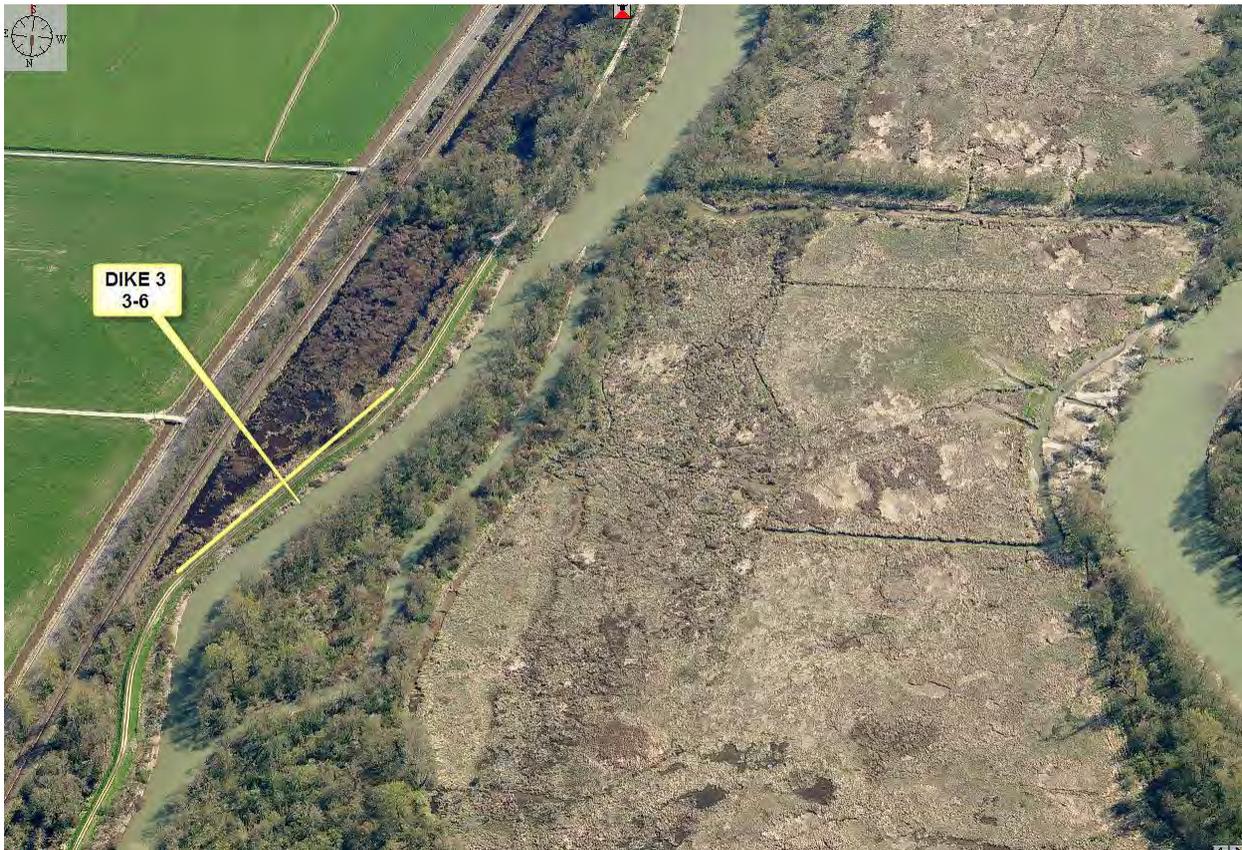
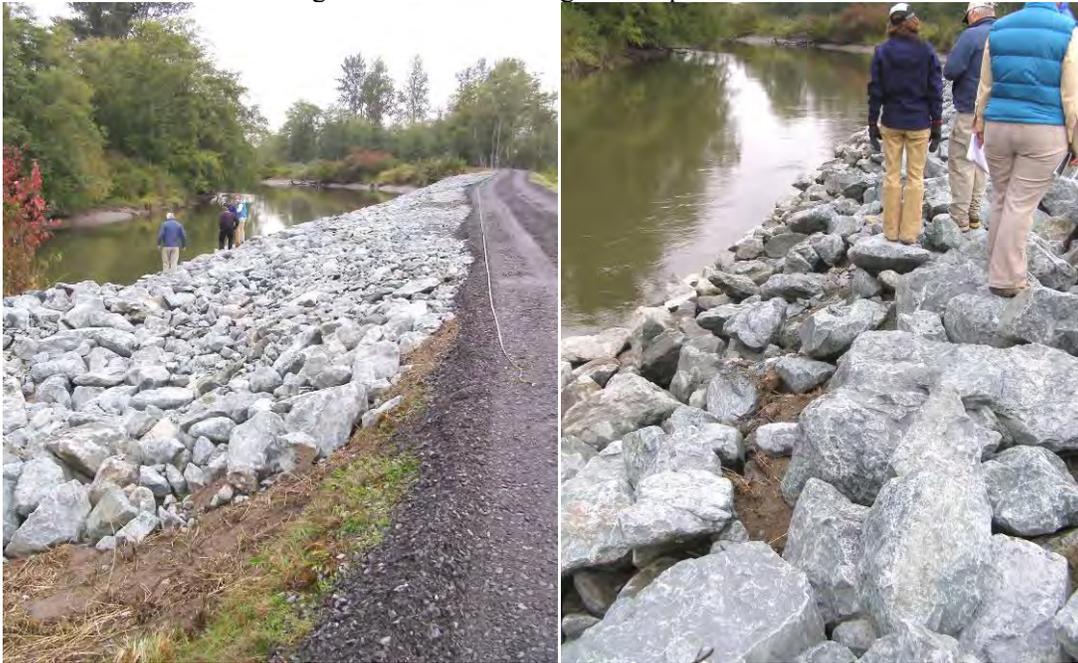
Figure 22: Site 3-6 Length of Repair: 525ft.

Figure 23: Site 3-6 Immediately After Construction, showing willow lift placement

- Site 3-6: This 2007 levee rehabilitation site is scheduled to be reworked in 2011. The 2007 repair was 375 LF. The riverward slope was reshaped to 3.5H:1V and armored with a three-foot blanket of class IV riprap. The section to be constructed in 2011 is 150 LF. Excess riprap was placed on the upper slope during the 2007 construction season to prevent erosion during a flood, but the weight increased the load on the slope. This can cause rotational failure of the levee. The excess rock will be excavated and reused on the downstream end of the site to tie the levee into the bank. A spall layer will be placed below the riprap, and the riprap will be replaced at the toe. Vegetation removed in 2007 consisted of Nootka rose, thimbleberry, salmonberry, shrubby willows, and blackberry on the riverward face that ranged from two to ten feet tall. Similar vegetation will be removed by the 2011 repair. The rootwads removed from within the levee during 2007 construction were placed onto the riverward face of the levee post-construction, shading the rock, increasing organic inputs to the river, and diversifying the bank line. Any rootwads removed for the 2011 repair will be staged during construction and placed on the levee face post-construction. The mitigation option installed in 2007 included one willow lift (~800 willows) at 10.2 feet below the levee top, at approximately 0.5 foot above OHW. Further mitigation options to be installed in 2011 will include a double willow lift and placement of anchored logs with rootwads throughout the full 3-6 repair site (525 LF). The riverward face above the willow lifts will be covered with soil and seeded with native grasses.

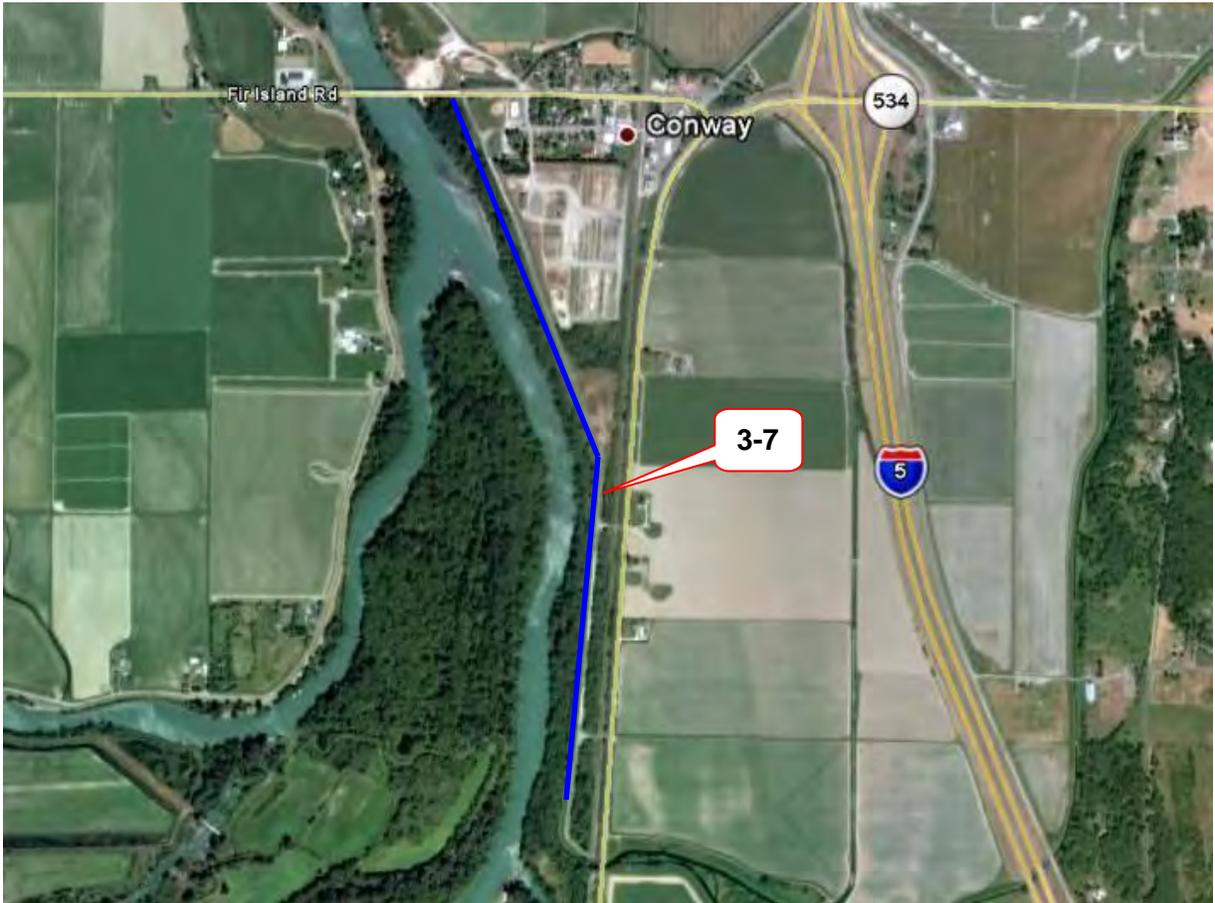
Figure 25: Site 3-7 Length of Repair: 6110ft, All work was along the backslope of the levee.

- Site 3-7: This 2007 repair site had no in-water or riverward work. The repair was 6,110 LF on the grassy backside of the levee. The Corps removed a layer of clay from the backslope and replaced it with soil and spalls. The disturbed area was hydroseeded after construction. No mitigation was required at this site as the work was limited to the backside of the levee.

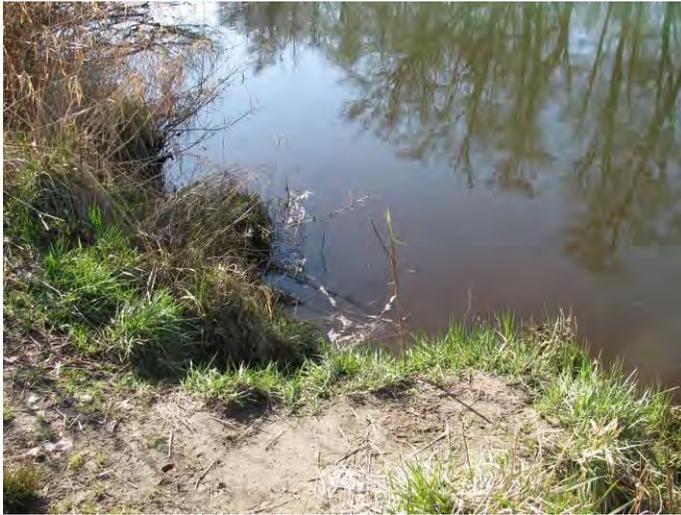
Figure 26: Site 3-8 Length of Repair: 225ft, work will remove brush on riverward side of levee, but will not impact the overstory trees behind the levee, as shown here.

- Site 3-8: This site will be constructed in 2011. This site is an un-armored earthen levee segment along Tom Moore Slough and requires 225 LF of repair due to an over-steepened bank. It is adjacent to the 2007 repair at site 3-5. The landward side of the levee is a forested wetland. Vegetation to be removed includes grasses, blackberry, Nootka rose, red osier dogwood, multiple willow clumps, and alders. The riverward slope will be reshaped to 2H:1V, covered with spall rock, and a three-foot blanket of class IV riprap. The levee crown will be topped with crushed gravel to create a driving surface for inspections. Construction will not disturb the landward slope or wetland. Several mitigation options will be installed at this site. Any rootwads removed for the 2011 repair will be staged during construction and placed on the levee face post-construction. A

double willow lift will be installed with the lowest lift at OHW. Anchored logs with attached rootwads will be placed along the toe of the repair to replace lost fish habitat. The riverward face above the willow lifts will be covered with soil and seeded with native grasses.

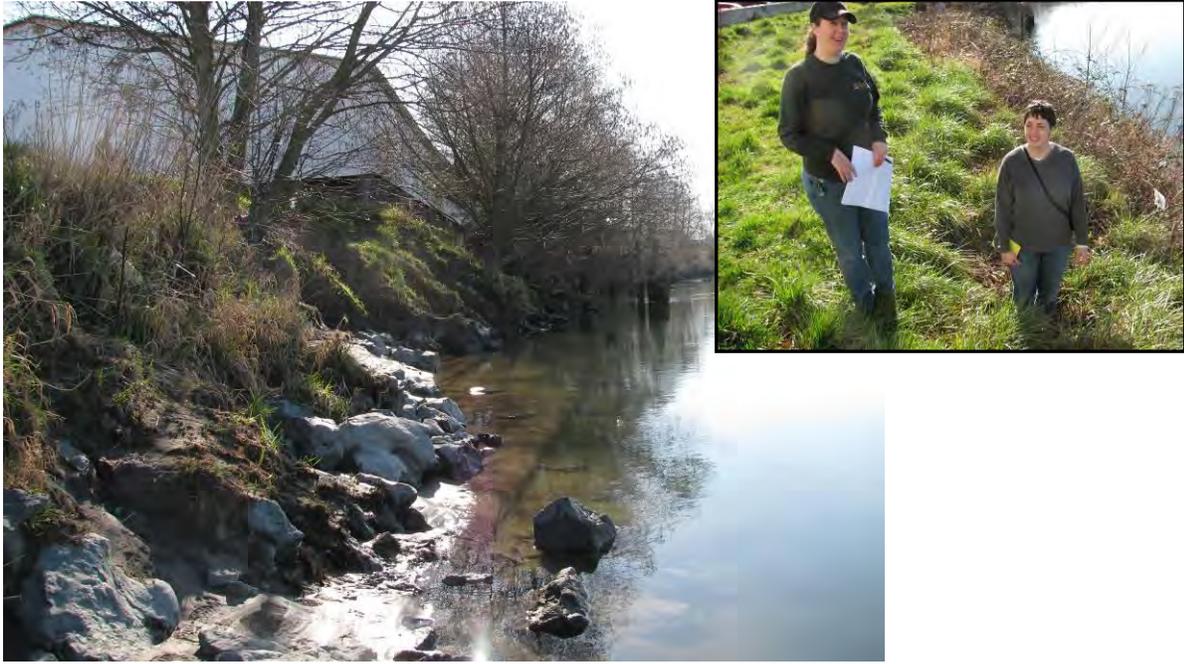
Figure 27: Site 3-11 Length of Repair: 200ft, smaller photo shows one of the sink holes at the site.

- Site 3-11: This site will be constructed in 2011. The site includes 200 LF of repair due to an over-steepened bank, loss of face rock, and several large sinkholes. This site is within the City of Mount Vernon. Vegetation to be removed includes blackberry, alders, and several young dogwood plantings at the top of the levee. The riverward slope will be reshaped to 2H:1V and covered with spall rock and a three-foot blanket of class IV riprap. Two mitigation options will be implemented at this site including a triple willow lift installed with the lowest lift at OHW, and the riverward bank above the willow lifts will be covered in dirt and hydroseeded following construction.

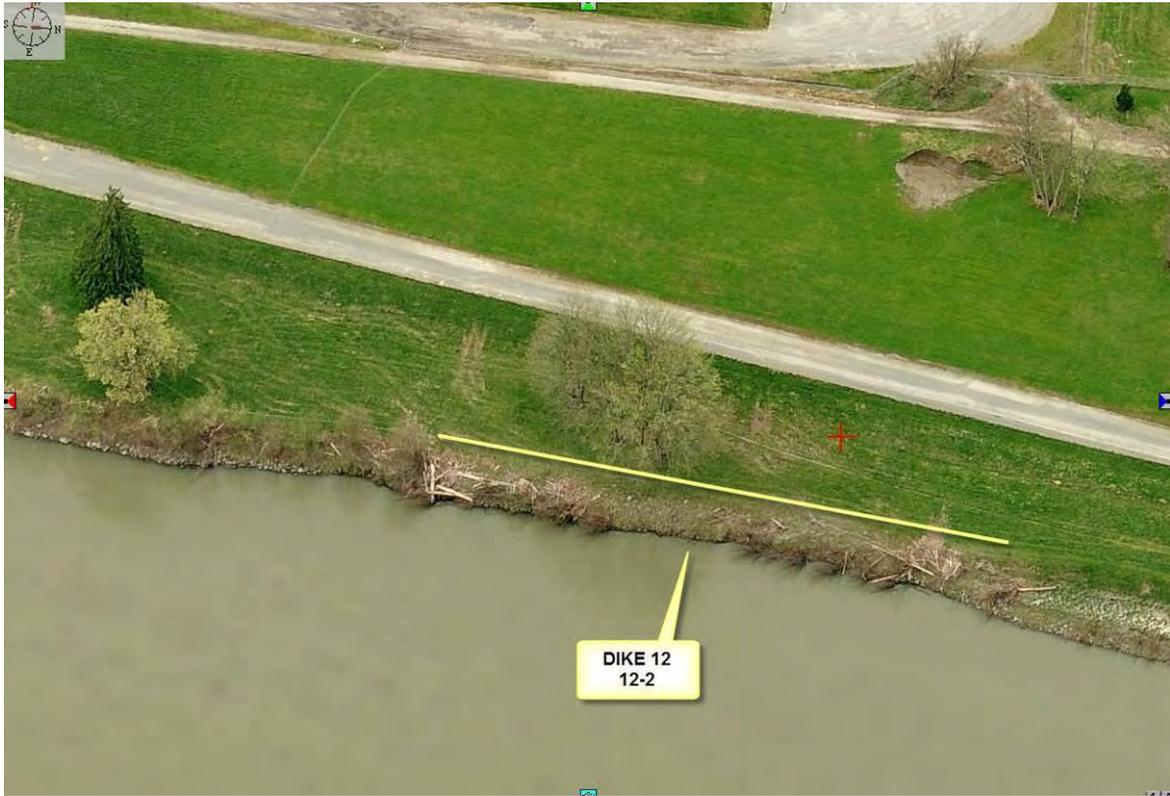
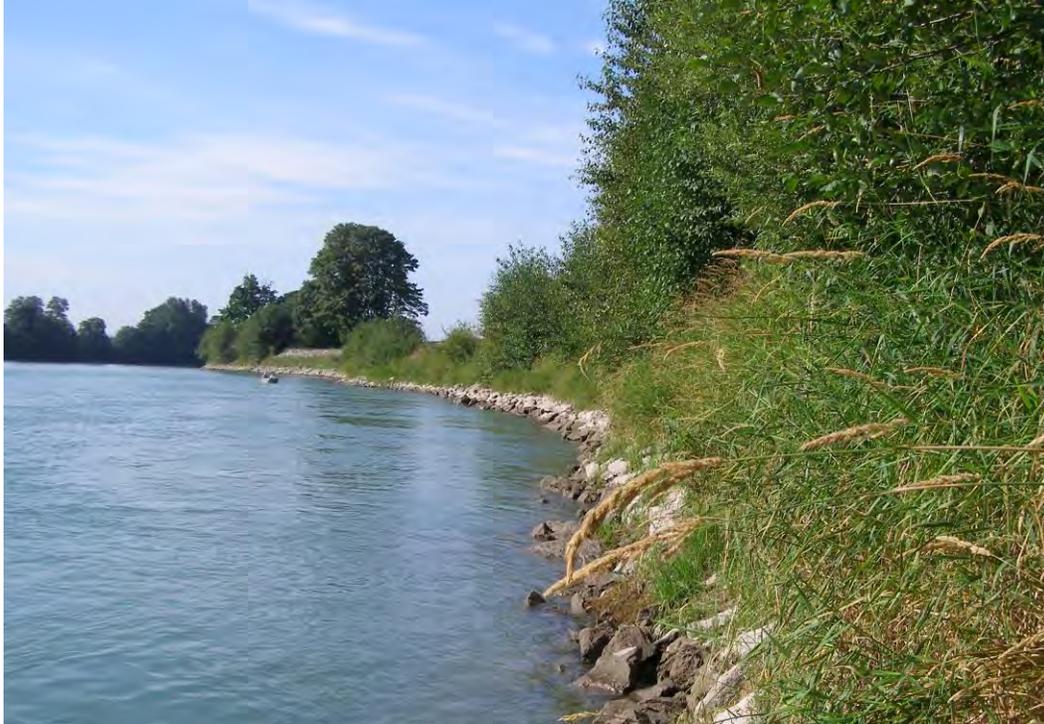
Figure 29: Site 12-2 Length of Repair: 261ft

Figure 30: Site 12-2 (in distance) August 2009 Post Construction, showing willow growth.

- Site 12-2: The Corps repaired 261 LF of levee in 2007. The riverward slope was reshaped to 2H:1V and armored with a three-foot blanket of class IV riprap, extending from OHW to the top of the bank. A spall blanket was extended 33 feet landward from the top of bank. Spalls and gravel were placed on the levee crown and access ramps to provide a driving surface for maintenance and inspection. Lost vegetation consisted of one row of short scrubby willows mixed with grass along the river. Four large cottonwoods stand near the repair. These trees were retained during the repair, though the roots may have sustained some damage. A total of 275 willows were installed as mitigation option in two lifts, one at 11 feet below the levee top and the other 14 feet below the levee top (at OHW).

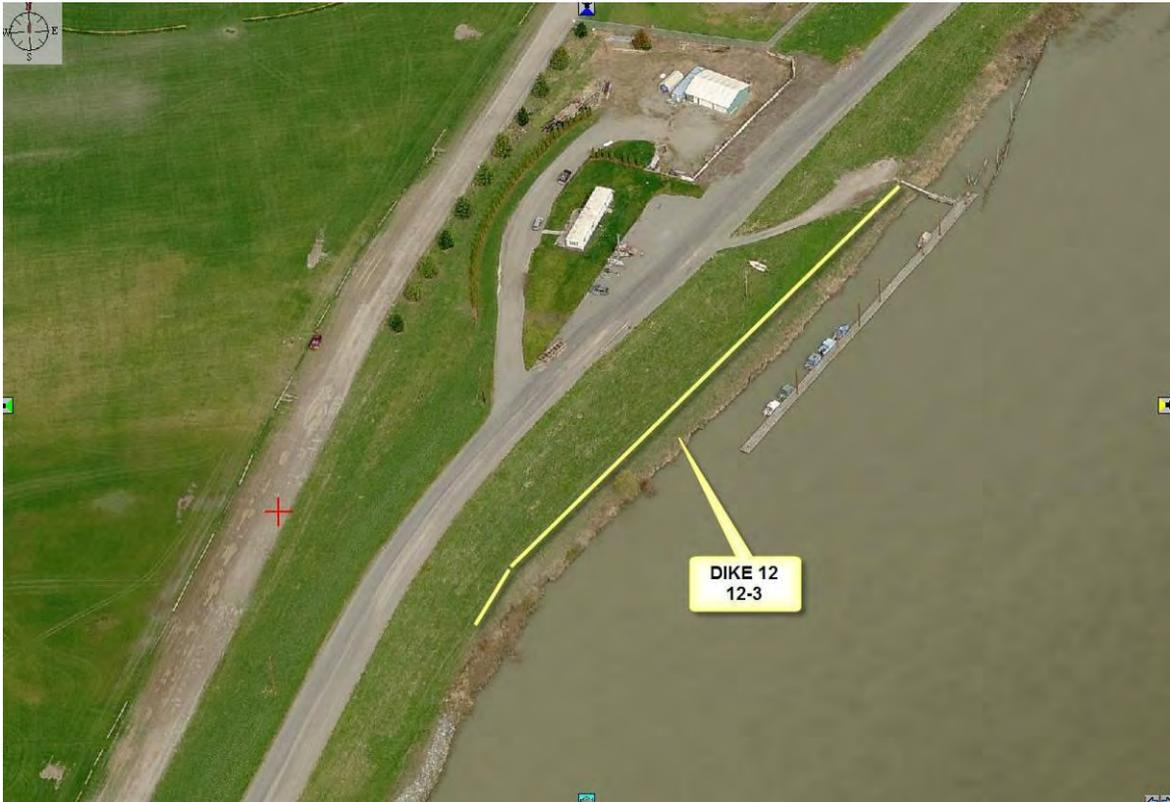
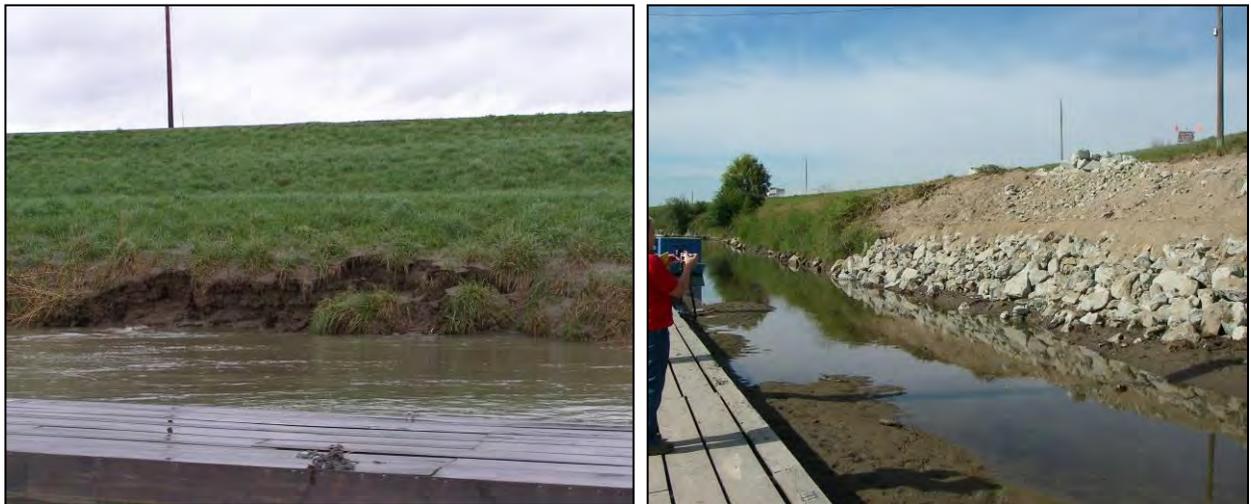
Figure 31: Site 12-3 Length of Repair: 511.5ft

Figure 32: Site 12-3. Before and after construction

- Site 12-3: The Corps repaired 512 LF of levee in 2007. The riverward slope was reshaped to 2H:1V and armored with a three-foot blanket of class IV riprap. A spall blanket was extended 29 feet landward from the top of bank. Removed vegetation consisted of mostly grass with several small native willows less than three feet tall. One corkscrew willow was retained through construction. Mitigation options installed in 2007 at this site include two willow lifts beginning at OHW, specifically 8.5 and 6.5 feet below the levee top with 1,845 willows. In 2011, further

mitigation will be installed including placing soil and hydroseed to the top of the bank above the willow lifts and planting three rows of native shrubs.

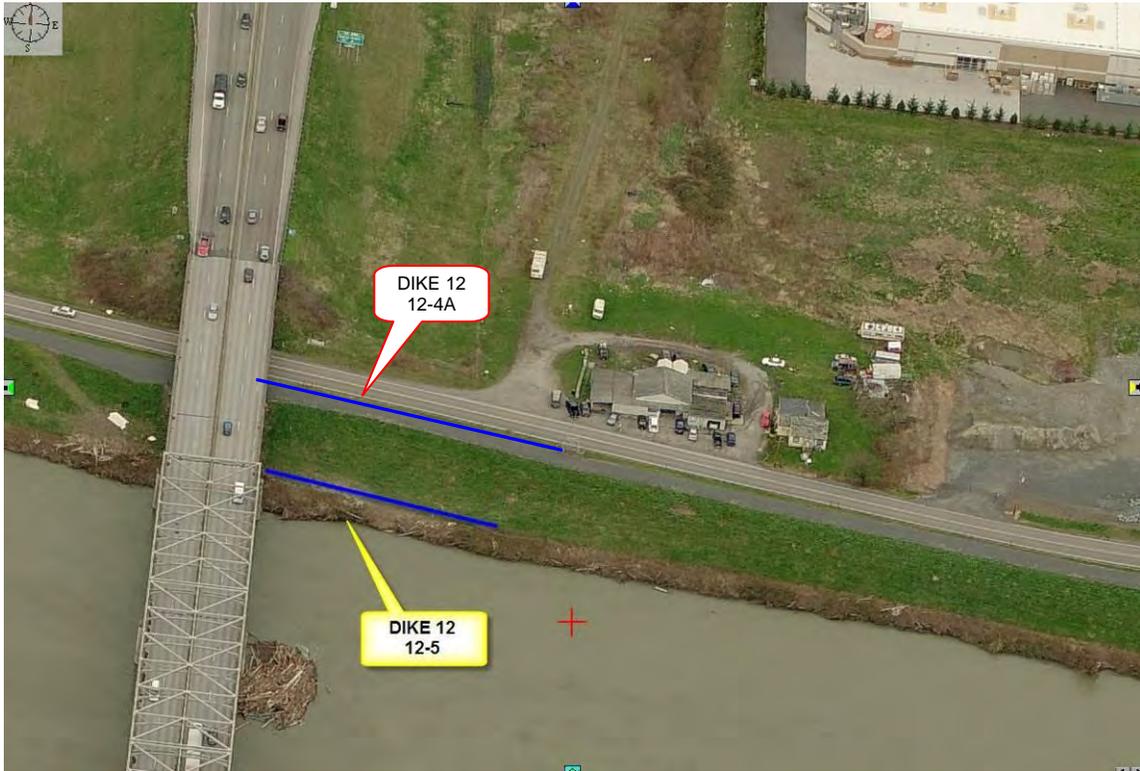
Figure 33: Site 12-5 Length of Repair: 236ft and Site 12-4a Length of Repair: 250ft

- Site 12-4A: This site was deferred from the 2007 construction season. The repair spans 250 LF of levee along Whitmarsh Road. The landward side of the levee is experiencing sloughing and material movement below Whitmarsh Road, which appear to be the effects of seepage. Ground-penetrating radar has shown an anomaly below the levee that may be causing or exacerbating the issue. If left unrepaired, the levee could fail, potentially resulting in the flooding of Burlington. The site is within the three-bridge corridor (a confined river section containing bridges for I-5, Riverside Drive, and Burlington Northern Railroad). The levee will be excavated to below the level of the adjacent road to explore the anomaly, and will be rebuilt in compacted lifts. The repair will not include any in-water work but will include work on the riverward side of the levee behind the bench. The site is a mowed grassy area. The disturbed area will be hydroseeded after construction and will quickly return to pre-repair habitat condition. Hydroseeding is the only mitigation option installed at this site.

- Site 12-5: The Corps repaired 236 LF of riverward levee in 2007. The riverward slope was reshaped to 2H:1V and armored with a three foot blanket of class IV riprap. A spall blanket was extended approximately 44 feet landward from the top of the bank. Spalls and gravel were placed on the levee crown and access ramps were created to provide a driving surface. Cleared vegetation consisted of short blackberry bushes, grasses, and one alder.

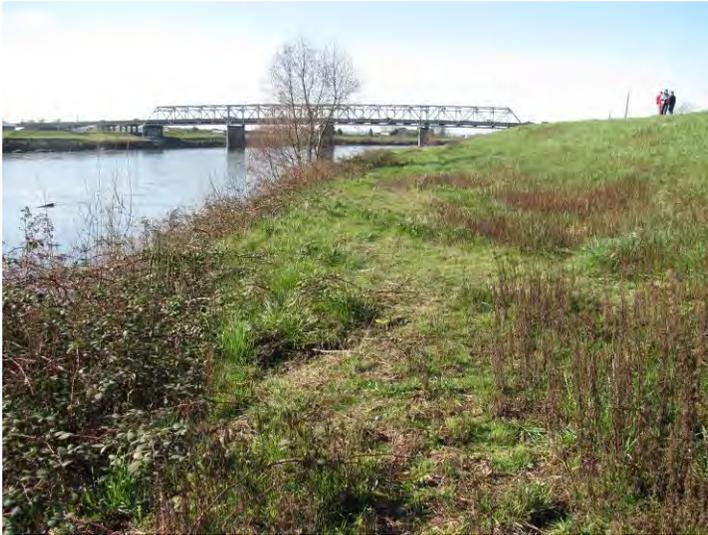
Figure 34: Site 12-4b Length of Repair: 970ft

- Site 12-4B: This site will be constructed in 2011. The site includes 970 LF of riverward repair due to loss of face rock. The toe rock appears to be intact, so in-water work should be minimal. Vegetation to be removed includes grass and blackberry with some bushy willows. The riverward slope will be reshaped to 2H:1V, spall rock will be placed, and a three-foot blanket of class IV riprap will be placed. As mitigation a triple willow lift will be installed with the lowest lift at OHW and the riverward bank above the willow lifts will be covered in dirt and hydroseeded.

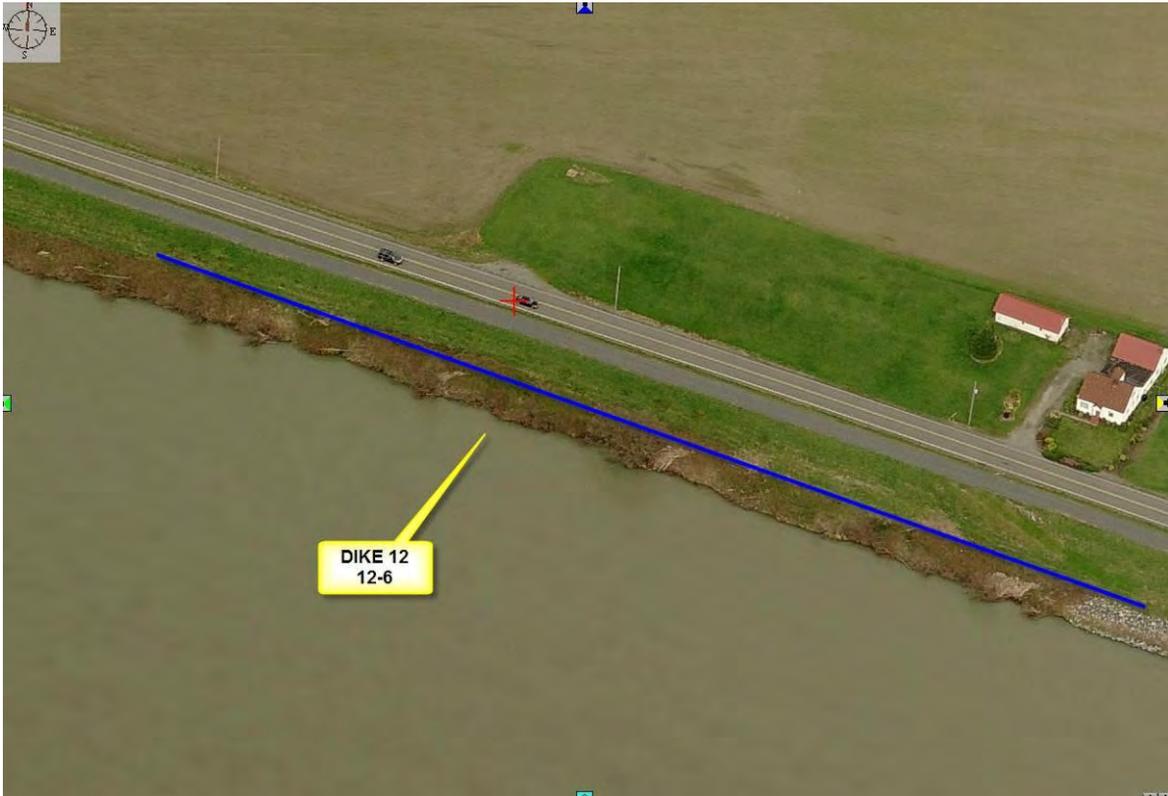
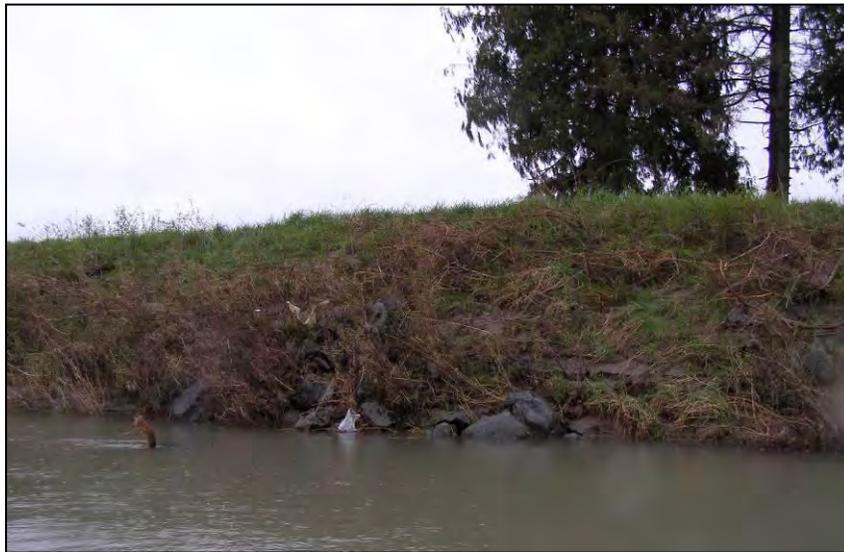
Figure 35: Site 12-6 Length of Repair: 651ft

Figure 36: Site 12-6 Before Construction

- Site 12-6: The Corps completed initial repairs in 2007 with a rework expected in 2011. In 2007, 651 LF of levee was repaired in two separate sections, with a 160 LF span between the two constructed areas. This 160 LF area will be constructed in 2011. The riverward slope was reshaped to 1.5H:1V and armored with a three-foot blanket of class IV riprap. The spall blanket extended approximately 21.5 feet landward from the top of the bank. Cleared vegetation consisted of brushy alders and willows ranging from eight to 15 feet tall that covered 50-70% of the shoreline. Blackberries dominated the groundcover. Mitigation options installed in 2007 included two willow lifts beginning at OHW, 7.6 and 11.6 LF below the levee top with 220 willows. The 2011 construction will include further mitigation. A double willow lift will be installed beginning at OHW or lower, similar to those installed in 2007. The riverward bank above the willow lifts will be covered in dirt and hydroseeded throughout the entire 12-6 repair site of 811 feet. Two rows of upper bank plantings will be planted along 250 feet of the site.

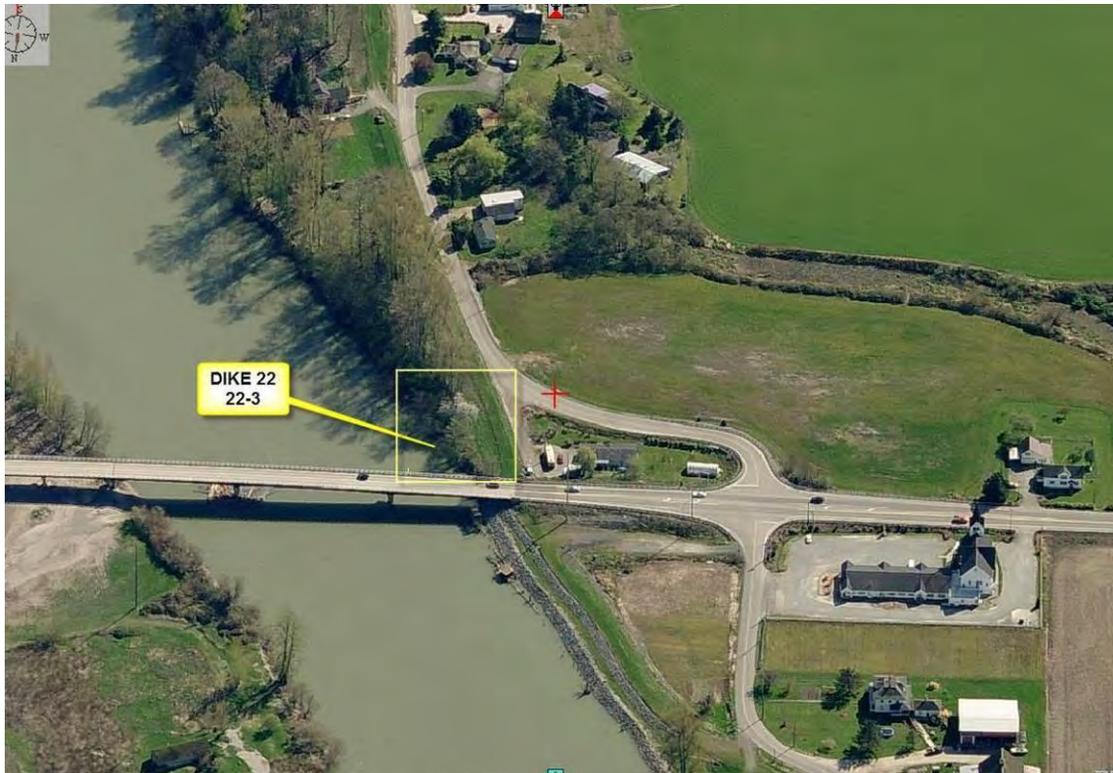
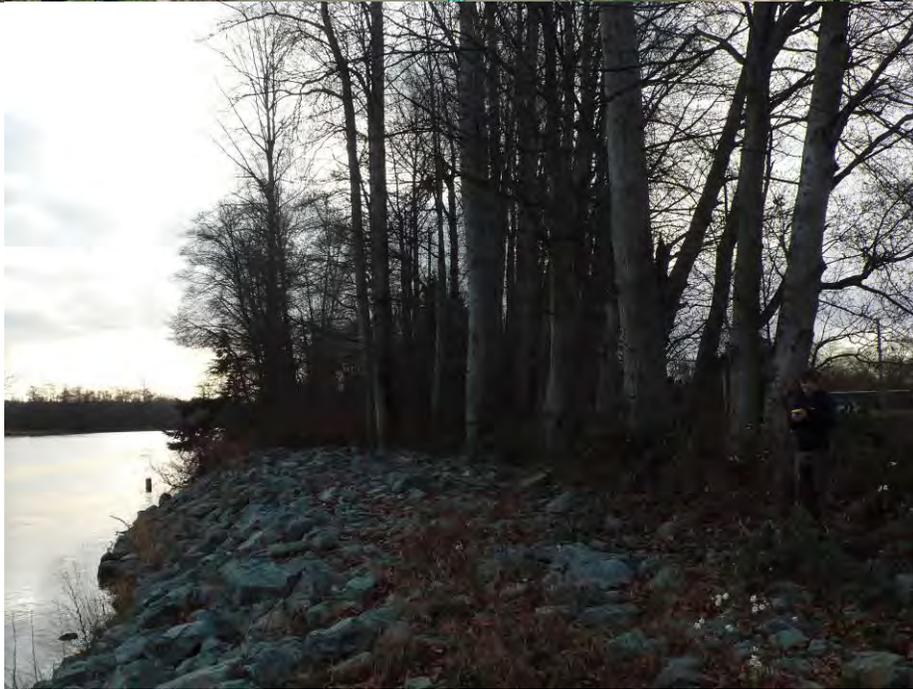
Figure 64: Site 22-3 Length of Repair: 273ft done in 2007, 110 ft to be done in 2011.
Second photo shows site in December 2009.

- Site 22-3: This 2007 levee rehabilitation site is scheduled to be reworked in 2011. The 2007 repair spanned approximately 273 LF of levee. The riverward slope was reshaped to 2H:1V and armored with a three-foot blanket of class IV riprap. The spall blanket was extended landward from the top of the bank. Spalls and gravel were placed to provide a driving surface on the levee crown and access ramps. The section scheduled to be reworked in 2011 is 110 LF. Excess rock was placed at this site during the 2007 repair, staged for this construction effort. The overburden will be removed and used to tie in the downstream end of the 2007 work. Cleared vegetation in 2007 consisted of 75 LF of predominantly blackberry and approximately 200 LF of mature riparian vegetation (cottonwoods and alders) with a dense understory. The 2011 work will remove 110 LF of mature riparian vegetation (cottonwoods and alders). In 2007, mitigation at the site included installation of one willow lift at 0.5 foot above OHW; 500 willows were planted. Mitigation in 2011 will include a double willow lift and two rows of native shrubs planted at the top of the riverward bank throughout the entire project reach (383 LF). The 2011 construction area as well as the 2007 repair will be covered with soil and hydroseeded.

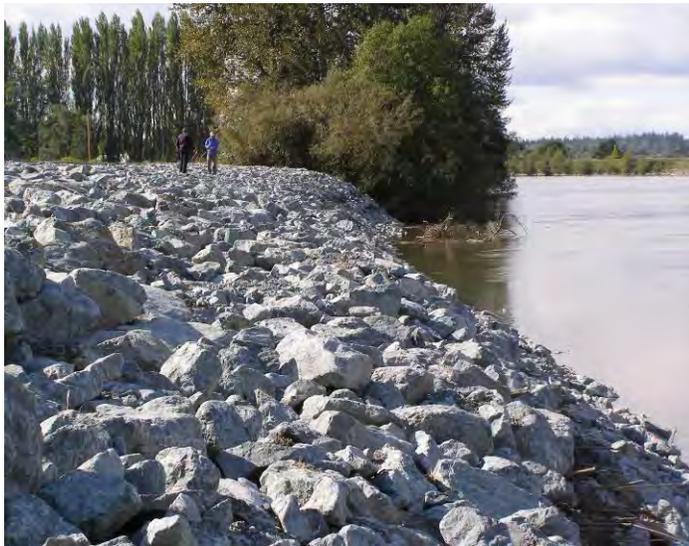
Figure 70: Site 22-8 immediately after construction in 2007 and in December 2009 showing willow growth.

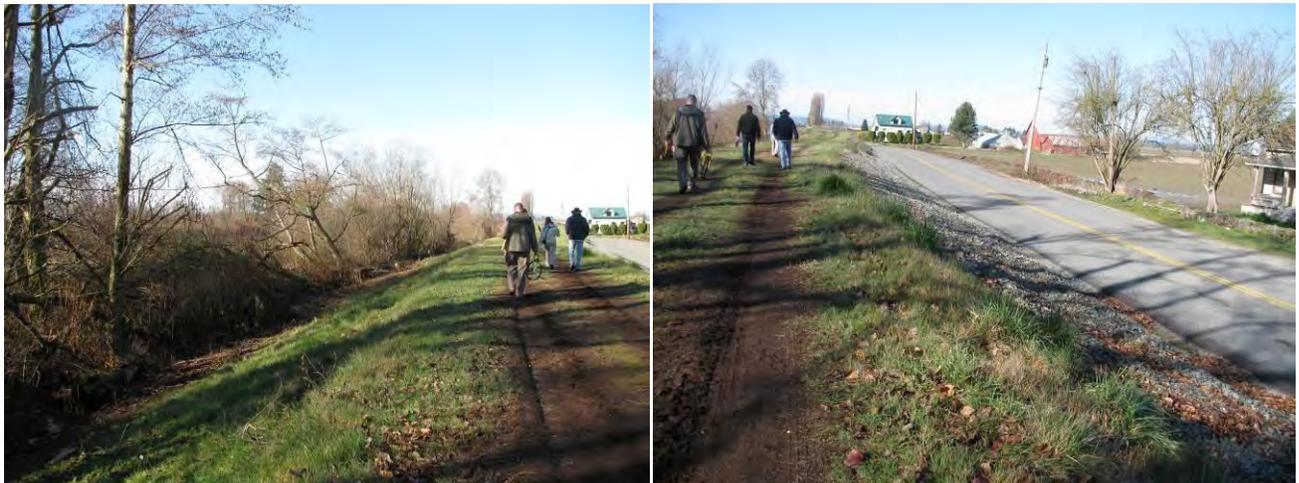
Figure 74: Site 22-11 Length of Repair: 800ft, this site will be repaired by installing a keyway, no riverward work is anticipated. No mitigation required.
