ENVIRONMENTAL ASSESSMENT

St. Maries Federally Authorized Levee Rehabilitation of Flood Control Works Benewah County, Idaho

September 2012

**US Army Corps
of Engineers®**
Seattle District

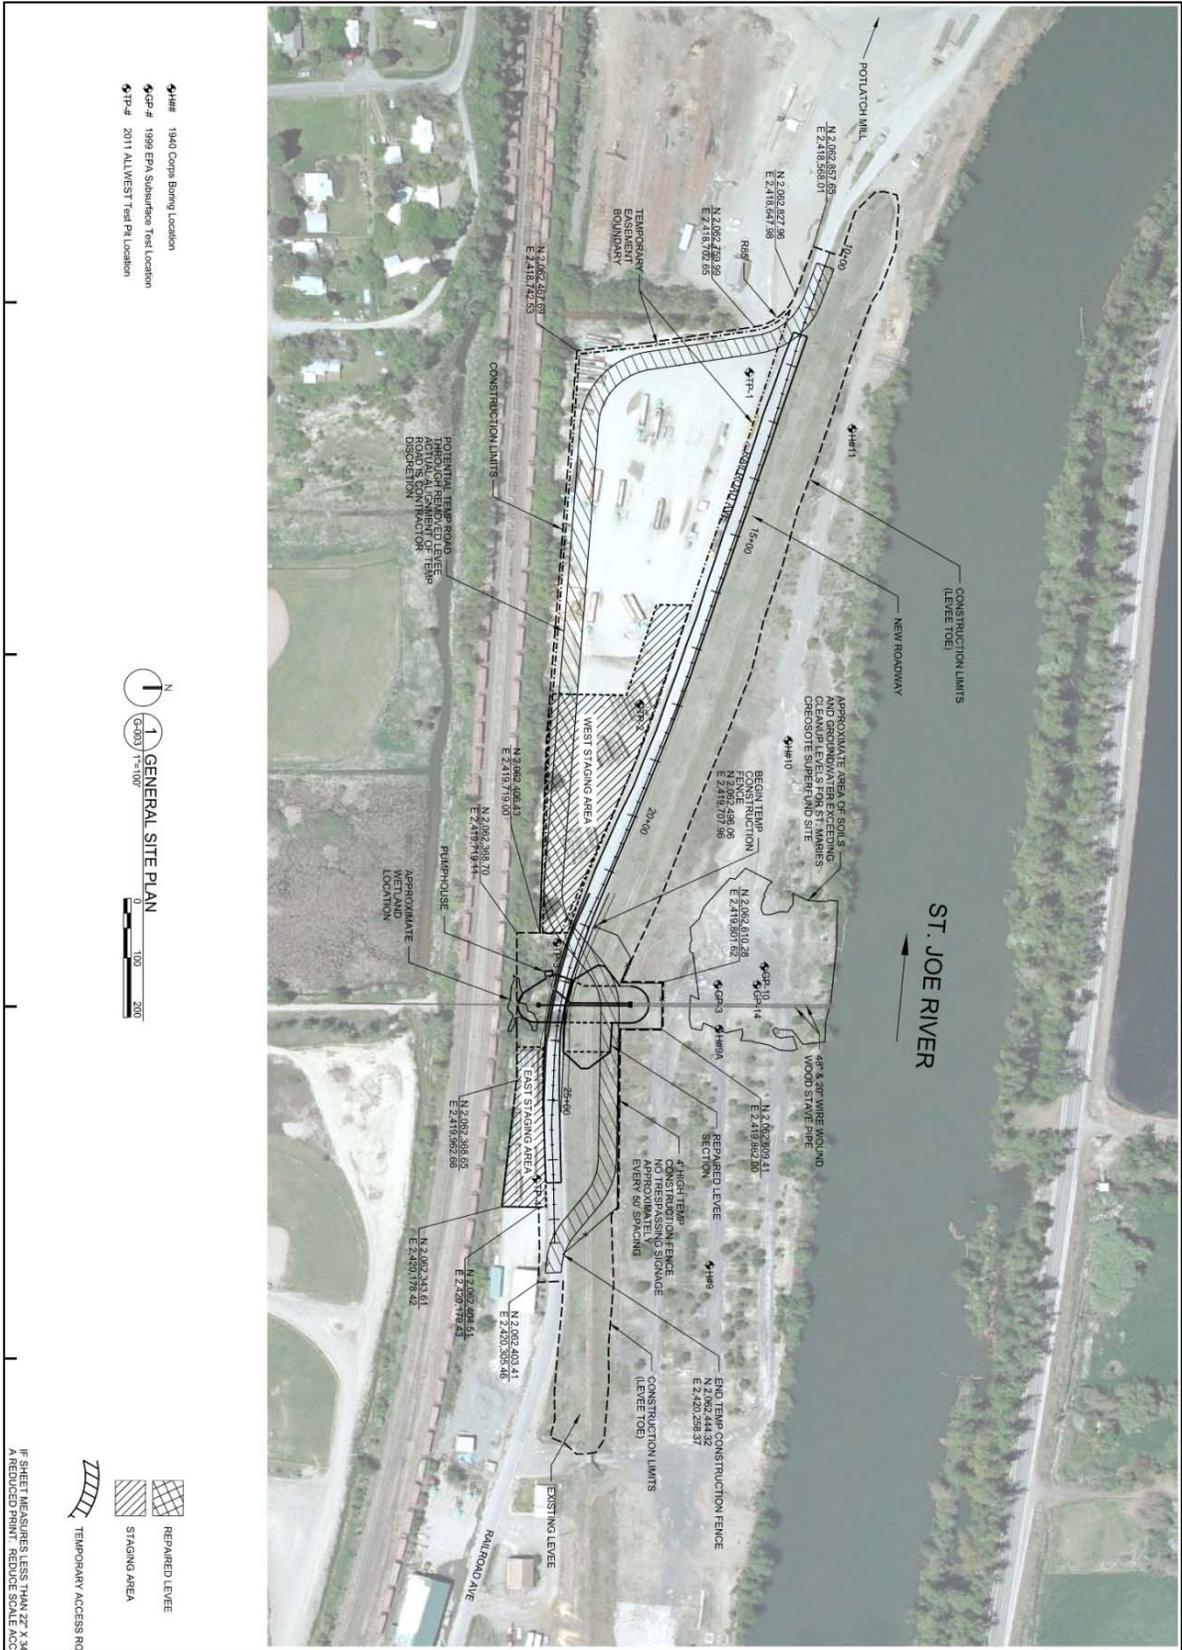
Figure 3. Plan view of Site 1.

The recommended repair alternative for Site 1 (Figure 3) is the Seepage Berm alternative plus pipe replacement. This alternative includes constructing a 3-foot to 4-foot seepage berm by essentially raising Railroad Avenue. The berm would create an effective seepage control structure. The seepage berm would include a non-woven filter fabric and 2 feet minimum depth of 2-inch minus subbase. The berm would be capped with aggregate base course and finished with 4 inches of asphalt pavement. The landward toe will be located such that the project will not involve filling the adjacent wetland. The project would be transitioned to the existing roadway height for approximately 100 feet at each end of the seepage berm at a reasonable roadway grade. The total length of the project would be 1500 feet to include these transition areas. Also, the Mutch Creek diversion pipe and the 20" pump house outlet pipe would be replaced to correct any postulated deficiencies in the conduits. It is theorized that, when the flap gates are closed on these pipes, pressure develops and any weak points in the pipes leak, creating pressure in the ground water and causing piping damage to the levee. The proposed repair would

entail replacing approximately 150 feet of the 48-inch Mutch Creek diversion pipe with 48-inch high-density polyethylene (HDPE) butt welded pipe and replacing approximately 120 feet of the 20-inch pump house outlet line with 20-inch HDPE butt welded pipe. Repair of the pipe through the levee, and rerouting of traffic during construction will require a portion of the levee, up to 500 feet, to be removed and rebuilt.

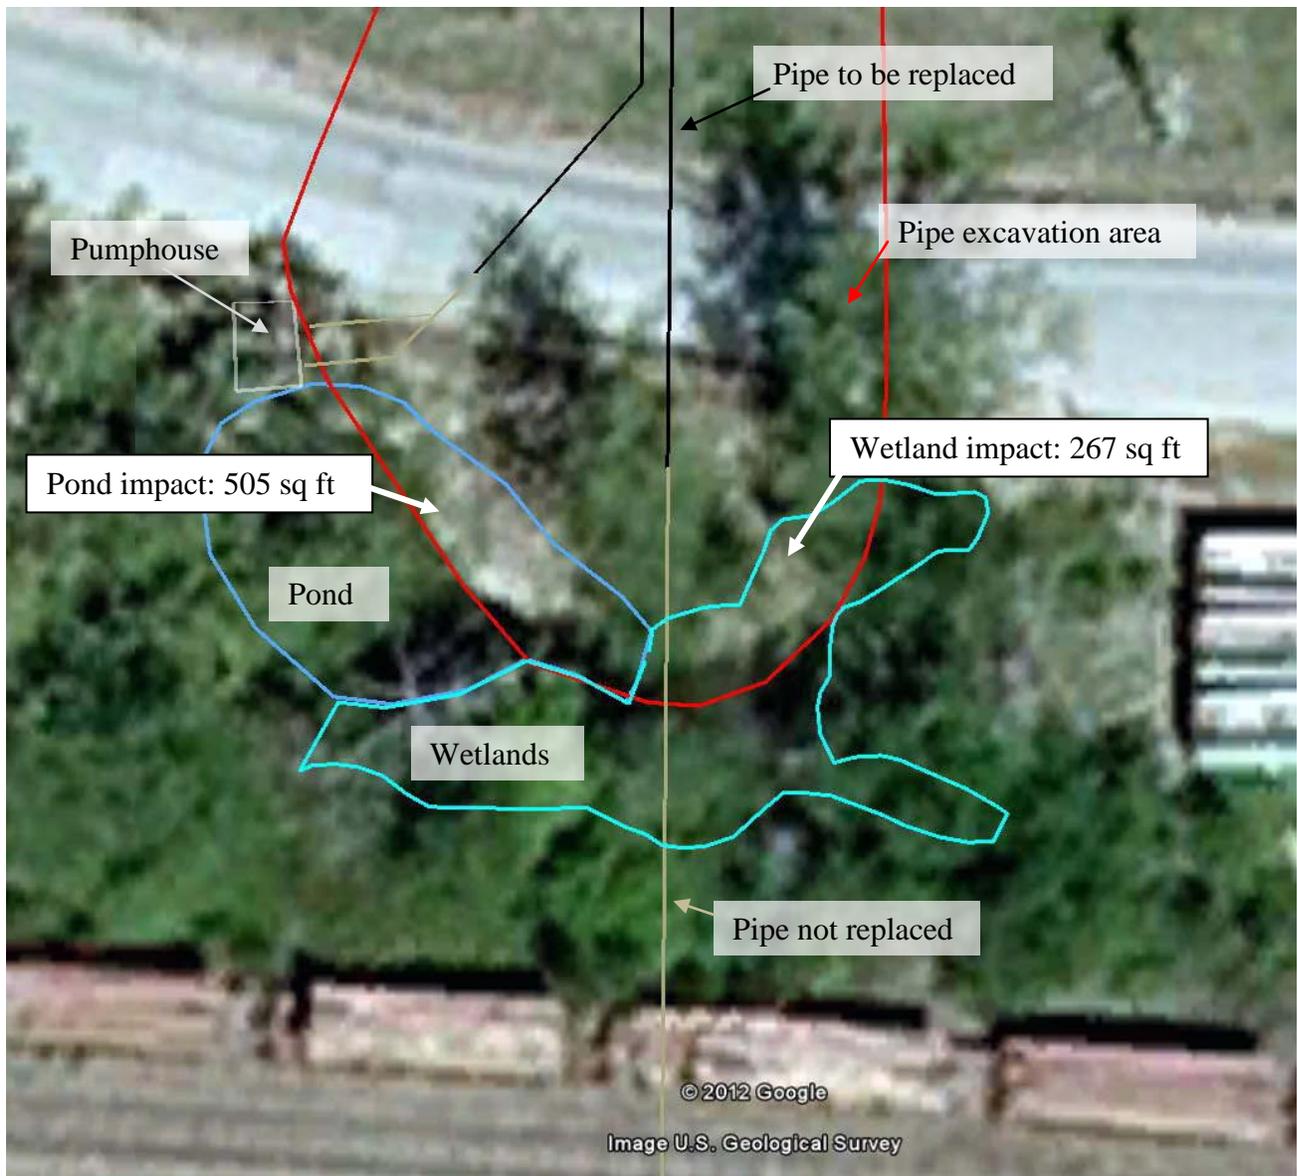
Figure 4. Wetland impact location at Site 1.

The seepage berm construction at Site 1 will avoid impacting the wetland and pond adjacent to the pump house; however, excavation for the pipe replacement will require temporary impacts of the wetland. Approximately 267 square feet of wetlands and 505 square feet of pond would be impacted (Figure 4). Construction would involve removal of vegetation, including up to 18 black cottonwood (*Populus trichocarpa*) ranging in size from 1 to 18 inches diameter at breast height (average 7 inches DBH). Once the pipe replacement is complete, the elevations would be rebuilt to resemble the pre-construction slopes and hydroseeding would be done within the repair area. It is anticipated that nearby cottonwood trees will naturally recolonize the area quickly.

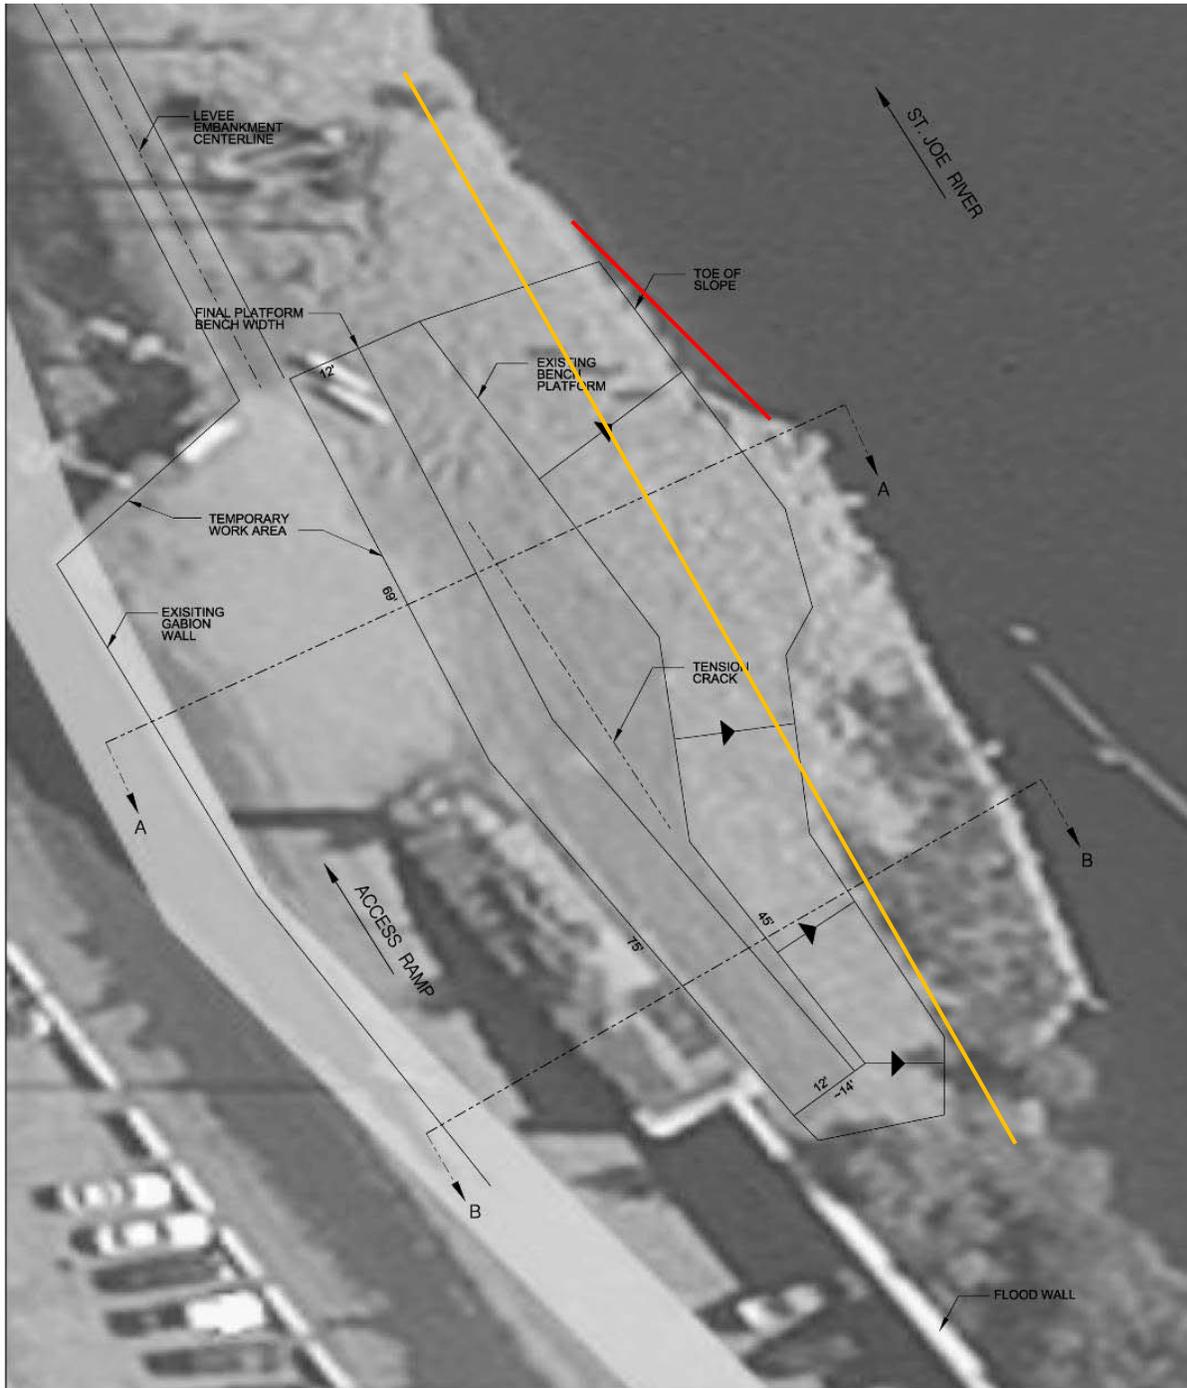
Figure 5. Plan view for Site 2. The orange line indicates the flood fight area, with red line indicating the portion of the flood fight in the water.

The repair proposed for 2012 at Site 2 (Figures 5 and 6) is the Repair in Kind, with some modification. The repair includes removing the overburden at this location to restore a stable riverward slope above ordinary high water. The tension crack occurred in material that was placed during the 2011 emergency repair. The tension crack is 60 feet long. It is on average 3

inches wide and 4 inches deep with a vertical displacement, meaning vertical distance from upper edge to lower edge, of 3 inches. At its widest point, the crack was measured at 7.5 inches wide with a vertical displacement of 8 inches. The total length of overburden removal is approximately 145 feet and would include excavation of the material above the waterline. No excavation would occur below the water. The working pad would be reduced to a 12-foot wide bench and the slopes would be re-graded to a more gradual slope to meet the new catch point.

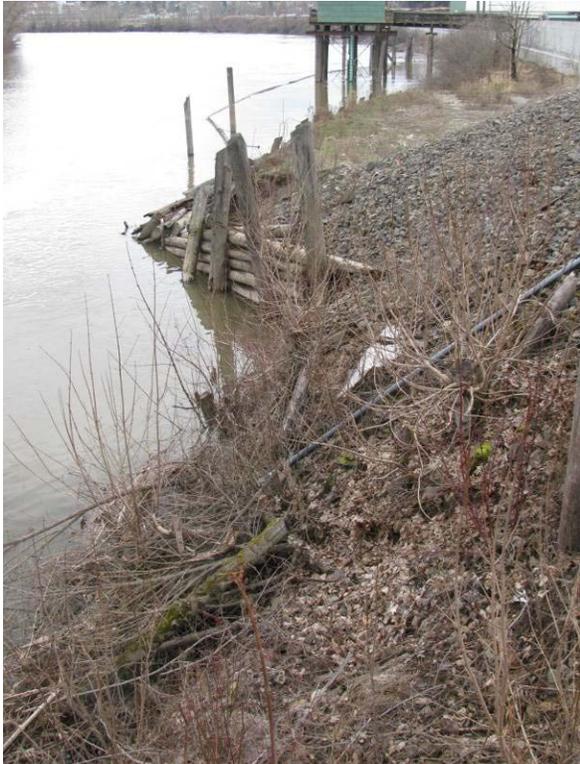
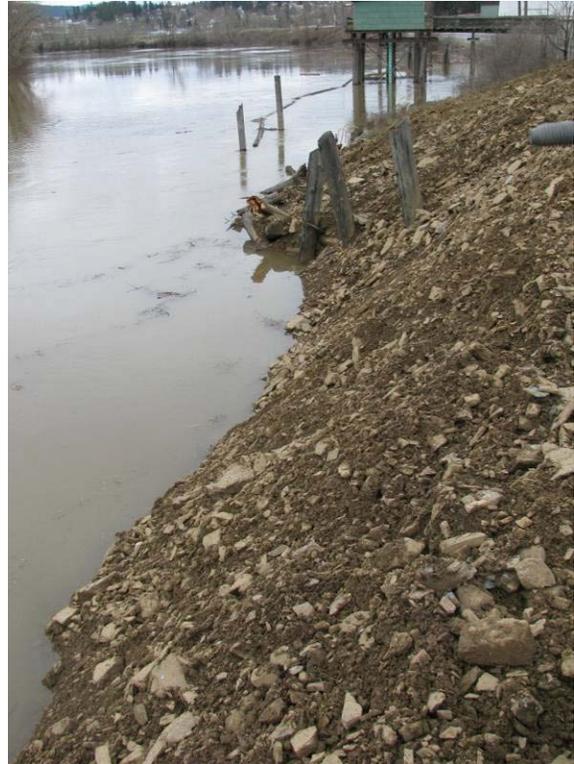
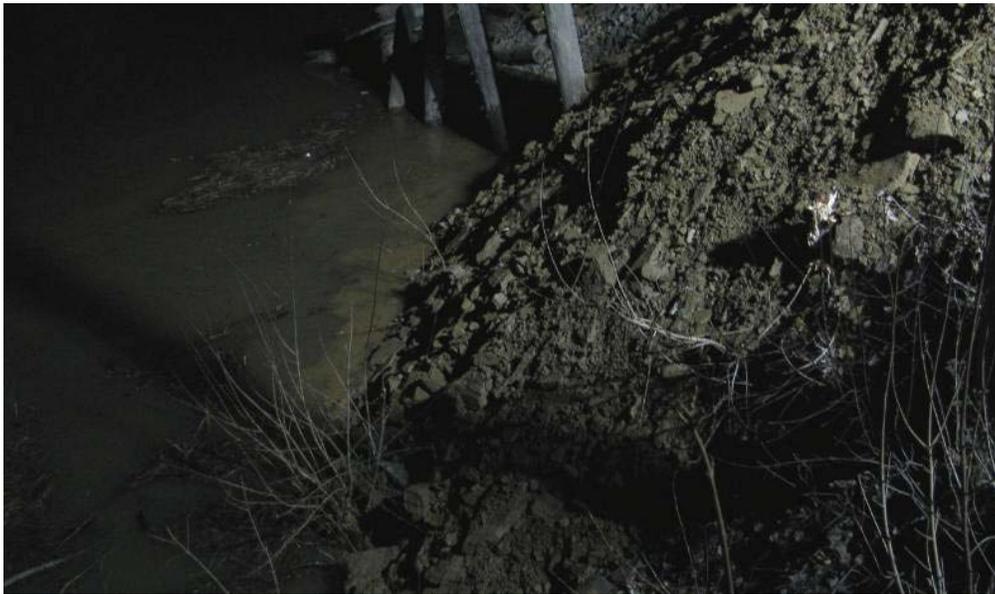
Site 2 before, after, and during the flood fight.

The first photo shows the vegetation and condition of the site prior to any work, the second shows the site after completion (showing inwater and out of water area) and the third shows the extent of turbidity visible during construction.

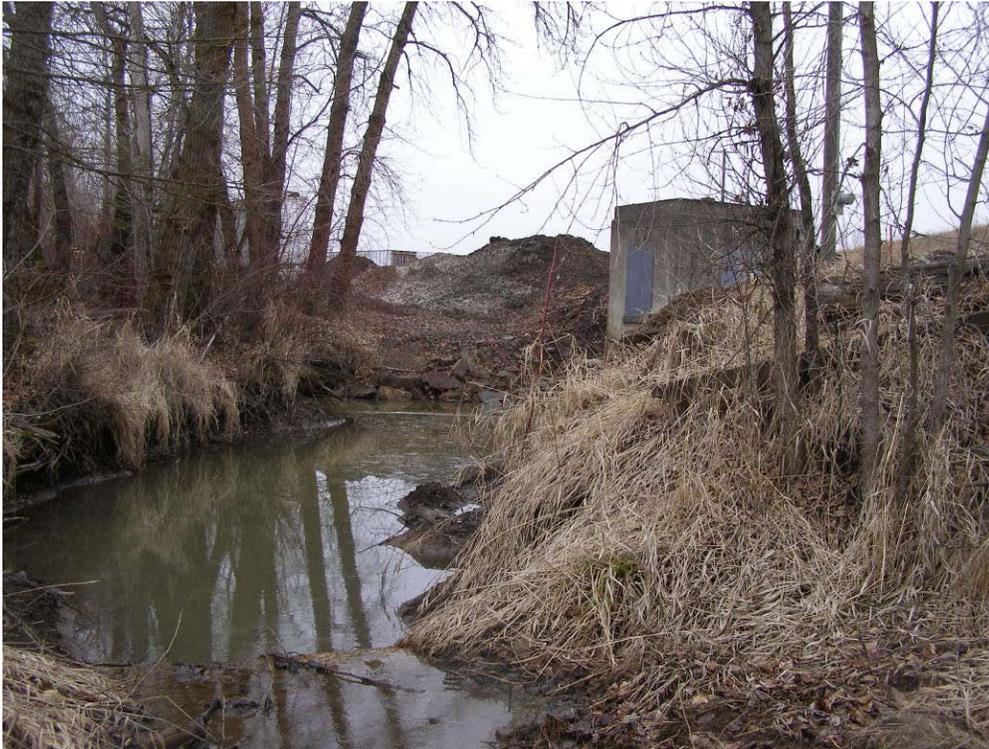
Wetlands and ponded area behind the pumphouse.

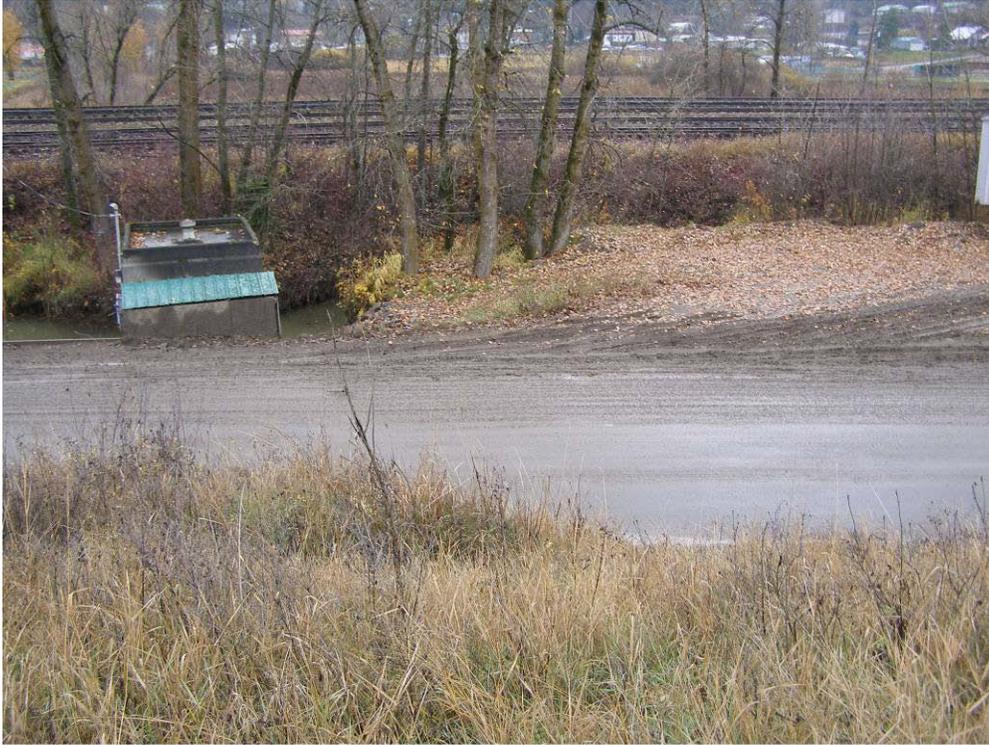
View of pumphouse and surrounding area from the levee crown.

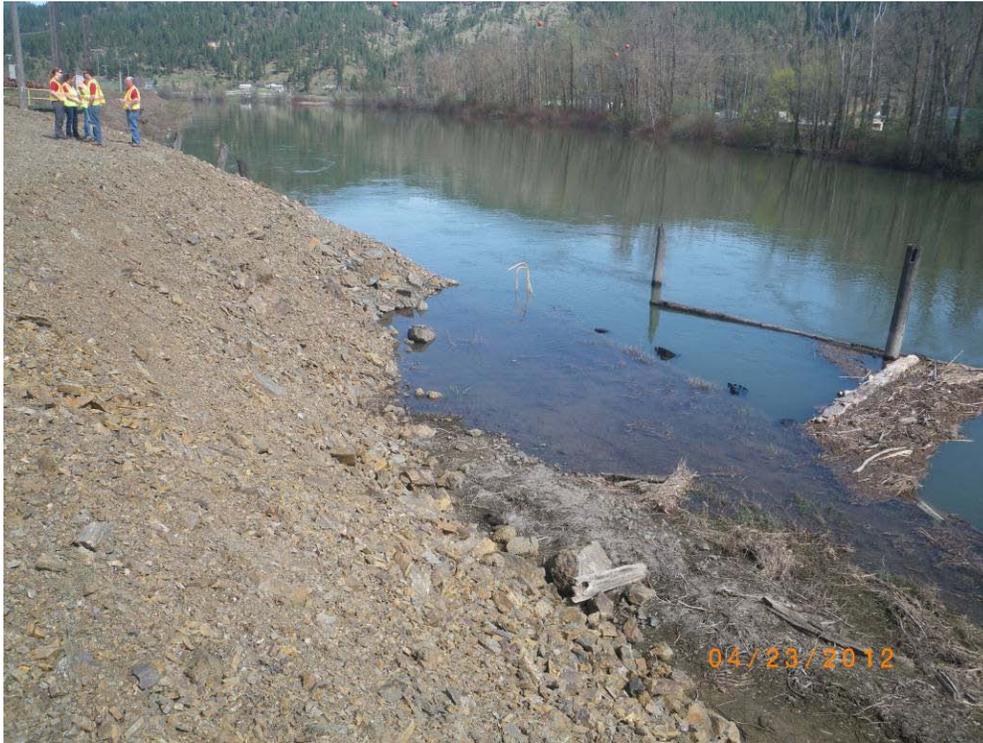
Material placed in 2011 flood fight, seen during a high water event (Calder gage at 12 feet)

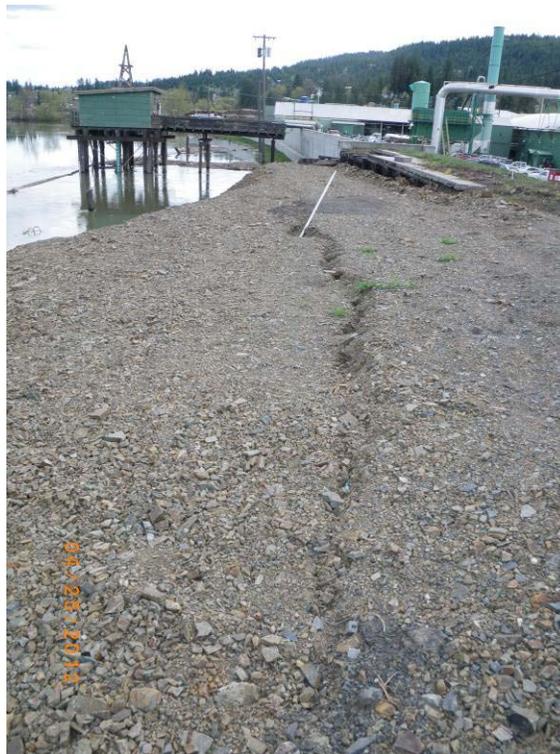
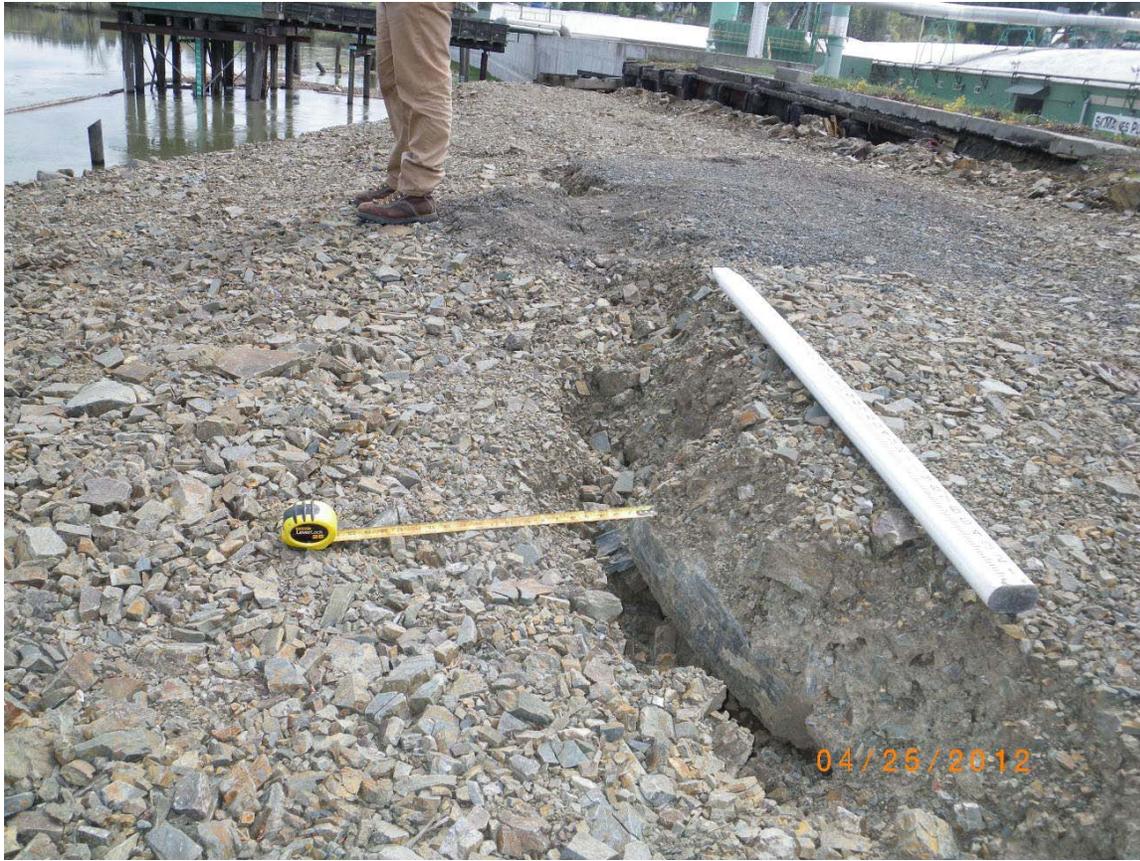
Visible tension crack in the material placed at Site 2.

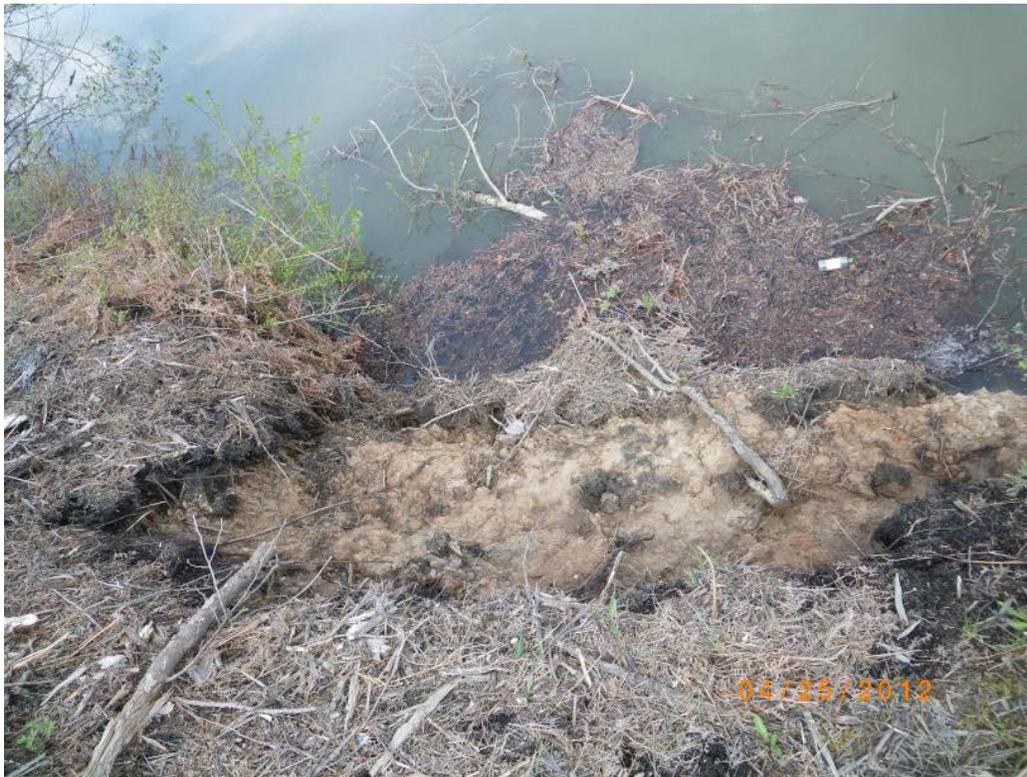
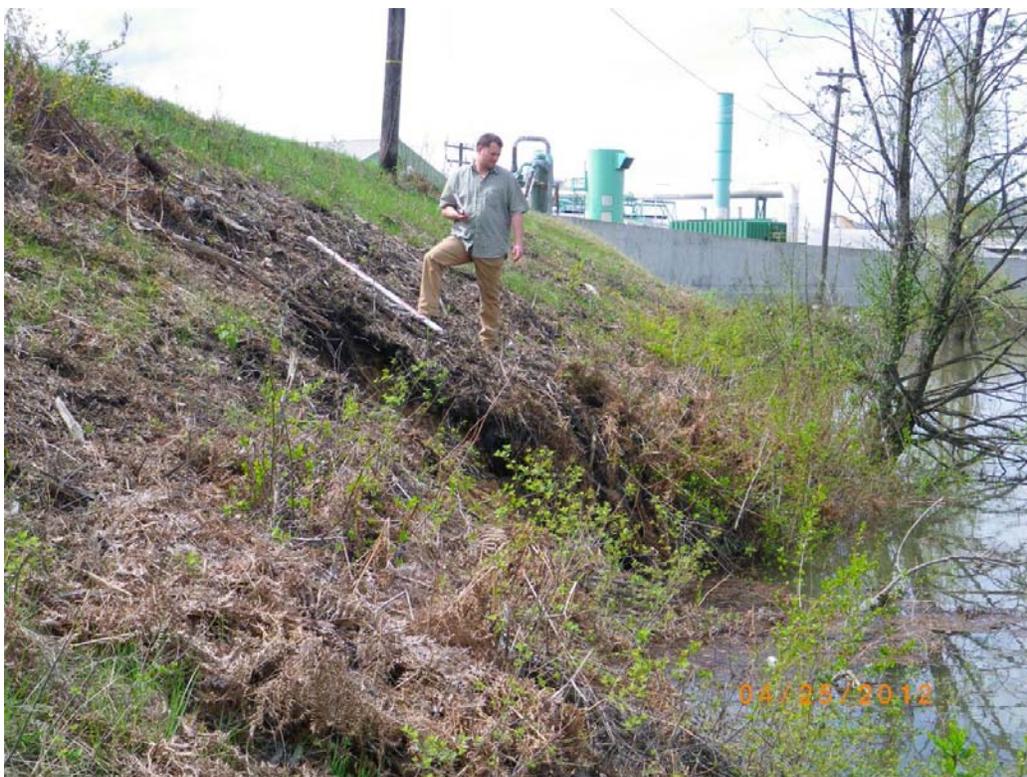
The sloughed area at Site 3.

The recommended repair alternative for Site 3 (Figures 7 and 8) is to Repair in Kind by restoring the pre-flood riverward slope. The repair would include armoring the slope above the existing bench with Class 2 riprap. Class 2 riprap includes rock 8 to 22 inches in diameter, with 50% of the rocks greater than 16 inches. The armor would include a 1 foot filter blanket (spall rock) that should also improve drainage from the slope. The weight and strength of this rock armoring is intended to buttress the slope, while nullifying any potential for erosion and bank undercutting. The full repair would be 160 feet. This repair will constitute a change in bank substrate at this location, placing rock on what had been an earthen bank. The repair will tie into existing rock at the downstream end, extending the armored bank by 160 feet. There is a bench just below ordinary high water (approximately two feet below the ordinary high water elevation), with the damaged bank being above that bench. The work will extend down to this bench, including rock placement below ordinary high water. Depending on the water level at the time of construction, the repair may require rock placement in the water. The finished profile of the levee will not extend beyond the pre-damaged toe, as defined by the upstream and downstream limits of undamaged levee and by maintaining the slope of the undamaged upper portion of the levee.

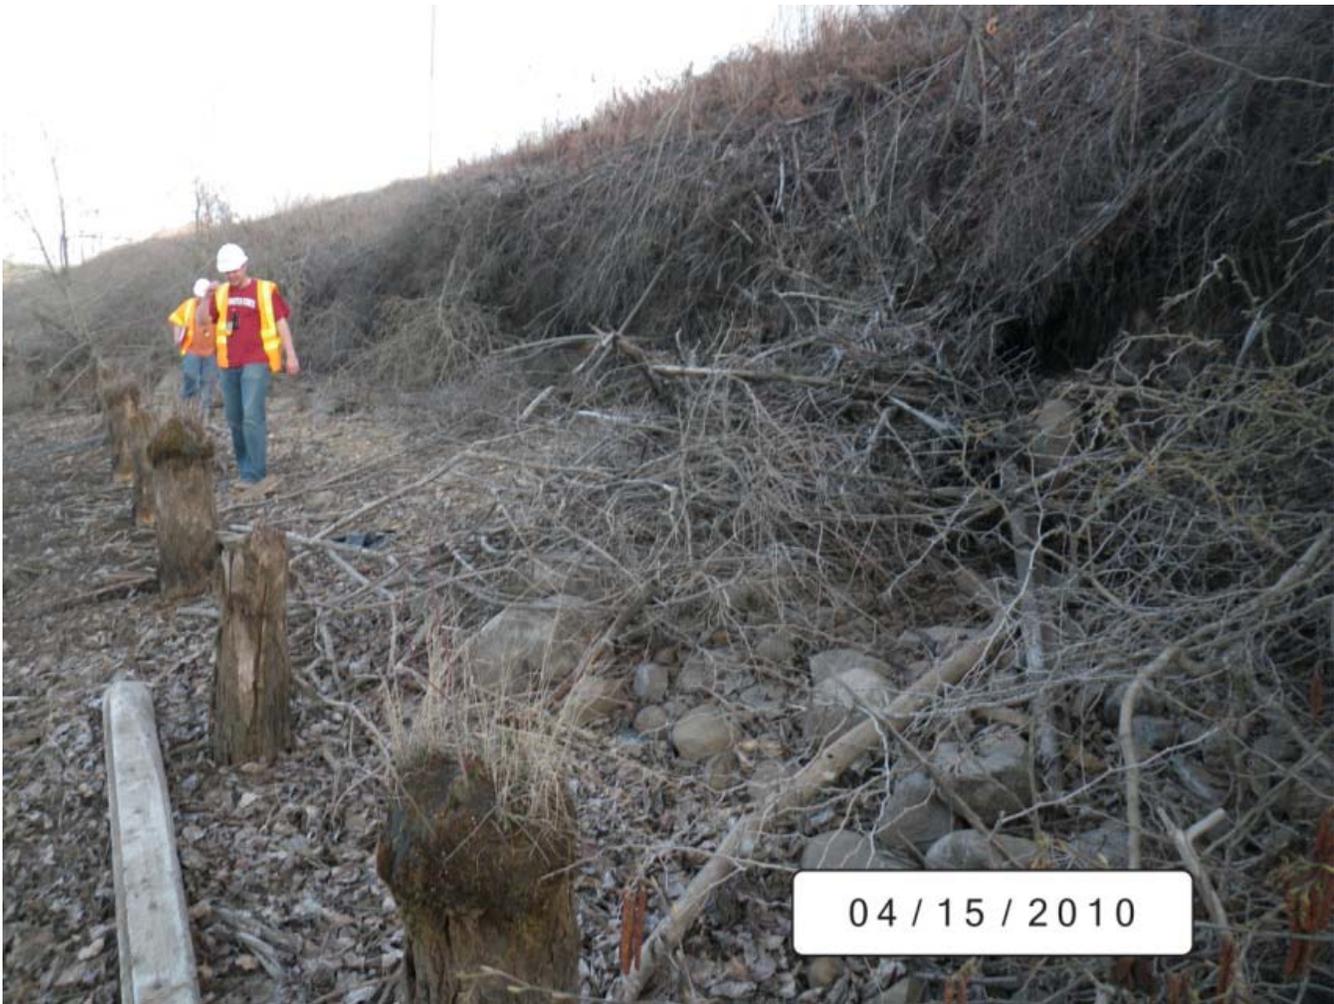
The sloughed area at Site 3, taken prior to current damage. Picture shows the bench at the toe of the levee.

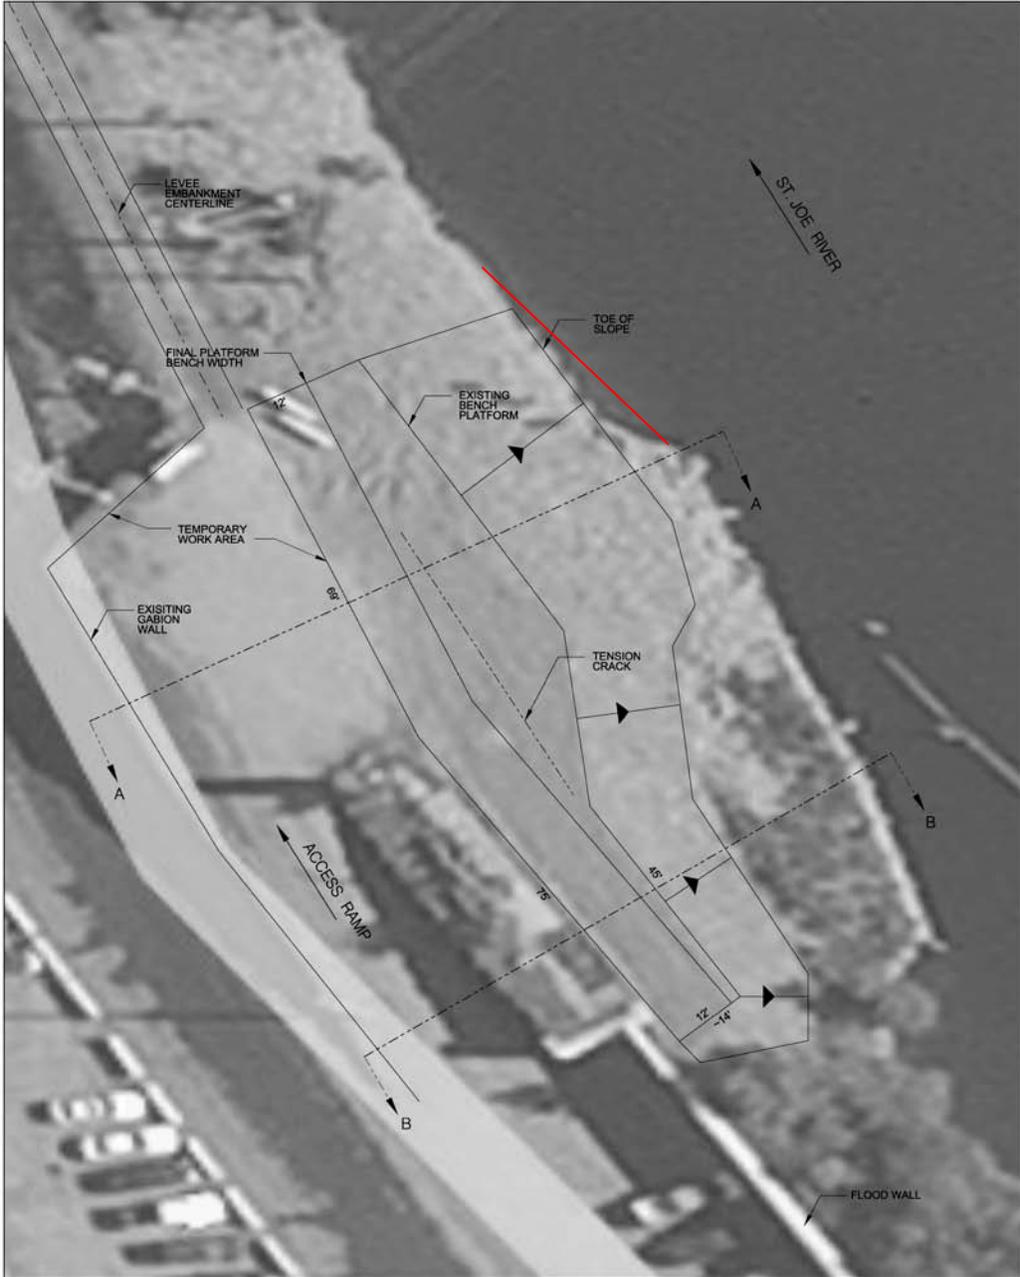
Figure 3. Plan view of Site 2. The flood fight (180 ft) included placement of material throughout the proposed repair area (145 ft) and slightly farther on each end. The red line indicates the portion of the flood fight that was conducted in the water.

The recommended repair alternative for Site 2 (Figure 3) includes removing the overburden at this location. The tension crack occurred in material that was placed during a 2011 high water. The total length of overburden removal is approximately 145 feet and would include excavation of the material above the waterline. No excavation would occur below the waterline. The working pad would be reduced to a 12-foot wide bench and the slopes would be re-graded to a more gradual slope to meet the new catch point.

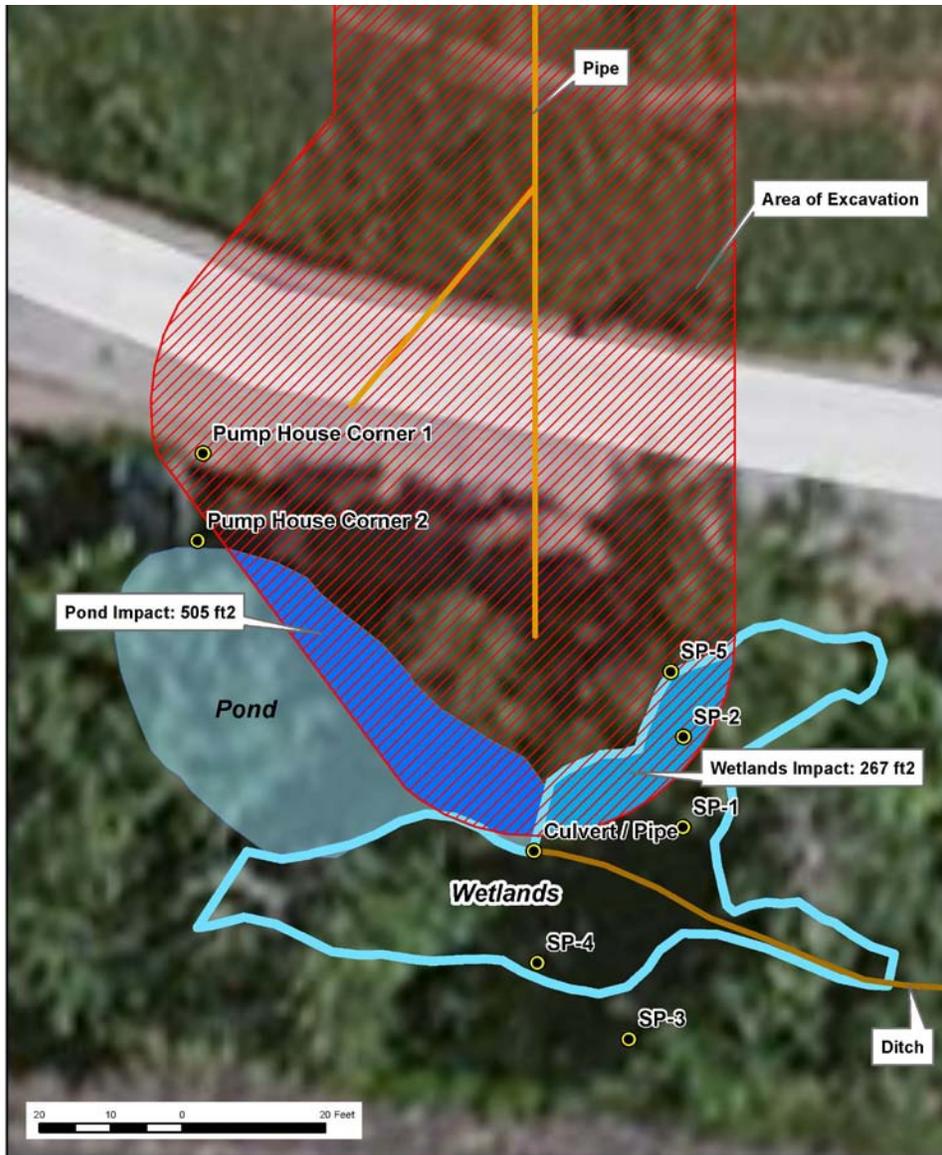
Figure 5. Wetland impacts location.

The seepage berm construction will avoid impacting the wetland and pond adjacent to the pump house, excavation for the pipe replacement will require some temporary impacts. Approximately 267 sq ft of wetlands and 505 sq ft of pond would be impacted.

Construction would involve removal of vegetation, including a small number of trees. Once the pipe replacement is complete, the elevations would be rebuilt to resemble the pre-construction slopes and native plantings would be done within the repair area.

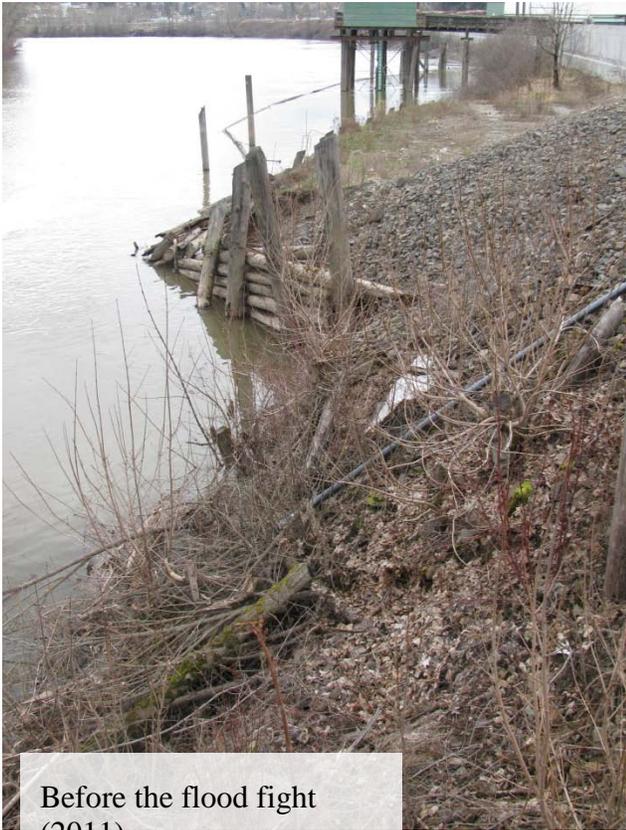
Before the flood fight
(2011)

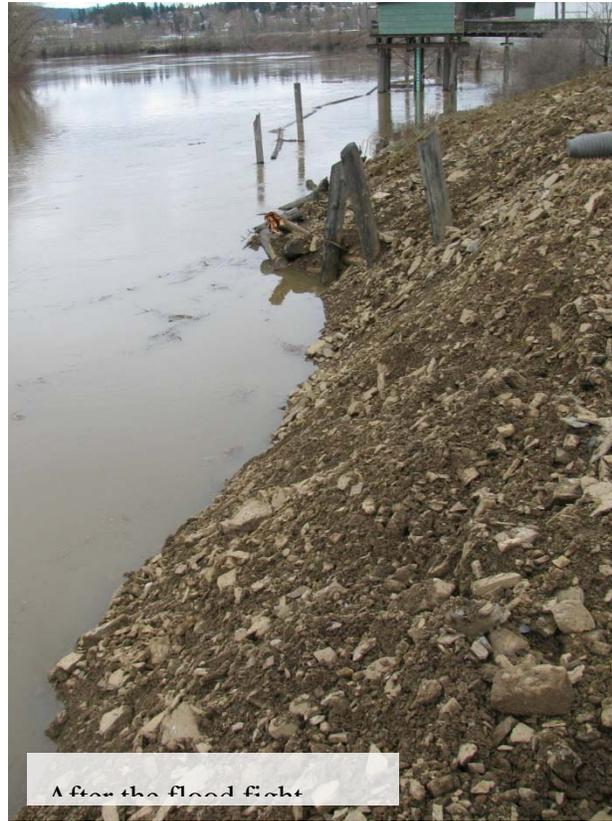
After the flood fight

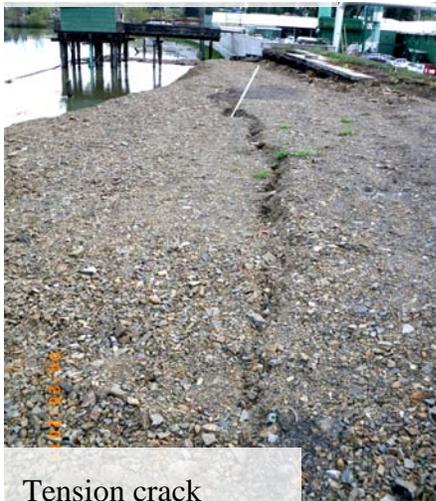
Tension crack
(2012)

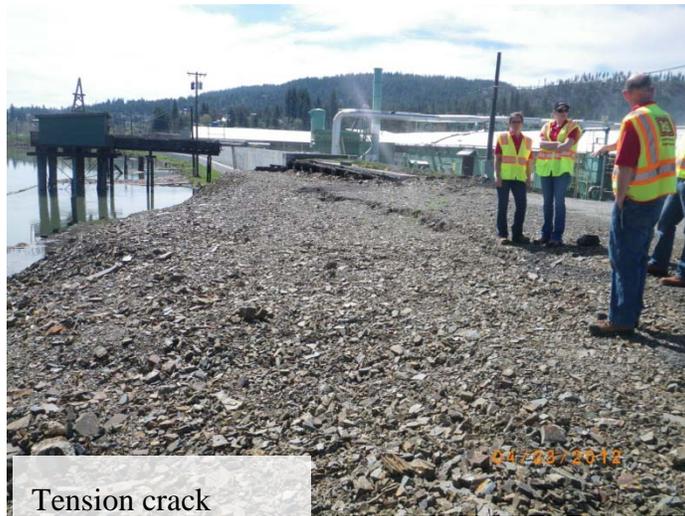
Tension crack
(2012)

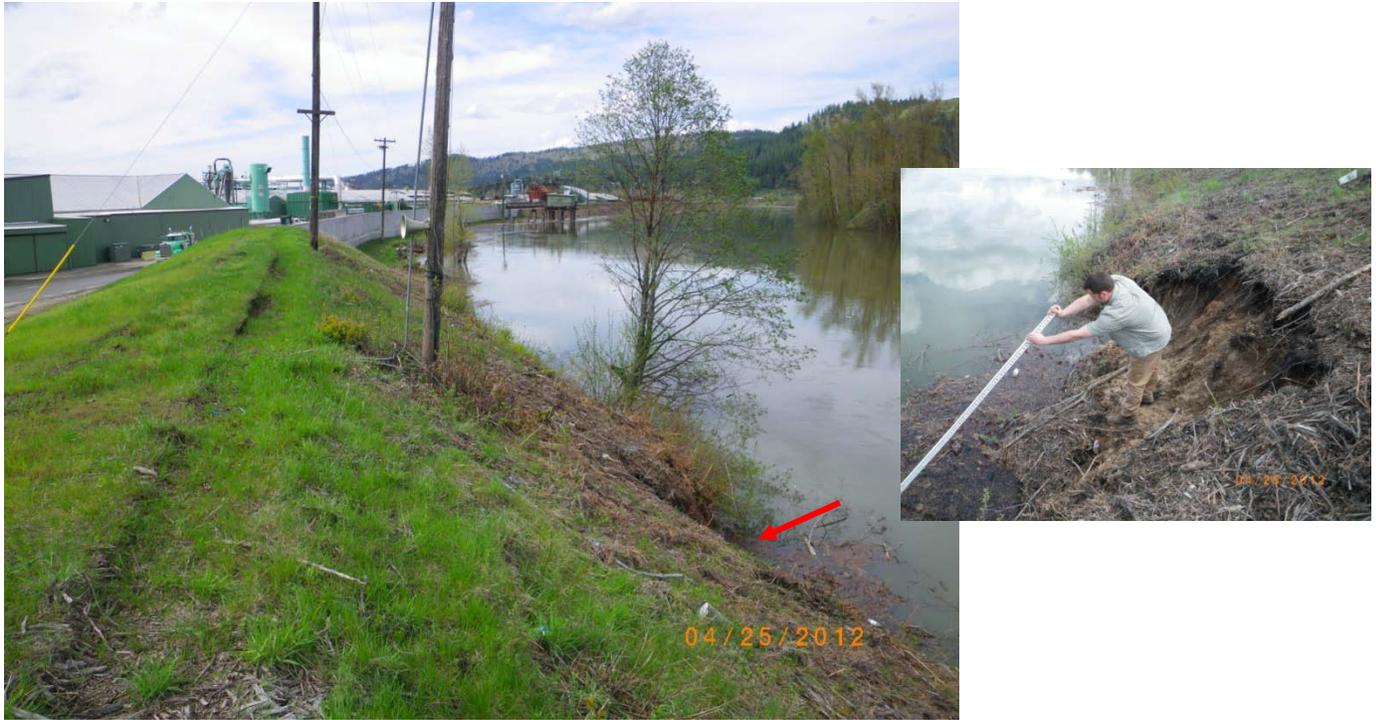
Figure 7. Photograph of Site 3. The red arrow indicates the rotational failure location.

The recommended repair alternative for Site 3 (Figure 4) includes armoring the slope with Class II riprap. The armor would include a 1 foot filter blanket that should also improve drainage from the slope. The weight and strength of this rock armoring is intended to buttress the slope, while nullifying any potential for erosion and bank undercutting. The full repair would be 160 feet. This repair will constitute a change in substrate at this location, placing rock on what had been an earthen bank. The repair will tie into existing rock at the downstream end, extending the armored bank by 160 feet.
