**INSPECTION REPORT
OF
ASBESTOS AND LEAD-BASED PAINTED
BUILDING MATERIALS**

**CAPEHART FAMILY HOUSING IMPROVEMENTS - PHASE 3
MALMSTROM AIR FORCE BASE
GREAT FALLS, MONTANA**

**MAXIM TECHNOLOGIES, INC.
303 IRENE STREET
HELENA, MONTANA**

October 21, 1999

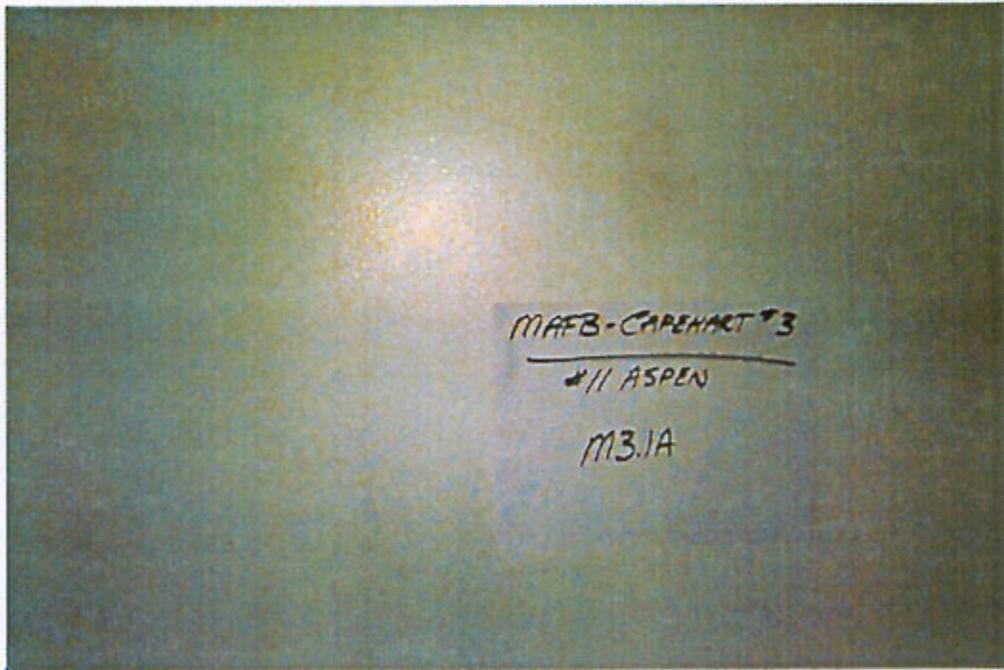
Photo 2 - Wallboard and Taping Material (M3.1)

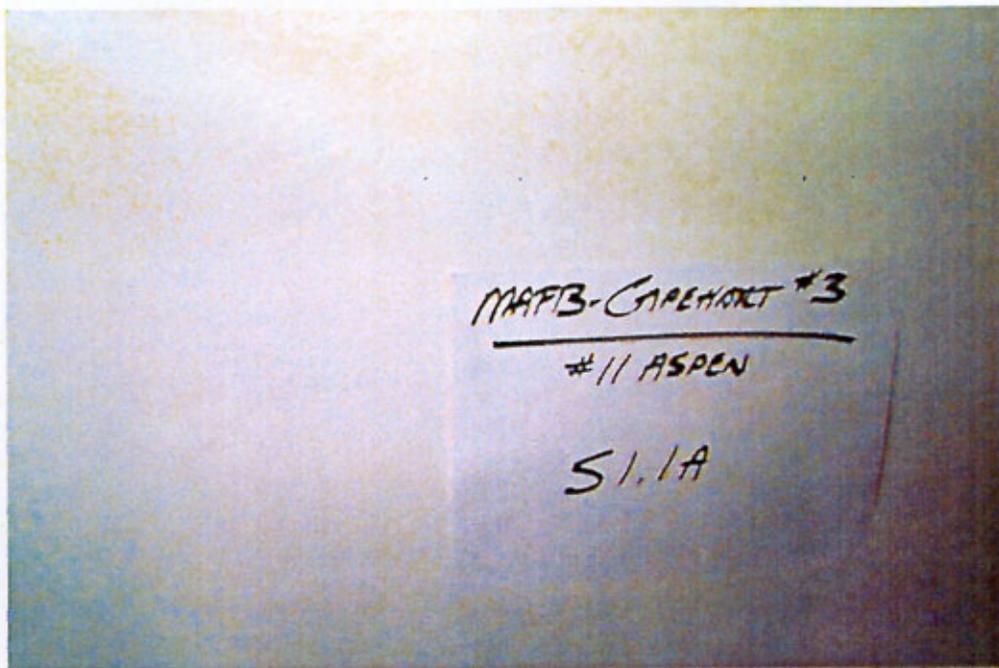
Photo 3 - Surfacing Compound (S1.1)

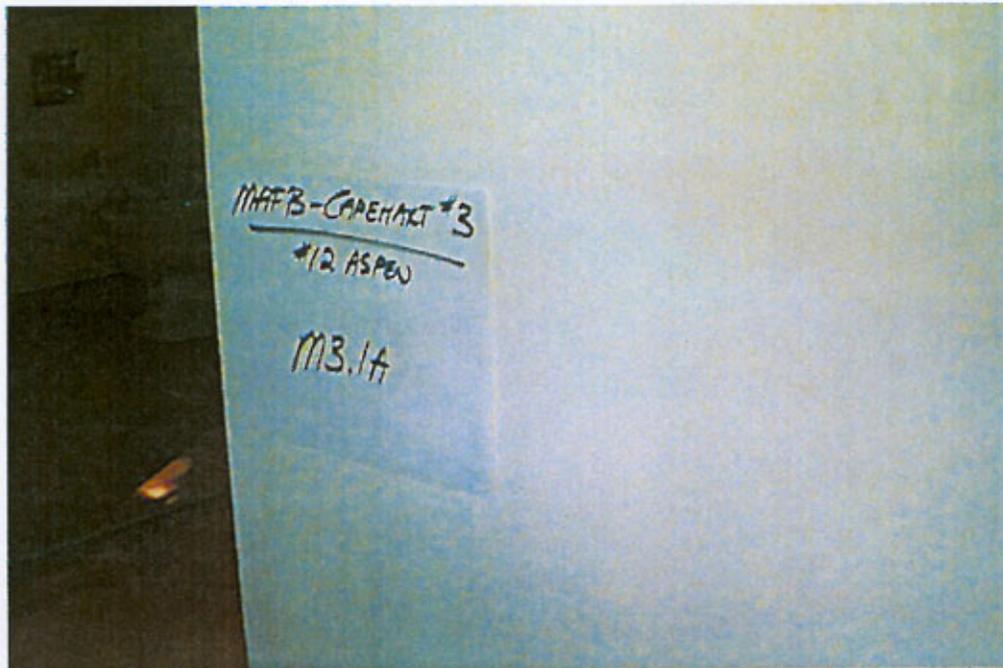
Photo 2 - Wallboard and Taping Material (M3.1)

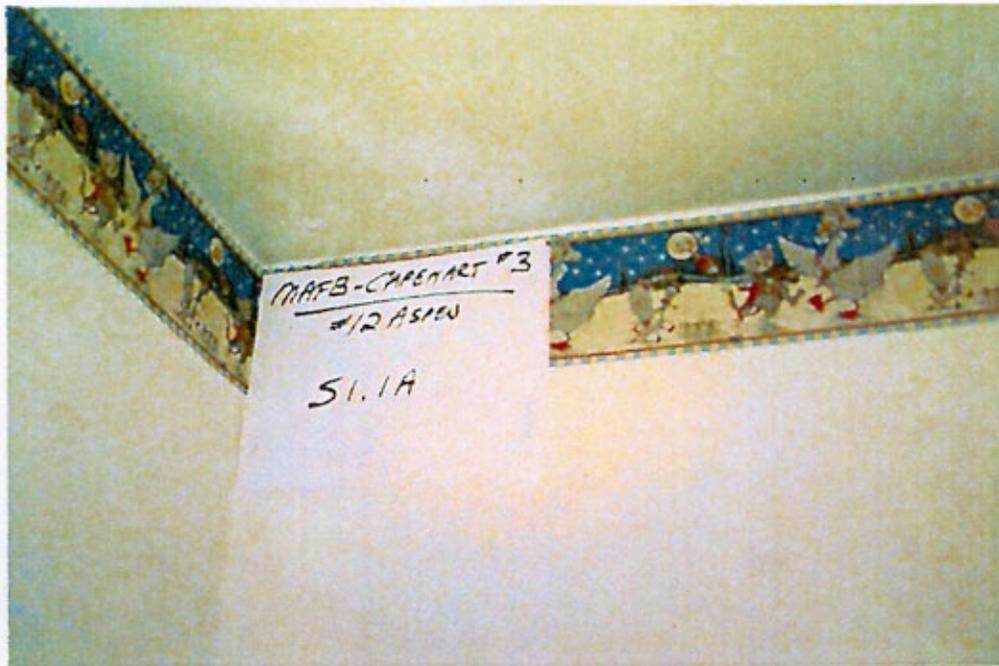
Photo 3 - Surfacing Compound (S1.1)

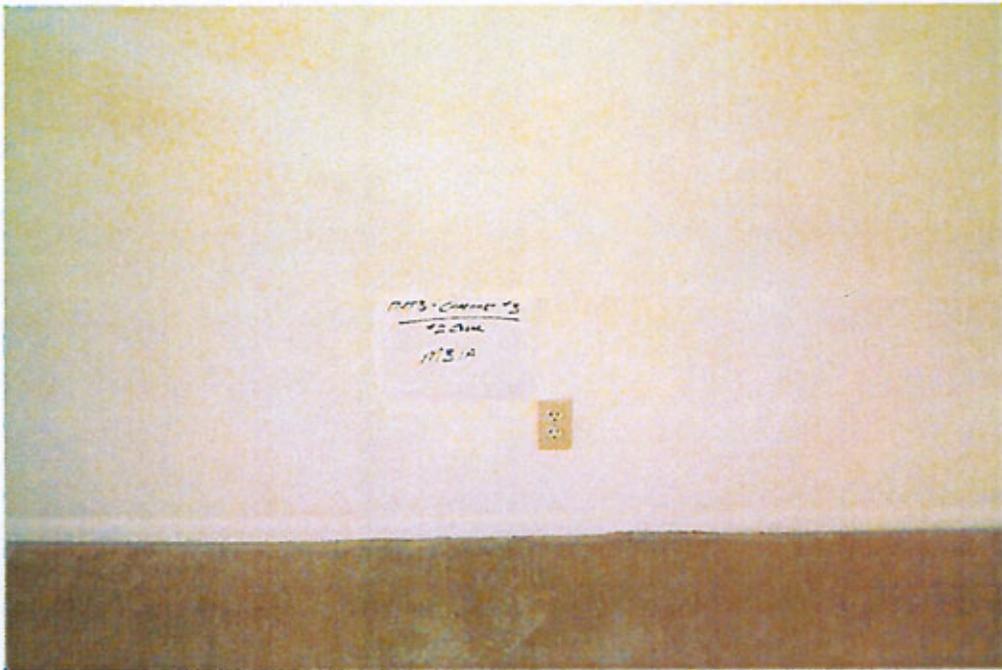
Photo 2 - Wallboard and Taping Material (M3.1)

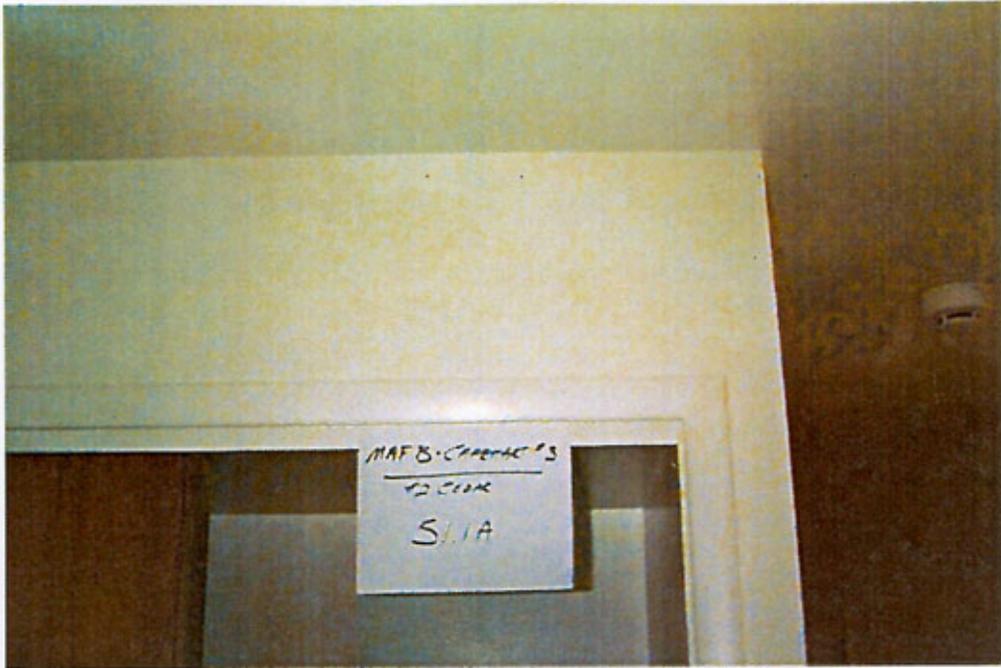
Photo 3 - Surfacing Compound (S1.1)

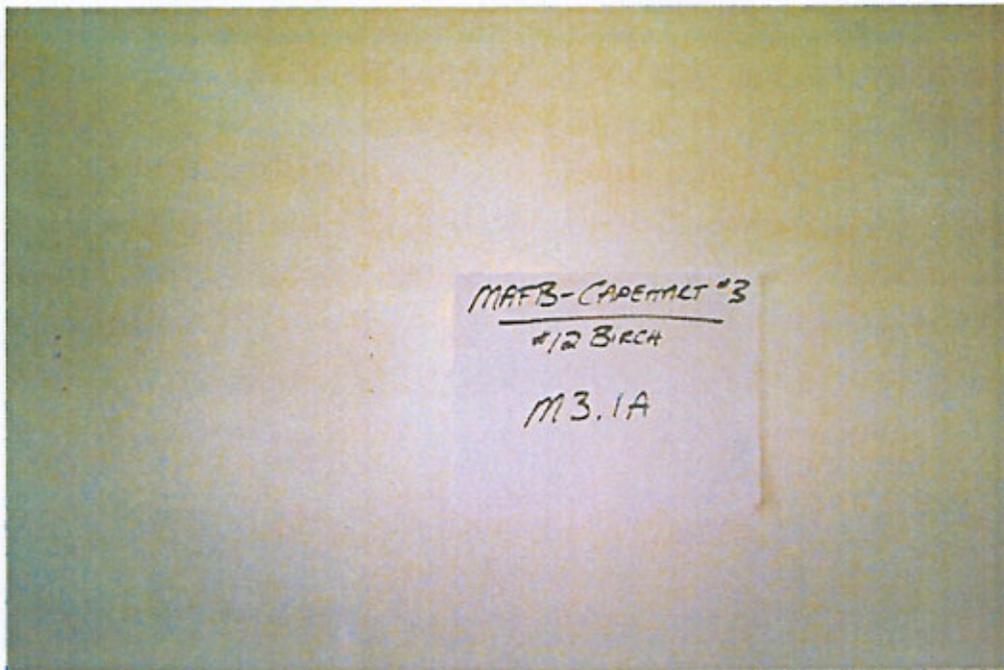
Photo 2 - Wallboard and Taping Material (M3.1)

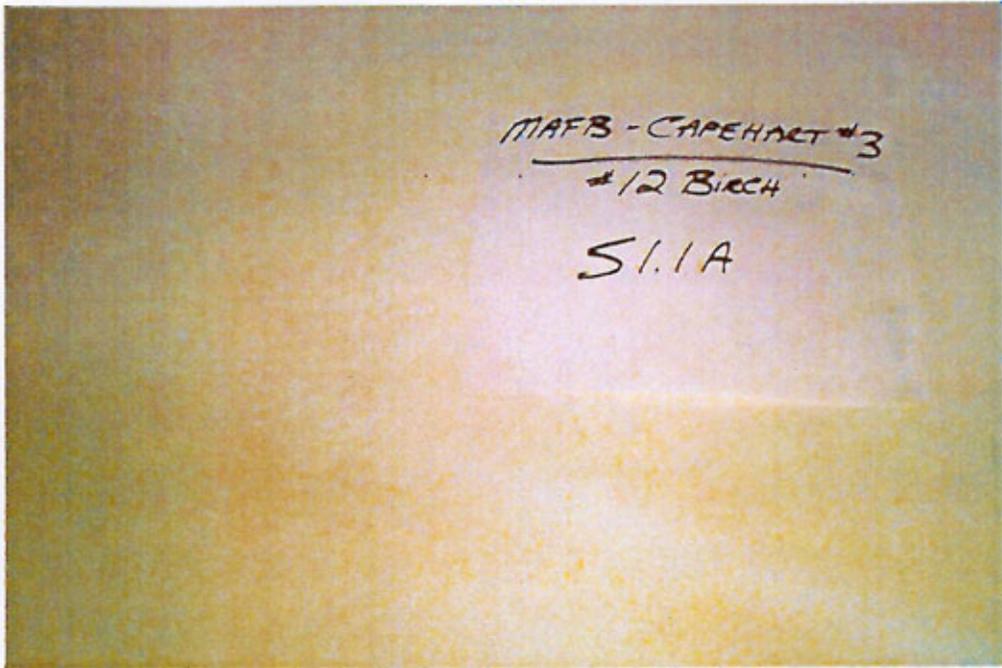
Photo 3 - Surfacing Compound (S1.1)

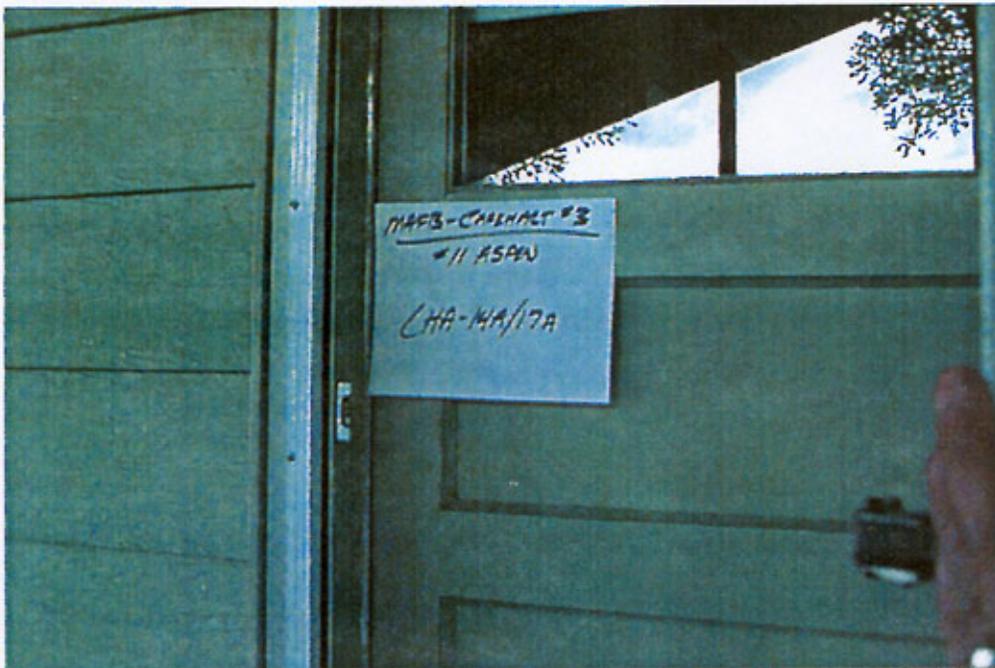
Photo 2 - Green Wood Door and Door Jamb (LHA-14F & 17F)

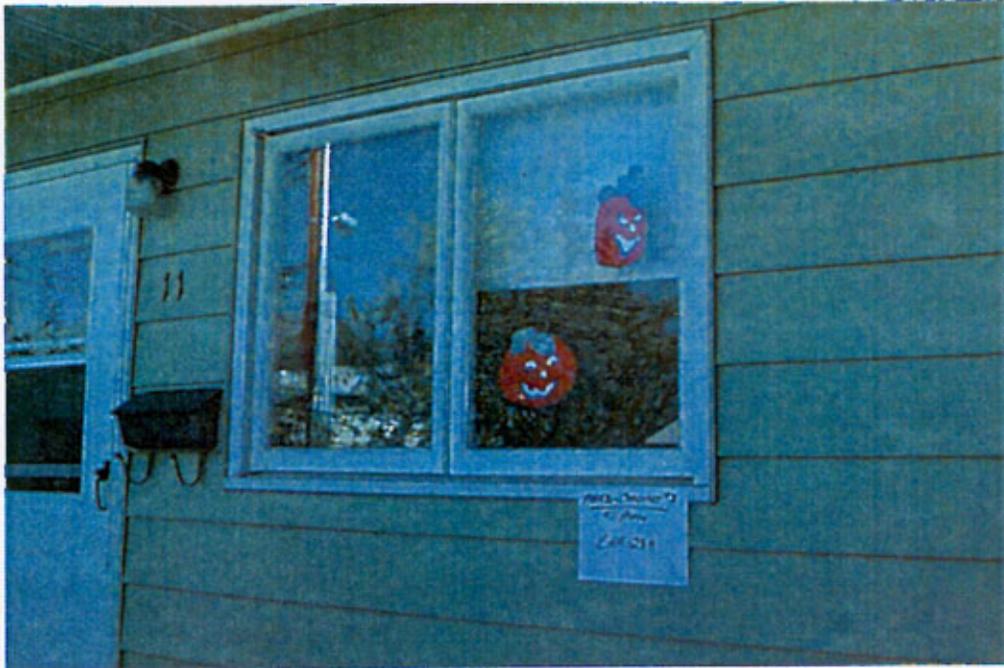
Photo 3 - White Wood Window (LHA-23A)

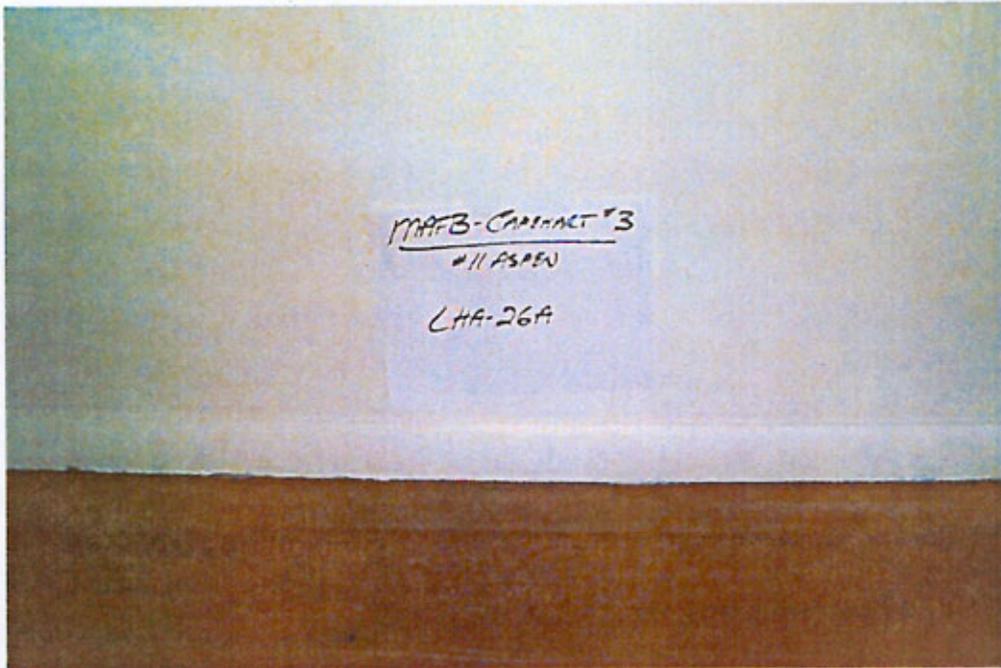
Photo 4 - White Wood Baseboard (LHA-26A)

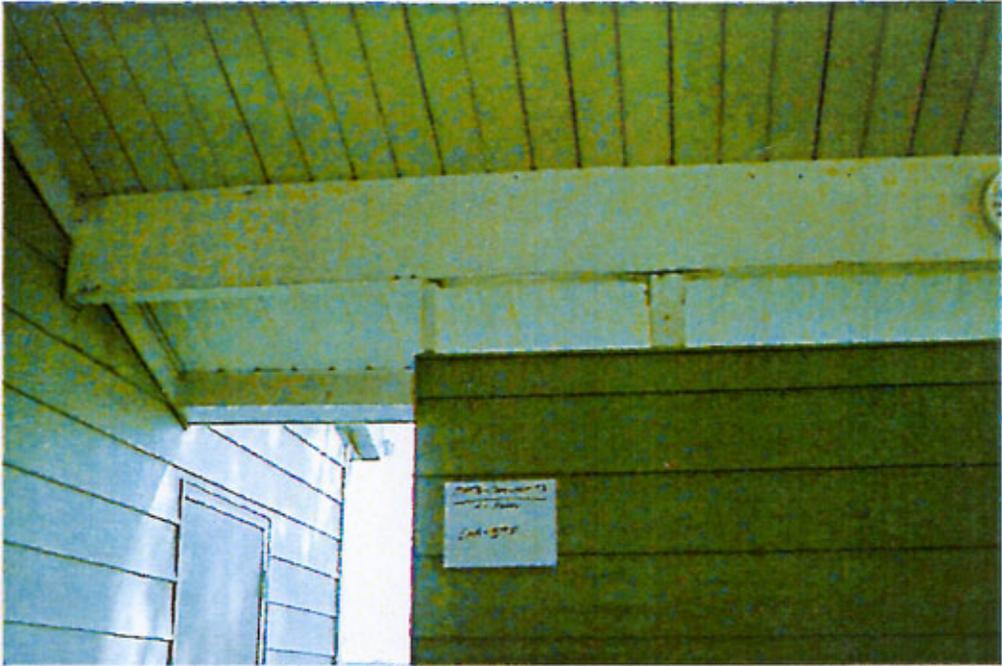
Photo 5 - Green Wood Soffit and Beams (LHA-59F)

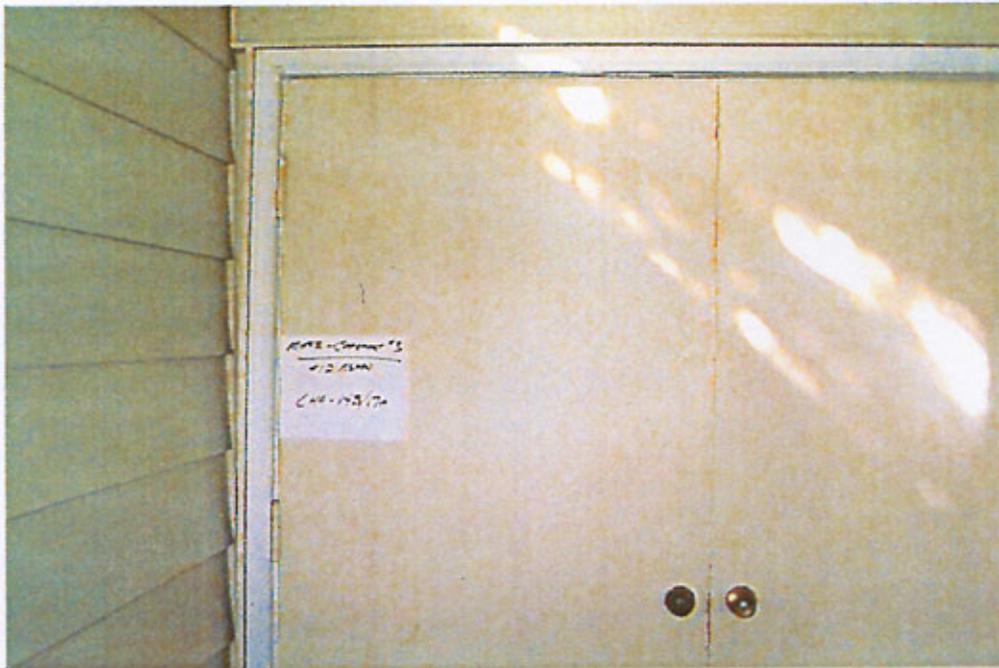
Photo 2 - Cream Wood Door and White Wood Door Jamb
(LHA-14B & 17A)

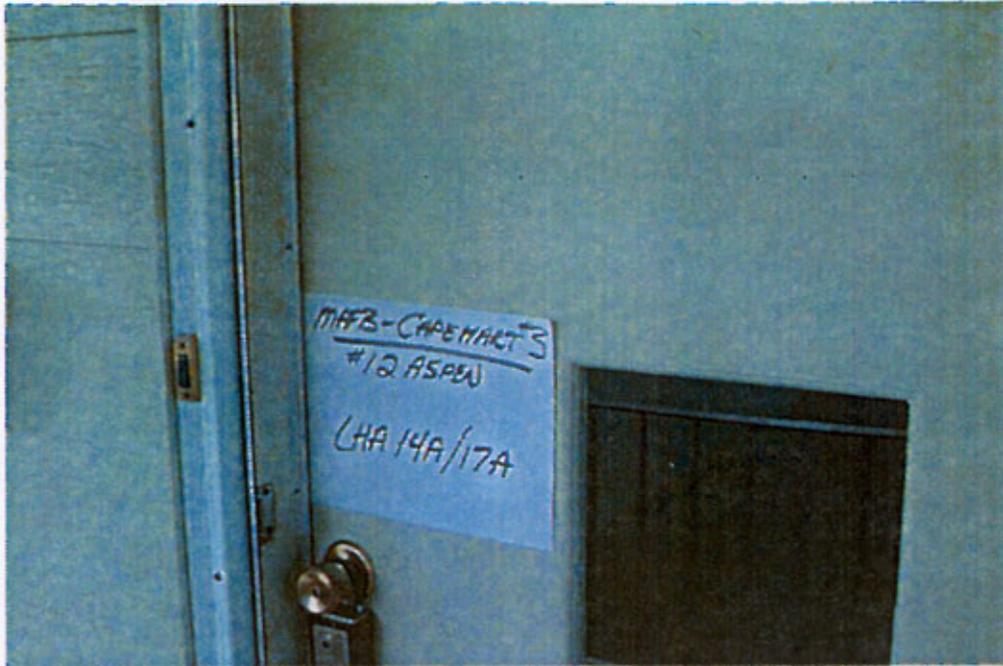
Photo 3 - White Wood Door and Door Jamb (LHA-14A &17A)

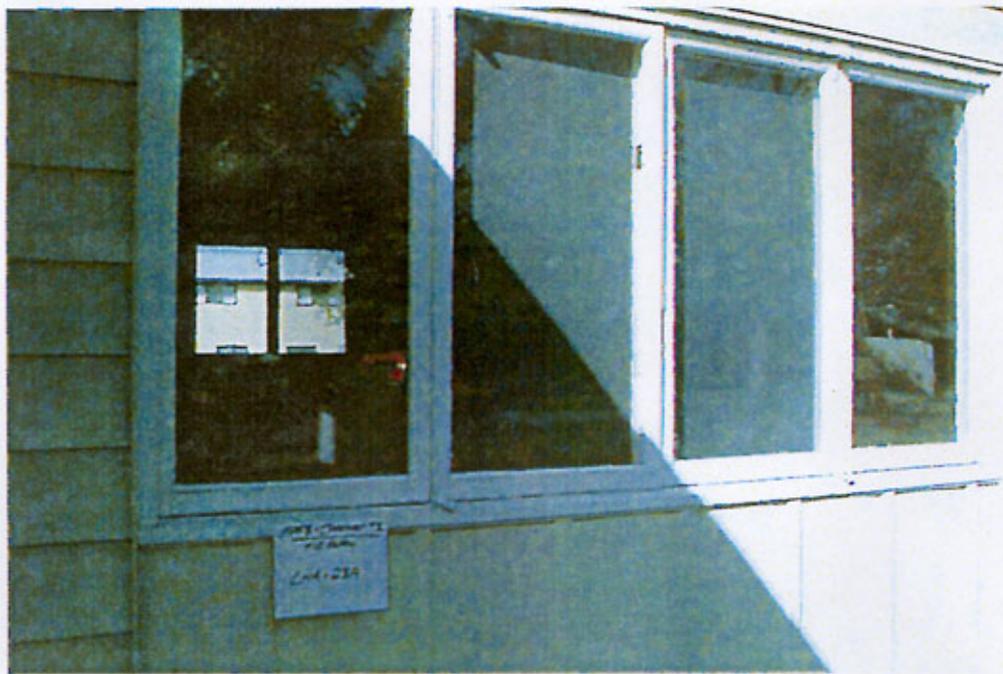
Photo 4 - White Wood Window (LHA-23A)

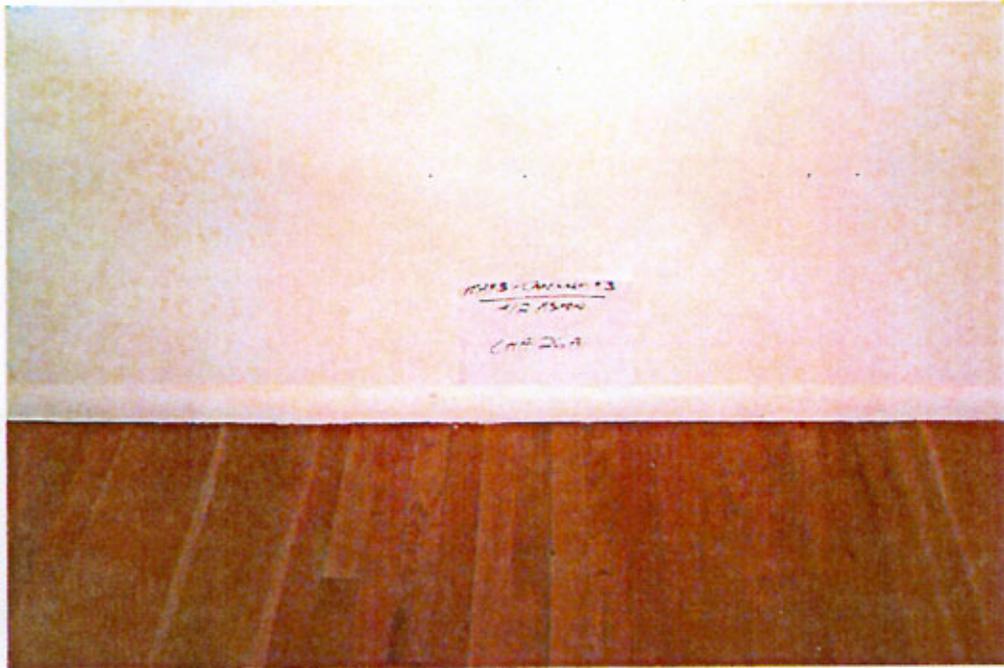
Photo 5 - White Wood Baseboard (LHA-26A)

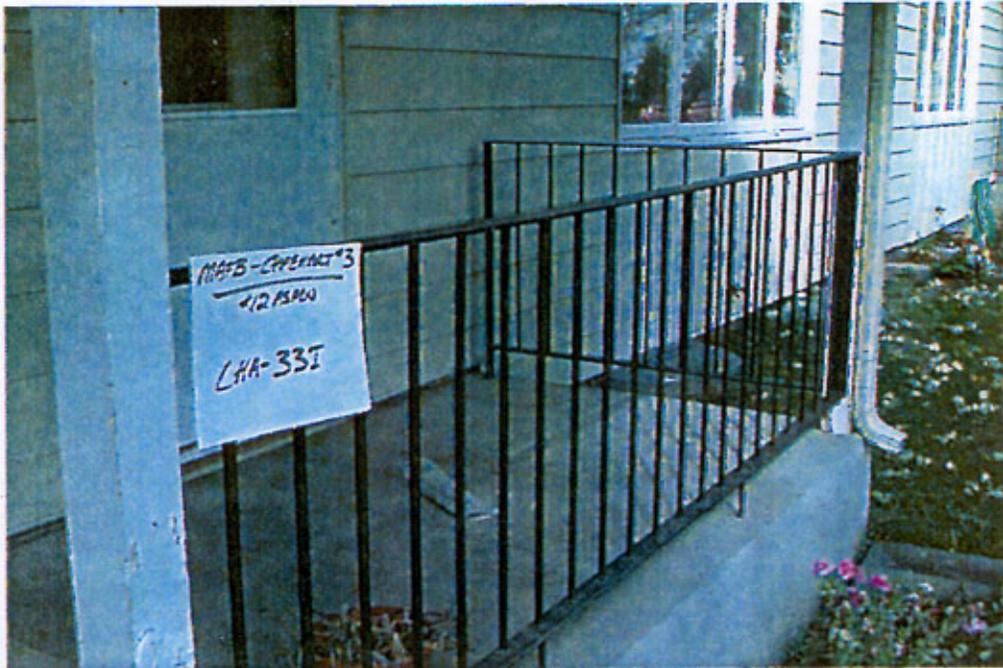
Photo 6 - Black Metal Handrail (LHA-33I)

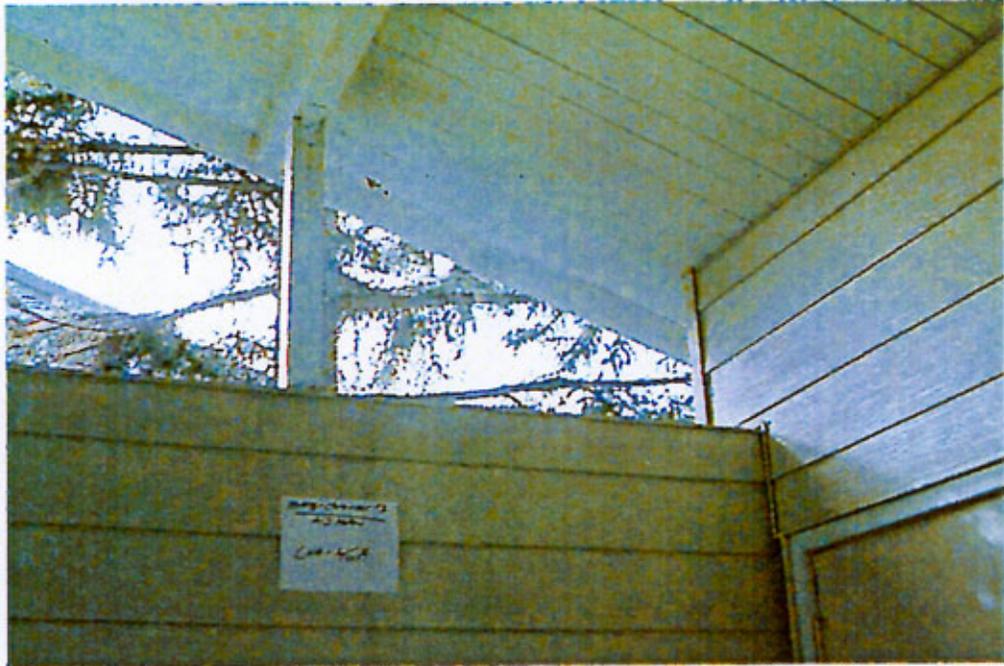
Photo 7 - White Wood Soffit and Beams (LHA-46A)

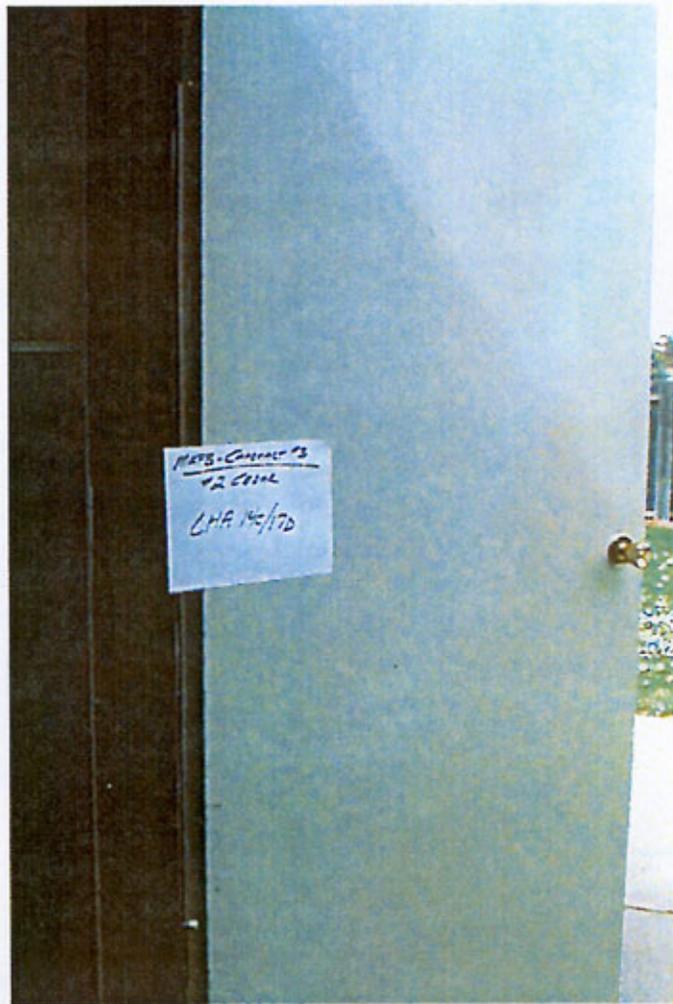
Photo 2 - Tan Wood Door and Brown Wood Door Jamb
(LHA-14C & 17D)

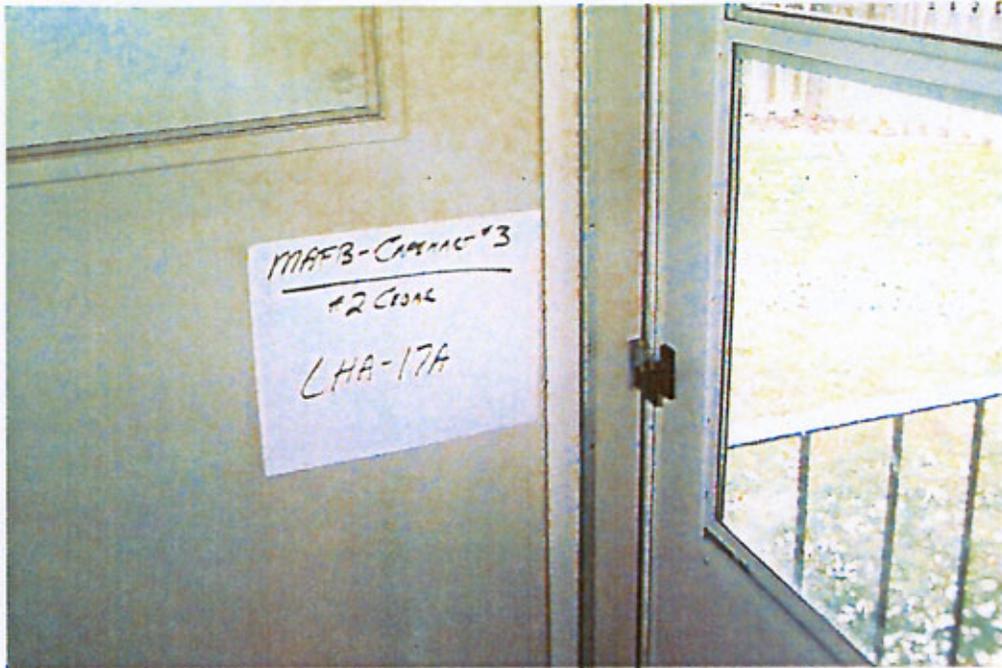
Photo 3 - White Wood Door Jamb (LHA-17A)

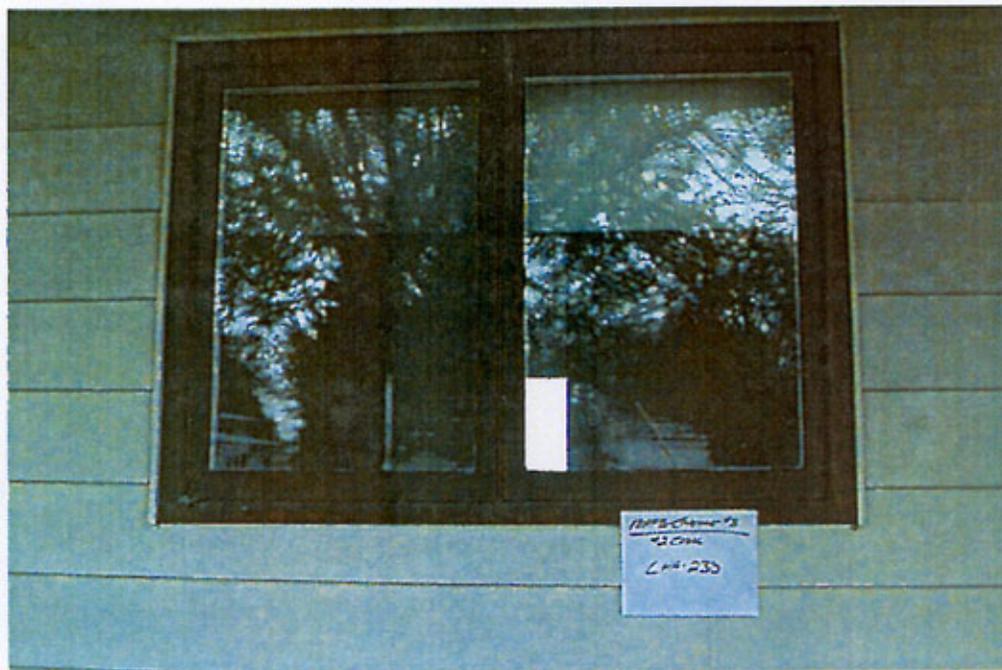
Photo 4 - Brown Wood Window (LHA-23D)

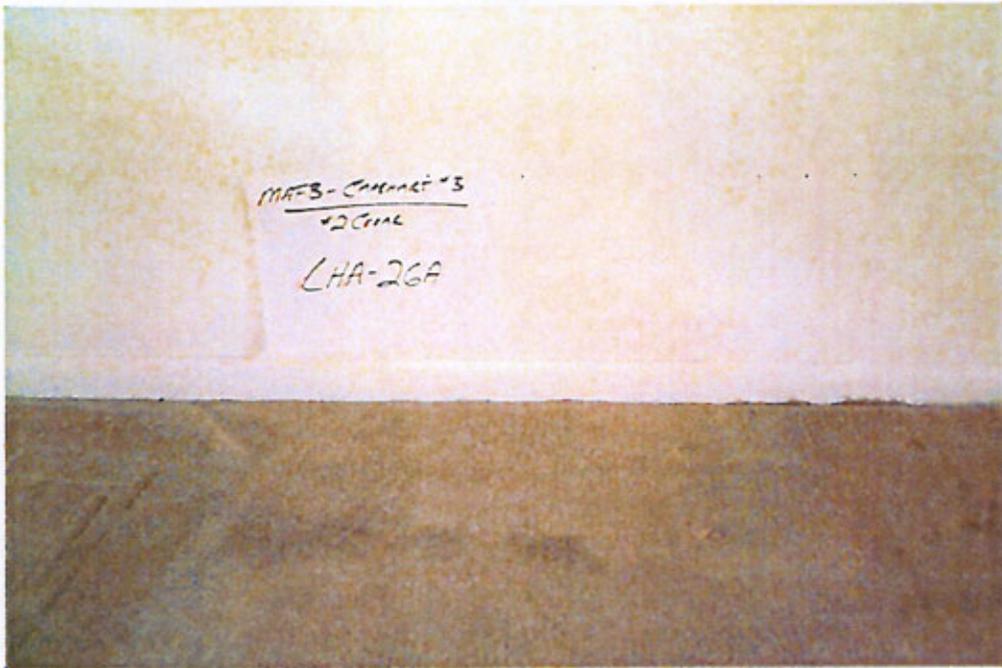
Photo 5 - White Wood Baseboard (LHA-26A)

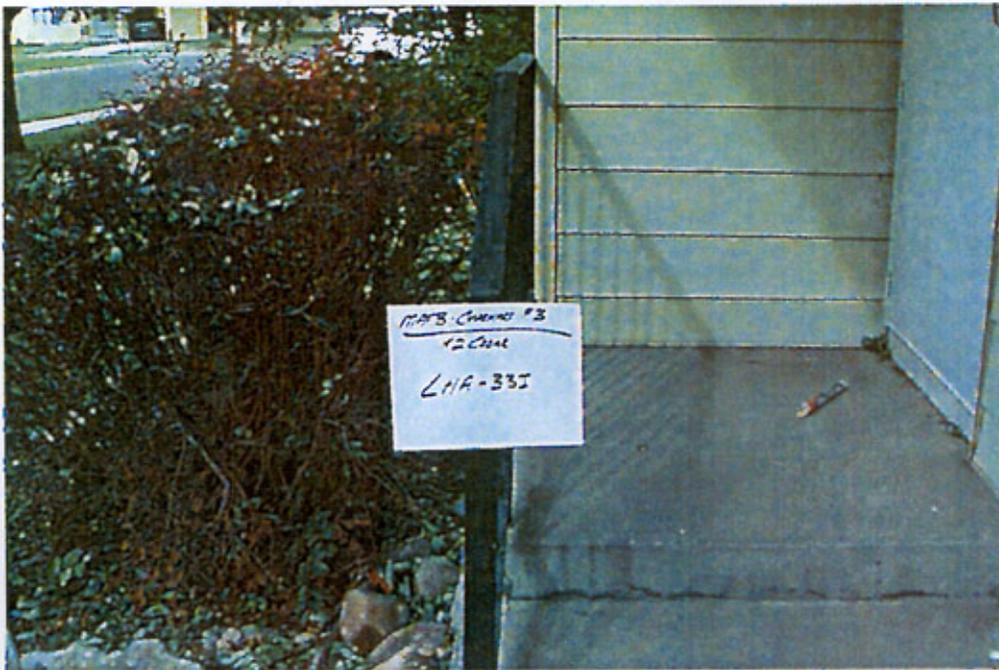
Photo 6 - Black Metal Handrail (LHA-33I)

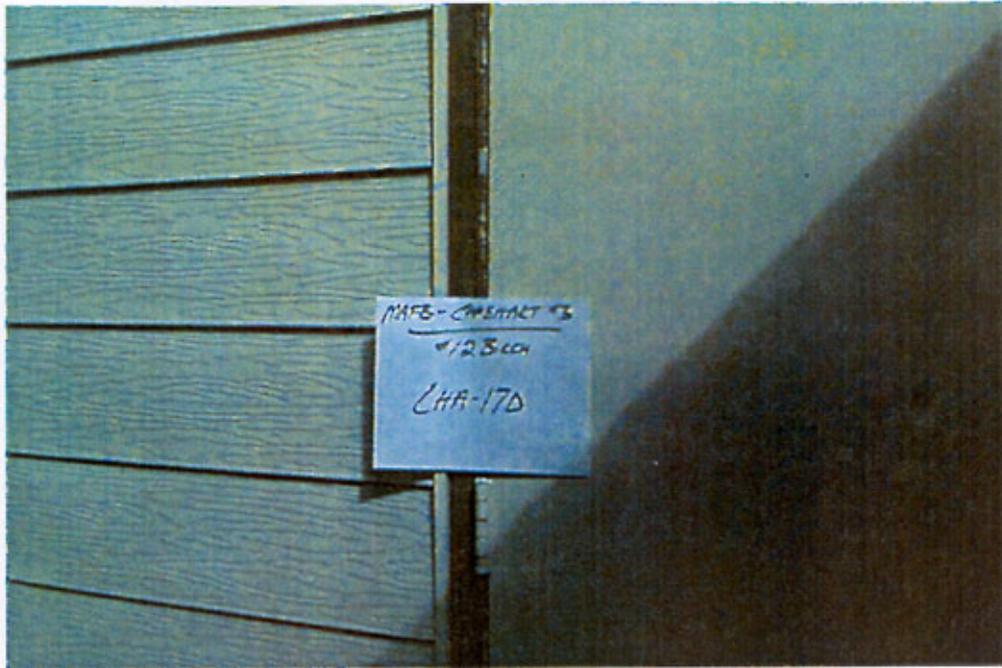
Photo 3 - Brown Wood Door Jamb (LHA-17D)

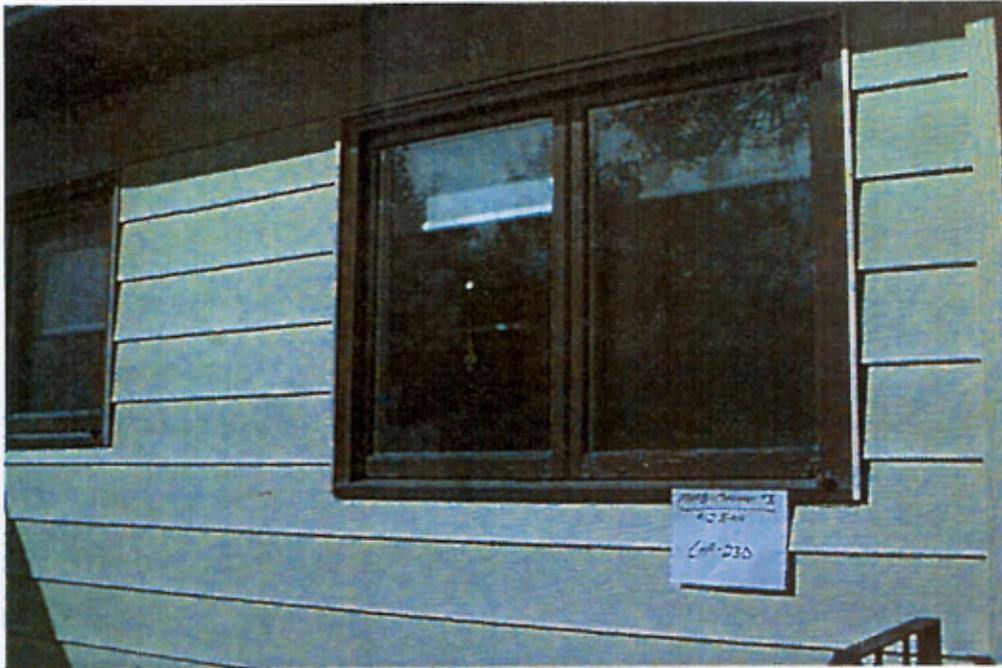
Photo 5 - Brown Wood Window (LHA-23D)

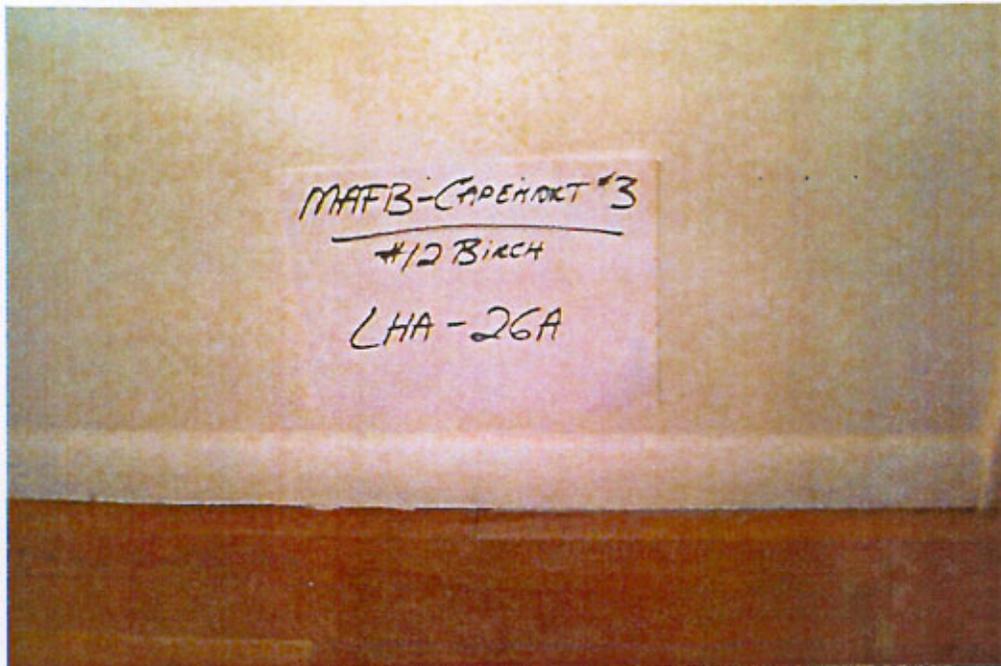
Photo 7 - White Wood Baseboard (LHA-26A)

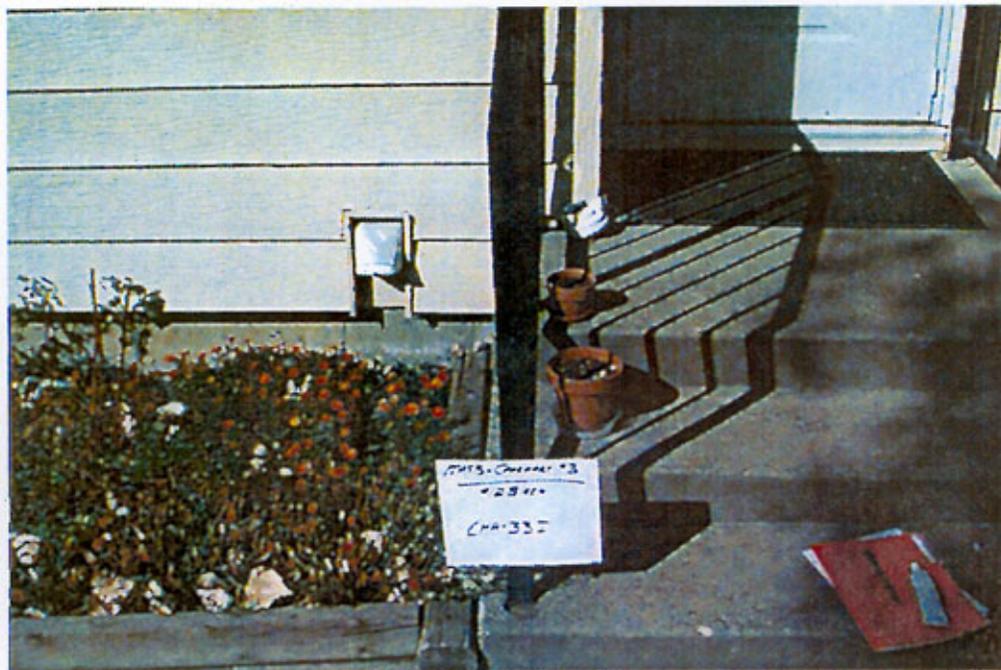
Photo 8 - Black Metal Handrail (LHA-331)

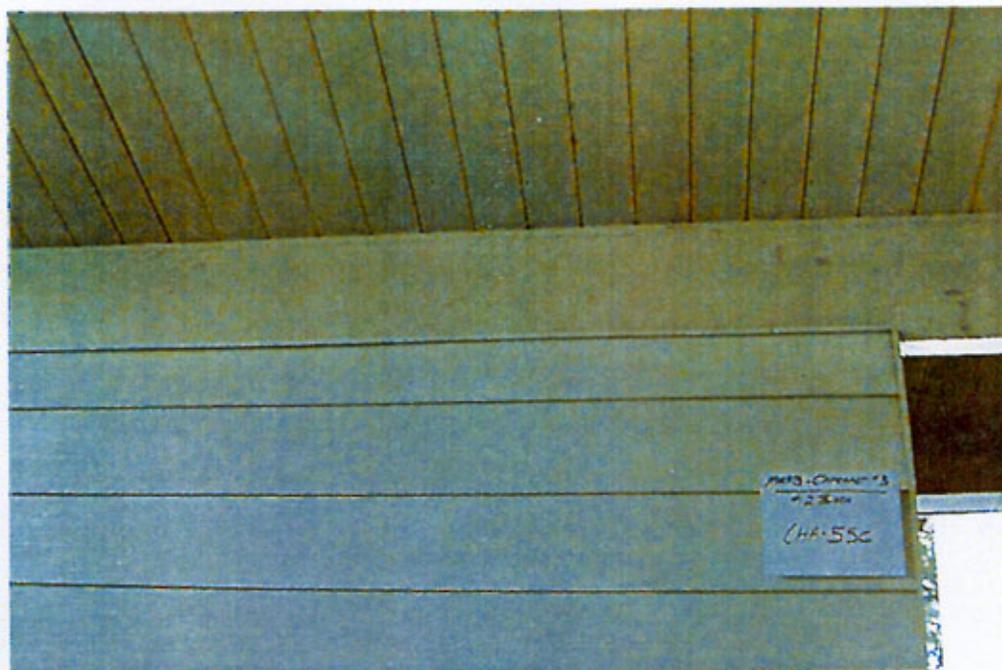
Photo 9 - Tan Wood Soffit (LHA-55C)
