**PROJECT EXECUTIVE SUMMARY
REHABILITATION OF FLOOD CONTROL WORKS
DUN-2-04**

**PROJECT INFORMATION REPORT
REHABILITATION OF FLOOD CONTROL WORKS
DUN-2-04**

SUBJECT: Hydrology and Hydraulics Report PL 84-99 Dungeness River

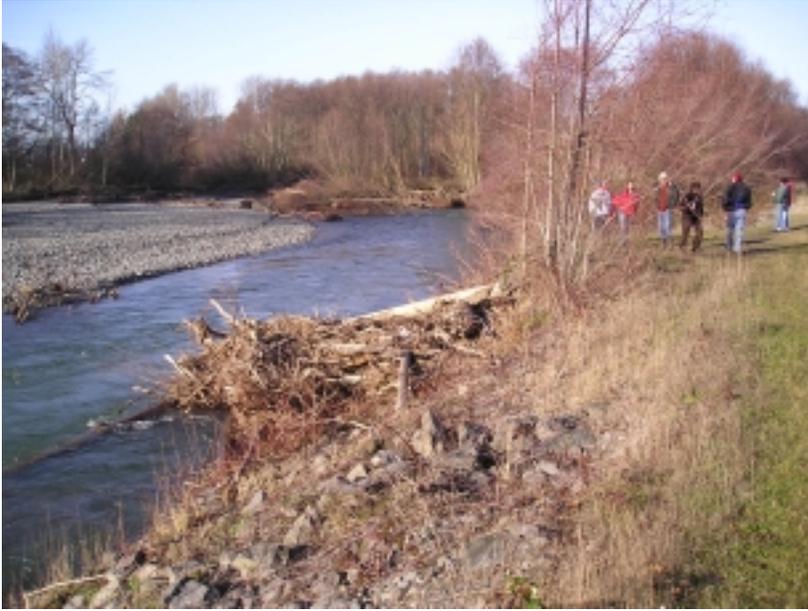
Dungeness River Federal Levee debris jam looking downstream.

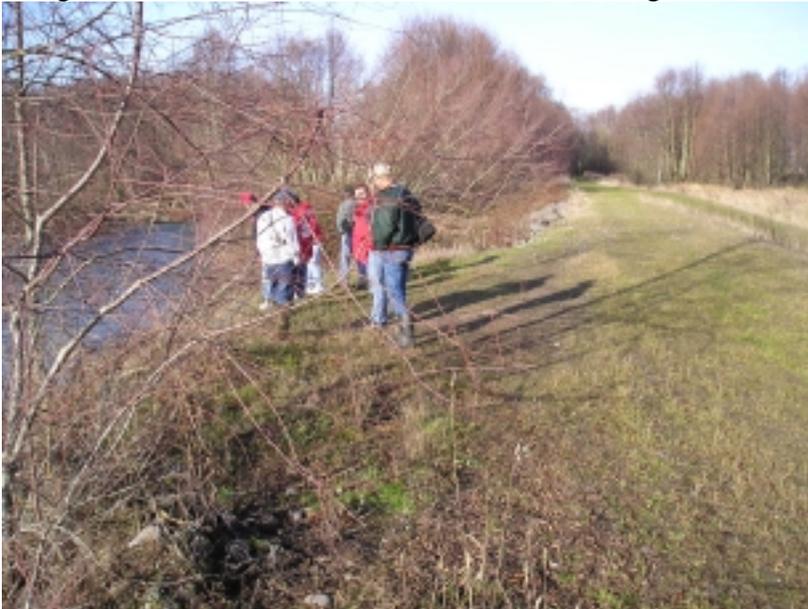
Dungeness River Federal Levee turnaround looking downstream.

B) Federally Authorized Levee – Damage occurred to the levee approximately 100 to 200 feet downstream of a levee construction project that took place in 2002. A woody debris jam formed at an existing turnaround in the levee resulting in toe scour for approximately 50 feet. The damage does not appear to be critical, since the top width of the levee at the turnaround is wider than the 12-foot top width of the rest of the levee.

B) Federally Authorized Levee – There is minor damage to the Federally Authorized Levee. The damage is toe loss and is primarily seen at the turnaround. *Figure G* shows that the toe loss at the turnaround threatens the turnaround itself, but does not necessarily decrease the level of protection.

B) Federally Authorized Levee – There is a minor reduction in the level of protection due to the toe loss. Thus, no immediate action is recommended. The toe loss and debris jam should be closely monitored, especially after future flood events.

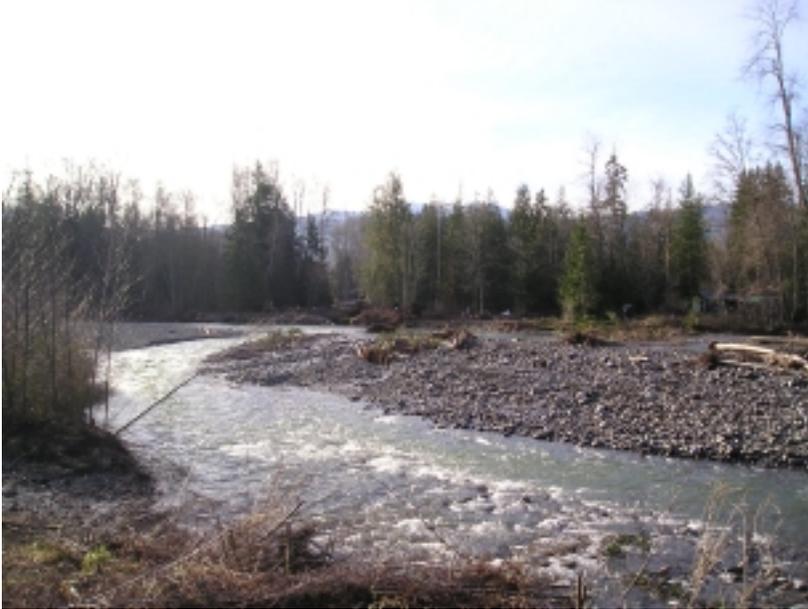
Sharp bend in Dungeness River looking u/s from Dungeness Meadows levee near Station 10+00.

A) Dungeness Meadows Levee – A sharp bend in the river exists at the upper end of the levee (Sta. 7+00). High stream velocities have caused scour along the toe of the levee. The toe of the levee has been eroded or has fallen into the developed scour hole. The damage to the levee extends approximately 500 feet downstream of Sta. 7+00. Toe loss is the primary damage resulting in nearly vertical slopes in some areas.

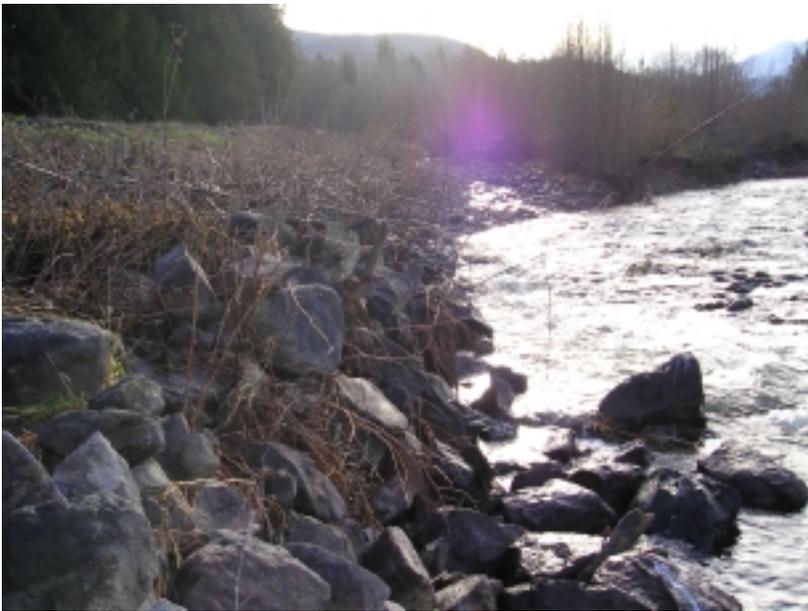
Dungeness Meadows Levee lost toe and vertical banks looking upstream near Station 10+00.

A) Dungeness Meadows Levee – Toe loss at levee station 7+00 has resulted in vertical slopes approximately five feet high. It was assumed that the levee would continue to erode at a 3:1 horizontal to vertical stable slope. The resulting reduction in levee height is considered to be the current protection level. The procedure is shown in *Figure E*. The toe loss present in December of 2003 reduces the current level of protection to a 15-yr flood event with zero freeboard. Predicted inundation levels of the Dungeness Meadows residential area for various flood events occurring after a possible failure of the levee are shown in *Figure F*.

A) Dungeness Meadows Levee – To repair the levee to its pre-flood condition, the toe and launchable toe must be replaced. The launchable toe provides a volume of material that will fall into a developing scour hole. The function of the launchable toe is to prevent the loss of riprap into the scoured region and to provide protection for the increased surface area due to scour. Up to 25 ft³/ft of riprap has been eroded along the damaged area, and 50 ft³/ft of additional riprap is needed to line the developing scour hole. This results in 2.5 cubic yards of riprap per linear foot, or a total of 1250 cubic yards for the 500 foot damaged section. *Figure H* shows the hydraulic characteristics along the levee. The channel is relatively steep producing near critical flows with average velocities ranging from 8 to 10 cfs at a 10-year event. Actual velocities at a sharp bend in the river can often be double the average computed velocities. Thus, class III riprap (30" material) should be used for this reach of the river.

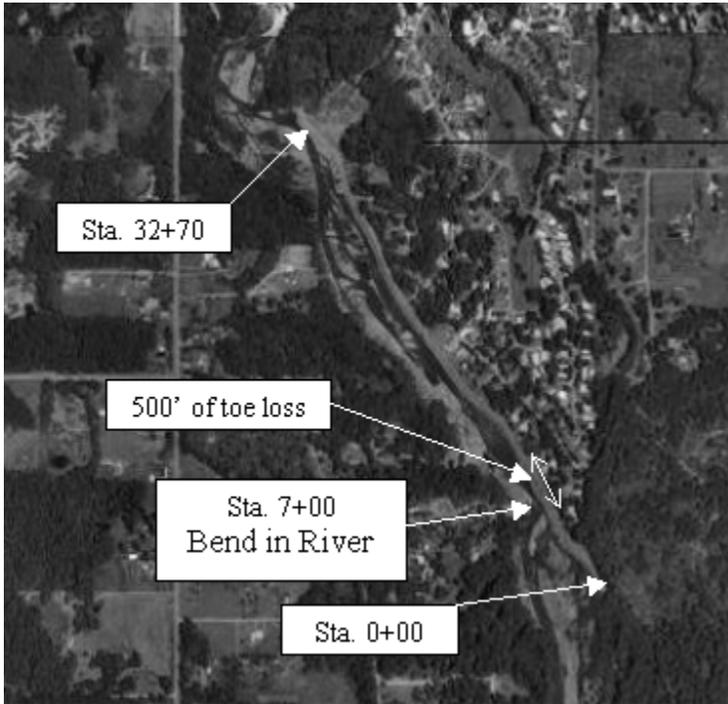
Figure D – Aerial Photo of the Dungeness Meadows Levee, 1985.

4. **Original Construction / Repairs:** Two levees on the Dungeness River (shown in *Figure A*) were investigated. Details are as follows:
 - A) Dungeness Meadows Levee – The Dungeness Meadows levee spans from River Mile 8.6 (Levee Station 0+00) to River Mile 7.98 (Levee Station 32+70) and is maintained by the Dungeness Meadows Homeowners Association (DMHA). The levee failed in the late 1970's and was rebuilt in 1980 and rehabilitated in 1981 and 1986. Using survey data from 1990, and modeling in HEC-RAS version 3.1, the levee was found to provide protection against the 100-yr flood with three feet of freeboard. The performance of the 1990 levee is shown in *Figure C*. The most recent levee inspection prior to 2003 occurred on 22 March 2002, a few months after the flood of record. The levee appeared to have held up against the flood, but the DMHA was recommended to closely monitor the levee at station 7+00, where the river makes a sharp bend (*Figure D*).
