Rehabilitation of Flood Control Works, Yakima Authorized Right and Left Bank Levees

AMENDED FINDING OF NO SIGNIFICANT IMPACT (FONSI)

Rehabilitation of Flood Control Works Yakima Authorized Right and Left Bank Levees

Supplemental Environmental Assessment for Right Bank
Site 5

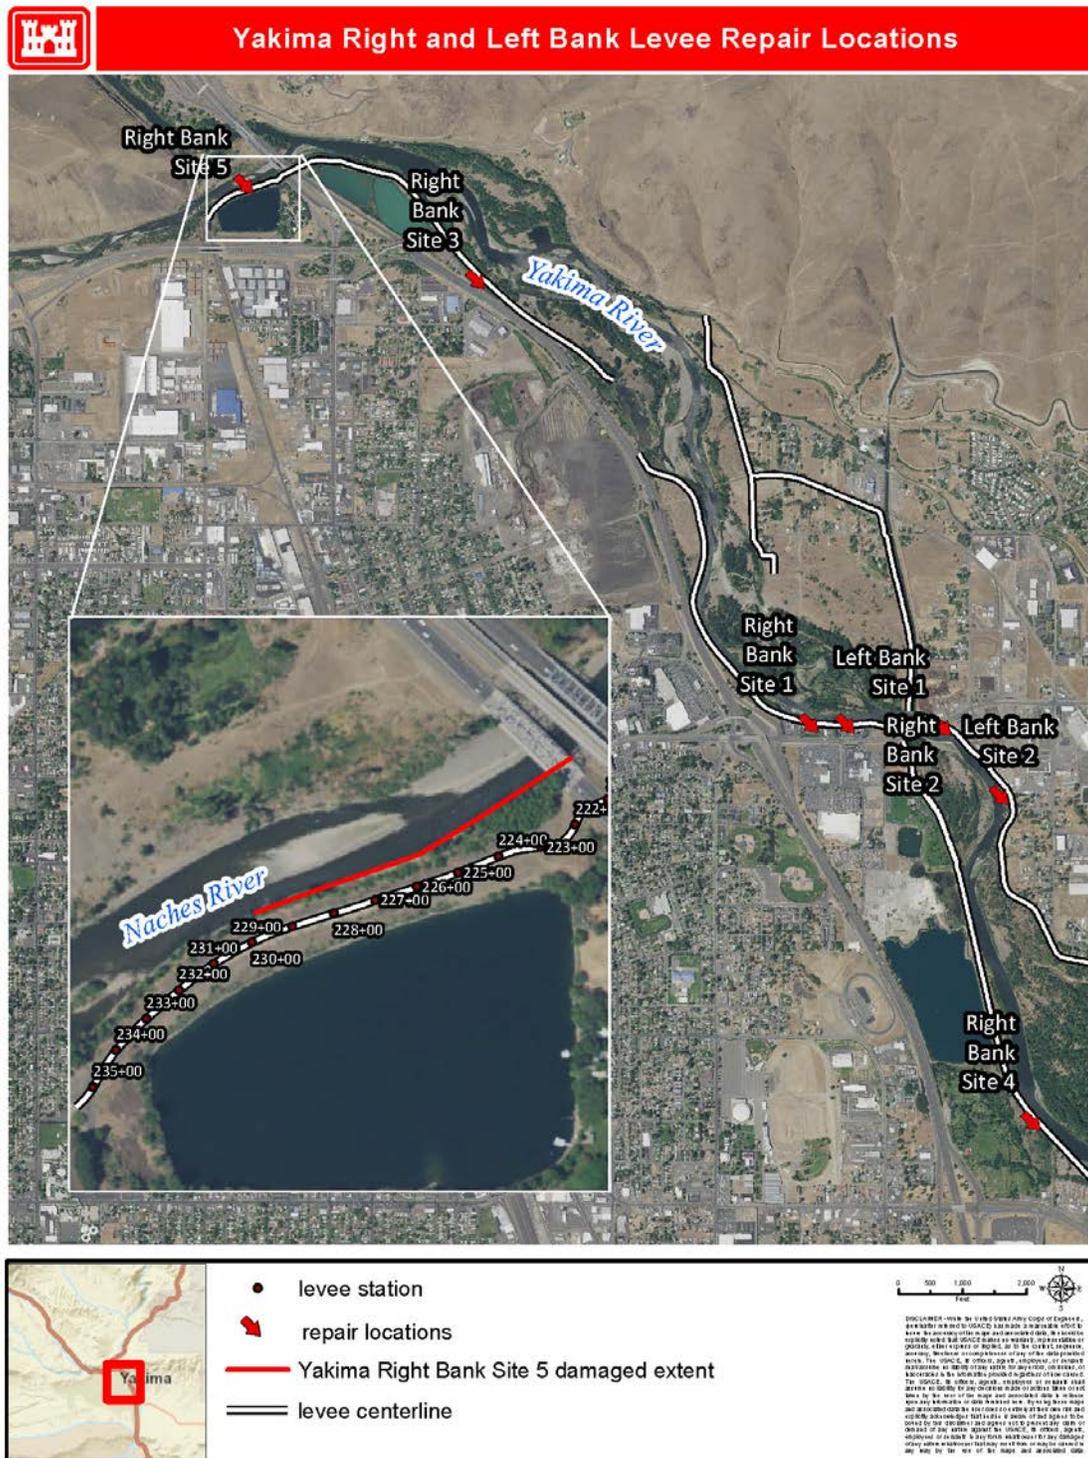
Figure 1. Location of all Yakima Right and Left Bank levee repairs and damage extent of Right Bank Site 5.

Damages to Site 5 extend from below the I-82 Bridge upstream 880 feet. This corresponds to Station 229+80 to 221+00. The damage consists mostly of loss of toe rock while a portion of the path under the bridge is falling into the river. Photographs of the damaged levee are found in Appendix A and Figure 1 illustrates the approximate extent of damage at Yakima Right Bank Site 5.

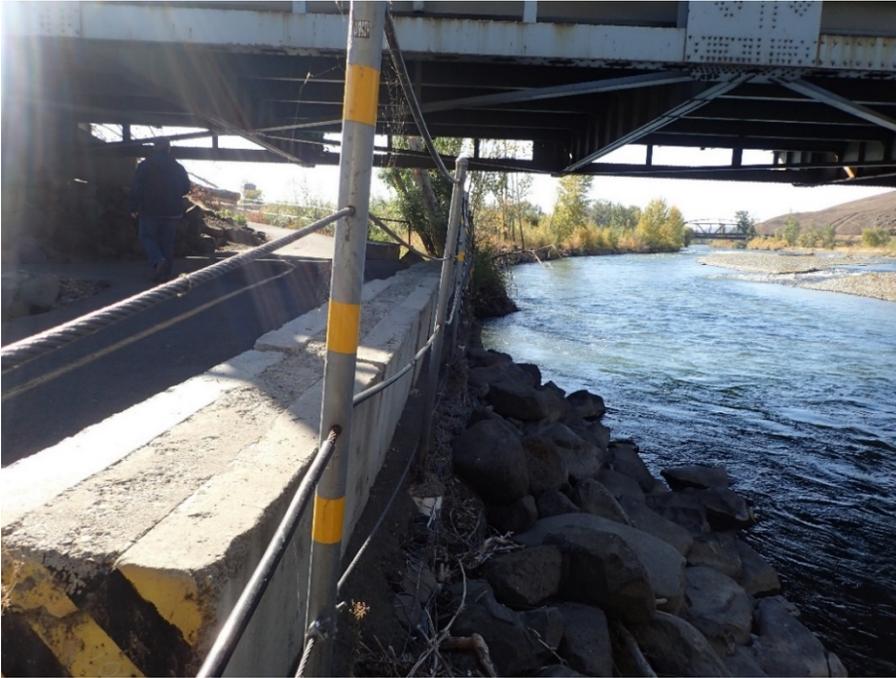
Photo 1. Photo taken from under the I-82 Bridge, looking upstream along the Naches.

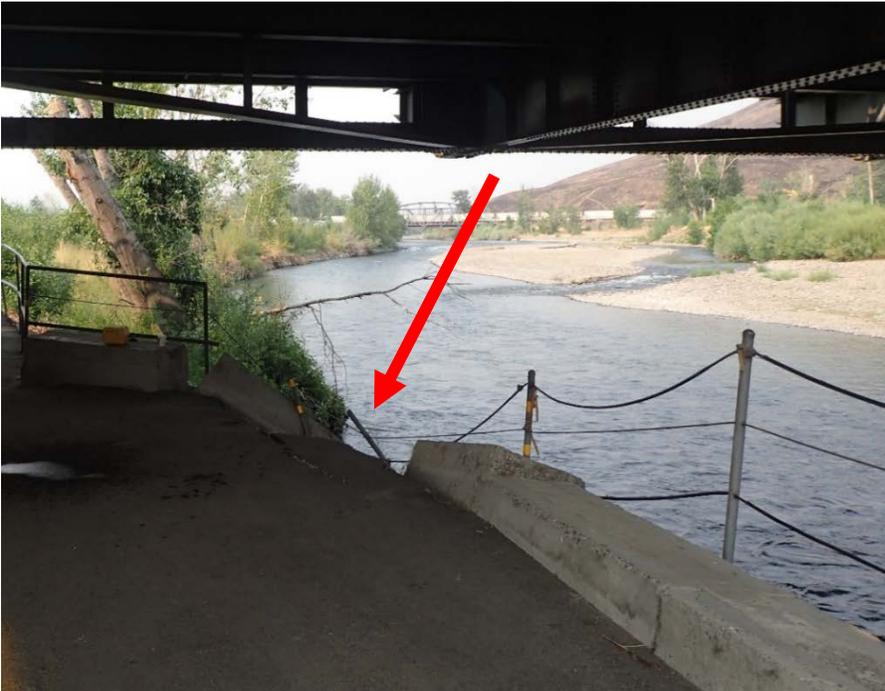
Photo 2. Damage located under the bridge includes erosion along the toe and undermining of the trail so that it is falling into the river. Photo is taken looking upstream along the Naches River from under I-82.

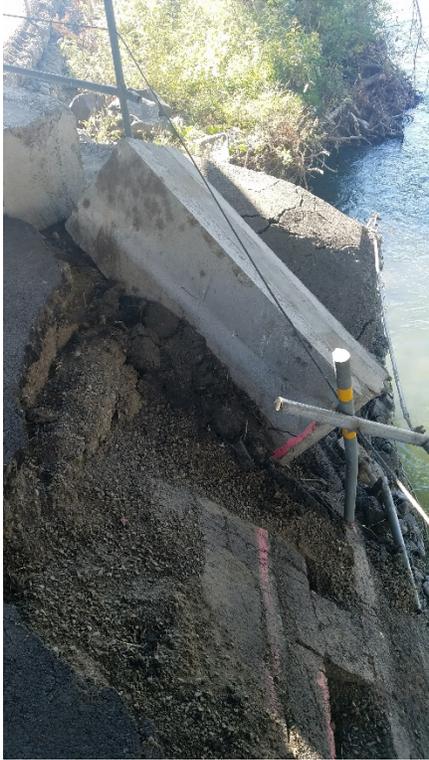
Photo 3. Another view of the damage underneath the bridge showing material eroding into the river below the bridge.

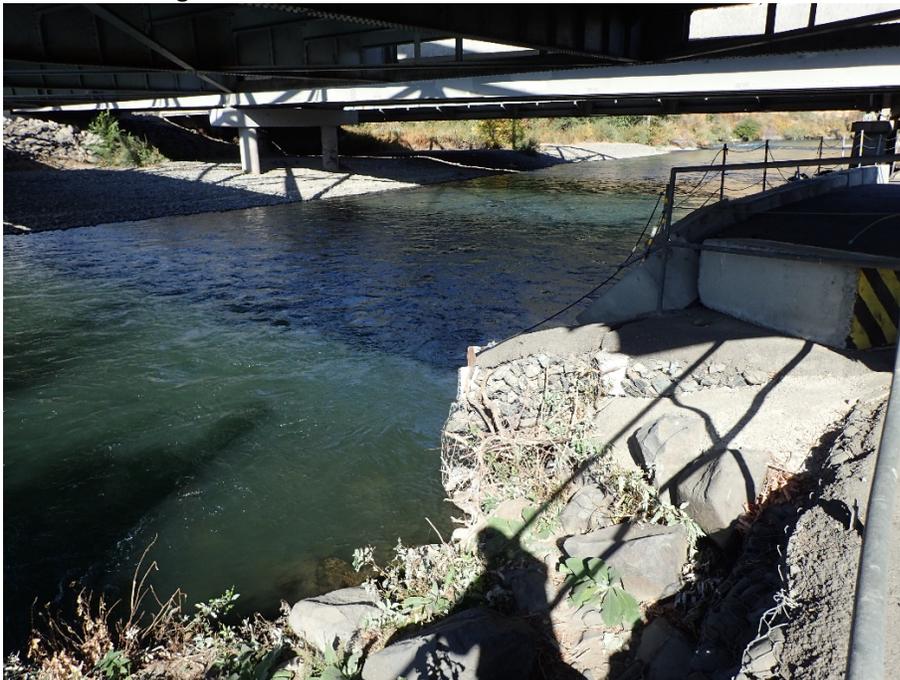
Along part of Section B flood waters washed away the riprap toe, daylighting gabion boxes and parts of the concrete bridge foundation of the bridge. Since little to no soil or levee embankment material is exposed, quarry spalls are not required. Therefore, only riprap would be placed in this section.

Photo 4. Another view of the damage underneath the bridge, including armor and exposed gabion boxes and concrete bridge foundation.

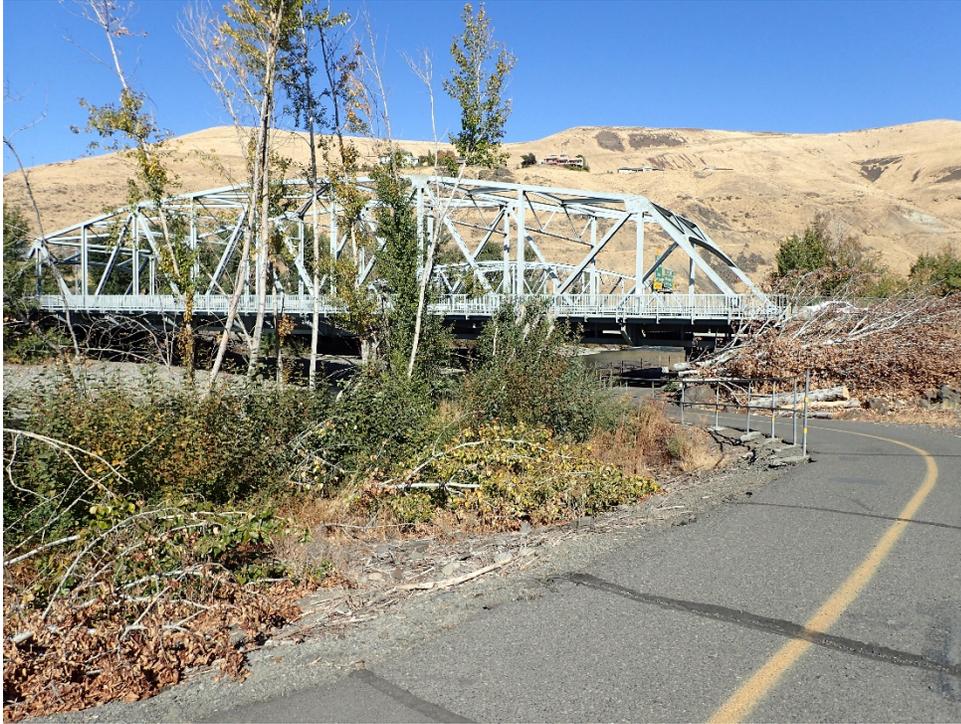
Photo 5. On levee top looking down the path which snakes along the levee downstream towards the I-82 Bridge.

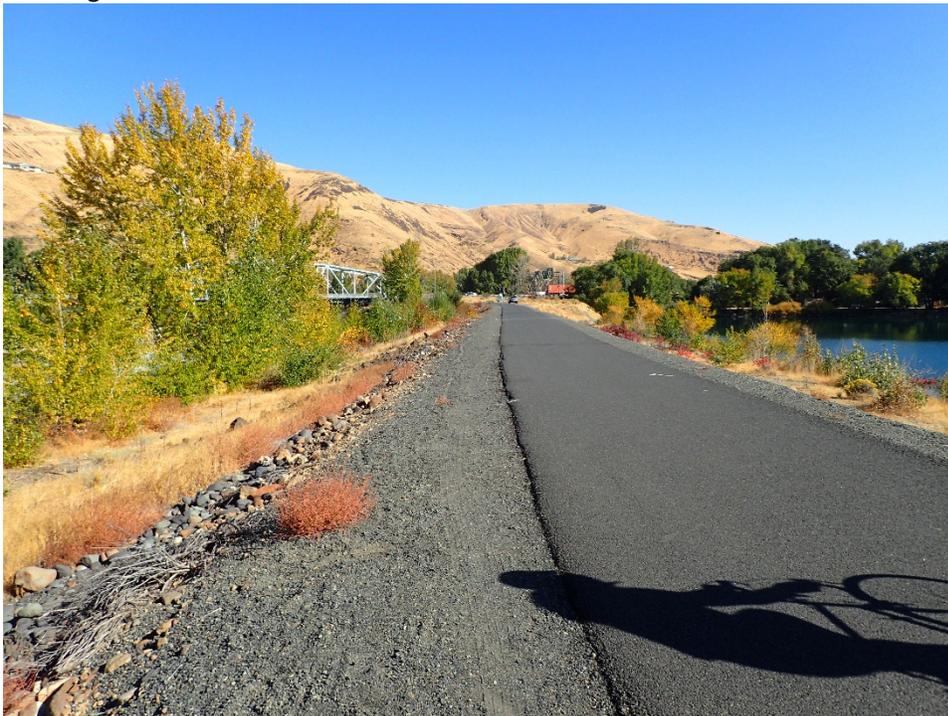
Photo 6. On top of levee looking downstream towards the I-82 Bridge. Upper slopes of riverward levee relatively free of vegetation for a majority of its length.

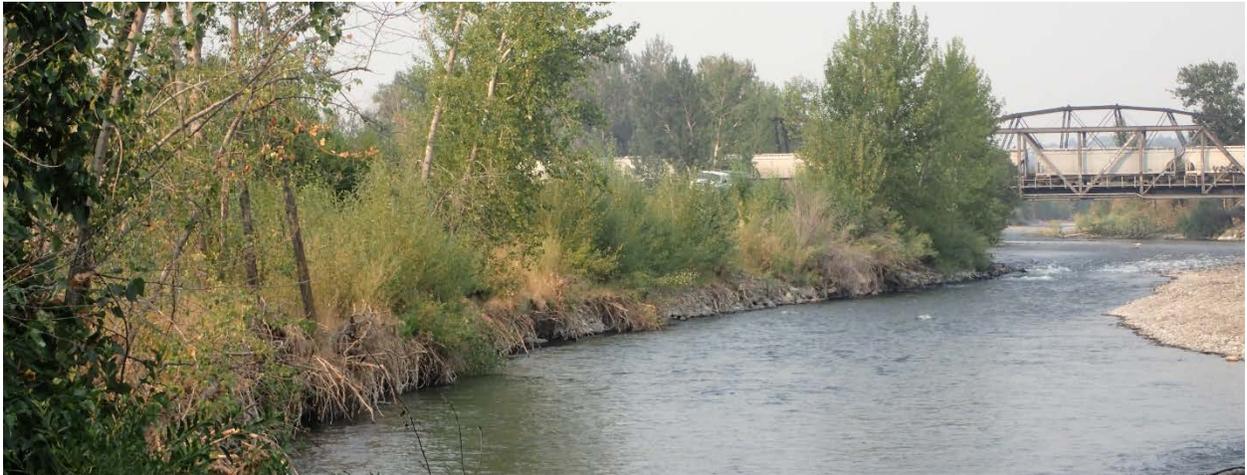
Photo 7. Photo taken below the I-82 Bridge looking upstream. Damages along levee riverward toe evident.

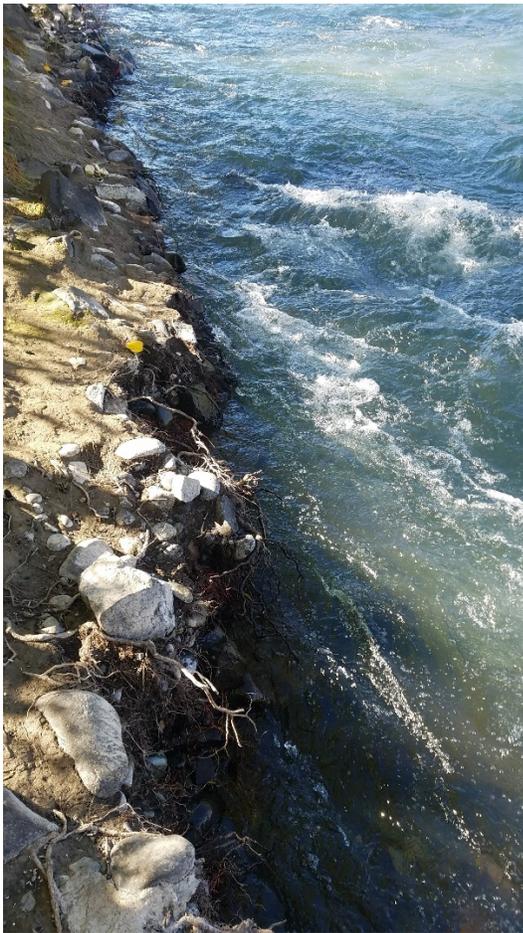
Photo 8. Close up on a section of the damage.

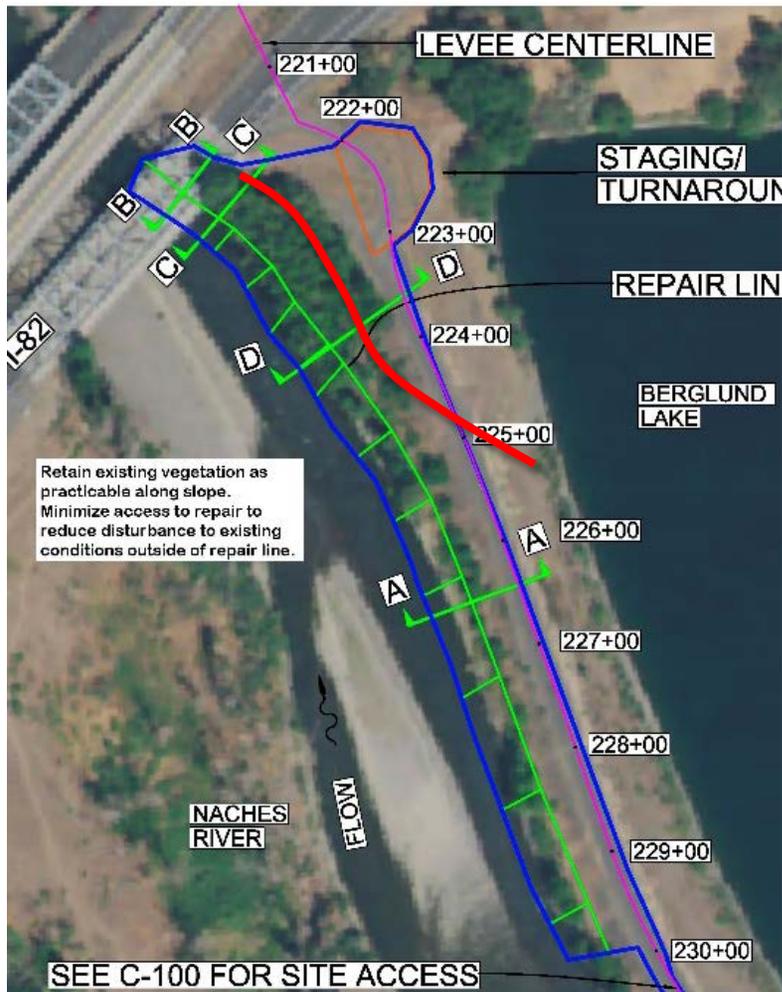
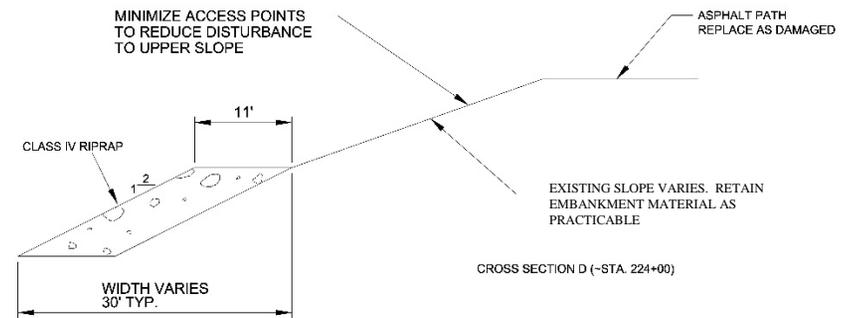
Typical Section D cross section. Mid-slope bench width varies. Note this cross section is missing the willow bundles which are in the design plan packet drawing for Site 5 (previous page).

This page contains details used in consultation with USFWS and NMFS. Cross Section D and this ingress path was created to show typical conditions at this part of the repair. Due to similarity in shape to Section A, it was not included in the final designs. However, it is included here to show the possible ingress to reduce vegetation impacts (See Note 13 above in the design plan).
