MEMORANDUM FOR: RECORD

**SUBJECT:** DETERMINATION REGARDING THE NO-TEST STATUS OF DREDGED MATERIAL FROM THE MOUTH OF THE BIRCH BAY VILLAGE MARINA ENTRANCE CHANNEL, WHATCOM COUNTY, WASHINGTON.

**Subject:** Maintenance Dredging Permit Renewal

**Birch Bay Village Community Club Marina:  
Coastal Processes Study &  
Analysis of Options for Dredge Spoils Disposal/ Beach Nourishment**

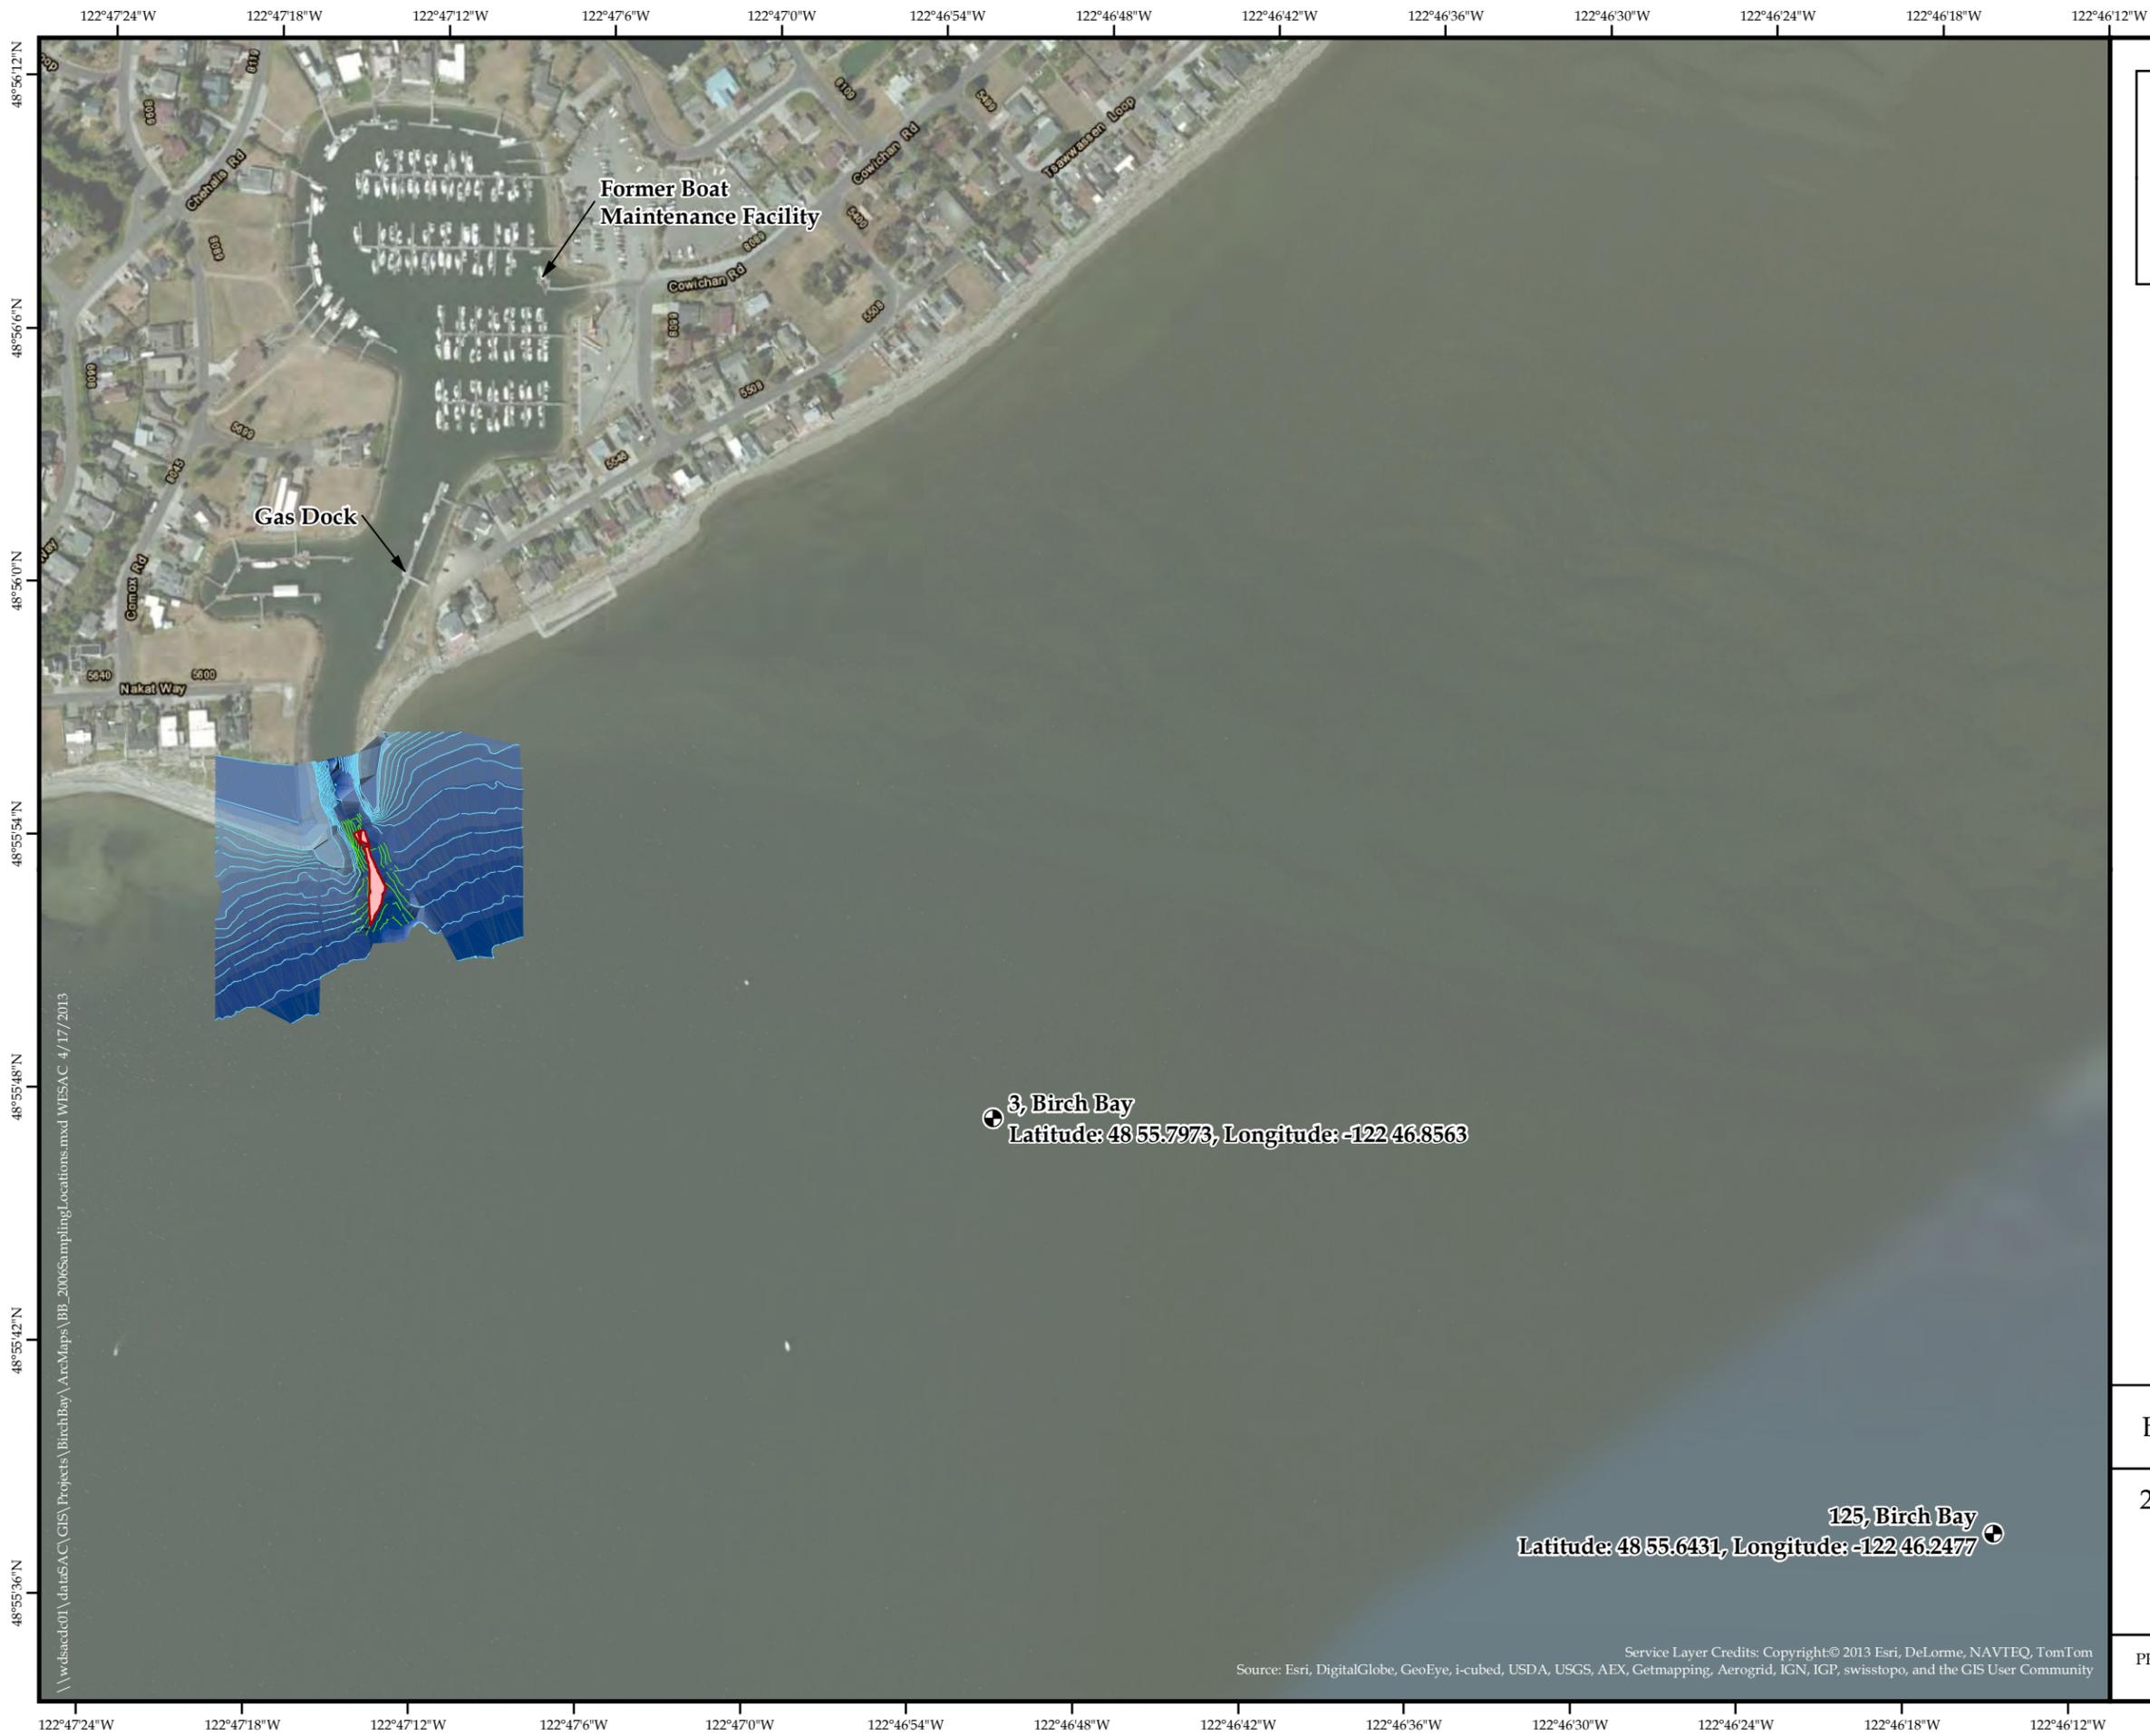
Figure 2

The marina fueling facility is located approximately 650 feet north of the project area (Figure 2). A non-serviceable boat maintenance rack that has not been used for years is located approximately 1,400 feet north of the project area. These potential sources are unlikely to impact the quality of sediment at the channel entrance.

Surface sediment samples from two locations within Birch Bay were collected and analyzed as part of a sediment quality survey that Ecology conducted (Sites 3 and 125; Figure 2) in 2006. The sample locations are proximate to the project site (Ecology 2012). Neither of these samples in the 2006 study had contaminant concentrations exceeding Sediment Quality Standards (including the samples from locations 3 and 125 in Birch Bay). The sediments in the Strait of Georgia region are largely non-toxic to benthic invertebrates in controlled laboratory tests.

2014 Marina Maintenance  
Dredging Project  
Nearest Sediment  
Sampling Sites

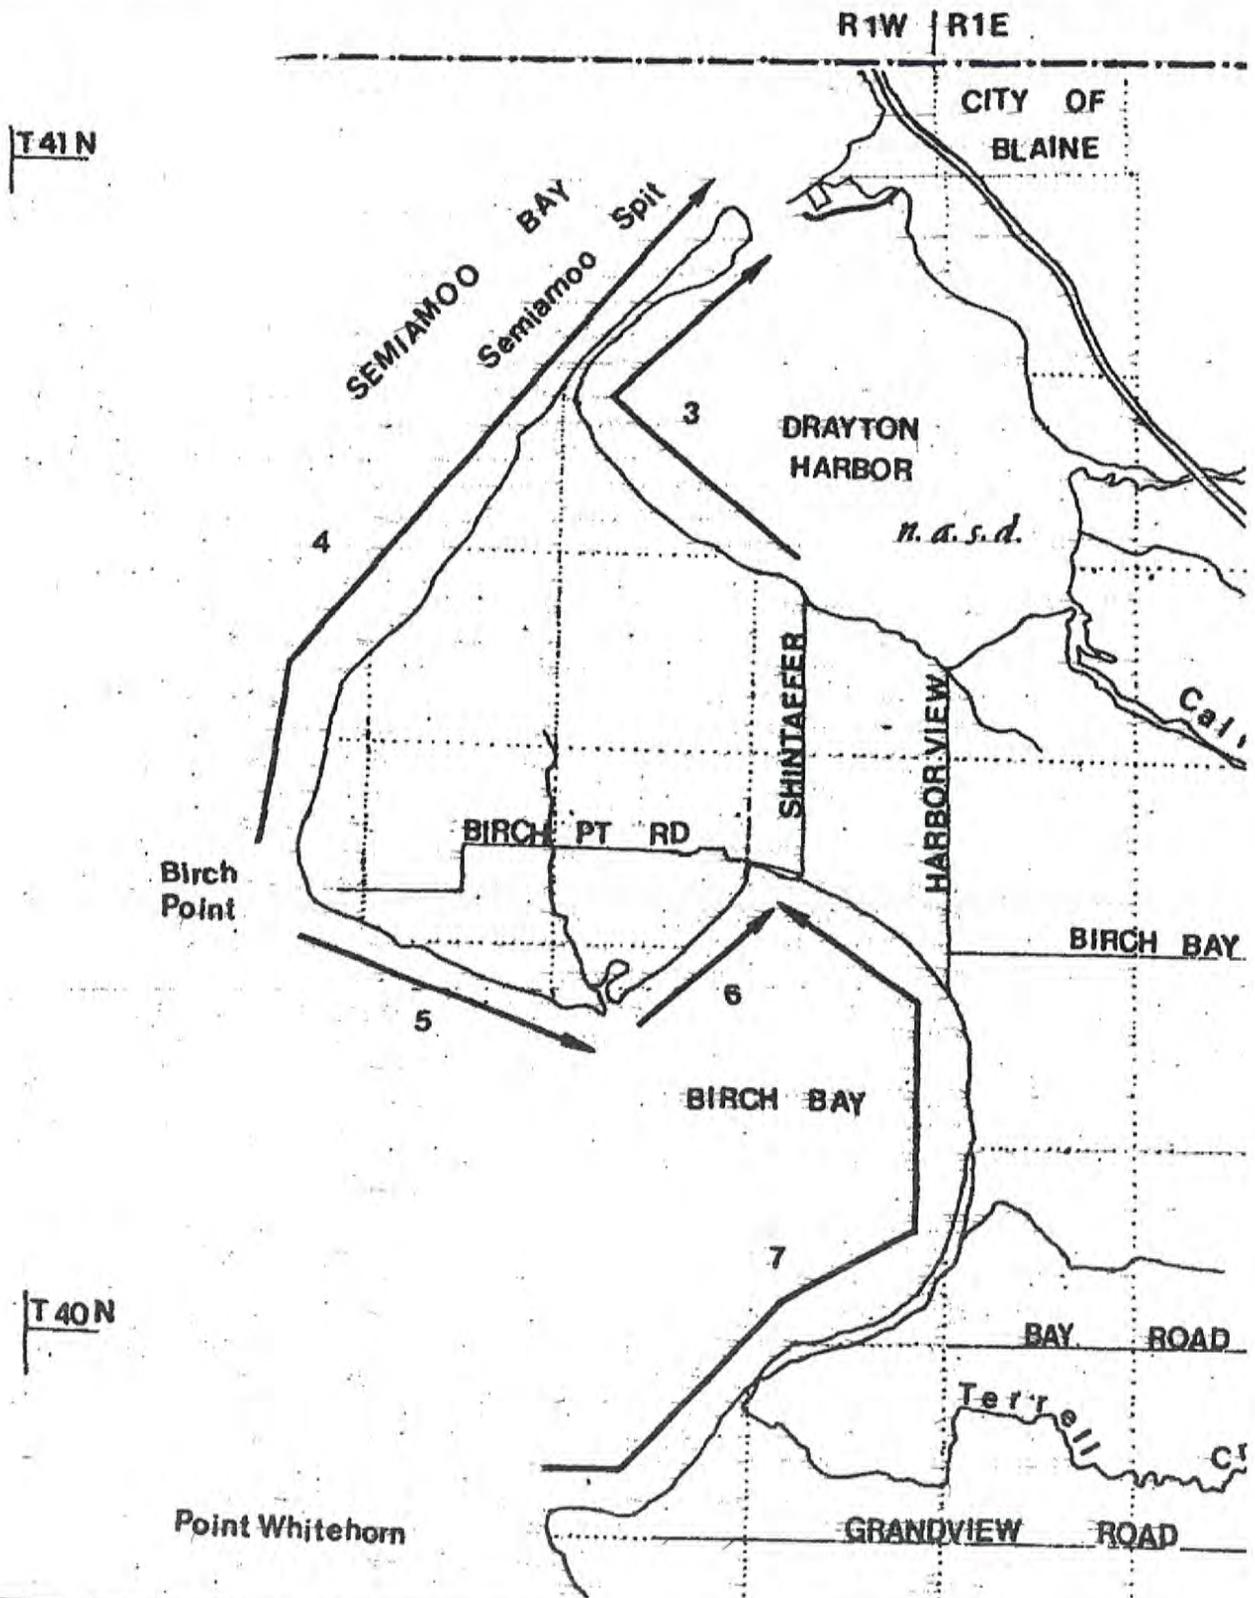
**Evidence:** Sediment grades finer from the marina to the northeast. The marina jetty shows accumulation on its southwest side and erosion on its northeast side. The erosion is now endangering several homes. This entire sector is an accumulation beach formed by a series of nested spits. These were built by waves generated by predominate northwest winds blowing across the 145 kilometer (91 mi.) fetch along the Strait of Georgia, which refract around Birch Point and the unnamed protuberance of the coast at the marina site, and continue into Birch Bay. Although these nested spits have been somewhat obscured by recent construction, they are still vaguely visible as a series of low, parallel ridges. At the most northerly corner of Birch Bay, at the end of this sector, a northeasterly prograding lobe of sediment nearly closes a small lagoon.

Figure 2. Net-shore drift map of the Birch Bay area from (Schwartz, et al., 1991).

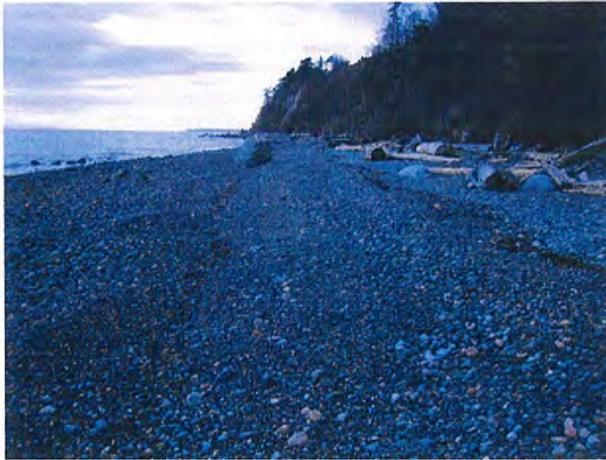
**Figure 3.** High-tide beach in the area west of the accretionary prism. Note mixture of pebble, sand, and cobble, and backshore area with drift logs.

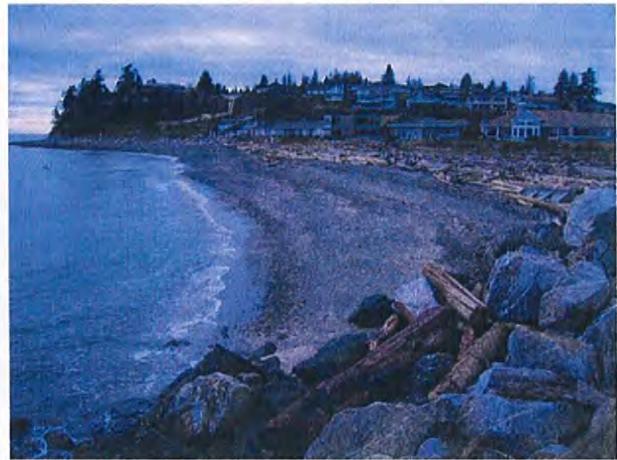
**Figure 4.** high-tide beach in the accretionary prism. Note sandy beach and very wide backshore area.

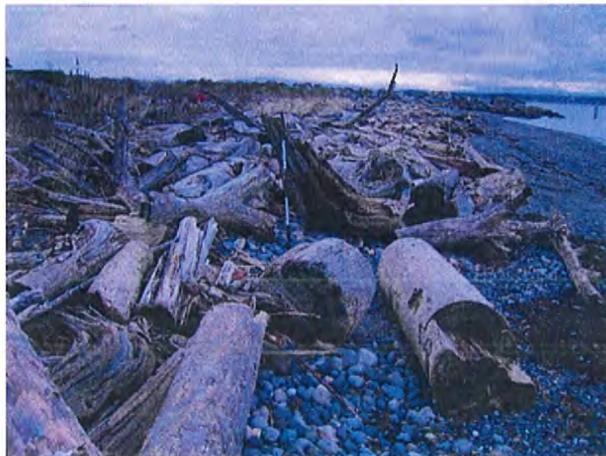
**Figure 5.** Backshore area in accretionary prism looking east. Note wide backshore area and sandy upper high-tide beach.

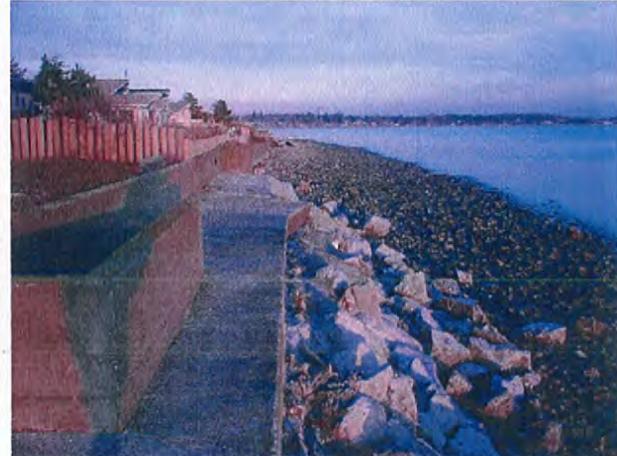
The 3 different areas described above also contain very different backshore areas. The area west of the accretionary prism has a narrow backshore area that contains drift logs. The backshore area in the accretionary prism is a very wide area that also contains dunegrass and abundant drift logs (Figure 5). The area east of the east jetty does not have a backshore area. The high-tide beach meets the toe of a row of bulkheads (Figure 6) at elevations that appear to be below MHHW (mean higher high water). The bulkheads in this area show many signs of beach lowering (erosion). The majority of the bulkheads in the 8 houses east of the entrance channel have had a new footing installed one or two times. This must have been in response to dramatic beach lowering and partial bulkhead failure (cracks). There was evidence for significant erosion of at least several feet (vertical) in the damage and changes in the structures, and likely more beach erosion occurred.

**Figure 6.** High-tide (cobble) beach east of east jetty. Note presence of continuous line of bulkheads and expended bulkhead toe protection.

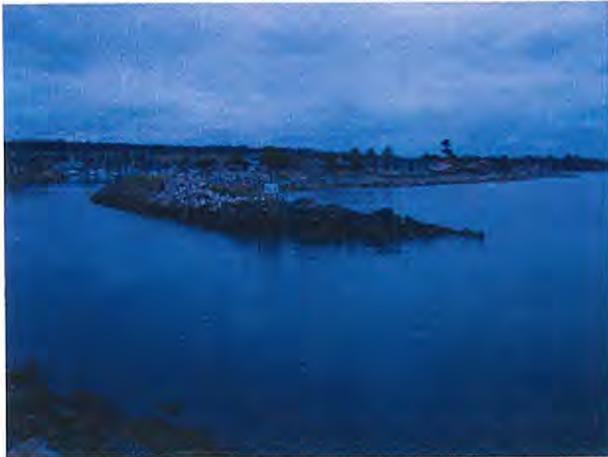
**Figure 7.** Entrance channel and east jetty looking NE. Photo taken at mid-tide from the outer end of the west jetty.

The entrance channel is generally 75-85 ft wide between the 0.0 ft MLLW contours as surveyed in late 2000 (Bluewater Engineering 2000, and Figure 7). The maximum channel depth in the inner channel (landward of the end of the E jetty) is around -8.0 ft MLLW (Bluewater Engineering 2000). The depth in the center of the channel east of the tip of the west jetty is generally -3 to -5 ft MLLW, with the deepest part of the channel a little deeper than -5.0 ft MLLW (Bluewater Engineering 2000). Depth measurements at selected sites were made by CGS through wading the channel area in January 2001. The measurements were correlated to preliminary tidal observations provided on a NOAA Internet site for elevation control. Field measurements and observations by CGS verified the Bluewater Engineering mapping.

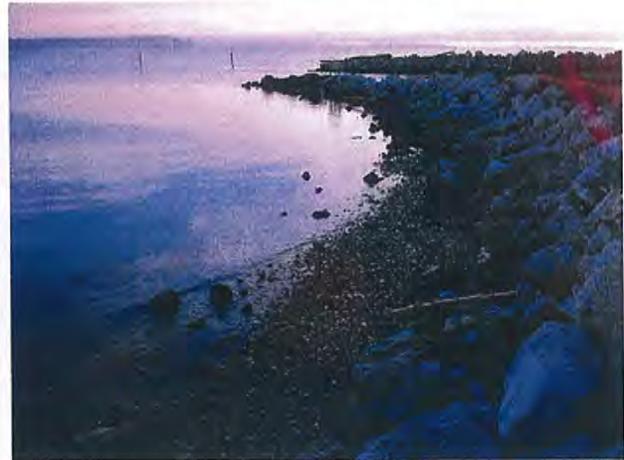
**Figure 8.** East jetty and entrance channel area, looking SW.
