NEAH BAY SECTION 107  
NAVIGATION IMPROVEMENT PROJECT  
NEAH BAY, WASHINGTON

APPENDIX C  
MARINE VEGETATION SURVEY

May 2018

**Neah Bay Channel Navigation Improvement Project: Marine vegetation in the area of proposed sediment disposal**

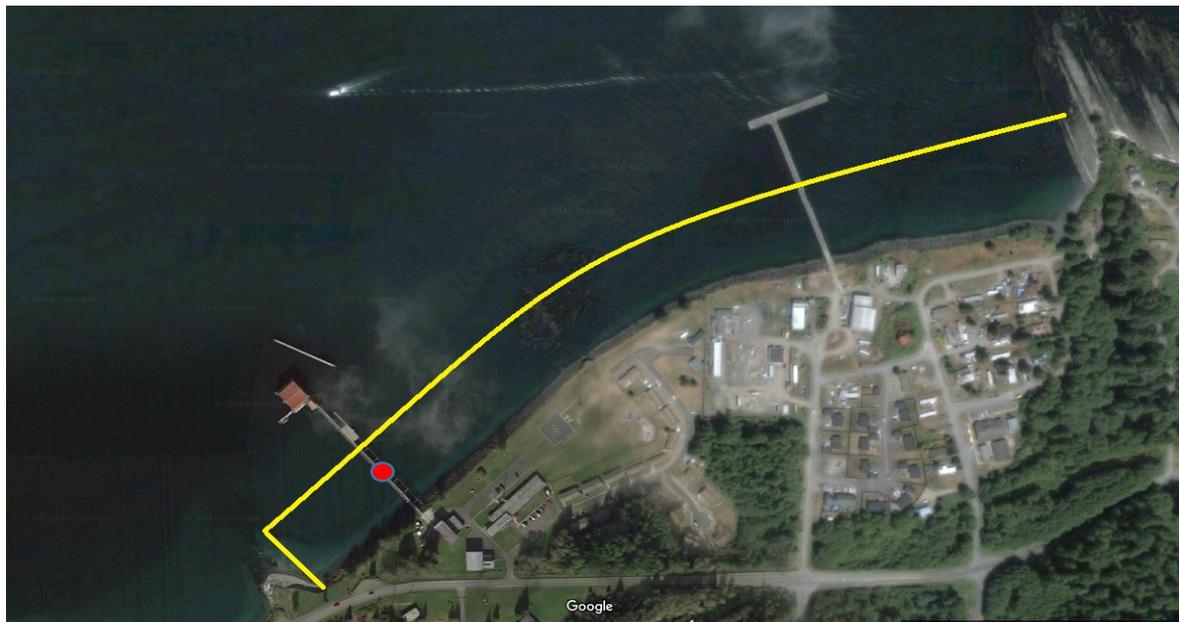
pier. This band extended from the USCG pier east roughly half way to the eastern pier. These findings were consistent with other Environmental Assessments from the area including the 2009 EA about Fish Gap Maintenance which found “no vegetation is present within the fish gap or Evans Mole,” Evans Mole being the western extent of our survey area. A 2005 marine survey by Pentec Environmental around the area of the USCG dock also observed no eelgrass.

Figure 4. Rough outline of eelgrass survey area. Approximate location of patch of eelgrass is marked with a red dot.

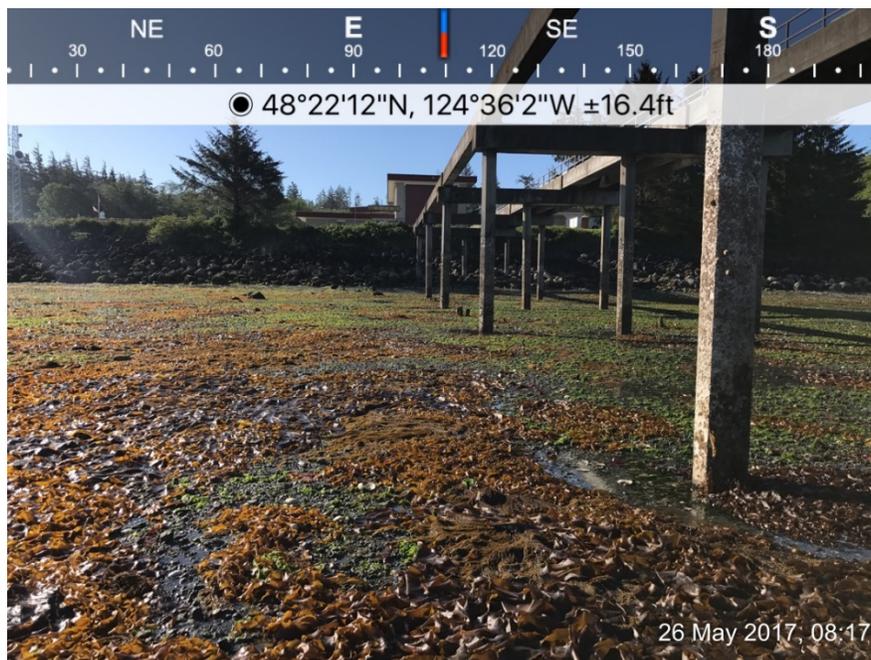
Figure 8. Standing next to the USCG pier looking shoreward.

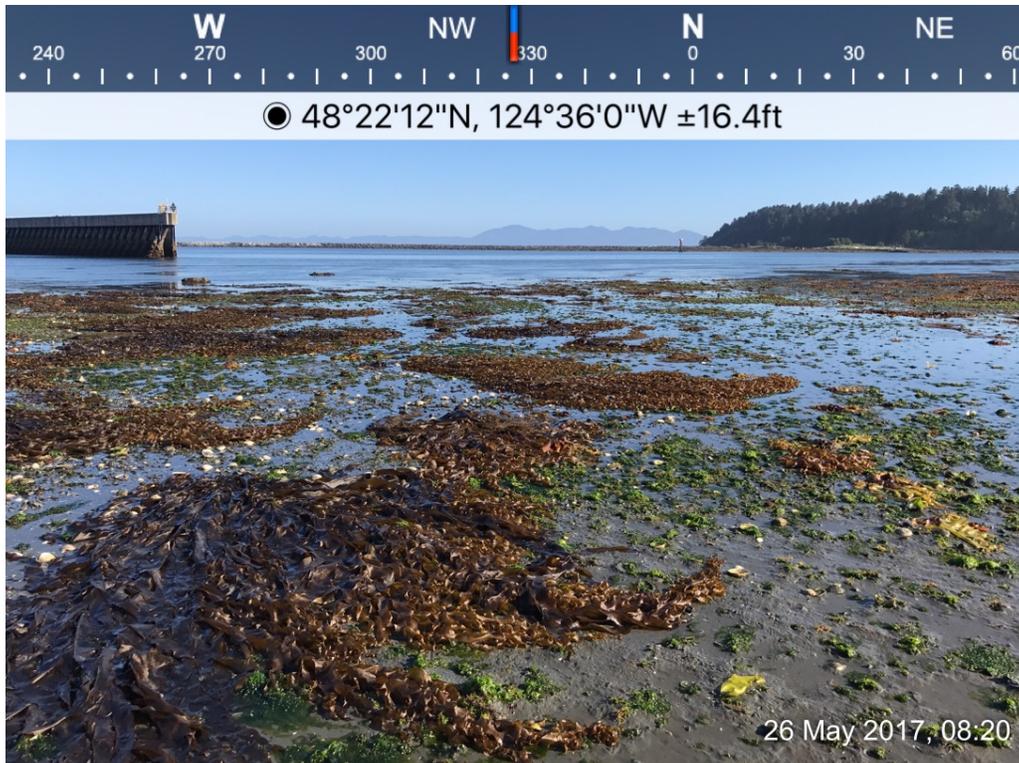
Figure 9. Looking seaward just east of the USCG pier.

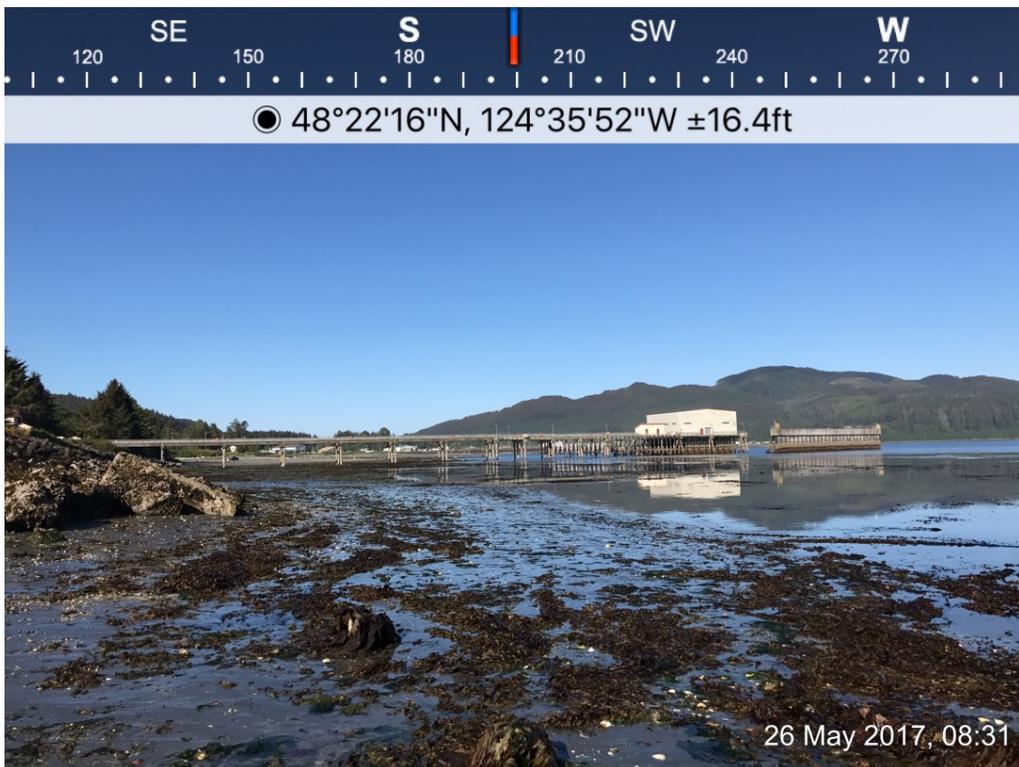
At the request of the Army Corps of Engineers a second shoreline survey was conducted during a -2.46 ft. tide on the morning of May 26, 2017. The verified tidal height ended up being just under -3 ft. (Figure 7). A much larger portion of the shoreline was exposed compared to the first survey and the weather provided greater visibility. Bill Parkin and Josh Buckingham of the Port of Neah Bay walked the proposed disposal area, took pictures, and once again checked out the site where grasses had been seen during survey 1. They did not see any seagrasses; the predominant vegetation was *Ulva spp.* (sea lettuce) especially around the USCG pier (Figure 8). As noted in survey 1, there are whole and partial clam shells scattered across the sand (Figure 9). As you move eastward down the shoreline toward the other dock the amount of vegetation decreases (Figure 10, Figure 11).

Figure 10. Shoreline view approximately halfway in between the two docks.

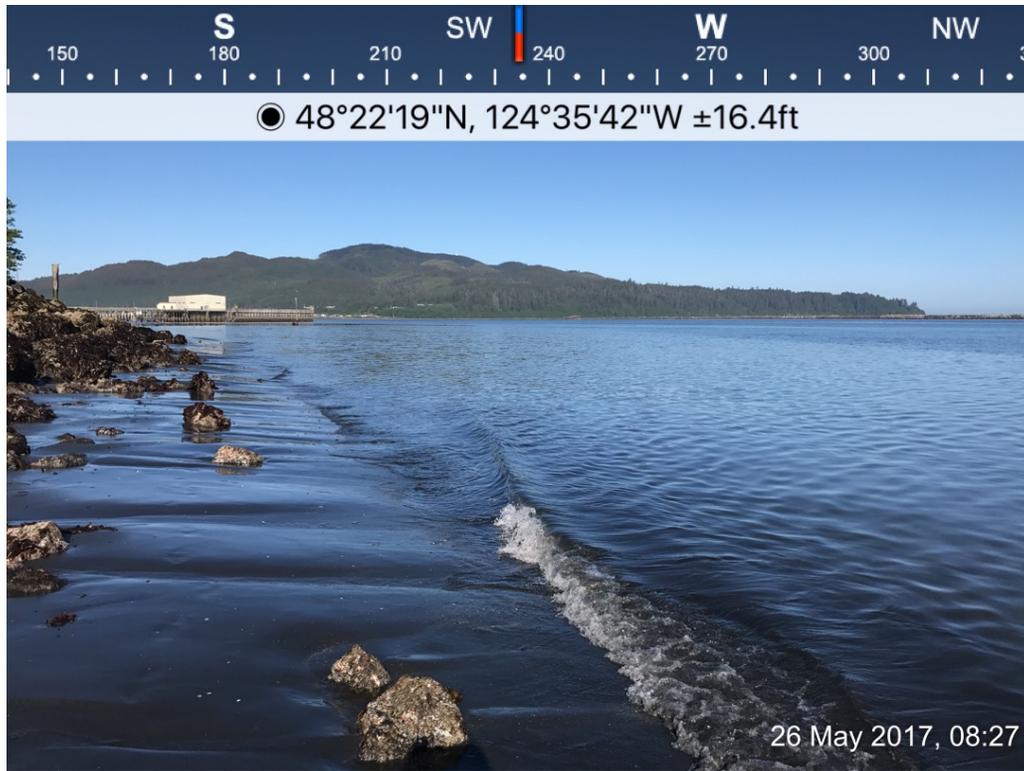
Figure 11. Shoreline view facing the USCG dock taken just west of the second dock.
