FINDING OF NO SIGNIFICANT IMPACT (FONSI)
MOULTON DAM #1 SPILLWAY AND EMBANKMENT IMPROVEMENTS PROJECT
BUTTE-SILVER BOW COUNTY, MONTANA

Title: Moulton Dam #1 Spillway and Embankment Improvements Project

Moulton Dam #1 Spillway and Embankment Improvements

Feasibility Report

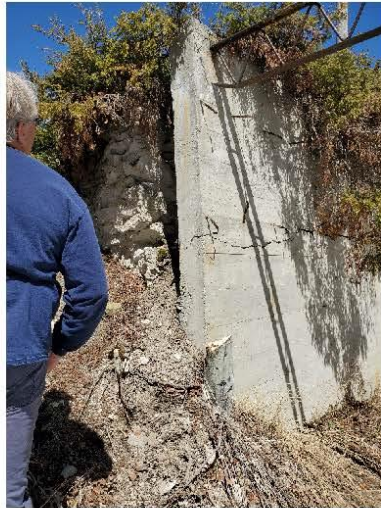
- The portion of the spillway that is concrete has significant structural issues including concrete deterioration, degradation, truss failure, erosion, and evident wall movement/buckling/cracking.
- The portion of the spillway that is earthen has considerable head cutting, erosion, seepage, piping of fine grain soils, woody debris, and trees.

Figure 3-1. Existing Spillway Wall

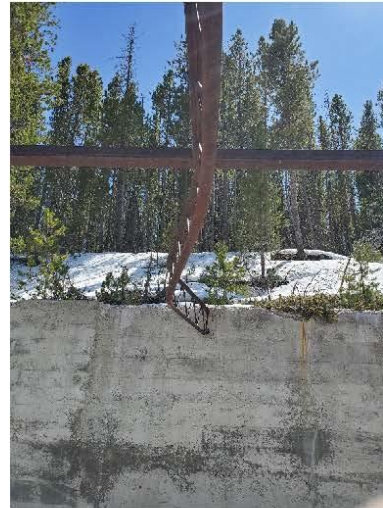
Figure 3-2. Existing Spillway Support Beams

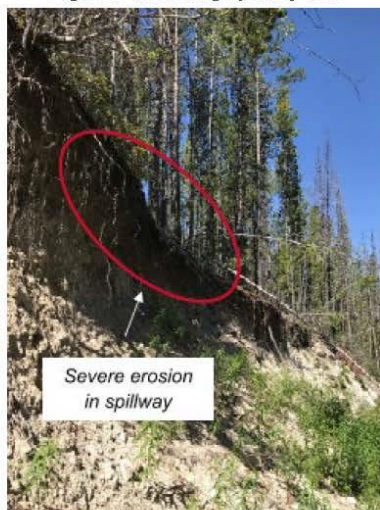
Figure 3-3. Spillway Erosion

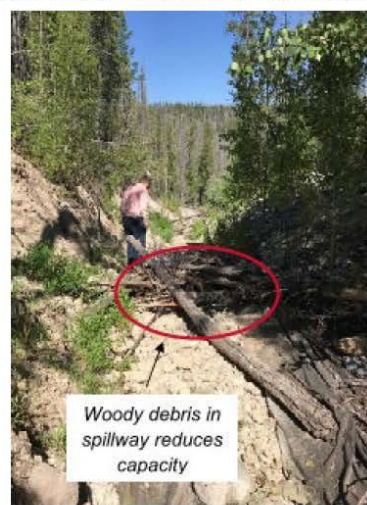
Figure 3-4. Spillway Debris

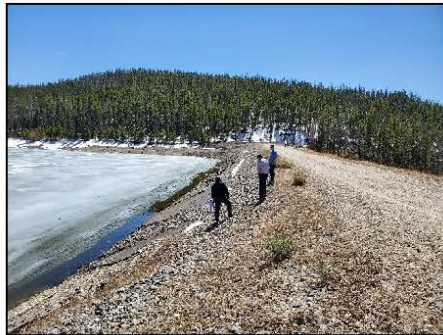
The existing dam was constructed in 1907 and has a 2:1 embankment slope with additional details provided above. In 1995 a geomembrane liner was placed on the upstream face of the dam to reduce seepage. Details on the geomembrane liner installation were not available. Based on visual observations, a geotextile is present over the liner and rock cover appears to have been placed over the top of the geotextile. The extent and design of the rock cover is unknown; however, rock cover is currently only present near the top and sides with most of the liner exposed. From bathymetric survey data, it also appears that material (assumed to be rock cover) has collected at the toe of the embankment. Therefore, it is assumed that the rock cover has sloughed off and collected at the toe of the embankment. Tires have been placed on the liner to hold it in place. As a result of the liner being unprotected and exposed to wave action, ice, and sun, it has degraded with damage and tears visible. Seepage along the dam embankment is also an identified issue and may increase as the liner continues to degrade. Figure 4-1 through Figure 4-4 show the existing dam embankment and liner.

Figure 4-1. Existing Dam Embankment and Liner (looking South)

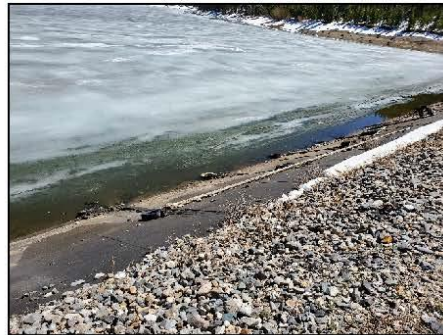
Figure 4-2. Existing Dam Embankment and Liner (looking East)

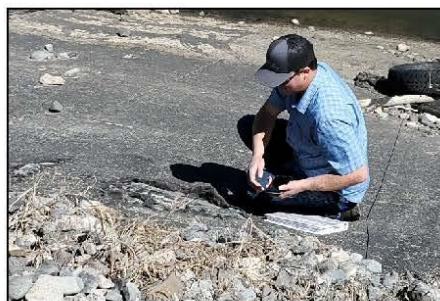
- The existing liner on the face of the dam has holes and tears. In addition, it appears to not be completely bonded across its extent.
- The liner is completely exposed to natural elements, which will result in further damage to the liner and continued degradation caused by sunlight.

Figure 4-4. Damage to Existing Liner
