Draft Environmental Assessment

Title: Moulton Dam #1 Spillway and Embankment Improvements Project

Prepared by the Non-Federal Sponsor: City and County of Butte-Silver Bow

January 2024

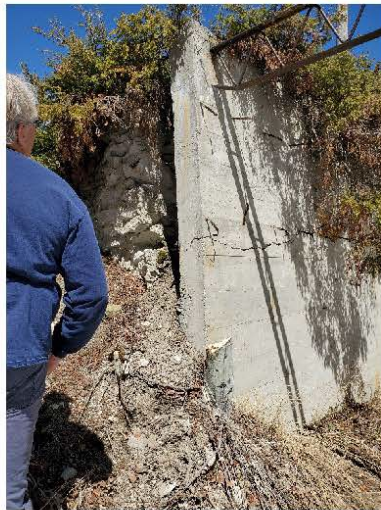
As described previously, the existing spillway is in poor condition. While the 'no-action' alternative has the lowest short-term cost, this option carries the highest risk due to the severe conditions of the existing structure. These known issues will persist and worsen, likely requiring possible emergency action in the future. This option also has the highest risk of catastrophic failure, which would ultimately result in the highest long-term cost. Photographs of the existing concrete and earthen spillway are shown in Figure 3-1 through Figure 3-4.

Figure 3-1. Existing Spillway Wall

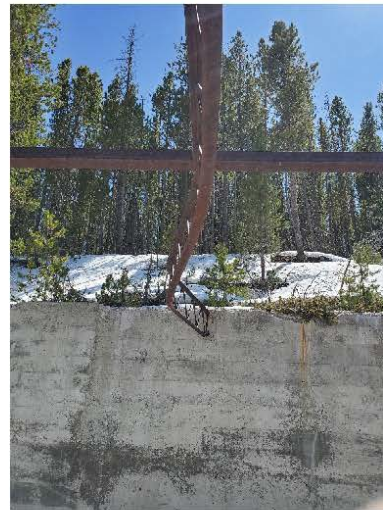
- The portion of the spillway that is concrete has significant structural issues including concrete deterioration, degradation, truss failure, erosion, and evident wall movement/buckling/cracking.
- The portion of the spillway that is earthen has considerable head cutting, erosion, seepage, piping of fine grain soils, woody debris, and trees.

Figure 3-2. Existing Spillway Support Beams

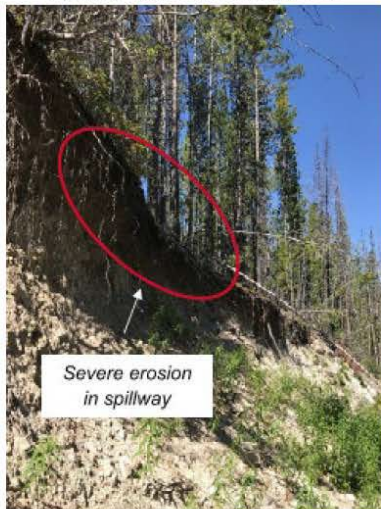
Figure 3-3. Spillway Erosion

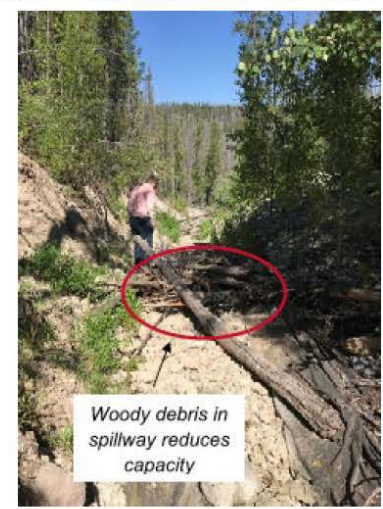
Figure 3-4. Spillway Debris

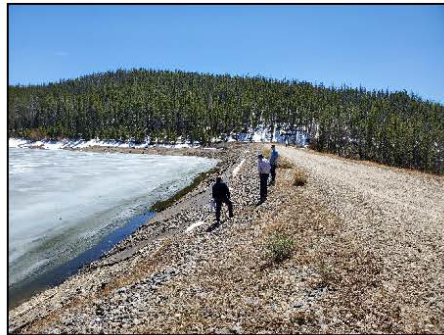
The existing dam was constructed in 1907 and has a 2:1 embankment slope with additional details provided above. In 1995 a geomembrane liner was placed on the upstream face of the dam to reduce seepage. Details on the geomembrane liner installation were not available. Based on visual observations, a geotextile is present over the liner and rock cover appears to have been placed over the top of the geotextile. The extent and design of the rock cover is unknown; however, rock cover is currently only present near the top and sides with most of the liner exposed. From bathymetric survey data, it also appears that material (assumed to be rock cover) has collected at the toe of the embankment. Therefore, it is assumed that the rock cover has sloughed off and collected at the toe of the embankment. Tires have been placed on the liner to hold it in place. As a result of the liner being unprotected and exposed to wave action, ice, and sun, it has degraded with damage and tears visible. Seepage along the dam embankment is also an identified issue and may increase as the liner continues to degrade. Figure 4-1 through Figure 4-4 show the existing dam embankment and liner.

Figure 4-1. Existing Dam Embankment and Liner (looking South)

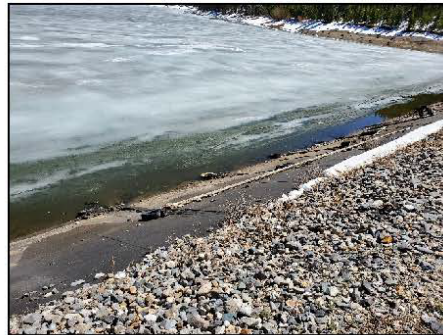
Figure 4-2. Existing Dam Embankment and Liner (looking East)

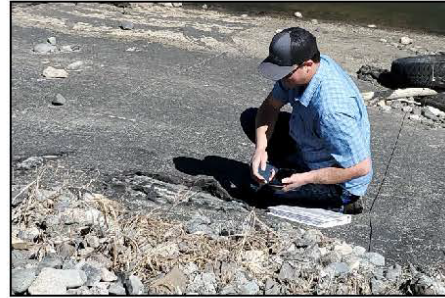
- The existing liner on the face of the dam has holes and tears. In addition, it appears to not be completely bonded across its extent.
- The liner is completely exposed to natural elements, which will result in further damage to the liner and continued degradation caused by sunlight.

Figure 4-4. Damage to Existing Liner
