LEVEE VEGETATION

National Policy and Regional Issues

Seattle District
US Army Corps of Engineers

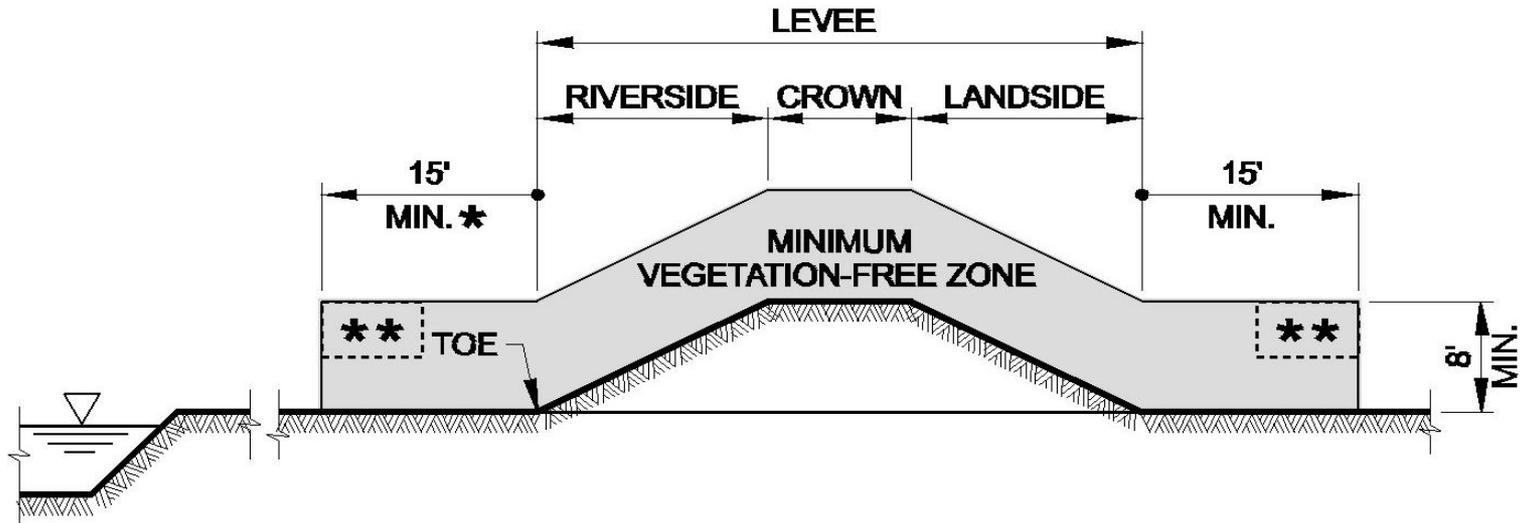
ETL 1110-2-571 Vegetation-free Zone for Basic Levee Section

* 15' OR DISTANCE TO EDGE OF NORMAL WATER SURFACE, IF LESS

** IN THIS 4' X 7' TRANSITION ZONE, TEMPORARY OBSTRUCTION BY LIMBS AND CROWN IS ALLOWED DURING DEVELOPMENT OF NEW PLANTINGS, FOR UP TO 10 YEARS

▽ NORMAL WATER SURFACE

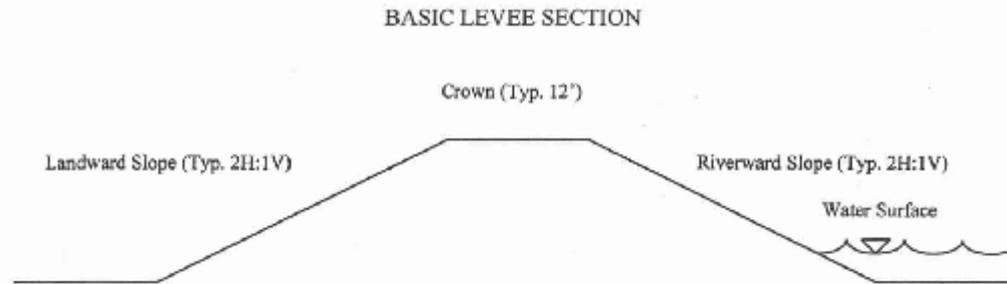
Seattle District Variance 1995

SLOPE	VEGETATION
LANDWARD SLOPE	Occasional woody vegetation less than 4" DBH. Spacing must allow for visual inspection of levee slope. 4' Dia. clumps of brush on 30' centers.
RIVERWARD SLOPE	Occasional woody vegetation less than 4" DBH. Spacing must allow for visual inspection of levee slope. 4' Dia. clumps of brush on 30' centers.
CROWN	Grasses which must be maintained for vehicle access. No woody stemmed vegetation.

1. Benches on the riverside of the levee can have unlimited growth as long as the root systems do not enter the levee prism.
2. Vegetation on all revetted riverward slopes designated as critical are limited to a maximum 4" DBH.
3. All levees will be managed to encourage herbaceous vegetation, shrubs and flexible stemmed type trees. (example: Hooker Willows)

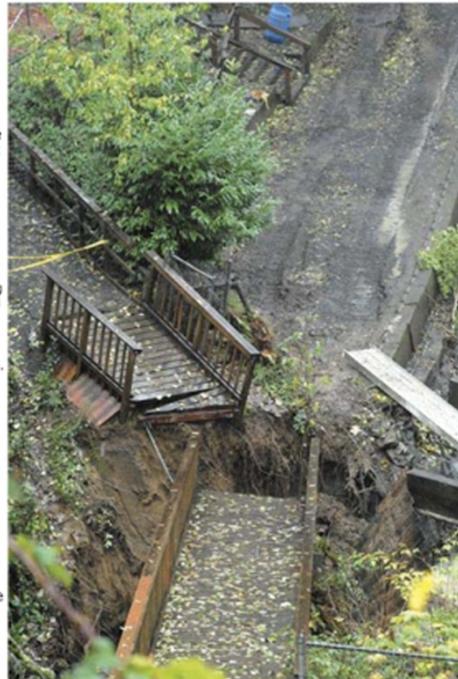
KATHY QUIGG | THE DAILY WORLD The Mill Creek dam burst Wednesday morning, breaking the pedestrian bridge at the north end of the Mill Creek Pond, and flooding nearby residential areas.

The Department of Ecology surveyed the area this morning and determined dislodged root balls from the fallen trees collapsed a three-foot by six-foot section of the dam. No homes were evacuated and no injuries were reported, ecology officials said. However, city officials said as many as 12 residences in Cosmopolis may have sustained some flooding where water was "above the sidewalk" said Police Chief Casey Stratton.

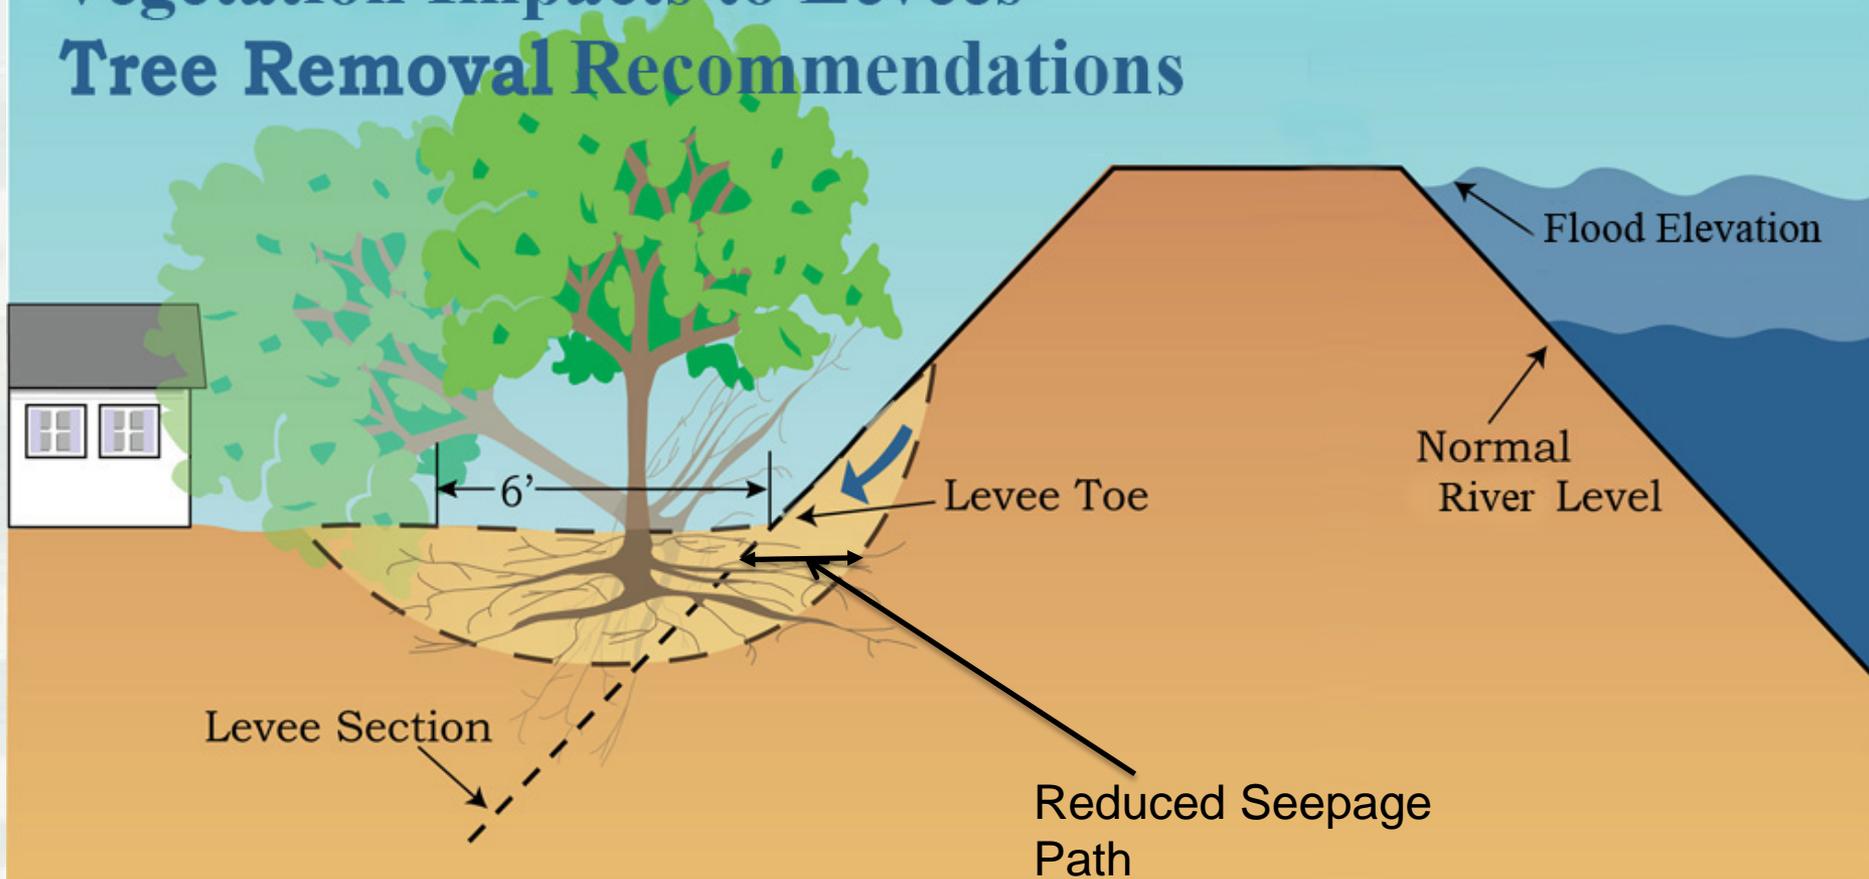
Tree Removal Recommendations

Roots of trees beyond the levee often extend into the levee section.
Roots ripped out weaken the levee, leaving paths for water to erode.

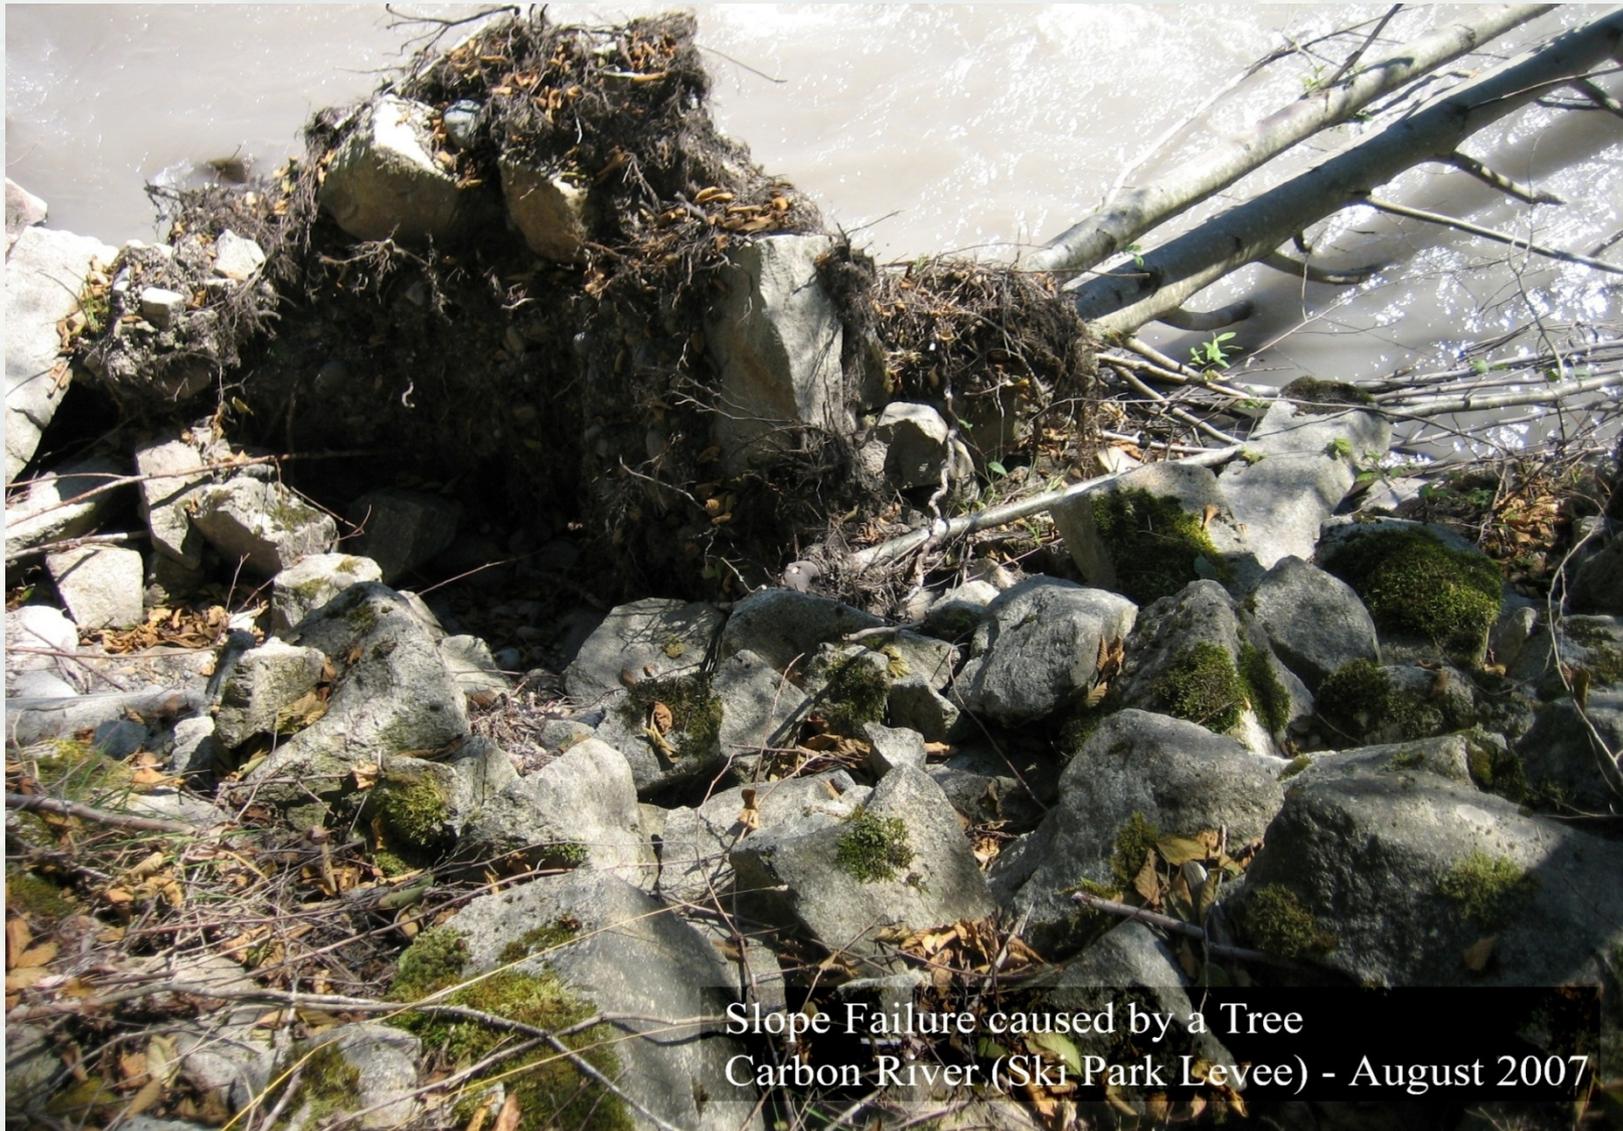
Overthrow

Slope Failure caused by a Tree
Carbon River (Ski Park Levee) - August 2007

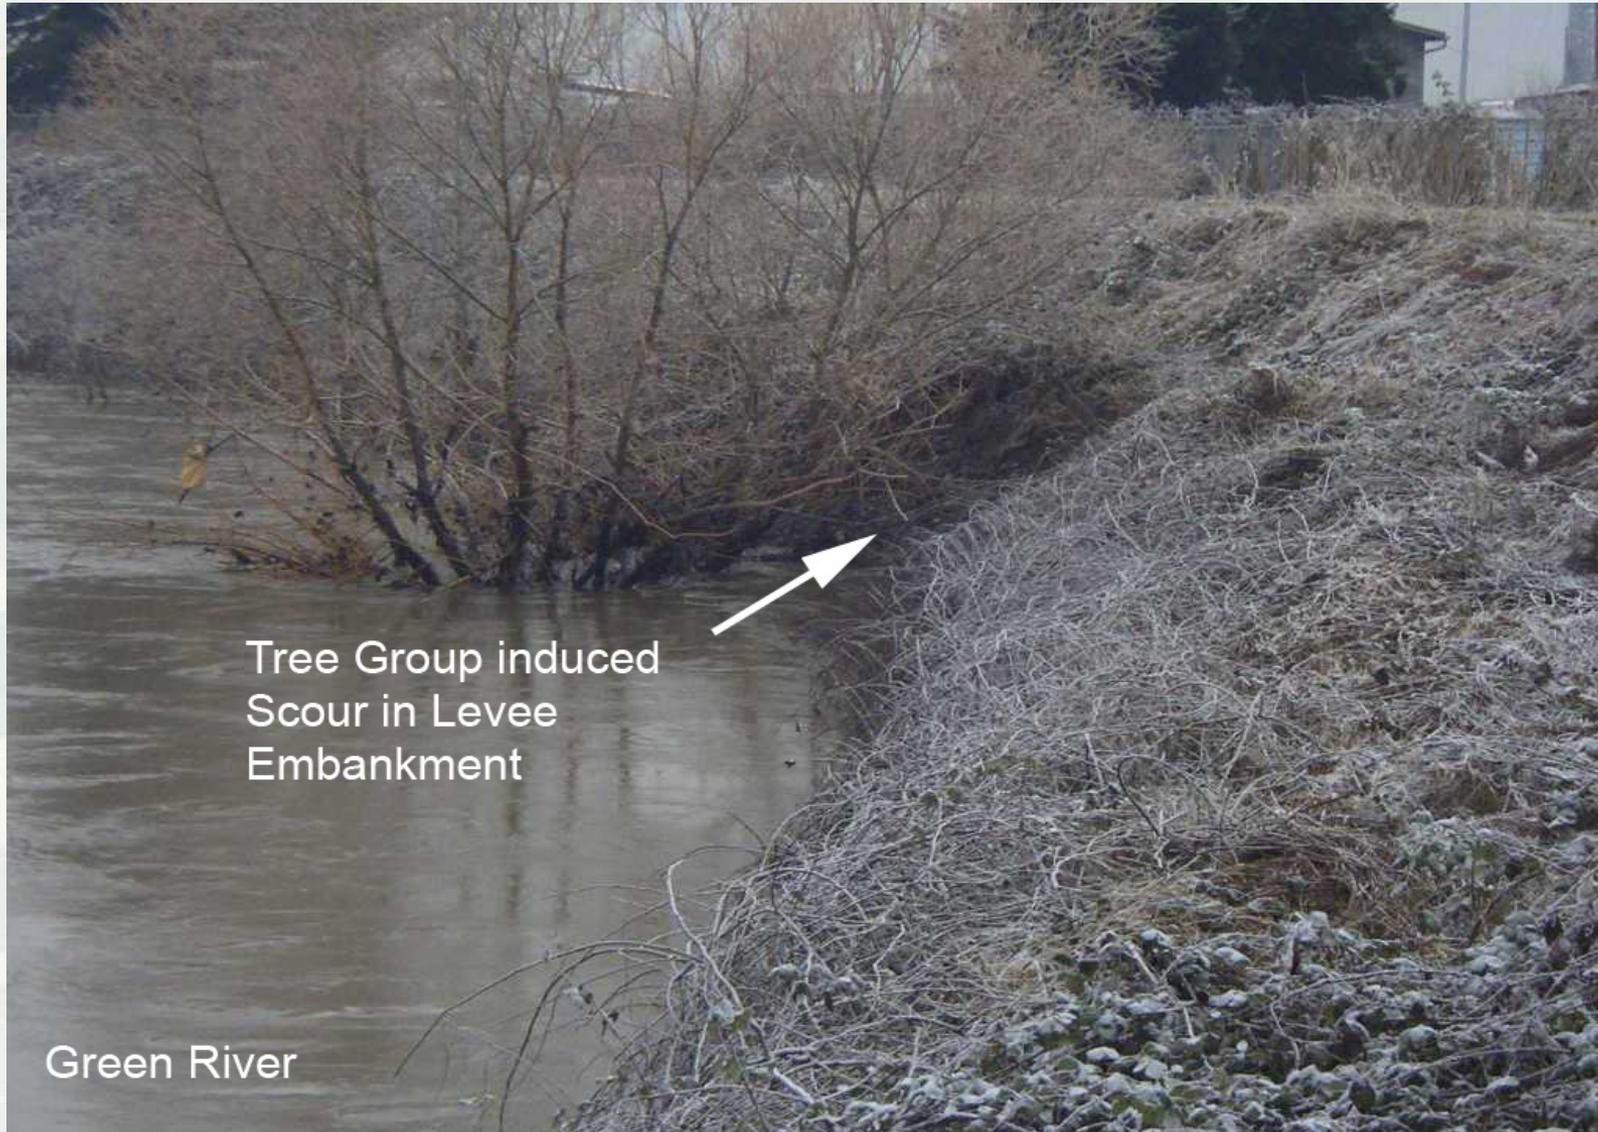
Localized Scour

Green River

Tree Group induced
Scour in Levee
Embankment

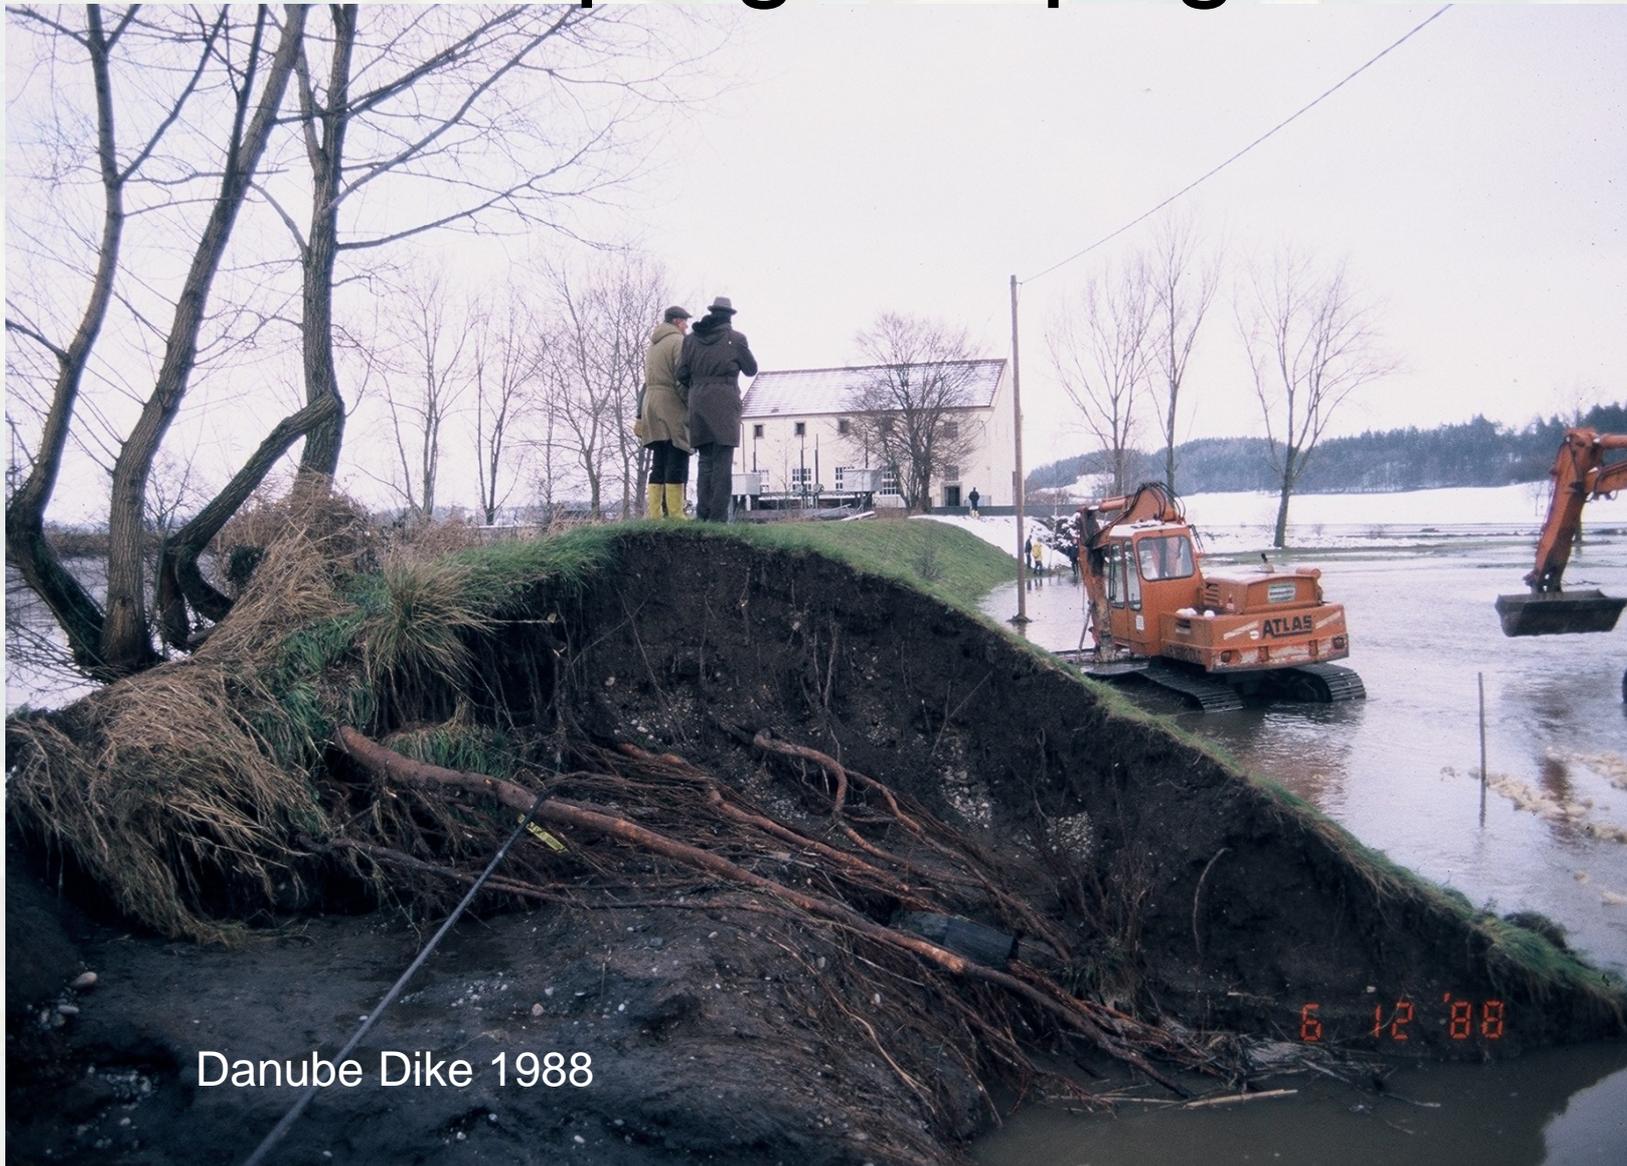
Piping/Seepage

Danube Dike 1988

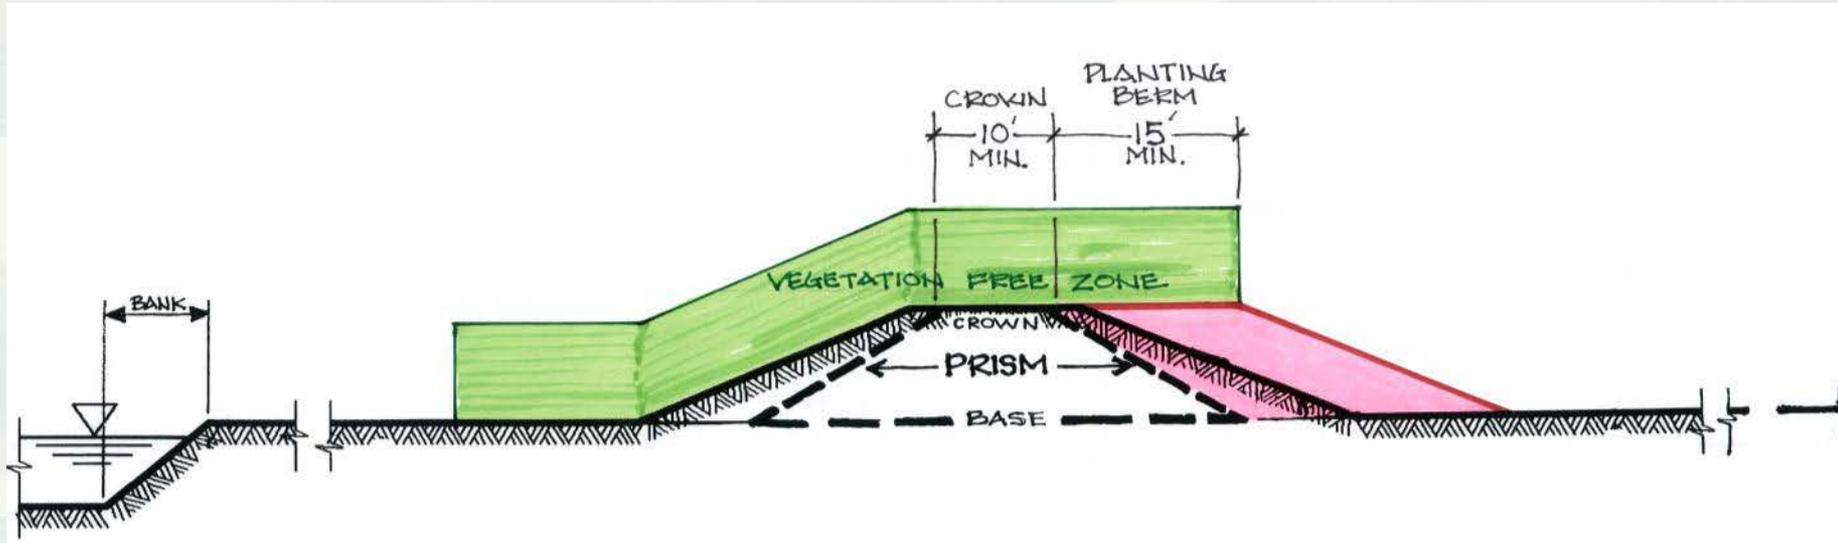
Example Section

Landside Planting Berm, shown in red, landward of the *prism*. Such a *Berm* may be approved at the discretion of the USACE district, and does not require a variance. The example shown here assumes a basic levee, with no appurtenant structures.
