MEMORANDUM FOR RECORD

SUBJECT: DETERMINATION ON THE SUITABILITY OF PROPOSED DREDGED MATERIAL TESTED FOR THE CRESCENT BAR RECREATIONAL IMPROVEMENT PROJECT (NWS-2010-1292) EVALUATED UNDER SECTION 404 OF THE CLEAN WATER ACT FOR EITHER IN-WATER OR UPLAND BENEFICIAL USE SITES.

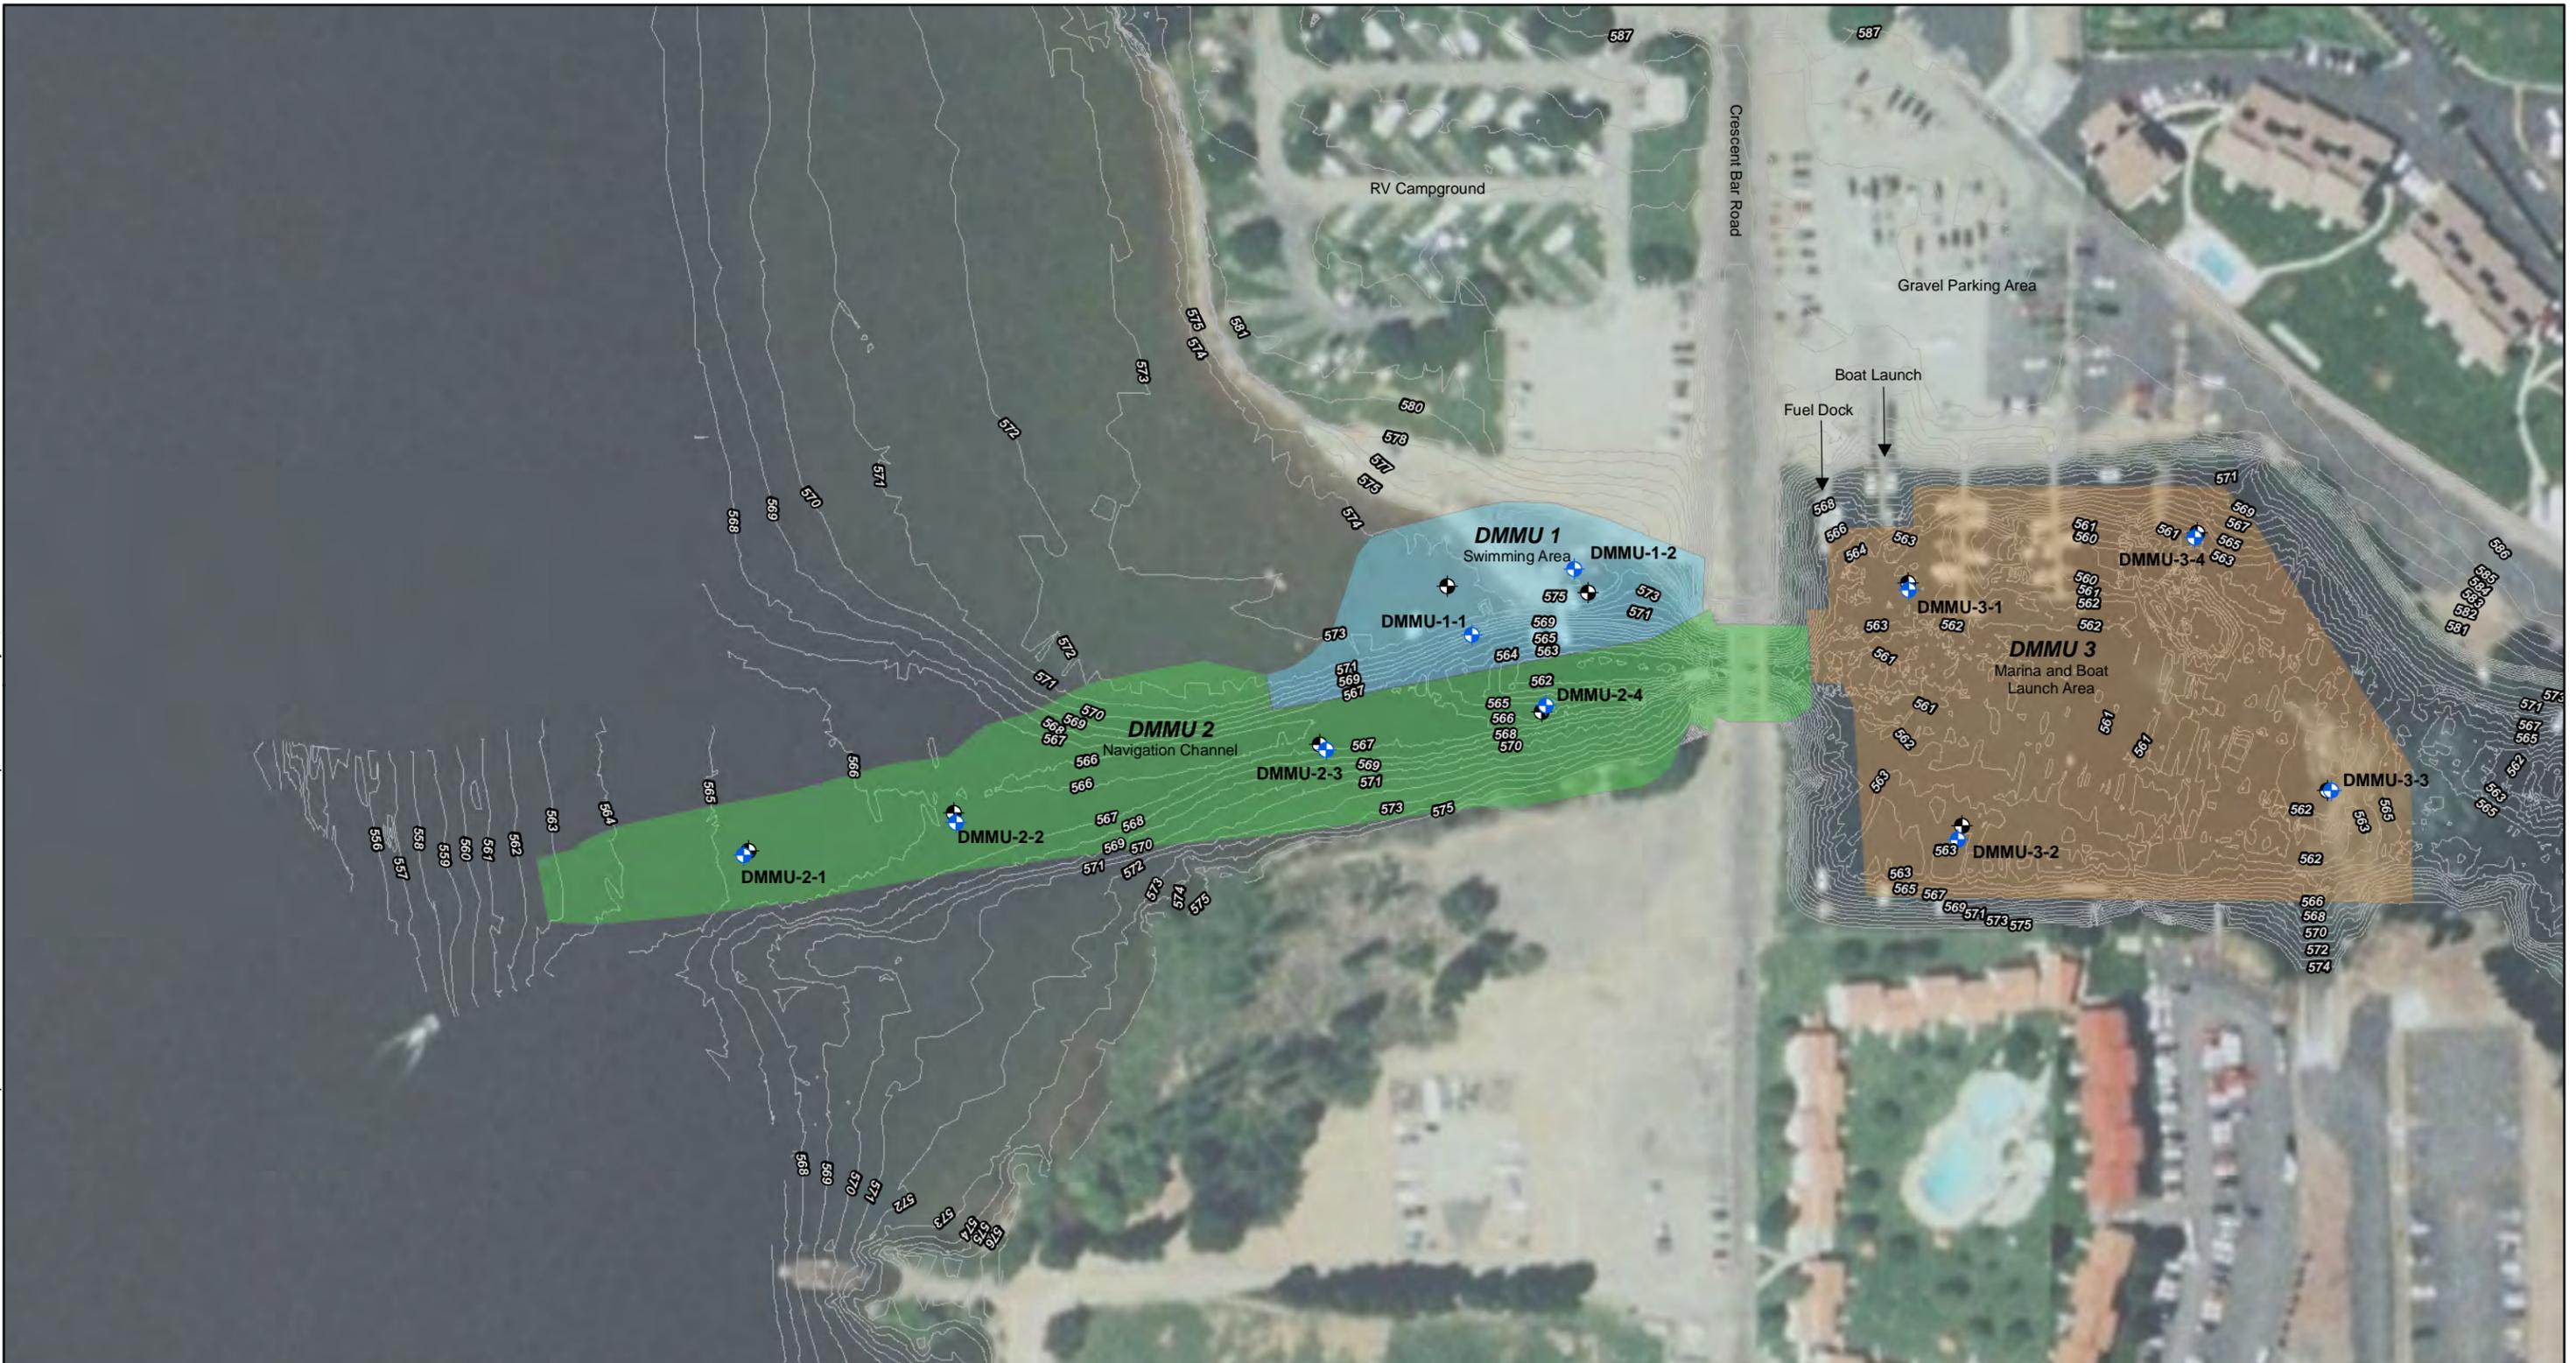
Dredge Material Management Units (DMMUs) and Sampling Locations	
Crescent Bar Recreational Improvements Project Crescent Bar, Washington	
	Figure 2

9. **Figure 1** depicts the site vicinity and **Figure 2** depict the locations for the 3 sampling locations and nine stations occupied for the 2011 characterization effort within each of the 3 DMMUs. DMMU-1 within the Swimming area consisted of composited from 2 stations/samples collected with a Sonic corer; whereas DMMU-2 within the navigation channel consisted of compositing 4 station/samples; and DMMU-3 within the marina/boat launch area consisted of compositing 3 station/samples. Sampling with the sonic corer at all nine locations occurred between February 8-10, 2011 (see **Table 2, Table 3**). A reference sample was collected on March 11, 2011 in Quilomene Bay, located approximately 7.25 miles south of the Crescent Bar Recreational Improvement Project area (**Figure 3**).

- Actual Sampling Location
 - Planned Sampling Location
- Dredge Material Management Units**
- DMMU 1
 - DMMU 2
 - DMMU 3
 - Contours (1-foot interval)

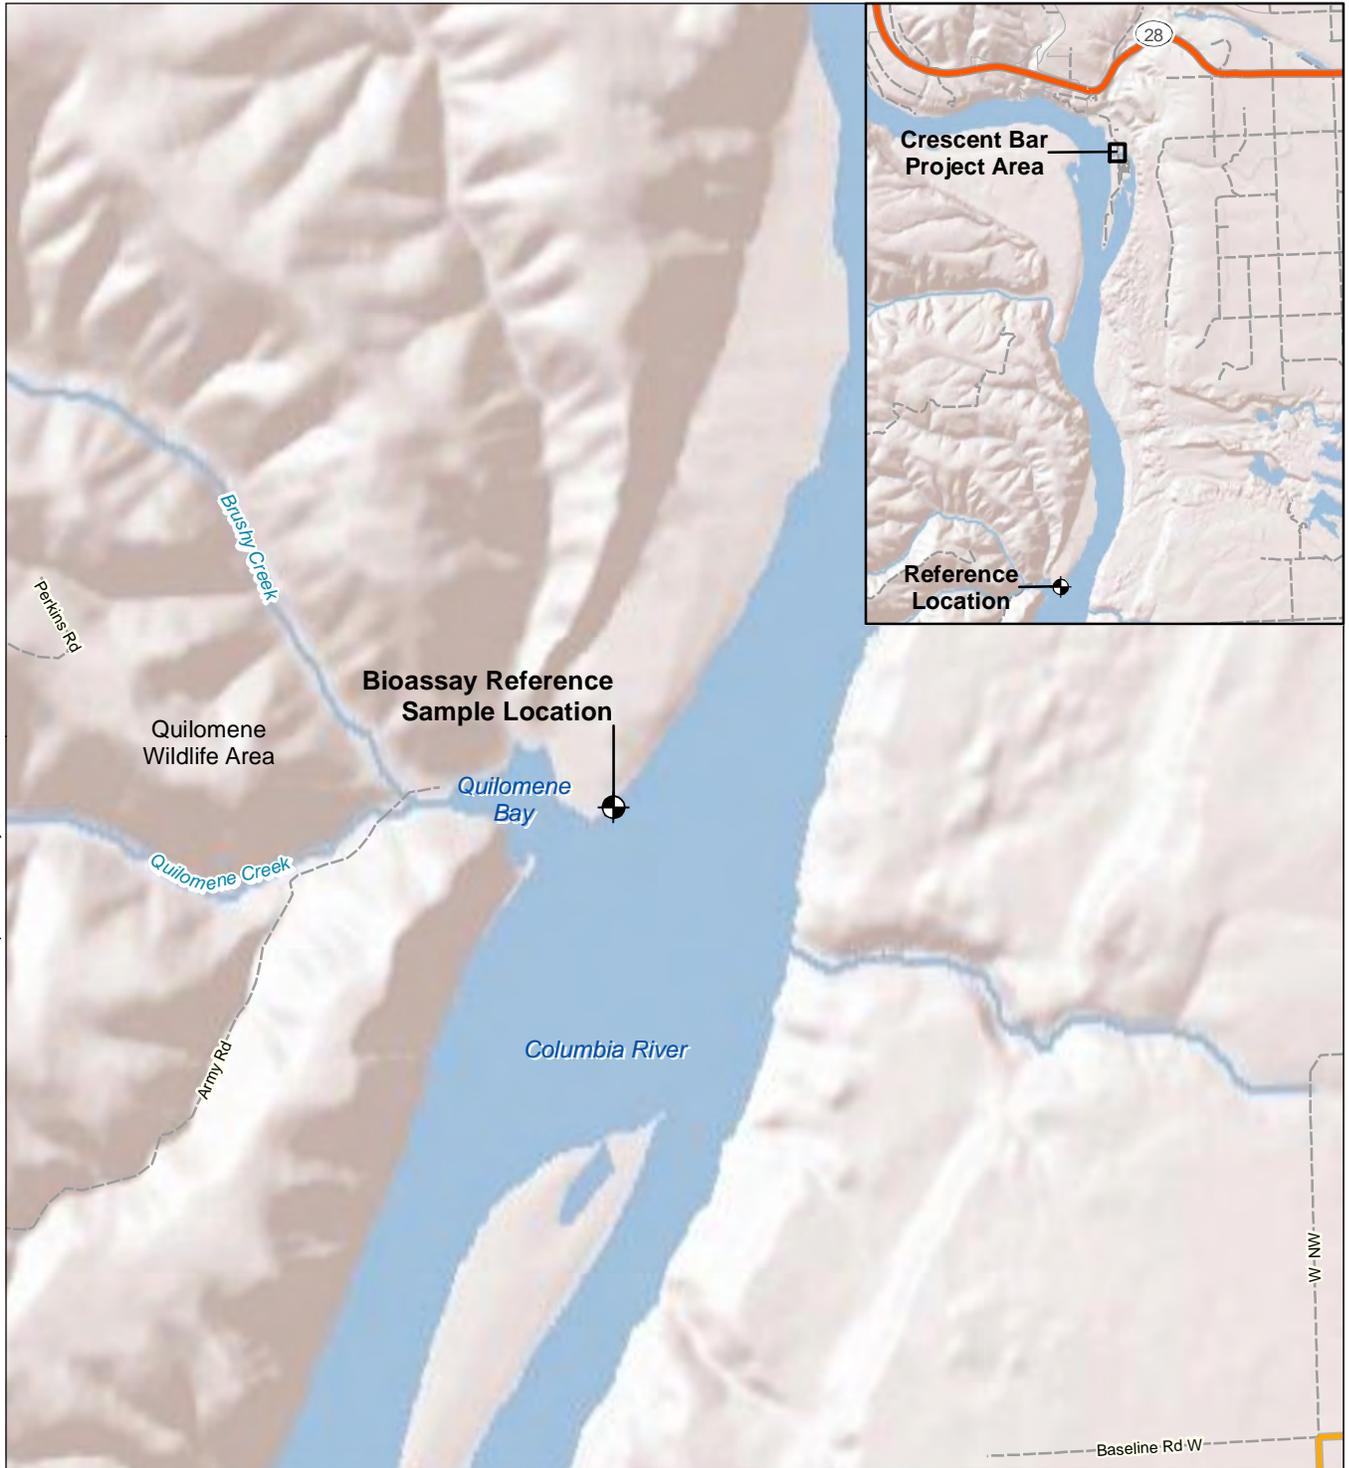
Figure 3

Bioassay Reference Sample Location
