MEMORANDUM FOR: RECORD

SUBJECT: DETERMINATION REGARDING THE EXCLUSIONARY STATUS OF DREDGED MATERIAL FROM THE POINT ROBERTS MARINA BYPASS OPERATION, WHATCOM COUNTY, WASHINGTON.

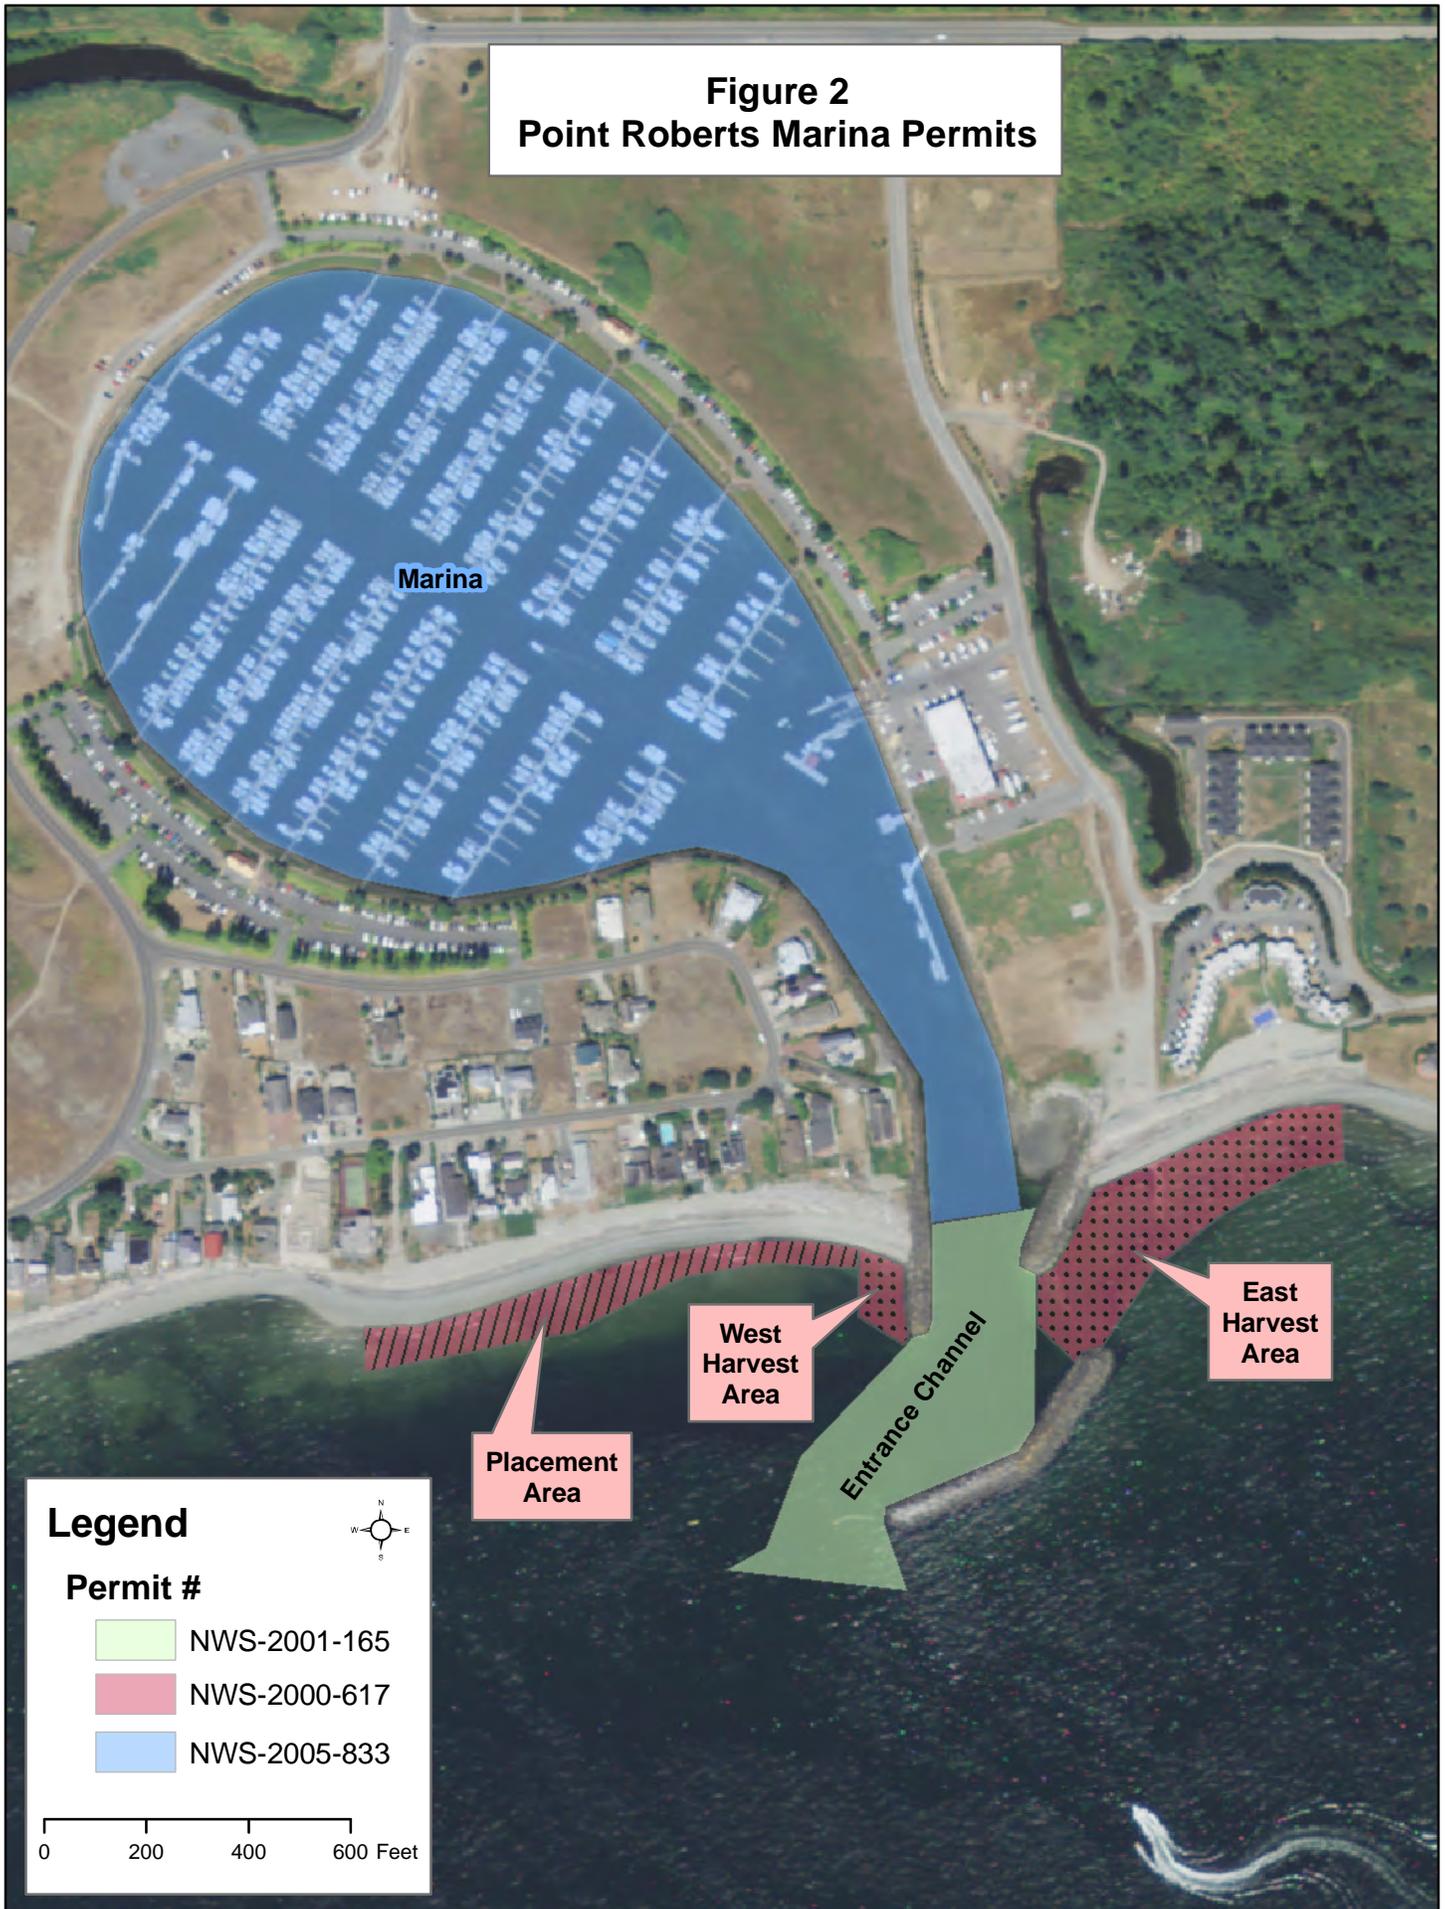
Figure 2
Point Roberts Marina Permits

2. **Background.** Point Roberts Marina currently holds three separate permits for dredging operations at its facilities (see Figure 2). A brief summary follows:

NWS-2000-617: 10-year permit for annual dredging of accumulated sediments in two areas adjacent to the entrance channel jetties and placement of the material in the nearshore area to the west of the entrance channel to maintain natural lateral movement of sediments along the shoreline.

NWS-2001-165: 10-year maintenance dredging (three events) of the marina entrance channel with placement in the nearshore stockpile area used for the bypass operation.

NWS-2005-833: one time dredging of the marina basin.

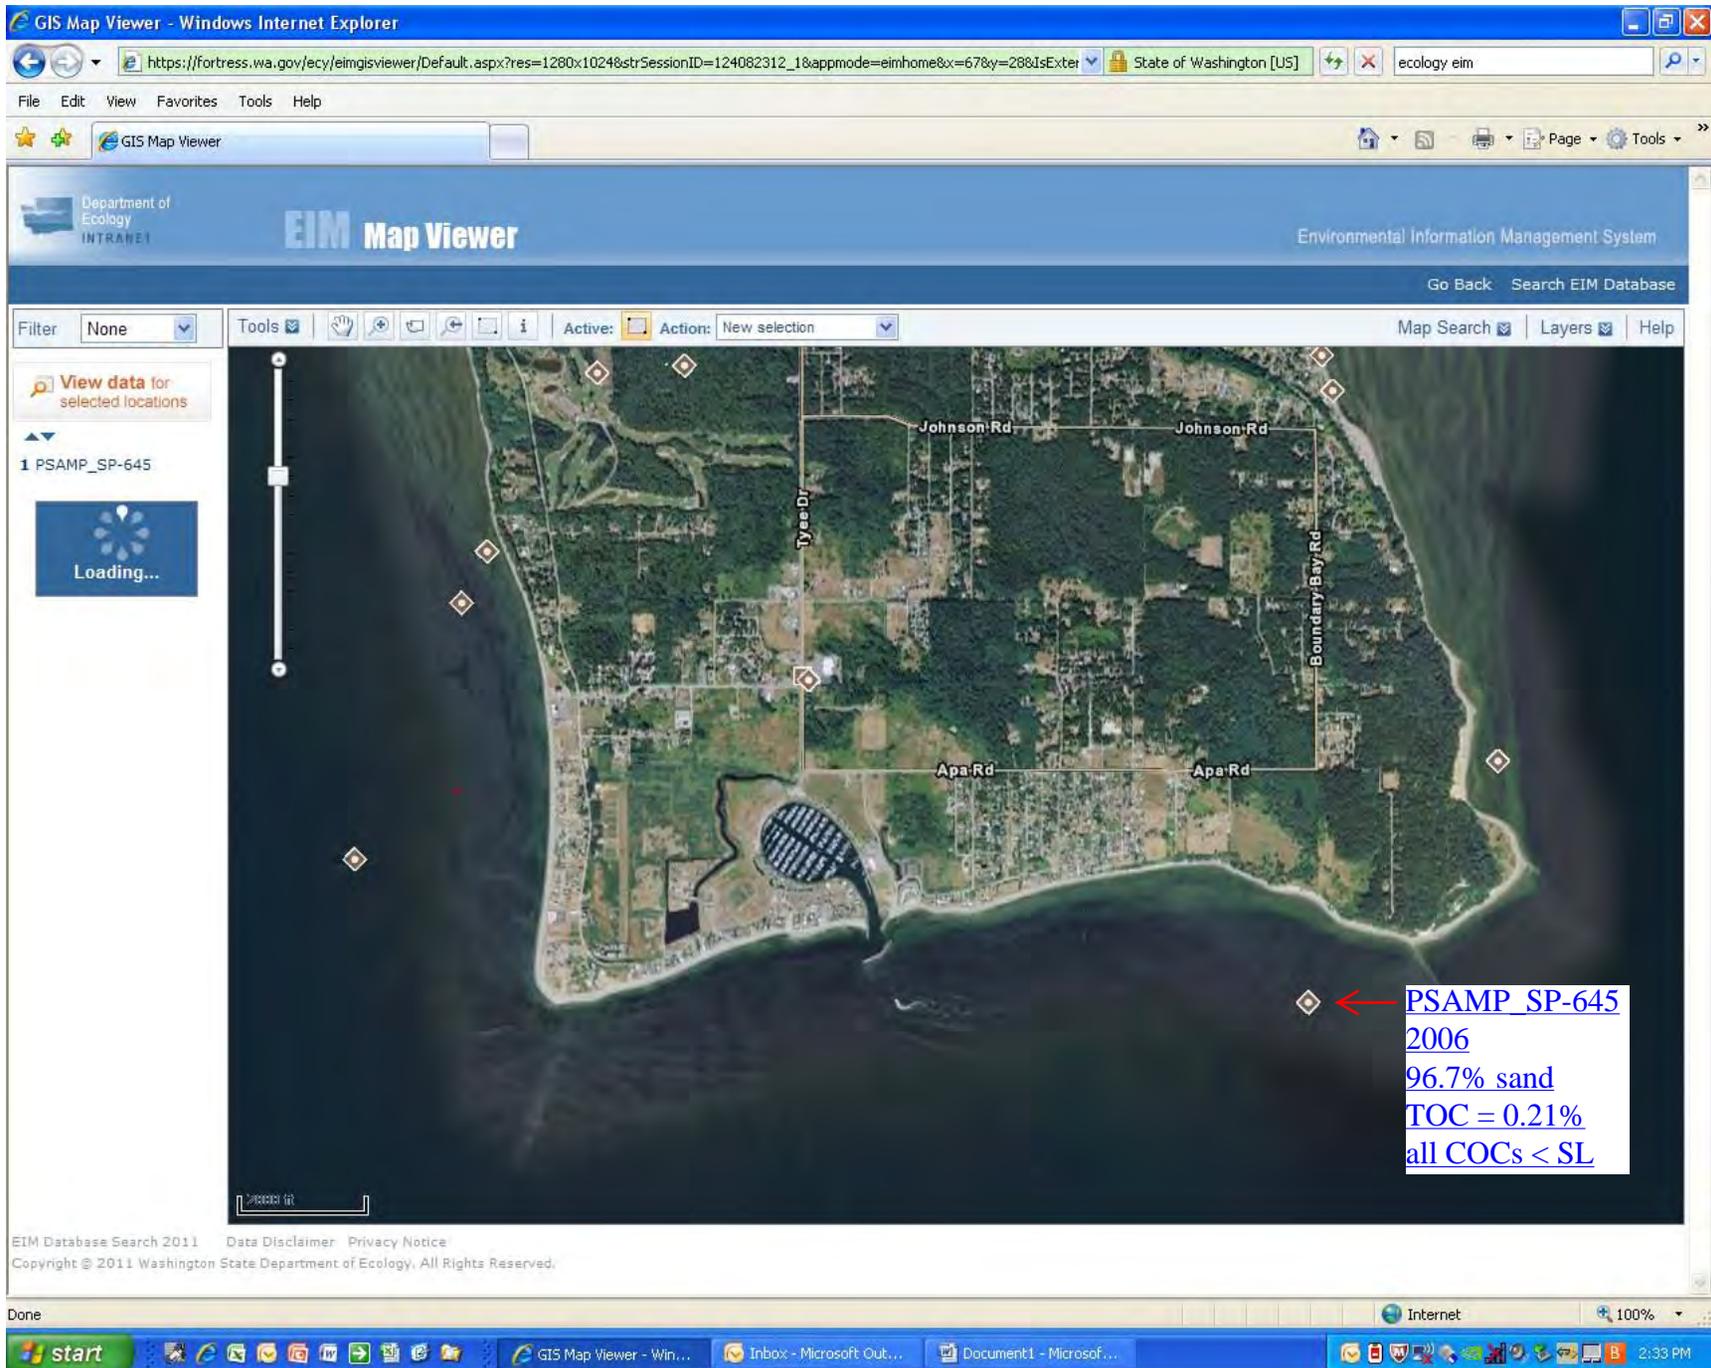
Figure 3

The Department of Ecology's Environmental Information Management system was also queried for data in the vicinity of the project. The closest sediment station updrift from the marina was from the Puget Sound Ambient Monitoring Program in 2006 (see Figure 3). Sediment from this station was predominantly sand with no SL exceedances.

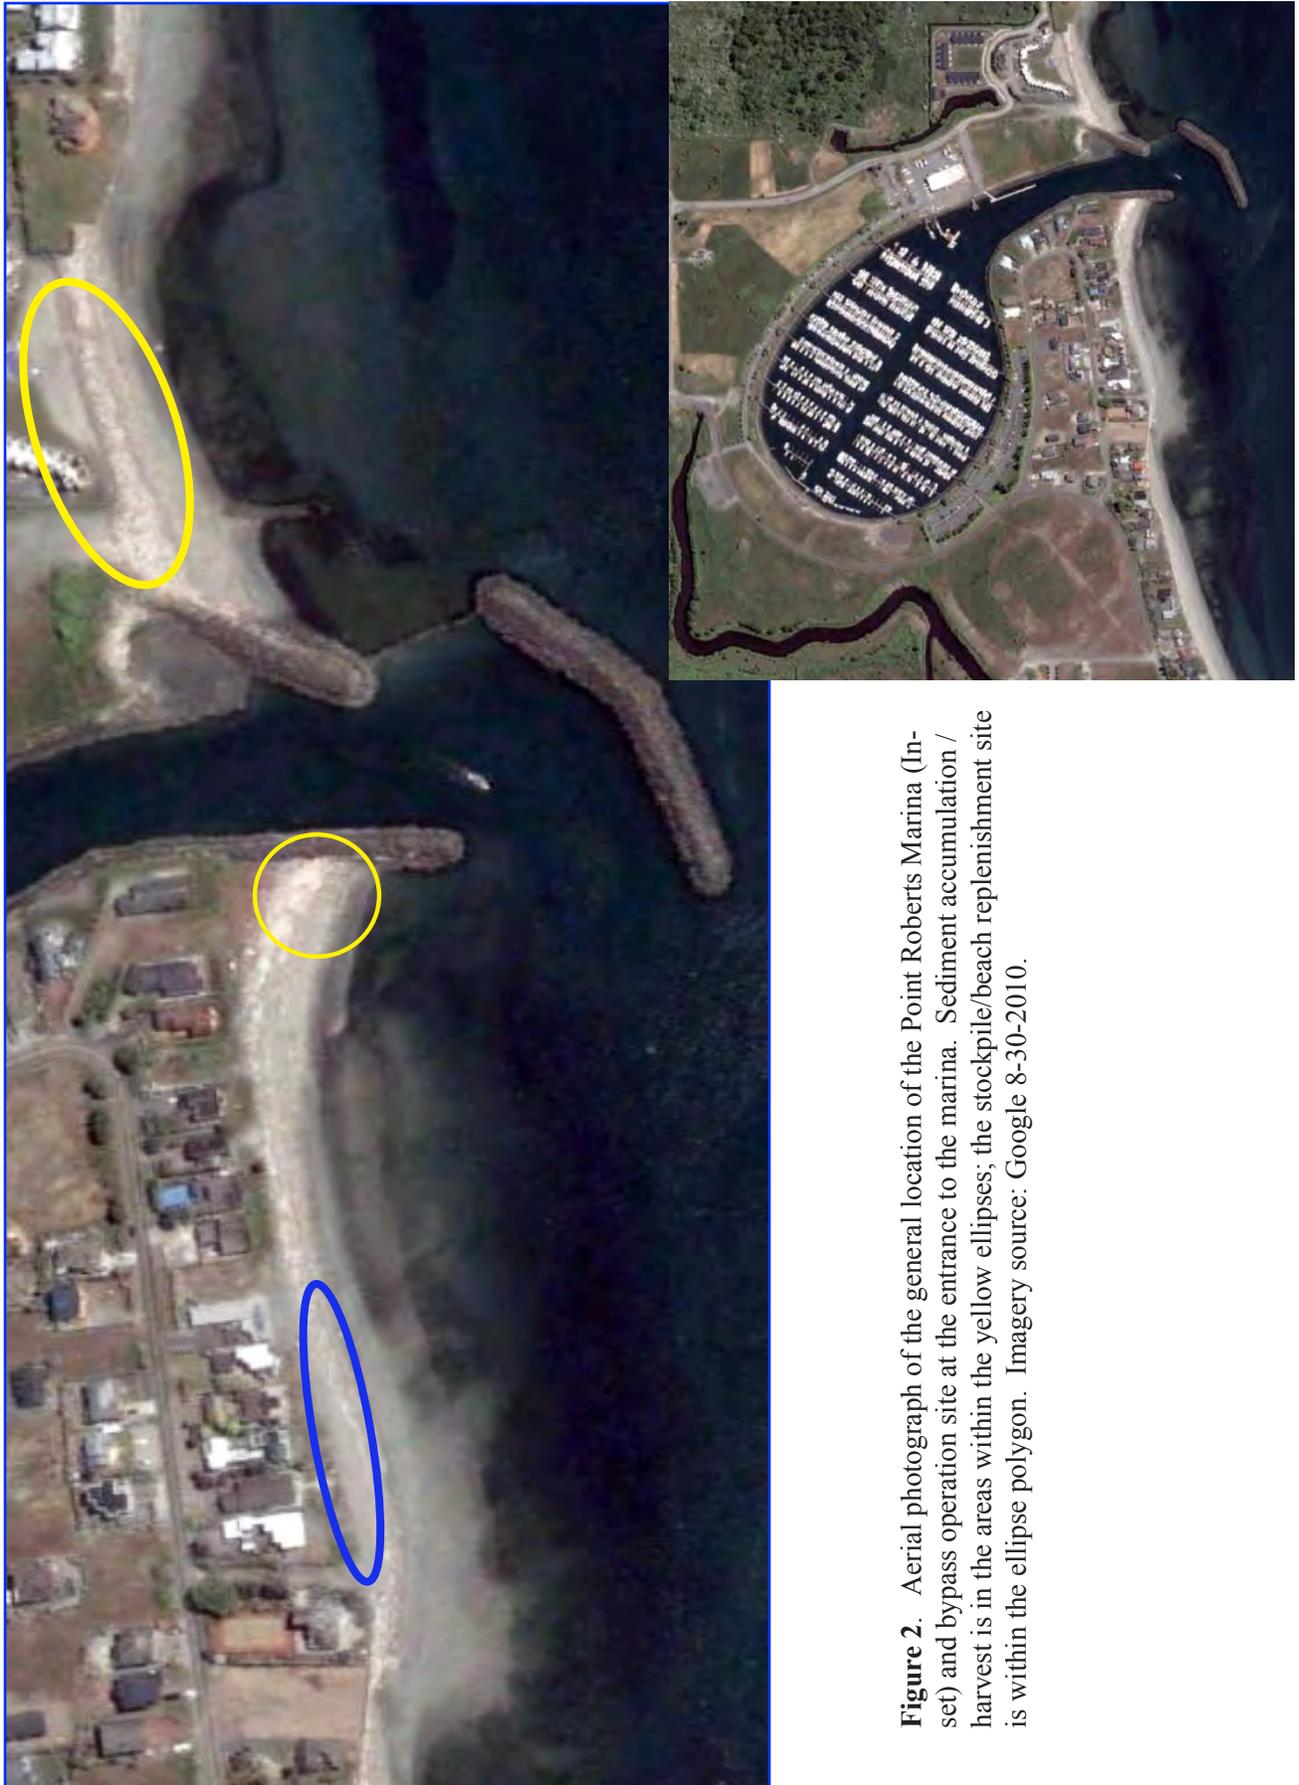
Figure 2. Aerial photograph of the general location of the Point Roberts Marina (Inset) and bypass operation site at the entrance to the marina. Sediment accumulation / harvest is in the areas within the yellow ellipses; the stockpile/beach replenishment site is within the ellipse polygon. Imagery source: Google 8-30-2010.

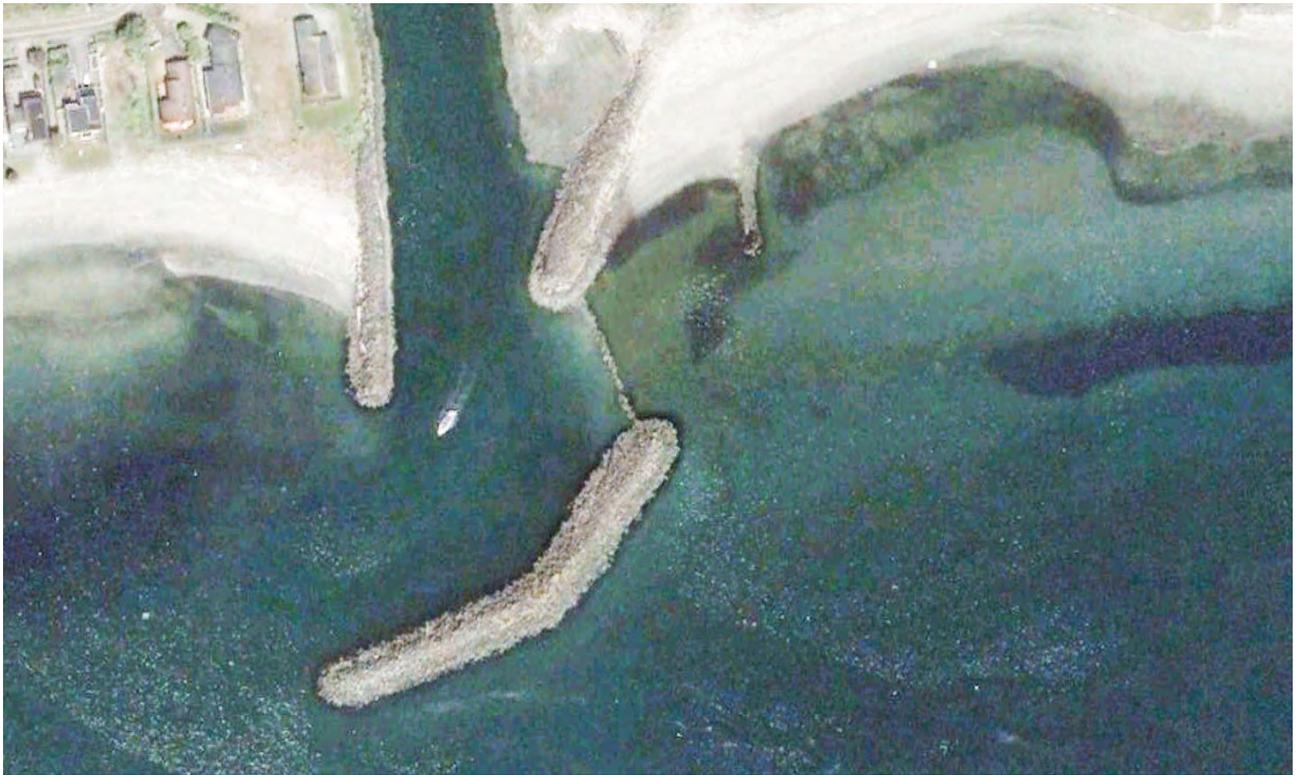
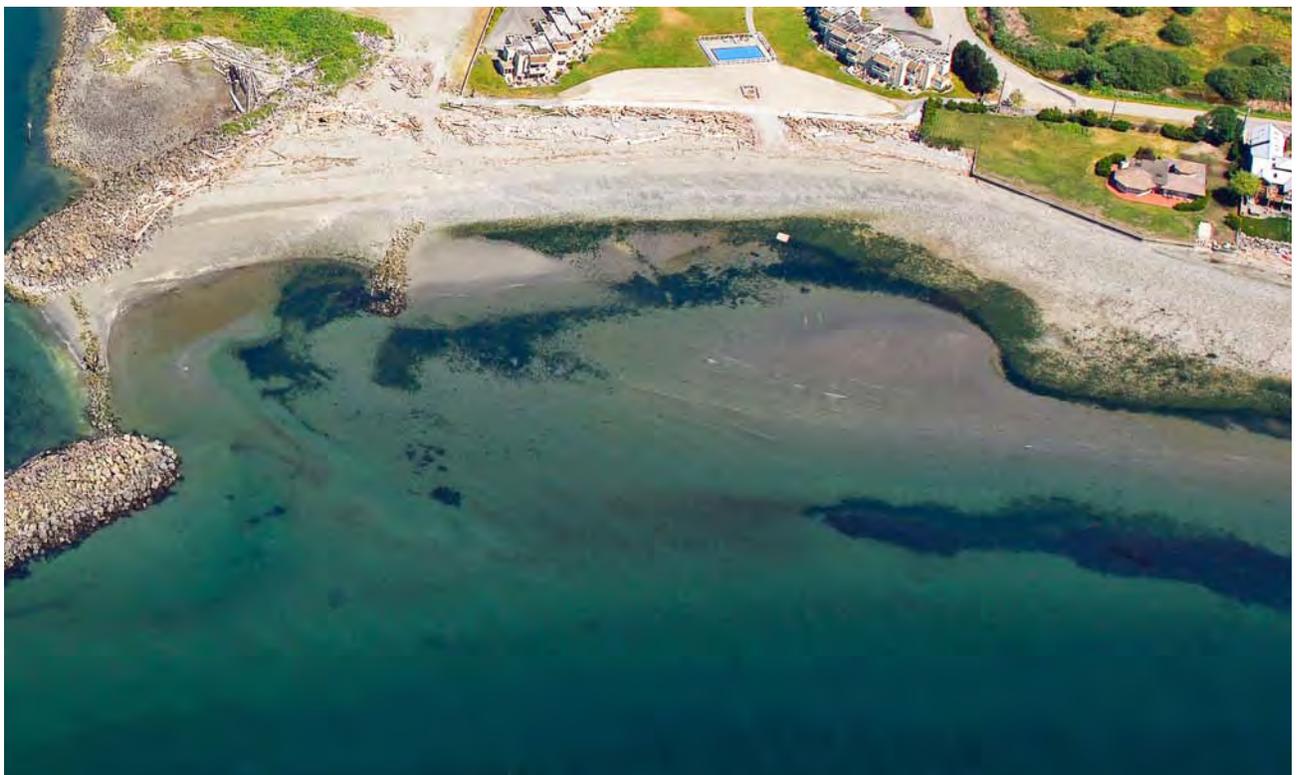
Figure 7. Aerial photo imagery of the harvest site. Top, photo Google, 5-22-2007. Bottom, photo WDOE, 6/28/06, tide elevation 0.6 ft MLLW. The large dark area in the right-hand corner of the photos is a patch of native eelgrass, which continues in a narrow band to the east. A similar band of eelgrass extending below ~ -2 ft MLLW is also visible west of the marina entrance (see also Figure 13). The remaining dark areas in and adjacent to the harvest site, are made up of the green algae, *Ulva*, which is either drifting or attached to underlying cobble and large gravel.

Figure 12. Eelgrass bed location east of the entrance channel, Point Roberts Marina, Point Roberts, Washington. Based on observations made August 28, 2000 and updated with field observations (December 16, 2011) and aerial photo imagery shown in Figure 7.

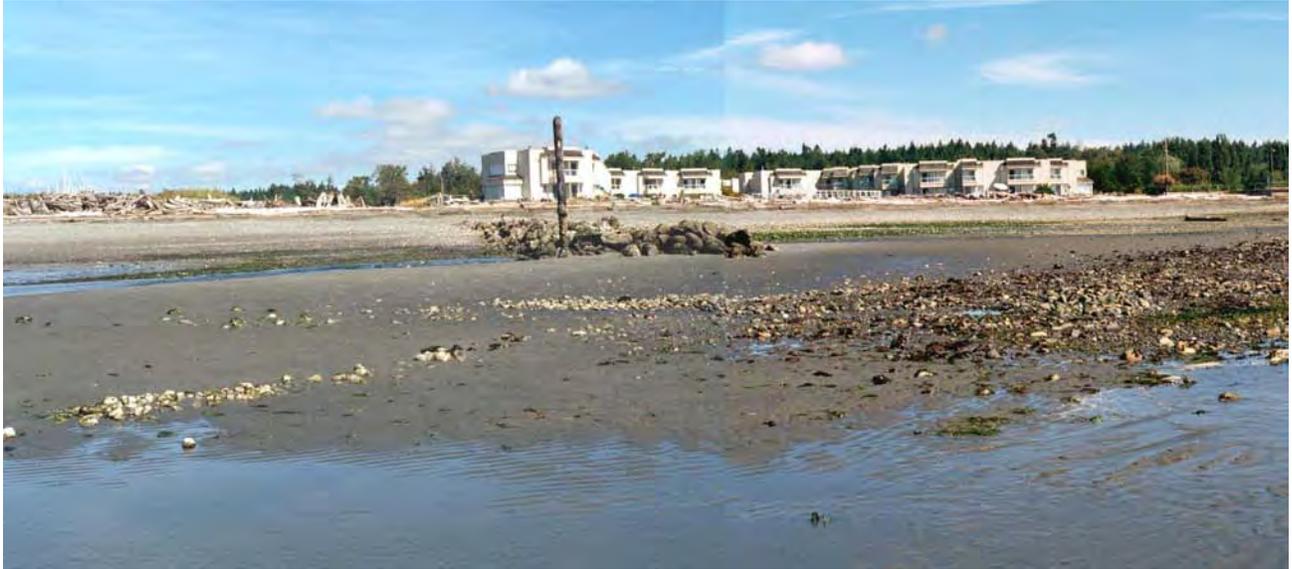
Figure 8. Harvest area, 8/28/00, at a tidal level of about -2 feet MLLW, and 13 months after beach harvest (Figure 9). A boulder berm protecting a stormwater outfall is visible in the center background.

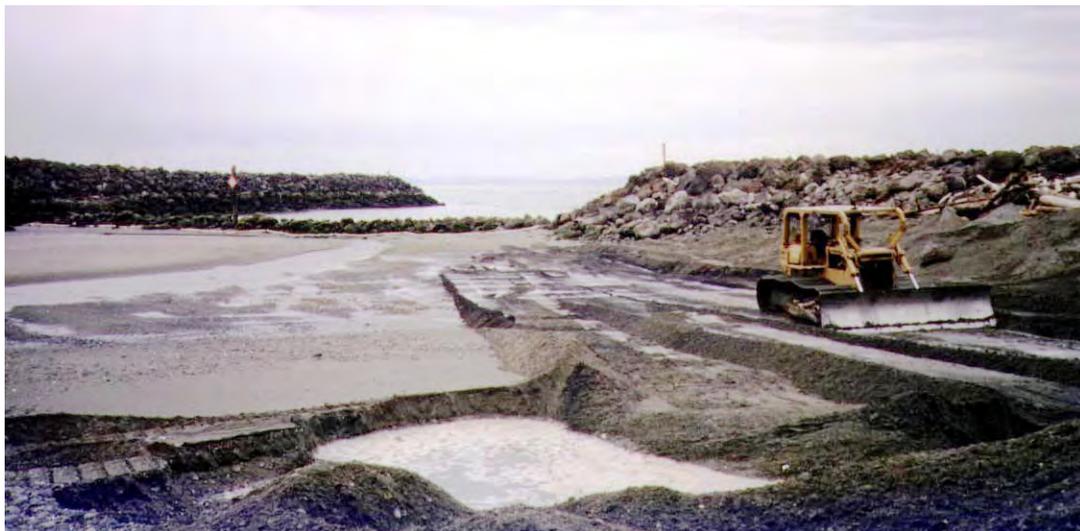
Figure 9. Harvest area, 7/14/99, -2.0 ft MLLW. The sediment harvest operation is underway, with seaward activity to about +2 feet MLLW. Current sediment harvest takes place at night, typically from mid to late November.

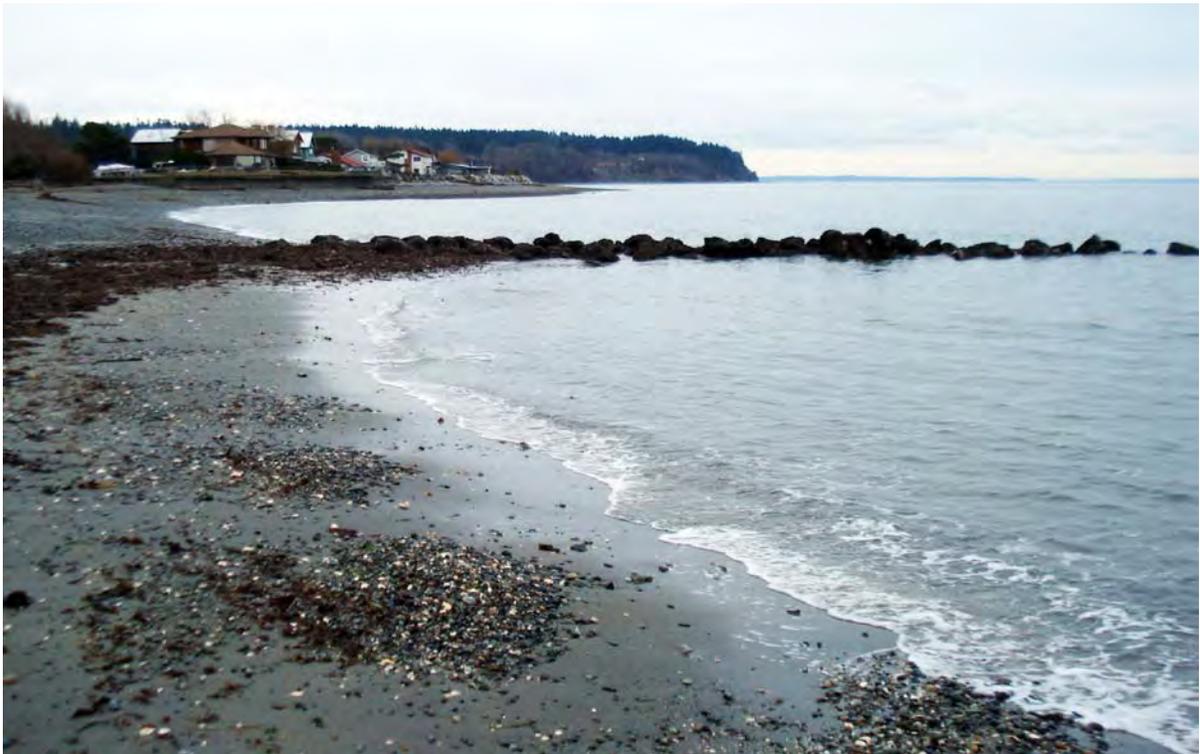
Figure 10. Beach within the harvest area, 12/16/2011, the waterline is at about 5 ft MLLW. A rock berm protects the stormwater outfall (also visible in Figures 7 and 8. Accreted beach sediments were harvested at this location the previous month.

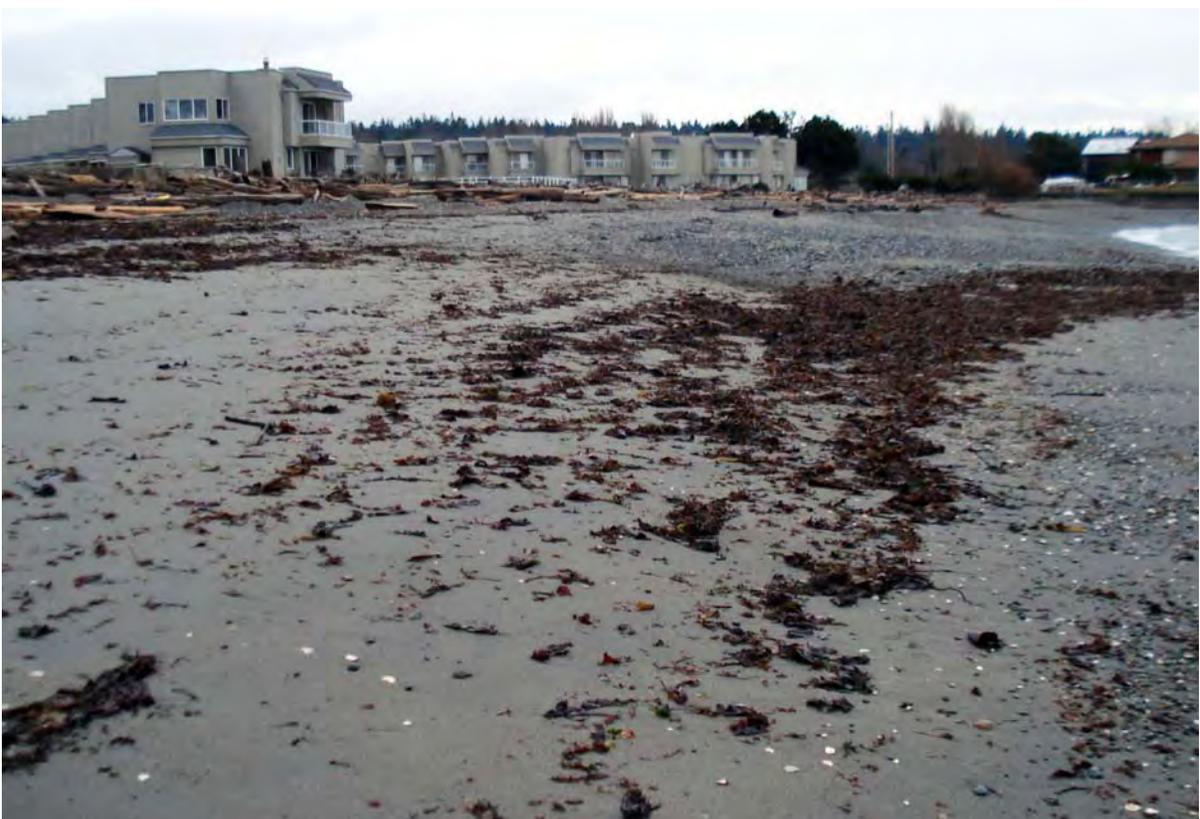
Figure 11. Sand and gravel in remainder of the harvest area, east of the stormwater outfall (12/16/2011).

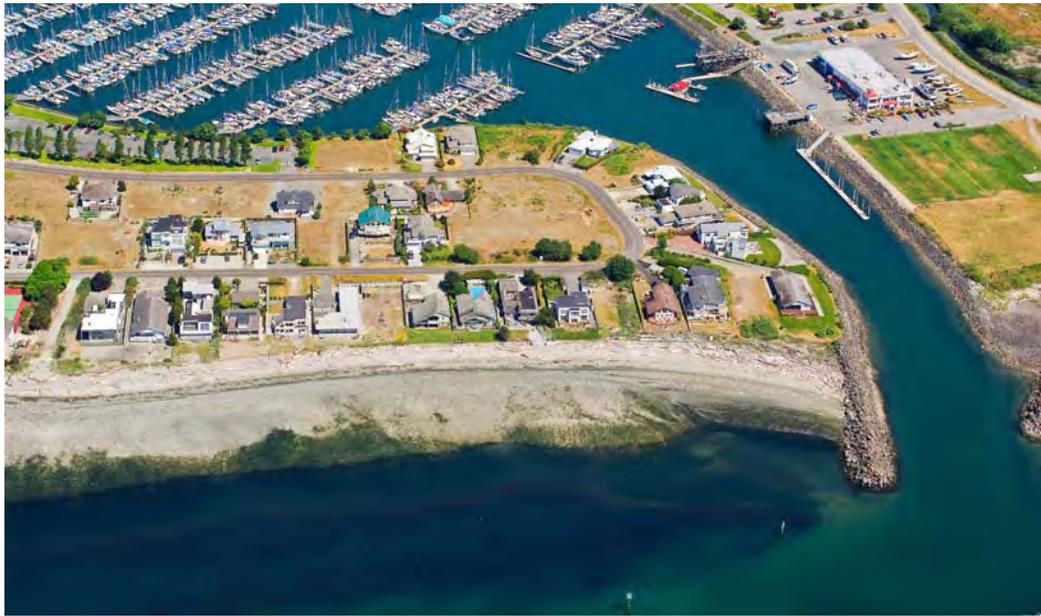
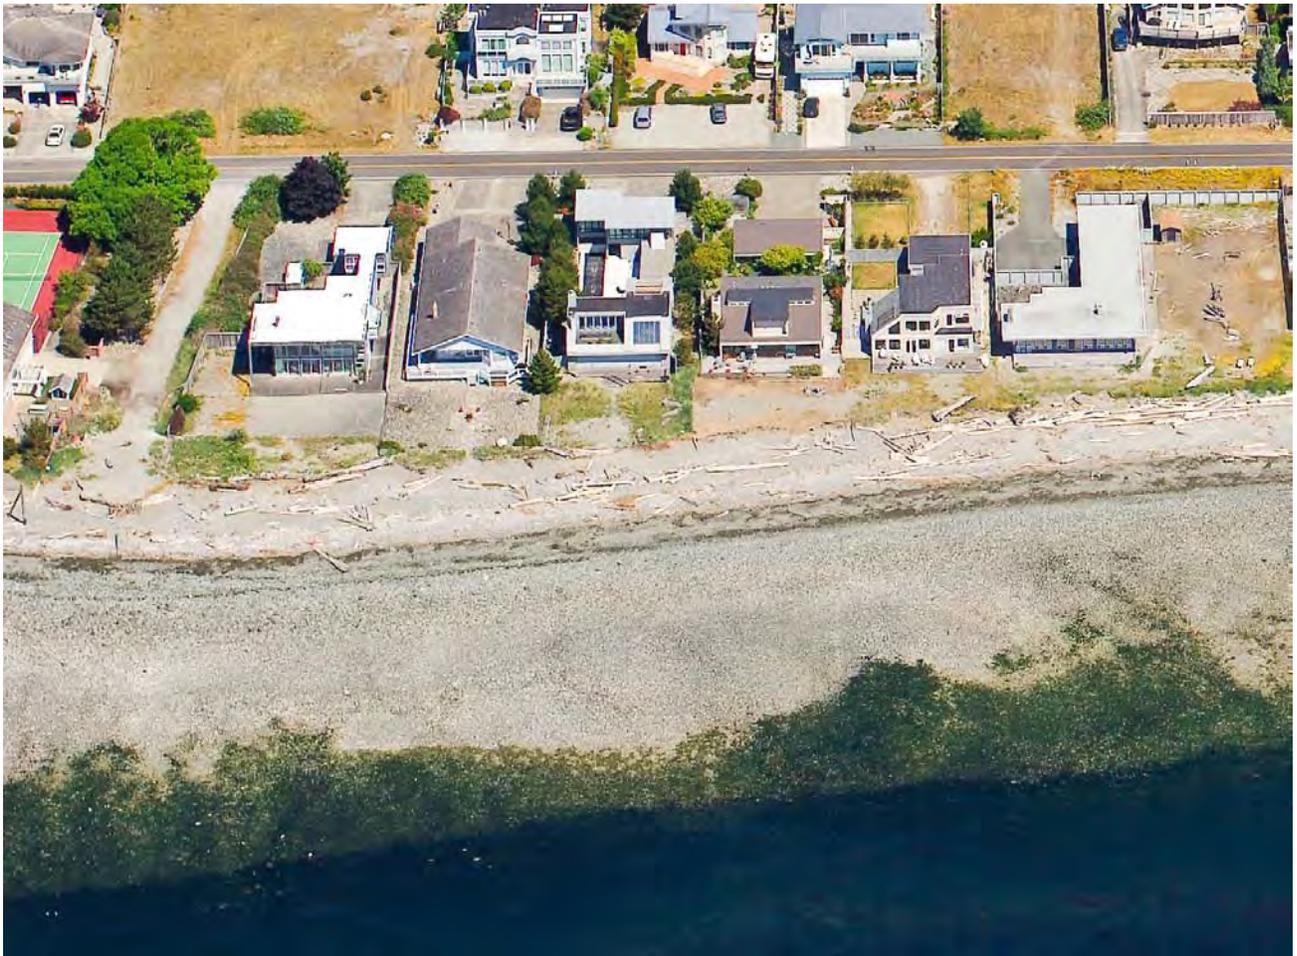
Figure 13. Top and bottom, bypass sediment stockpile area, photos WDOE, 6/28/06, tide elevation 0.6 ft MLLW. Top, there is a secondary harvest site at the northwest corner of the west jetty (Figure 3). Bottom, harvested sediments are spread on the high beach facing the homes. At the time this photograph was taken all or most of the stockpiled sediments had been dispersed by long-shore transport.

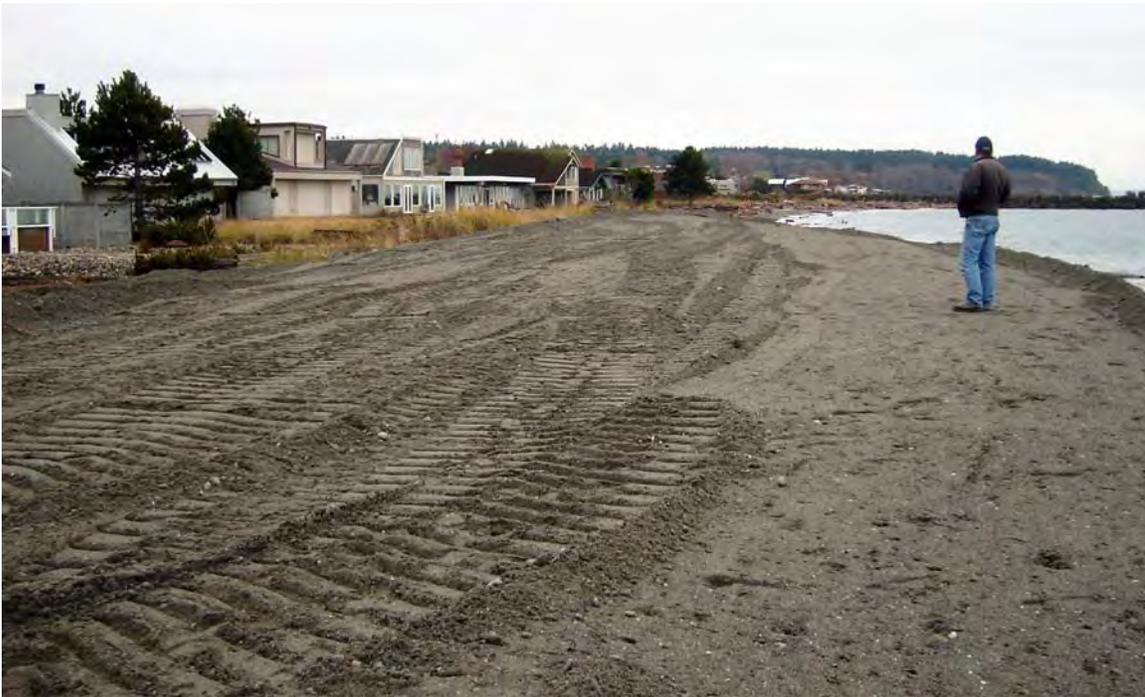
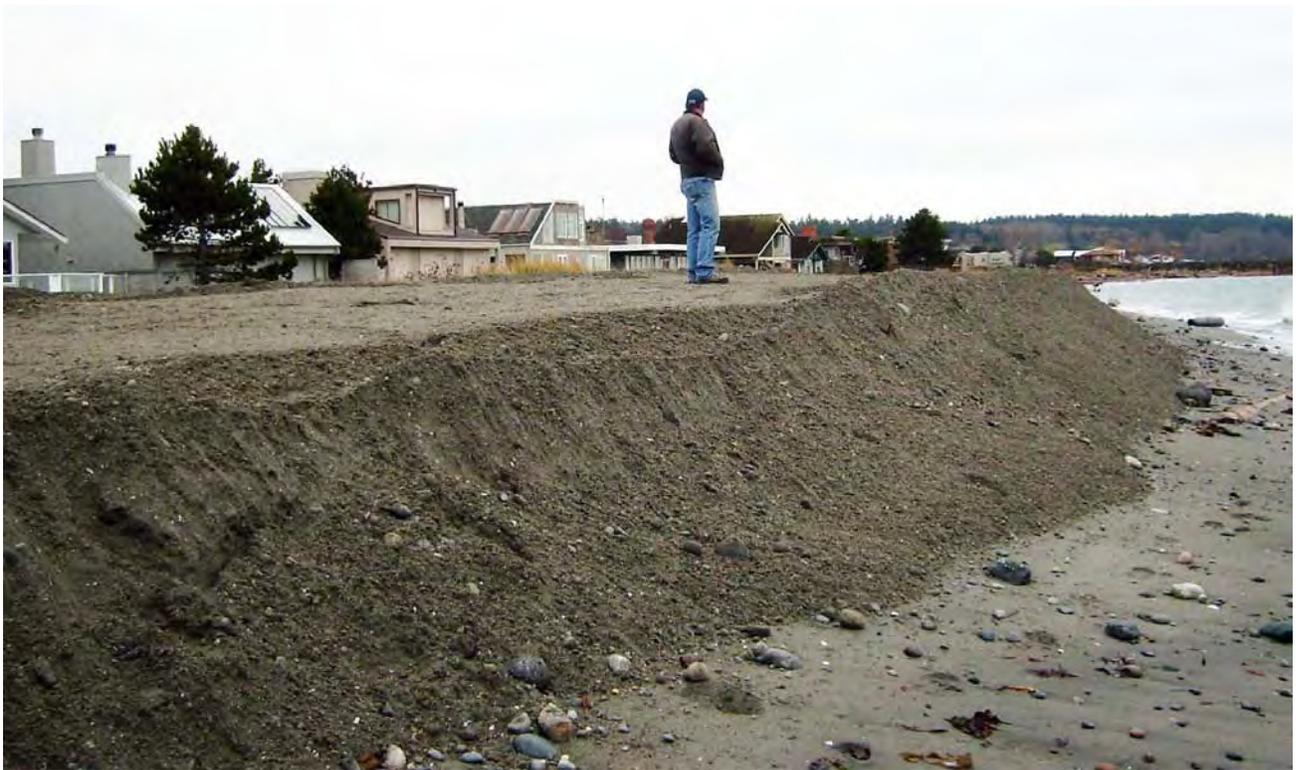
Figure 14. Surface and seaward edge of the stockpile area, 11/29/2011. These beach sediments were fed by erosion from the bluffs at Lilly Point, east of the marina and visible in the far right.

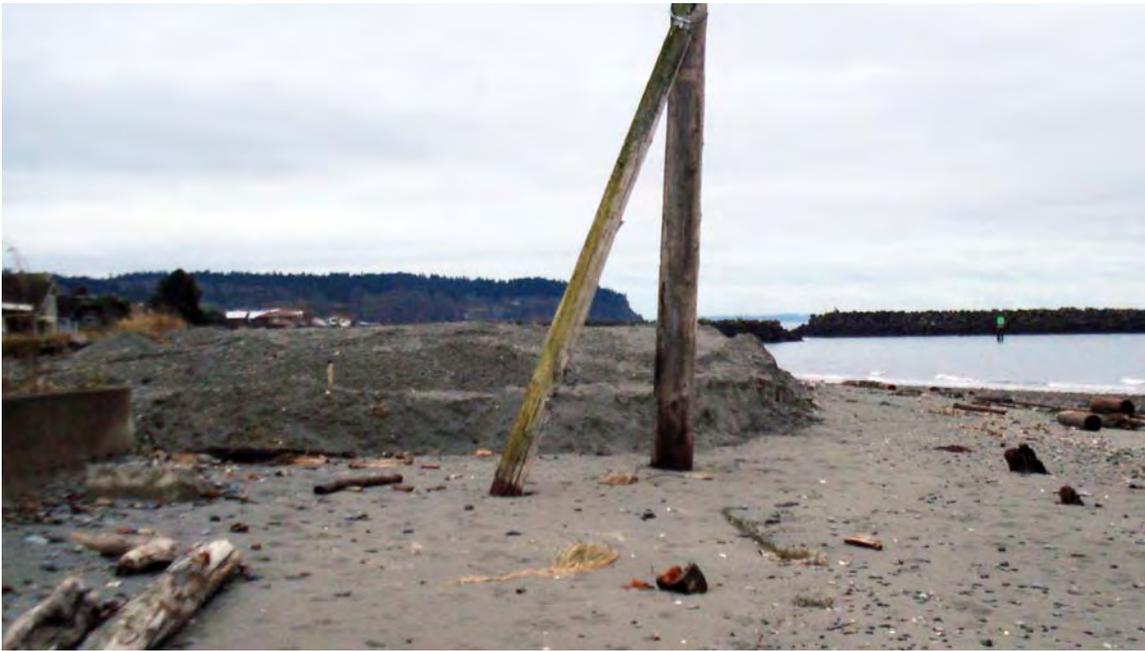
Figure 15. West edge of the stockpile area, 12/16/2011. Stockpiled beach sediments are beginning to be eroded and distributed westerly by late fall and winter storm waves.

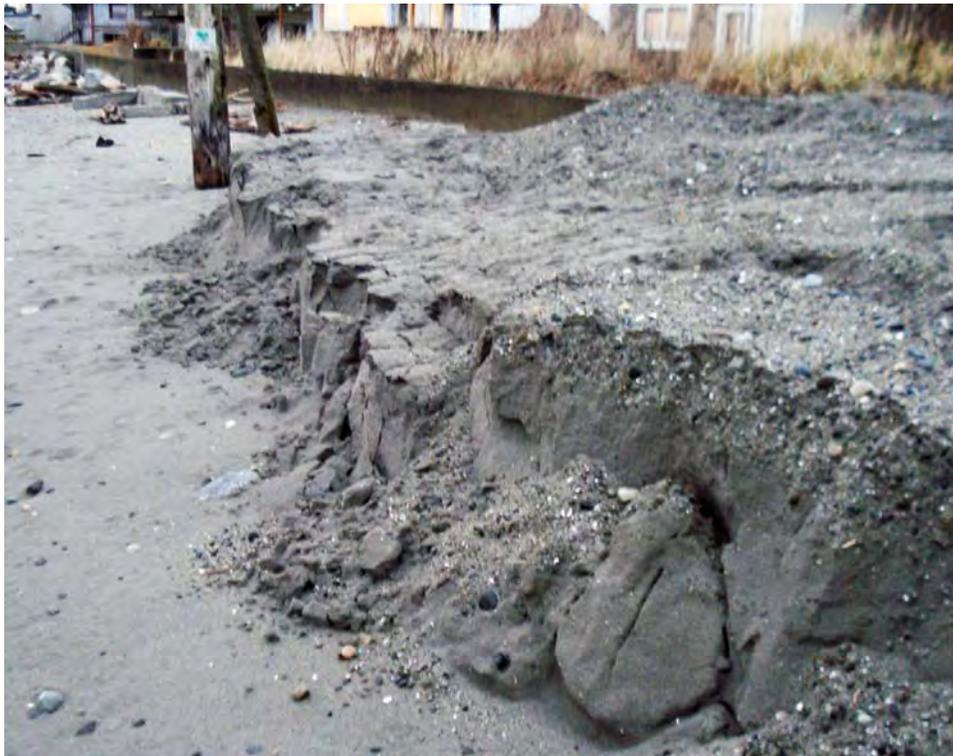
Figure 16. Eroding compacted and consolidated beach sediments at the Stockpile Area, 12/16/2011..
