**SUBJECT:** DETERMINATION REGARDING THE SUITABILITY OF PROPOSED DREDGED MATERIAL FROM THE KITTITAS COUNTY BOAT RAMP RECREATIONAL IMPROVEMENT PROJECT (NWS-2012-944) EVALUATED UNDER SECTION 404 OF THE CLEAN WATER ACT FOR IN-WATER BENEFICIAL USE.

Kittitas County Boat Ramp Recreational Improvements Project  
Vantage, Washington

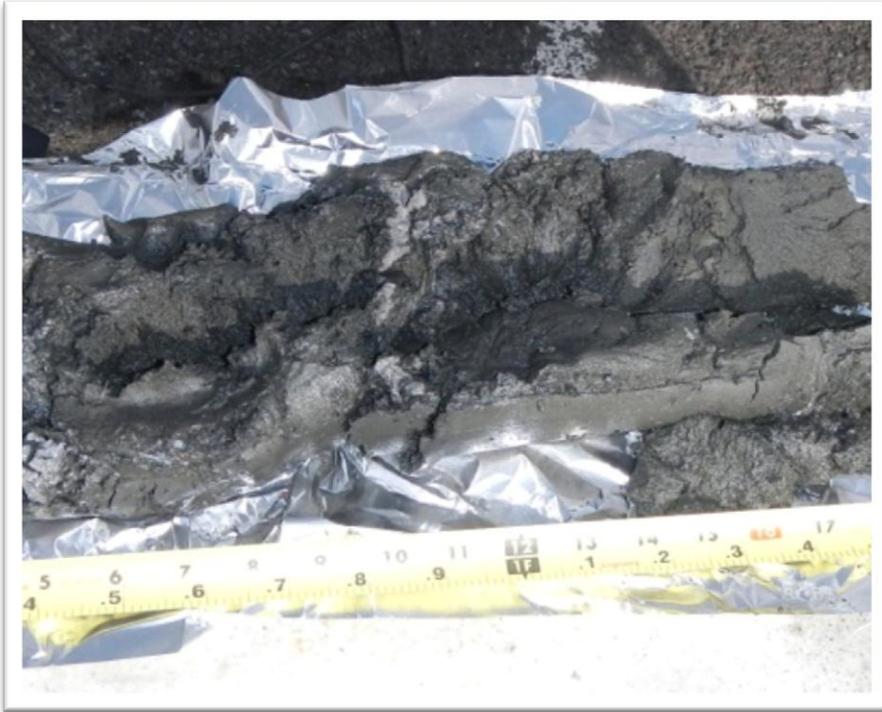
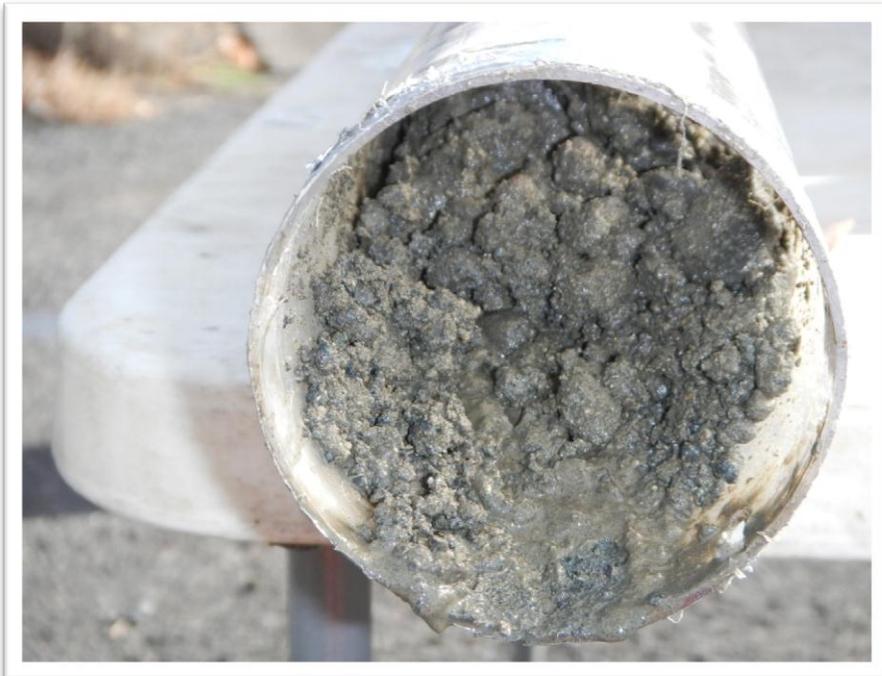
Figure 2.  
Core Photographs of Core 1-1

Surface, fine-grained material observed at coring locations

Underlying coarse-grained material (gravel with sand /silt) observed  
at coring locations

5. **Sampling.** Sampling took place February 12, 2013 using a Vibracore, and followed the approved SAP, with one minor deviation. Cores from three stations were collected to a depth of 2.5 to 3 feet and were terminated due to refusal or because the underlying coarse-grained native deposits were encountered, see Figure 2 for core photos and Figure 3 for sample locations. Table 2 and Figure 3 show the depths of each core, depths of dense outburst flood deposits and boundary between surface and subsurface DMMUs. Two cores were collected from sample station DMMU1-1 – the first core penetrated to 3 feet, but the percent recovery was below the acceptance criteria so a second core was also collected. The second core penetrated to 2.0 feet and the percent recovery was acceptable, so sediment from the second core was included in the composite. However, a core log was only completed for the first core from station DMMU1-1. Material collected from the three stations was composited into a single analytical sample representing DMMU 1.

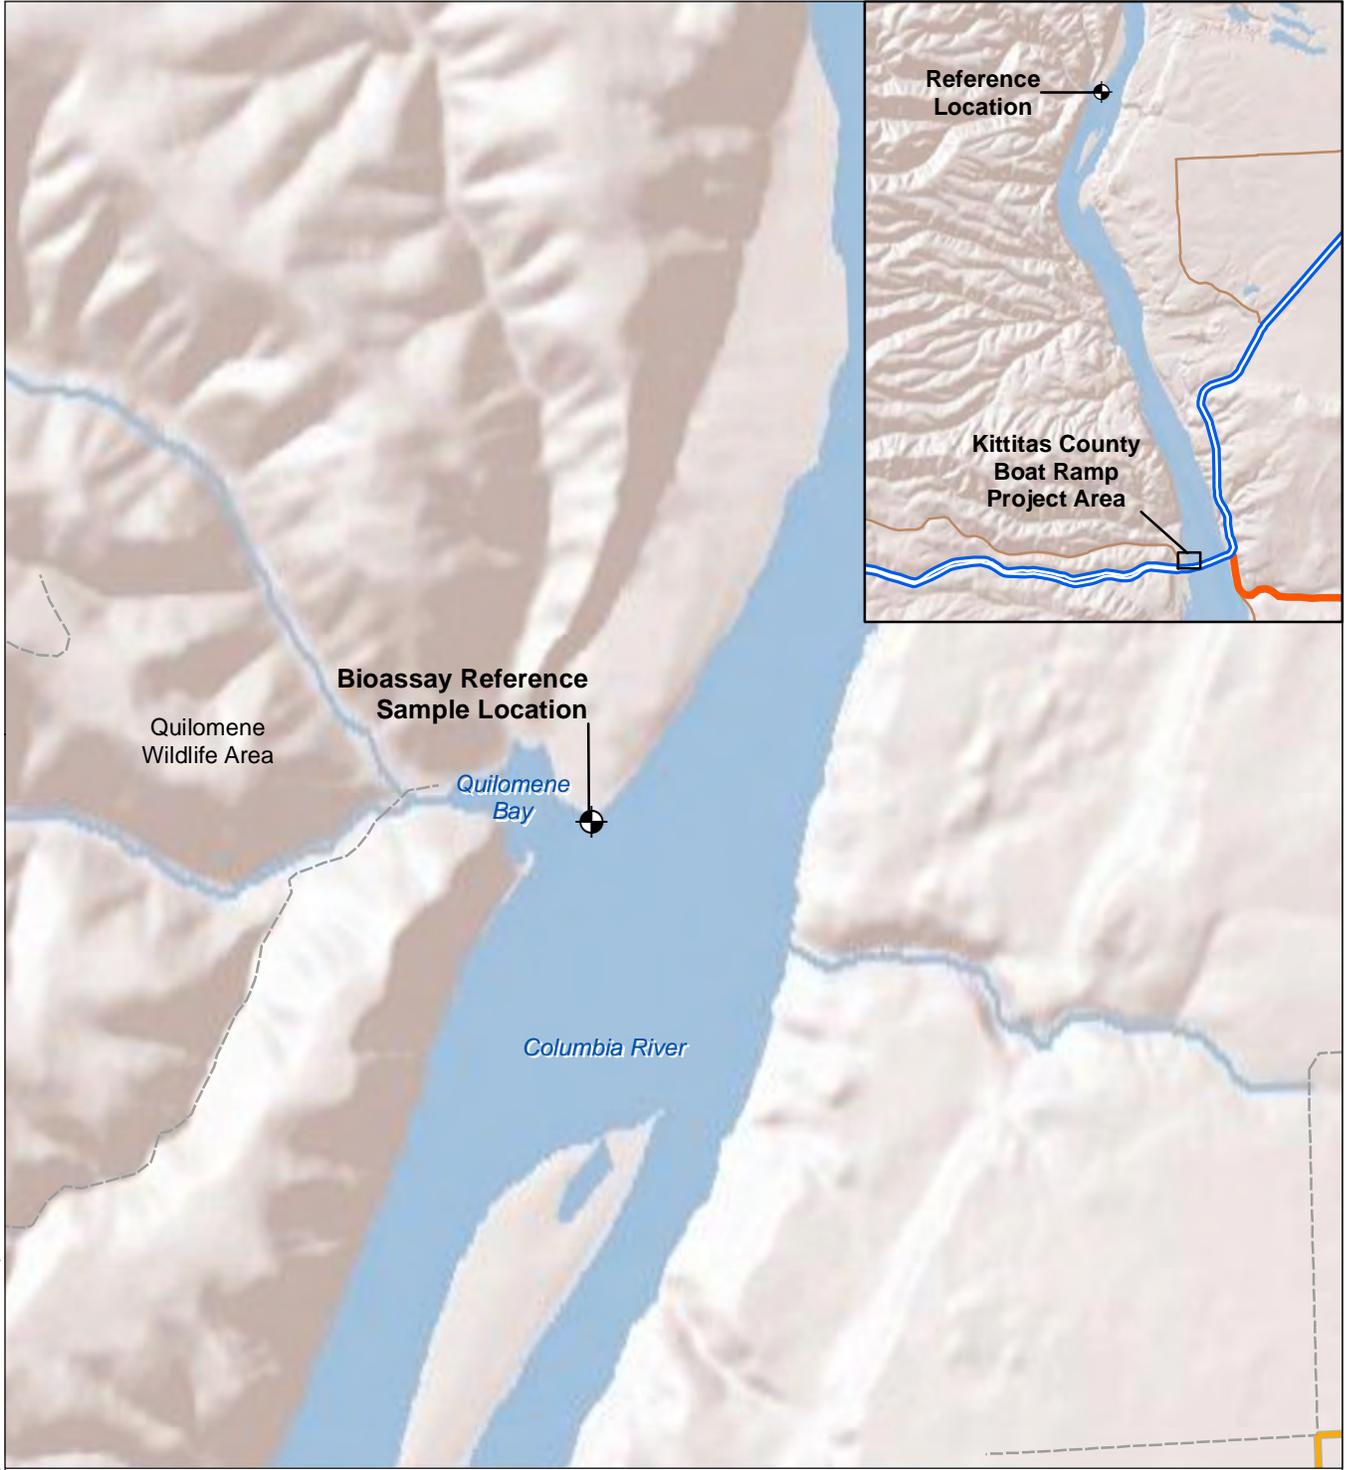
<b>Figure 4</b>

<b>Bioassay Reference Sample Location</b>	
Kittitas County Boat Ramp Recreational Improvements Project Vantage, Washington

- 7. Biological Analysis.** Archived DMMU 1 material was subjected to toxicity testing with the *Chironomus dilutus* 10-day growth and survival bioassay and the *Hyalella azteca* 10-day survival bioassay (USEPA, 2000 and ASTM, 2000). Selection of a sediment reference site was coordinated with the DMMP agencies. A reference sample was collected from Quilomene Bay Wildlife Refuge Area (Figure 4), on March 30, 2013. Wet sieving of the reference sediment was performed immediately after collection, and the percent fines was estimated to be between 30-50%. Subsequent grain size analysis at the analytical laboratory determined the percent fines was 49%, a good match for the test sediment with 45.5% fines.
