Mud Mountain Dam

Mud Mountain Dam controls floods in the lower White and Puyallup River valleys! The U.S. Army Corps of Engineers built the dam on the White River in the 1940's. The Corps also made channel improvements and built levees on the lower Puyallup River. Together, these structures have saved an estimated \$308 million in flood damages. The project currently helps protect the homes and businesses of about 400,000 people. The dam regulates flooding by holding back water from heavy rains and melting snow in the reservoir, then releasing it slowly back into the river. The reservoir is usually empty, except for the normal flow of the White River.

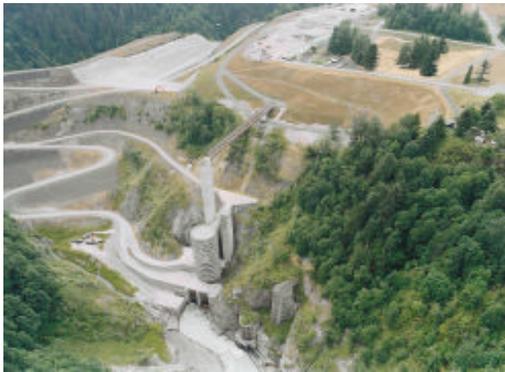
Aerial view

Completely filled, the reservoir would stretch 5.5 miles and cover 1,200 acres.

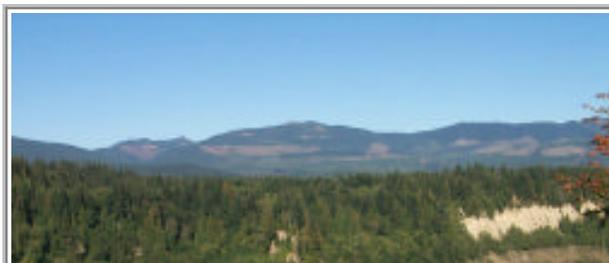
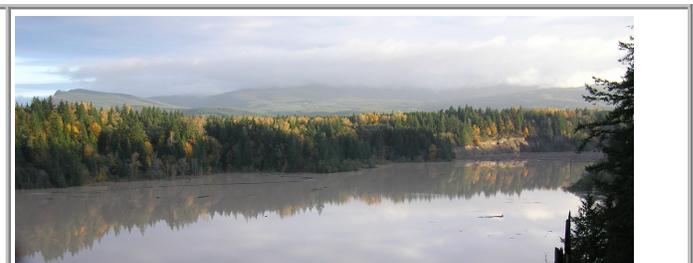
These pictures below show the White River at normal elevation and the most recent flood event in November 2006.

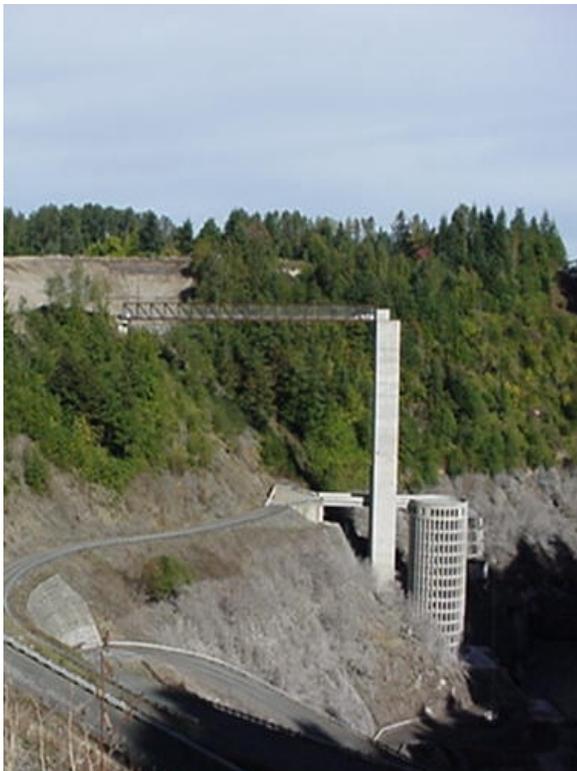
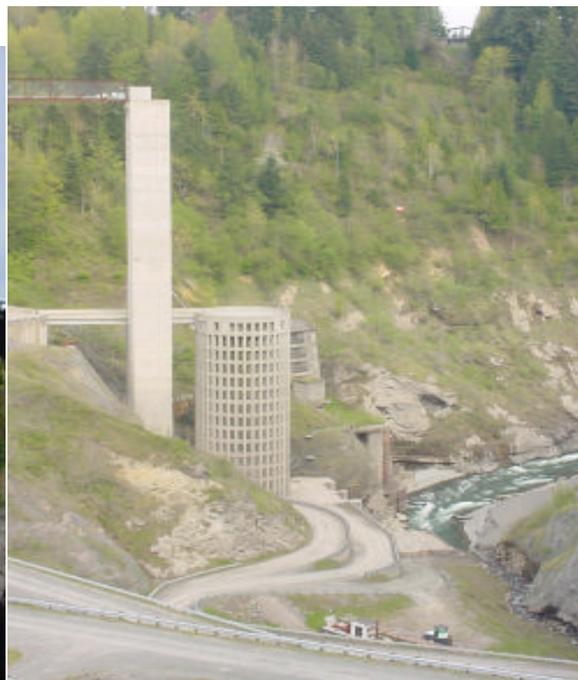
The 365 Foot Intake Structure

The "new" Mud Mountain Dam intake works, completed in 1995, consist of a single intake tower, replacing the structures originally built with the dam in the 1940s, and two new tunnels, which are connected within the dam to the original tunnels. The entrances to both new tunnels are located in the new intake tower. Also, as part of the tower contract, a new outlet structure was constructed at the end, or outlet, of the original tunnel alignment. These features are currently used to control project discharges, and have done so since the 1995 flood season. This work was done as part of an overall Dam Safety Assurance Program at Mud Mountain Dam, which also included a concrete diaphragm (cutoff) wall installed along the axis of the original dam embankment in 1990.

one in November 1995 and another in February 1996 (See Below). These floods not only tested and proved the effectiveness and safety of the new intake works, they also revealed some improvements that could be made. These improvements are also the result of "lessons learned" from nearly 8 years of operating the project for flood control since the new intake works were completed. Some necessary repairs have also been identified. Some of the work on improvements and repairs has been completed, while other improvement work is currently underway at Mud Mountain Dam or planned for the future. In the photo, the new intake tower trashrack (lower right) can be seen, and on the left, the higher vent shaft with pedestrian bridge leading from right embankment. The old intake structures for the 9-foot and 23-foot diameter tunnels are below the new one, obscured by the shadow in this photo. Some of the more visible future work at the dam will be demolition of both of the old intake structures.
