Mud Mountain Dam Intake Works Improvements

Floods during winter 1995_1996

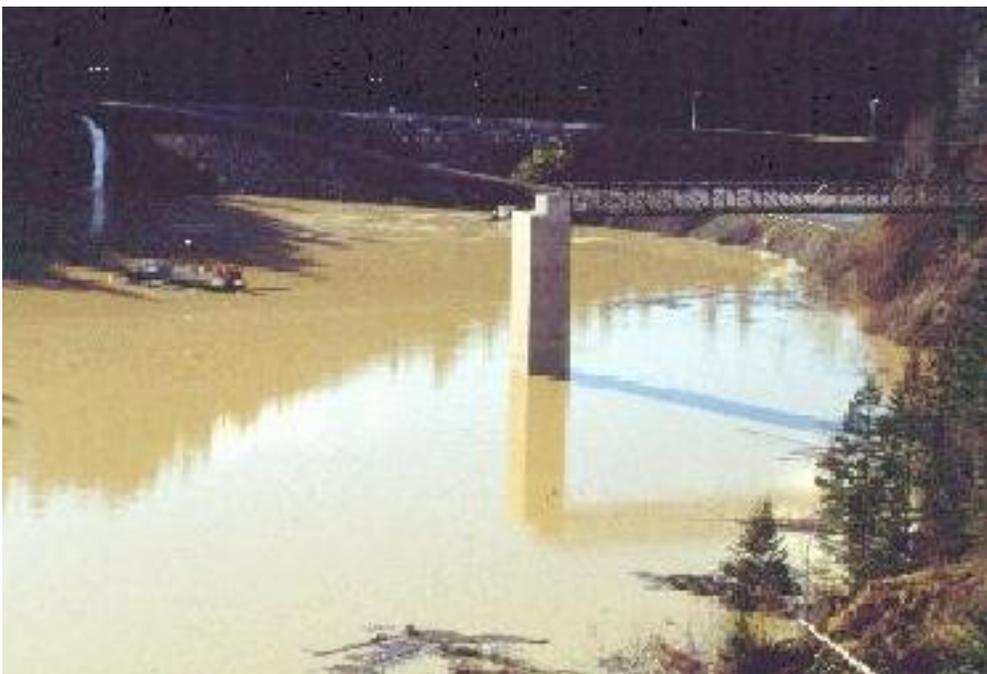
The Log Bronc Near Lower Cascade Falls

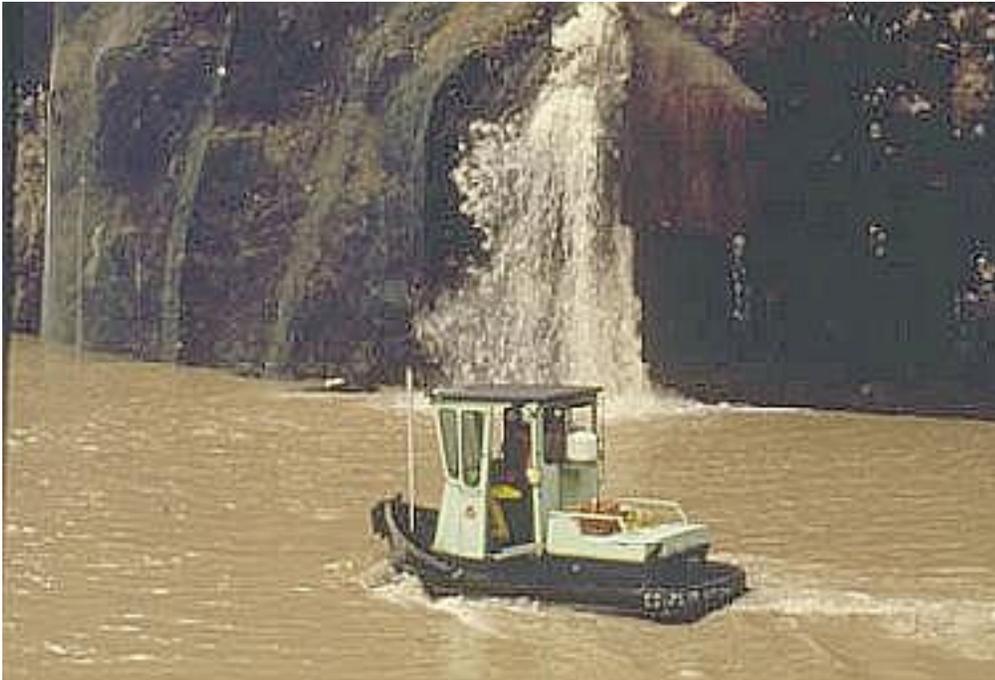
Debris Barge

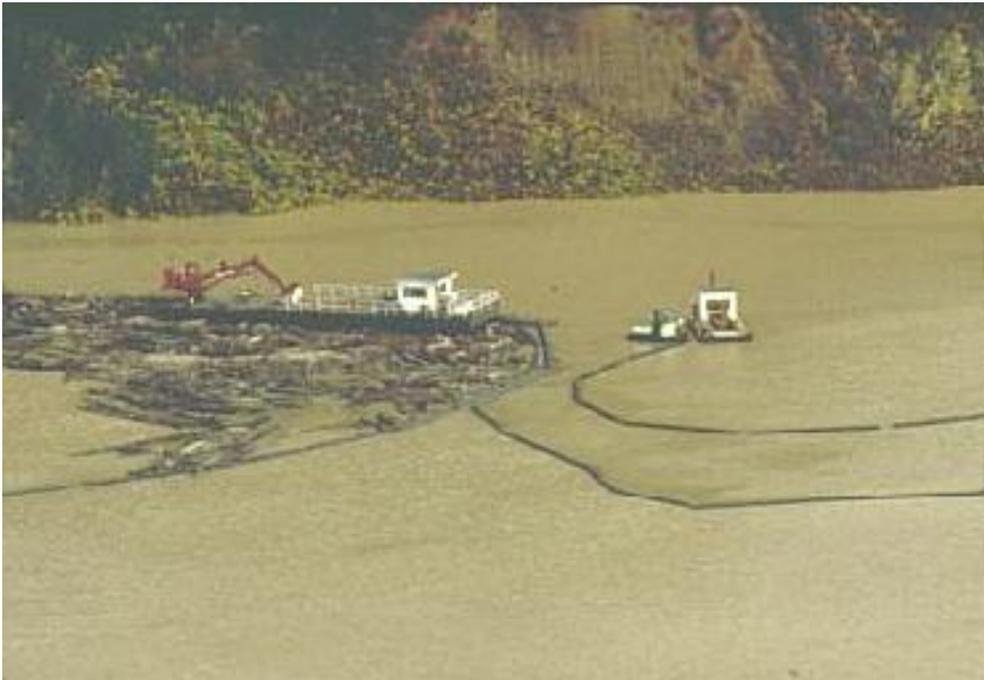
The Rising Pool Looking Upstream
