# Middle Green River Habitat and Large Woody Debris Monitoring

*Prepared for:*  
**U.S. Army Corps of Engineers**  
**Seattle District**  
and  
**Tacoma Public Utilities**

*Prepared by:*  
**R2 Resource Consultants**  
15250 NE 95th Street  
Redmond, Washington 98052

## **2007 Data Report**

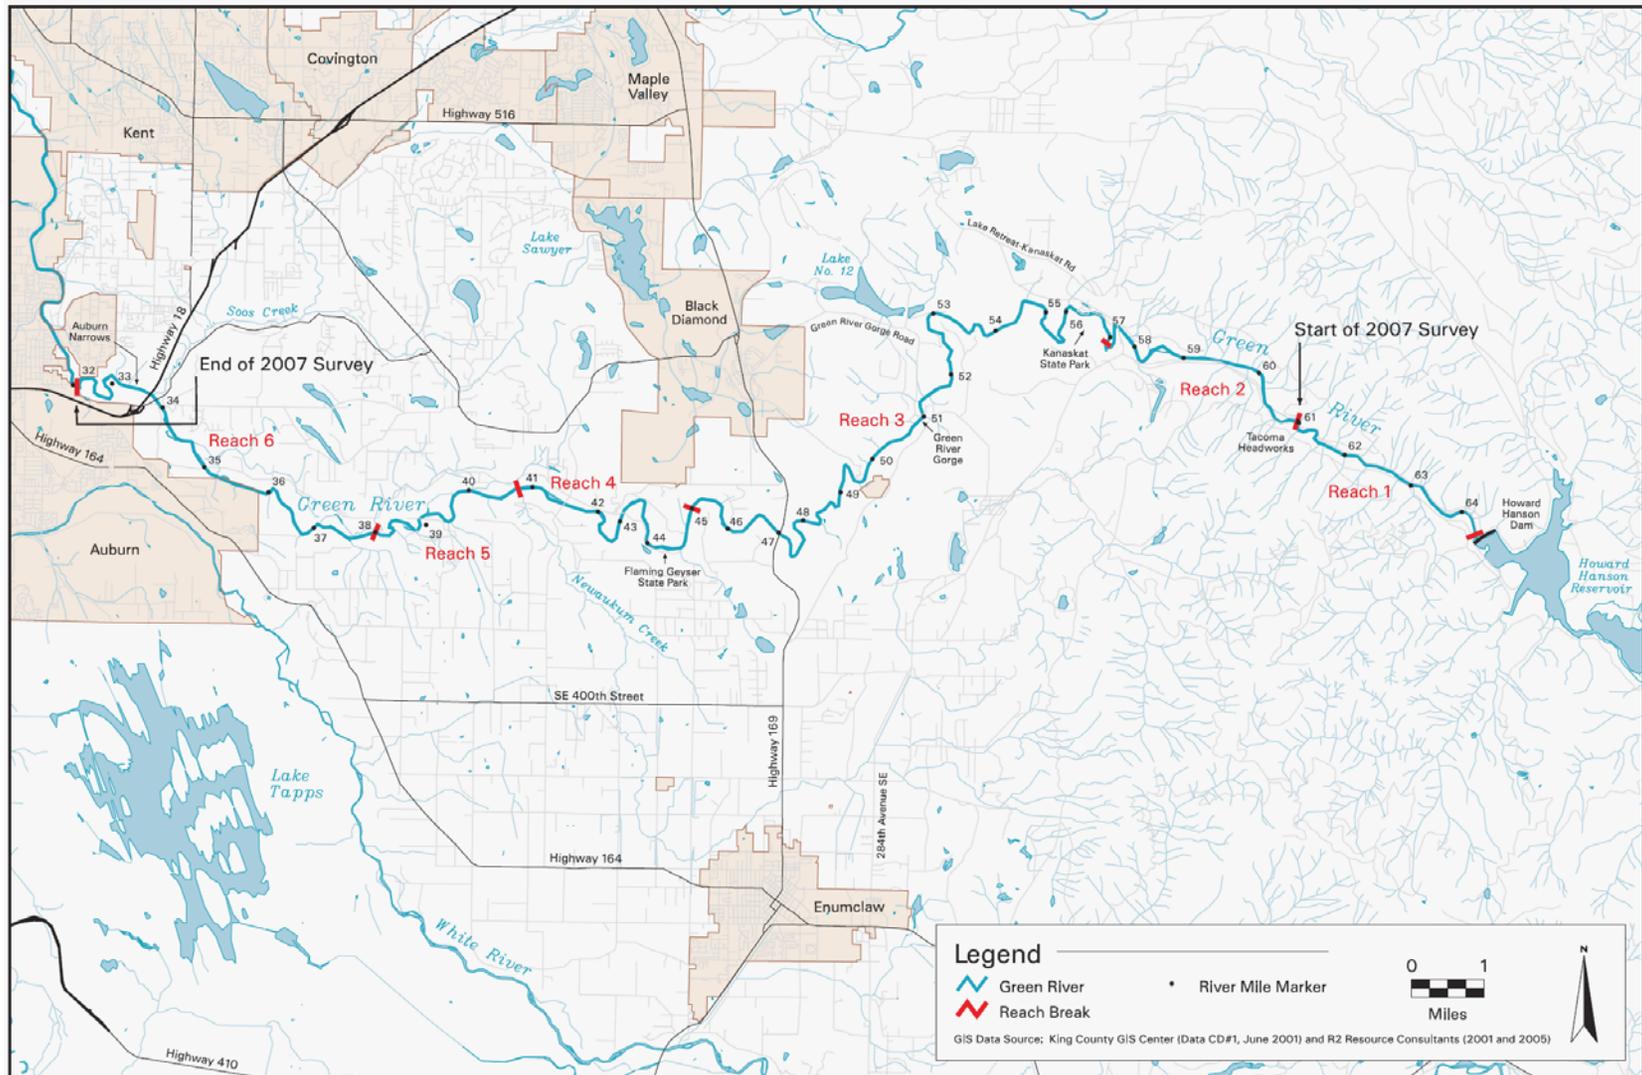
Figure 2-1. Middle Green River LWD and habitat monitoring area.

The 2007 LWD and habitat survey extended from the Tacoma Headworks (RM 61.0) downstream to the Auburn Narrows at approximately RM 32.0 (Figure 2-1). This survey length

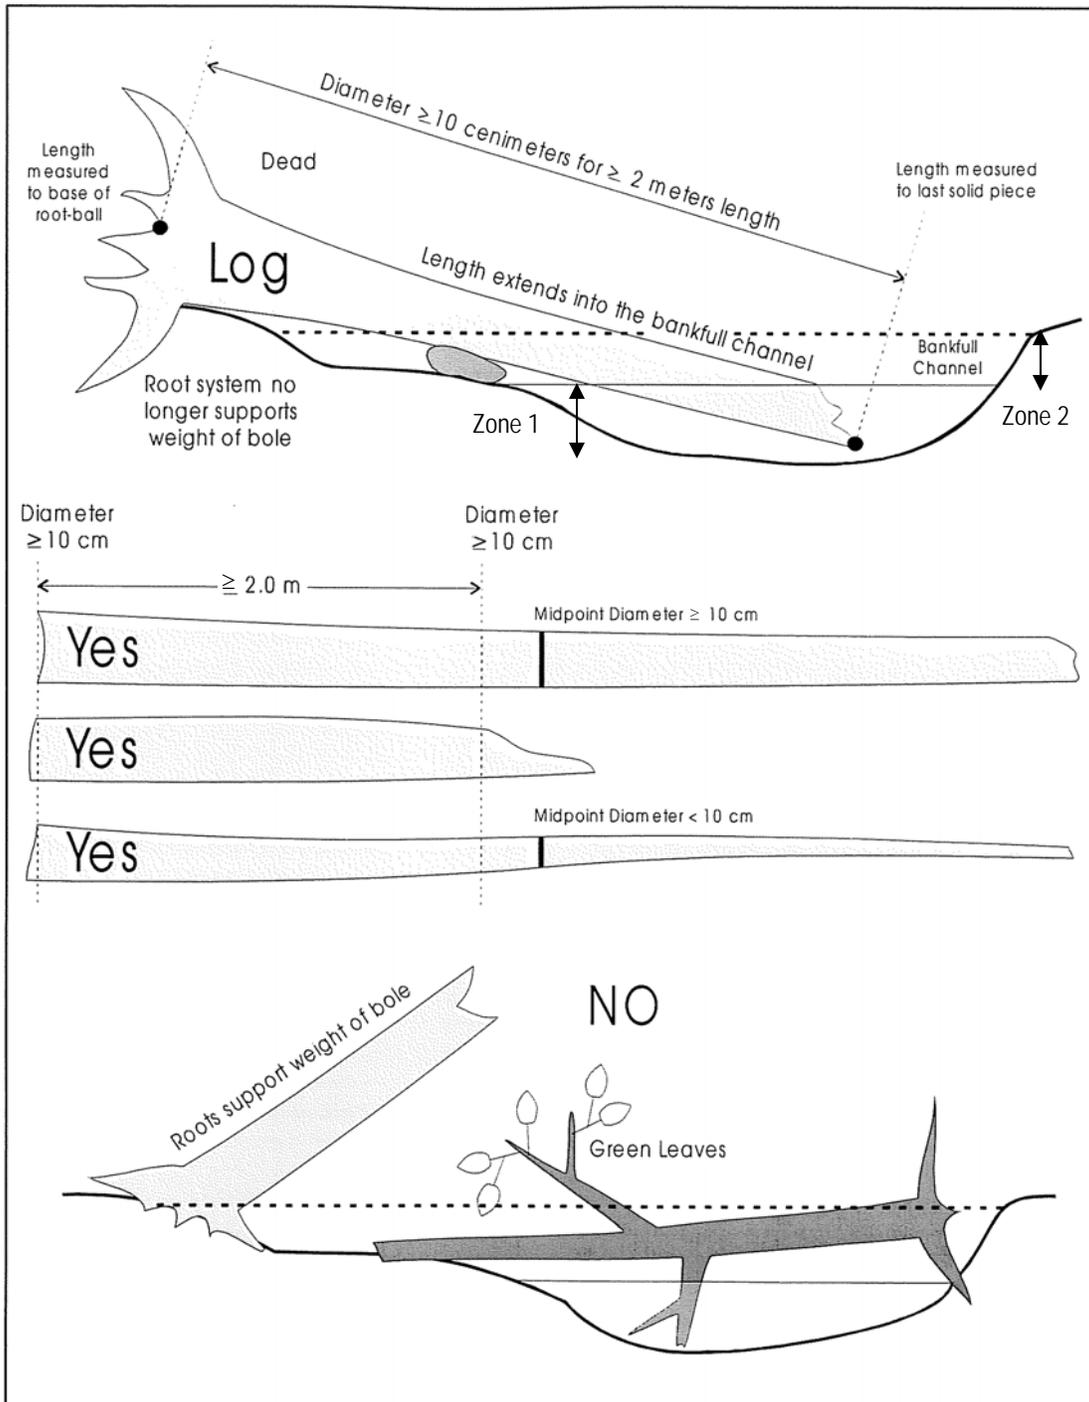
Figure 3-1. Size criteria for identification of individual log utilized in 2001, 2005, and 2006 monitoring surveys of the mainstem middle Green River, King County, Washington (after Schuett-Hames et al. 1999).

pieces, small; 50 to 100 pieces, medium; and greater than 100 pieces, large. The location of all large-sized LWD jams and most small and medium-sized jams were marked on aerial photographs.

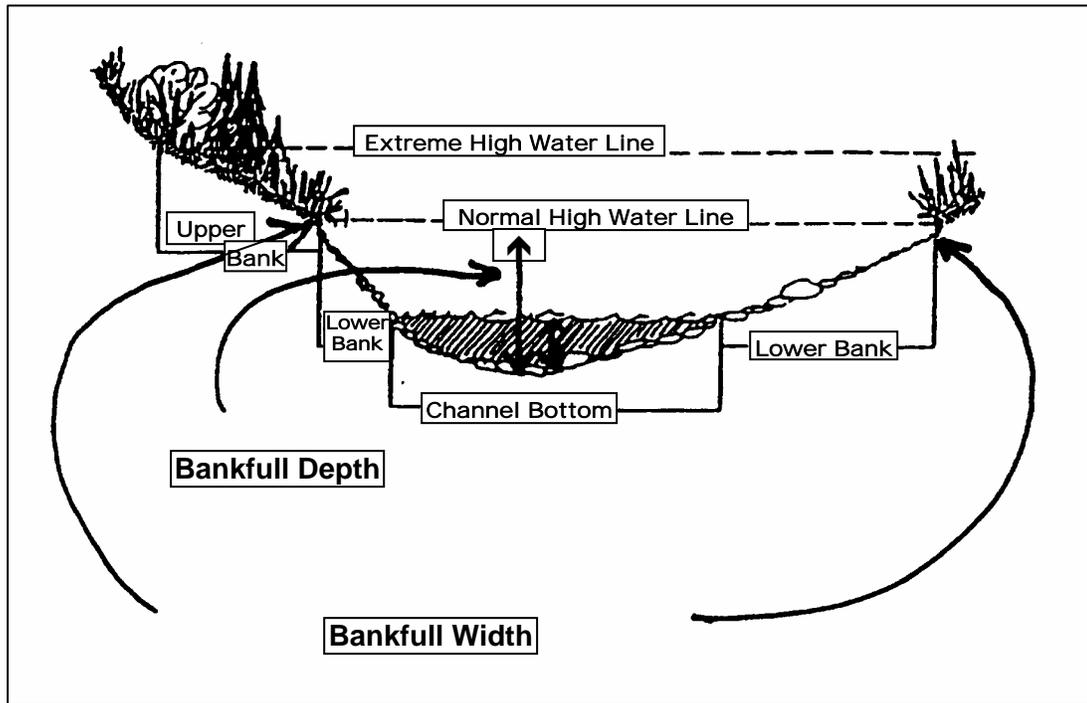
Figure 3-2. Identification of bankfull width, bankfull depth, and lower bank (adapted from Pfunkuch 1975).

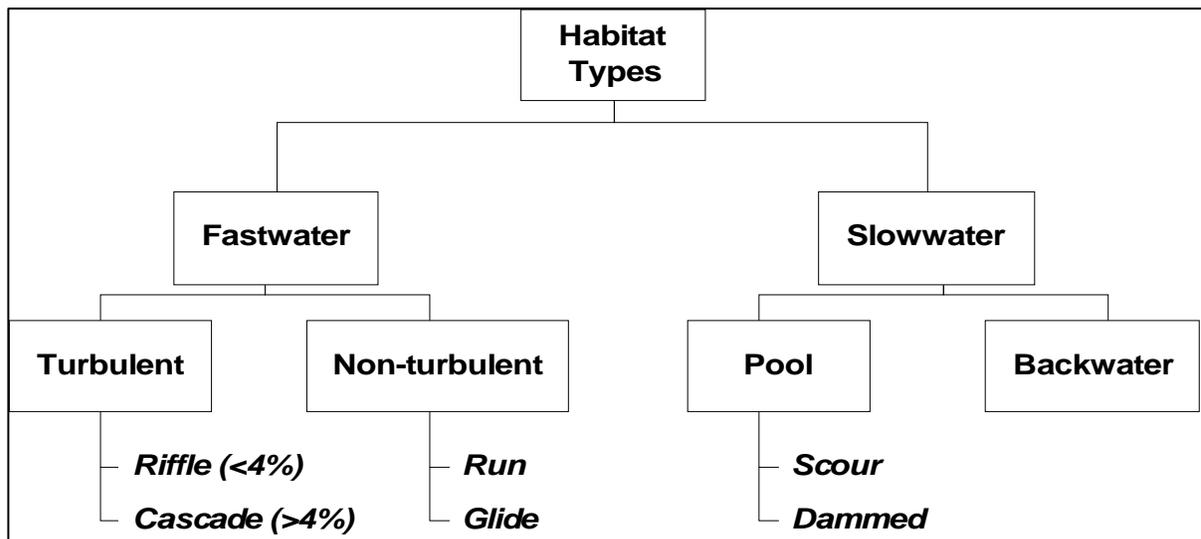
Figure 3-3. Habitat type classification system for upper Green River baseline mainstem habitat monitoring (adapted from Hawkins et al. 1993).

than pools, quantitative measurements were only collected in pool habitat units. Habitat units were classified according to a modified version of the hierarchical system developed by Hawkins et al. (1993). This system recognizes two basic classes of habitat: fast water habitat and slow water habitats. For this survey, those basic habitat classes were further broken down into seven habitat types (Figure 3-3).

Fast water habitat types generally have a velocity that is greater than 0.3 meters per second. Fast water habitat types are further characterized as turbulent or non-turbulent. Fastwater habitats exhibiting surface turbulence include cascades and riffles. Turbulent, fast water habitats with a water surface slope greater than 4 percent are classified as cascades. Turbulent fast water habitats with a water surface slope less than 4 percent are classified as riffles.

Fast water habitats that do not exhibit surface turbulence often appear pool-like because of their depth and lack of surface agitation. However, unlike pools, non-turbulent fastwater habitats do not exhibit a well-developed depression. Non-turbulent habitat units that are deep and swift with a well-defined thalweg are classified as runs. Non-turbulent fastwater habitats with low to moderate velocity, a uniform bed, and no defined thalweg were classified as glides.

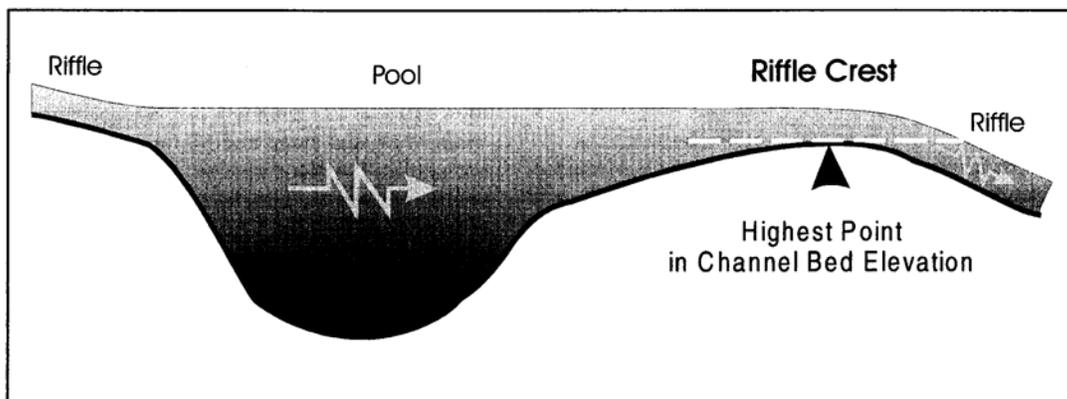
Figure 3-4. Upstream and downstream boundaries used when defining a pool habitat unit (adapted from Pleus et al. 1999).

Pool habitat units are bounded by an upstream pool head and a downstream riffle crest (Figure 3-4). For the unit to be classified as a pool habitat unit, the concave depressional area was required to occupy at least 25 percent of the wetted channel width and have a residual depth greater than 1.0 meter.<sup>3</sup> Smaller pool units were noted on the map and described in field notes, but not measured. Quantitative measurements were collected at each pool habitat unit. Each pool habitat unit was located using GPS (where possible). Pool length and width were measured using a laser rangefinder. The length of each pool shall be measured along the center of the wetted channel. Three to six width measurements per pool perpendicular to the pool centerline were obtained depending on the pool length and complexity. The maximum pool depth was measured using a graduated wading rod or a 2-pound weight attached to a surveyors tape. Riffle crest depths were measured to the nearest 0.1 meter graduated wading rod.

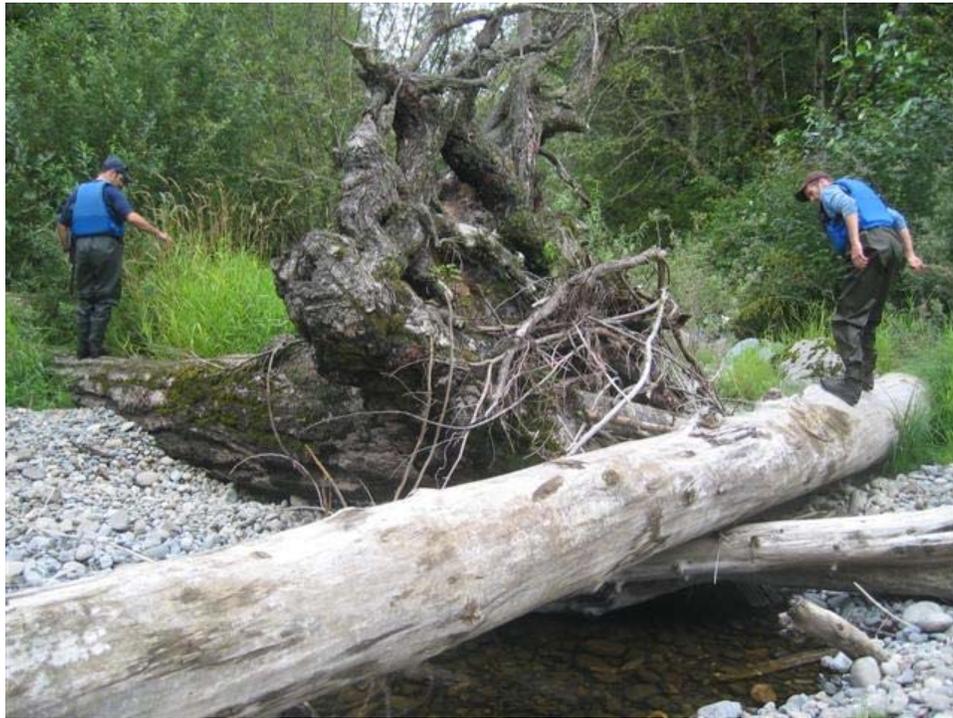
Figure 3-5. Surveyors estimating the size of LWD on the Green River, Washington, 2007.

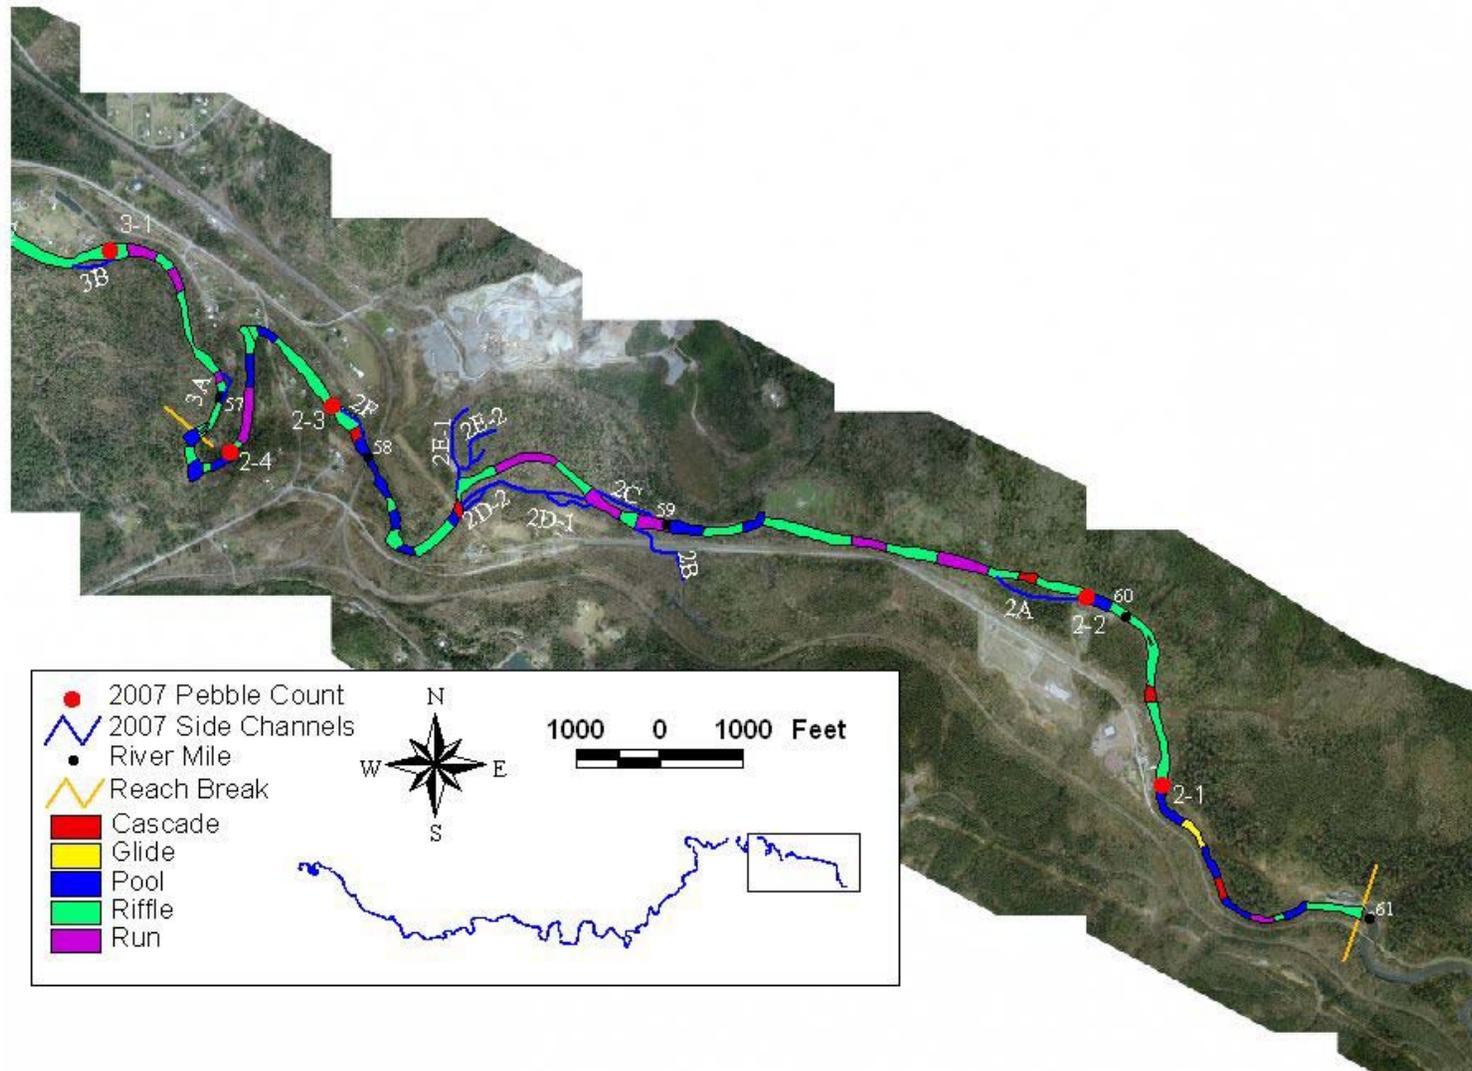
Figure 4-2. Middle Green River physical habitat in Reach 2, 2007.

The dominant habitat type was riffle, comprising more than half of the habitat length (51.6%). Pools were the next most common habitat type, comprising approximately 25 percent of the reach by length. Runs, cascades and glides were also present (17.4, 4.7, and 1.9% respectively). These ratios are very similar to those found in the 2001 habitat survey. Sixteen pools were identified in Reach 2. The majority of the pools were formed by bedrock. Only one pool (6.3%) was formed by wood. Five mainstem and two side channel LWD jams were identified in Reach 2. All of the jams were small in size (Appendix D).

Substrate in Reach 2 consisted primarily of bedrock and boulders. Pebble counts were conducted in riffle habitat types that tended to be composed of smaller material than was observed in the steeper stream sections. The mean  $D_{50}$  for the four pebble counts was 69.8 mm,

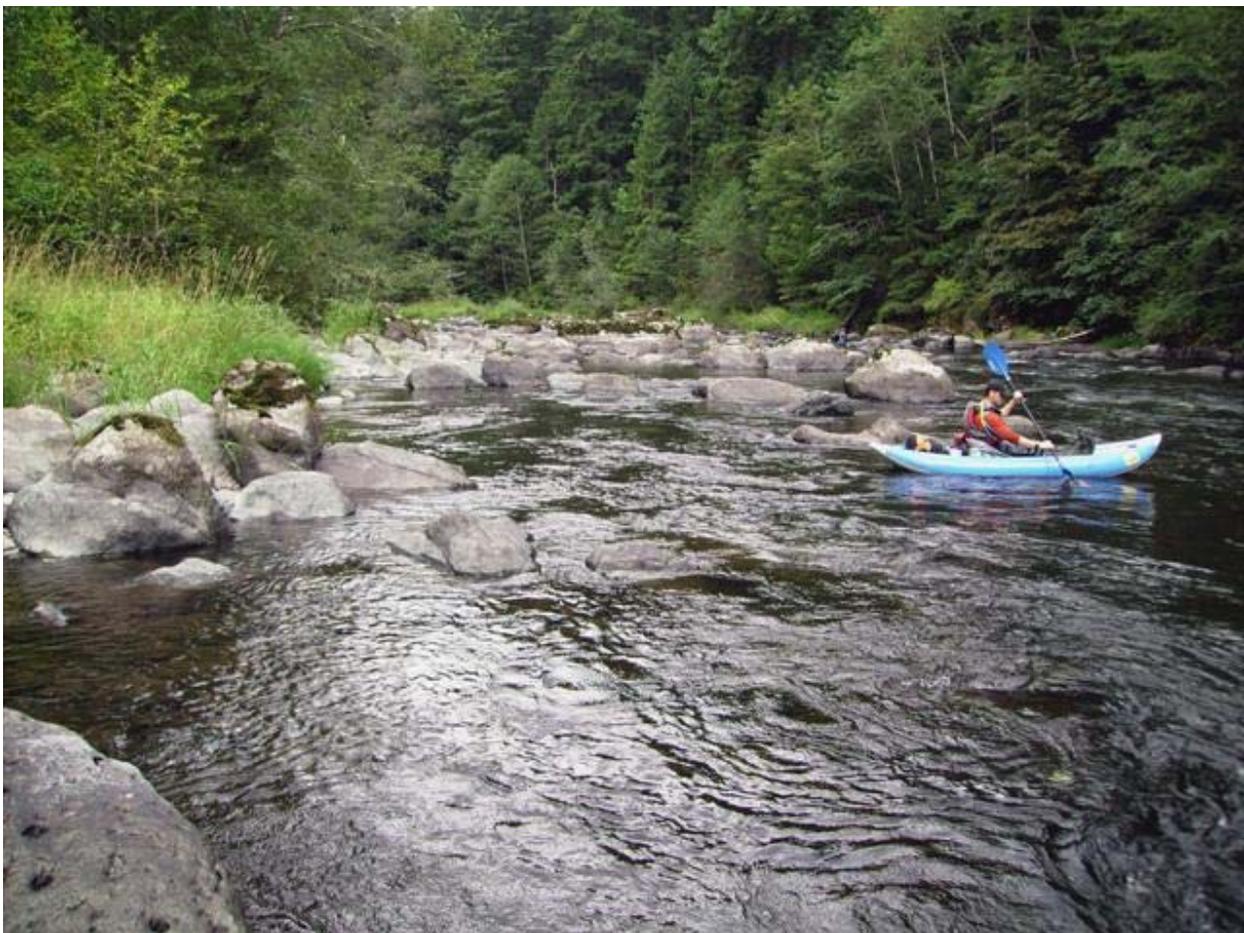
Figure 4-3. Representative habitat of Reach 3, Green River, Washington 2007.

Reach 3 encompasses a deep bedrock canyon known as the Green River gorge (Figure 4-3). The survey of Reach 3 took place over August 22, 23, and 24. The reach is approximately 12 miles long extending from Kanaskat State Park (RM 57) to Flaming Geyser State Park (RM 45) (Figures 4-4 and 4-5). The average stream flow during the survey was 311 cfs as measured at the Auburn, Washington stream gage (USGS #12113000) and 182 cfs as measured at the Palmer Washington stream gage (USGS #121067000). Summary statistics for habitat data collected in Reach 3 are presented in Table 4-2.

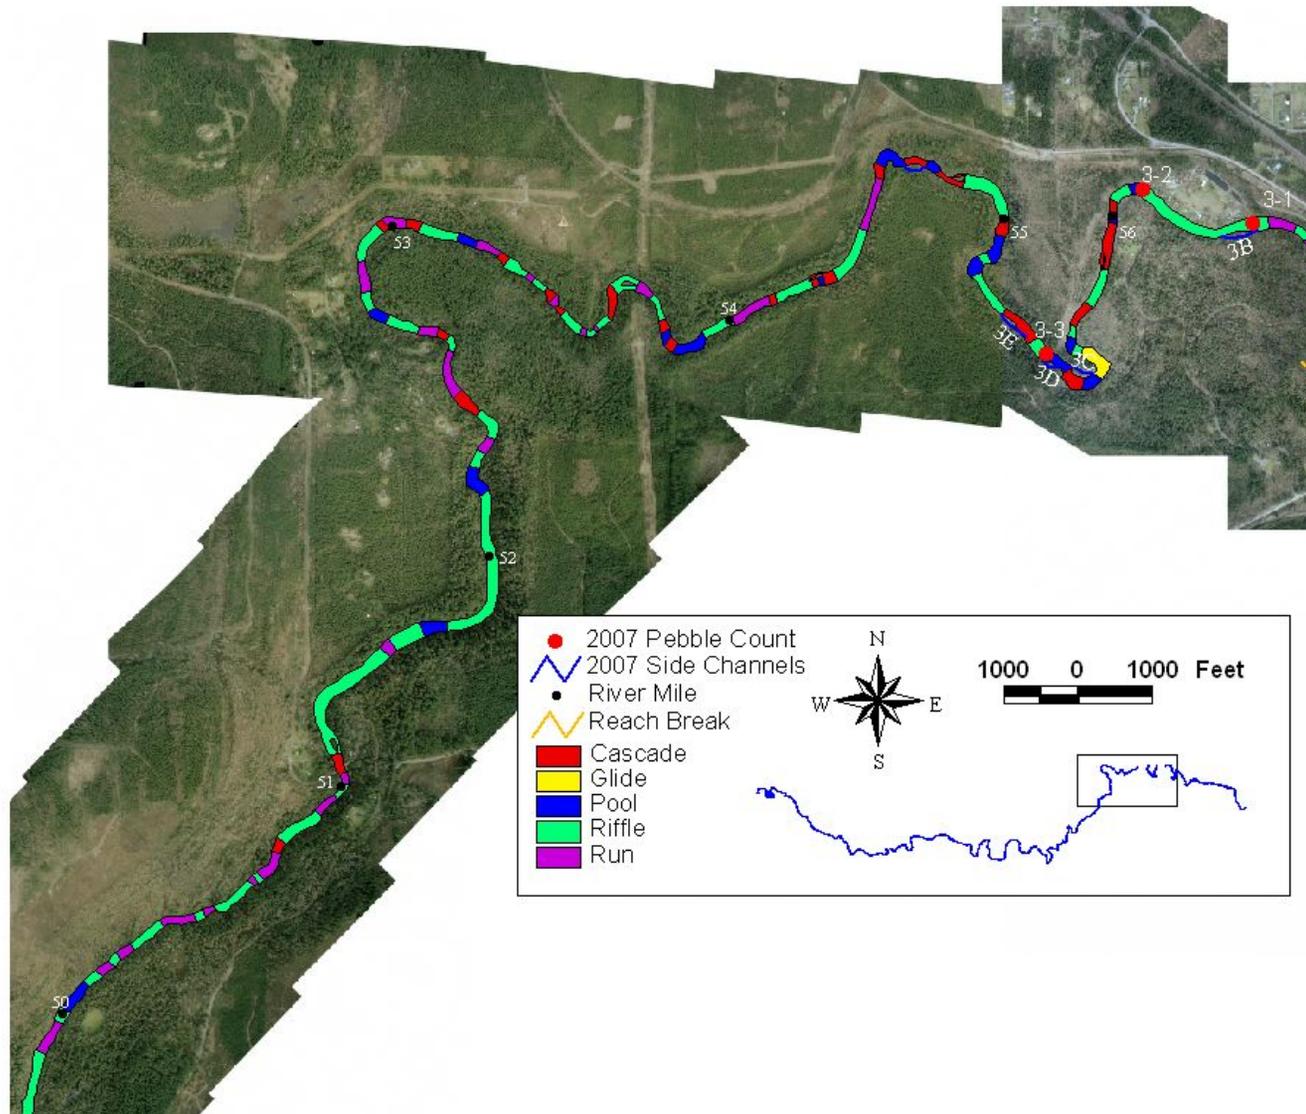
Figure 4-4. Middle Green River physical habitat in the upstream half of Reach 3, 2007.

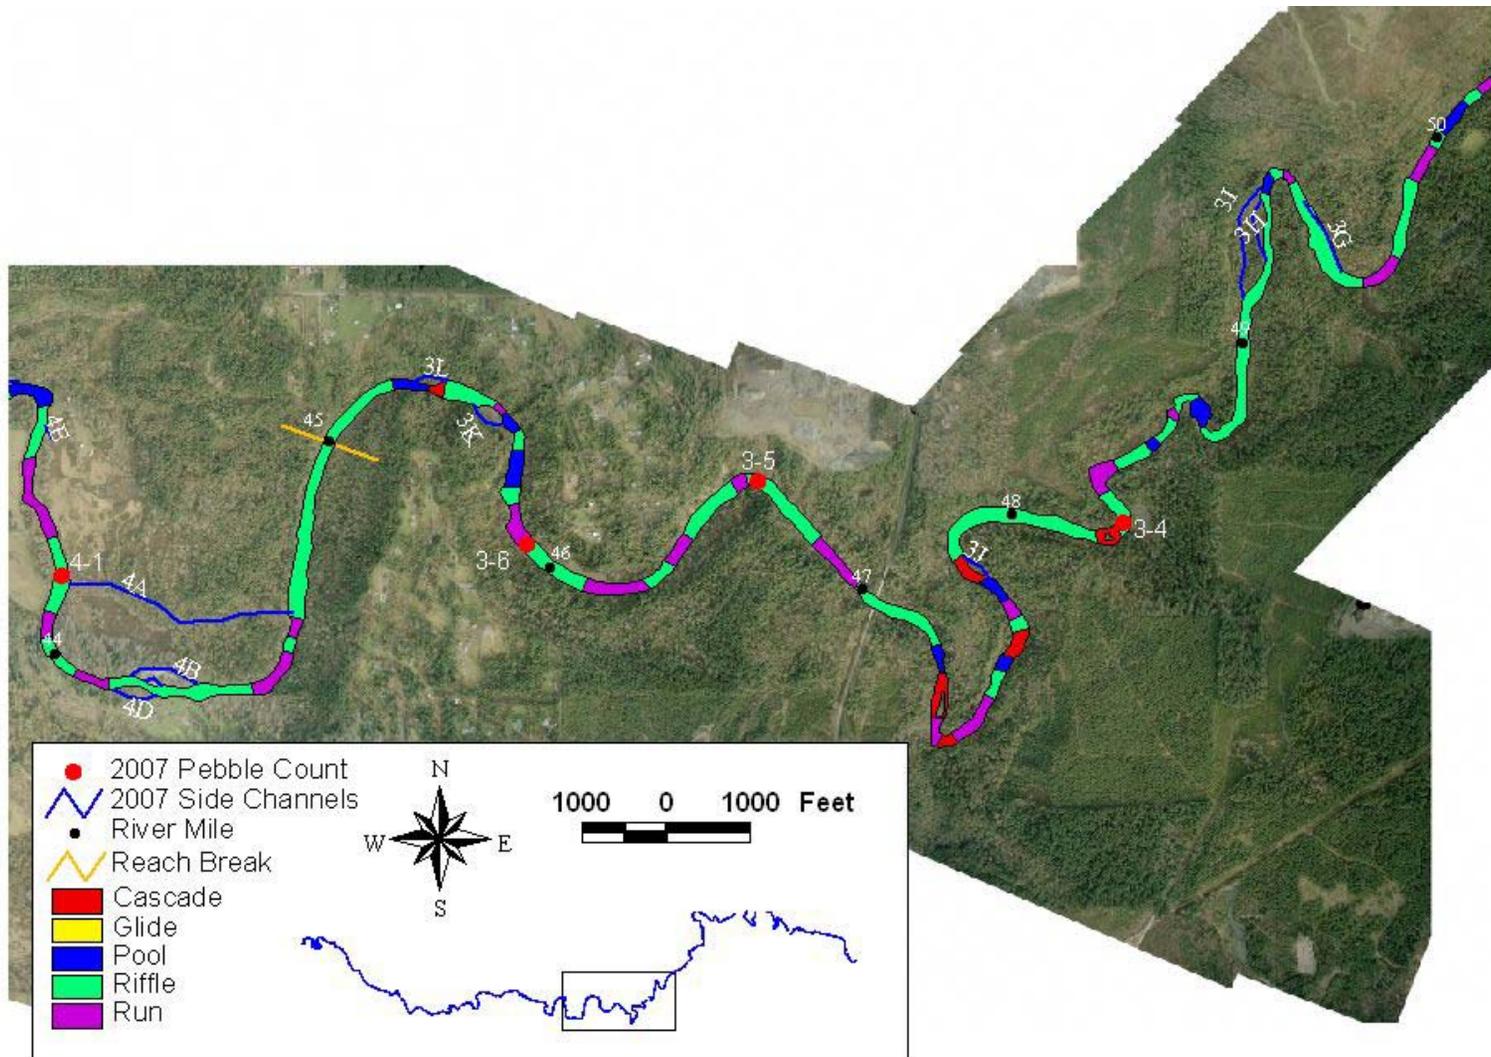
Figure 4-5. Middle Green River physical habitat in the downstream half of Reach 3.

The dominant habitat type in Reach 3 was riffle, which comprised 56.5% of the habitat by length. 19% of the reach consisted of run habitat. Pools only accounted for 11.5% of the habitat in Reach 3. Cascade units accounted for 13 percent of the reach by length. A total of 27 pools were identified in Reach 3. The dominant pool formation factor was bedrock, responsible for the formation of 88.9 percent (n=24) of the pools. The 2007 survey took place at a higher flow level than the 2001 survey, possibly increasing surface turbulence of pools causing fewer units to be labeled pool habitat and more units to be runs instead. Twelve side channels were surveyed in Reach 3 (Section 4.2). A total of 33 LWD jams were counted in Reach 3, all located within the mainstem river. These were all small jams, with the exception of four medium sized jams (Appendix D).

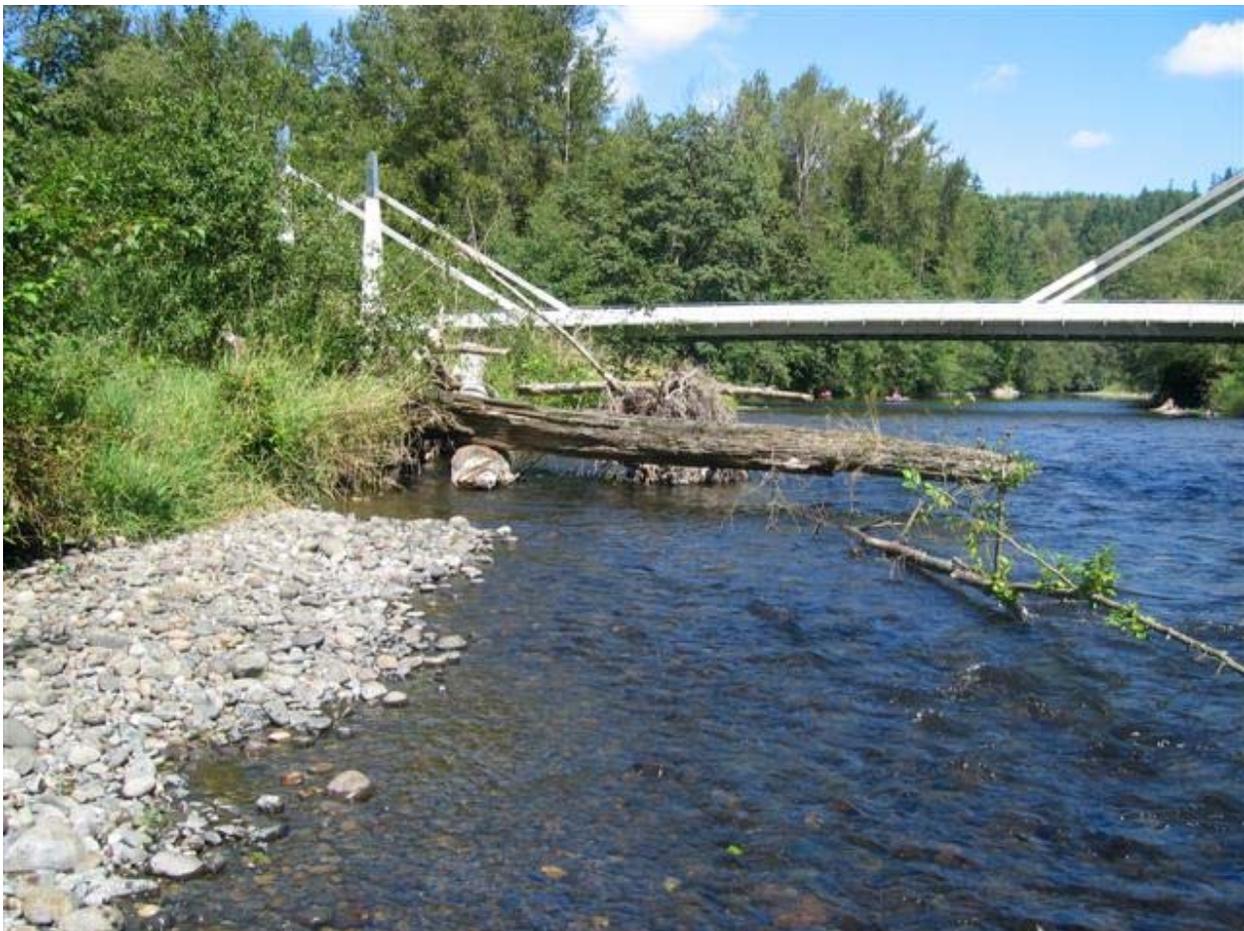
Figure 4-6. Representative habitat of Reach 4, Green River, Washington 2007.

Reach 4 was surveyed on August 27, 2007. The reach is approximately 4.2 miles long extending from Flaming Geyser State Park (RM 45) to Newaukum Creek (RM 40.8) (Figures 4-6 and 4-7). The average stream flow during the survey was 331 cfs as measured at the Auburn, Washington stream gage (USGS #12113000). Reach 4 consists of a wider floodplain channel than upstream with predominately riffle-pool or riffle-run bedforms.

Summary statistics for Reach 4 are presented in Table 4-3. The dominant habitat type in Reach 4 was riffle (60.0%). Run was the next most common type, accounting for 23.1% by length of the habitat. Cascade and pool units were also present (4.9 and 11.1% respectively). Only five pools were identified in Reach 4. Bedrock was the dominant pool formation factor. Eight side channel complexes were surveyed in Reach 4 (Section 4.2). A total of 14 mainstem and 5 side channel jams were identified in Reach 4 (Appendix D).

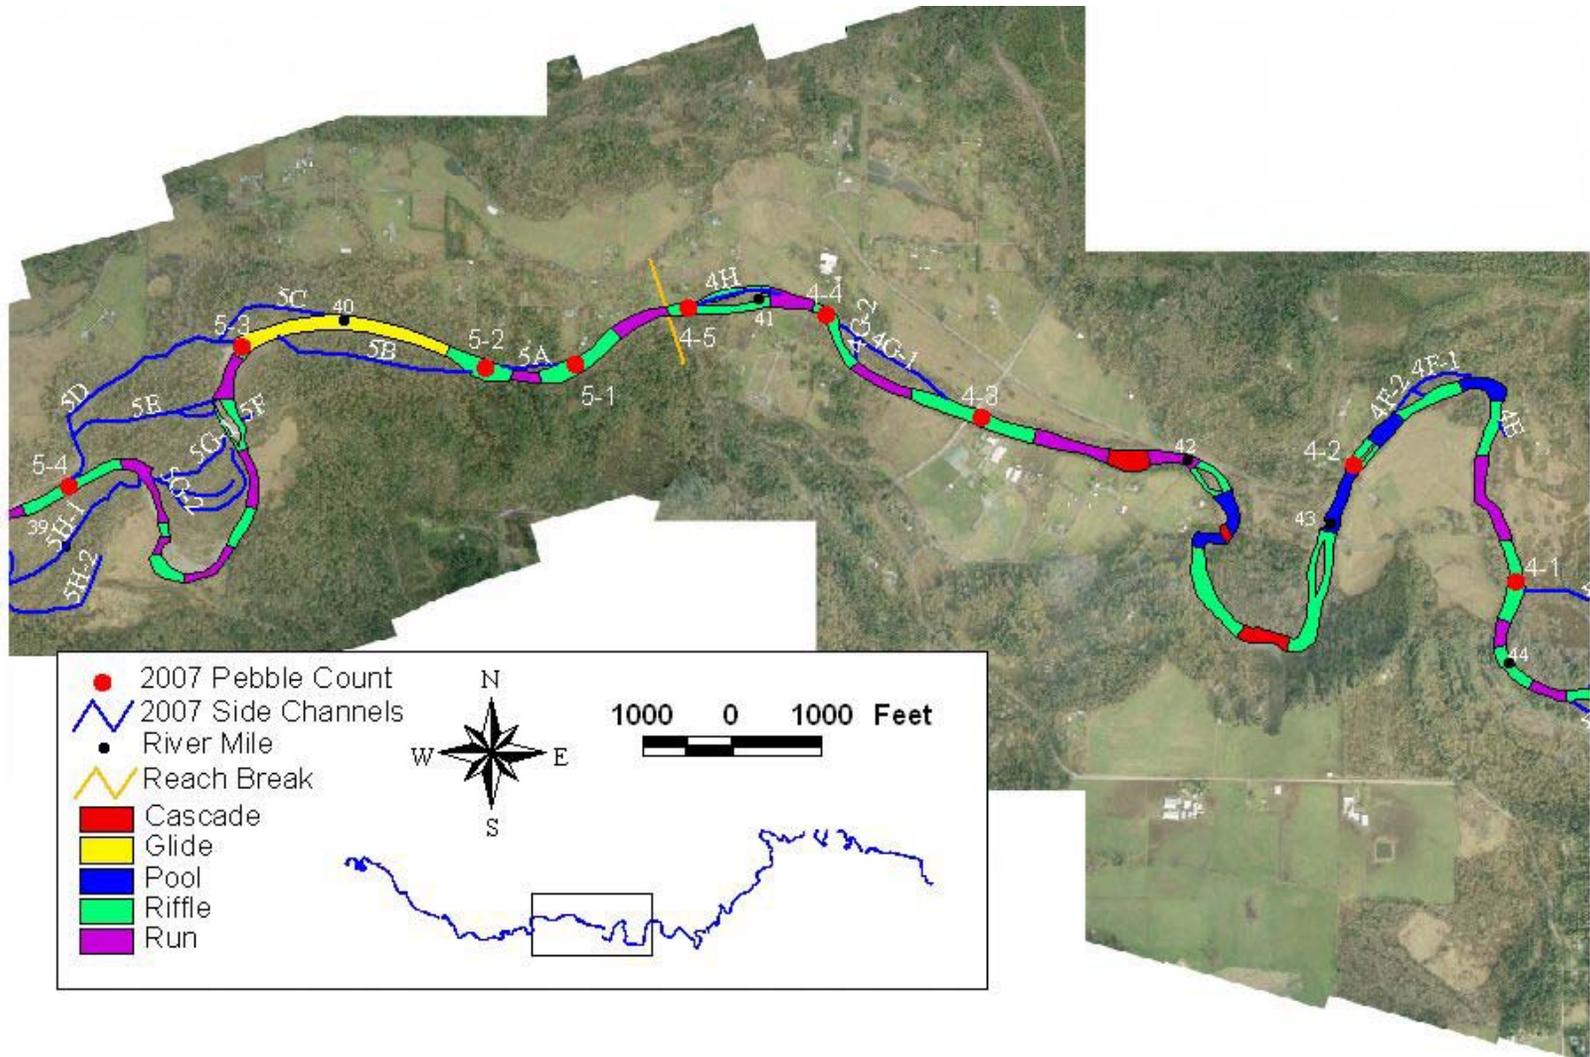
Figure 4-7. Middle Green River physical habitat in Reach 4, 2007.

Substrate in Reach 4 is primarily gravel and cobble. The average D<sub>50</sub> particle size for five pebble counts was 66.8 mm, ranging from 48.0 to 96.9 mm.

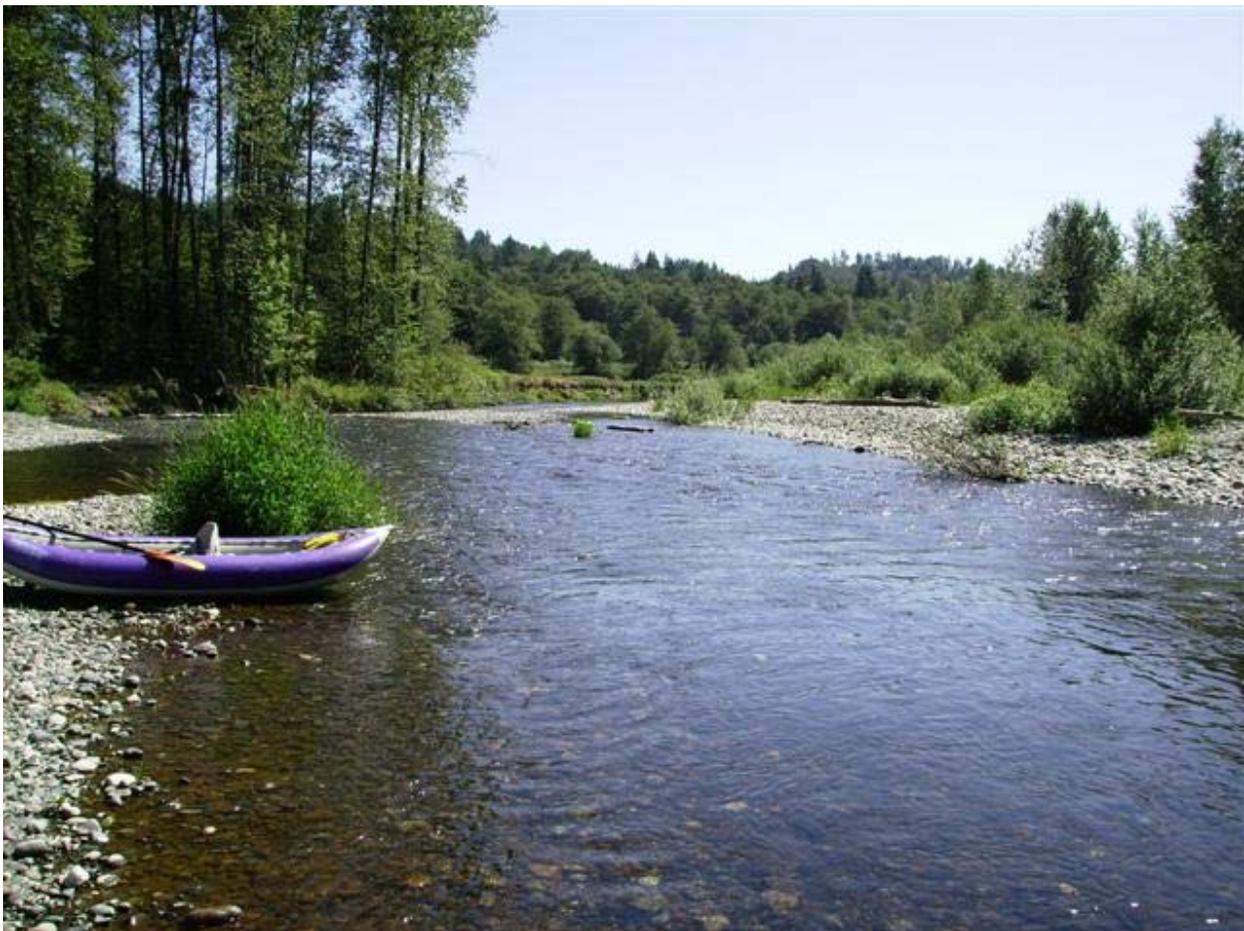
Figure 4-8. Representative habitat of Reach 5, Green River, Washington 2007.

Reach 5 was surveyed on August 28 and 29 (Figure 4-8). The reach is approximately 2.8 miles long extending from Newaukum Creek (RM 40.8) to Loans Levee (RM 38.0) (Figure 4-9). The average stream flow during the survey was 314 cfs as measured at the Auburn, Washington stream gage (USGS #12113000). This reach of the middle mainstem Green River has experienced frequent channel shifts in the past ten to twenty years and contains numerous side channels that were not surveyed as part of the 2001 survey. Since the winter of 1996-1997, almost half of the mainstem flow had been redirected into a large side channel near RM 40 (R2 2002). The main river channel has now shifted significantly since the 2001 survey from flowing in a meander back to a more direct mainstem route just before RM 38.0. Habitat summary statistics are presented in Table 4-4.

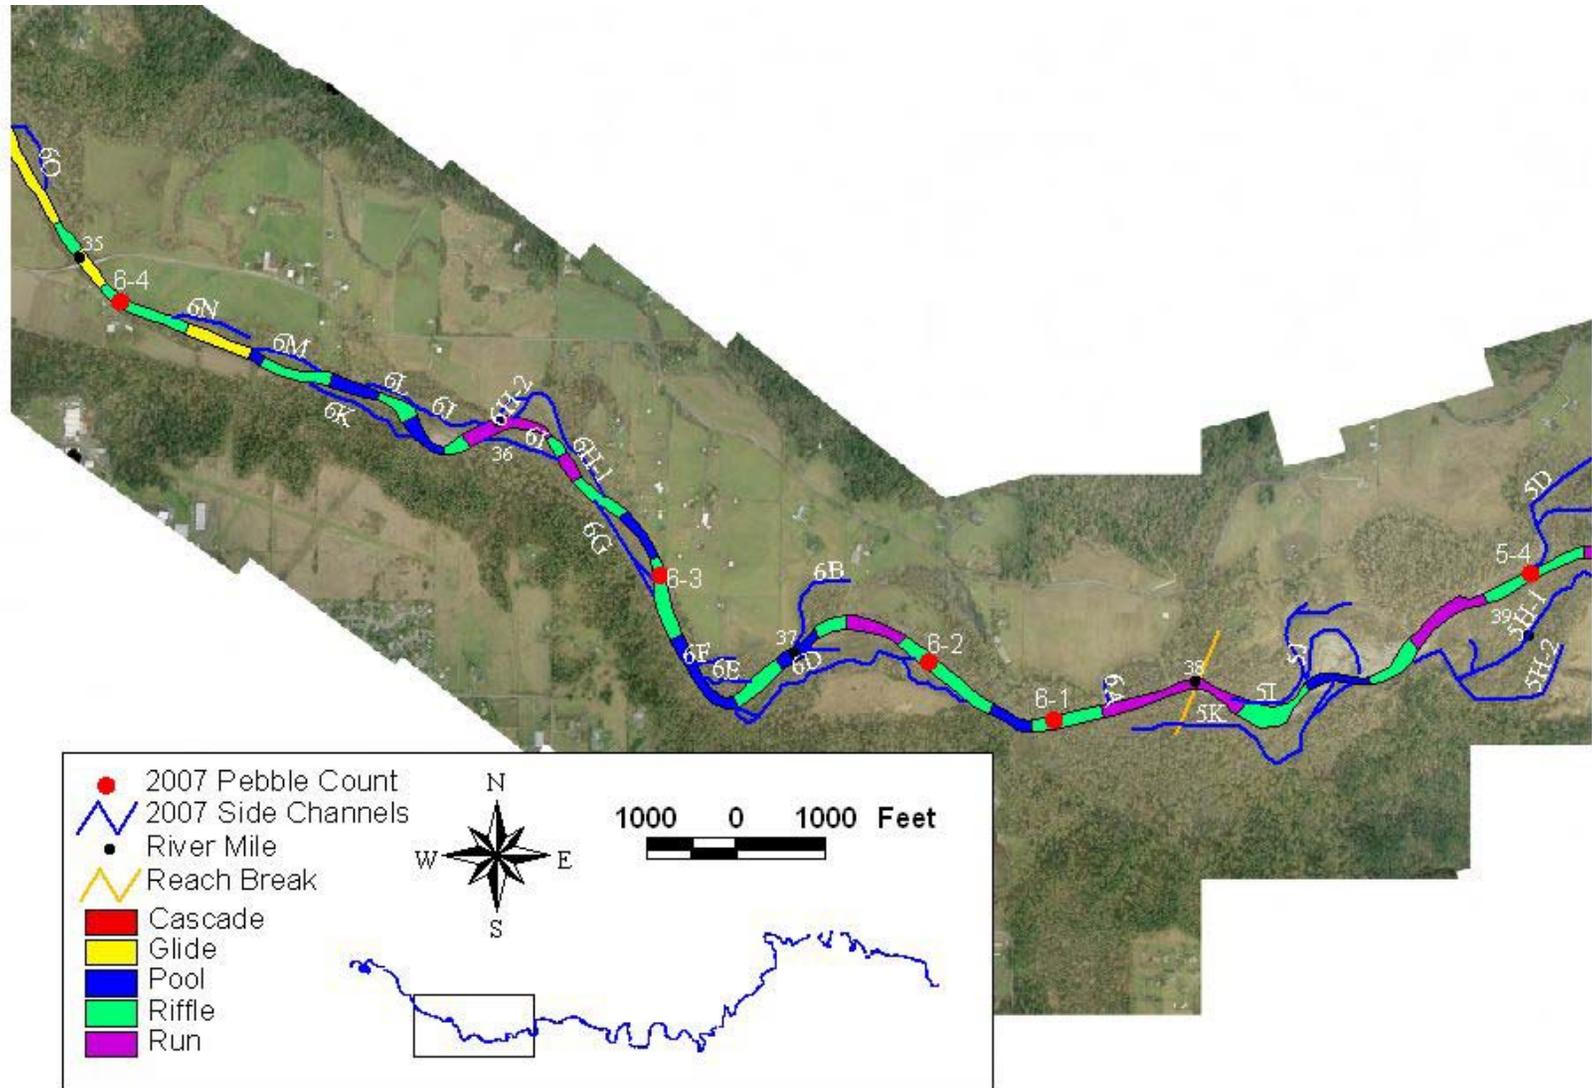
Figure 4-9. Middle Green River physical habitat in Reach 5, 2007.

The dominant habitat type in Reach 5 was riffle, measuring 42.9% by length. Run was the next most common measuring 36.4%. No cascade units were present in this reach. Only one pool was present in Reach 5 (4.8% by length). The return of the river to a more direct route near RM 38.5 has eliminated a large number of pools identified in the 2001 habitat survey. The single pool was formed by woody debris. Reach 5 is a braided channel with multiple flow paths and gravel bars. Eleven side channel complexes were surveyed in this reach (see Section 4.2). Eight mainstem and 13 side channel LWD jams were counted in Reach 5 (Appendix D).

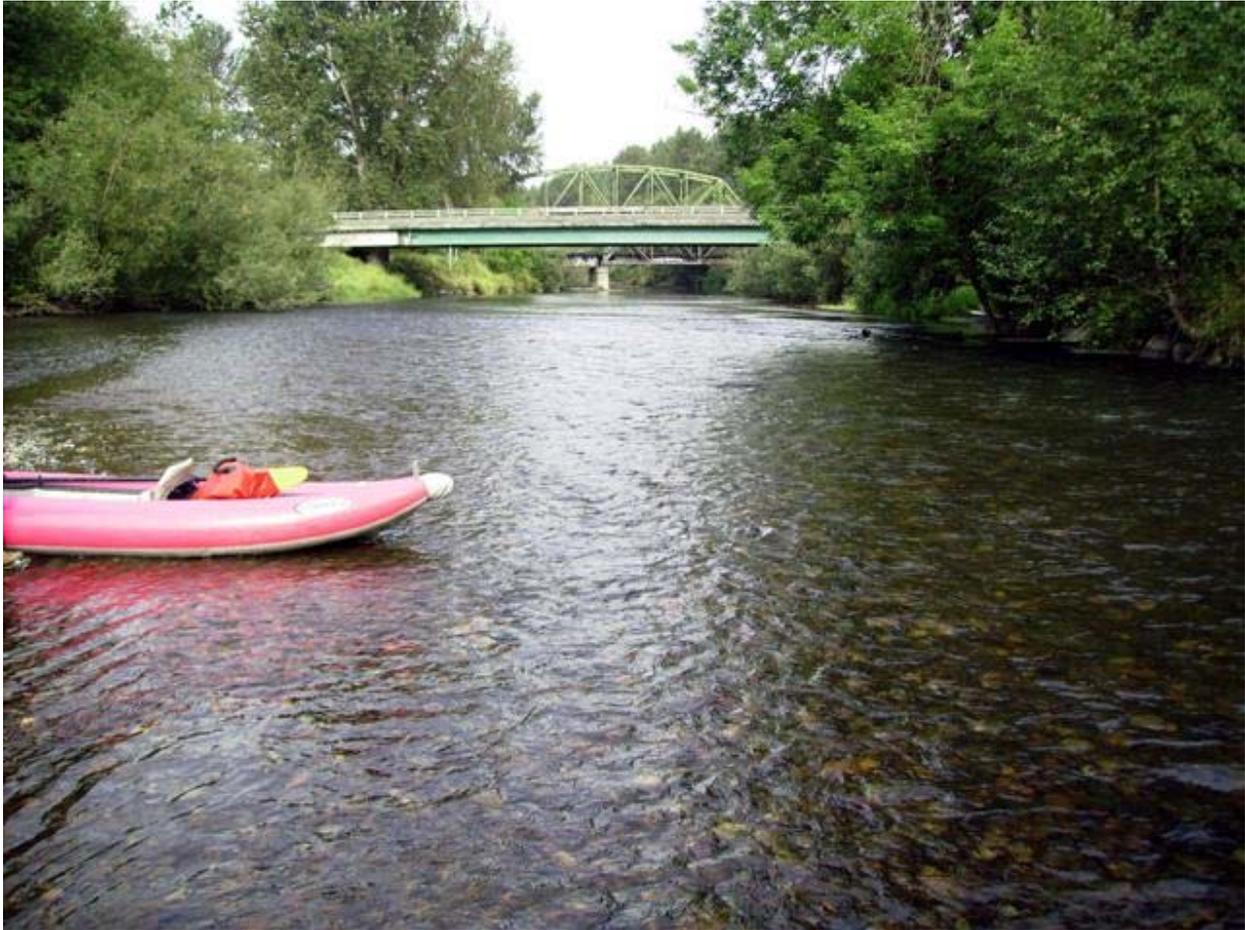
Figure 4-10. Representative habitat of Reach 6, Green River, Washington 2007.

The survey of Reach 6 took place from August 29 through August 31. The survey reach was approximately 6.0 miles long extending from Loans Levee (RM 38.0) to the Auburn Narrows (RM 32.0) (Figure 4-10 and 4-11). The average stream flow during the survey was 314 cfs as measured at the Auburn, Washington stream gage (USGS # 12113000). This reach is currently constrained between levees for most of its length. Jam 6-Q is a very large channel spanning jam located near the Auburn Narrows at RM 33. Habitat summary statistics for Reach 6 are presented in Table 4-5.

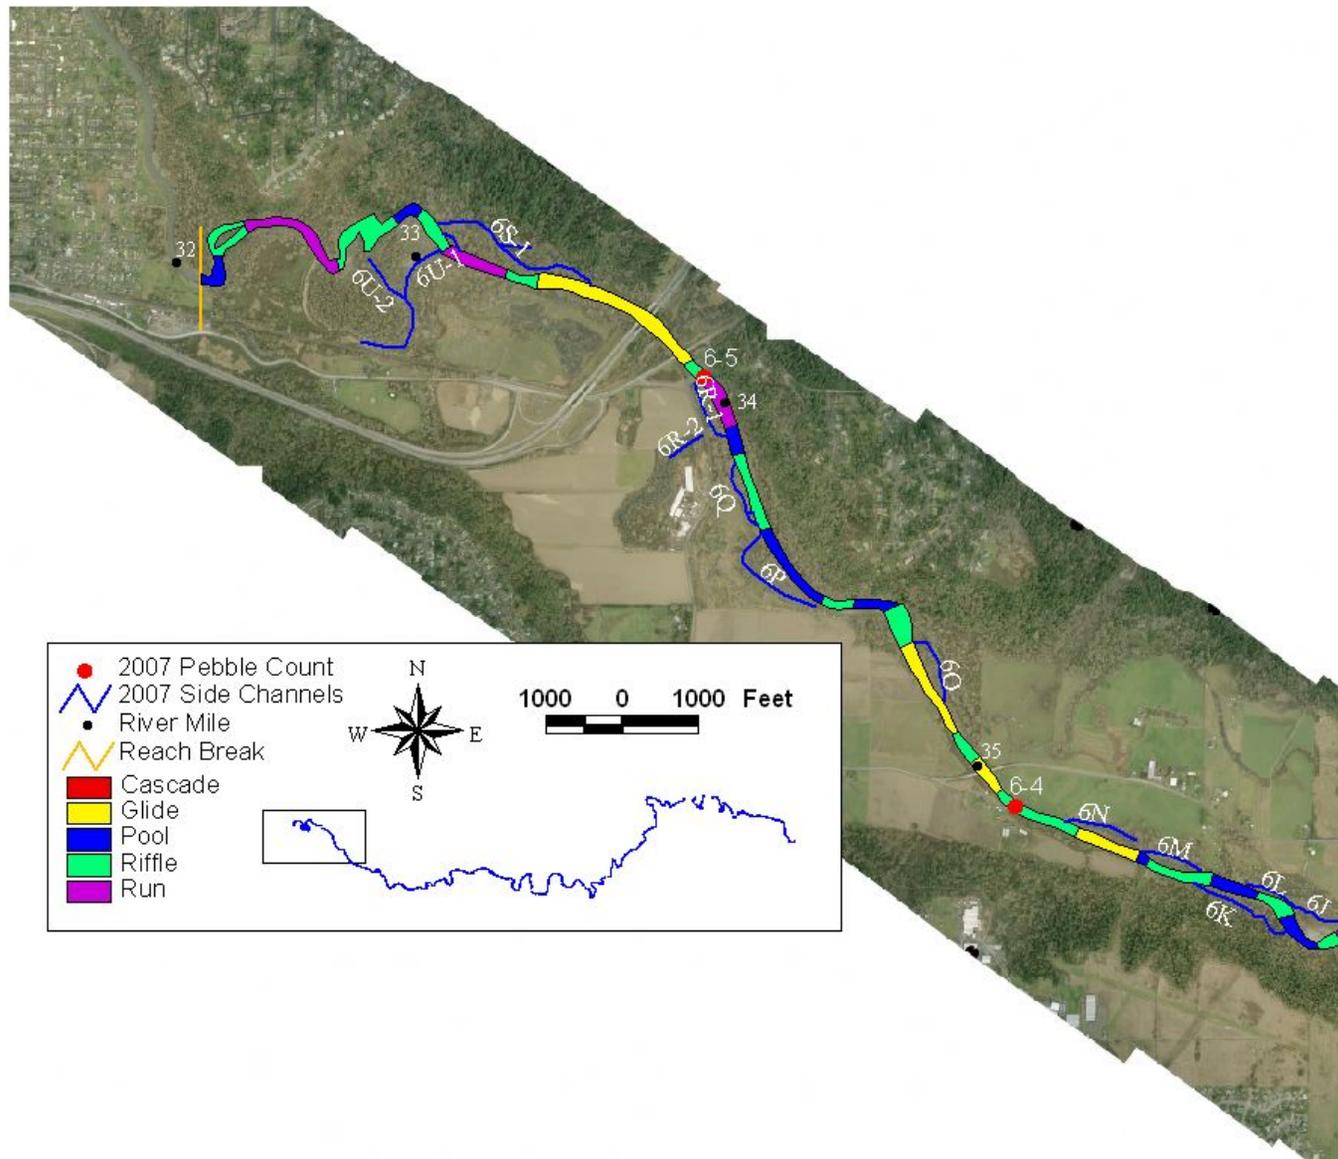
Figure 4-11. Middle Green River physical habitat in Reach 6, 2007.

The dominant habitat unit measured in Reach 6 was riffle, accounting for 41.9% of the habitat by length. Run units comprised 25.2% and pool units 19.1% of the habitat. Thirteen pool units were identified in Reach 6. Bedrock and bedform were the dominant pool formation factors. Three pools (23%) were formed by wood. Twenty-two side channel complexes were surveyed in Reach 6 (see Section 4.2). A total of 19 mainstem and 9 side channel jams were counted in this reach (Appendix D).
