# Middle Green River Habitat and Large Woody Debris Monitoring

*Prepared for:*  
**U.S. Army Corps of Engineers**  
**Seattle District**  
and  
**Tacoma Public Utilities**

*Prepared by:*  
**R2 Resource Consultants**  
15250 NE 95th Street  
Redmond, Washington 98052

## **2007 Data Report**

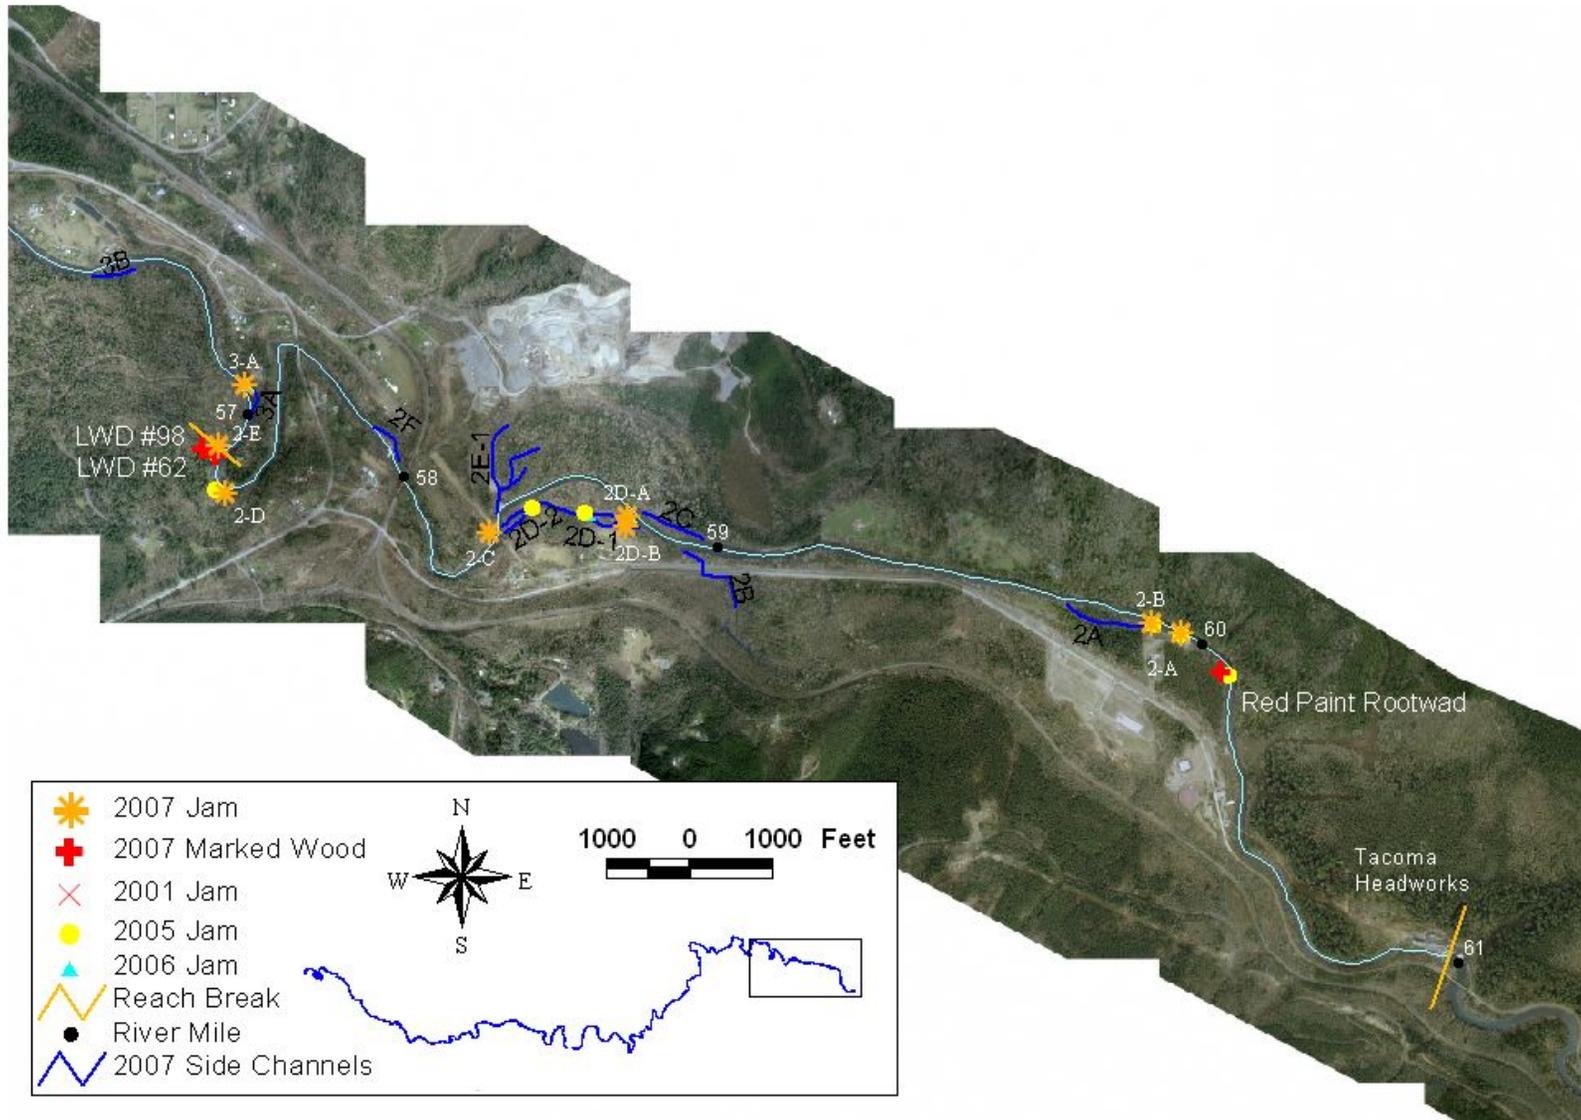
Figure 5-1. Middle Green River LWD in Reach 2, 2007.

Supplemental gravel has also been placed in the Green River starting in August 2003 (Table 5-6). A total of 17,207 cubic yards has been placed over the previous three years. This gravel is visually distinguishable from the native gravel in the river, and was observed dispersed throughout Reach 2.

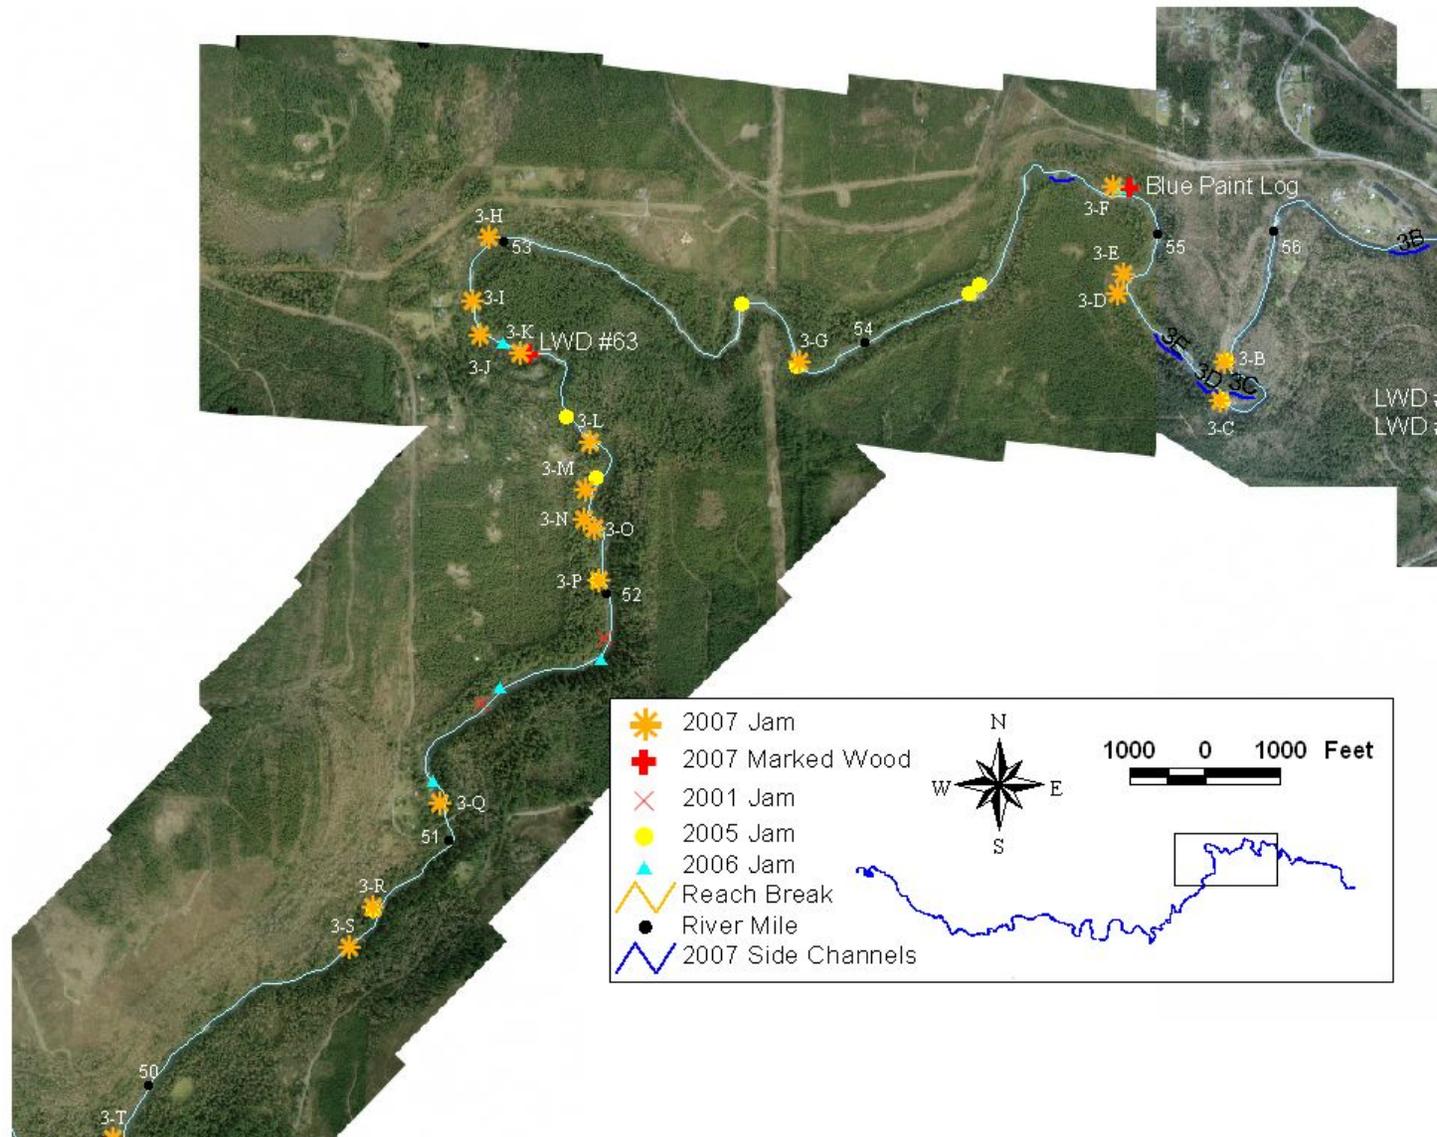
Figure 5-2. Middle Green River LWD in the upstream half of Reach 3, 2007.

The survey of Reach 3 took place over August 22 through 24. The reach is approximately 12 miles long extending from Kanaskat State Park (RM 57) to Flaming Geyser State Park (RM 45) (Figures 5-2 and 5-3). The average stream flow during the survey was 311 cfs as measured at the Auburn, Washington stream gage (USGS #12113000). Summary statistics for Reach 3 are provided in Tables 5-7, 5-8 and 5-9. One tagged log, #63 was located in Jam K (RM 52.7). Log #63 was originally placed as rack material in ELJ2 near RM 60 in 2003. Log #63 was observed in 2005 and 2006 in side channel 2D (RM 58.5). No other tagged wood was observed below this reach in 2007.

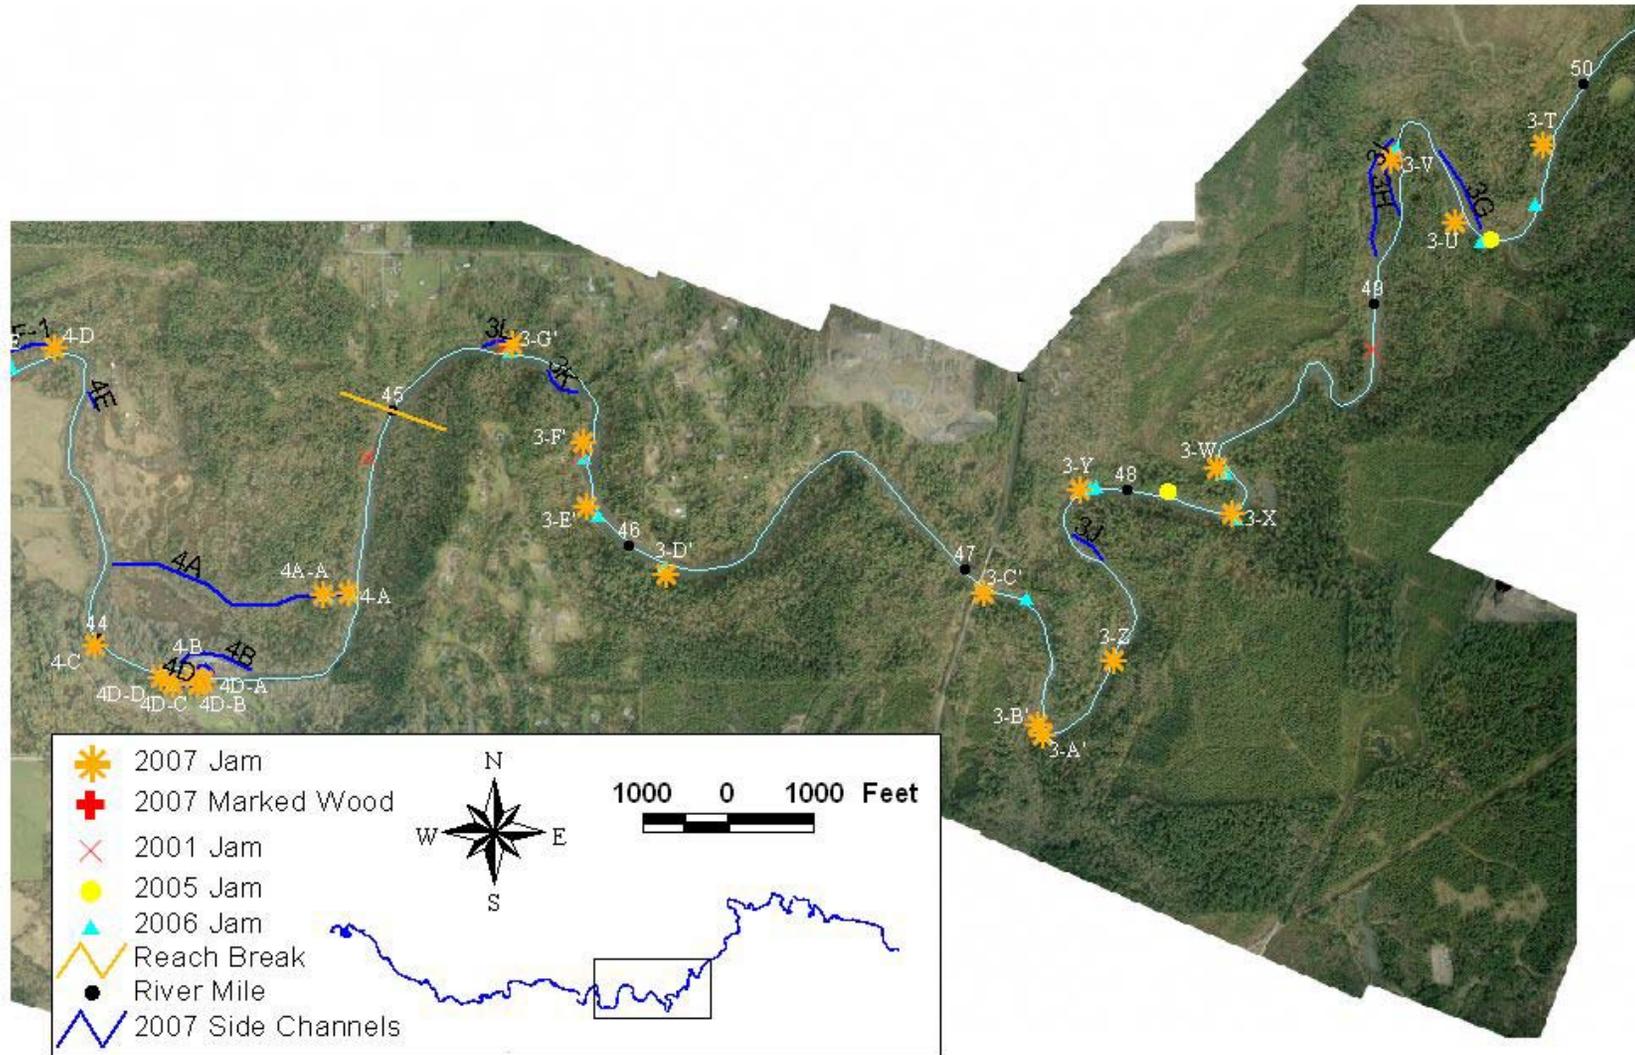
Figure 5-3. Middle Green River LWD in the downstream half of Reach 3, 2007.

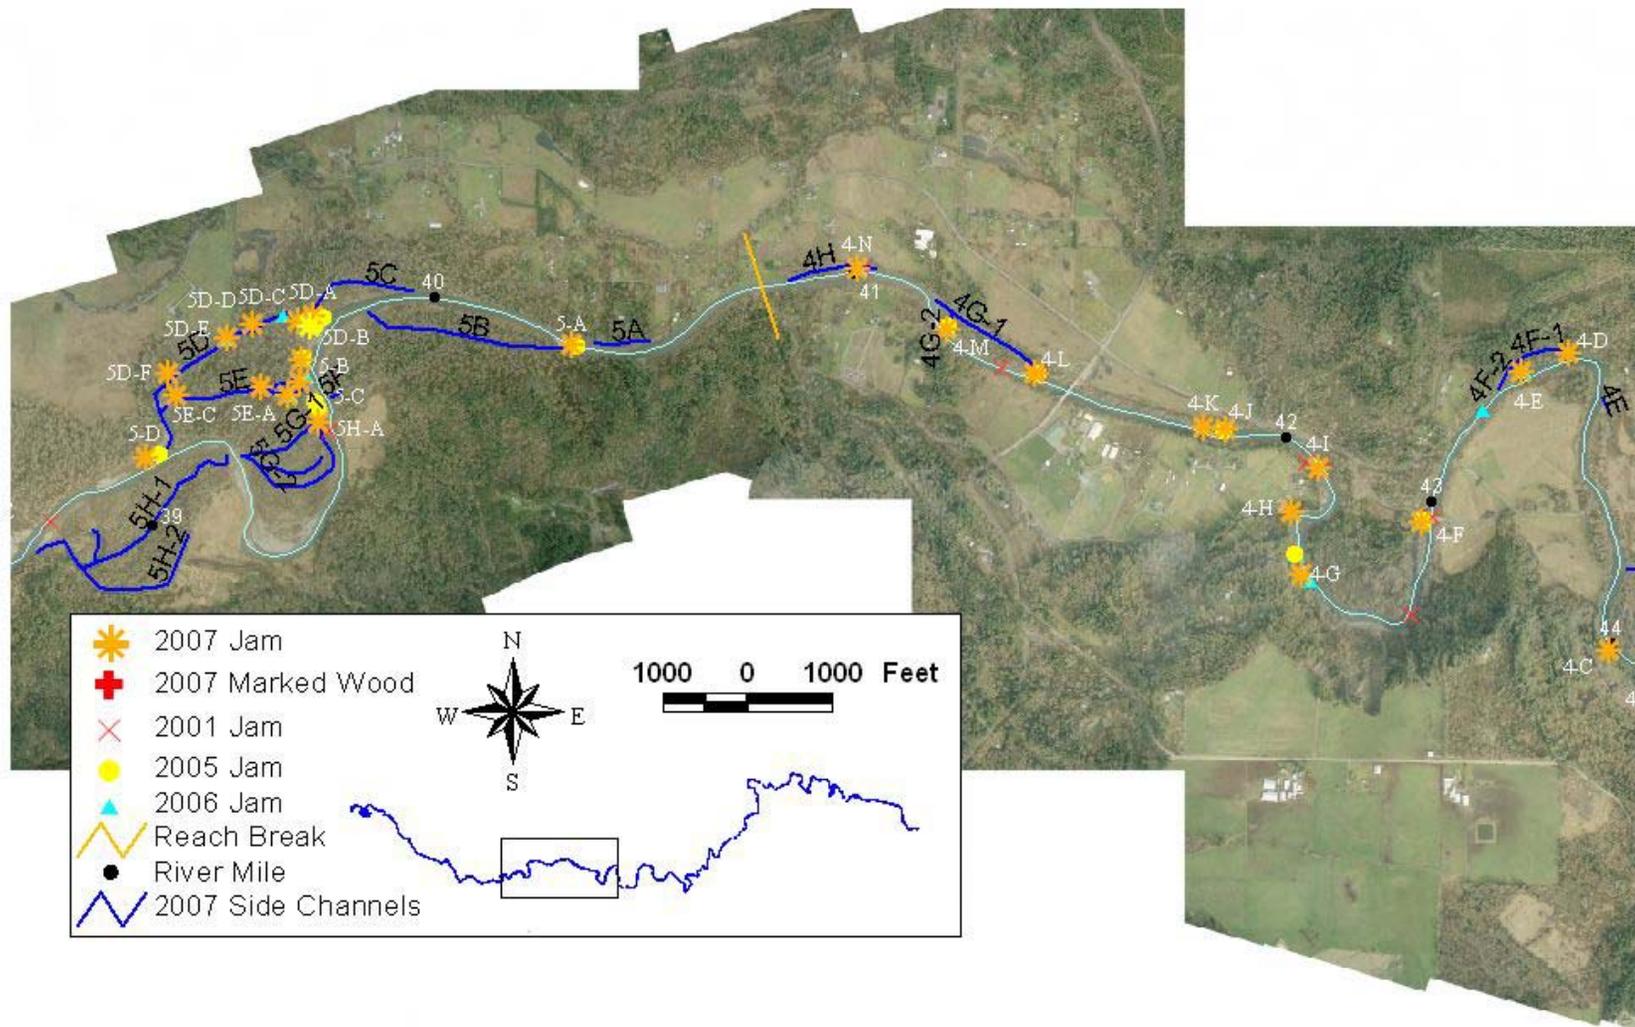
Figure 5-4. Middle Green River LWD in Reach 4, 2007.

Reach 4 was surveyed on August 27, 2007. The reach is approximately 4.2 miles long extending from Flaming Geyser State Park (RM 45) to Newaukum Creek (RM 40.8) (Figure 5-4). The average stream flow during the survey was 331 cfs as measured at the Auburn, Washington stream gage (USGS #12113000). Comparison of summary statistics for the 2001 and 2005-2007 LWD surveys of Reach 4 are presented in Tables 5-10 to 5-12.

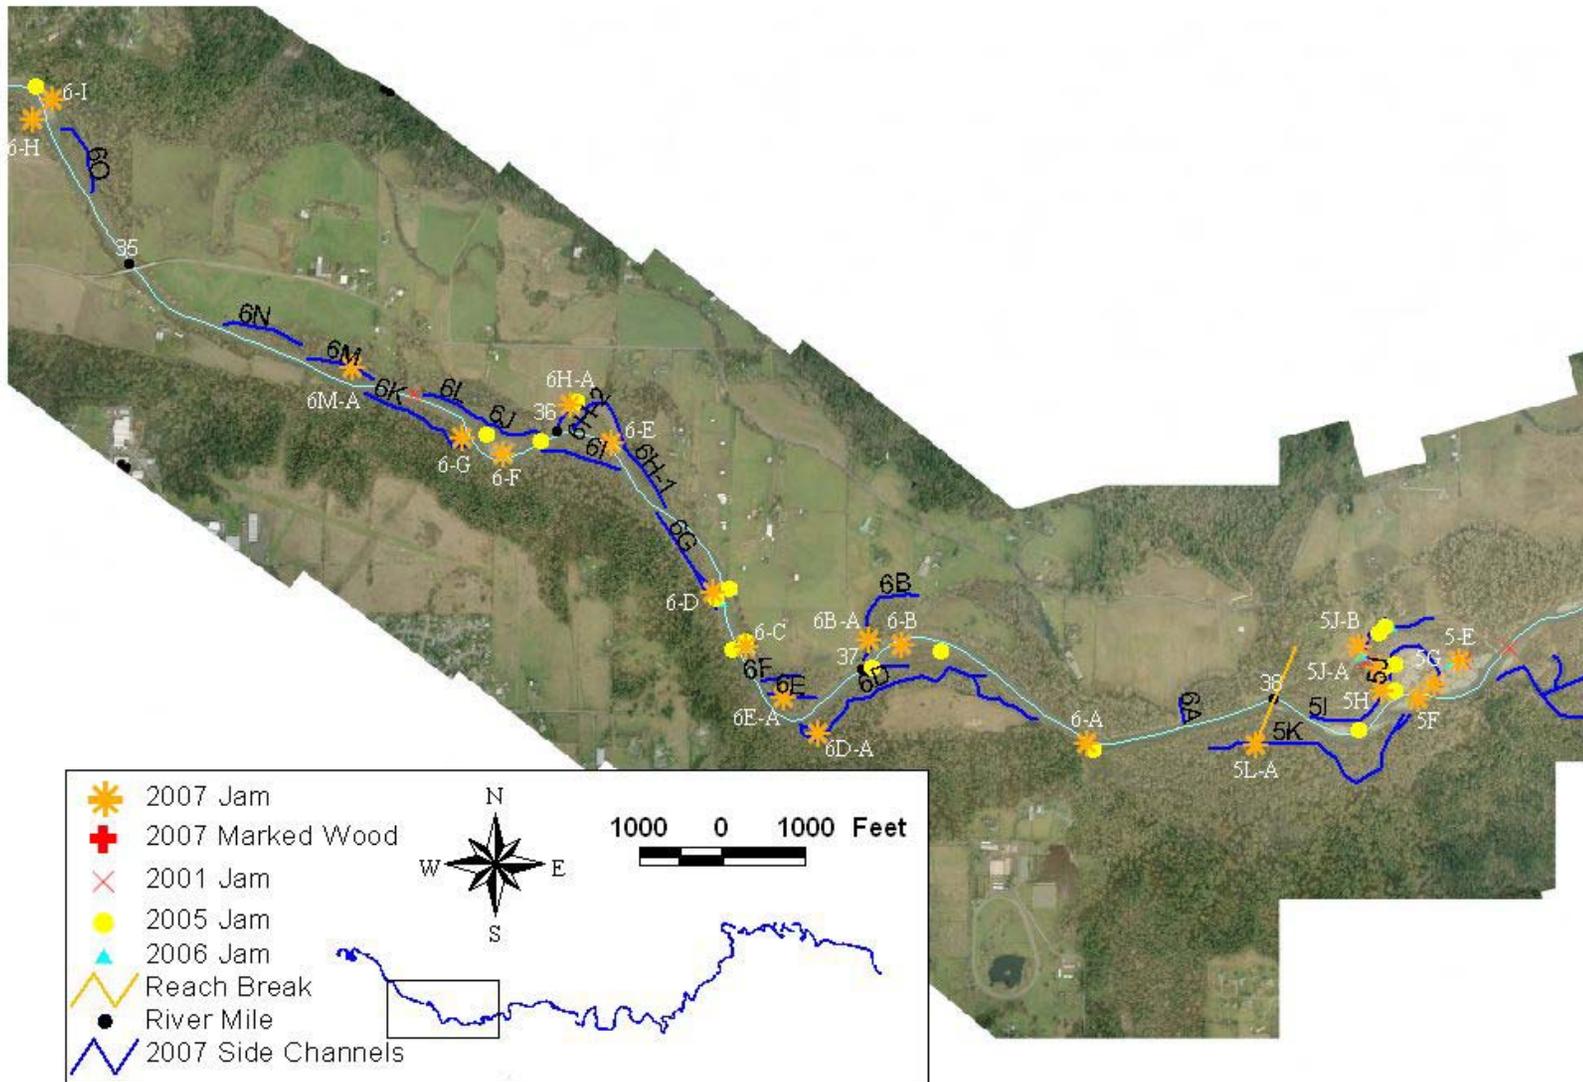
Figure 5-5. Middle Green River LWD in Reach 5, 2007.

Reach 5 was surveyed on August 28 and 29, 2007. The reach is approximately 2.8 miles long extending from Newaukum Creek (RM 40.8) to Loans Levee (RM 38.0) (Figure 5-5). The average stream flow during the survey was 314 cfs as measured at the Auburn, Washington stream gage (USGS #12113000). This reach of the middle mainstem Green River has experienced frequent channel shifts in the past ten to twenty years and contains numerous side channels that were not surveyed as part of the 2001 LWD survey. Since the winter of 1996-1997, almost half of the mainstem flow has been redirected into a large side channel near RM 40 (R2 2002). This side channel was transmitting approximately forty to fifty percent of the flow at the time of the 2001 survey, but was not included as part of that survey (R2 2002). Summary statistics for the 2001, 2005, and 2006 LWD surveys of Reach 5 are presented in Tables 5-13, 5-14, and 5-15.

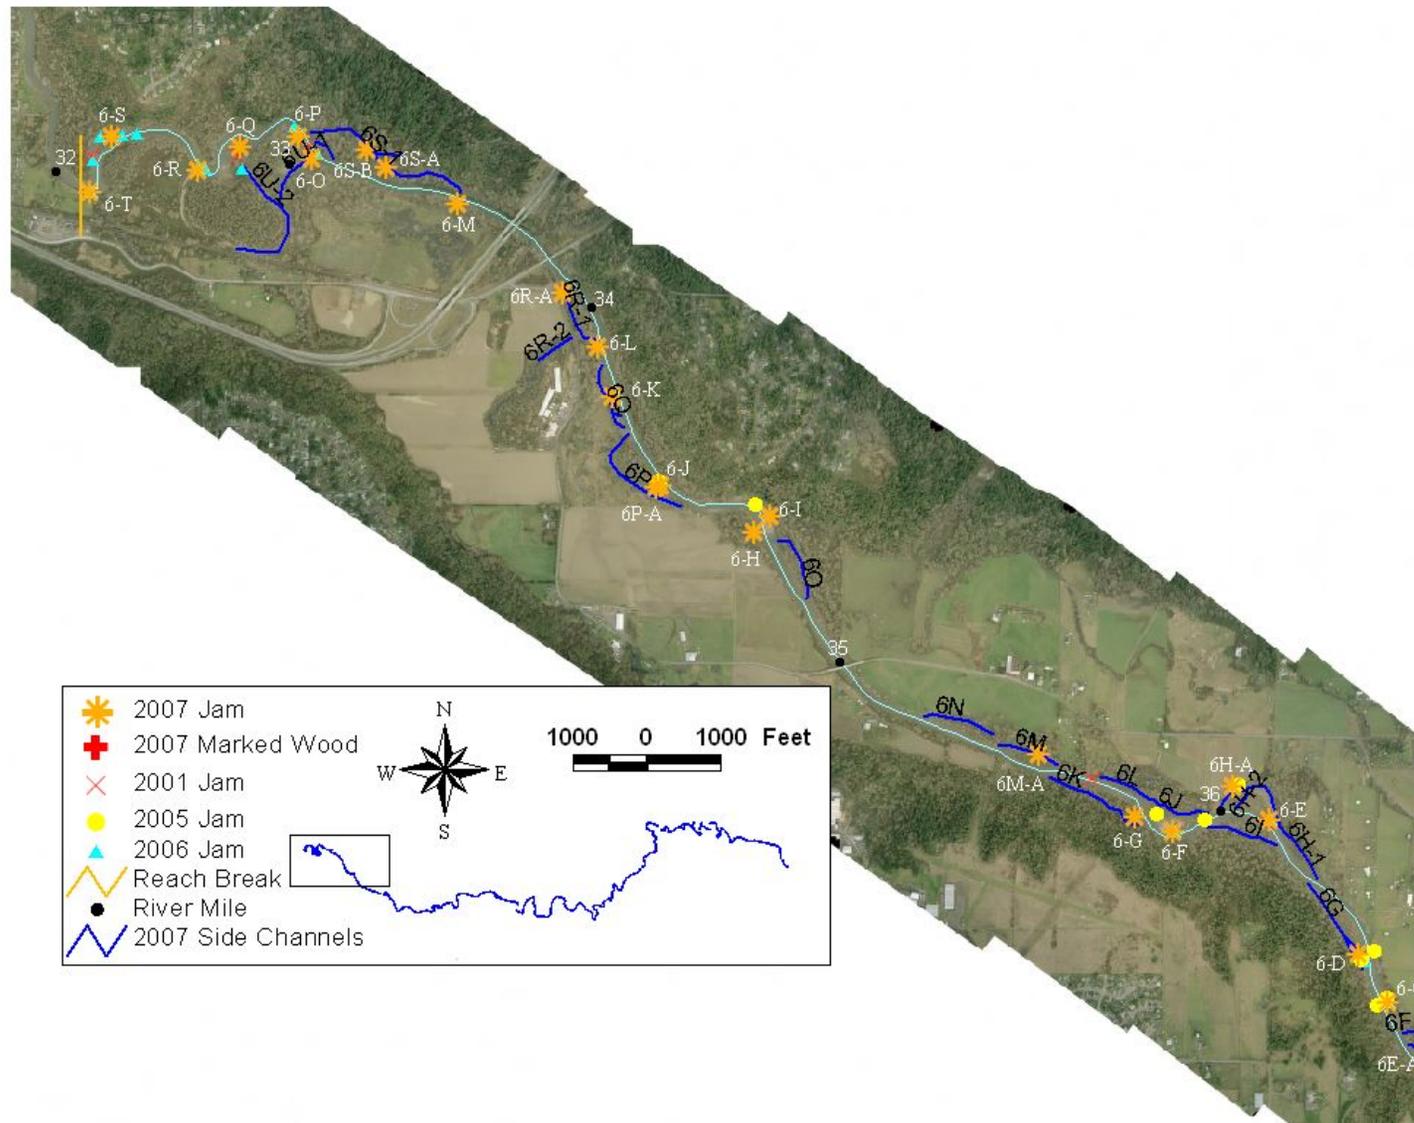
Figure 5-6. Middle Green River LWD in Reach 6, 2007.

Reach 6 was surveyed on August 29, 30, and 31, 2007. The survey reach was approximately 6.0 miles long extending from Loans Levee (RM 38.0) to the Auburn Narrows (RM 32.0) (Figure 5-6). The average stream flow during the survey was 314 cfs as measured at the Auburn, Washington stream gage (USGS # 12113000). There is a large amount of woody debris located between RM 32 and RM 33. Four jams were identified in the mainstem in this reach (6-Q to 6-T). The wood here is mobile and the exact number of jams has changed over the years according to what pieces are actually touching (definition of a jam includes all pieces that are in contact with each other). Jam 6-Q is the largest jam, a channel spanning structure that includes hundreds of individual pieces. Summary statistics for Reach 6 are presented in Tables 5-16, 5-17, and 5-18.

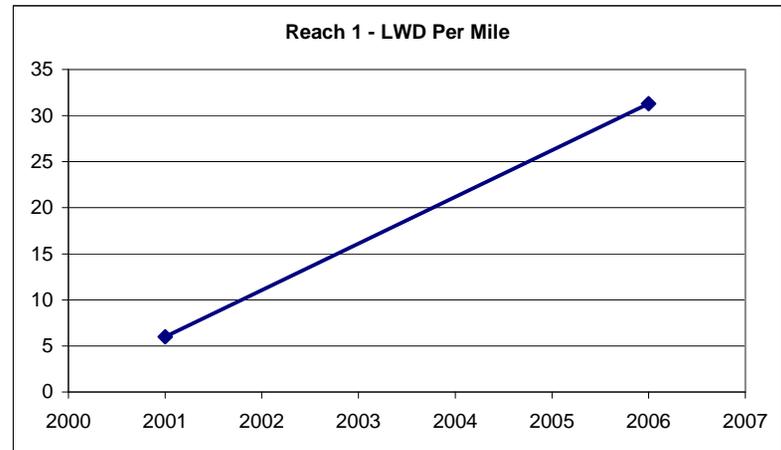
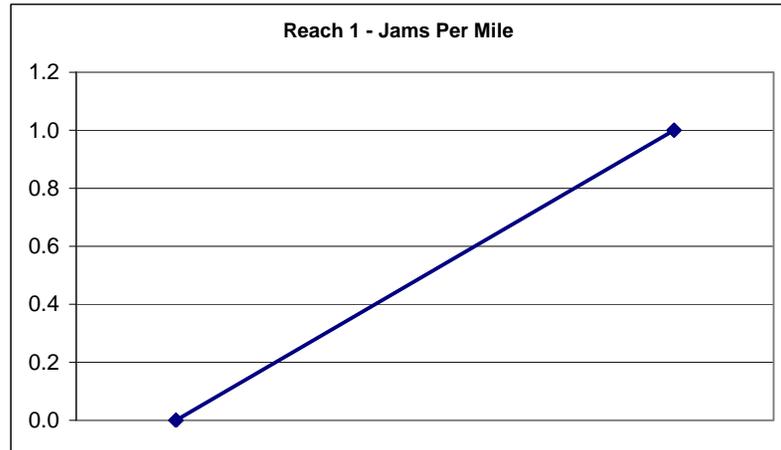
Reach 1	Survey Year	Total LWD	LWD Per Mile	Key Pieces Per Mile	Jams Per Mile
	2001	18	6	0.29	0
	2006	94	31.3	0.6	1

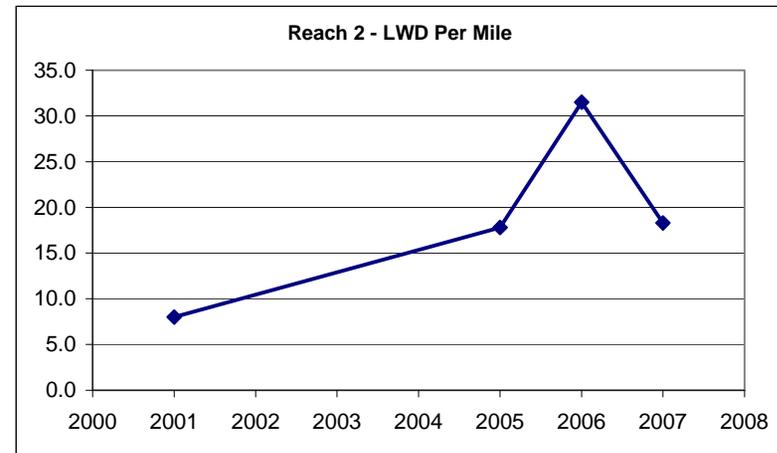
Reach 2	Survey Year	Total LWD	LWD Per Mile	Key Pieces Per Mile	Jams Per Mile
	2001	36	8.0	0.5	0.0
	2005	83	17.8	1.5	1.3
	2006	126	31.5	1.8	1.5
	2007	73	18.3	0.0	1.8
