Upper Green River Baseline Habitat Monitoring 2005 / 2006

Prepared for:
**U.S. Army Corps of Engineers
Seattle District**

Prepared by:
R2 Resource Consultants, Inc.

July 2007

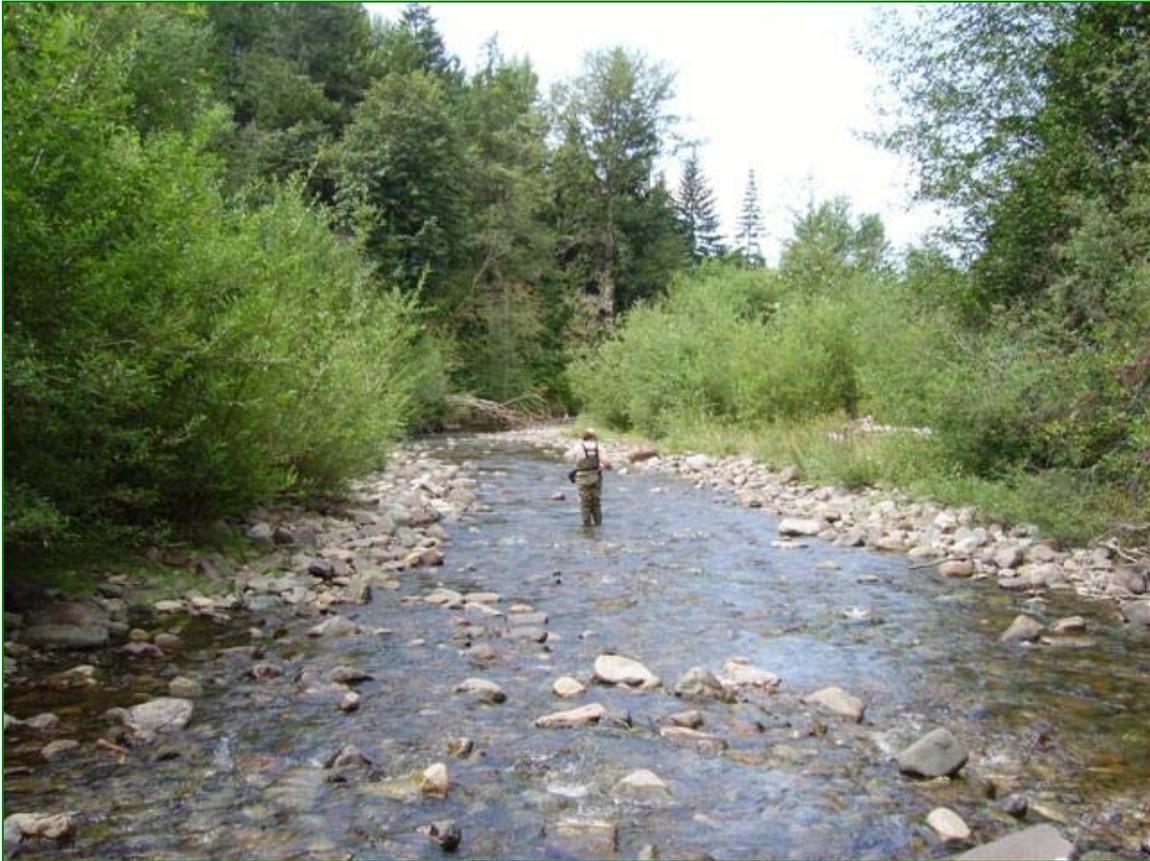
Section 1 was the most upstream section surveyed on the mainstem Green River (Figure 6). This section began at the High Trestle Railroad Bridge and continued downstream approximately 1.1 miles to the confluence with Sunday Creek (Figure 7). This section was surveyed on 23 August 2006, during low flow conditions. Inflow at HHD on this date was 136 cfs (USACE 2007). Water temperature at the time of the survey was 13°C. From the steep headwaters above, the valley floor in this reach becomes increasingly broad and flat (Williams et al. 1975). The habitat in this section is primarily long riffles (75.7% by area) interspersed with shorter pool units (22.2%), and some run habitat (2.2%) (Table 1). Eight individual pools were identified in this section (Appendix A). Average residual pool depth was 2.4 feet, reflecting the low stream flow present during the survey. Woody debris was the dominant pool forming factor accounting for 75 percent of all pools formed. The amount of woody debris per mile was greater in this section than in any of the Green River surveyed downstream, however, the number key pieces per mile was low (0.9) (Table 2). There were seven jams identified (6.3 per mile) in Section 1 (Appendix B). Jams A and F were pool forming factors for pool reference unit #s 302 and 308 respectively.

Figure 6. Section 1 of the upper Green River mainstem habitat survey, King County, Washington, 2006.

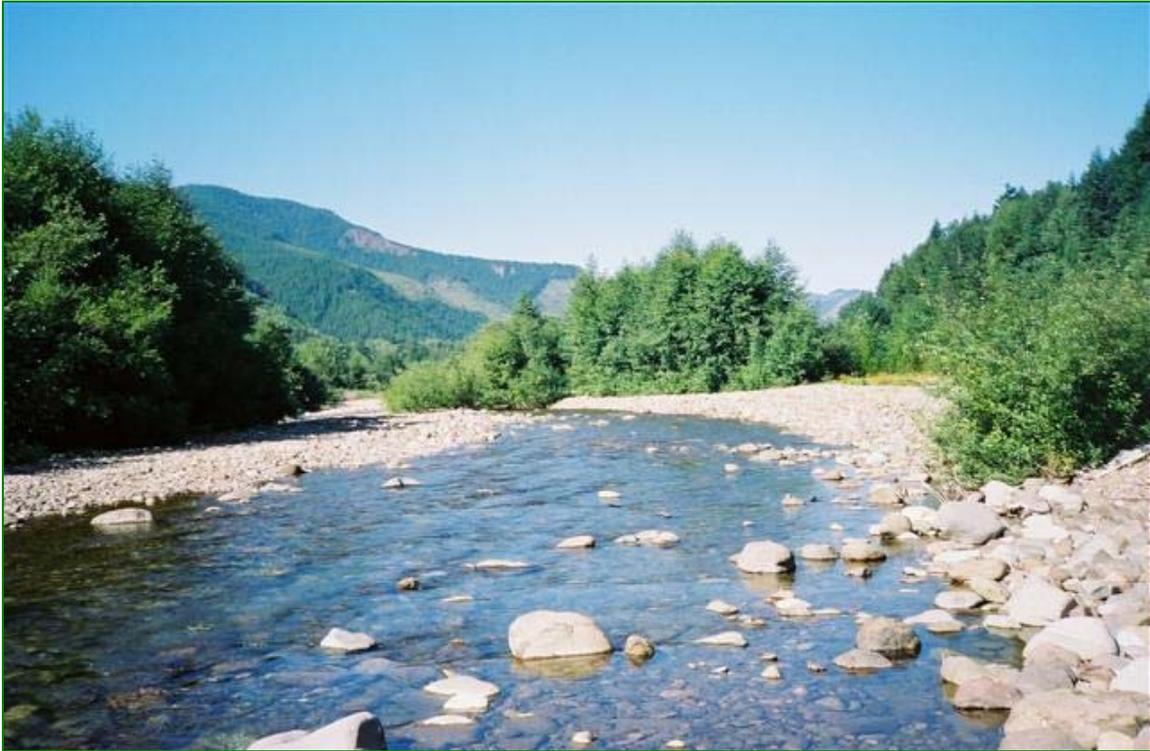
Section 2 began consecutively downstream to Section 1 at the mouth of Sunday Creek. This section was surveyed during summer low flow conditions on 9 and 10 August 2005 (Figure 8). Average inflow discharge at HHD for these dates was 176 cfs (USACE 2007). Sunday Creek is a major tributary to the Green River, substantially increasing stream flow at this point. This section is 5.0 miles in length, ending at the mouth of McCain Creek (RM 79.7) (Figures 8, 9 and 10). Section 1 is an unconfined floodplain channel that meanders through a wide valley with some highly braided areas (Figure 8). The channel primarily alternated between pool and riffle habitat. The dominant habitat type was riffle, comprising 47.7 percent of the habitat area. The next most common habitat type was pool, comprising 43.9 percent by area (Table 3). Run units were also present (8.5 percent). Average wetted width nearly doubled over the upstream Section 1 to 60.6 feet.

Figure 8. Section 2 of the upper Green River mainstem habitat survey, King County, Washington, 2006.

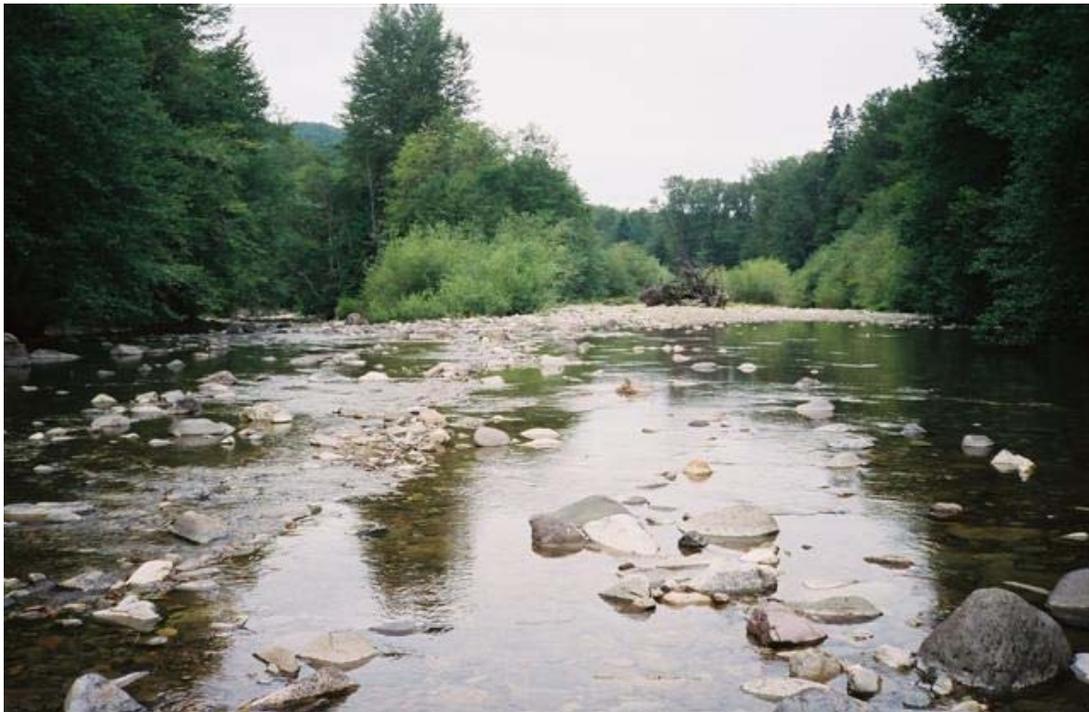
Figure 11. Section 3 of the upper mainstem Green River habitat survey, King County, Washington, 2005.

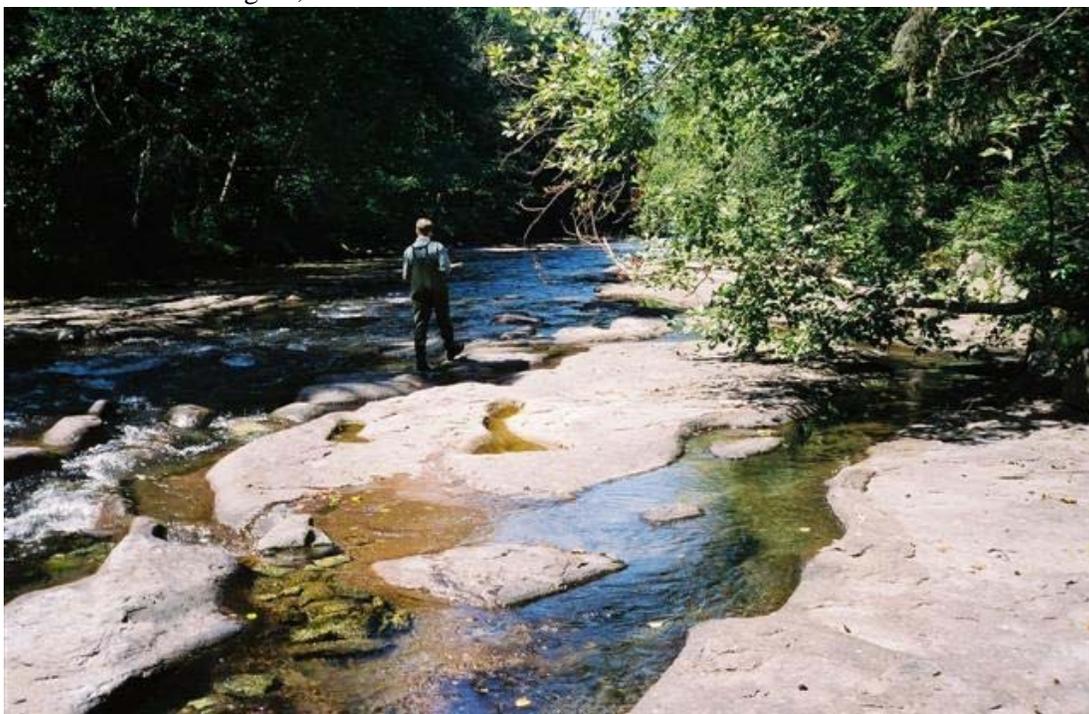
The initial bedrock reach (approximately 4,500 feet) contained very different habitat conditions from the other stream sections (Figure 12). This portion of the channel was straight, confined and contained little gravel substrates. Very little woody debris was present in the bedrock reach. An old man-made bridge abutment contains woody debris near the entrance of Rock Creek. This jam consisted of twelve key pieces that were not included in woody debris totals. Six pebble counts were completed in Section 3. The average D50 was 89.3mm (Appendix B).

Figure 12. Bedrock reach of Section 3, upper mainstem Green River habitat surveys, King County, Washington, 2005.

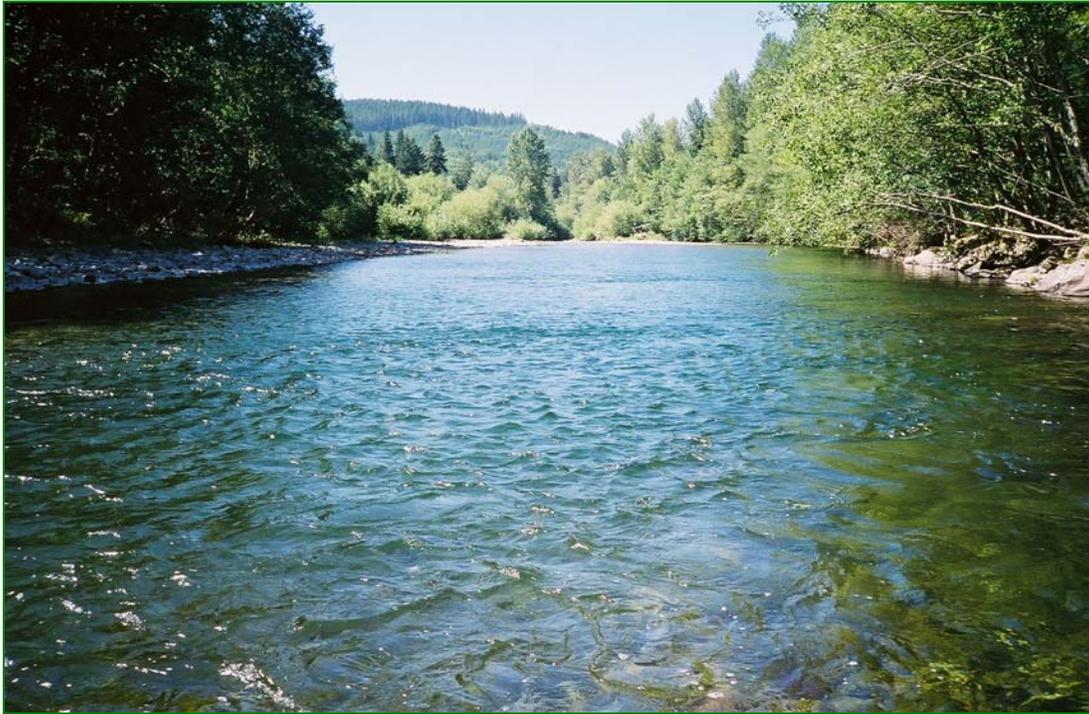
Figure 16. Section 4 of the upper mainstem Green River habitat survey, King County, Washington, 2005.

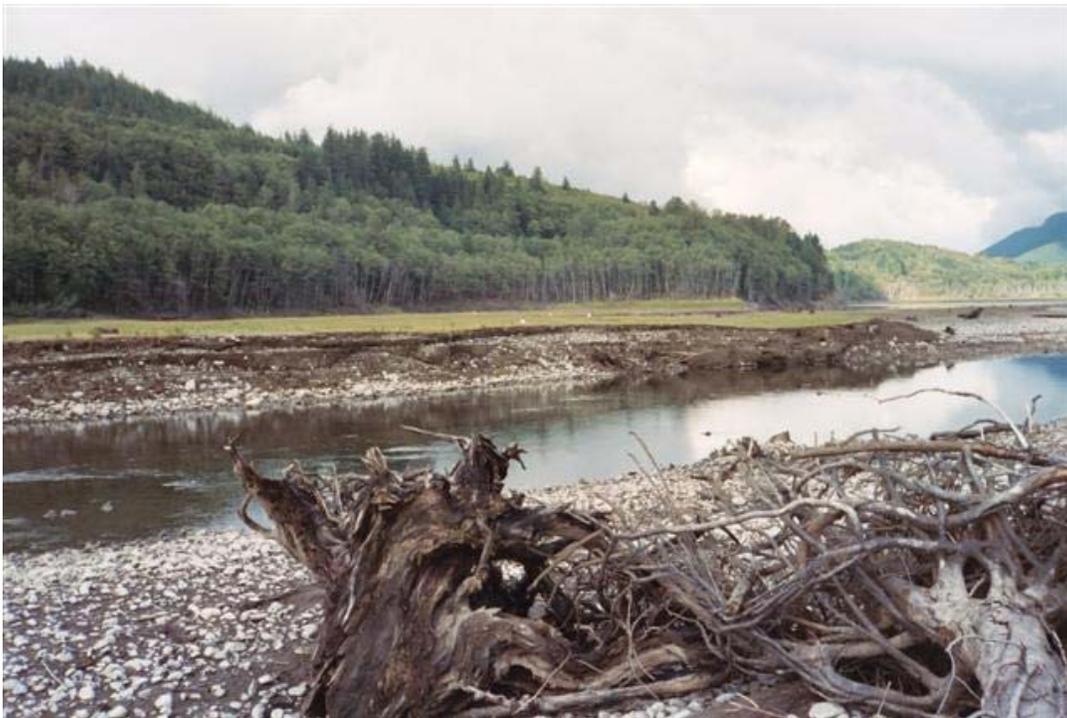
Figure 23. View of Section 5 survey end at Howard Hanson Reservoir, upper mainstem Green River habitat surveys, King County, Washington, 2006.

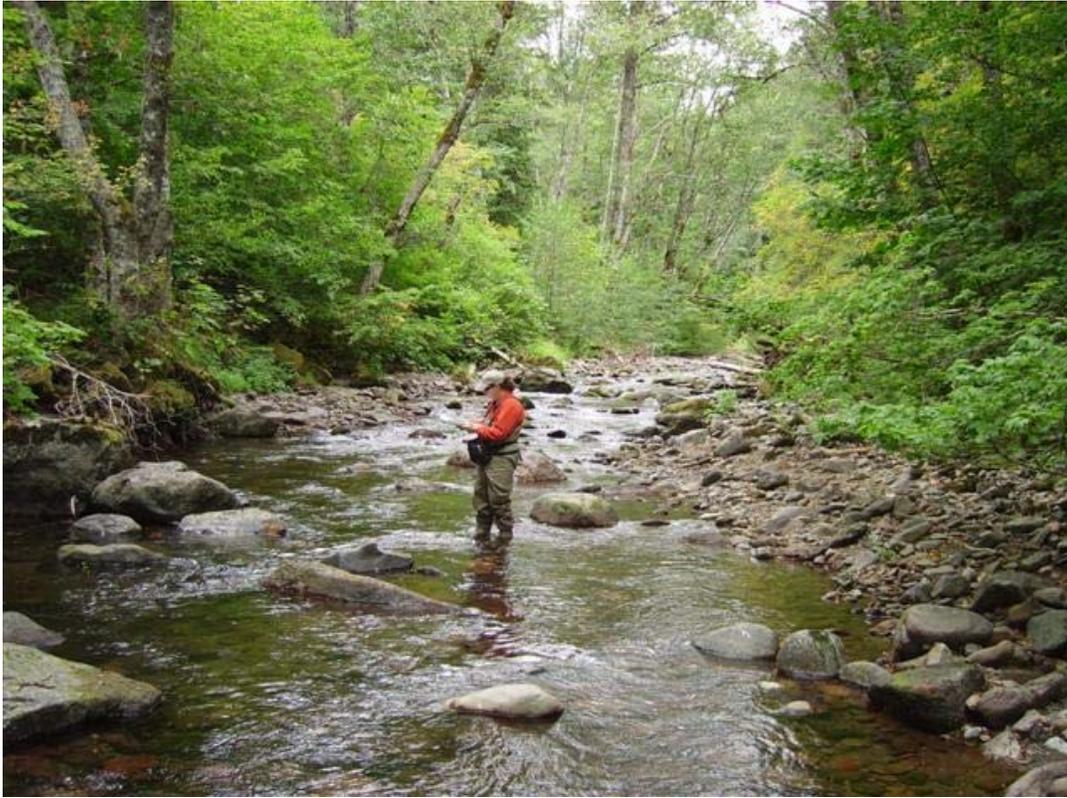
The survey of Sunday Creek was performed on 23 and 24 August 2006. The survey began at the confluence of Snow and Sunday Creeks (RM 3.5), and continued southerly downstream to the Green River (Figure 25). Streamflow at the time of the survey was very low (Figure 26). Water temperature measured 10.5°C. Sunday Creek exhibits moderate stream gradient conditions and is less mountainous than other tributaries in the area (Williams et al. 1975).

Figure 25. Sunday Creek, upper mainstem Green River habitat surveys, King County, Washington, 2006.

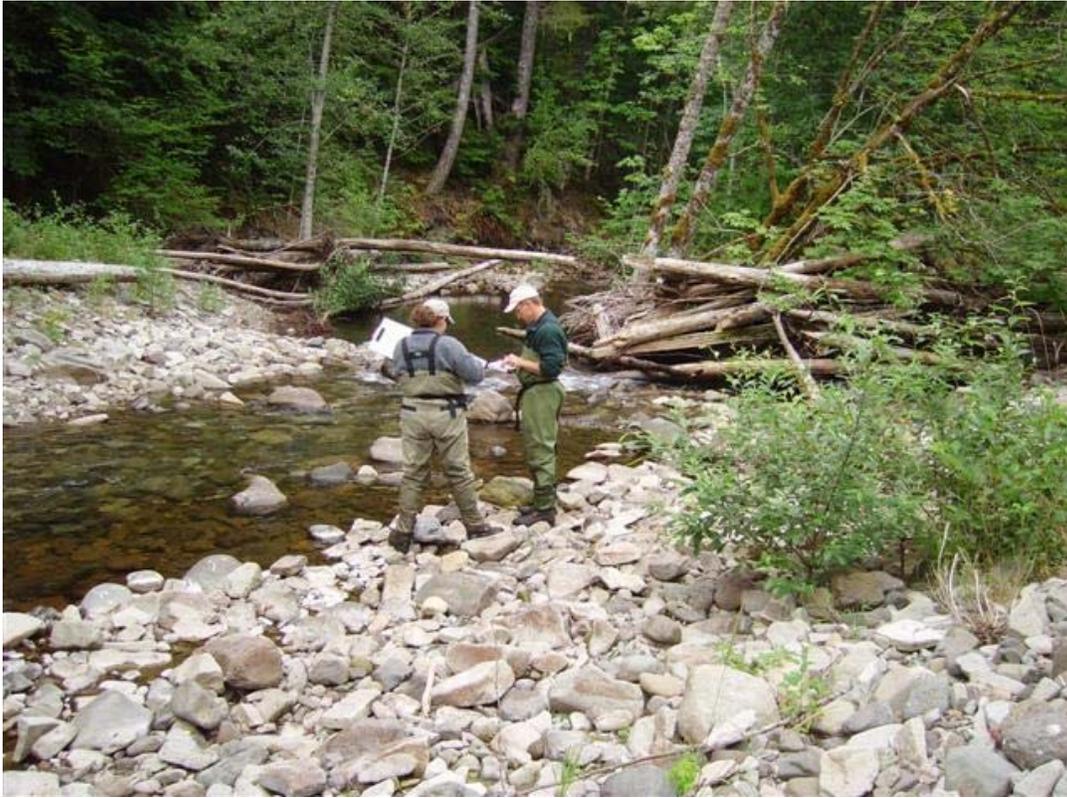
From the confluence of the West Fork downstream to the powerline crossing, Smay Creek has a broad floodplain with many side channels and braided channel areas (Figure 29). The stream in this section is very dynamic, however it is somewhat confined on the west bank by the road.

Figure 29. Smay Creek near survey start, upper mainstem Green River habitat surveys, King County, Washington, 2006.

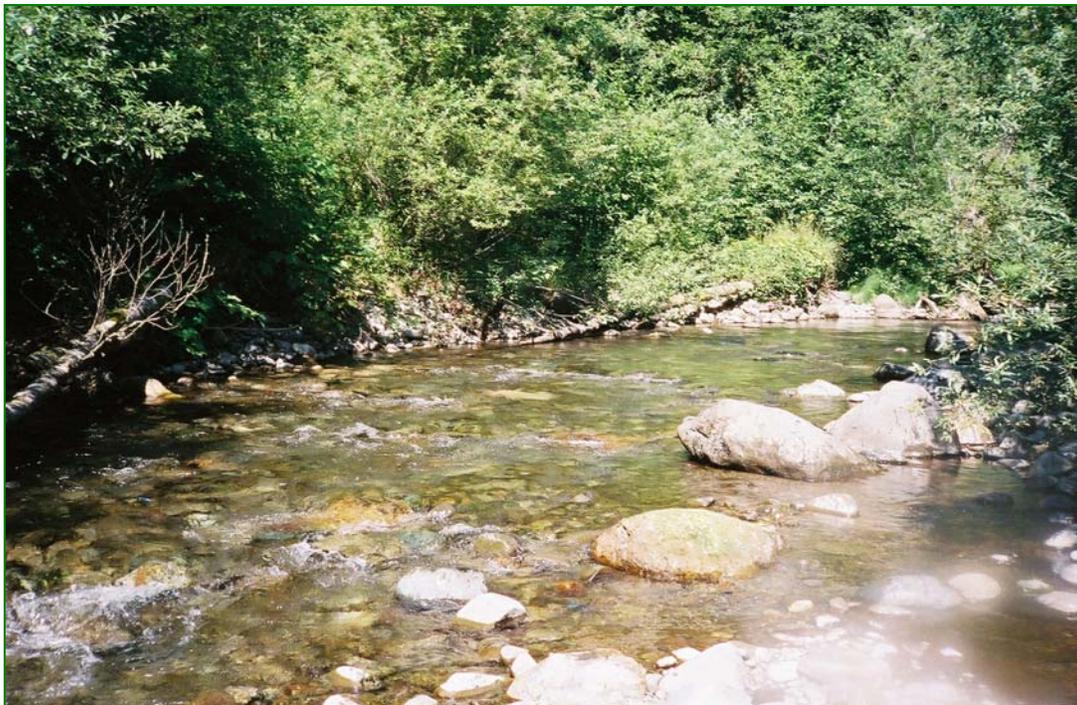
The North Fork Green River is one of the major tributaries to Howard Hanson Reservoir, entering on the northern shore (Figure 32). The survey of the North Fork Green River by R2 Resource Consultants began on 26 July 2005 and extended through 27 July 2005. The upstream survey end, elevation 1,320 feet, was estimated using topographical maps to be approximately 2.2 miles upstream from the reservoir inundation zone at the time of the survey (Figure 33). The North Fork Green River was surveyed from the approximate elevation of 1,320 downstream 2.2 miles to the reservoir inundation zone (1,147 feet). Summary habitat statistics are presented in Table 15. The channel alternates between pool, riffle and cascade bedforms. The mean bankfull width was 134 feet, while the mean wetted width measured 27.9 feet. Riffle was the dominant habitat type accounting for 59.6% of the total habitat by length.

Figure 32. North Fork Green River, upper Green habitat survey, King County, Washington, 2005.

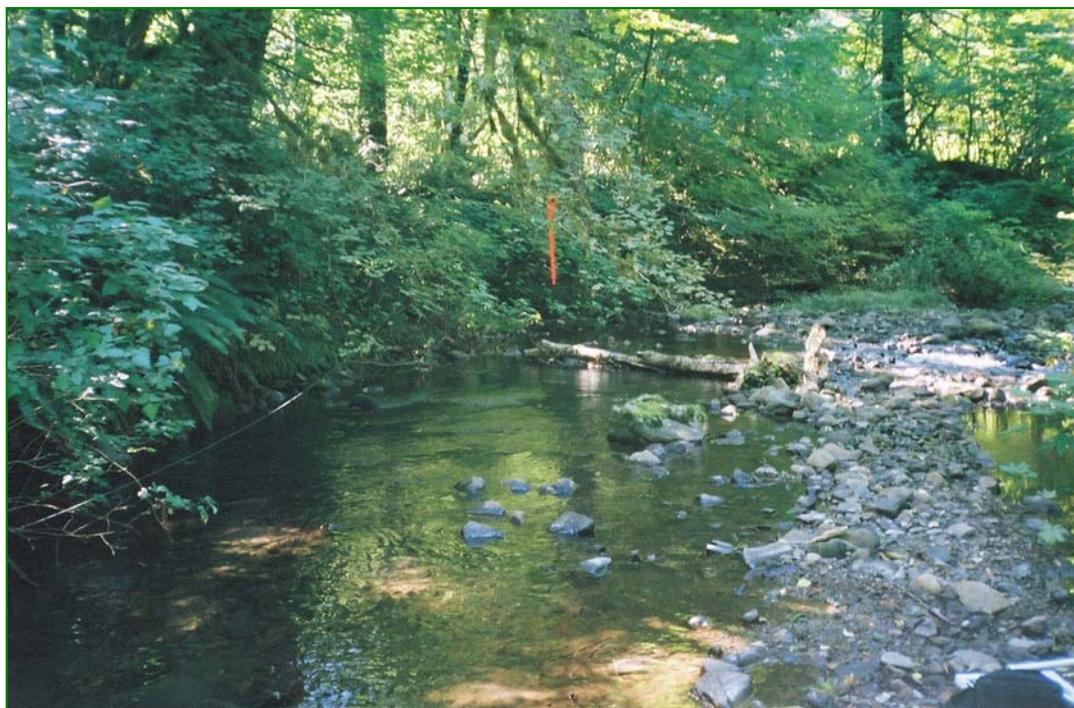
Figure 35. Gale Creek, upper Green River habitat survey, King County, Washington, 2005.

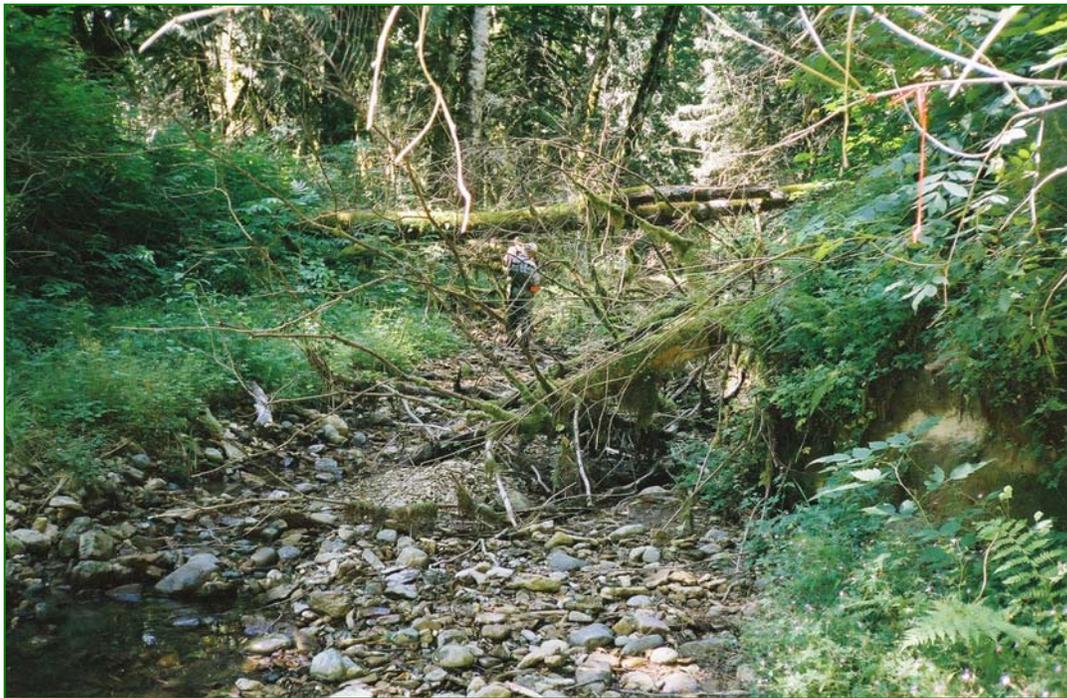
Cottonwood Creek is a small tributary to Howard Hanson Reservoir (Figure 41). It enters the reservoir on the northern side near the North Fork Green River. The lower 500 feet of the stream was surveyed on 26 July 2005. This is the reach from the culvert under the 5530 road downstream to the reservoir inundation zone (approximate elevation of 1,147 feet) (Figure 40). There is no flowing water in Cottonwood Creek immediately above the culvert (Figure 42). However, small isolated pools of stagnant water were present. The surveyed reach below the culvert has very low flow and is nearly dewatered in sections. Habitat data for Cottonwood Creek are summarized in Table 23.

Figure 41. Cottonwood Creek near downstream survey end, upper Green River habitat surveys, King County, Washington, 2005.

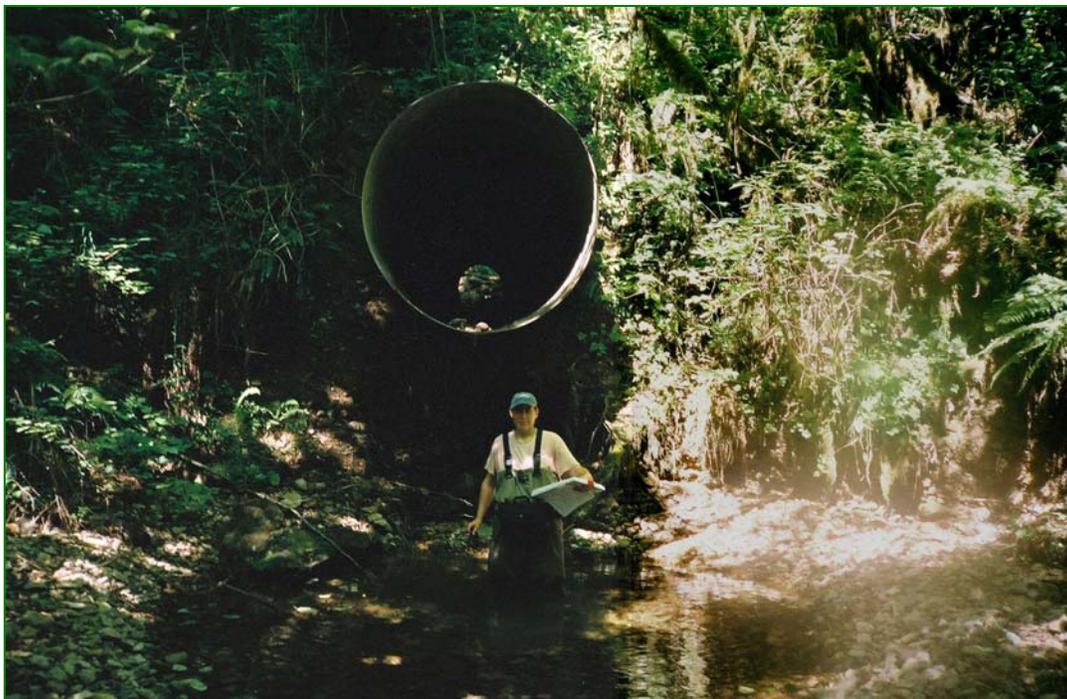
Figure 42. Culvert under 5530 road on Cottonwood Creek, dry at time of photo, upper Green River habitat surveys, King County, Washington, 2005.

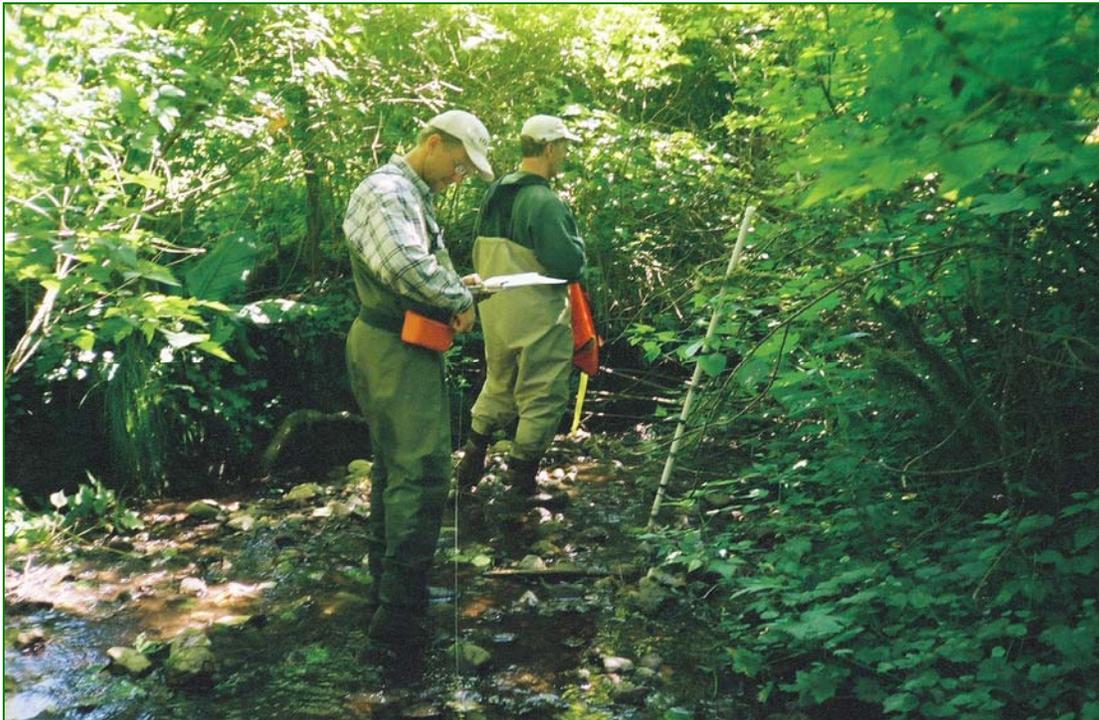
McDonald Creek flows southerly into Howard Hanson Reservoir just west of Gale Creek on the northeastern corner of the reservoir (Figure 43). The McDonald Creek survey encompassed 3,110 feet (0.59 miles). The survey began at an approximate elevation of 1,240 feet and went downstream through the culvert under Road 5530 to the reservoir inundation zone near elevation 1,147 feet (Figure 44). The overall gradient for this reach of McDonald Creek was 3.0 percent. The stream had heavy canopy cover, 95.5 percent, and thick riparian brush in spots. These conditions inhibited the use of GPS equipment. Streamflow in McDonald Creek was estimated to be less than 2 to 3 cfs. The summary data for McDonald Creek are presented in Table 25.

Figure 43. McDonald Creek, upper Green River habitat surveys, King County, Washington, 2005.

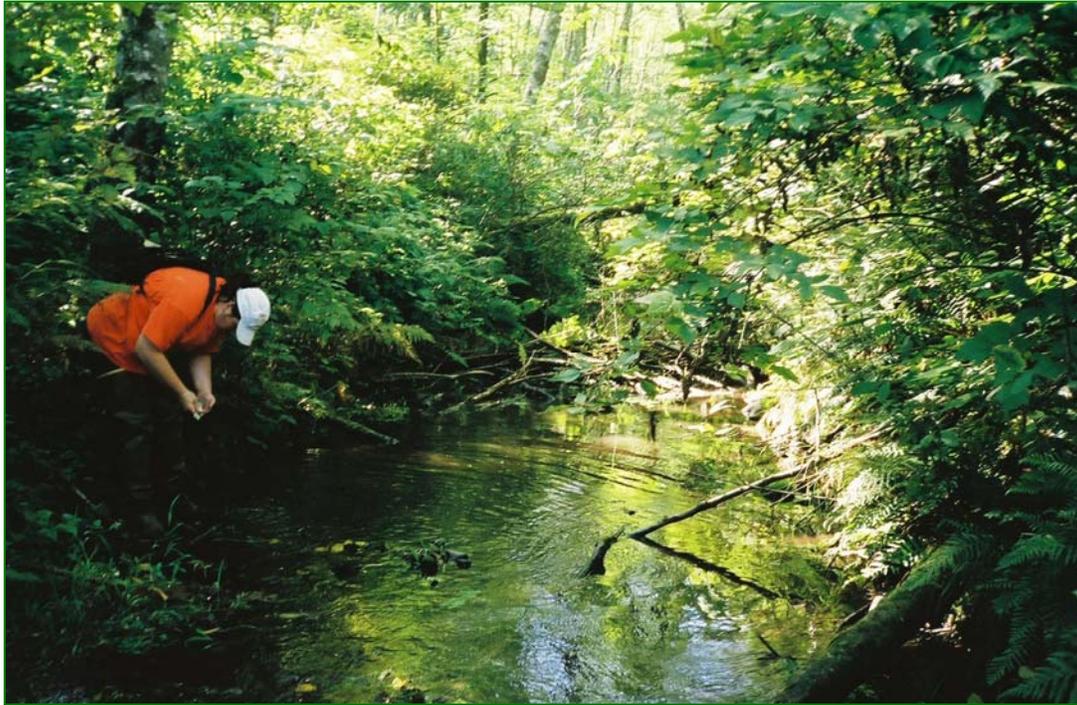
The pebble count was taken in Signani Slough in the only wadable riffle location that natural gravel was present (Figure 45). The substrate D_{50} from this count measured 42.8 mm. The substrates below the culvert contain excellent salmonid spawning gravel. Pink salmon were observed spawning in this area later in the fall.

Figure 45. Pebble count location in Signani Slough, upper Green River habitat surveys, King County, Washington, 2005.
