**Water Year 2004 Monitoring Report
Howard Hanson Dam Additional Water Storage Project
Zone 1 Fish Habitat Restoration Project
Green River, Washington**

**Howard Hanson Dam
Additional Water Storage Project
Zone 1 Fish Habitat Restoration Project**

Water Year 2004 Monitoring Report

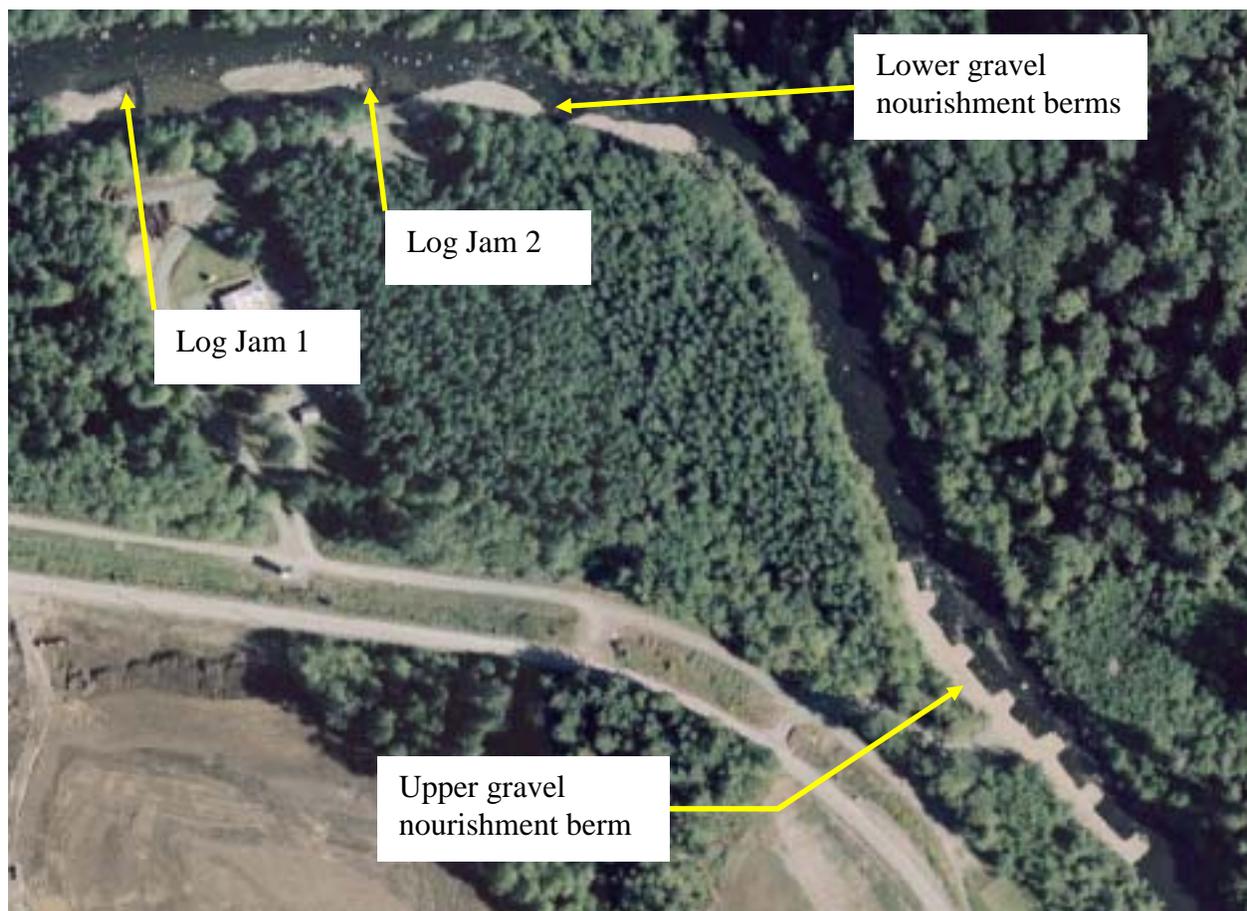
Figure 1. Post construction aerial photo of constructed gravel berms and log jams at RM 60 of the Green River, 21 September 2003.

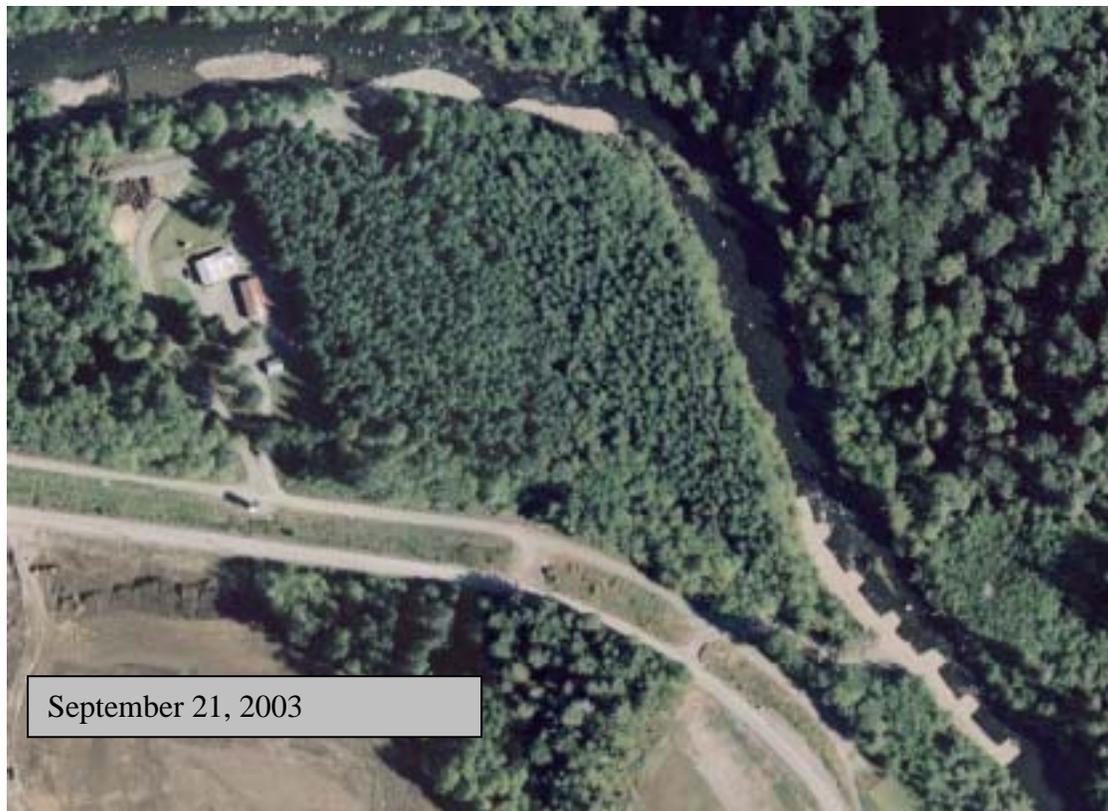
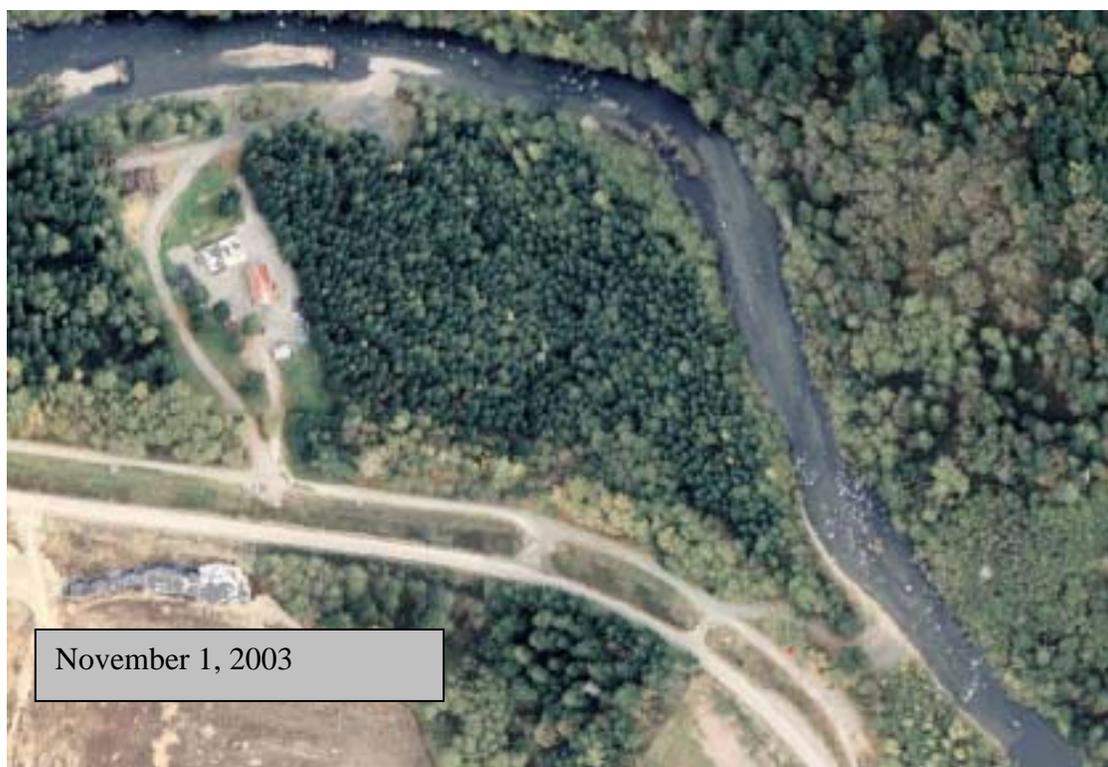
Figure 4. Zone 1 before and after gravel berm erosion from October flood event (2,450 cfs).

Gravel berm configuration did not appear to be an important factor in berm erosion. The upstream berm appeared to erode more efficiently; however, this section of the river is also steeper. Each berm configuration was efficiently eroded at relatively moderate flows indicating that future gravel loading does not require special configuration to facilitate gravel erosion.

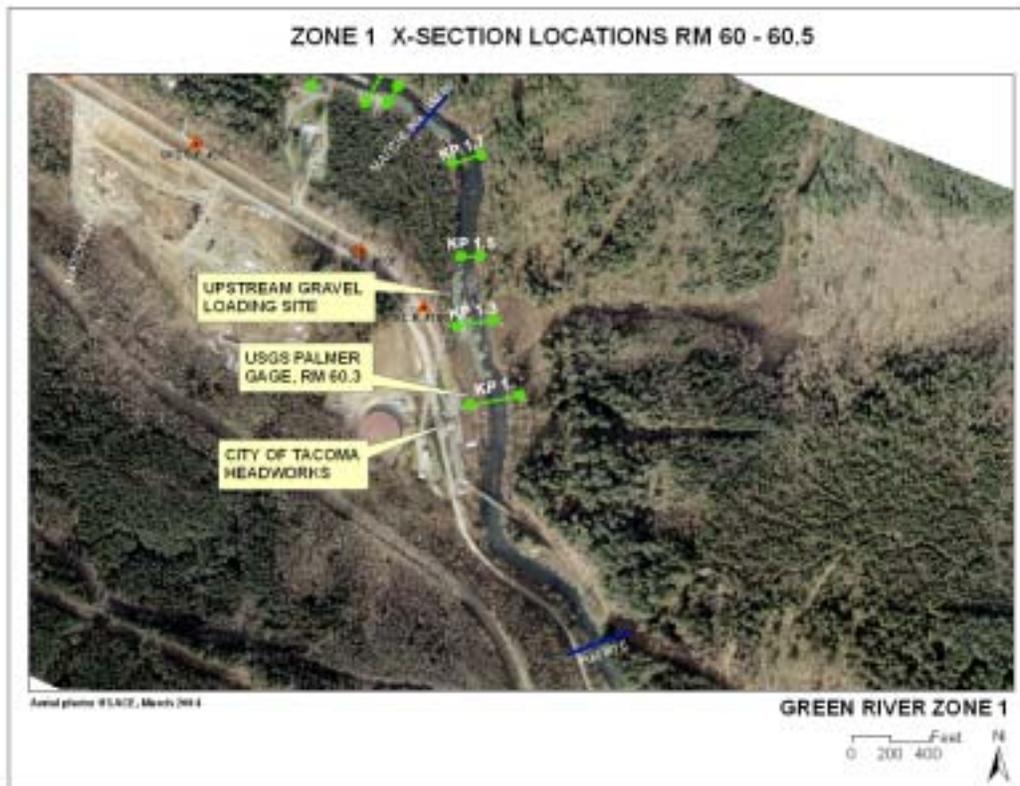
Figure 6. Cross section locations RM 60 – 60.5.

Twenty-eight baseline cross-sections were established in 2002 (USACE 2003c). Permanent cross sections were established with cap and rebar and adjacent tagline post; intermediate cross sections were also established with rebar endpoints and have decimal numbering system. Cross section locations are identified in Figures 6-8.

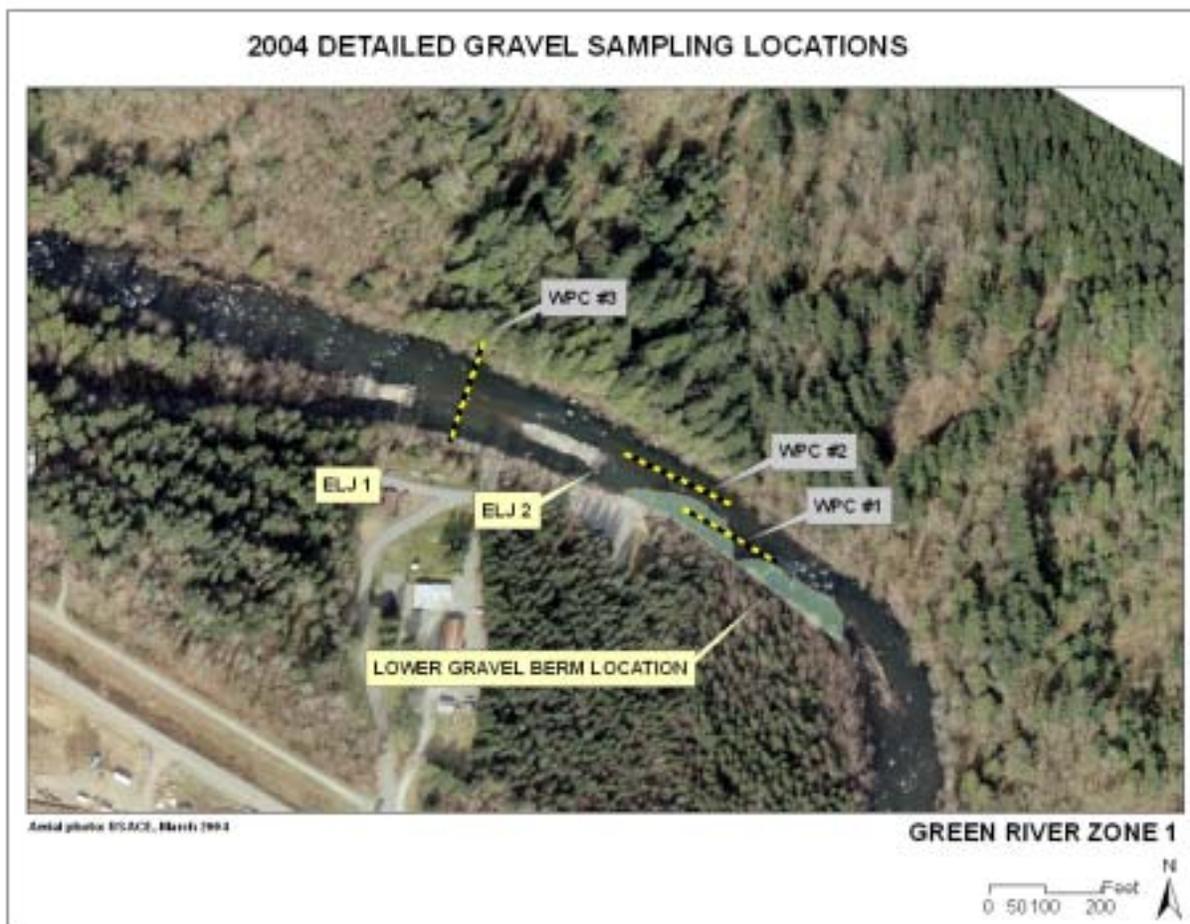
Figure 17. 2004 pebble count locations.

Sediment size distribution and composition data was collected using the Wolman pebble count method. This consisted of collecting samples along a channel grid at predefined monitoring sections (Figure 17). The grid was a 100-ft long strip where pebbles were measured at 2 ft intervals along the grid. The median axis diameter of each pebble was measured using an engineer scale. The original plan required Wolman counts at all cross sections. USACE decided to restrict the pebble counts to sections that had readily observable changes in the dominant streambed material. These changes are most pronounced at KP 2.0 and KP 3.0, and to a lesser extent at KP 1.7, KP 3.2, and KP 4.0.

Figure 18 shows the change in streambed composition at KP 2.0 and 3.0 from the baseline condition. The d-50 bed material size decreased 65% at PC#3 and 76% at PC#2. PC#3 is taken across KP 3.0. PC#2 is taken along the river, perpendicular to KP 2.0 atop a mid channel gravel bar. PC#1 is taken mid-channel between KP 1.7 and KP 2.0

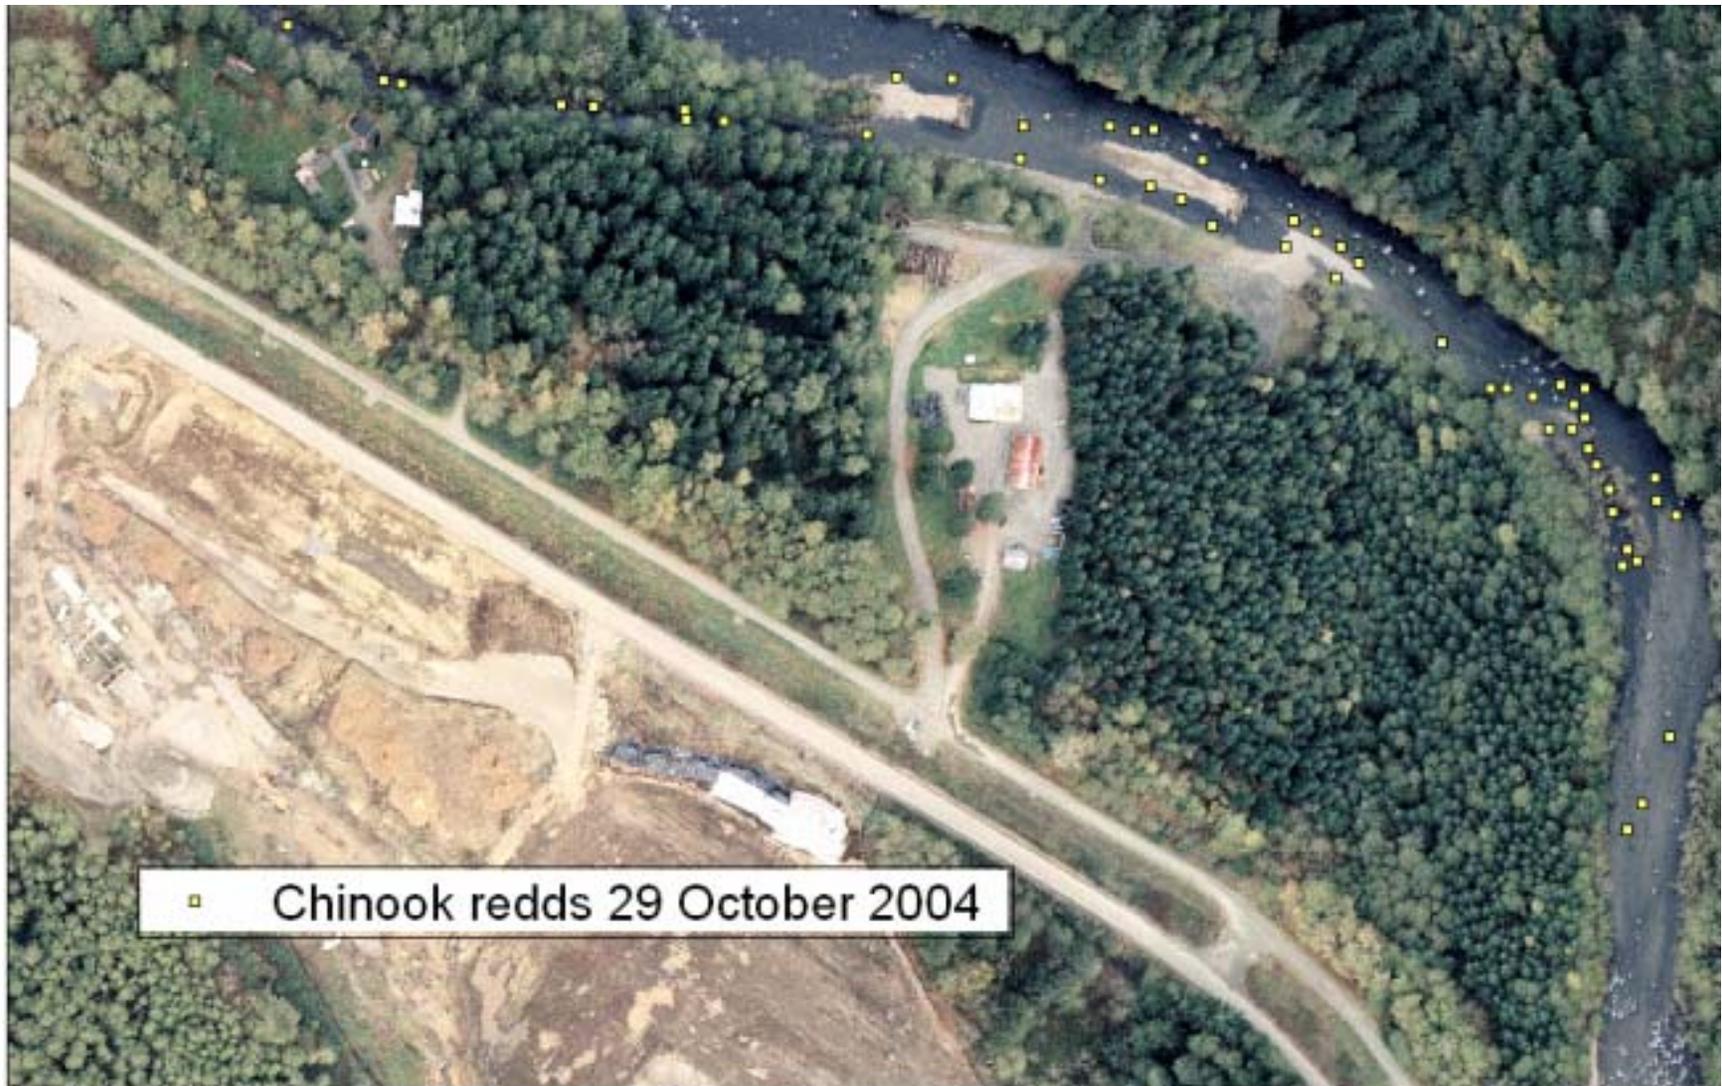
Figure 20. Location of Chinook salmon redds in Restoration Zone 1, Green River, 29 October 2004.

A second spawning survey was conducted on 29 October 2004. A total of 68 adult salmon (3.0 salmon•1,000 ft⁻¹) were observed (Table 5; Figure 20). Coho salmon were the most abundant live species at the time of the second spawner survey, accounting for more than 51% of the live fish; however, Chinook salmon accounted for more than 84% of the redds, and 96% of the carcasses that were observed.

Chinook redd density ($52.3 \text{ redds} \cdot 1,000 \text{ ft}^{-1}$) observed in this study during the initial survey was higher than the average Chinook redd density observed in the upper Green River from 1999-2004 by WDFW ($20.3 \text{ redds} \cdot 1,000 \text{ ft}^{-1}$; std. dev. = 12.9). In addition, total Chinook redd density combining both surveys ($72.3 \text{ redds} \cdot 1,000 \text{ ft}^{-1}$) is more than three times the mean density obtained by WDFW from 1999-2004 (Figure 21). While higher than 2003, the Chinook redd densities observed in Restoration Zone 1 compare favorably to densities obtained from the highest concentration of Chinook spawners on the Green River (Malcom 2002). Overall redd densities in the reach were buoyed by large concentrations of spawning Chinook observed downstream from the Kanaskat-Palmer Highway Bridge in 2004 (see Appendix D).

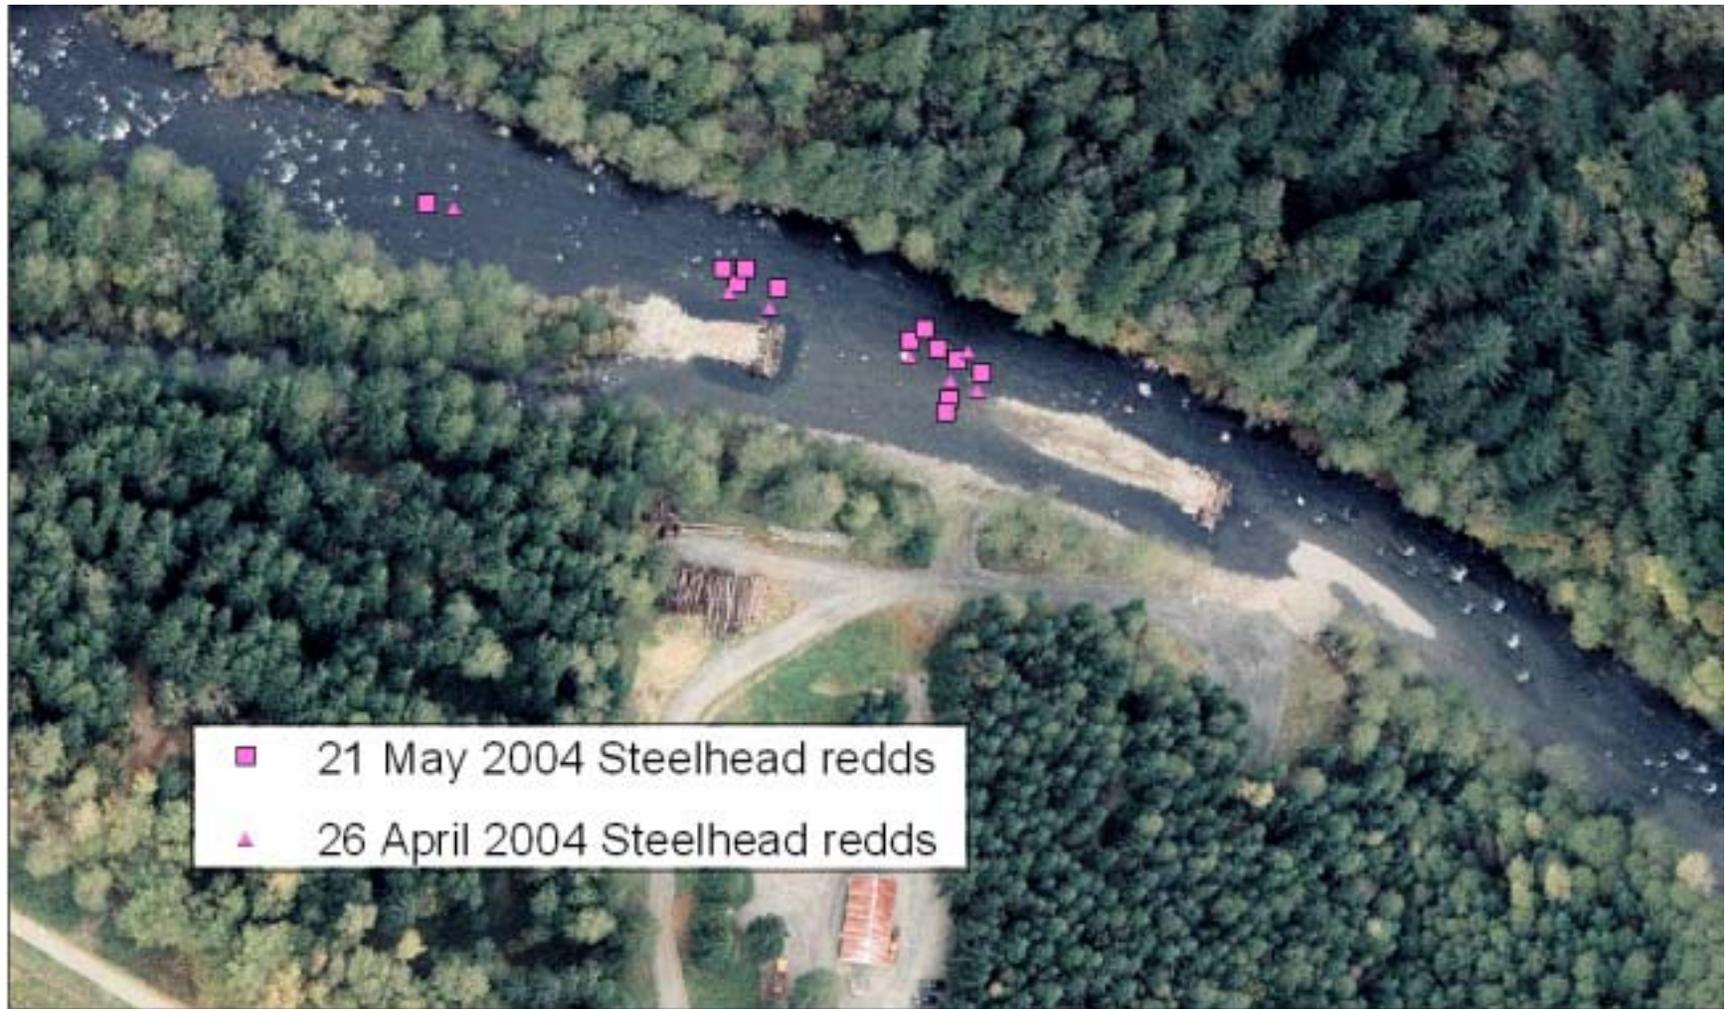
Figure 24. Location of steelhead redds in Restoration Zone 1, upper Green River, King County, Washington, 26 April and 21 May 2004.

Steelhead redd data (number and locations) were collected within ELJ test and control sites on 26 April and 21 May 2004. Overall steelhead redd density was greatest within the ELJ 2 test site (Figure 24; Table 7). Steelhead redd densities ranged from 33.9 redds•1,000 ft⁻¹ (ELJ 2 Test Site) to zero at the ELJ 2 Control Site. All live steelhead were observed holding under the upstream footprint of the ELJ structure. The redd densities observed within Restoration Zone 1 are higher than the average redd density (7.4 redds•1,000 ft⁻¹; std. dev. = 6.2) observed by WDFW in the upper Green River from 1998-2004 (Cropp 2004).

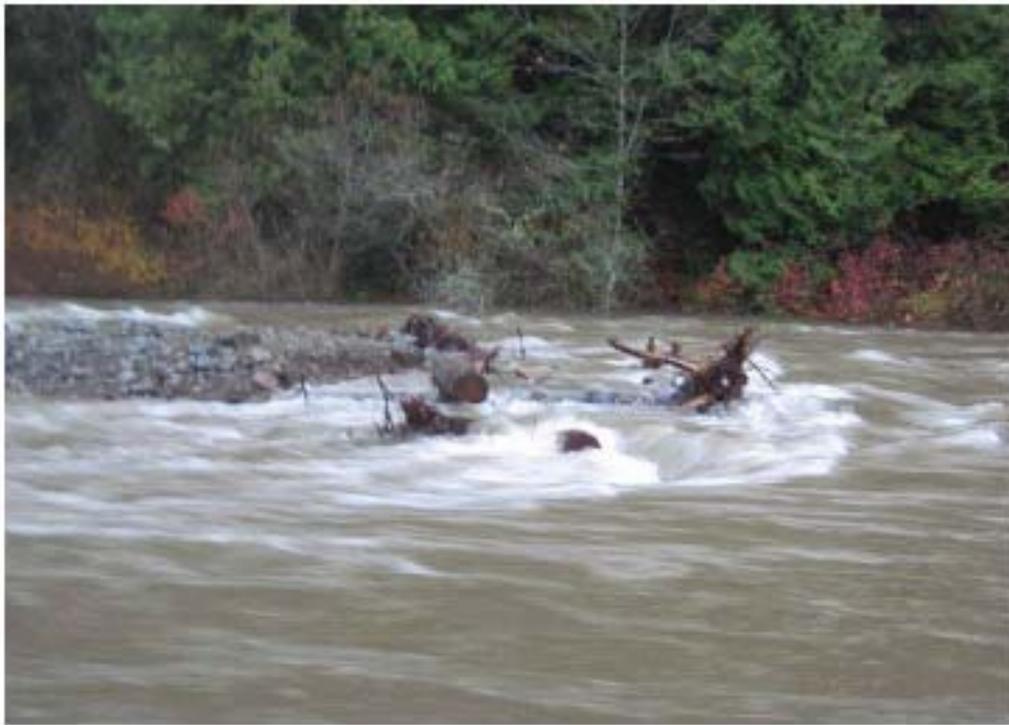
Monitoring indicated that ELJ2 was beginning to overtop at much lower discharges than expected based on the design analysis. On November 18, 2003, ELJ2 was overtopped at a flow of 4,300cfs (Figure 28). This was attributed to several factors including 1) log jam construction was approximately ½ foot lower in elevation than the original design, 2) an underestimate of water surface profile elevations from the hydraulic model, and 3) changes in scour hole conditions. Details regarding factors one and two can be found in the Final Design Memorandum for 2004 Construction.

Figure 28. ELJ 2 Nov 18, 2003 4,300 cfs

Factor three is the result of the dynamic nature of sediment transport through the reach. Photo analysis indicated that overtopping of ELJ2 occurred at 4,300cfs whereas higher flows on January 30, 2004, resulted in a 1 to 2 feet lower water surface elevation for a 4,815cfs event (Figures 28, 29). In November it is likely that gravel berm erosion and transport resulted in infilling of the ELJ scour holes resulting in the above described conditions. What this information indicates is that the scour holes are highly dynamic and that the influence of the upstream gravel nourishment features will likely mean that the log jams will experience a range of flood stage conditions for a variety of flows, and the flood stage height will be dependent on the amount of gravel in the scour hole. For periods when gravel loading into the scour hole is high, water surface elevations will likely be higher. As gravel is transported through the reach residual sediments in the scour holes will begin to be evacuated, and the scour holes may enlarge. This will increase the cross sectional area resulting in lower water surface elevations.

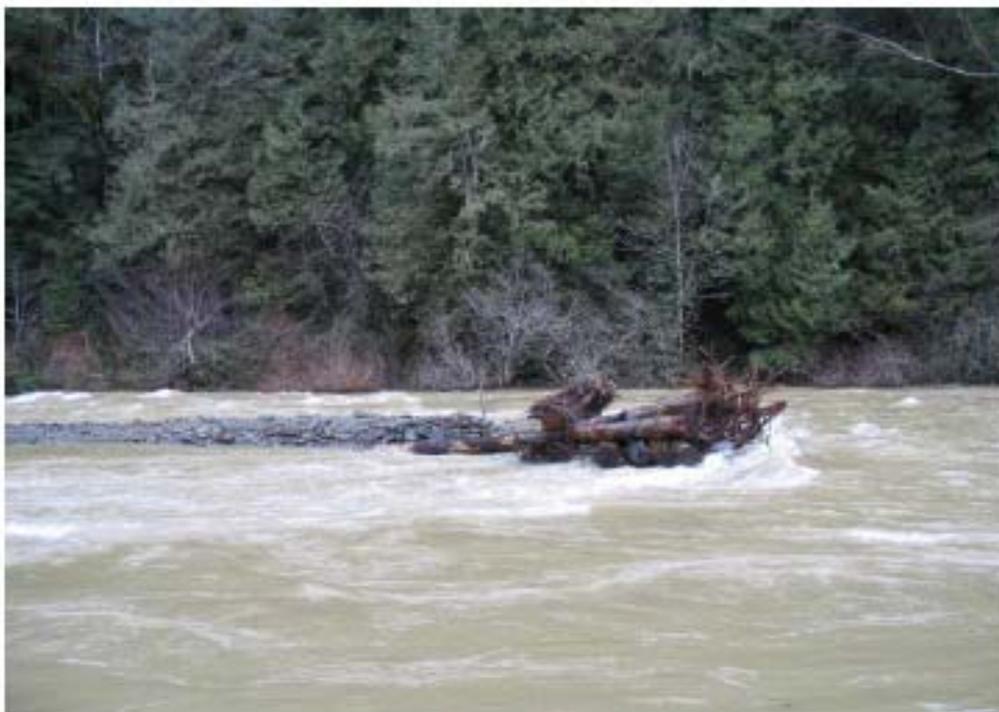
Figure 29. ELJ 2 Jan 30, 2004 4,815 cfs

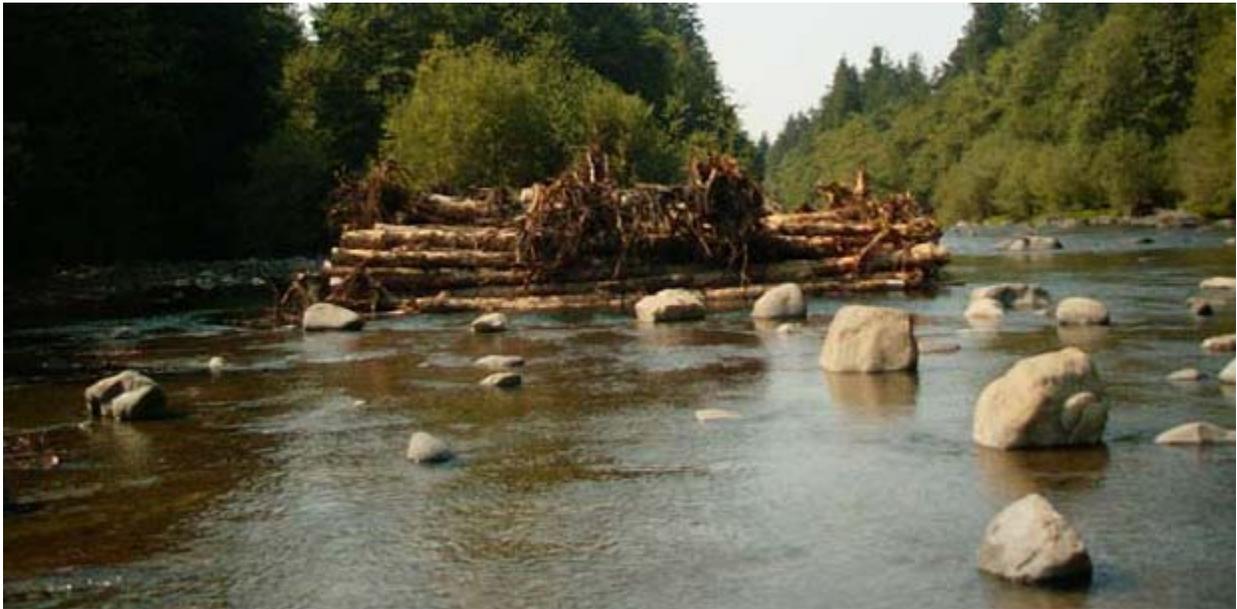
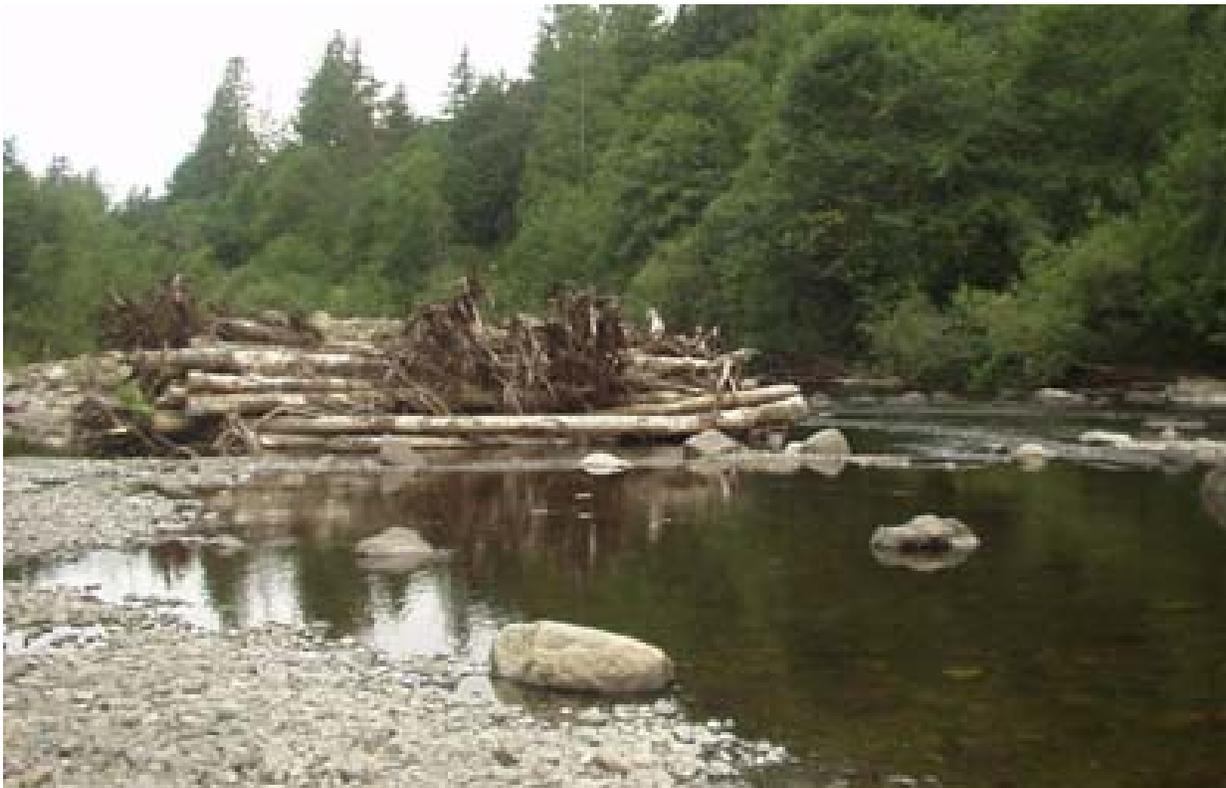
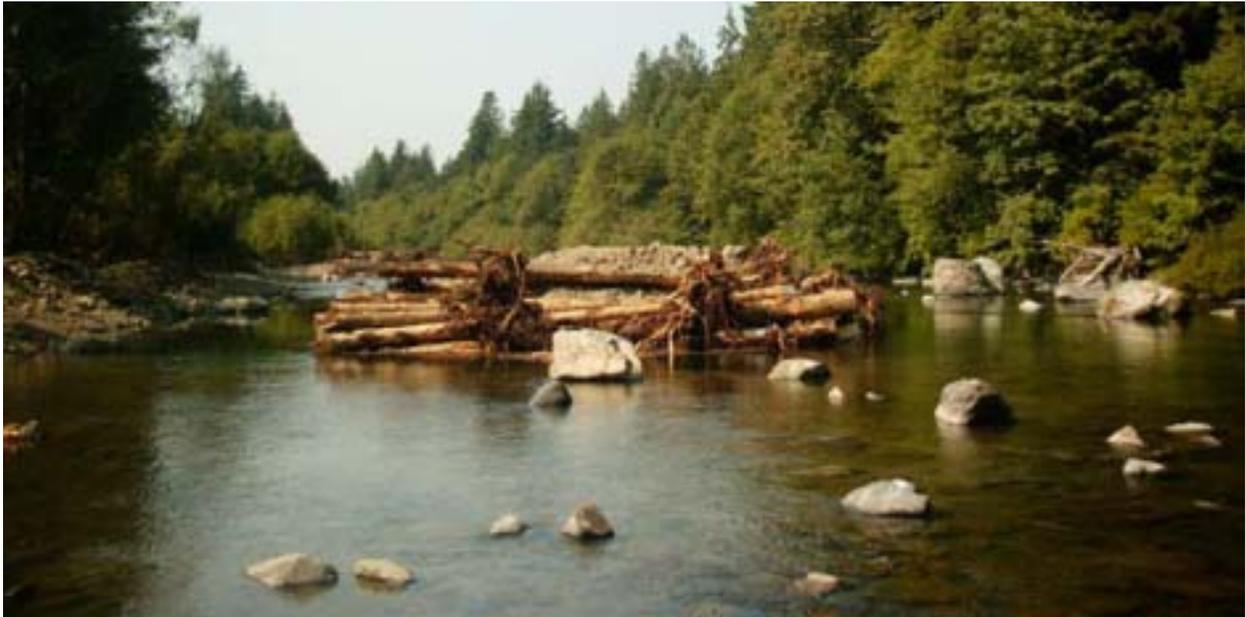
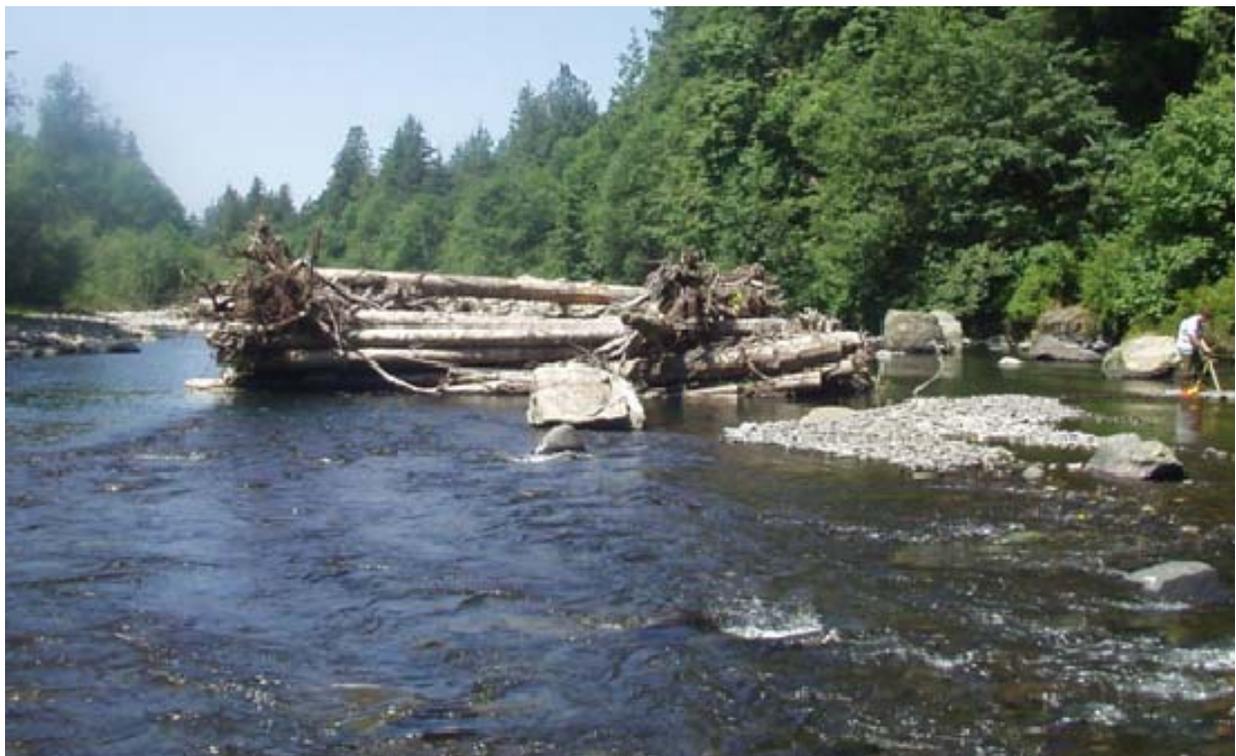
In 2004, log jams were evaluated visually and compared to 2003 photos. No obvious changes to the log structure of the downstream ELJ 1 (Figures 30 and 31) or the upstream ELJ 2 (Figures 32 and 33) were observed. As mentioned above, overtopping of ELJ did occur at undesired flows and ballast was lost from the structure (section 4.2.1.4). Based on visual observations and photographic comparison, the two ELJs generally appear stable and have not experienced serious settlement or deformation.

Figure 30. ELJ 1 September 3, 2003

Figure 31. ELJ 1 August 2, 2004

Figure 32. ELJ 2 September 3, 2003

Figure 33. ELJ 2 August 2, 2004

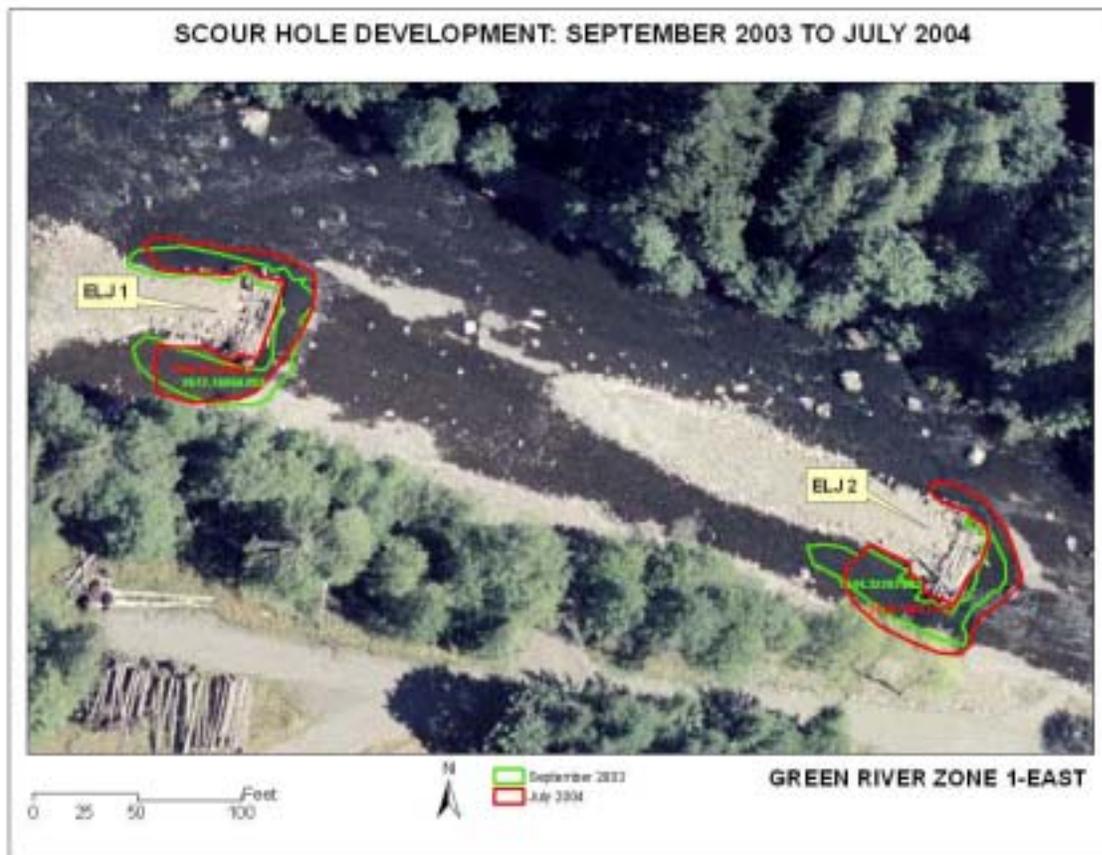
Pool area in front of the log jams was measured by area and depth. The apparent invert of the ELJ 2 scour hole was located at the left corner of the racking material, looking downstream. The surveyed invert elevation was 841.85 ft. The field-surveyed water level at the time was elevation 850 ft. The pool tail-out crest elevation was not surveyed, but was estimated to be about 1-ft below the field water surface for a residual pool depth of 7 ft. The 2003 as-built pool invert for ELJ 2 was around elevation 840.0. The pool depth thus decreased by nearly 2 feet over the year. This is approximately 5 ft less than the 12.0 ft estimated design depth. The left side scour pool around ELJ 1 had nearly filled in (1/2-2/3 full) with nourishment gravel (as-built invert was 838 ft). The invert was not surveyed in 2004. Since scour pool depths are greatest during high flow events, it is not possible to say that the design scour pool depth is being maintained at either jam. Clearly, conditions at the lower jam are different, since the degree of pool infilling is more severe.

Figure 35. Scour hole development at ELJs.

Gravel nourishment effects the morphology of the scour hole development. Gravel waves were observed to partially fill in scour holes after flood events where gravel transport was occurring (USACE 2004b). Once the majority of gravel had passed through the reach, the sediment transport capacity around the scour holes increased, and pool sediments were scoured out. This lowered flood levels at comparable discharges (Figure 28 and 29).

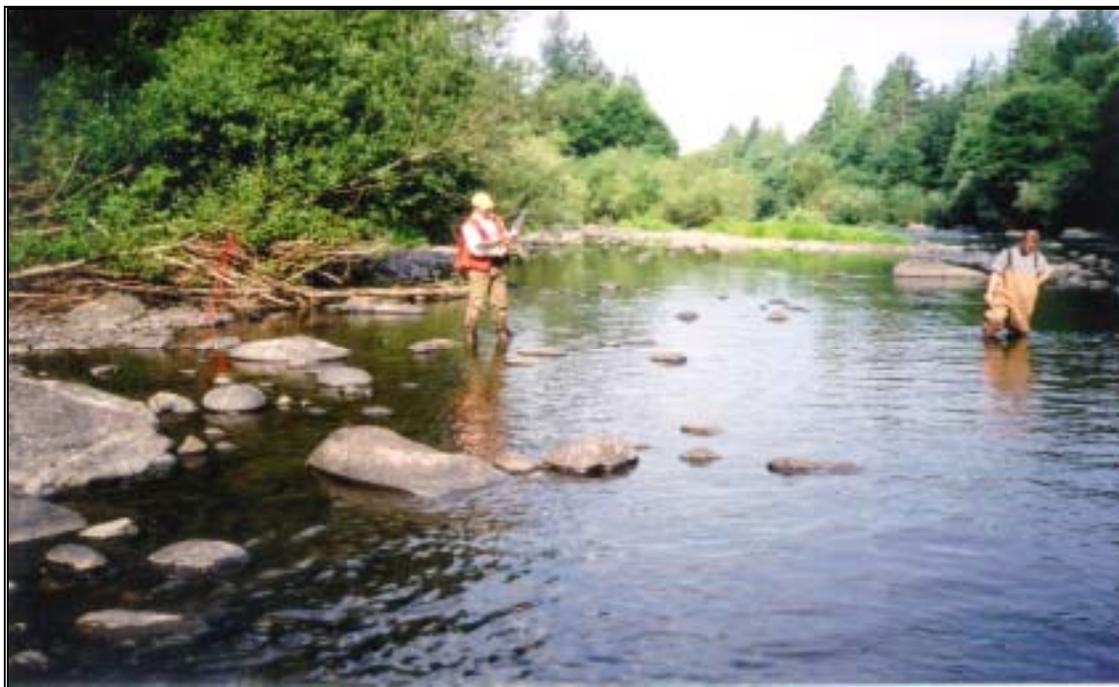
Figure 39. Downstream pre-construction view of ELJ Control Site 1, 5 August 2003.

A post-treatment experimental design was used to determine the response of juvenile salmonids to ELJ construction by comparing densities at control sites to juvenile salmonid densities at treatment sites. Control sites (Figures 39 and 41) with similar habitat characteristics to the treatment sites (Figures 38 and 40) were identified prior to conducting biological surveys on 5 August 2003 in consultation with USACE personnel. Candidate control sites were initially identified using the baseline habitat survey information (USACE 2003a). In order to minimize the effects of non-treatment factors, control sites were located as near as possible to treatment sites.

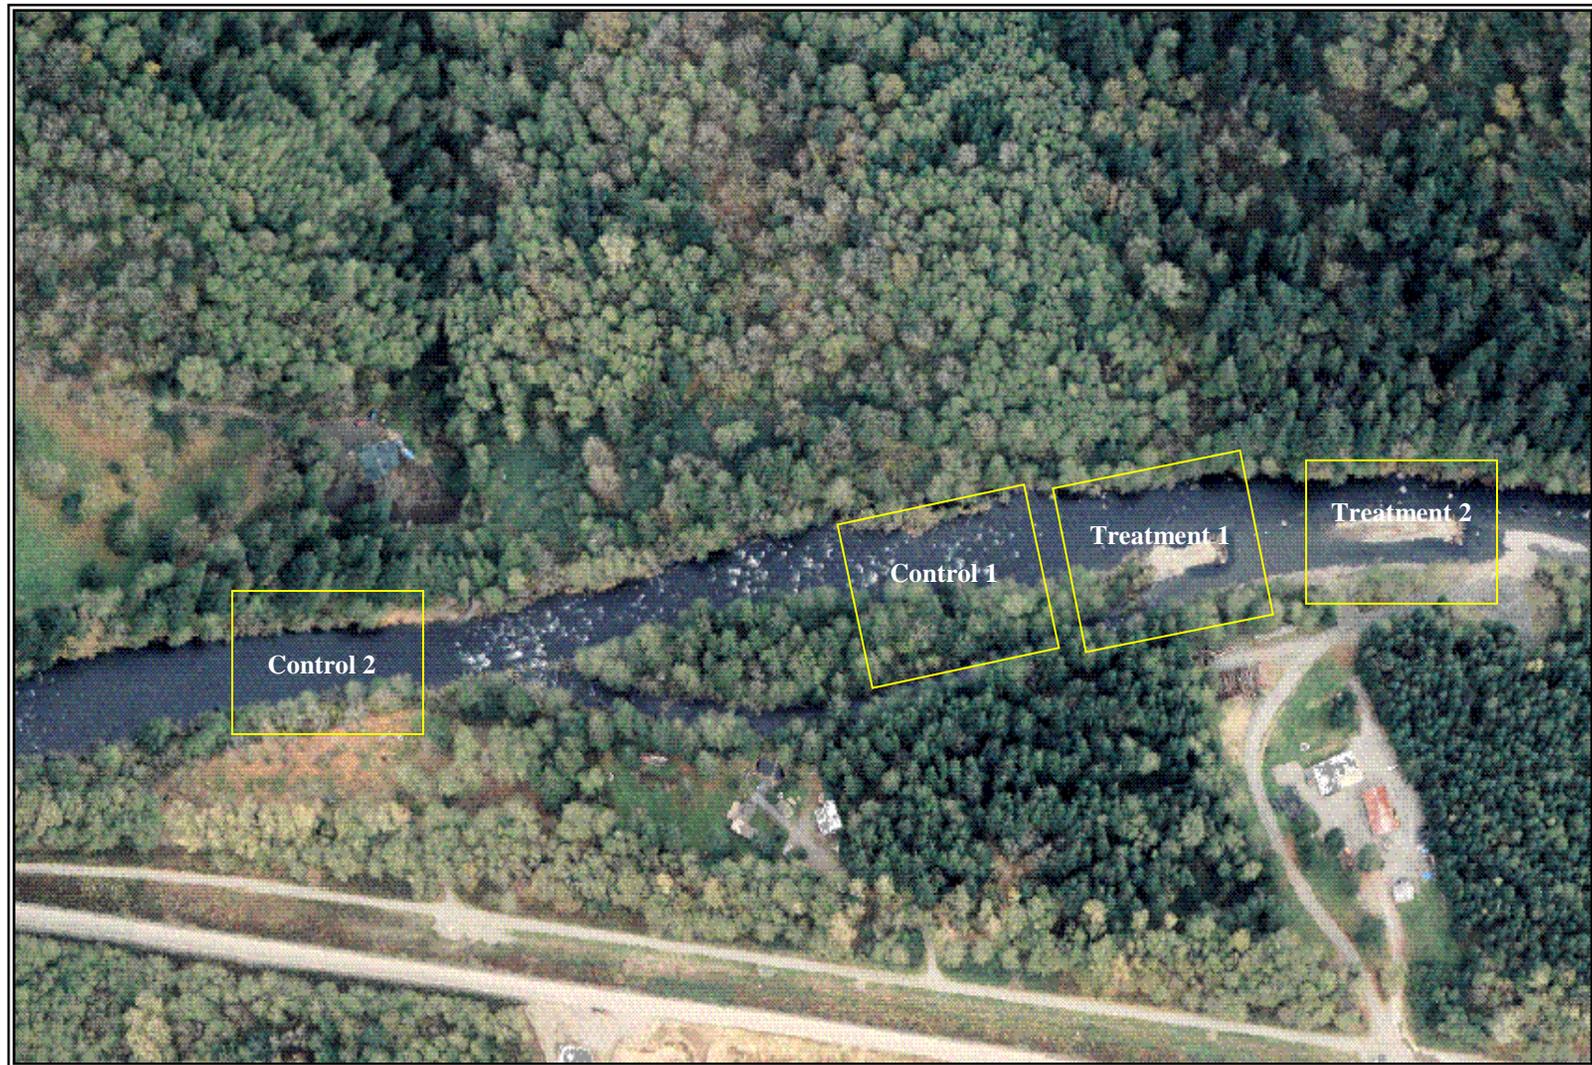
Figure 42. Location of treatment and control snorkel sites with the restoration zone.

Each treatment and control site was delineated into a 100 linear ft reach of river channel (linear count) that encompassed the ELJ as well as a footprint site, consisting of only the ELJ and immediate area surrounding it (footprint count) (Figure 42). Control and treatment footprint counts were delineated using an assumed ELJ footprint area of 70- X 50-ft (USACE 2003b). The footprint count was included in the linear foot count but was separated to examine the influence of the ELJ structure itself on juvenile salmonid densities.
