**Water Year 2005 Monitoring Report  
Howard Hanson Dam Additional Water Storage Project  
Zone 1 Fish Habitat Restoration Project  
Green River, Washington**

**Howard Hanson Dam  
Additional Water Storage Project  
Zone 1 Fish Habitat Restoration Project**

**Water Year 2005 Monitoring Report**

**Prepared By:  
U.S. Army Corps of Engineers and  
R2 Resource Consultants, Inc.**

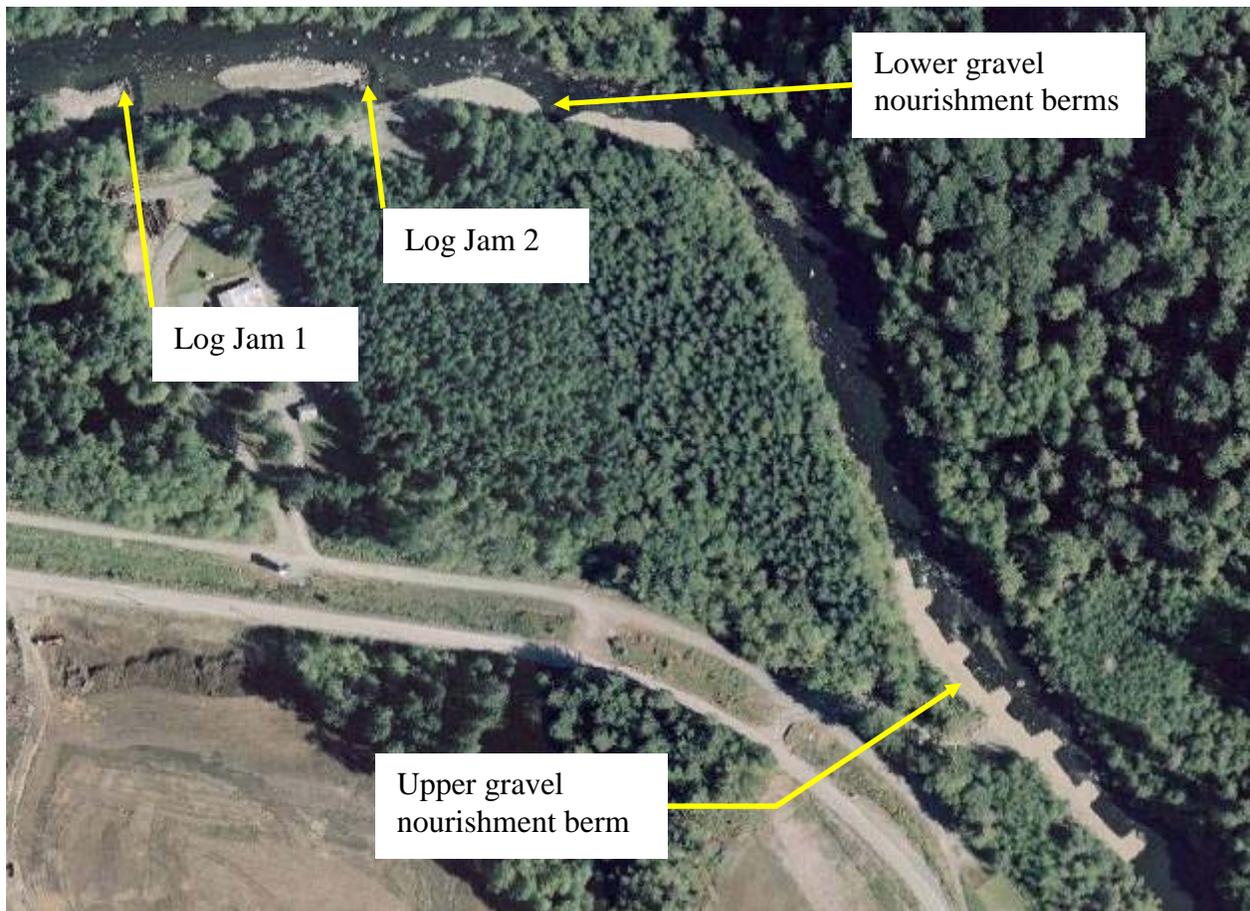
Figure 1. Post construction aerial photo of constructed gravel berms and log jams at RM 60 of the Green River, 21 September 2003.

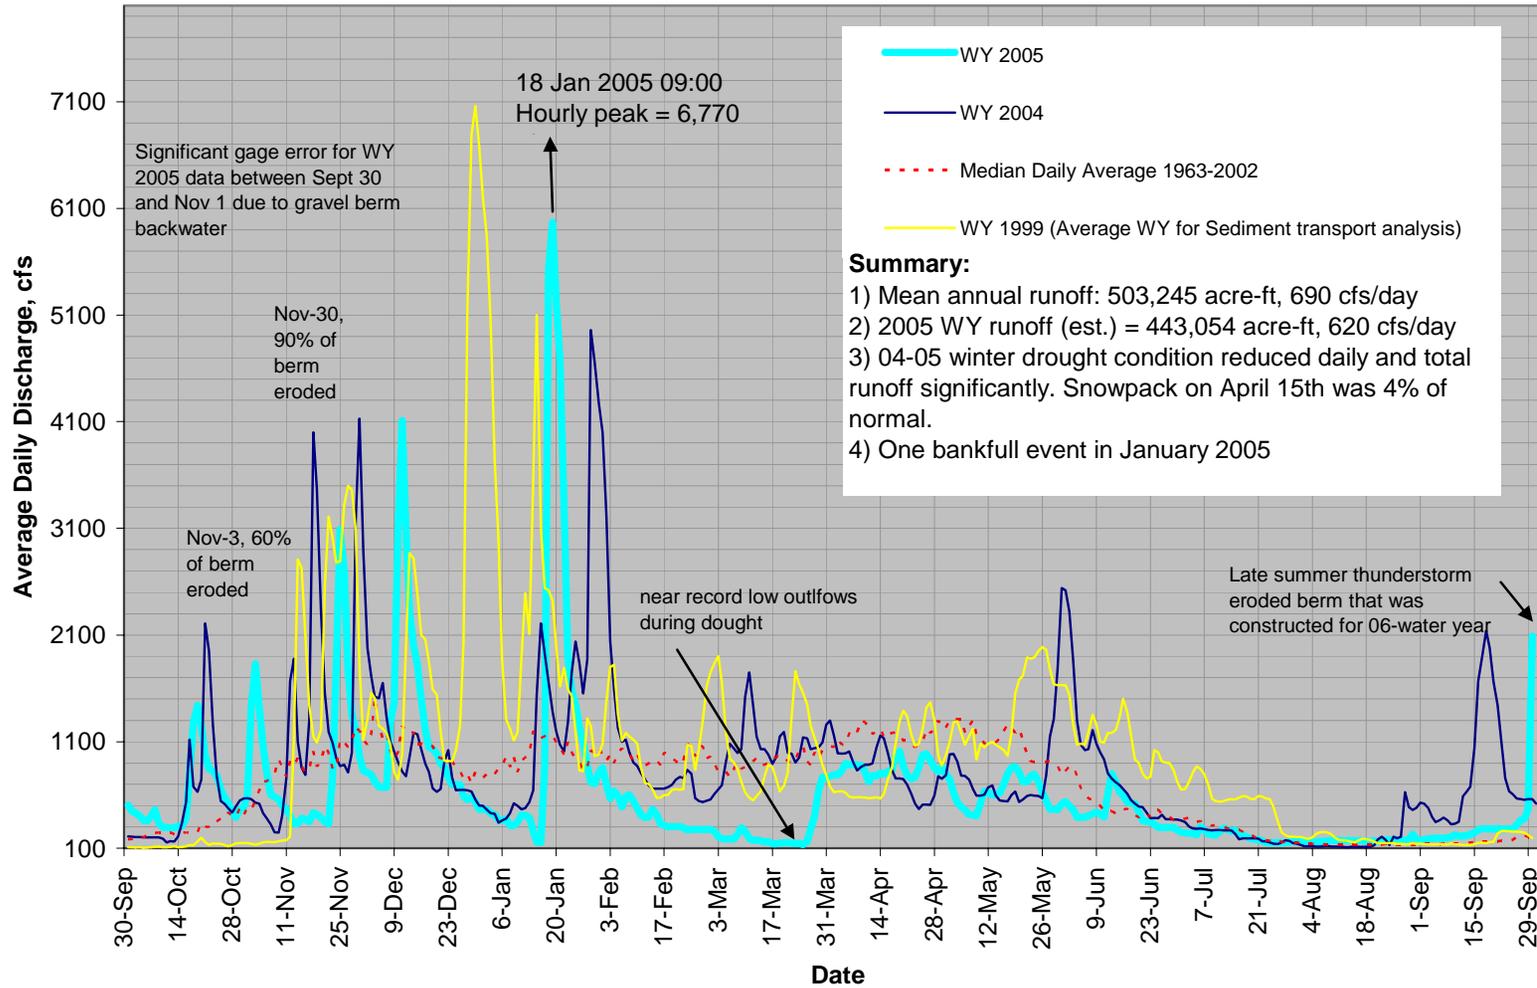
Figure 2 illustrates the annual hydrograph for the 2005 water year (October 1, 2004 - September 30, 2005), as measured at the USGS gage at Palmer (#12106700), located at RM 60.3 in Zone 1, just above the upper gravel loading site. The gage is downstream from HHD and reflects routine management of outflows for flood control, provision of in-stream minimum flows for fisheries, and water supply needs. Compared to the average annual hydrograph (Figure 3), 2005 was characterized by its low total runoff (85% of normal), near record low inflow in March (<1% non-exceedance), and successive high flows that ceased after the 18 January, 2005 bankfull event (1.5 year recurrence interval). Snow pack was 4% of normal on April 15<sup>th</sup>, 2005 (L. Schick, pers. Communication) and drought conditions were declared by Governor Gregoire.

Figure 2. Green River at Palmer 2005 Water Year Hydrograph.

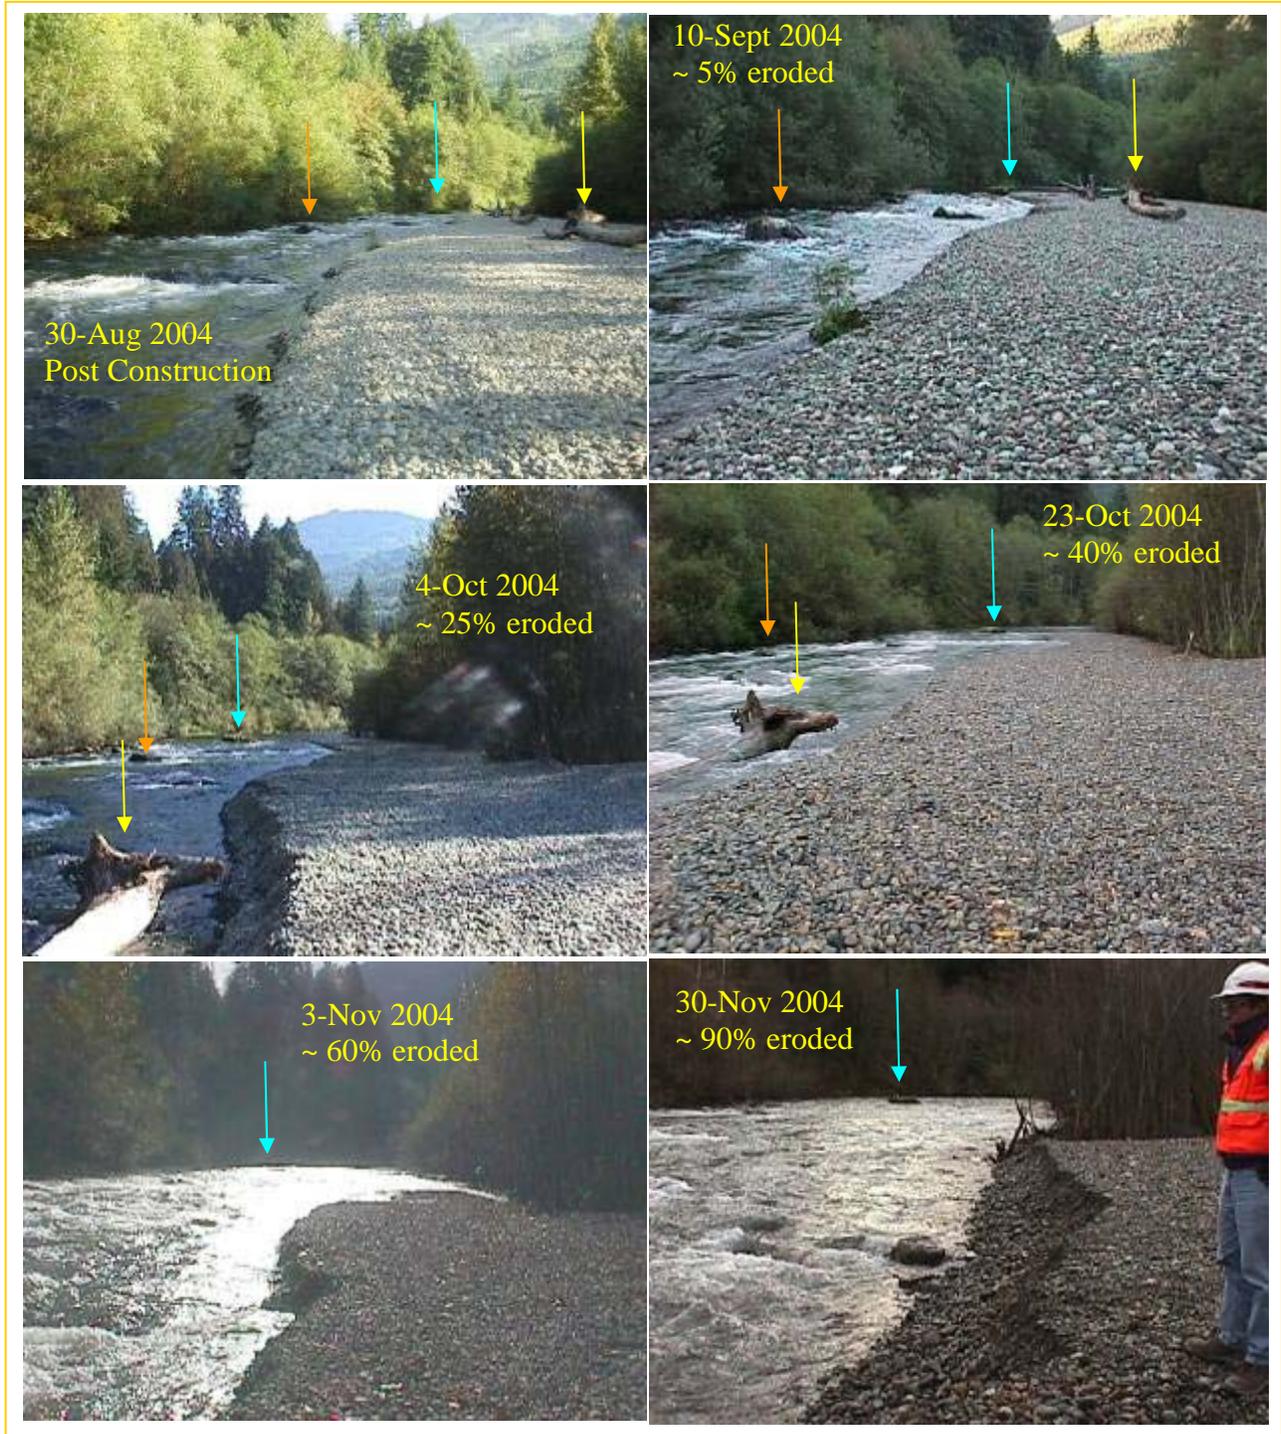
Figure 6. Erosion of upstream end of upper gravel nourishment berm, showing LWD transport

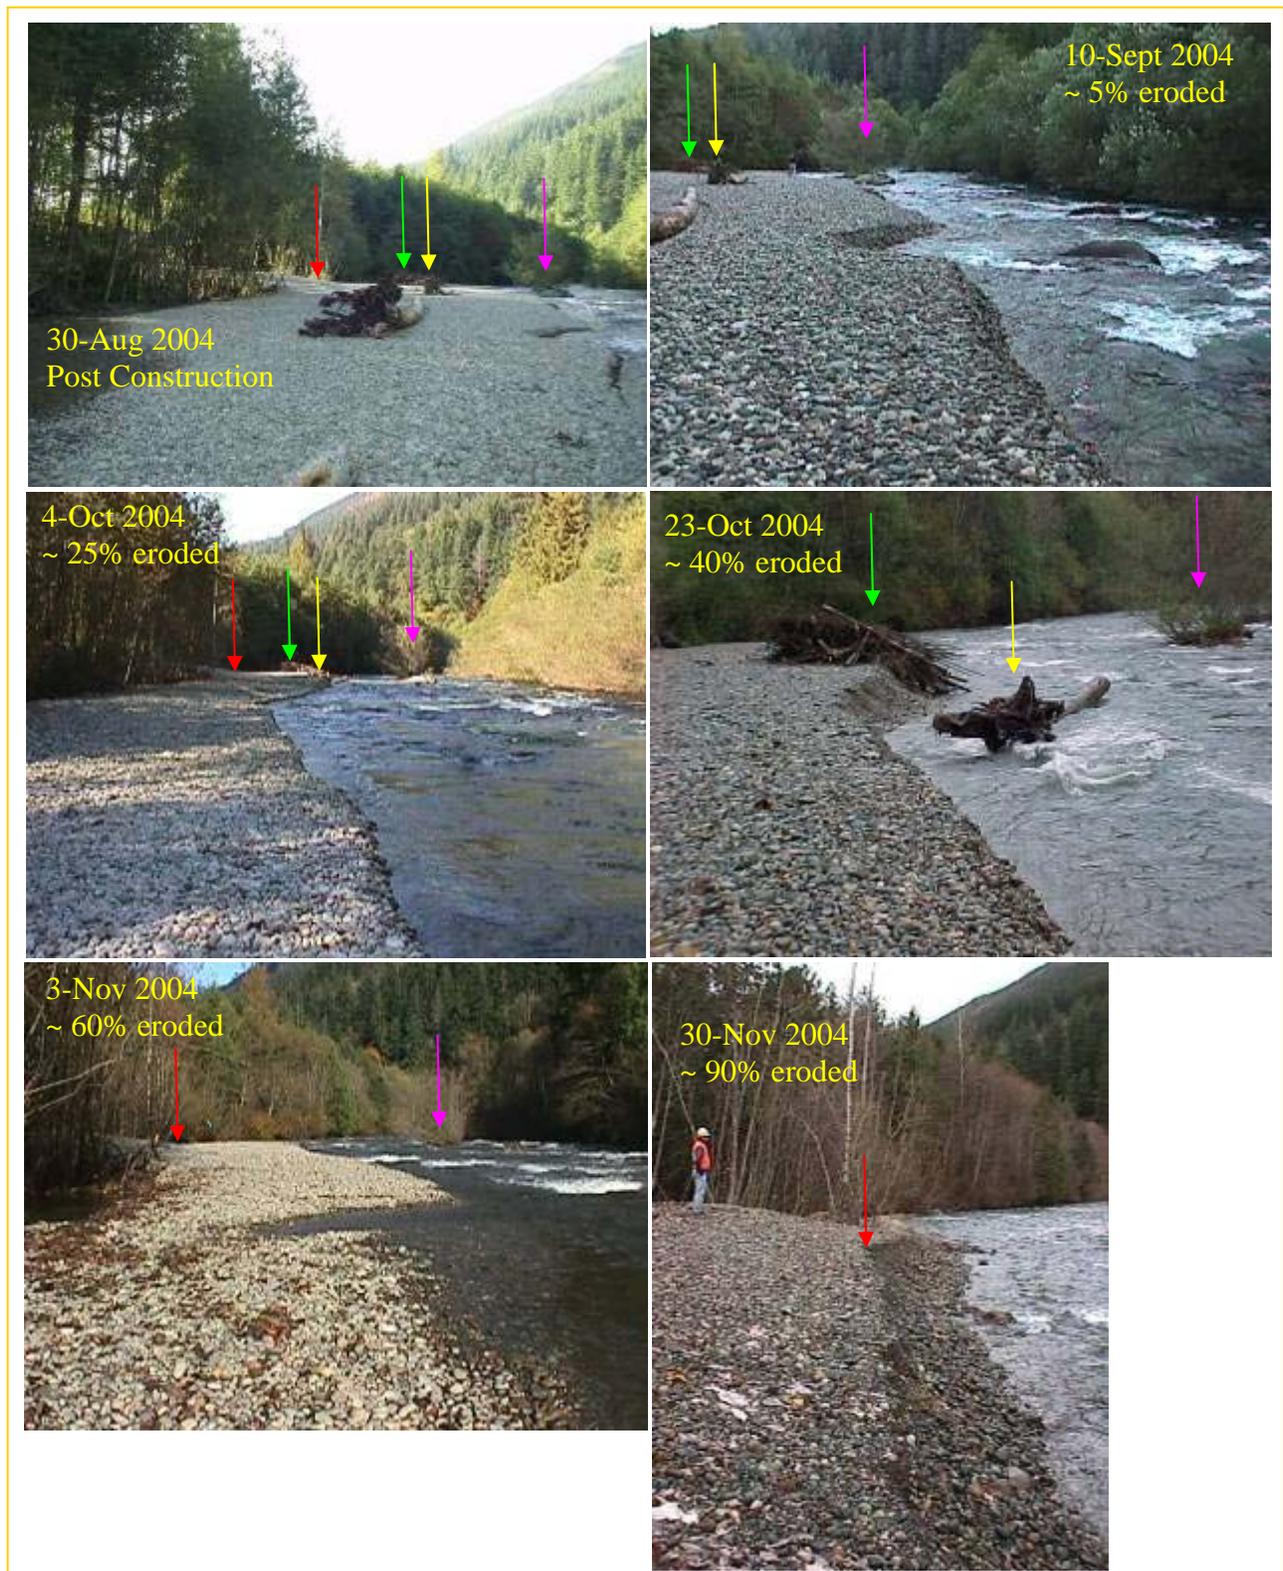
Figure 7. Erosion of downstream end of upper gravel nourishment berm, showing LWD transport

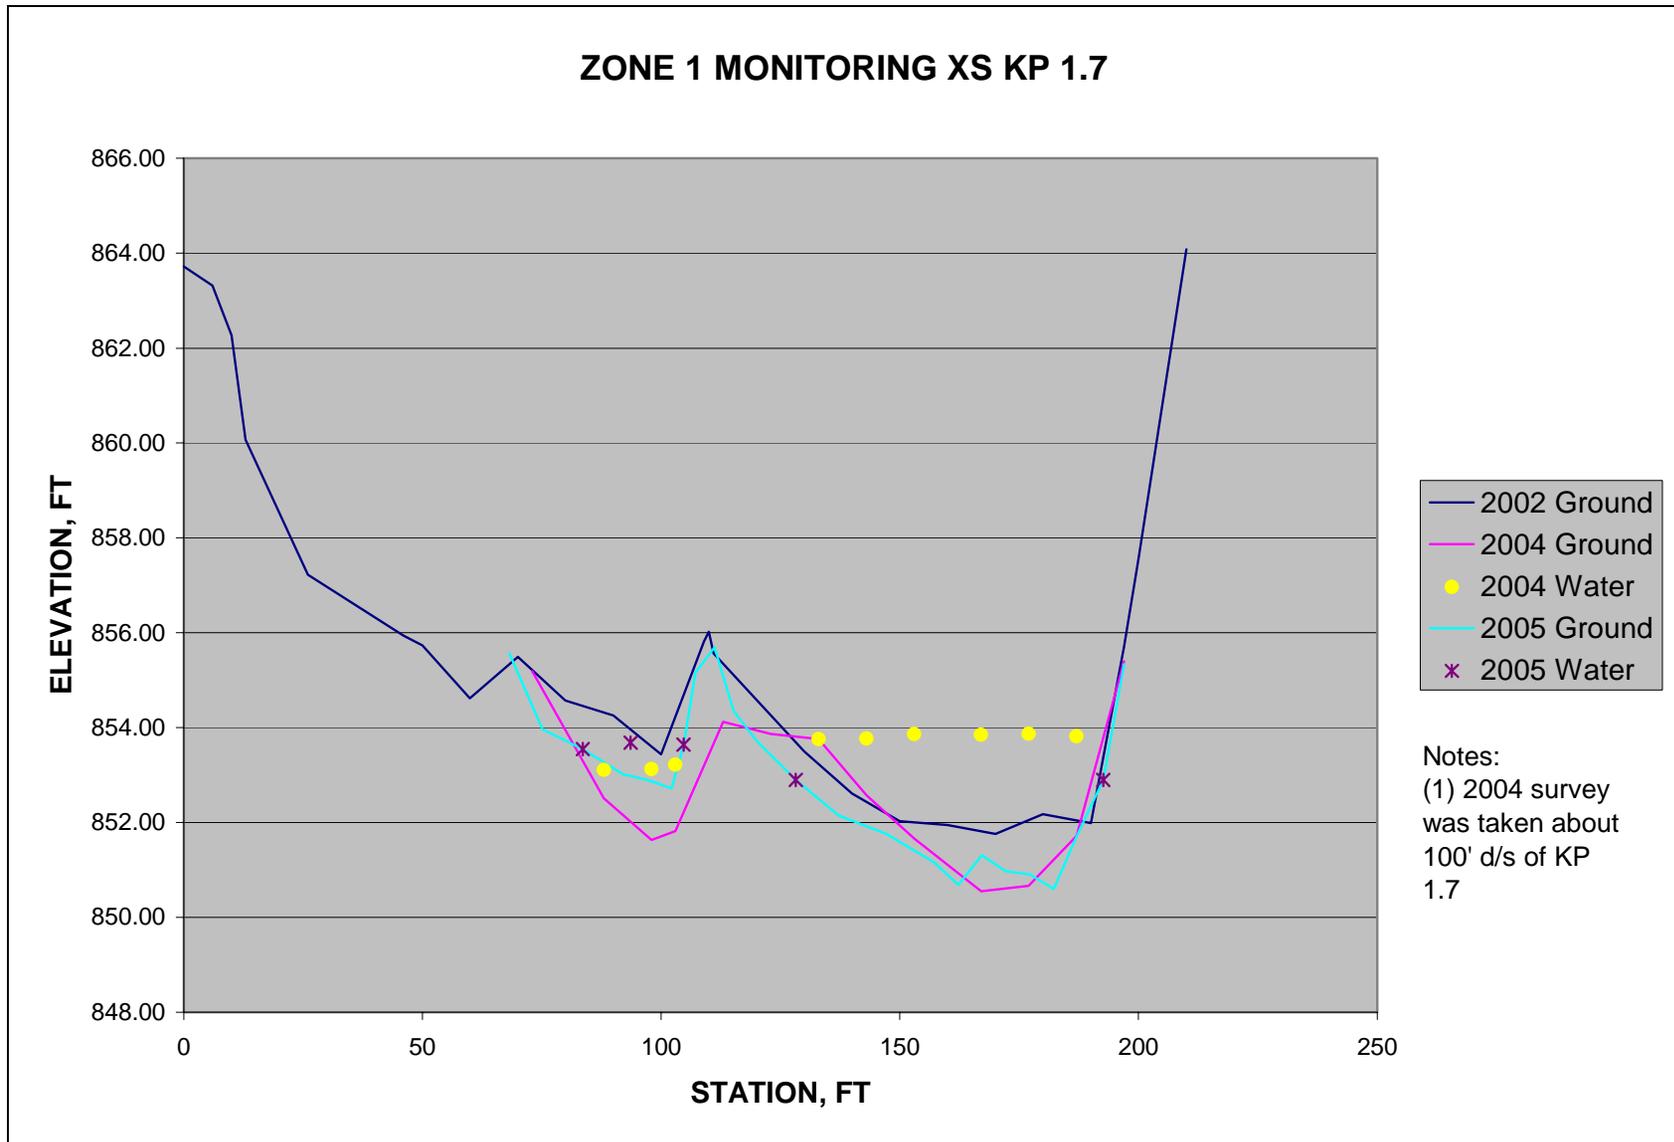
Figure 14. Cross section survey data KP 1.7 (WY 2004 flow at Palmer, 8/3/04, 120 cfs, WY 2005 7/28/05, 151 cfs).

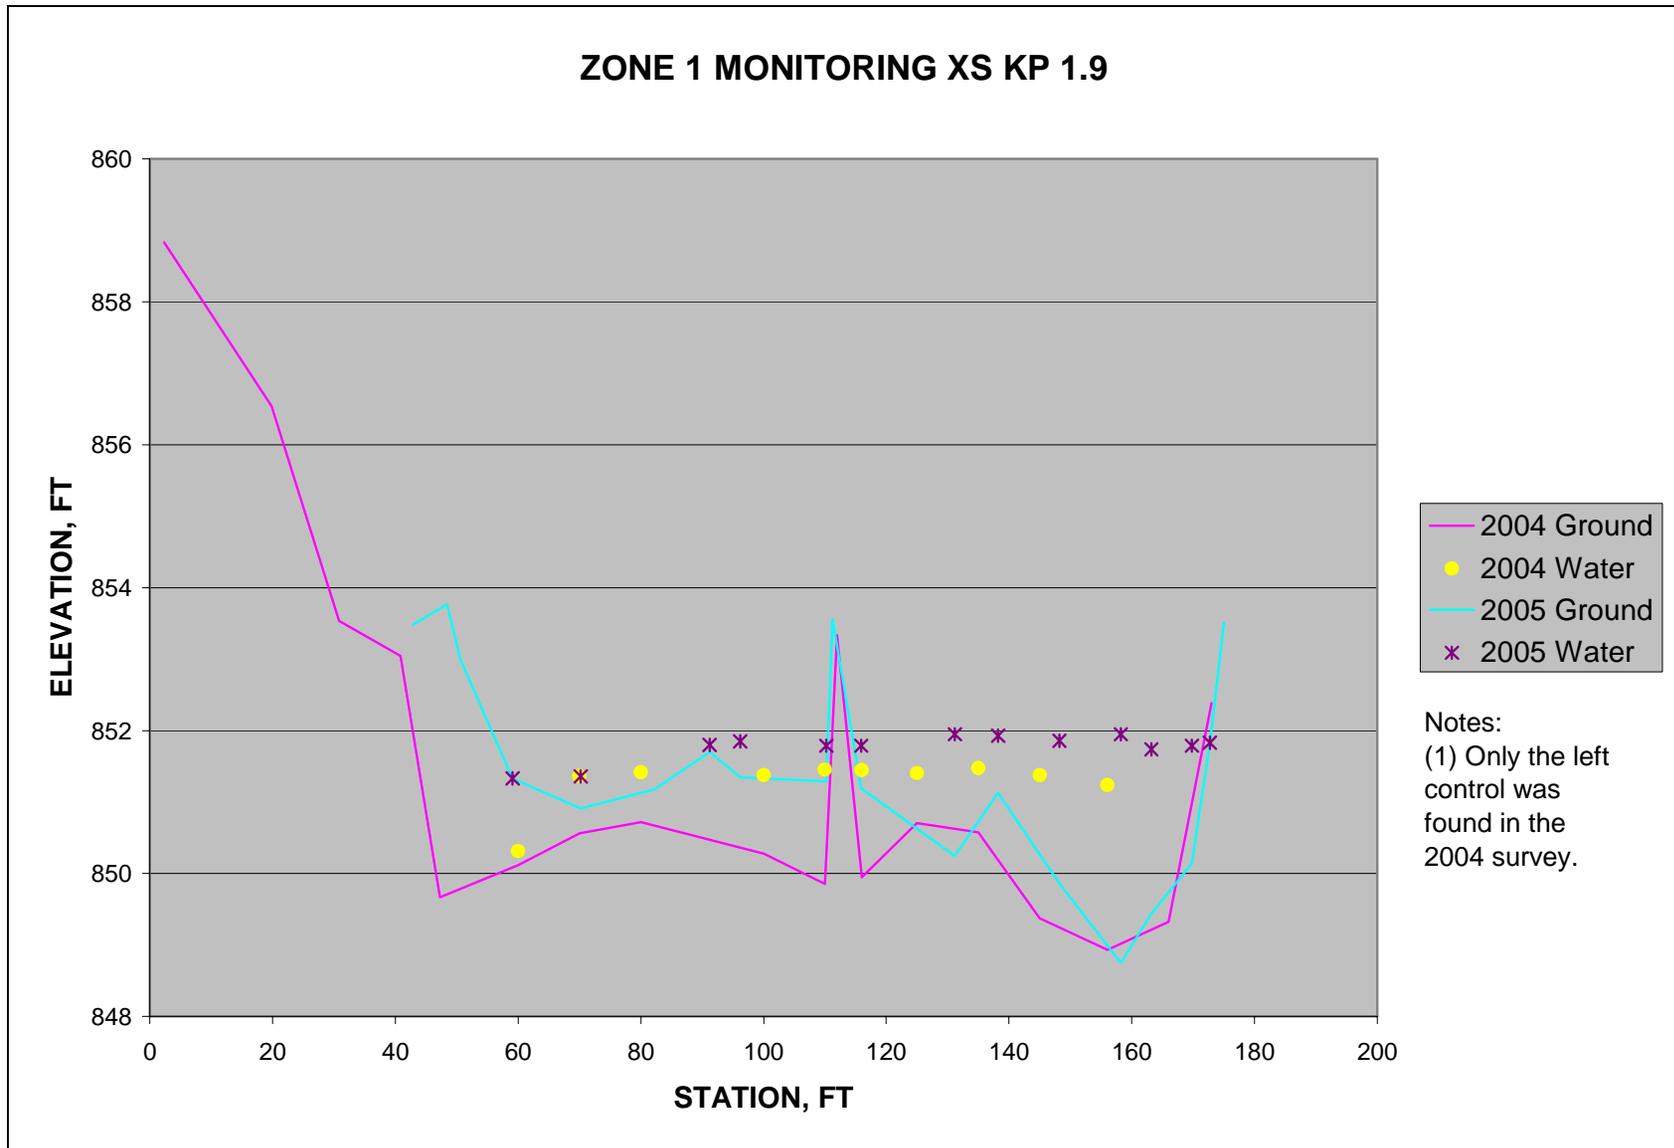
In 2004, it was observed that significant amounts of gravel are being stored between KP 2.0 and 3.0. Other surveyed cross sections only indicated minor changes. In 2005 a similar trend of gravel storage continues above both logjams. Over 1 ft of aggradation was recorded at KP 1.9 in the middle of the channel, and over 3 ft of aggradation was recorded on the left bank. The thalweg near the right bank appears to have scoured somewhat. At KP 3.0 the channel has continued to fill, with over 1.5 ft of aggradation recorded in the middle of the channel upstream of ELJ 1. The thalweg has also aggraded somewhat. Upstream of the ELJs, at KP 1.7, the trend observed in the field (aggradation) is not observed in the cross section surveys. It is not clear at this point if the apparent scour at this section is indeed occurring despite the presence of clearly visible gravel bars (Appendix C). It is notable that the water level in the side channel is higher in the side channel than main channel, since this is opposite of what was observed in 2004. WY 2006 results will be used as a check against the WY 2005 results to see if this trend is still observed. If it is not observed the 2005 data will be assumed to be in error, unless some other explanation can be found. At KP 3.2, just downstream of ELJ 1, change remained limited. Some deposition was observed in the main channel, side channel, and on top of the vegetated island. The majority of deposition observed was along the left bank of the main channel. A common feature to all surveyed sections is the location of the thalweg along the right bank. Between WY 2004 and WY 2005 deposition along the left bank seems to have concentrated flow to a greater degree on the right bank. This is most apparent at KP 1.9, just above ELJ 2.

Figure 15. Cross section survey data KP 1.9 (WY 2004 flow at Palmer, 8/3/04, 120 cfs, WY 2005 7/28/05, 151 cfs).

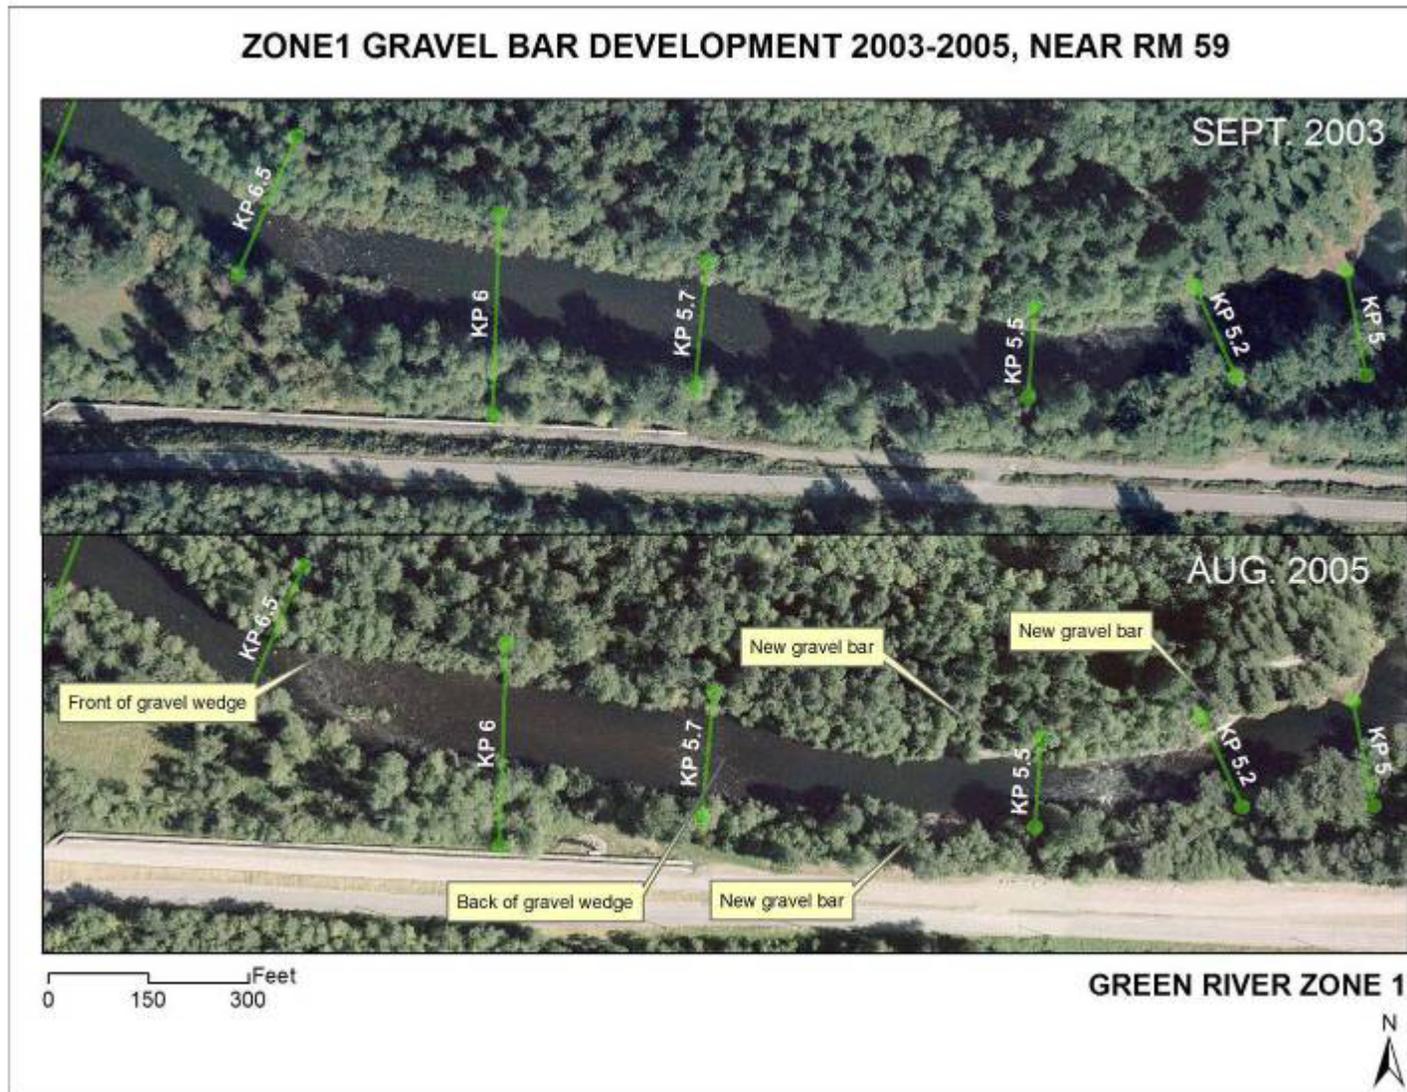
Figure 18. New gravel bars and paving near RM 59 as a result of nourishment gravel placement near RM 60.

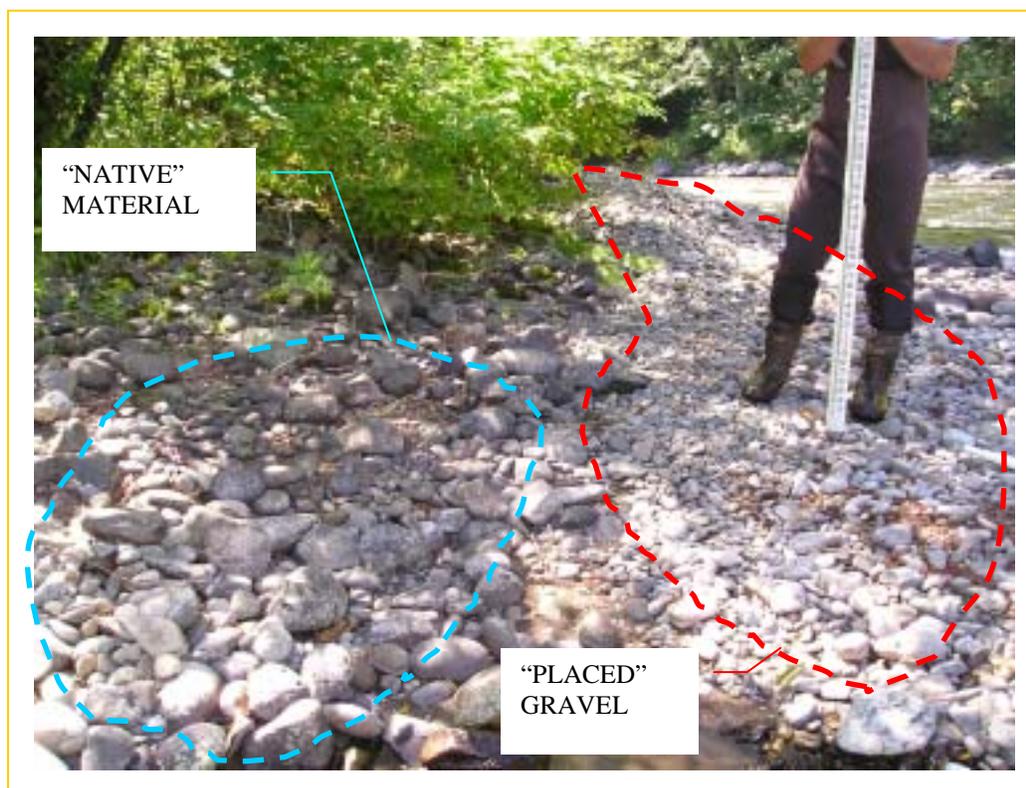
Figure 19. Example of difference of native and placed gravel deposit near KP 9.

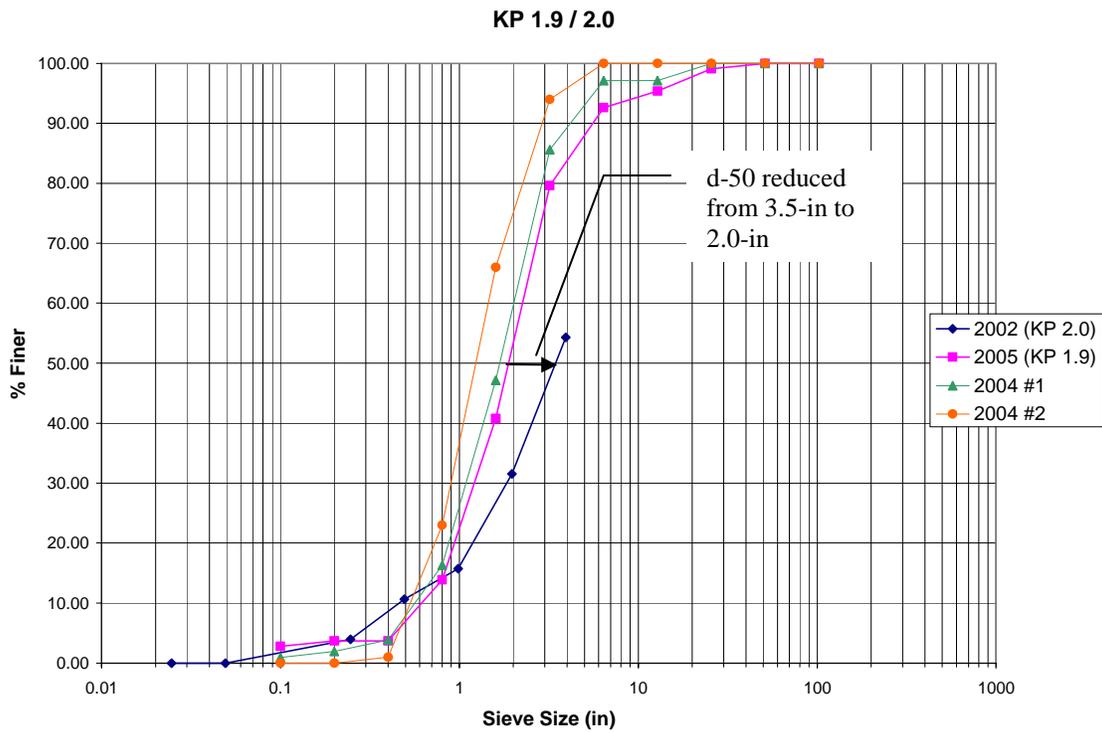
The major change observed in the data contained in Table 4 is a fining of the bed around the logjams where the deepest deposits are observed (KP 1.9/2, 3). The change was not observed at other locations; in fact the data suggest a slight coarsening of the bed at runs located above the project (KP 1) and just below the logjams (KP 4). However at the bottom end of the study area (KP 8, 9, 10), the bed noticeably fined. From the grain size data, it appears that there are two waves of gravel in the study area, although the patch mapping suggests there are three waves (the third located near the boat launch). The boat launch was reported to have a significant amount of gravel in the baseline study

Figure 27. Change in dominant grain size (d-50) upstream of ELJ 2.

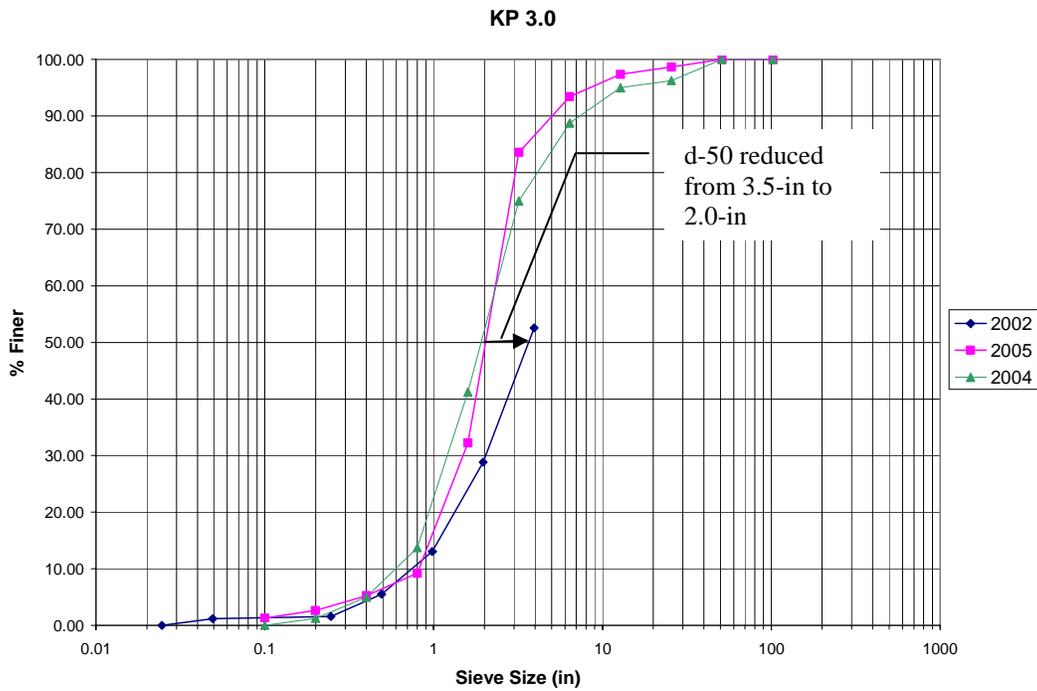
Figure 28. Change in dominant grain size (d-50) upstream of ELJ 1.

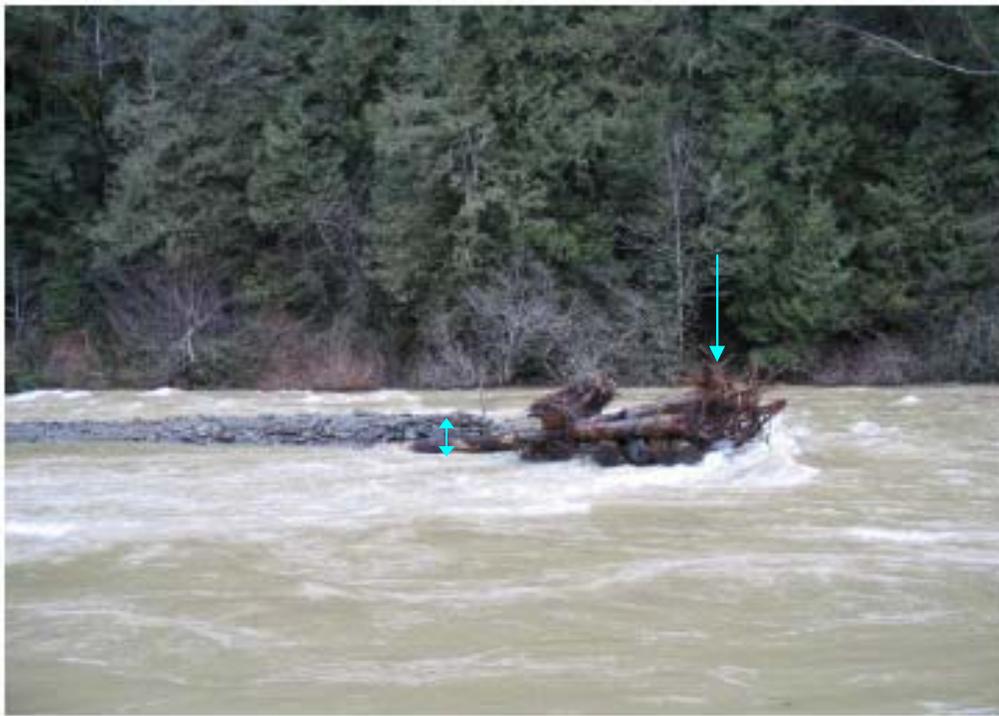
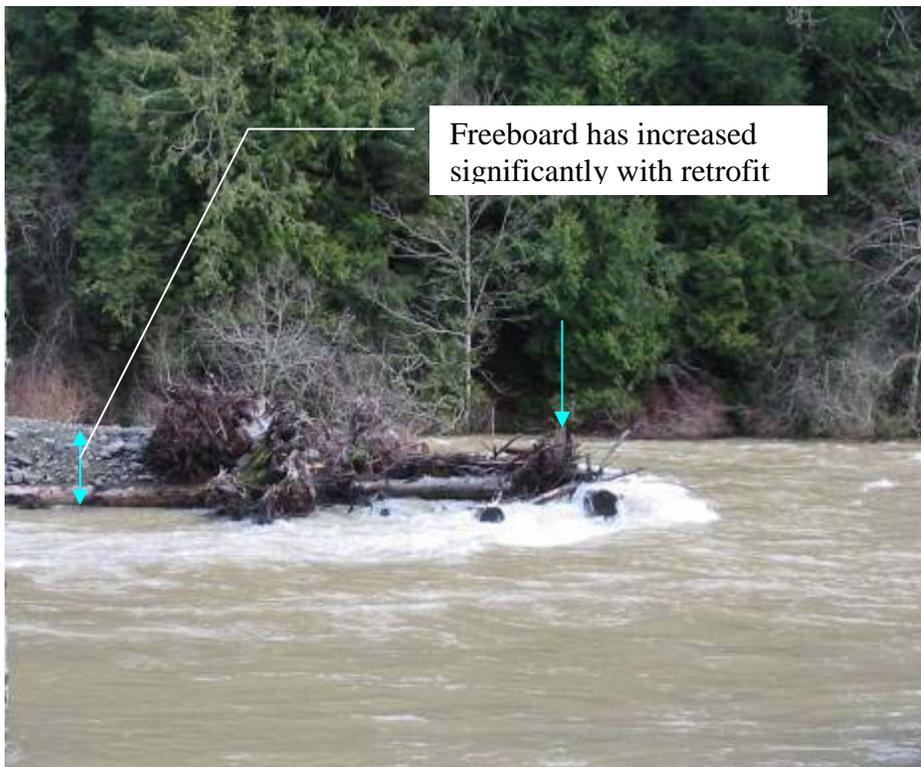
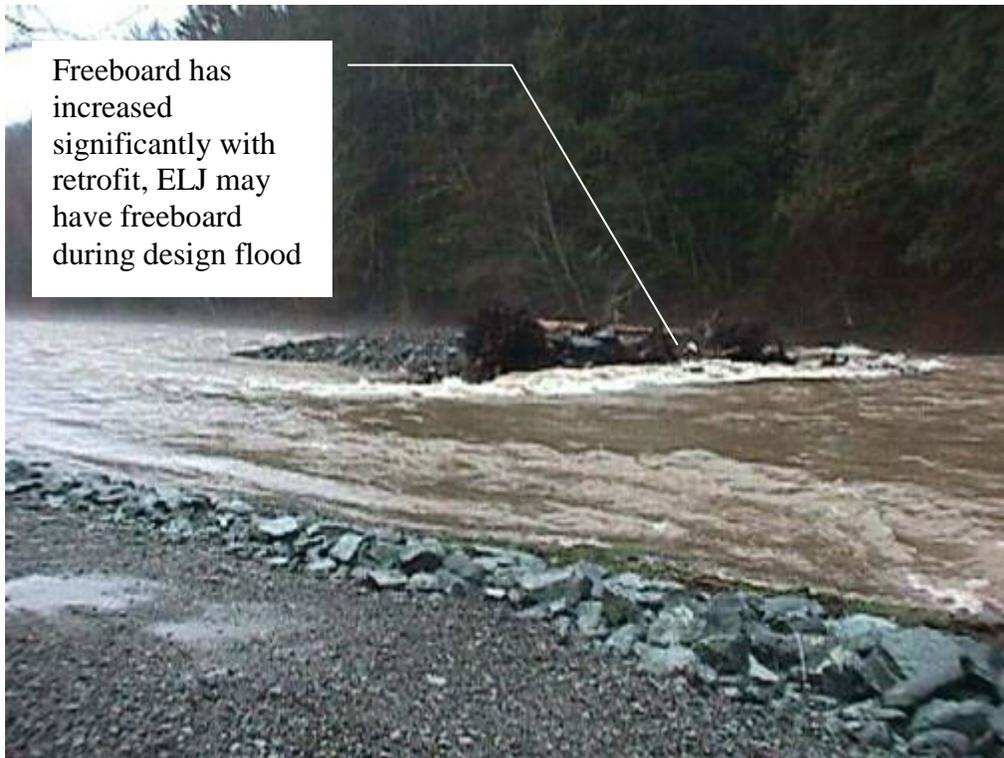
WY 2005 high flow monitoring indicates that ELJ 2 has benefited from the 2004 retrofit. The freeboard appears to have increased dramatically (Figures 33-34, 37). Few signs of ballast or log instability were observed. The freeboard appears to be about even with the design freeboard, and overtopping is not anticipated at or below the design flood event.

Figure 33. ELJ 2 Jan 30, 2004 4,815 cfs

Figure 34. ELJ 2, 20 Jan 2005 5,200 cfs (after retrofit)

Figure 37. ELJ 2, 18 Jan 2005 6,450 cfs, 3 hr after peak of 6,770 cfs

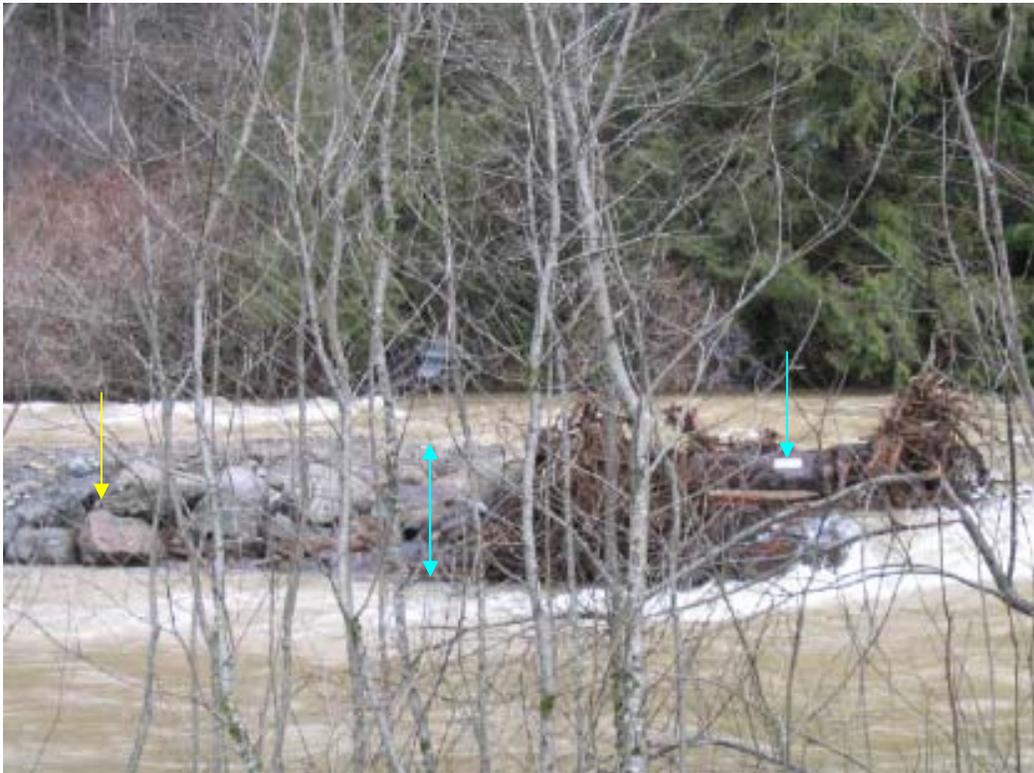
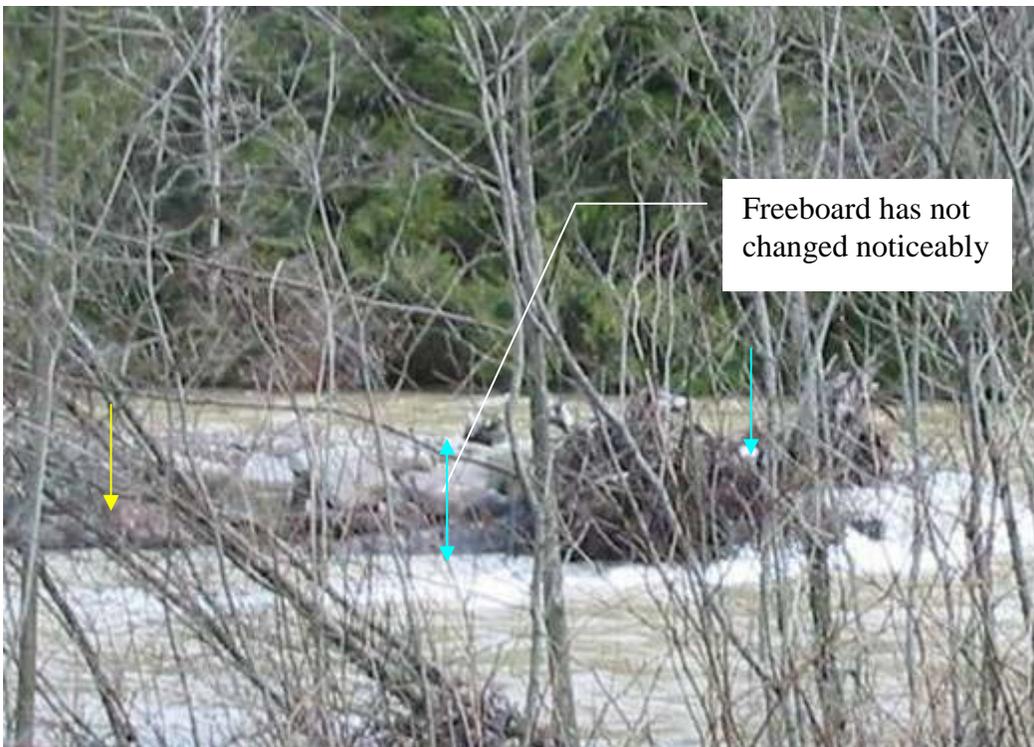
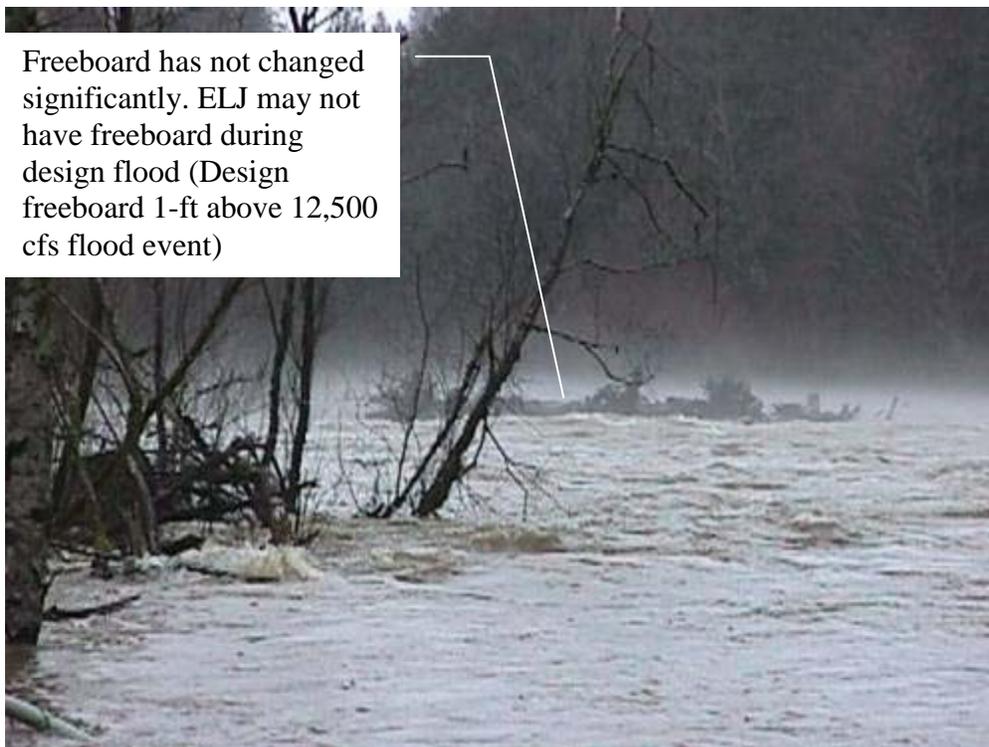
WY 2005 high flow monitoring indicates that ELJ 1 continues to maintain its freeboard despite bed aggradation experienced upstream and downstream of the ELJ (Figures 35-36, 38). The freeboard appears to be less than the design freeboard, and overtopping is anticipated at or below the design flood event. Since the ELJ is designed to resist flotation, failure would not be a concern unless there was dramatic loss of ballast material. Ballast and wood loss will be monitored to see if retrofit of ELJ 1 will be necessary in the future.

Figure 35. ELJ 1 Jan 30, 2004 4,815 cfs

Figure 36. ELJ 1, 20 Jan 2005 5,200 cfs

Figure 38. ELJ 1, 18 Jan 2005 6,450 cfs, 3 hr after peak of 6,770 cfs
