**Water Year 2005 Monitoring Report  
Howard Hanson Dam Additional Water Storage Project  
Zone 1 Fish Habitat Restoration Project  
Green River, Washington**

**Howard Hanson Dam  
Additional Water Storage Project  
Zone 1 Fish Habitat Restoration Project**

**Water Year 2005 Monitoring Report**

**Prepared By:  
U.S. Army Corps of Engineers and  
R2 Resource Consultants, Inc.**

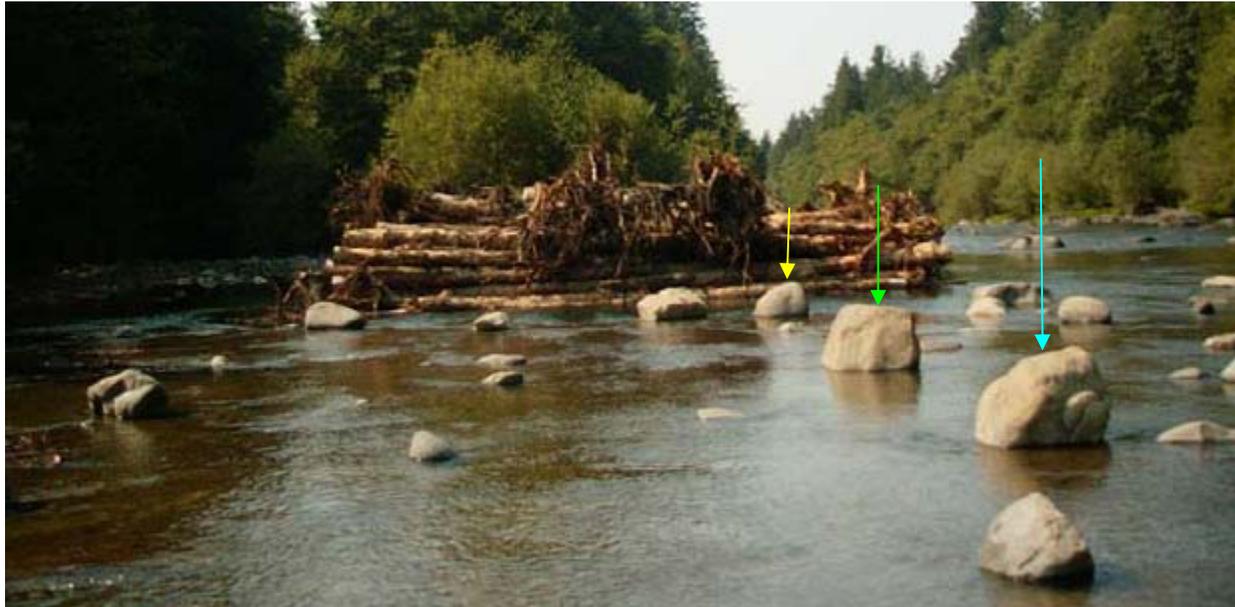
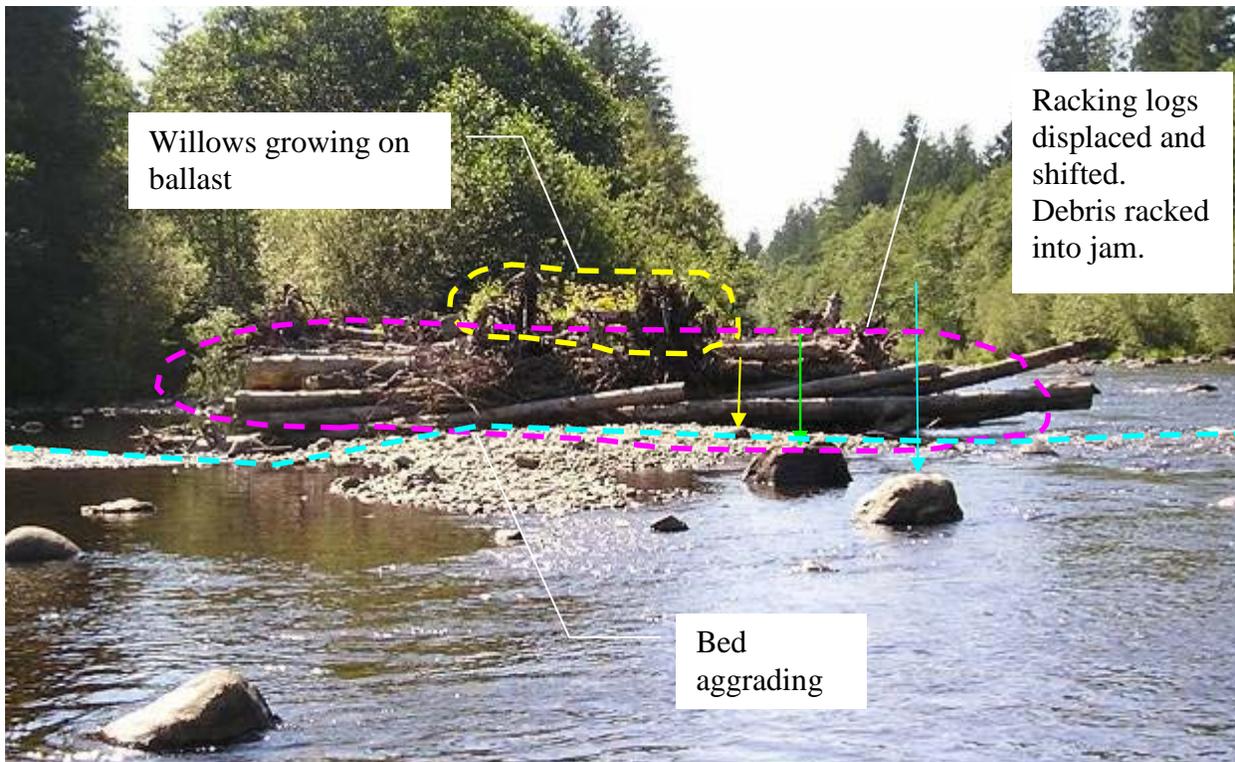
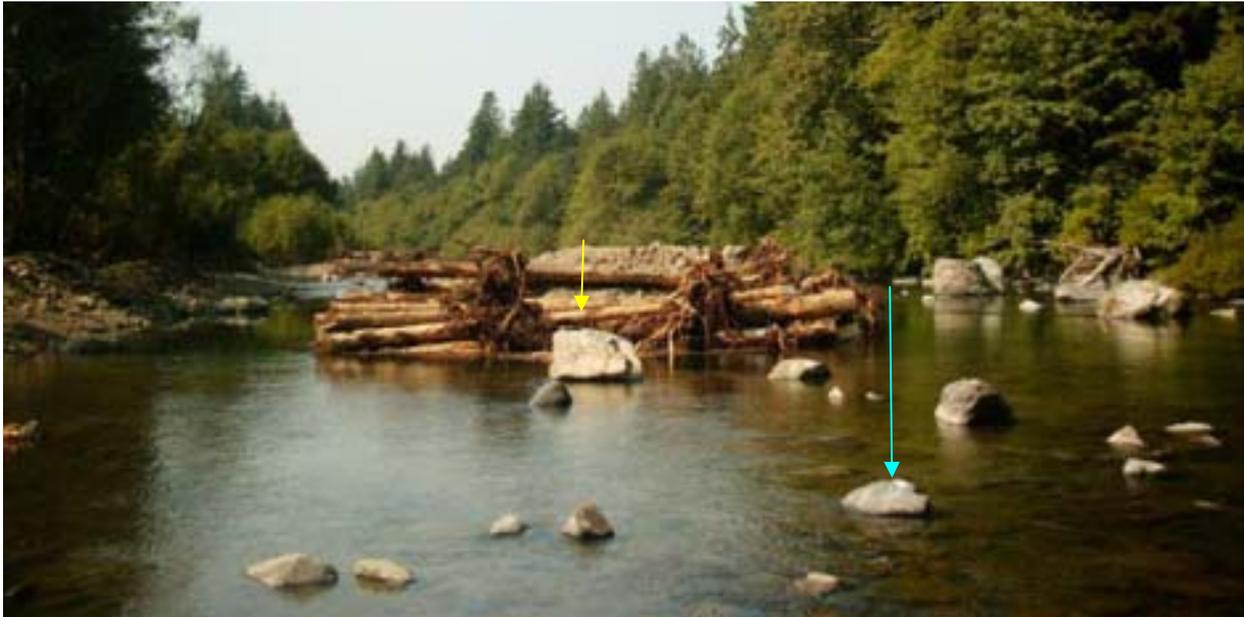
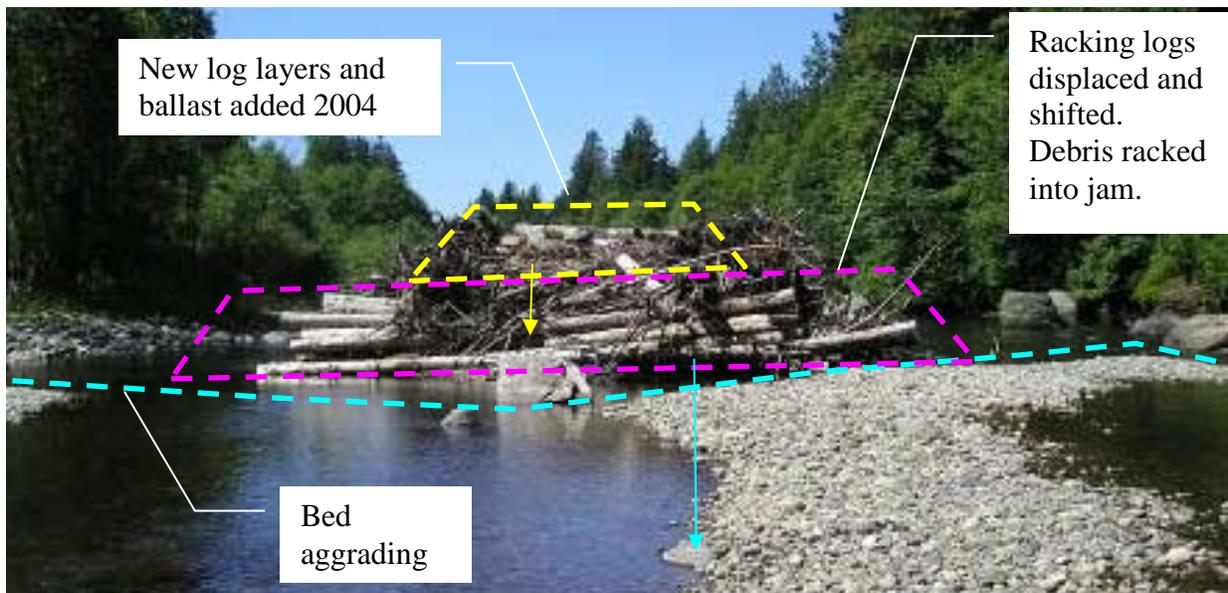
No significant change in the wood loss or accumulation has been observed since construction, as seen in Figures 39-42, although several racking logs that were placed on the front of the log jams have been repositioned by two years of high flow events. In 2004, some of the racking pieces were found downstream; two were found racked into an existing wood jam in Kanaskat Palmer state park, and one was found near KP 8 in a side channel, racked into an existing logjam. No new logs were found downstream of the ELJs in WY 2005, although the racking wood has continued to shift noticeably since WY 2004. ELJ stability is not at risk from loss of racking members, although ongoing loss of racking members could be indicative of conditions that over time may result in loss of structural stability through erosion of ballast material or structural members.

Figure 39. ELJ 1 September 3, 2003

Figure 40. ELJ 1 July 25, 2005

Figure 41. ELJ 2 September 3, 2003

Figure 42. ELJ 2 July 25, 2005

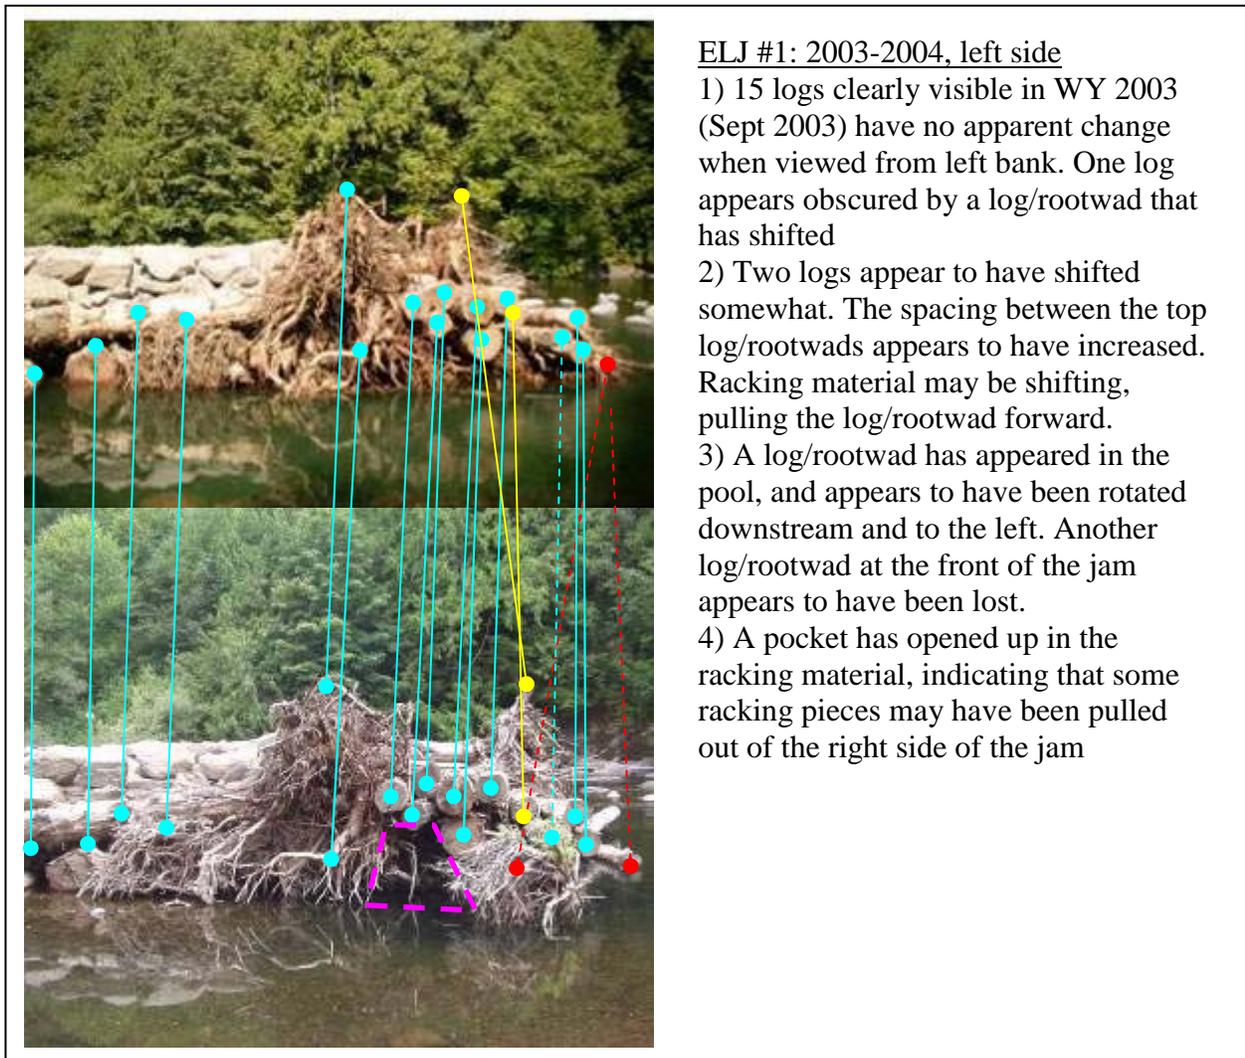
Figure 43. ELJ 1 Log Position Changes, WY 2003-2004

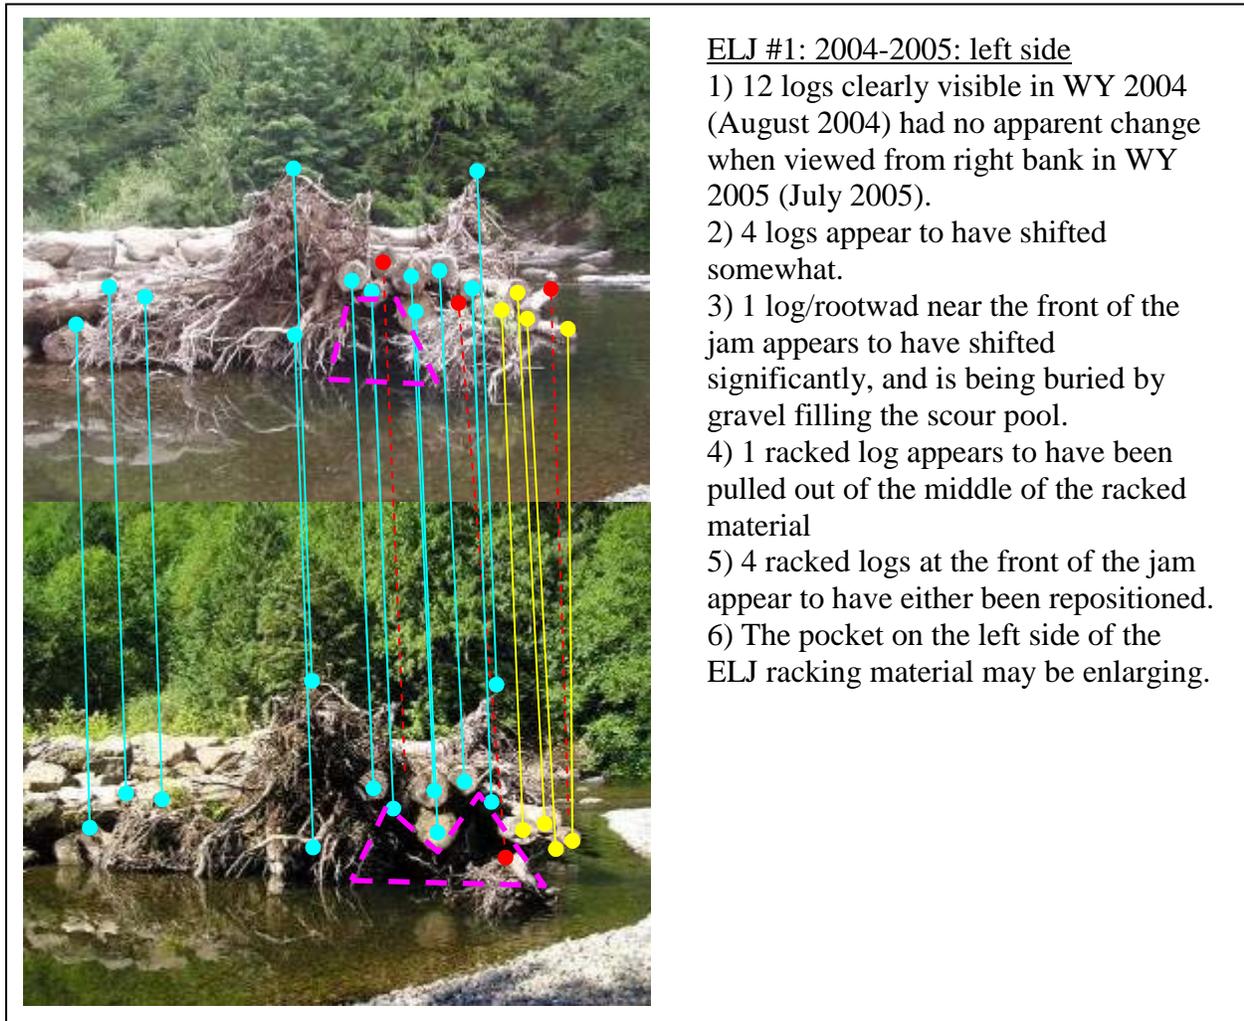
Figure 44. ELJ 1 Log Position Changes, WY 2004-2005

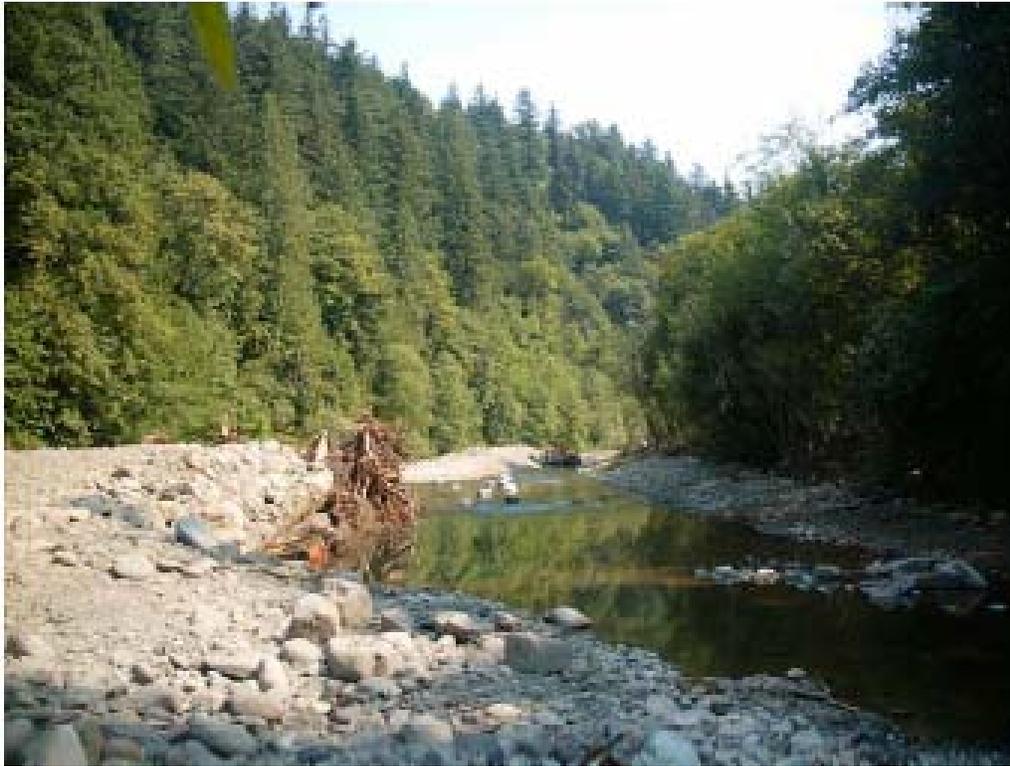
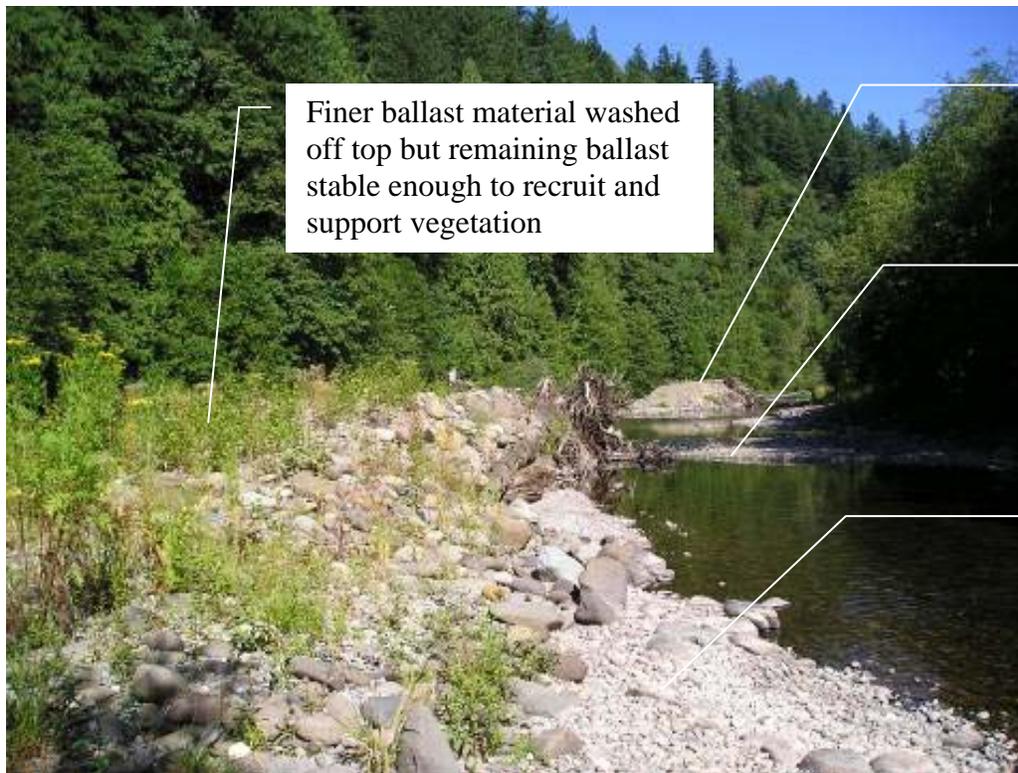
No unacceptable losses of ballast were observed in WY 2005, despite the relatively steep side slopes (> 1.5H:1V) of the ballast retrofit at ELJ 2 (Figures 49-50). ELJ 1 has experienced some noticeable coarsening of the surface ballast material, but no indications of significant ballast loss have been observed to date. Vegetation, including willow and alder seedlings, is beginning to colonize the entire backside of ELJ 1 despite the ballast being noticeably lower than designed. Additional detail regarding the design analysis for the 2004 retrofit construction can be found in the 2004 retrofit design memorandum (USACE 2004b).

Figure 49. September 3, 2003, Post Construction, Ballast for ELJ 1, left side

Figure 50. July 25, 2005 Ballast for ELJ 1, left side

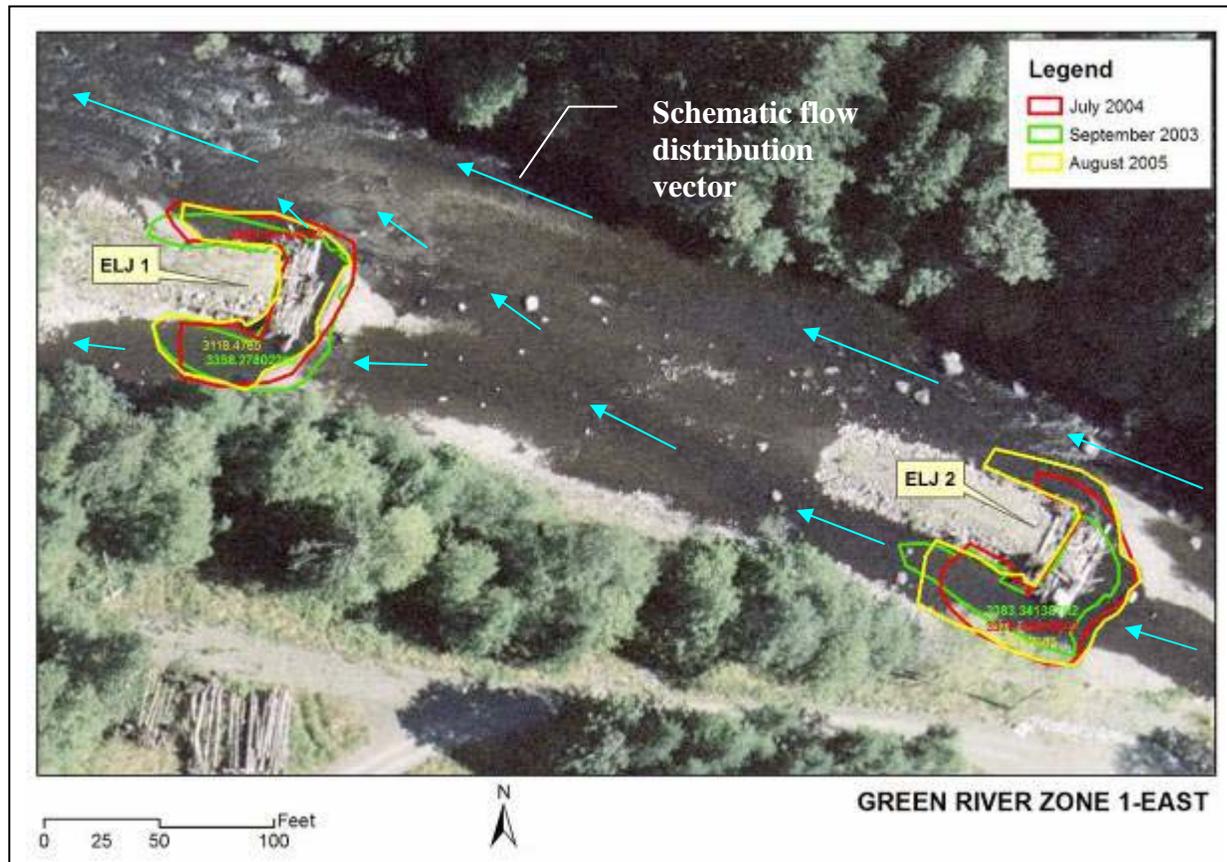
Based on high flow site visits in October 2003 and January 2004, the river appeared to have more flow in the side channel relative to the baseline condition. During the January 2004 high flow event (6,010 cfs), an estimate was made based on site observations of the flow distribution around the log jams. It was estimated that at the upper end flow is about 60-70% to the right of ELJ 2, and 30-40% to the left. Between the ELJs, about 10-15% of the flow returns to the right main channel. About 25% of the flow enters the side channel, and 75% remains in the main channel. On January 20, 2005, USACE estimated that the flow distribution around ELJ 2 was 50% left and 50% right of the jam. Flow left of the jam expanded downstream of the ELJ 2 ballast returning to the main channel upstream of ELJ 1. At ELJ 1, 25-40% of flow was left of the jam and the remainder was to the right of the jam. Some portion of the flow was returning to the main channel through the raked material on the front of the jam. Compared to the 2004 high flow monitoring, it is possible that flow into the side channel is increasing.

Figure 51. Scour hole development and flow distribution at ELJs (August 2005 aerial imagery)
