DRAFT FINAL SITE INSPECTION REPORT
Camp Abbot Volume 1 - DATA REPORT
Deschutes County, OR
FUDS PROPERTY No. F10OR0041

Site Inspections at Multiple Sites, NWO Region
Formerly Used Defense Sites
Military Munitions Response Program

March 30, 2007

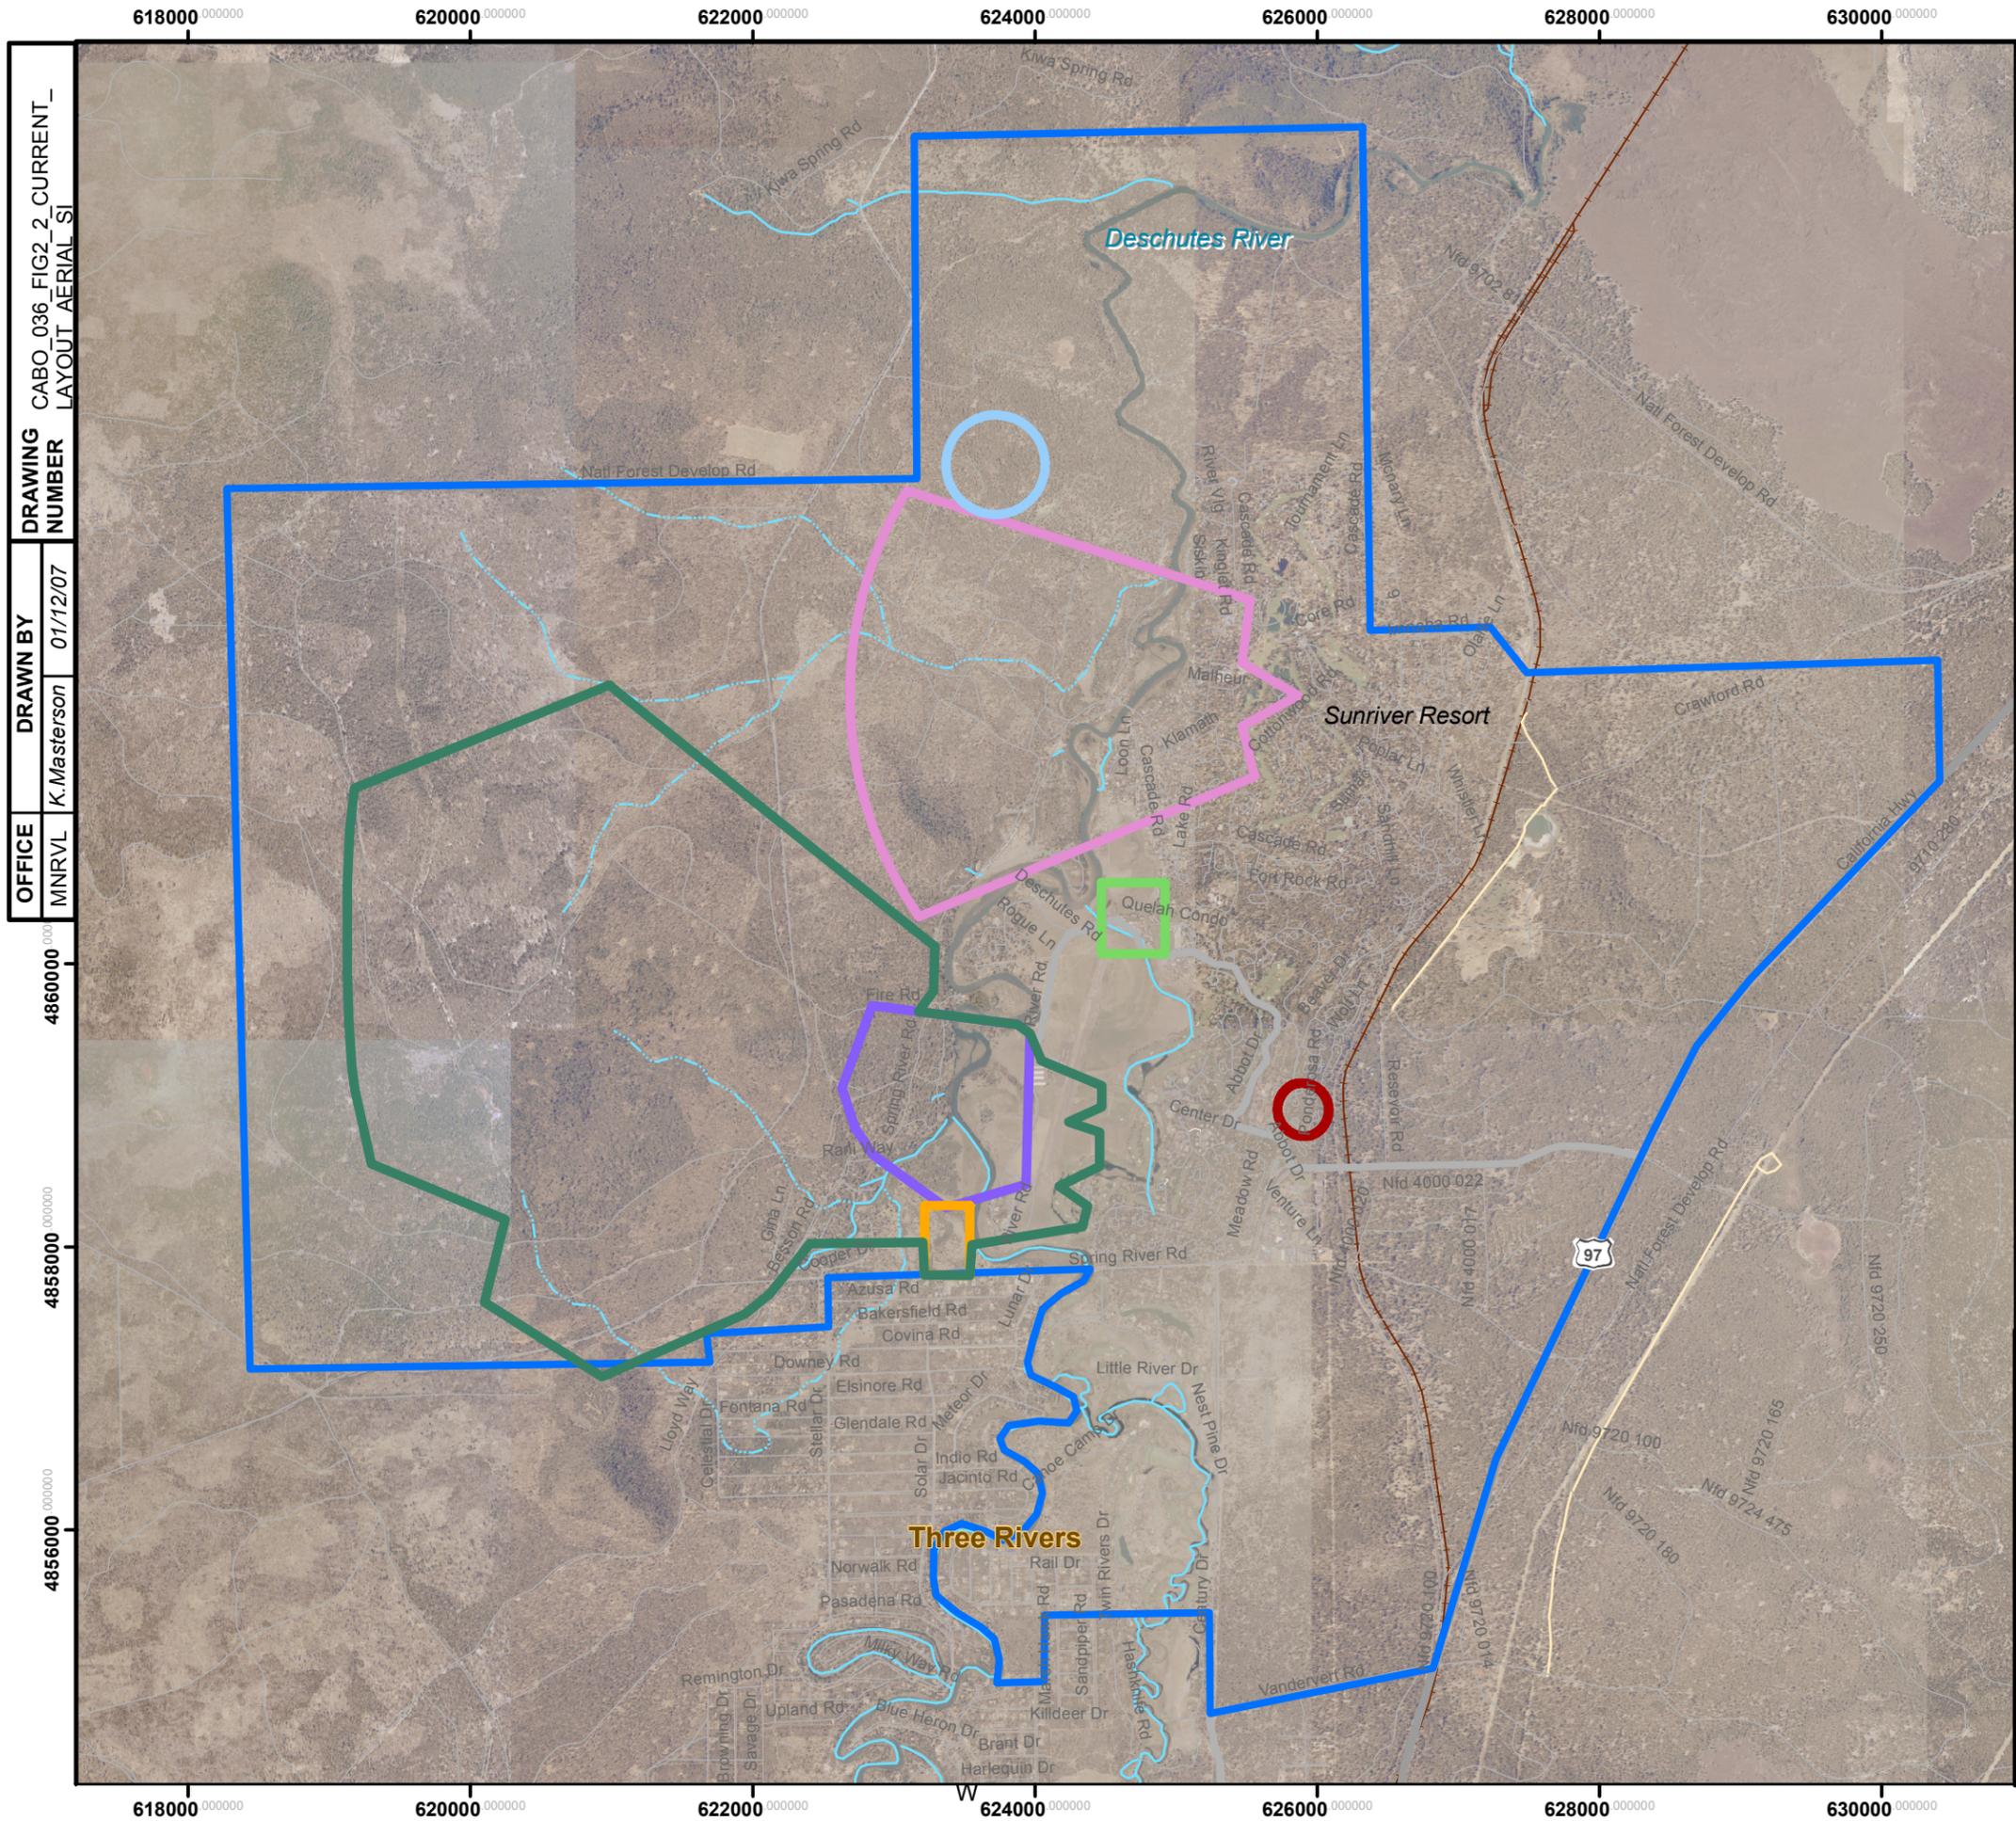
FIGURE 2-2
CURRENT AERIAL PHOTOGRAPH
 CAMP ABBOT

NOTES:
 1) Aerial photo was obtained from the U.S. Department of Agriculture, Service Center Agencies; photo is from the USDA-AFPO National Agricultural Inventory Project (NAIP), 2003.

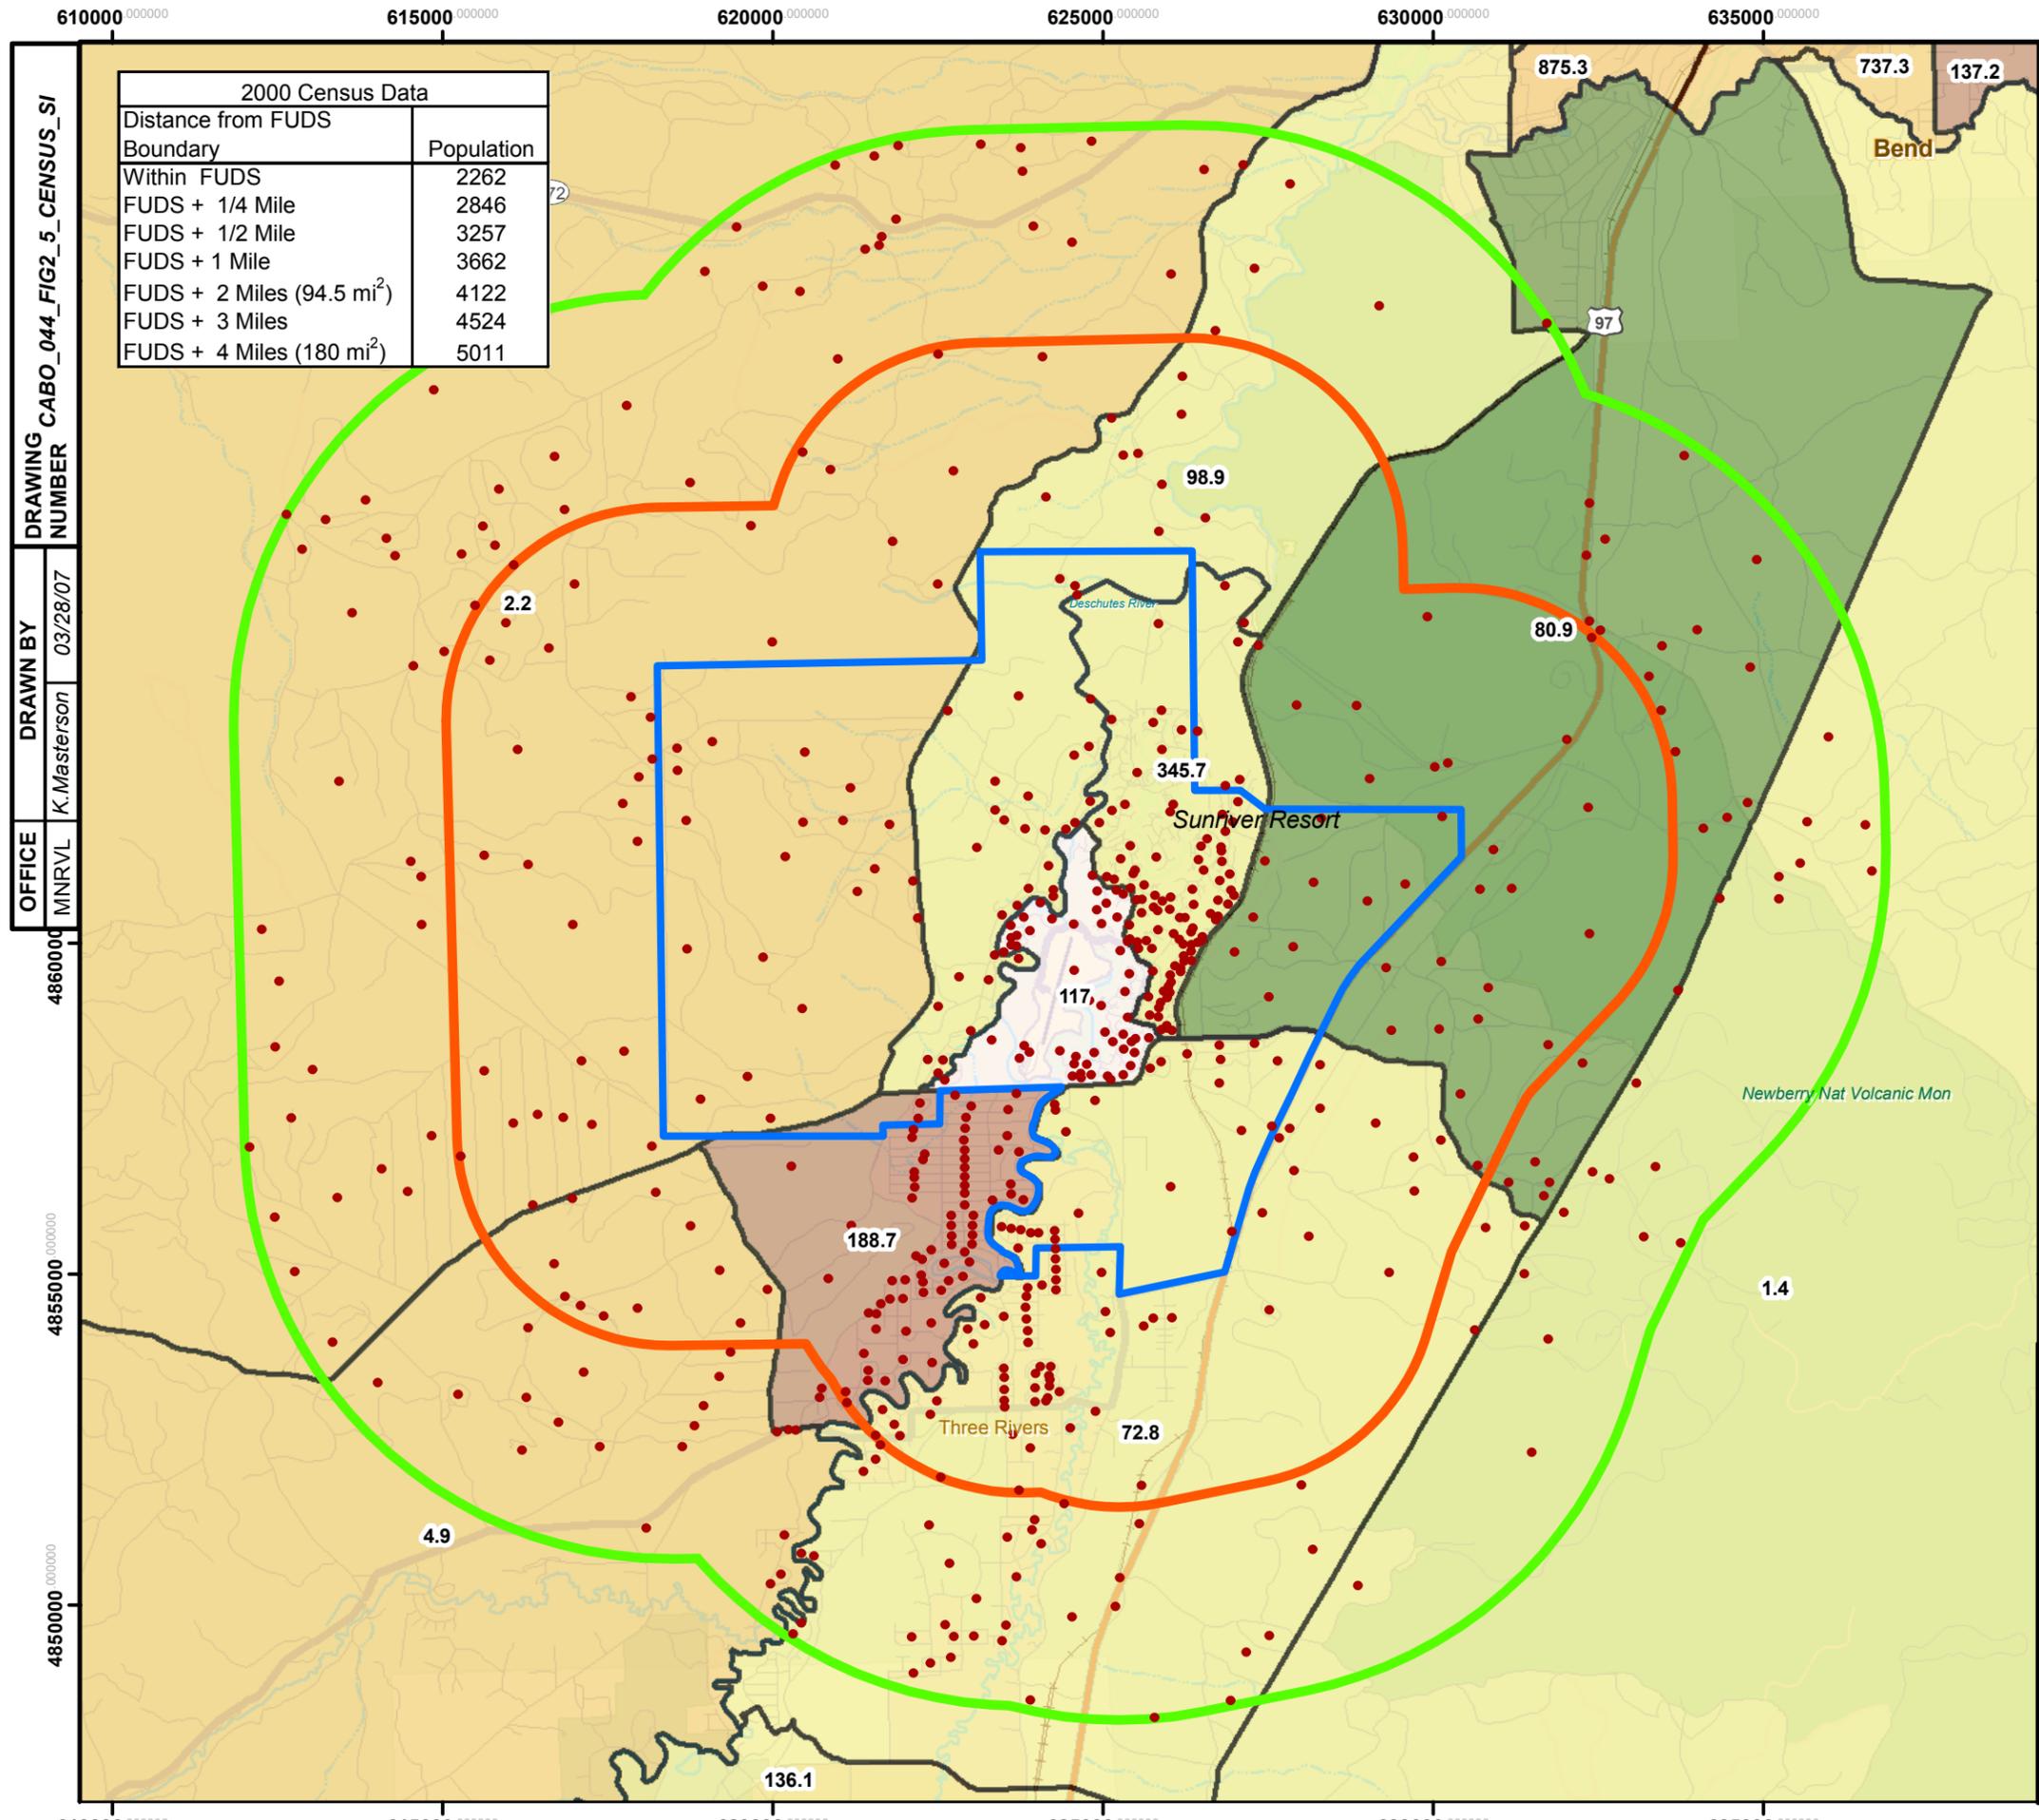
FIGURE 2-5
CENSUS DATA
WITHIN A 2-MILE AND 4-MILE RADIUS OF
THE FUDS BOUNDARY
 CAMP ABBOT

2000 Census Data	
Distance from FUDS Boundary	Population
Within FUDS	2262
FUDS + 1/4 Mile	2846
FUDS + 1/2 Mile	3257
FUDS + 1 Mile	3662
FUDS + 2 Miles (94.5 mi ²)	4122
FUDS + 3 Miles	4524
FUDS + 4 Miles (180 mi ²)	5011

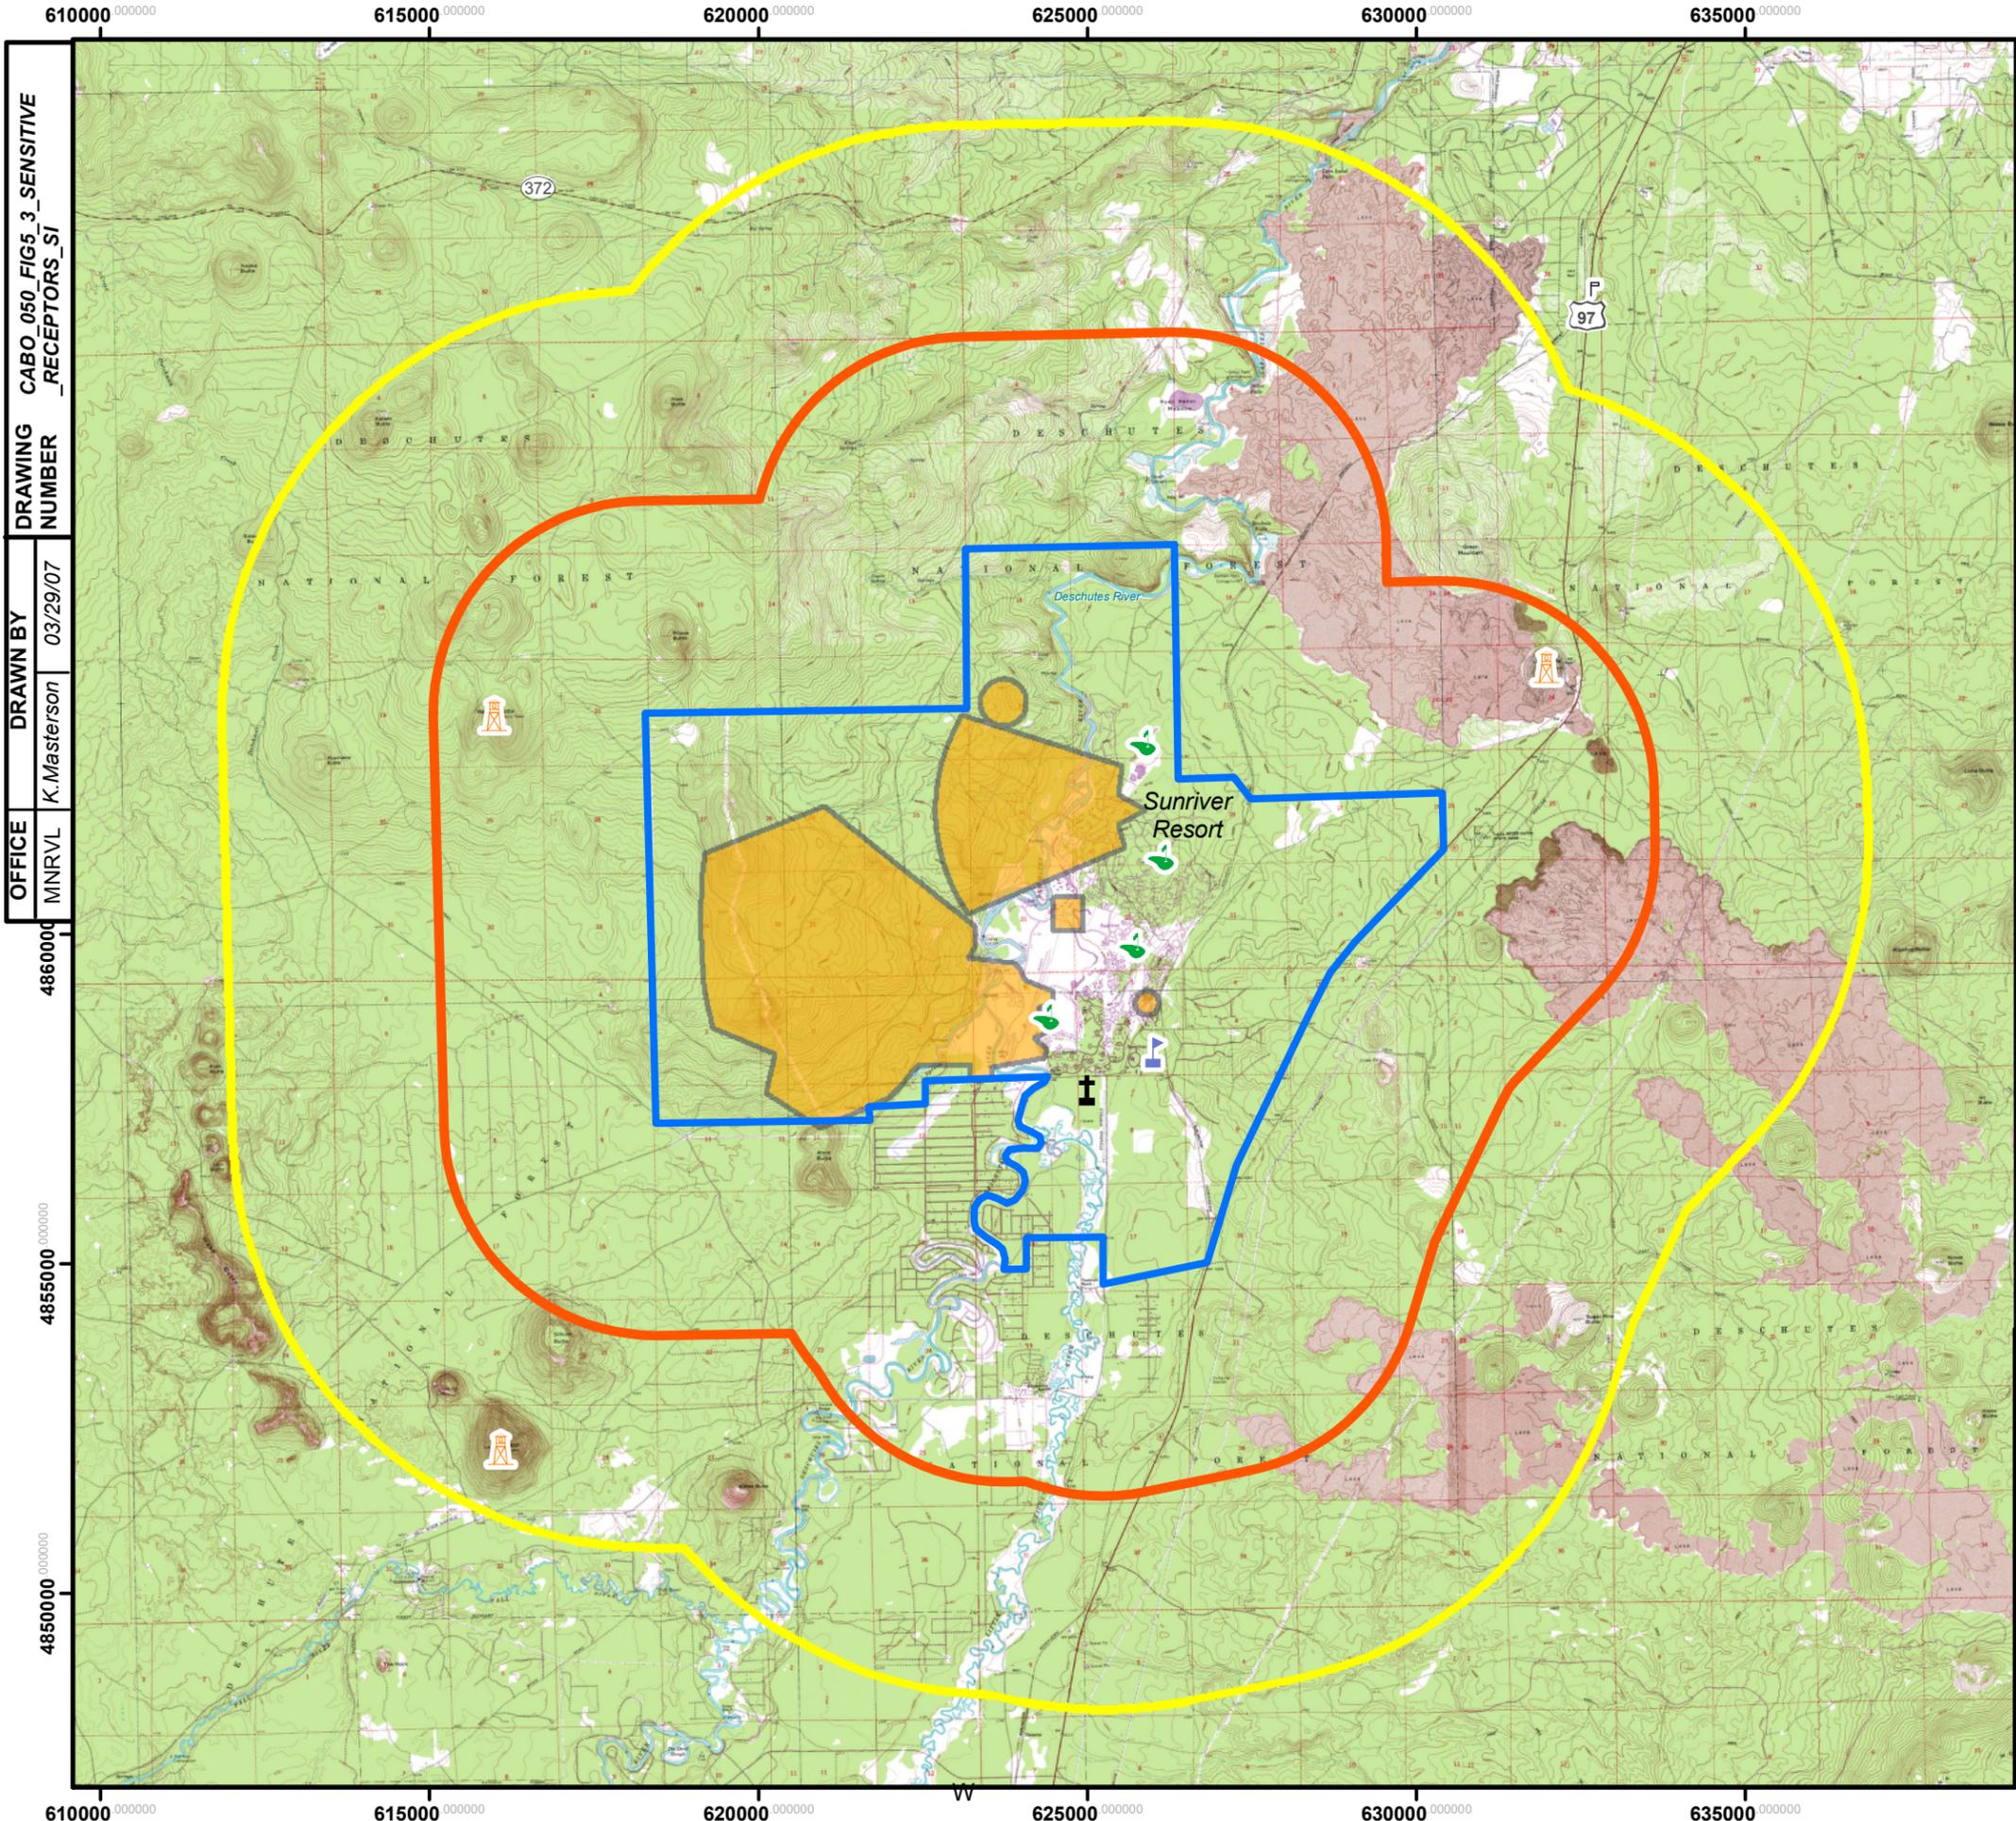
FIGURE 5-3
SENSITIVE RECEPTORS
WITHIN A 2-MILE AND 4-MILE RADIUS
OF THE FUDS BOUNDARY
 CAMP ABBOT

- Camp Abbot FUDS Boundary
- 2-Mile Radius from Camp Abbot FUDS Boundary
- 4-Mile Radius from Camp Abbot FUDS Boundary
- Golf Course
- Lookout Tower
- Harper Cemetery
- School

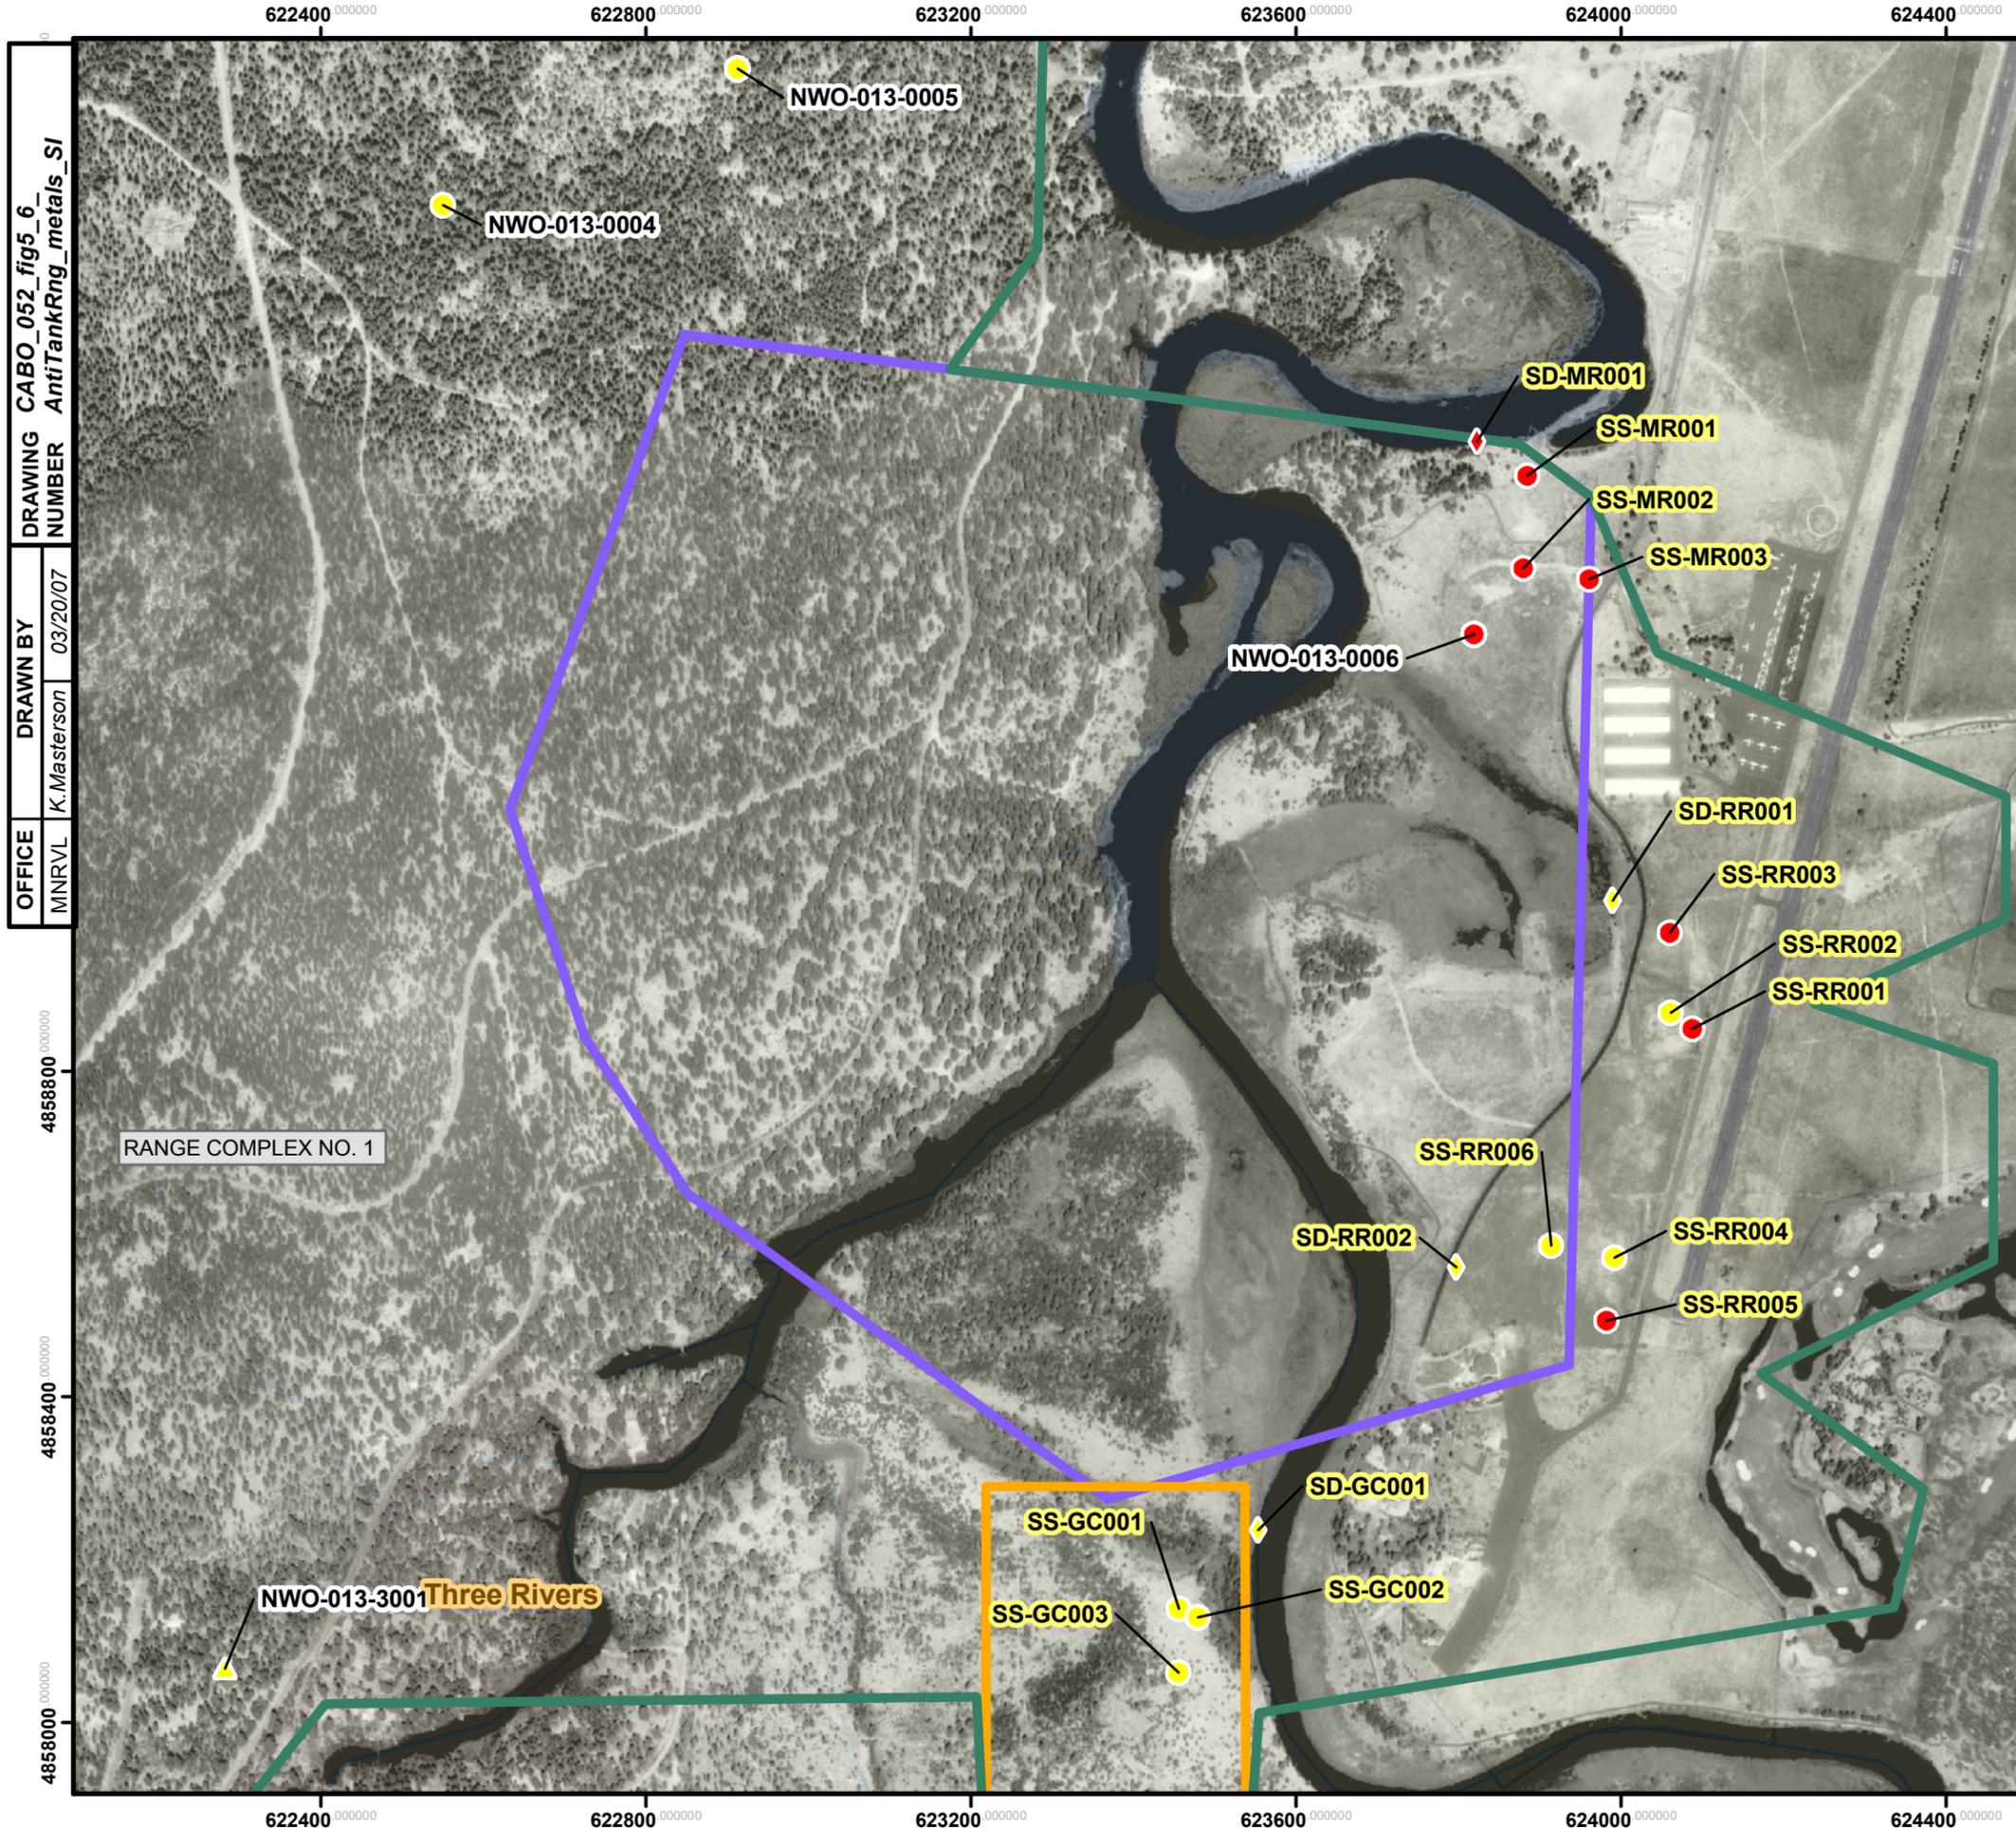
FIGURE 5-6
METALS RESULTS
ANTI-TANK RANGE
 CAMP ABBOT

66 Based on historical evidence and results of the SI field activities, there is evidence of MEC,
67 munitions debris, and use of explosives occurring within the Anti-Tank Range, the Mortar
68 Range, and the Demolition Area. Based on the historical occurrence of MEC, the Anti-Tank Range,
69 the Mortar Range, and the Demolition Area are recommended for RI/FS.

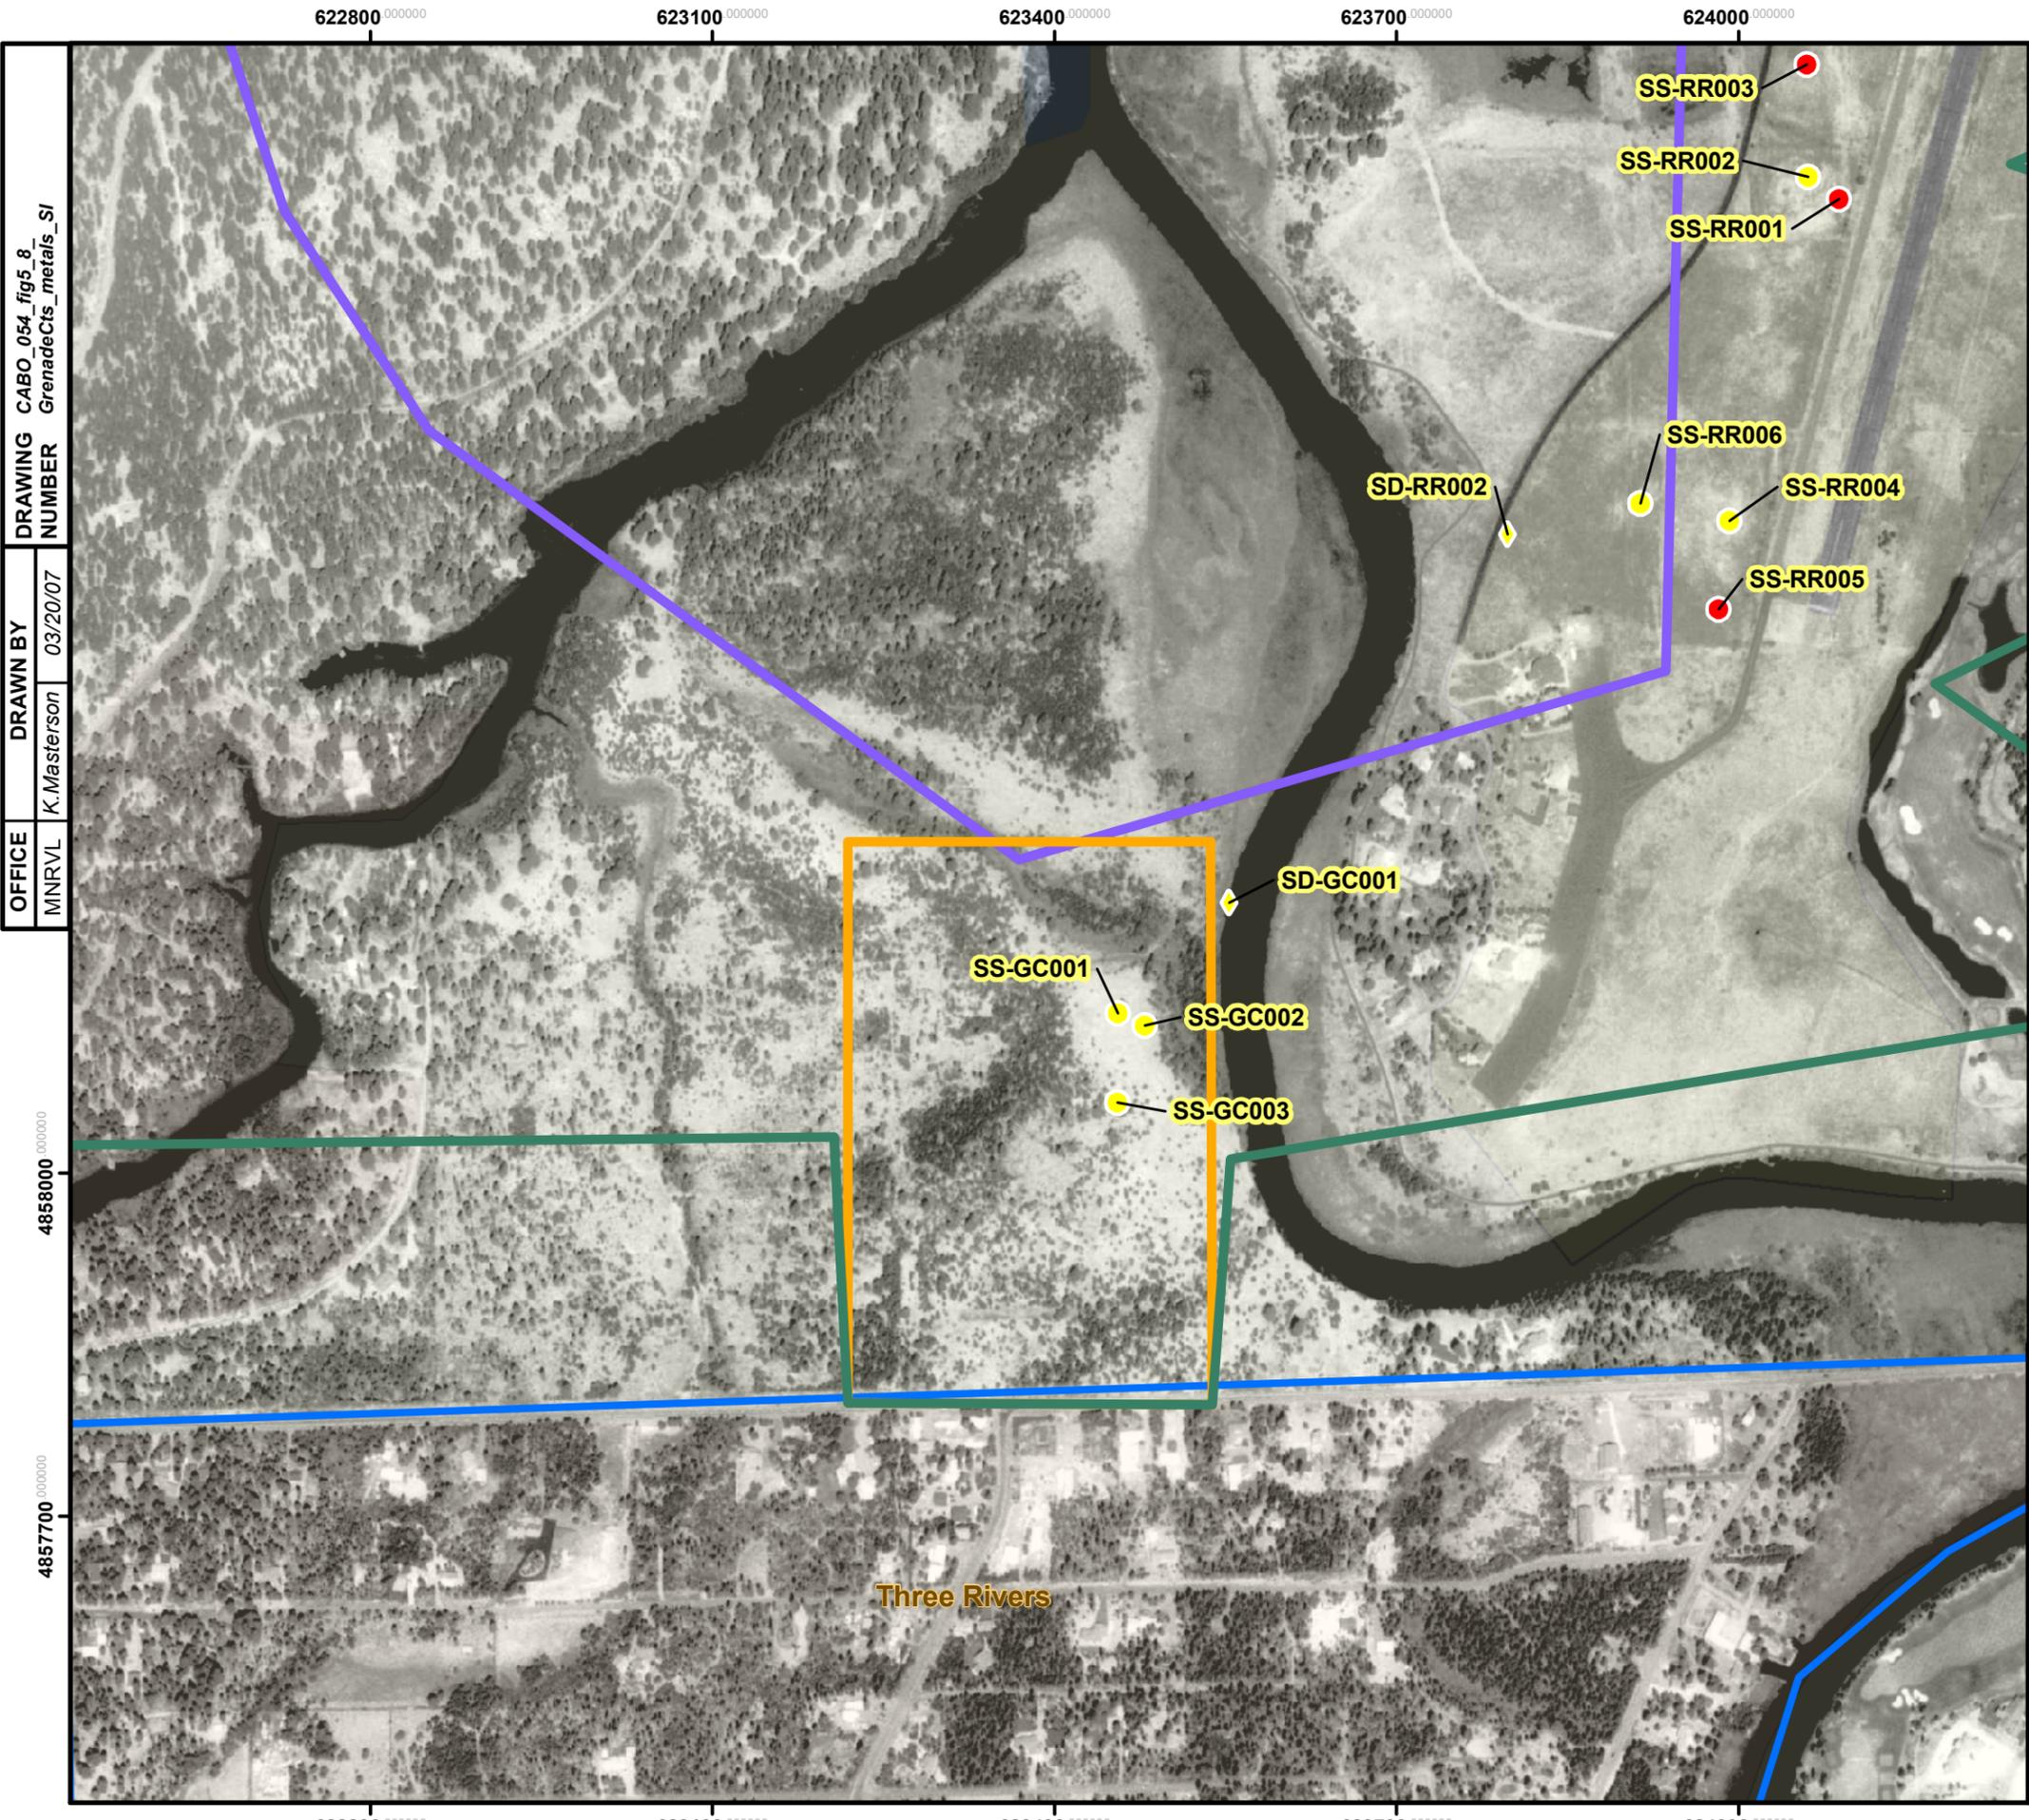
FIGURE 5-8
METALS RESULTS
GRENADA COURTS
CAMP ABBOT

85 Historically, no MEC or munitions debris, other than a grenade spoon and expended lead bullets,
86 have been found at the Grenade Courts. Based on the types of MEC that may be present and the
87 limited investigation that has been conducted, the overall MEC risk is considered to be moderate
88 and the Grenade Courts area is recommended for RI/FS.
