FINAL SITE INSPECTION REPORT

Camp Abbot

FUDS Property No. F10OR0041

Site Inspections at Multiple Sites, NWO Region
Formerly Used Defense Sites
Military Munitions Response Program

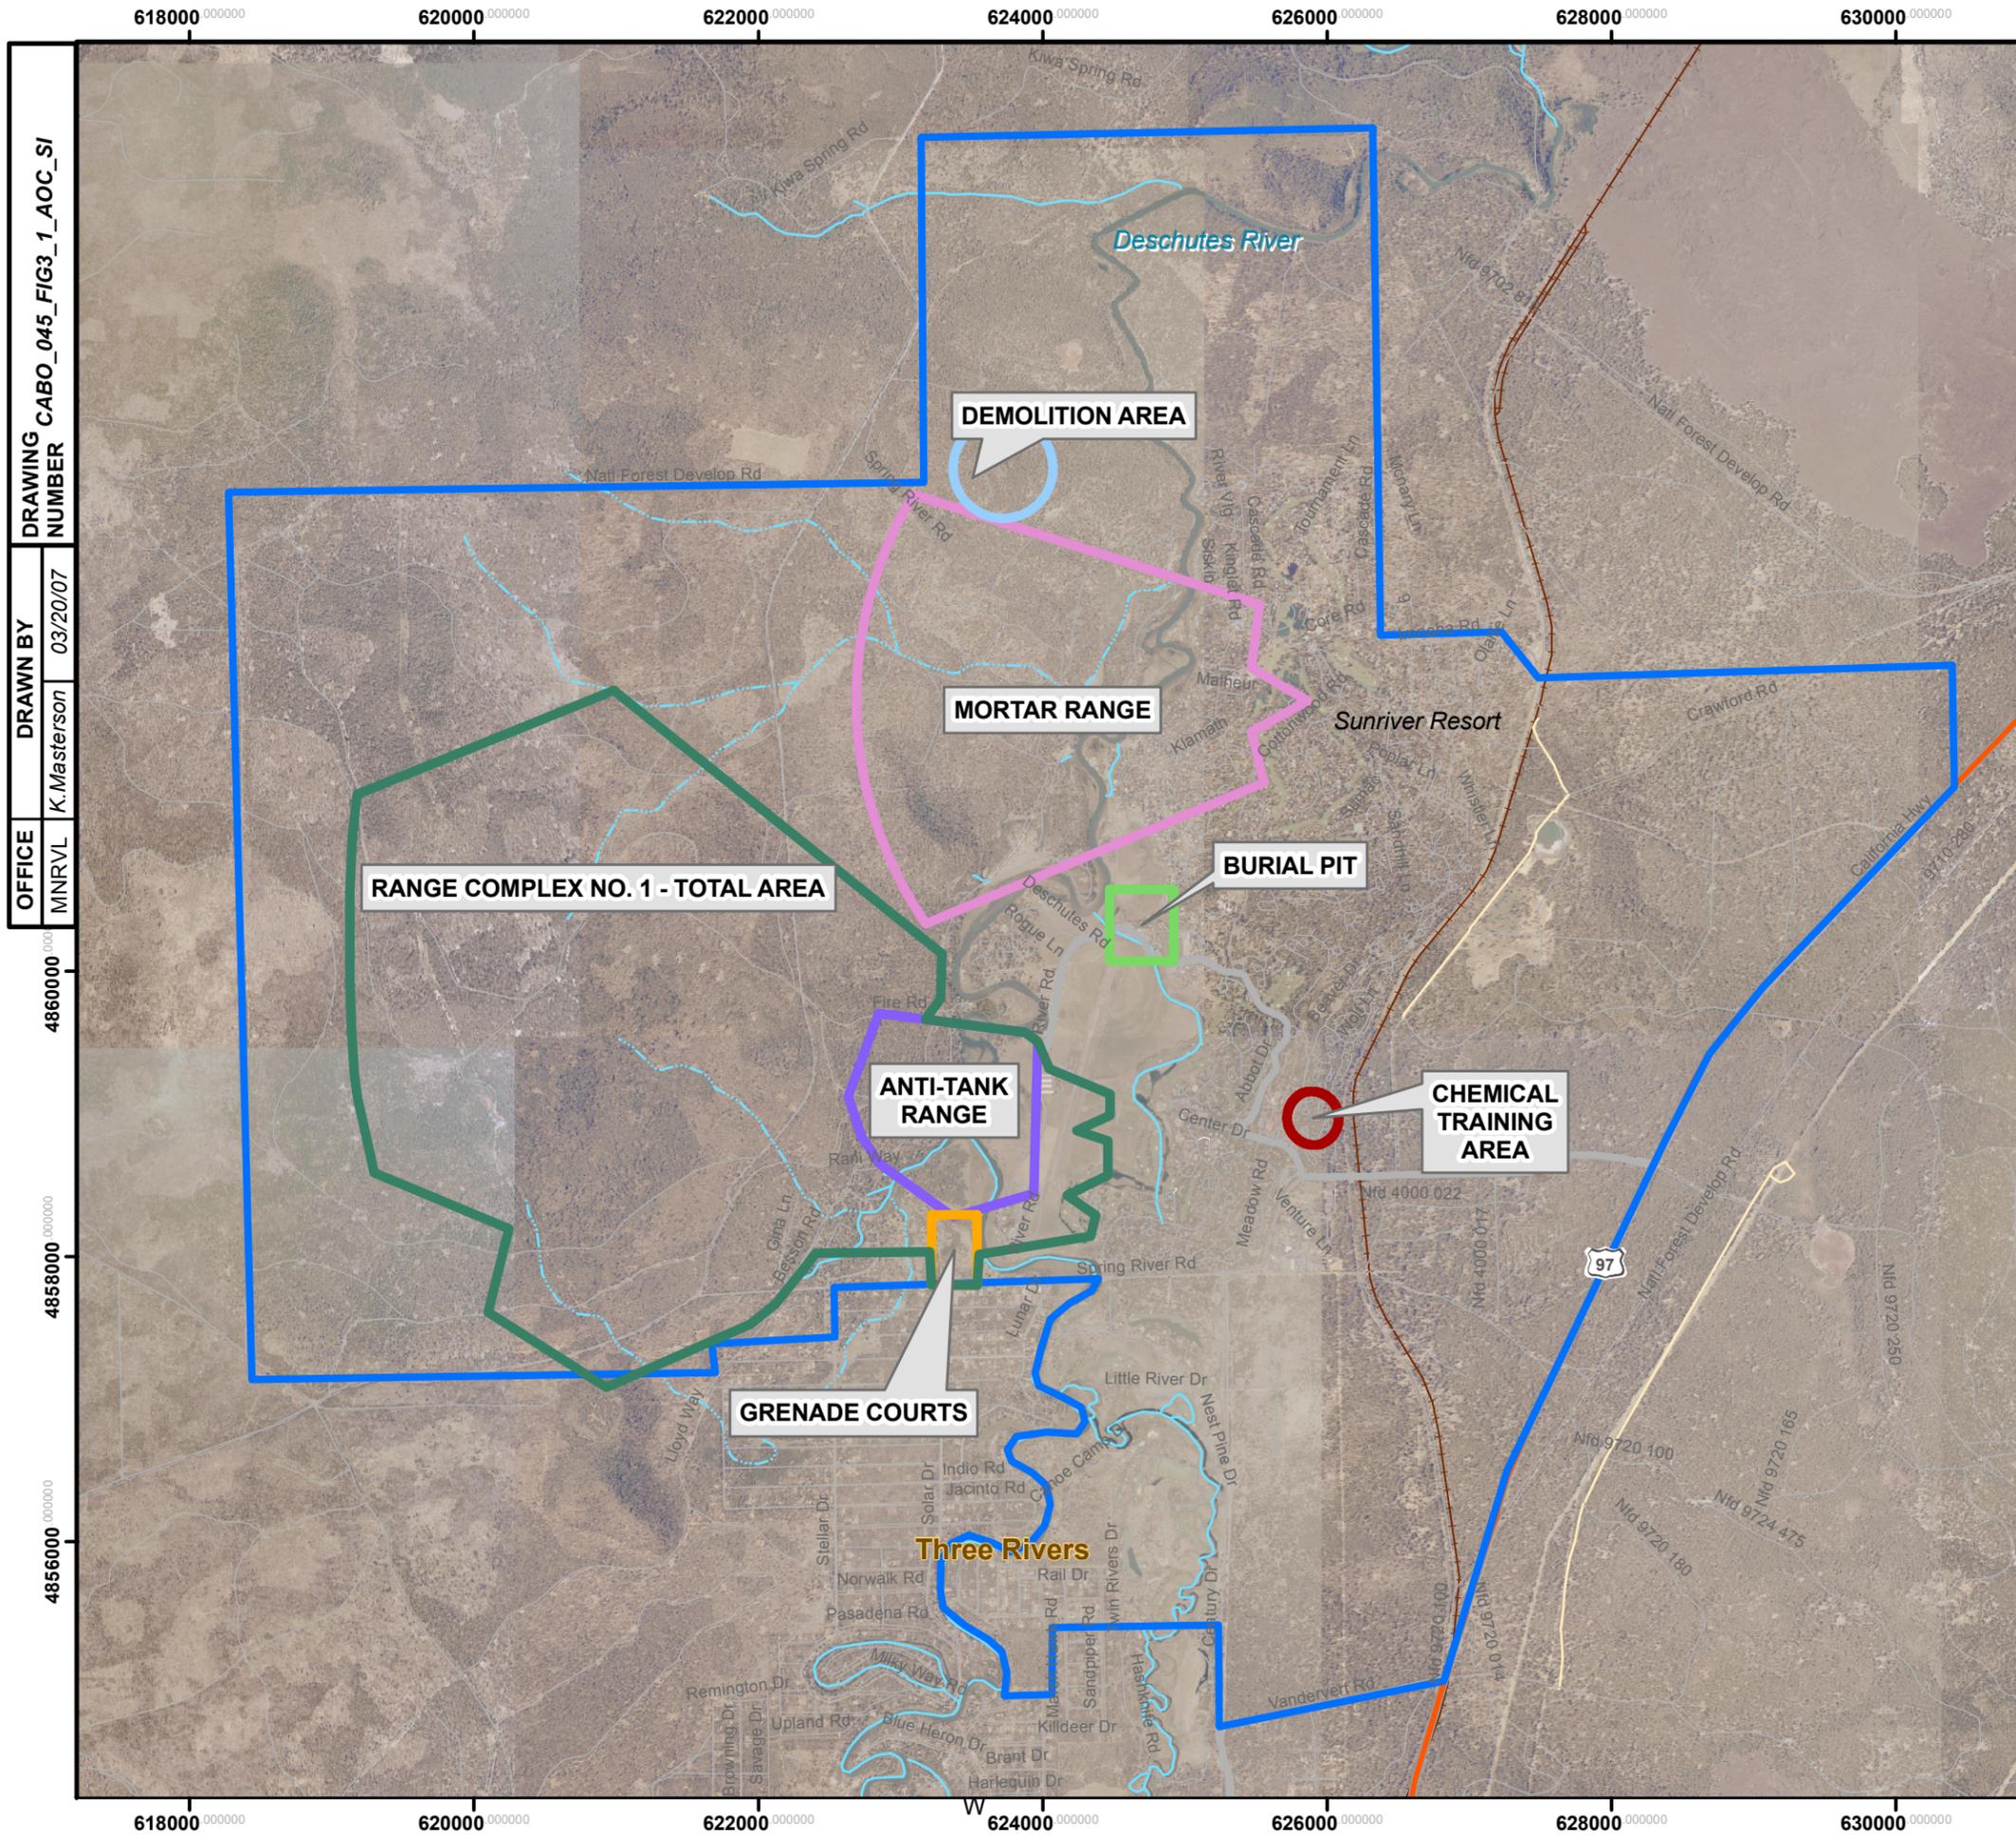
FIGURE 3-1
AREAS OF CONCERN
 CAMP ABBOT

352 The USACE completed an ASR Supplement in 2004, which identified Range Complex No. 1,
353 Mortar Range, Demolition Area, Anti-Tank Range, Grenade Courts, Burial Pit, and Chemical
354 Training Area as AOCs. A risk assessment was completed on the explosives safety hazard
355 related to munitions. The risk assessment did not address the environmental hazards associated
356 with munitions constituents. The Risk Assessment Code (RAC) score was assigned to each
357 AOC. Possible scores range from high (1) to low (5). All AOCs received a score of 1 (high risk)
358 except for Range Complex No. 1, which received a score of 5.

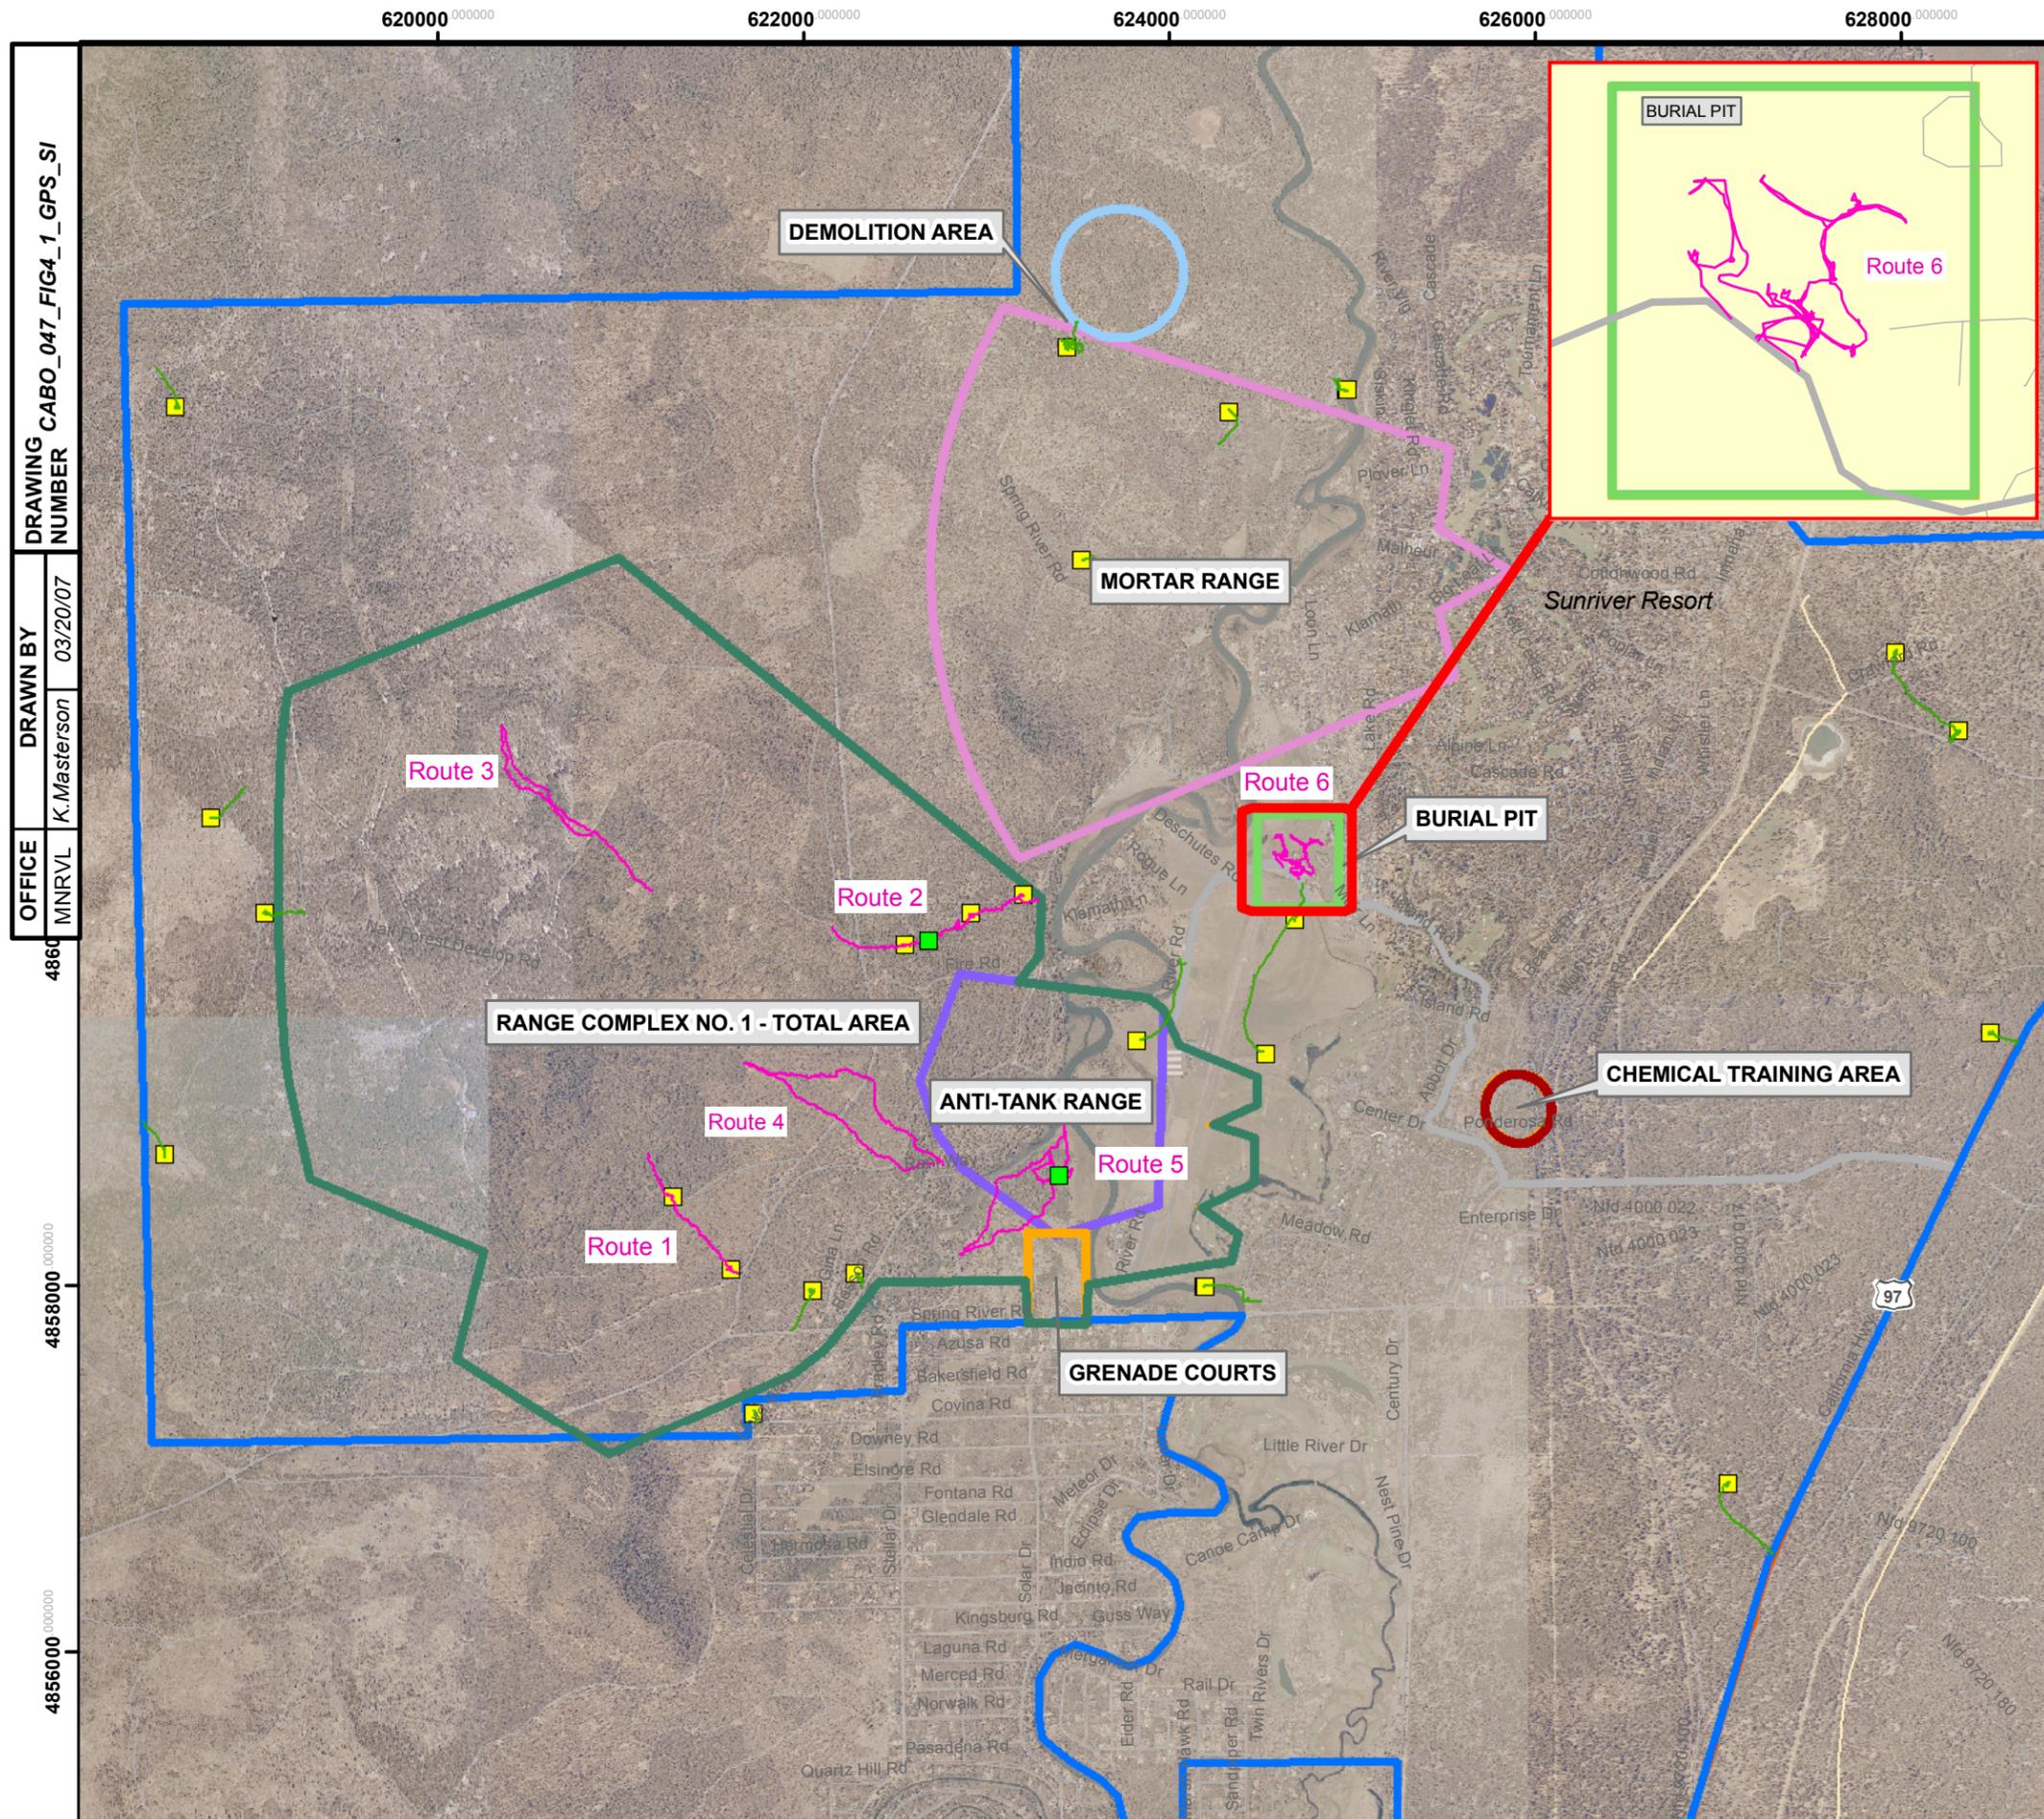
FIGURE 4-1
VISUAL RECONNAISSANCE PATHS
 CAMP ABBOT

- Camp Abbot Property Boundary
- Anti-Tank Range AOC Boundary
- Burial Pit AOC Boundary
- Chemical Training Area AOC Boundary
- Demolition Area AOC Boundary
- Grenade Courts AOC Boundary
- Mortar Range AOC Boundary
- Range Complex No. 1 AOC Boundary
- Field Sample
- Subsurface Anomaly
- Reconnaissance Path
- MEC Avoidance Path

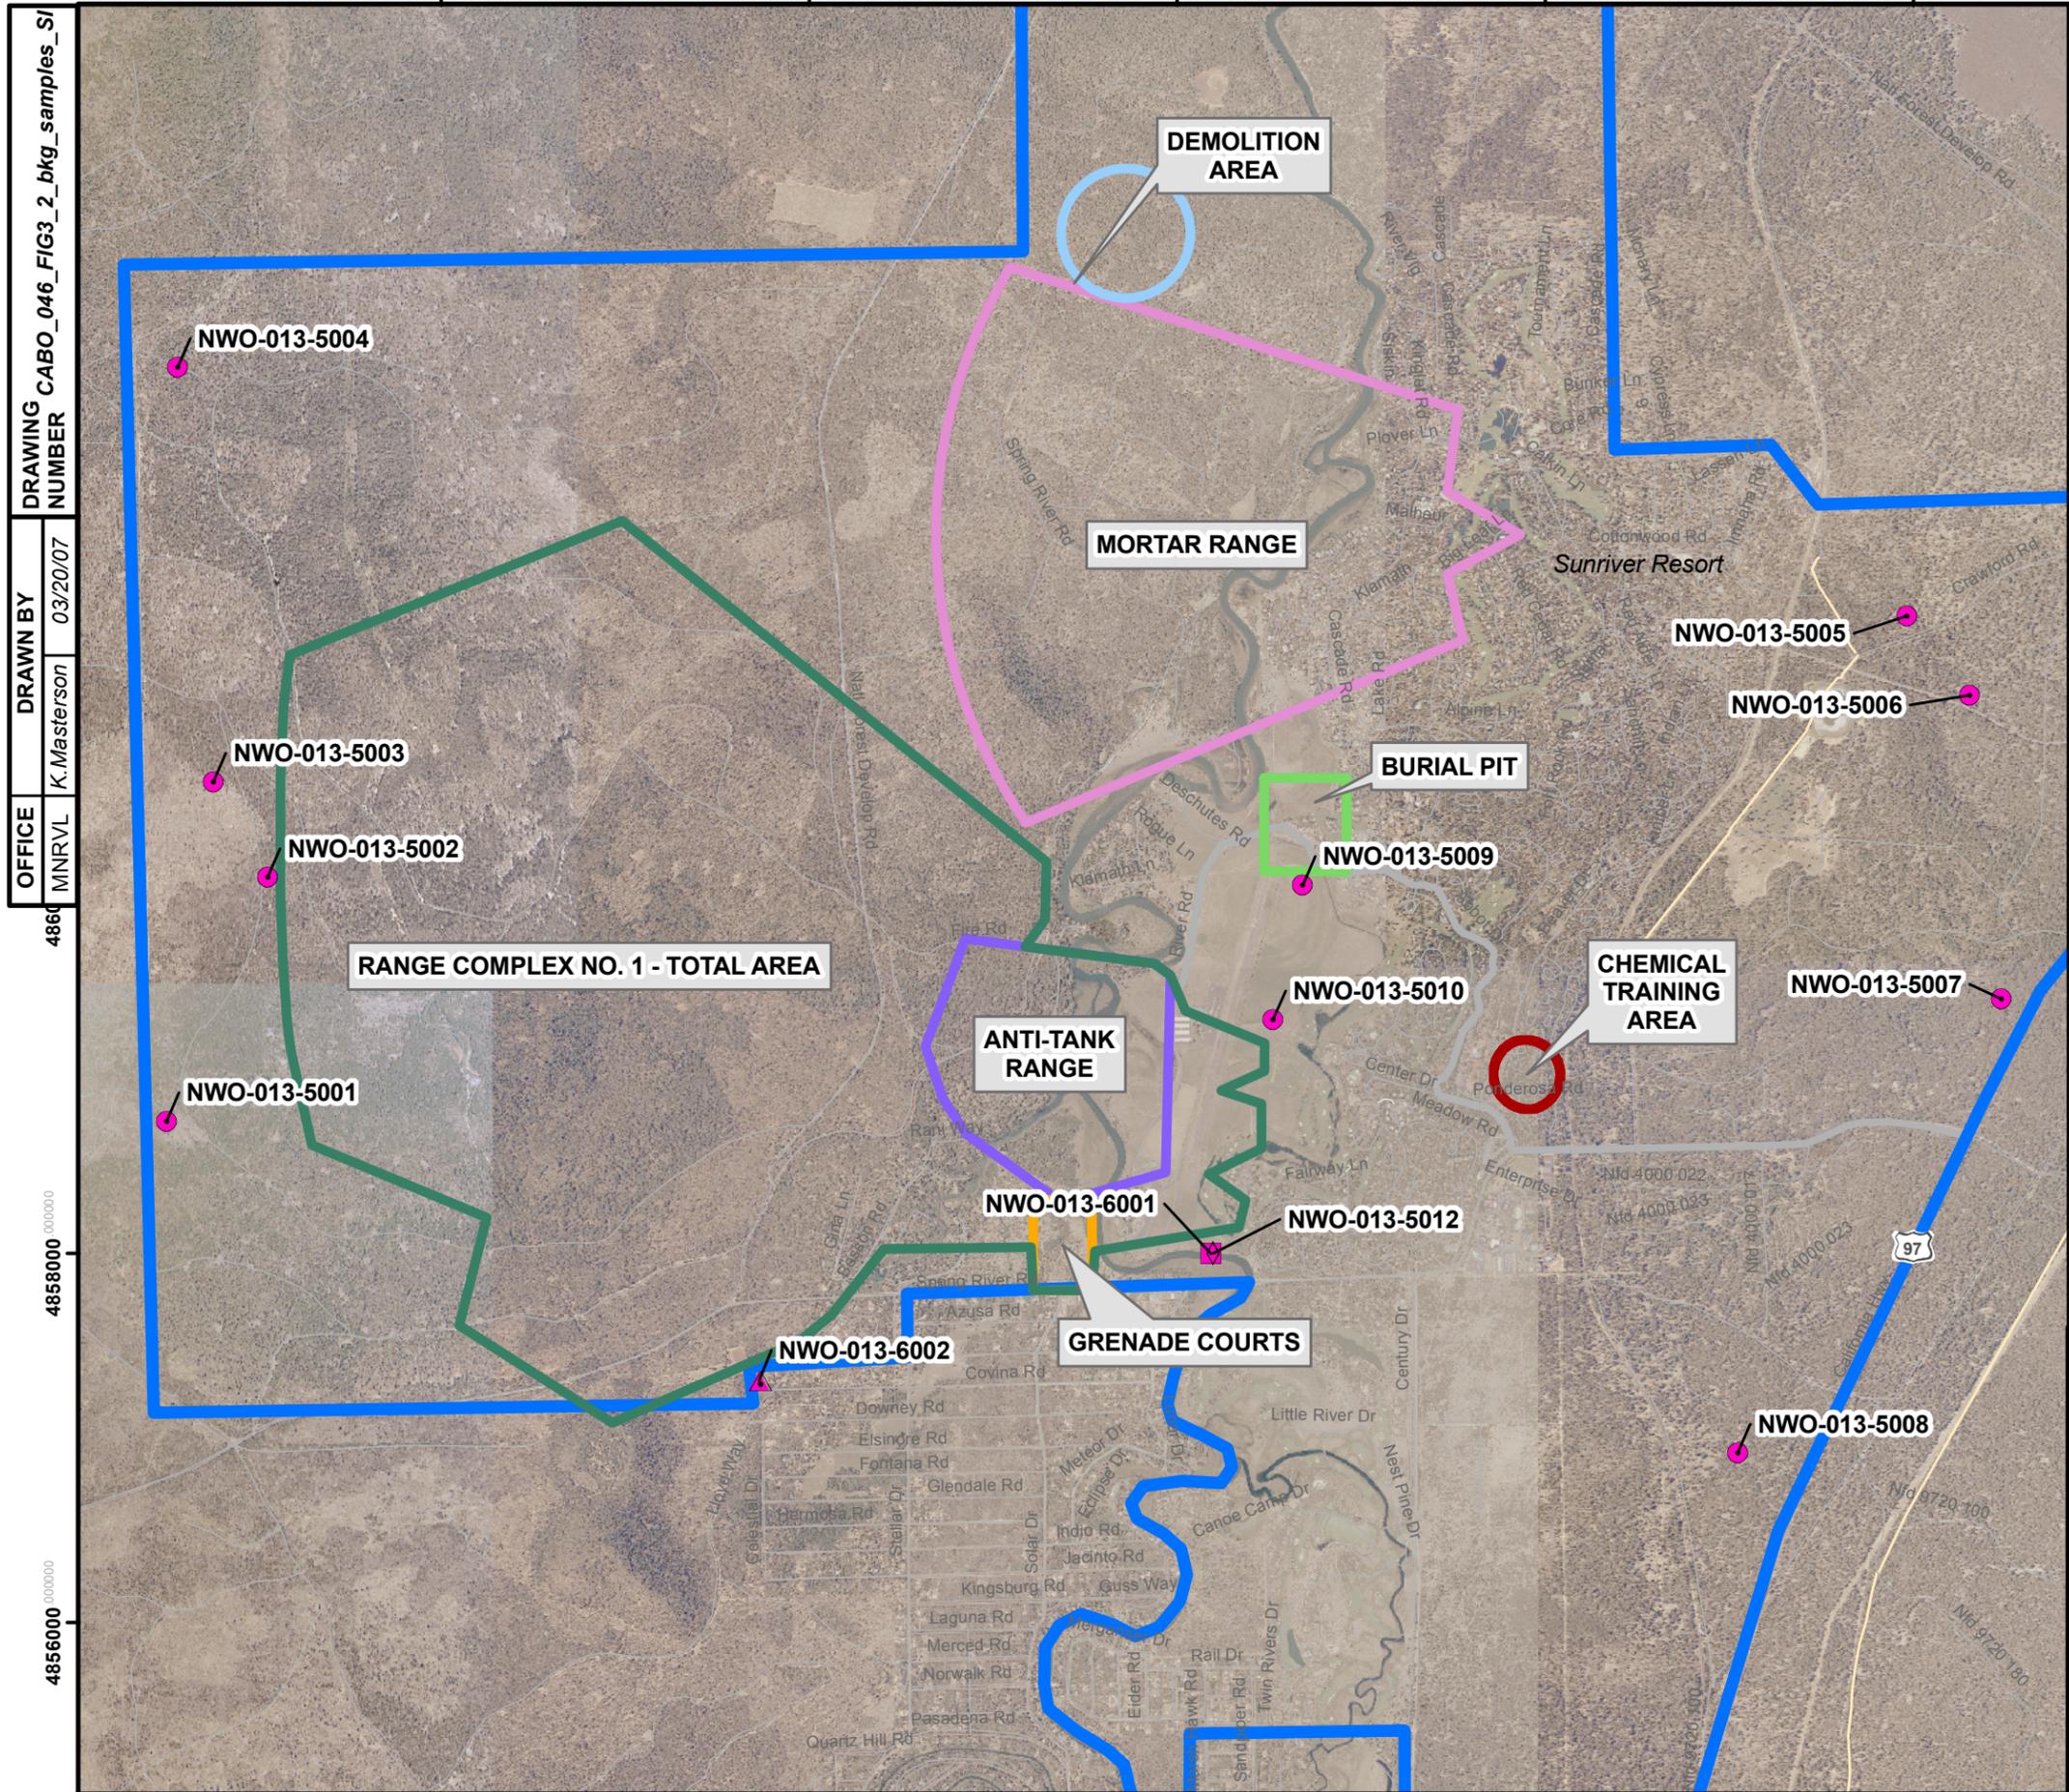
FIGURE 5-4
BACKGROUND SAMPLE LOCATIONS
 CAMP ABBOT

- Camp Abbot FUDS Boundary
- Anti-Tank Range AOC Boundary
- Burial Pit AOC Boundary
- Chemical Training Area AOC Boundary
- Demolition Area AOC Boundary
- Grenade Courts AOC Boundary
- Mortar Range AOC Boundary
- Range Complex No. 1 AOC Boundary
- Background Soil Sample Location
- ◆ Background Sediment Sample Location
- Background Surface Water Sample Location
- ▲ Background Groundwater Sample Location

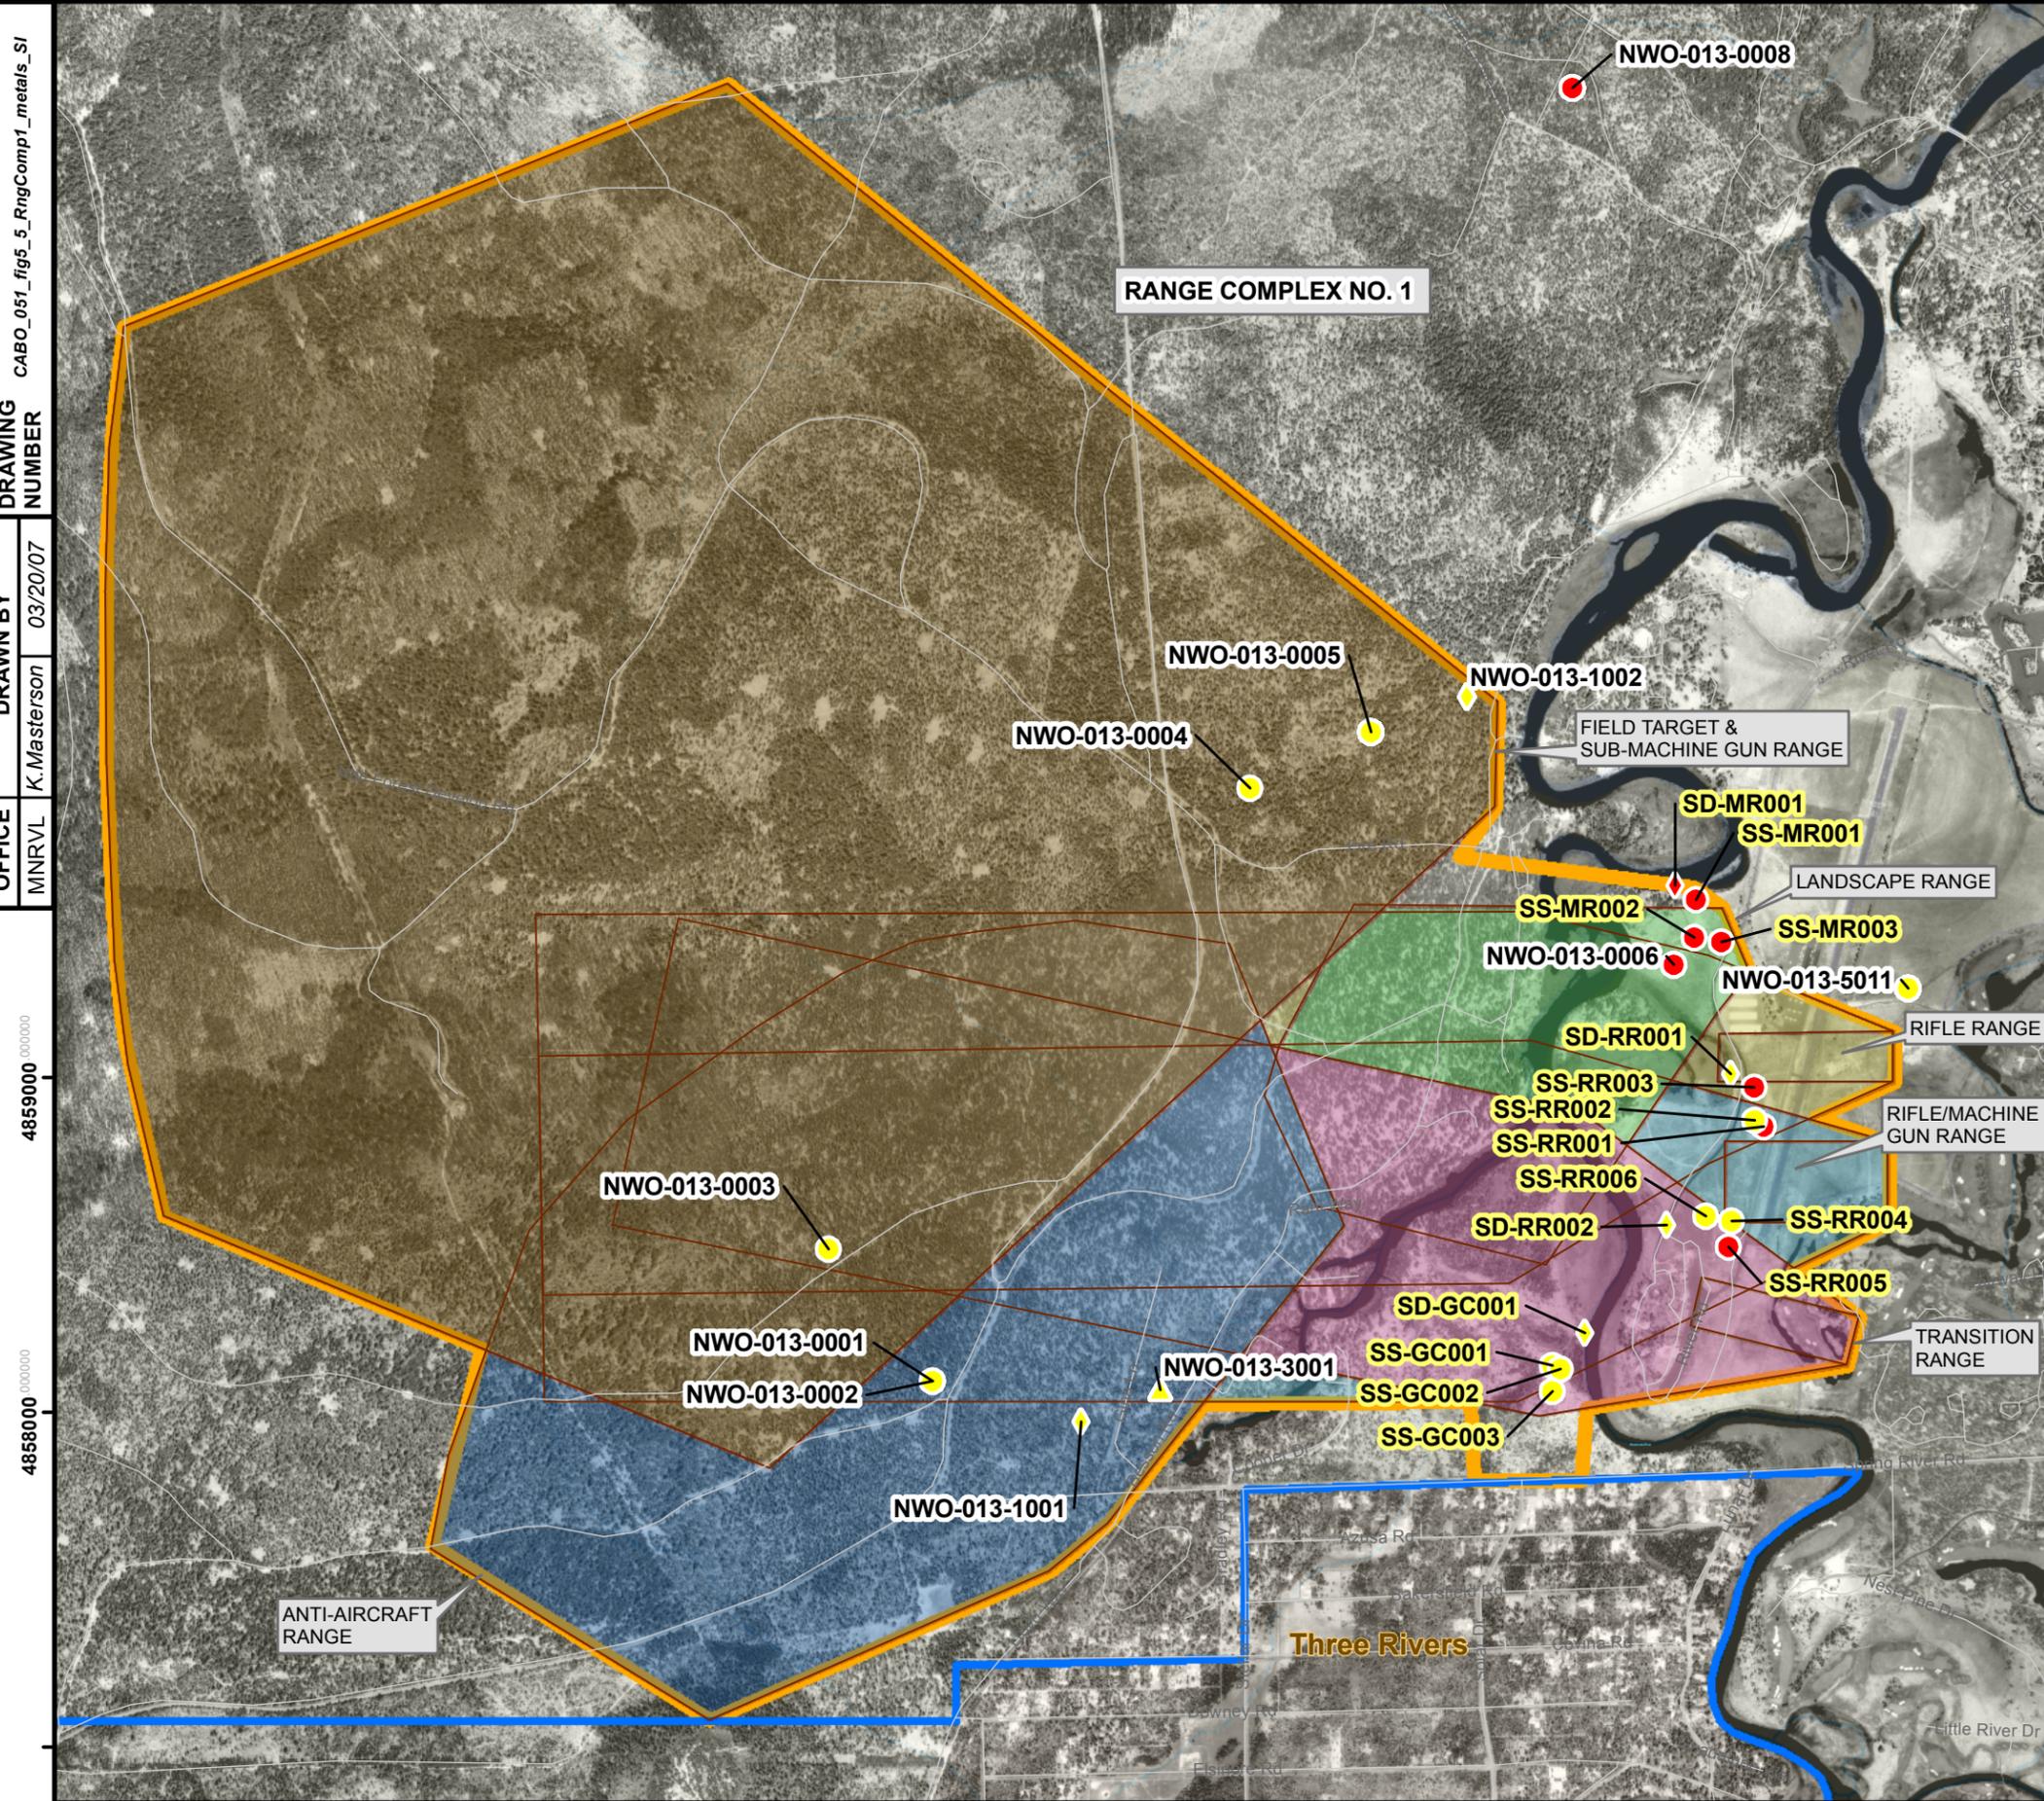
64 Following consultation with ODEQ, a recommendation of NDAI with respect to MC is made.
65 Although, ecological screening values were exceeded and a potential for ecological impact is
66 present, the risk is not considered to be sufficient to warrant a Remedial Investigation/Feasibility
67 Study (RI/FS).

- Camp Abbot FUDS Boundary
- Range Complex No. 1
- Subrange Boundary
- Soil Samples Results Greater than Background and Greater than Eco or Human Health Screening Values
- Sediment Sample Results Greater than Background and Greater than Eco or Human Health Screening Values
- Soil Sample Results Less than Background and/or Less than Eco or Human Health Screening Values
- Sediment Sample Results Less than Background and/or Less than Eco or Human Health Screening Values
- Groundwater Sample Results Less than Background

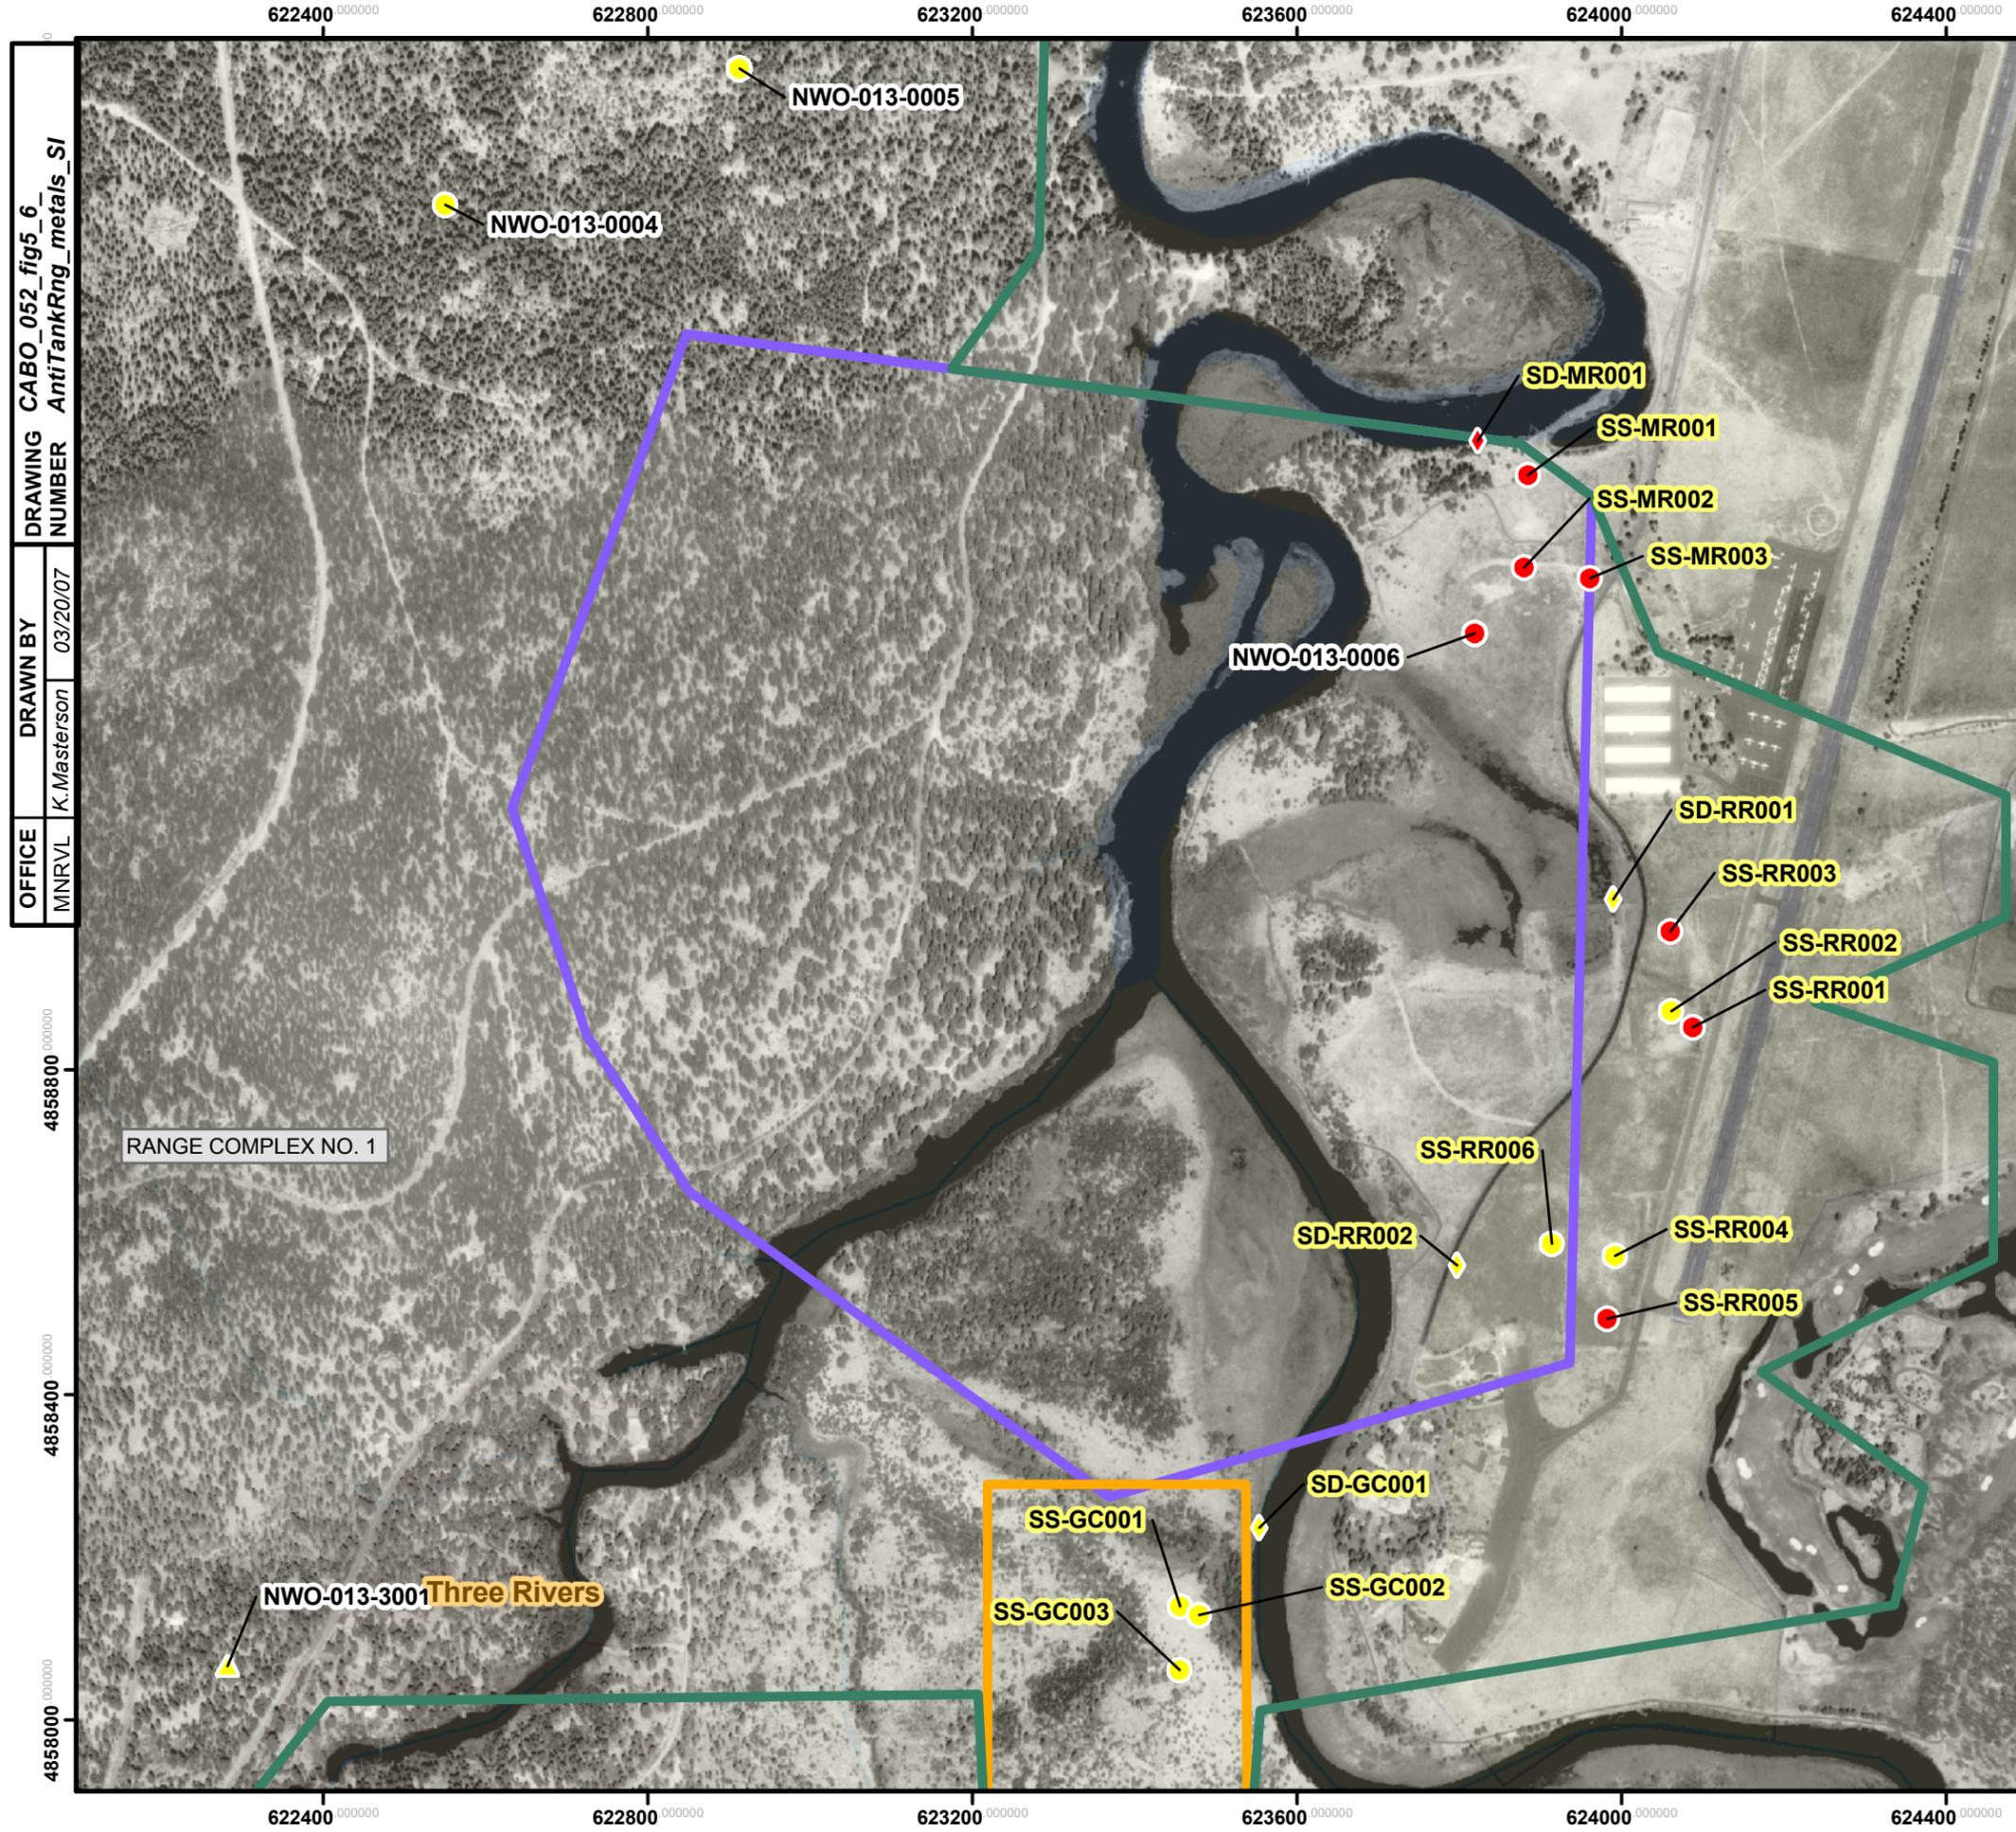
FIGURE 5-6
METALS RESULTS
ANTI-TANK RANGE
 CAMP ABBOT

71 Range, and the Demolition Area. Based on the historical occurrence of MEC, the Anti-Tank
72 Range, the Mortar Range, and the Demolition Area are recommended for RI/FS.
