FINAL SITE INSPECTION REPORT

Camp Abbot

FUDS Property No. F10OR0041

Site Inspections at Multiple Sites, NWO Region
Formerly Used Defense Sites
Military Munitions Response Program

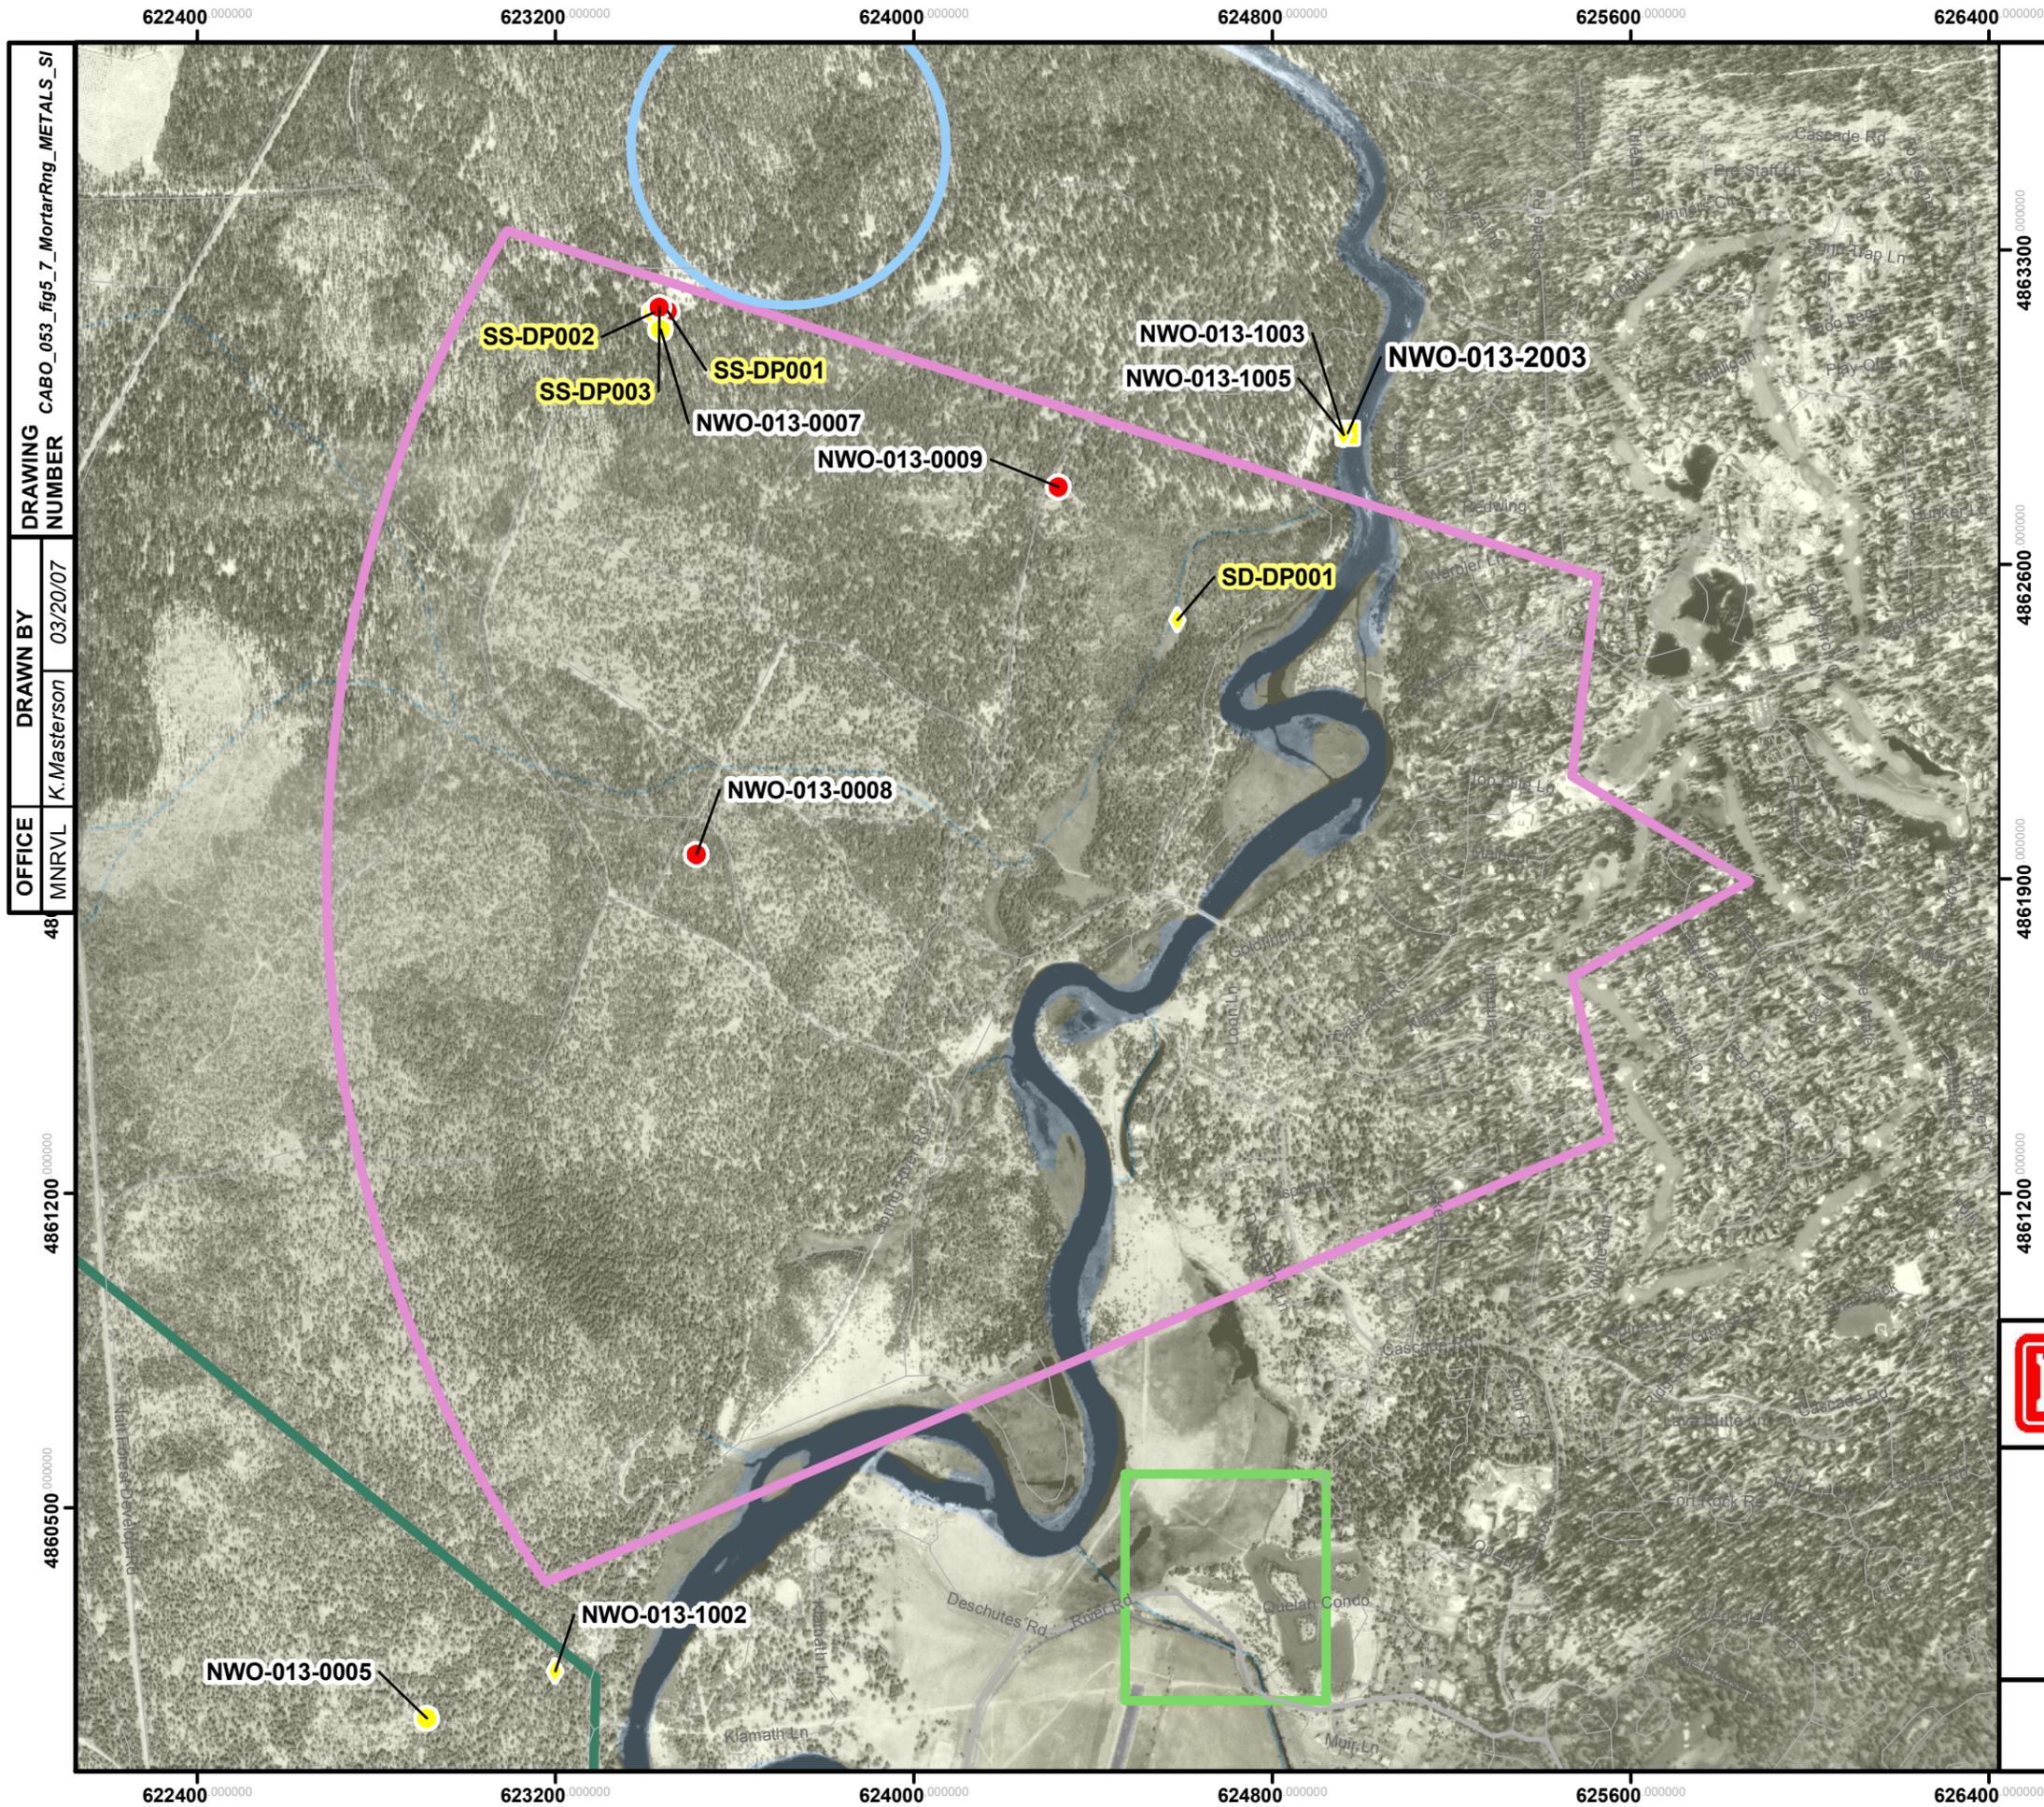
FIGURE 5-7
METALS RESULTS
DEMOLITION AREA / MORTAR RANGE
CAMP ABBOT

73 Iron was detected at concentrations above the background and human health screening value in
74 soil samples from the Demolition Area and the Mortar Range. Iron is a common rock forming
75 mineral and the bedrock at Camp Abbot is basaltic, which has high iron content. These elevated
76 iron concentrations may reflect natural variation in the soils. Additionally, iron is not a
77 Comprehensive Environmental Response Compensation, and Liability Act (CERCLA)
78 hazardous substance and therefore a recommendation based on iron alone cannot be used to
79 recommend RI/FS.

80 The Camp Abbot background concentration and ecological screening value was exceeded for
81 barium, chromium, and lead in soil samples. The exceedances indicate that adverse ecological
82 impacts may occur in soil. Following consultation with ODEQ, a recommendation of NDAI
83 with respect to MC is made. Although, ecological screening values were exceeded and a
84 potential for ecological impact may be present, the risk is not considered to be sufficient to
85 warrant an RI/FS.
