FINAL SITE INSPECTION REPORT

Fort Flagler Military Reservation

FUDS PROPERTY No. F10WA0316

Site Inspections at Multiple Sites, NWO Region
Formerly Used Defense Sites
Military Munitions Response Program

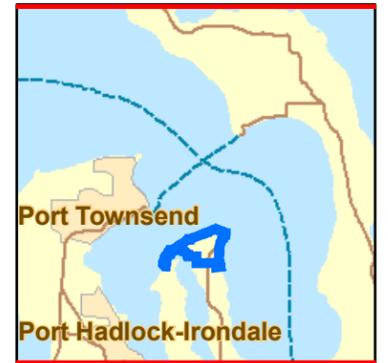
FIGURE 1-2
RANGE CONFIGURATION FROM THE
MMRP RANGE INVENTORY
 FORT FLAGLER MILITARY RESERVATION

160 Of the 27,682 total acres reported for the Range Complex, the INPR Supplement indicates 550
 161 acres were on land and 27,132 acres were water acres. Due to overlapping range fans, the
 162 acreage of the individual sub-ranges is greater than the acreage of the Range Complex itself.
 163 Figure 1-2 shows the ranges identified in the ARC.

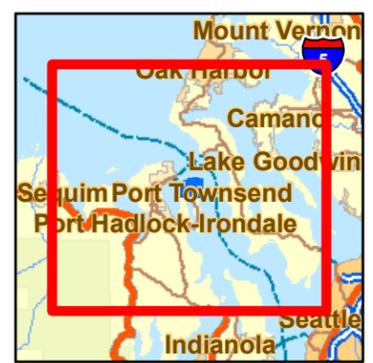
FIGURE 2-6
SURFACE WATER DRAINAGE
 FORT FLAGLER MILITARY RESERVATION

299 The primary surface water feature in the area is Puget Sound, a saltwater, tidal water body that
300 surrounds the site on three sides. There are no established streams on Ft. Flagler. Figure 2-6
301 shows the surface water features in the vicinity of Ft. Flagler.

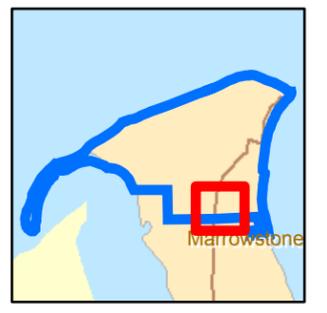
FIGURE 7-1
TRANSITION RANGE 2
RECONNAISSANCE
 FORT FLAGLER MILITARY RESERVATION

975 A visual reconnaissance of Transition Range 2 was completed during the week of February 20,
976 2007. The location of the range is in a very heavily wooded area with dense undergrowth. No
977 visual evidence of the range could be identified due to the heavy vegetation. The only indication
978 that the area was once cleared was that the forest trees were primarily alder and fir, while the
979 surrounding area was a more mature forest growth consisting of fir, hemlock, and cedar. The
980 length and coverage of the visual reconnaissance routes indicated in the SSWP could not be
981 achieved due to the thick vegetation preventing traverse. No evidence of firing positions or
982 target areas was identified during the visual reconnaissance, or could be observed on aerial
983 photographs. Figure 7-1 shows the reconnaissance pathway completed for this AOC.

954 Transition Range 2 is a single AOC shown on Figure 7-1. The location of this AOC is only
955 known from the War Department map that was obtained during the TPP meeting. This War
956 Department map is included in Appendix L. The INPR Supplement (USACE, 2004b) identified
957 Transition Range 2, but the location was unknown. The Transition Range likely consisted of
958 individual firing lanes which soldiers transitioned along, engaging targets from various positions
959 (fox hole, window, and prone) and at varying distances.
