# DRAFT FINAL SITE INSPECTION REPORT

## Fort Flagler Military Reservation

### Jefferson County, WA

#### FUDS PROPERTY No. F10WA0316

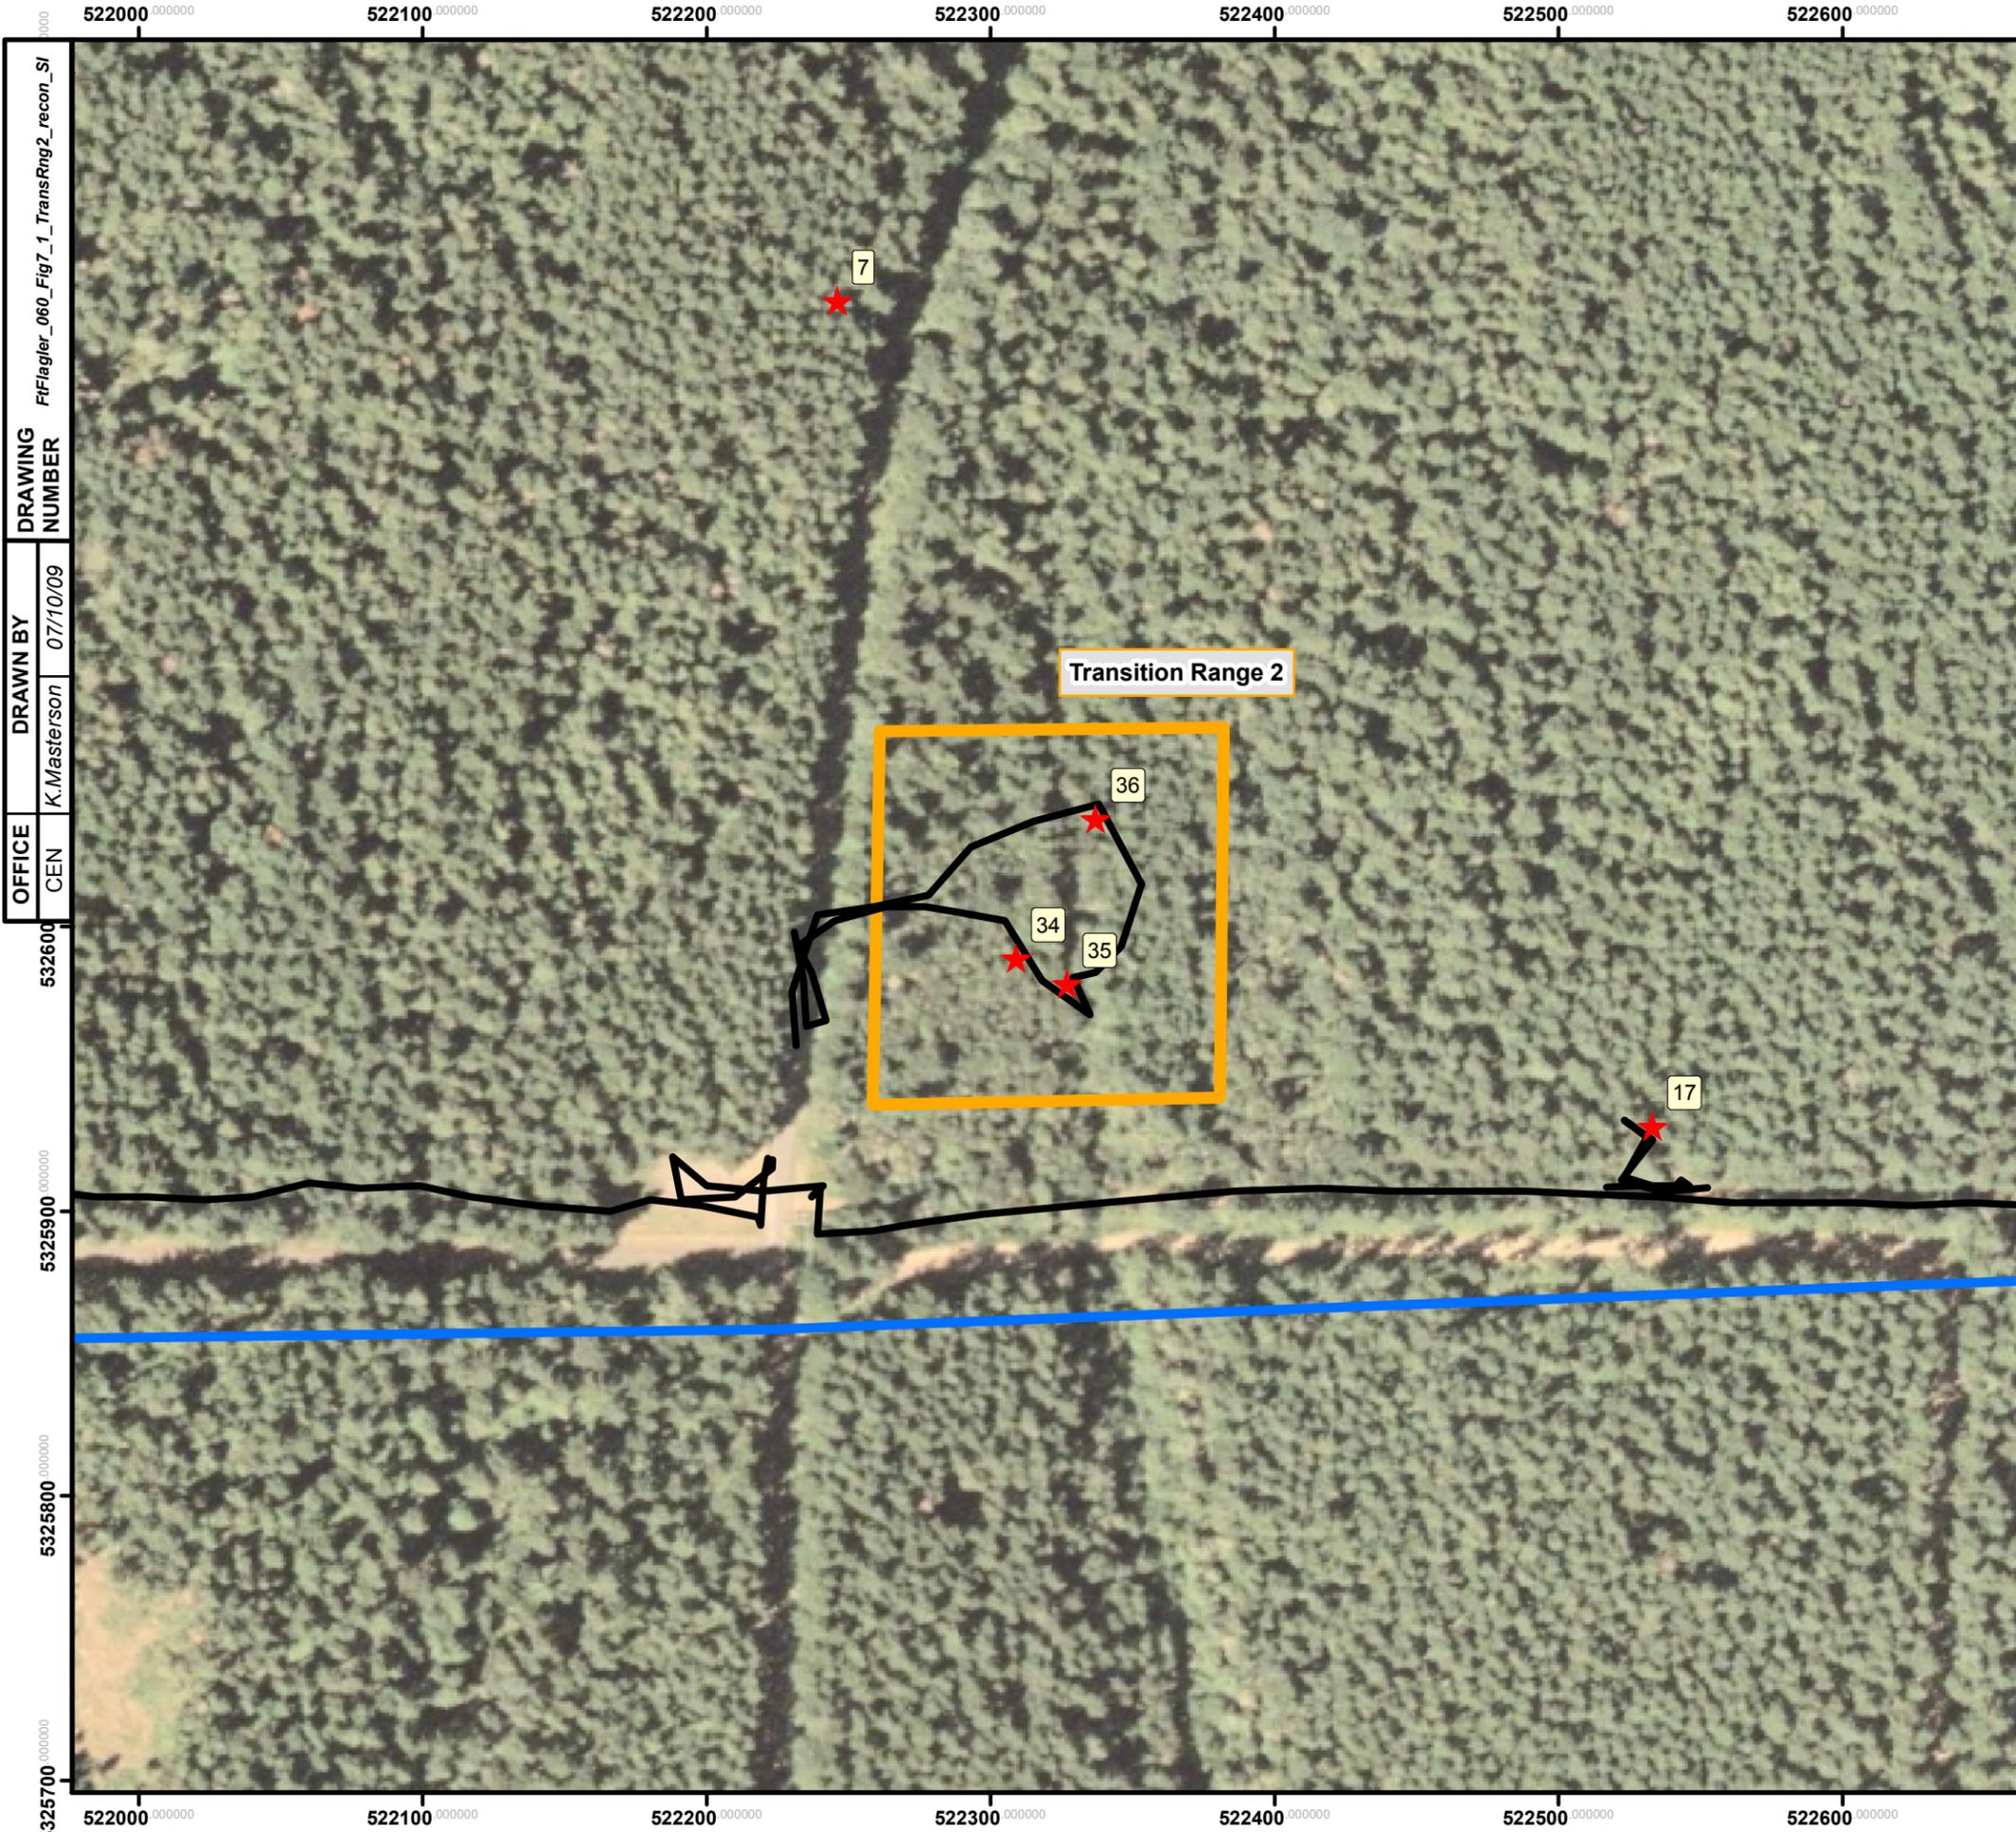
**FIGURE 7-1  
TRANSITION RANGE 2  
RECONNAISSANCE**

967 A visual reconnaissance of Transition Range 2 was completed during the week of February 20,  
968 2007. The location of the range is in a very heavily wooded area with dense undergrowth. No  
969 visual evidence of the range could be identified due to the heavy vegetation. The only indication  
970 that the area was once cleared was that the forest trees were primarily alder and fir, while the  
971 surrounding area was a more mature forest growth consisting of fir, hemlock, and cedar. The  
972 length and coverage of the visual reconnaissance routes indicated in the SSWP could not be  
973 achieved due to the thick vegetation preventing traverse. No evidence of firing positions or  
974 target areas was identified during the visual reconnaissance, or could be observed on aerial  
975 photographs. Figure 7-1 shows the reconnaissance pathway completed for this AOC.

946 Transition Range 2 is a single AOC shown on Figure 7-1. The location of this AOC is only  
947 known from the War Department map that was obtained during the TPP meeting. This War  
948 Department map is included in Appendix L. The INPR Supplement (USACE, 2004b) identified  
949 Transition Range 2, but the location was unknown. The Transition Range likely consisted of  
950 individual firing lanes which soldiers transitioned along, engaging targets from various positions  
951 (fox hole, window, and prone) and at varying distances.

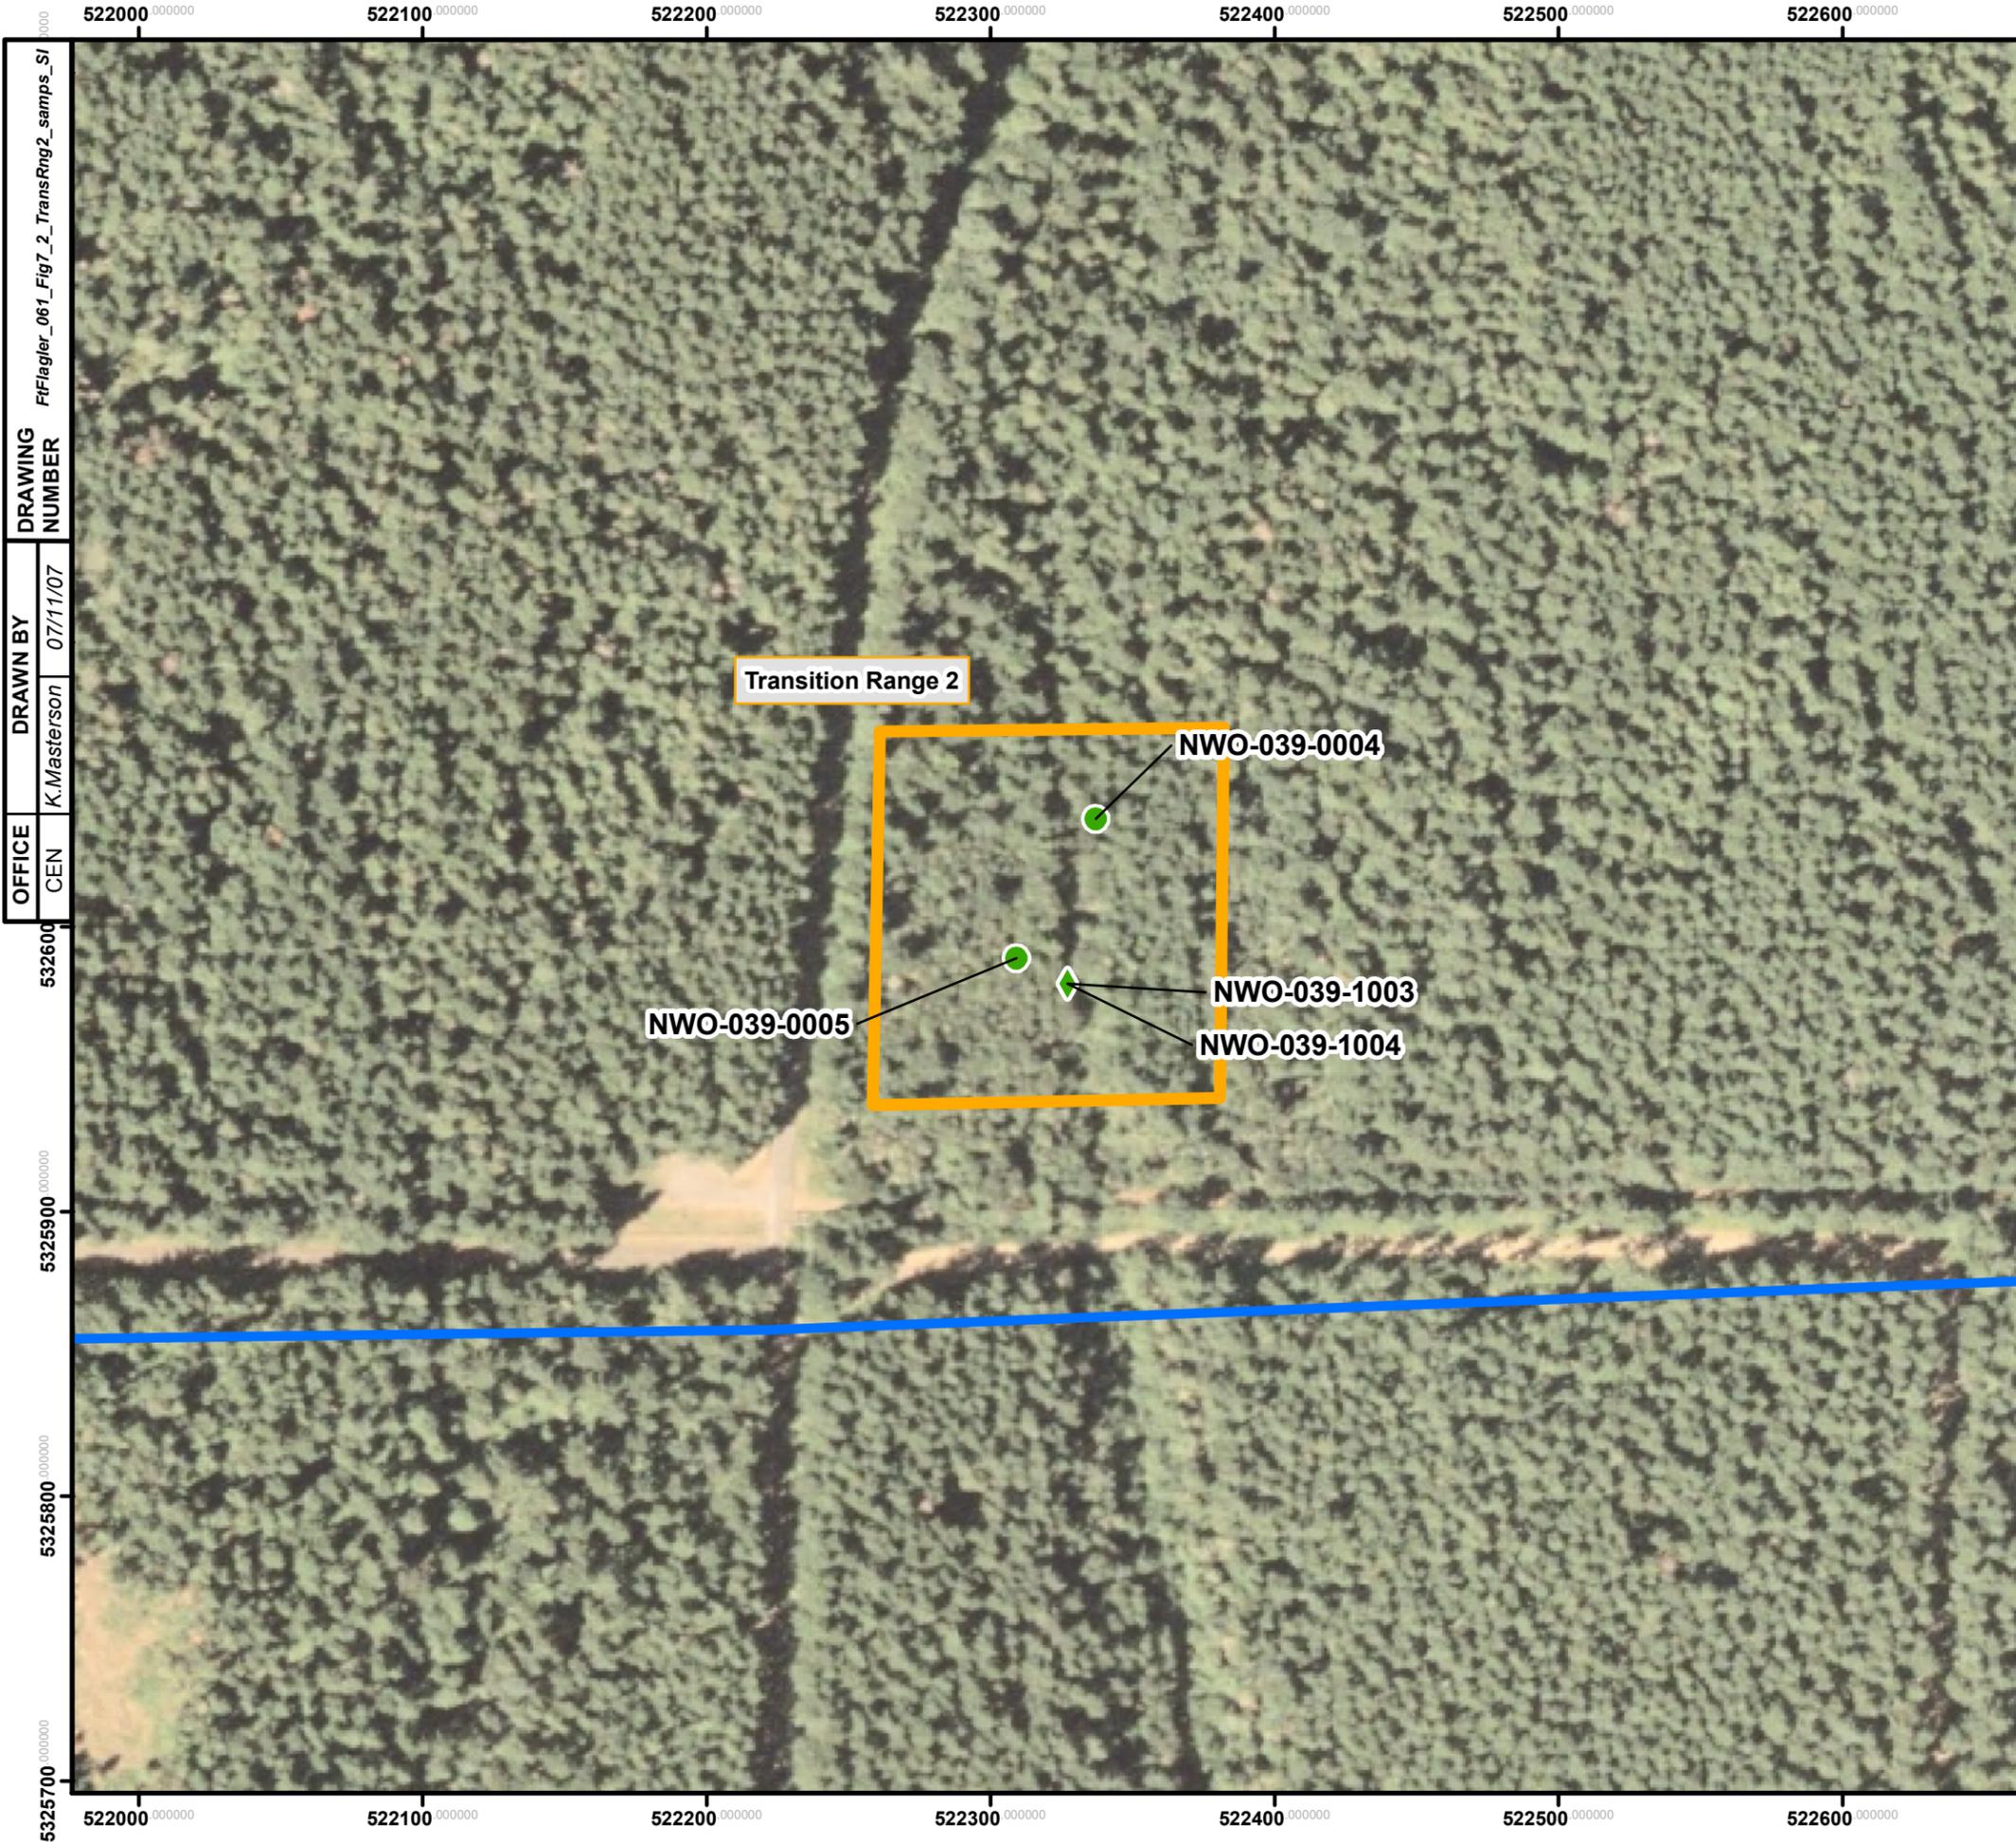
**FIGURE 7-2**  
**TRANSITION RANGE 2**  
**SAMPLE LOCATIONS AND LEAD RESULTS**  
 FORT FLAGLER MILITARY RESERVATION

63 Based on historical use of the range and results of the SI field activities, there is no evidence of  
64 MEC or munitions debris (other than small arms use) at the Transition Range 2. Analytical  
65 results from soil and sediment sampling indicated that lead concentrations were below  
66 background concentrations. A recommendation for NDAI for both MEC and MC is made for  
67 Transition Range 2.

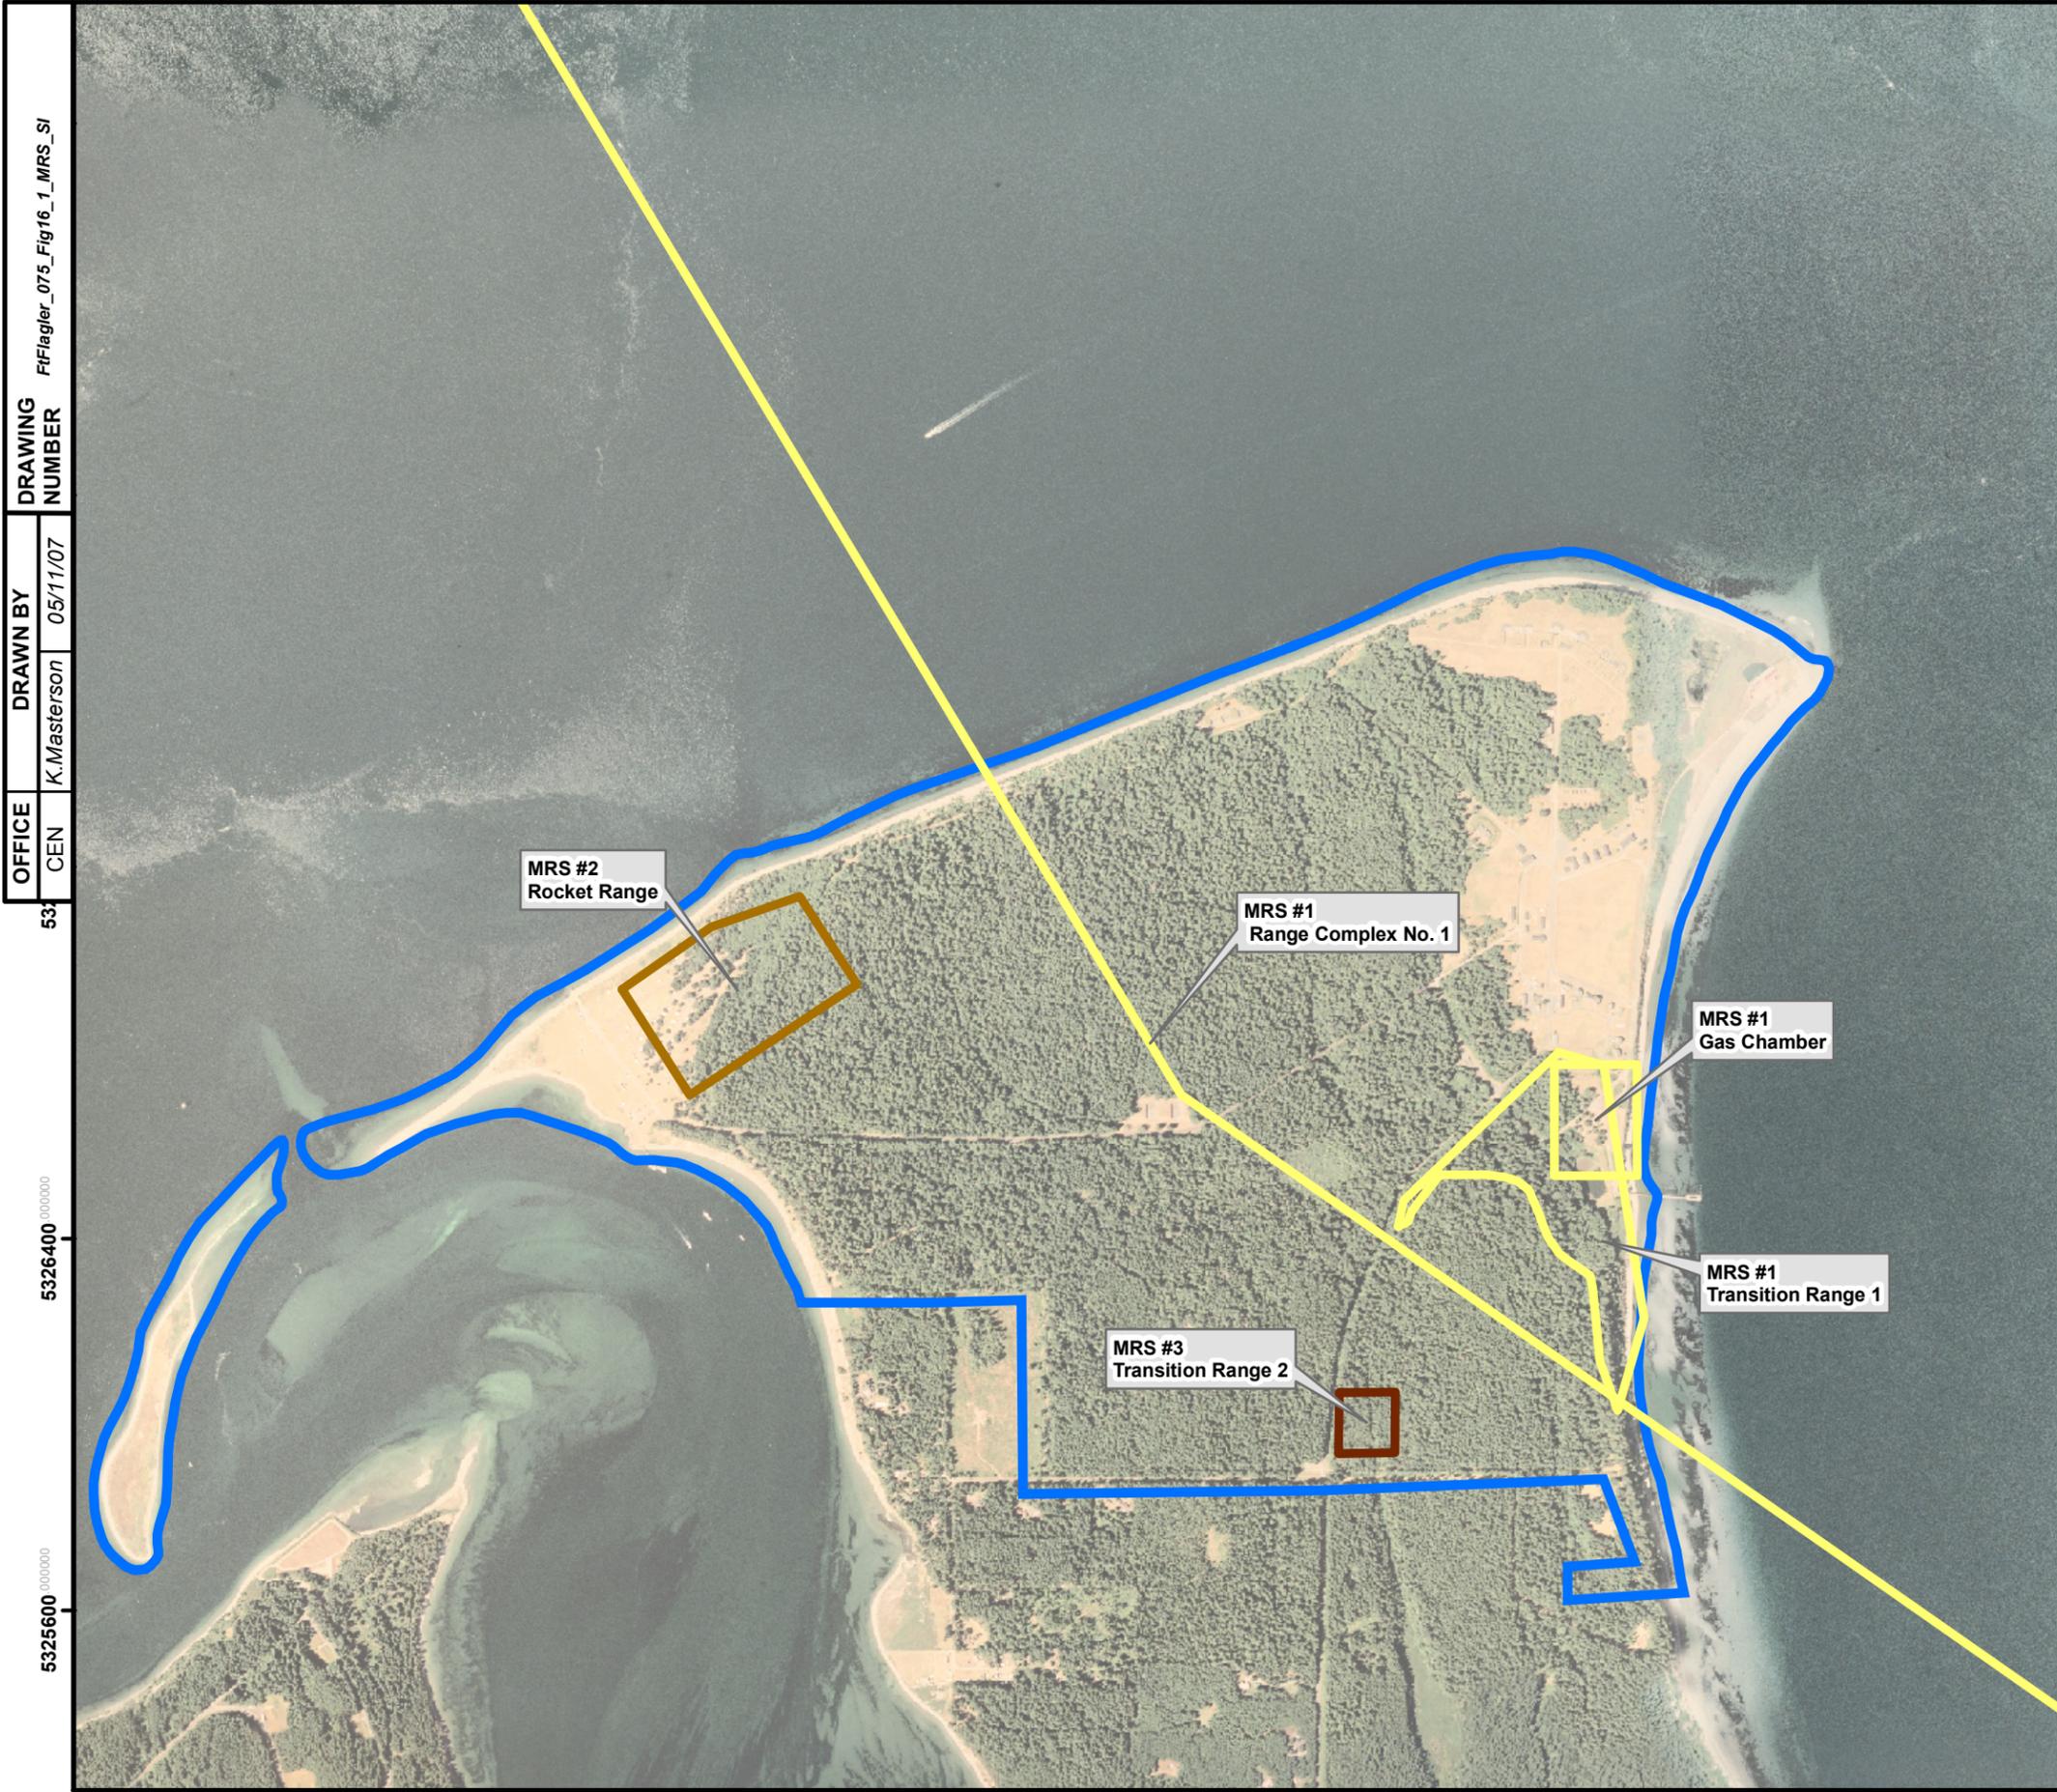
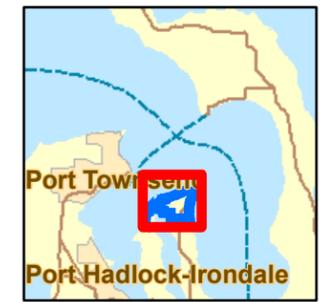
**FIGURE 16-1**  
**MUNITIONS RESPONSE SITES**  
 FORT FLAGLER MILITARY RESERVATION

1857 Based on the use and physical distribution of the AOCs at Ft. Flagler, three MRSs are identified  
1858 (Figure 16-1):
