Skagit River Flood Control Project: Environmental Restoration and Mitigation Planning

EVALUATION AREA STUDIES

Draft Report
April 2002

TETRA TECH, INC.
Infrastructure Services Group

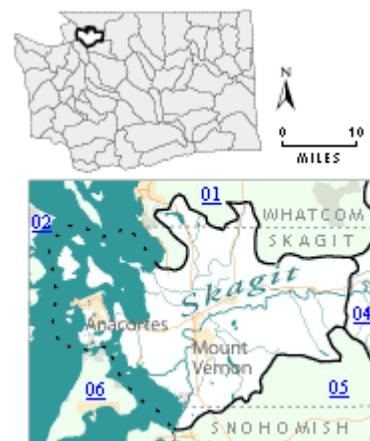
Figure 1. Project area map

The Skagit River drains 8,270 km², including lands within British Columbia and Washington’s northwest Cascade Range and empties into Skagit Bay in the vicinity of LaConner and Conway, Washington (Figure 1). Downstream of Mt. Vernon, the mainstem splits into two major distributary channels, the North and South Forks, which encompass Fir Island. In the northern portion of the study area, the Samish River is present. Several existing sloughs in this northern area may once have served as flood overflow channels from the Skagit River and also drained a large area of freshwater wetlands (General Land Survey Office Maps, 1866-1885). Flood flows in the Skagit River historically ranged across the Skagit and Samish Flats and entered Padilla and Samish Bays.

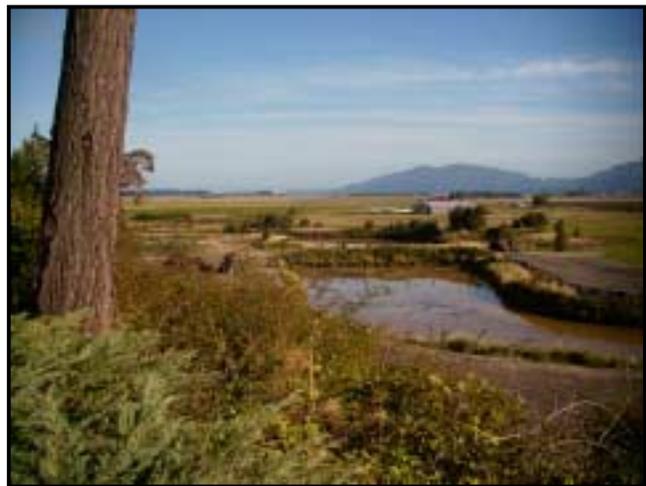
At the tide gates, marsh and channel width was approximately 100 feet (30 m). Water quality was visually extremely turbid, and monitoring by the Skagit Stream Team (2000) indicates that turbidity is frequently high (15-89 NTUs), with high fecal coliform concentrations (up to 400 colonies/100 ml geometric mean) and low DO concentrations (0.10 - 6.6 mg/L). Additional water quality sampling, done by WDOE in 2000, reports that dissolved oxygen and turbidity measurements exceeded state water quality criteria in every month of that year (WDOE 2002). Initially, it was thought that recent dredging in the channel just downstream of Bayview-Edison Road had caused the highly turbid water, but aerial photos from previous years show that the water has the same level of turbidity much of the year and the turbidity extends all the way upstream to the end of the slough/ditch system. The water quality conditions may be due to iron-fixing bacteria or silty runoff from farm fields or both. A large cattle ranch is located along D'arcy Road, upstream of the evaluation area, and the water quality appears very poor (turbid and foamy) downstream of the ranch. Some saltwater intrusion occurs upstream of the tidegates at high tides (gates are not closed entirely; Skagit Stream Team, 2000). Riprap is present along the right bank of the slough, downstream of Bayview-Edison Rd. The channel substrate is fine silty mud and surrounding soils are primarily silt loams and fine sandy loams.

Downstream of the levee crossing, the habitat was a mixture of low marsh, middle/high marsh and mud flat. The low marsh habitat was dominated by seaside arrowgrass (*Triglochin maritimum*) (10%), *Scirpus maritimus* (30%), salt grass (70%), and Pacific silverweed (40%). The middle/high marsh habitat was dominated by Douglas aster (20%), Pacific silverweed (75%), *Chenopodium rubrum* (50%), and salt grass (30%). On the levees, dominant species were alder, Himalayan blackberry, velvet grass, and European beachgrass. Upstream of the Bayview-Edison crossing, there is an area of natural second-growth forest vegetation along the left bank for approximately 1000 ft (300 m) and a hybrid poplar plantation along both banks, which provides some shading and buffering of the channel, temporarily.

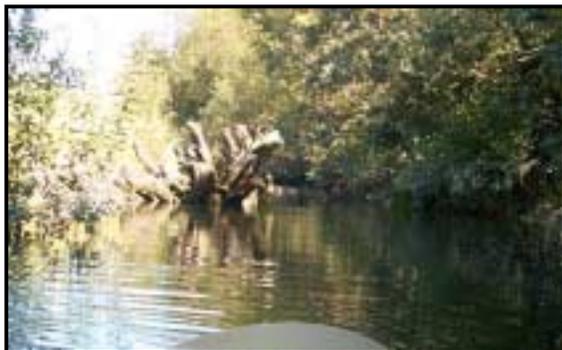
Sullivan Slough, south of Chilberg Road, is comprised of a braided channel system, which runs through an approximately 500 ft (152 m) wide brackish and salt marsh habitat, constrained on both sides by levees. The area is a mosaic of salt and fresh water, riparian, and upland habitats. A narrow riparian zone has become established on the levees. The dominant vegetation was *Carex lyngbyei* (60%), willow (40%), broad leaf cattail (40%), and narrow leaf cattail (30%) with lesser cover of kneeling angelica (*Angelica genuflexa*), impatiens, Douglas aster, *Scirpus validis*, horsetail (*Equisetum telmateia*) and reed canary grass. Cottonwoods were also present adjacent to and on the levees. Levees on both banks were overgrown with willows, cottonwoods and upland shrub species. The high invasive purple loosestrife (*Lythrum salicaria*) was also observed in at least one location in the slough. The diversity of vegetation is high and generally dominated by native species, and communities transition from riparian to brackish marsh to saltwater marsh habitat. Apparently, since the construction of the jetty between the Swinomish Channel and the NF Skagit River, Sullivan Slough has been filling in with sediment (Steve Hinton, pers. comm.). Much of what was formerly intertidal mudflat or shallow subtidal habitat is now transitioning to vegetated salt marsh.

The wetted width of the slough, downstream of Chilberg Road, during high tide varies between approximately 10-40 ft (3-12 m). Substrate was fine mud and sand and surrounding soils are primarily sandy loams and silt loams. Water was only slightly turbid. Numerous pieces of LWD were present, many of them fallen cottonwoods from the adjacent riparian zone. Numerous branching blind channels exist in this marshy area.

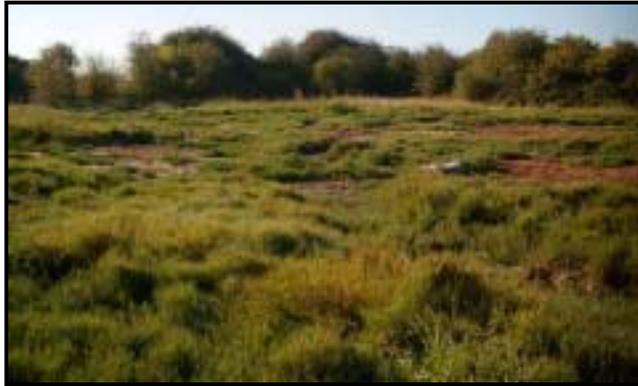
A tidal channel is present throughout Telegraph Slough, ending in high salt marsh immediately south of Highway 20. The slough is a mosaic of upland, riparian, high marsh, middle marsh and low marsh habitats. In low marsh areas, braided channels of silt/mud substrate were present, and became more defined and larger with less vegetation as they neared the Swinomish Channel. The water that does not drain entirely

out of the slough was highly turbid and had extensive algae growth on the surface. In at least two locations within the Slough, two low marsh channels are present and separated by upland islands. The Slough is bordered at both right and left banks by levees.
