Environmental Assessment

Startup Training Levee Flood Fight

Snohomish County, Washington
January 18, 2005

**Startup Training Levee Flood Fight
Snohomish County, Washington
18 January 2005**

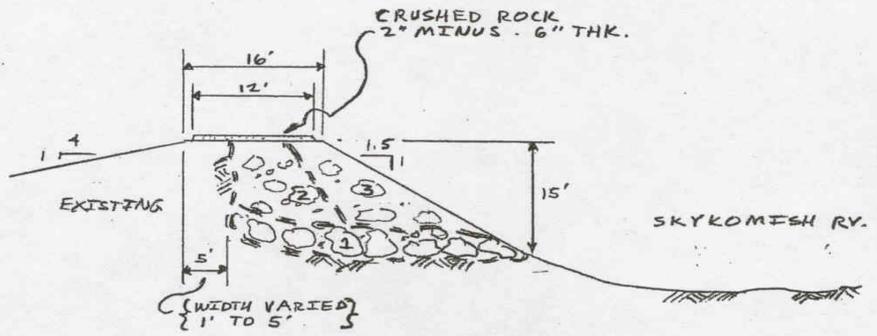
TYPICAL SECTION
SCALE 1" = 20'

1. 18" - 48" ANGULAR ROCK
2. 24" MINUS ANGULAR ROCK
3. 36" MINUS ANGULAR ROCK

The preferred alternative repaired the 200' of erosion by placing class IV riprap and spalls (*Appendix B*). The work was conducted during the flood event which prevented the placement of an engineered toe structure. Woody structures to be placed adjacent to the eroded levee section was discussed but eliminated due to high flood water levels and unknown soil conditions on the affected bench (*Appendix C*).

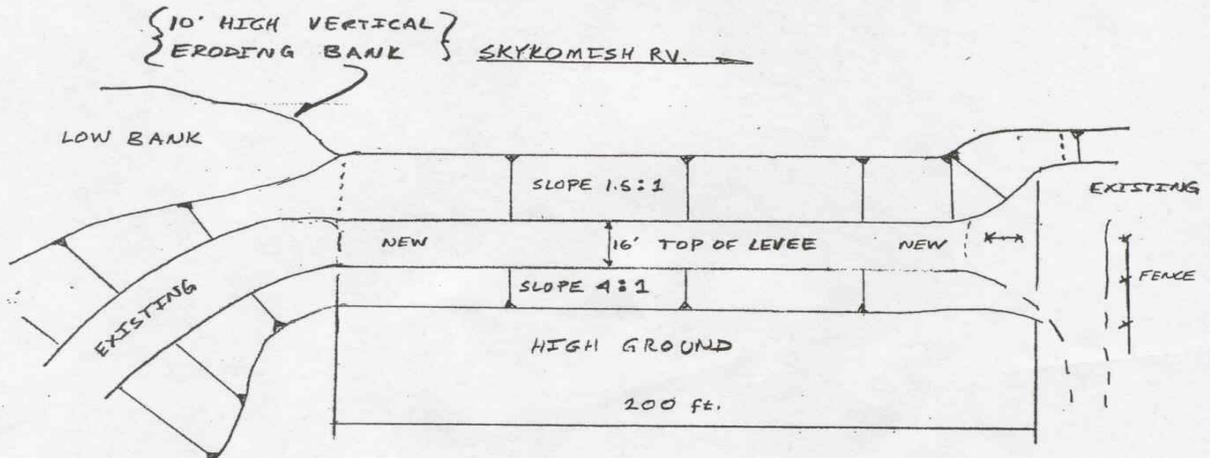
PLAN VIEW
SCALE 1" = 50'

* MEASUREMENTS OUTSIDE OF 200' NEW LEVEE APPROX.

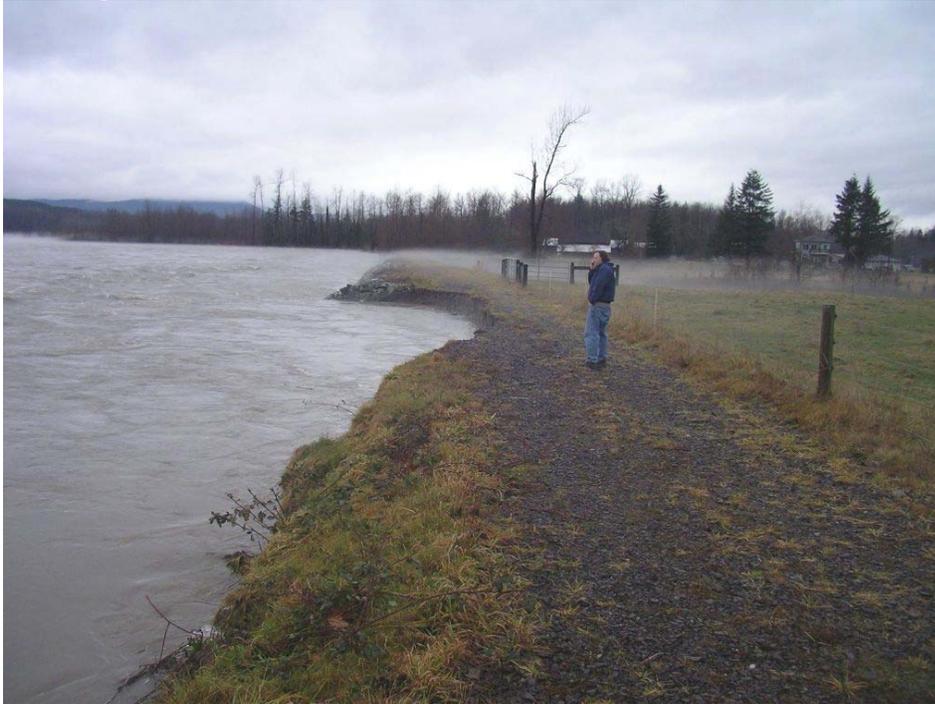
Photo 1. Startup levee prior to flood fight. Erosion limits were greater than shown at time of flood fight.

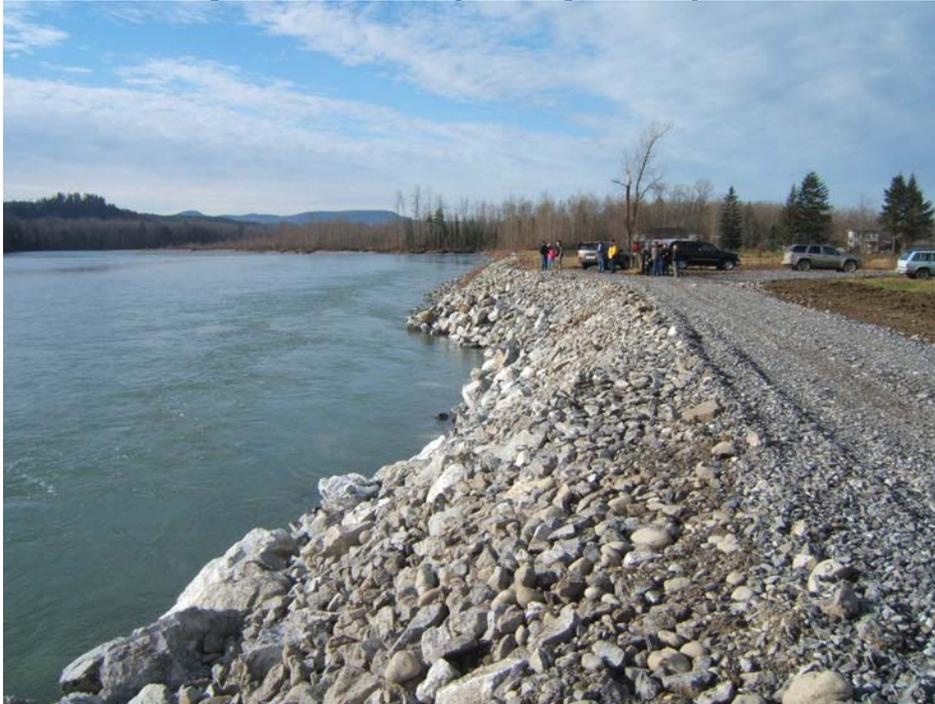
Photo 2. Levee prism after flood fight. Scope and alignment was dictated by erosion limits.

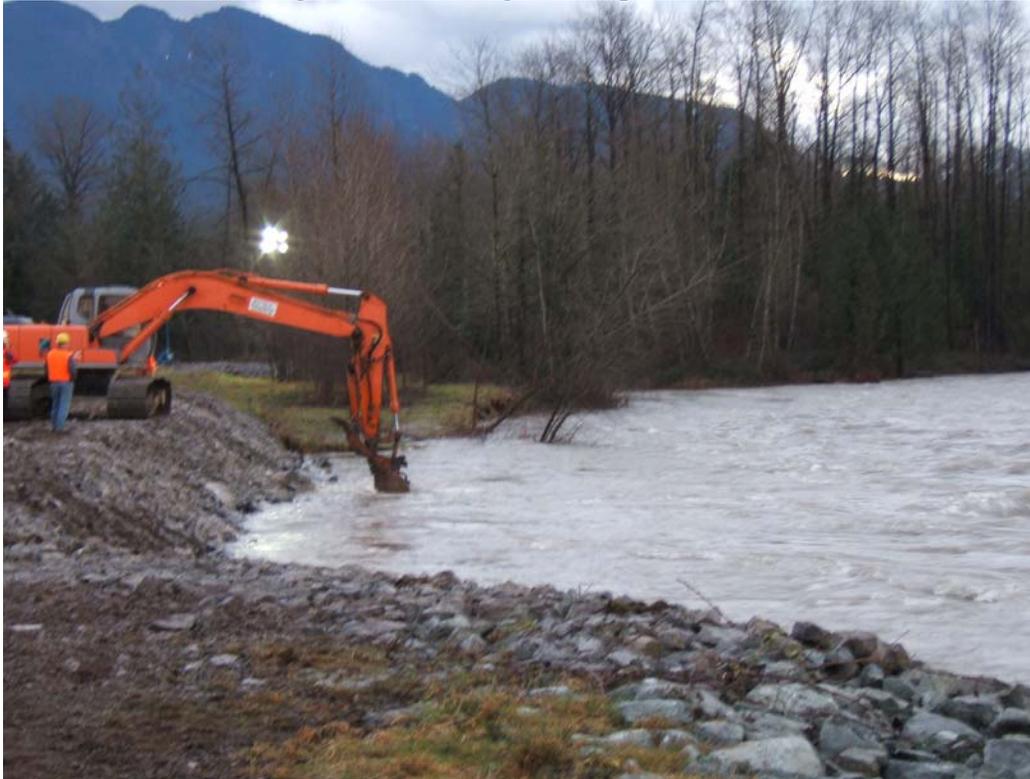
Photo 3. View showing end of flood fight and upstream limit of work.

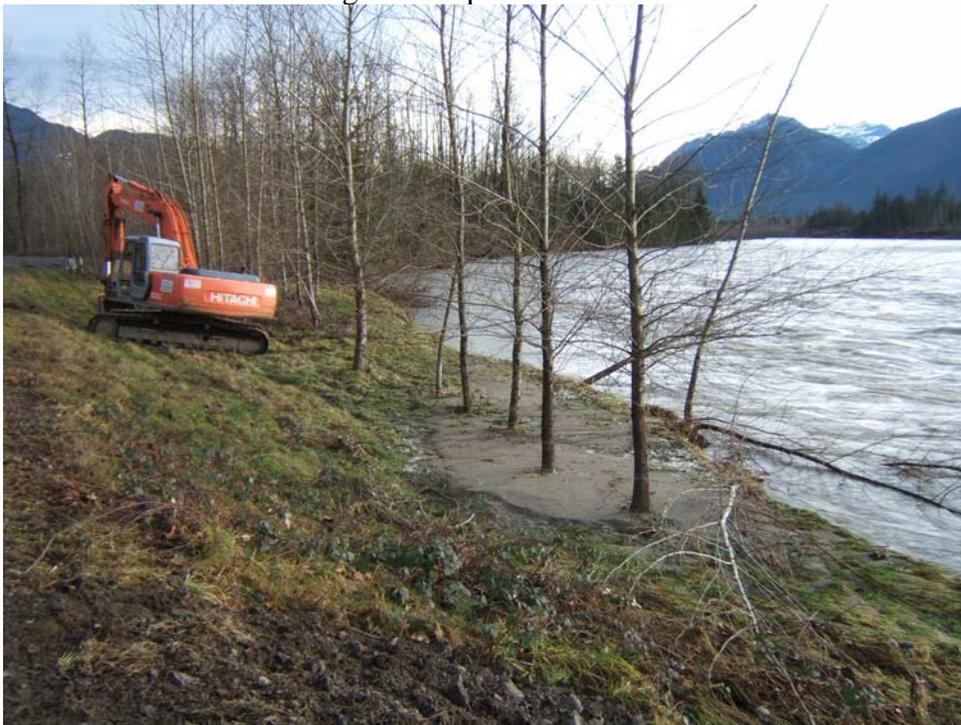
Photo 4. Area of remaining bench upstream of revetment work.
