Acoustic and Video Measurements of Fish Passage at the Hiram M. Chittenden Locks:

A Year 2000 Focus on the Salt Water Drain and Spill Bay #2

Final Report to:

BioSonics, Inc  
4027 Leary Way Northwest  
Seattle, Washington 98107

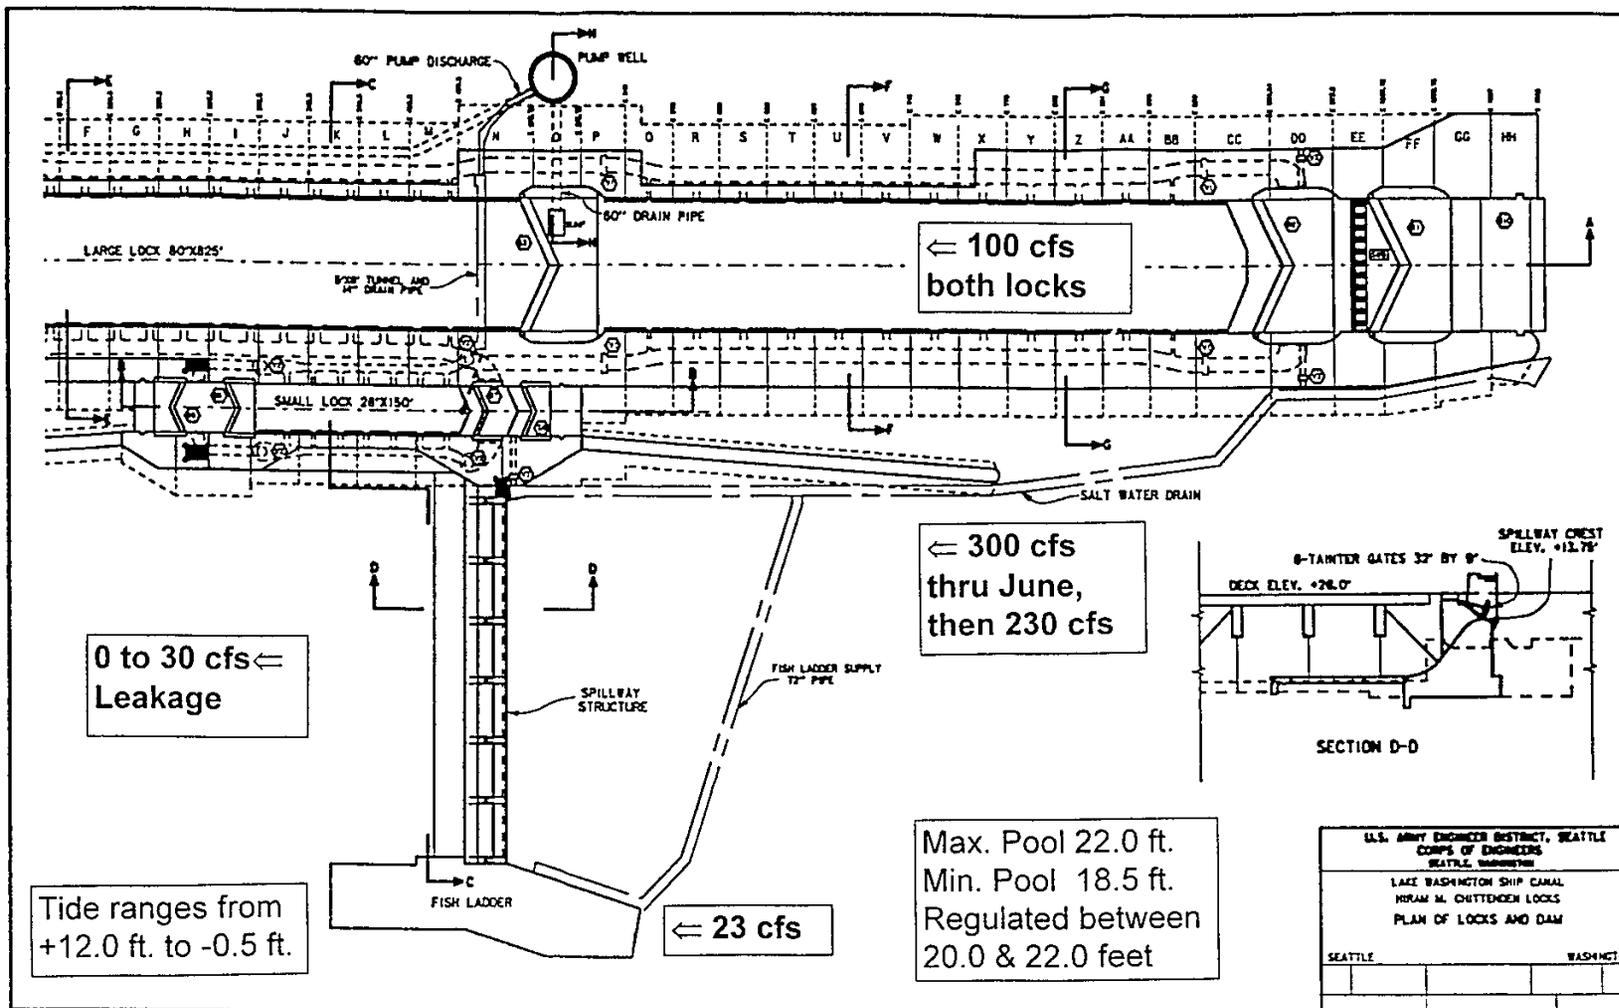
Figure 3. Plan view of the Locks including low flow volumes per outlet (from Fred Goetz, USACE)

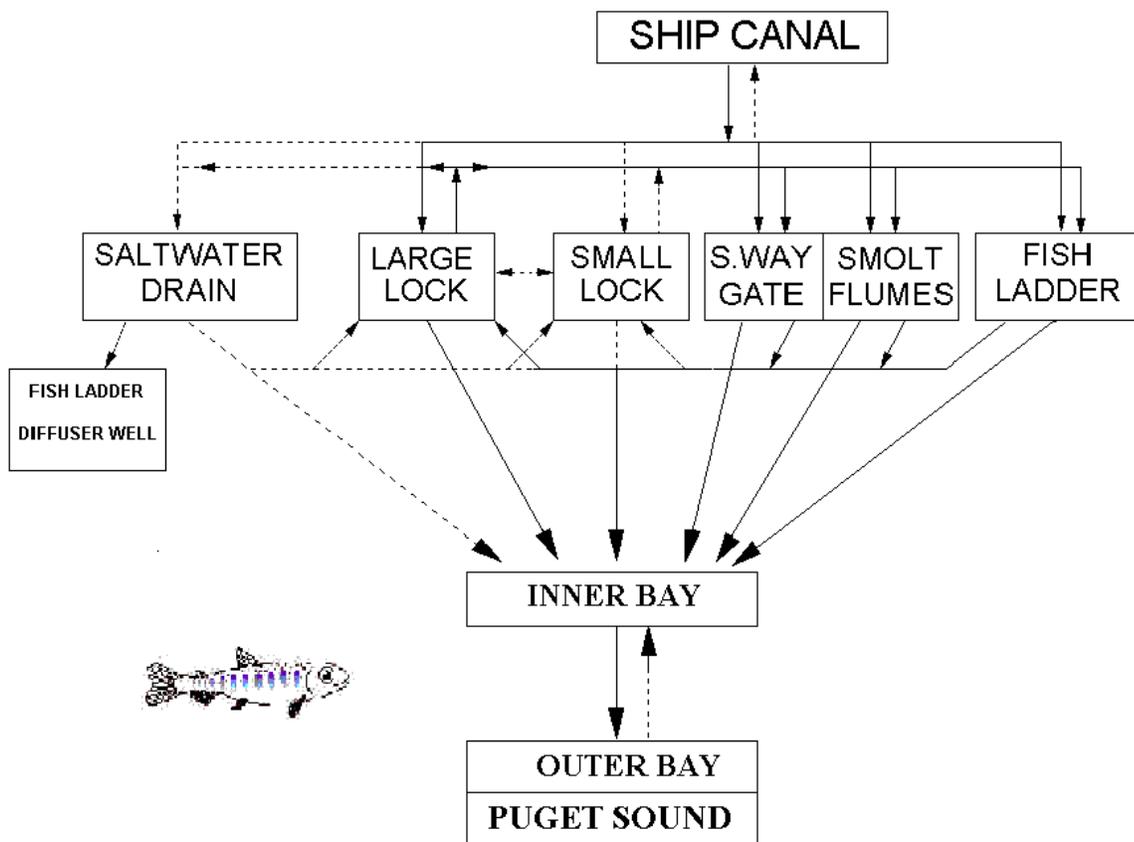
**Figure 4.** Conceptual model of observed (solid line) and possible (dashed line) downstream passage routes for juvenile salmon at the Hiram M. Chittenden Locks (from Fred Goetz, USACE).

The Locks provides the only passage route into and out of the Lake Washington drainage for several species of salmon and steelhead. Adults enter the system through the fish ladder on the south bank or pass through the navigation locks. Smolts that have been rearing or released in the system must pass through the structure on their migration to the sea. There are 12 different routes that smolts can use to pass into the marine environment: 1) the fish ladder; 2) one of 6 spillway gates; 3) prototype smolt slide (up to 1999) or four smolt passage flumes (beginning in 2000); 4) the old salt water drain and over the spillway at the north end; 5) the salt water drain through the fish ladder auxiliary water supply; 6) entrainment into the small lock filling culverts; 7) volitional migration through the small lock miter gates and downstream as boats; 8) entrainment into the small culverts (2 x 4 ft. side portals) during down lockage in the small lock; 9) entrainment into the large lock filling culvert intakes and into the upper lock chamber; 10) entrainment into the large lock filling culverts and into the full lock chamber; 11) entrainment into the small (2 x 4 foot) culverts during down lock (of the upper or full lock chambers); and 12) volitional migration through the large lock miter gates and down lock as boats. Data from previous studies indicate that both smolts and adults may pass through the structure multiple times. [Figure 3 and 4](#) present diagrams modeling the potential paths that salmonid smolts might take through the project.

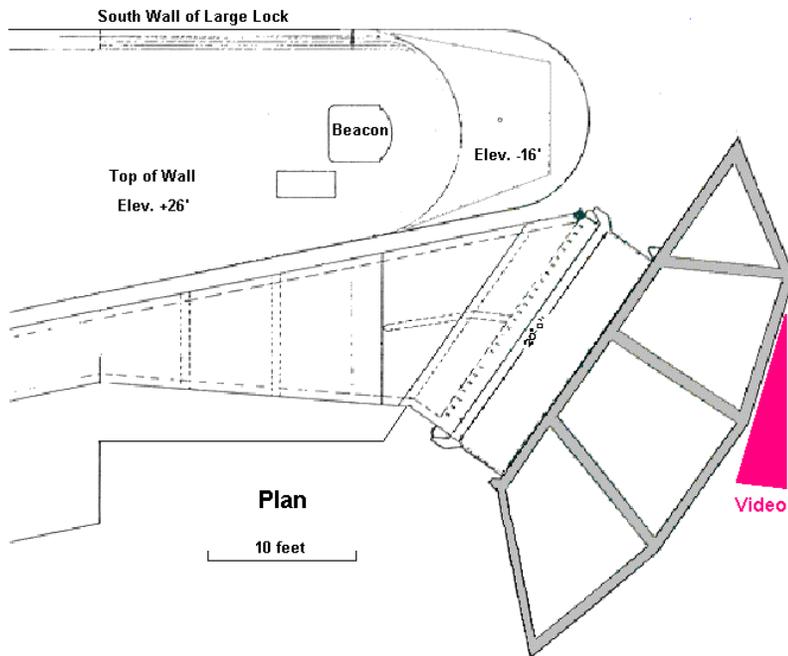
**Figure 5. Plan view of salt-water drain intake showing location of video camera mount and approximate field of view.**

The camera housing was clamped to a pipe mount attached at mid-height of one of the vertical stainless steel bars at the mouth of the salt-water drain. The camera depth was about 47 feet below the surface. We decided to use no auxiliary lighting to insure that the measurement equipment did not affect fish behavior. The mount location and approximate field of view are shown in Figure 5. The zoom lens was adjusted to the widest field of view and the focus was set to infinity.

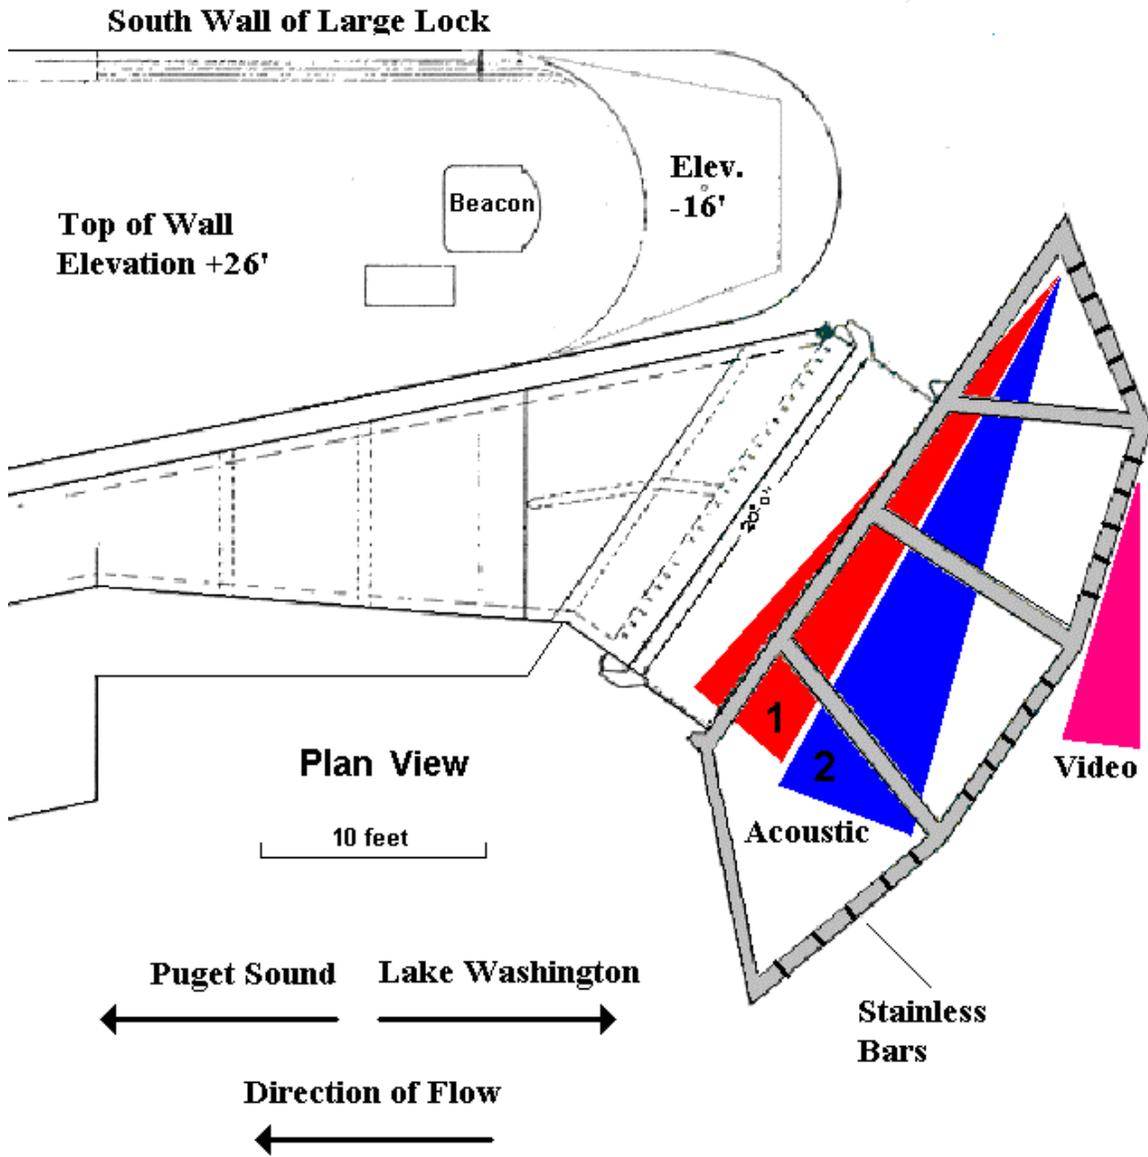
**Figure 6.** Plan view of salt-water drain intake (with roof transparent) showing position relative to pier between large and small locks.

The primary system for minimizing salt-water intrusion involves the use of a settling basin immediately east of the large lock and a siphon system to return the salt water to the marine environment. The intake of this system is located to the southeast of the end of the pier, between the large and small locks, at a depth of 50 feet. A fan-shaped intake structure ([Figures 6-7](#)) houses 4 openings 12 feet across and 4 feet high. The intake structure is constructed of concrete. Vertical bars of 1x3 inch stainless steel are spaced at 2-foot intervals to block the entrance of large objects. The floor of the structure is lined with bags of concrete. Considerable scouring has jumbled the bags and scoured underneath the northern sidewall. The dimensions of the structure decrease to 2 feet high by 20 feet across at the innermost part of the structure, at which point the flow is vectored upward into a manifold that transitions to the shape of a pipe ([Figure 8](#)).

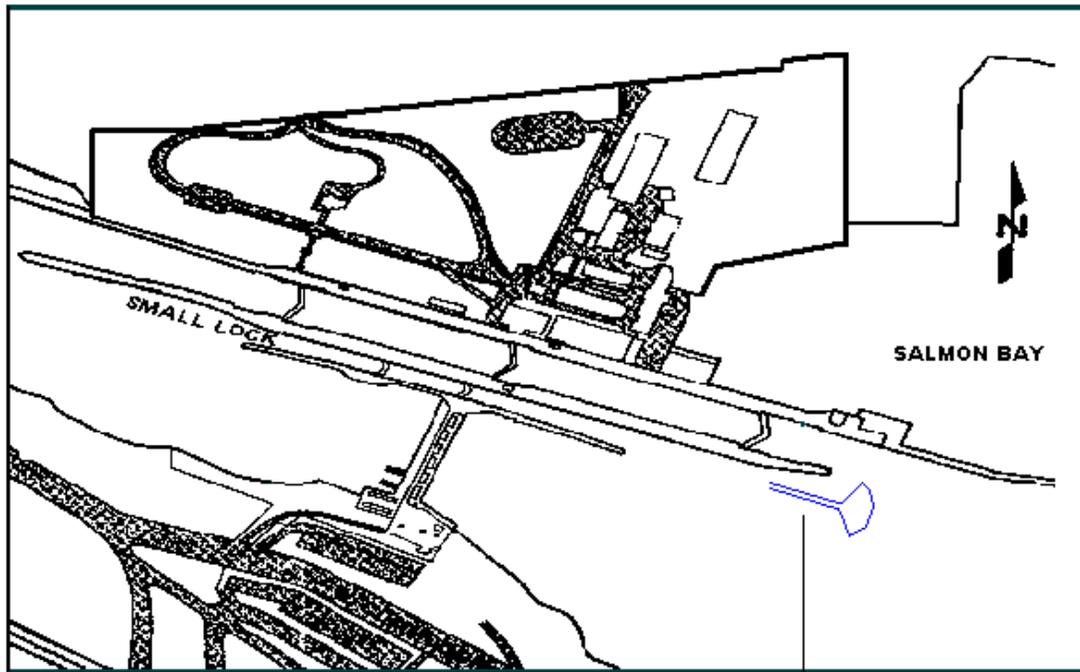
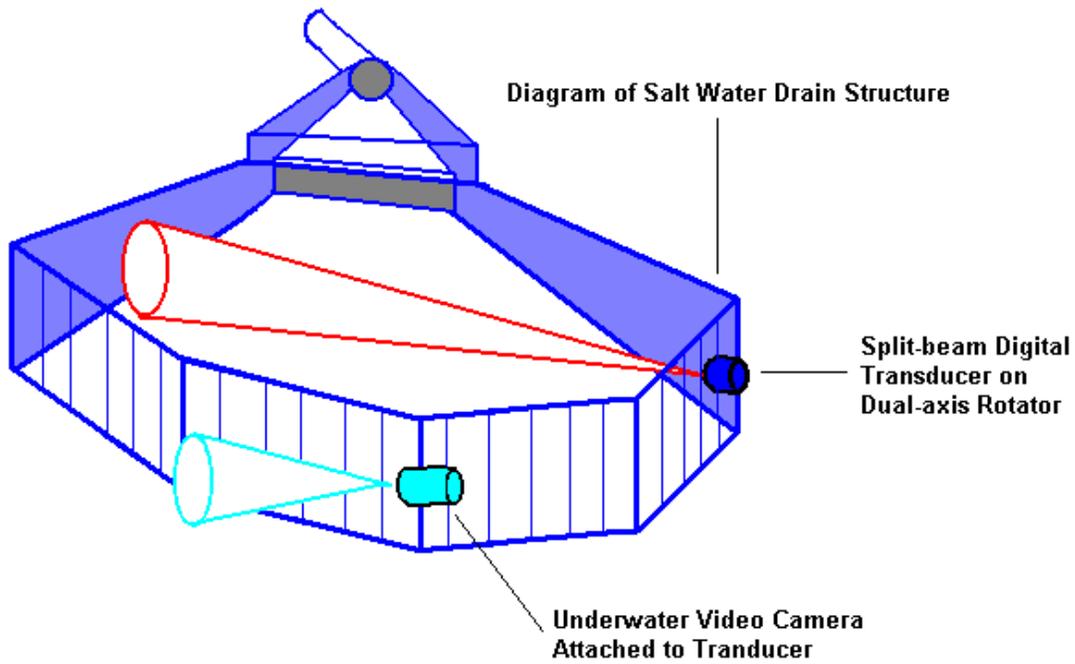
Approximate Position of Salt Water Drain

Diagram of Salt Water Drain Structure

Split-beam Digital Transducer on Dual-axis Rotator

Underwater Video Camera Attached to Transducer

**Figure 7.** Isometric representation of salt-water intake.

A DT6000 200 kHz split-beam scientific echo sounder manufactured by BioSonics was used to detect fish inside the intake structure. The echo sounder used a 6-degree nominal beam angle circular transducer. The transducer was mounted on a dual-axis rotator attached to the northernmost stainless steel vertical bar (see Figure 6). The assembly was mounted such that the transducer was about 3.5 feet from the floor of the intake gallery. The horizontal and vertical aiming angles were controlled remotely. From April 24 through May 31, the transducer was aimed toward the transition point at the rear of the structure (see aiming angle #1 in Figure 6). No fish were observed by the sonar system in this configuration, either due to shadowing by the rear wall or to reduced fish detectability associated with high passage velocity. On June 1<sup>st</sup>, the transducer was rotated upstream and aimed across the intake opening as shown by aiming angle #2 in Figure 6. The vertical angle was minutely adjusted to maximize sonar detection range and minimize returns from the bags of concrete forming the floor of the intake.

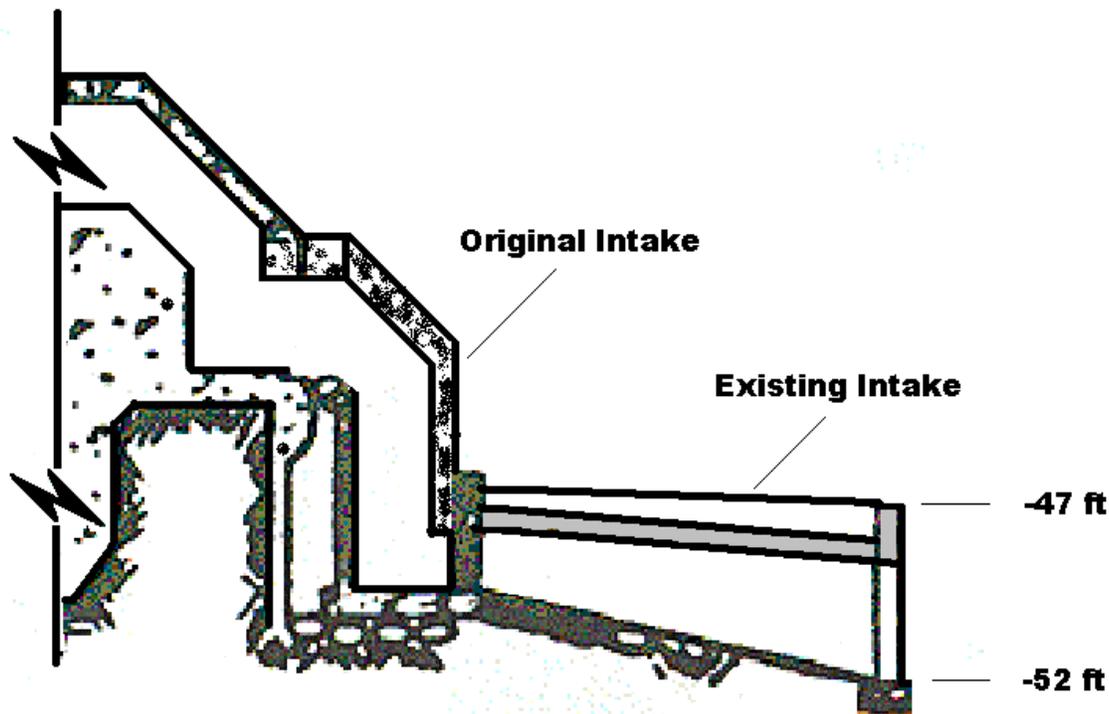
**Figure 8. Cross Sectional View Through the Salt Water Drain Intake Structure**

The flow through the salt water drain system is driven by gravity and flows through pipes to two locations; one flows into a diffuser system in the fish ladder, while the second passes through a chute at the north end of the spill bay section. The flow through the diffuser is 160 cfs, and the flow through the chute is 140 cfs. When both paths are opened, the velocity at the mouth of the salt-water drain is approximately 1.5 feet per second (assuming a mouth opening of 192 square feet and a flow of 300 cfs). The water accelerates as it arrives at the back of the structure, where drawings indicate an opening 2 feet high and 20 feet across. 300 cfs passing through a 40 square foot opening would produce velocities approaching 8 feet per second. Before studies commenced, divers rearranged the concrete bags to form a relatively level and smooth floor of the drain structure. Divers observed and removed considerable debris, primarily ropes, plastic sheets, and tarps, that were wound around the vertical stainless steel bars.

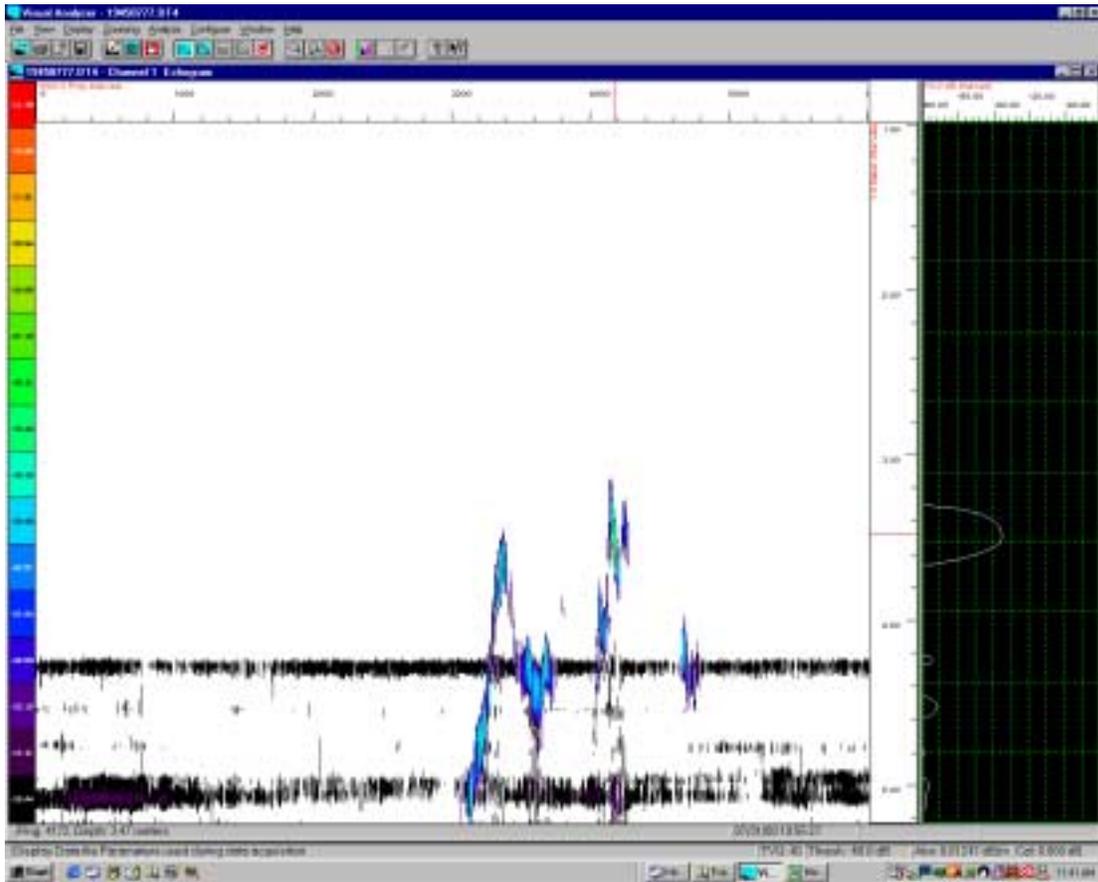
**Figure 9.** Echogram showing large targets resisting entrainment flow.

The video system mounted in front of the salt-water drain intake observed fish swimming in the incoming flow, and typically resisting entrainment for long time periods. Fish observed by the video camera did appear in the upper half of the observed field. In addition, the flow entering appeared to have about a 30° downward angle from horizontal as it approached and entered the mouth of the salt-water drain. The echo sounder sound field was located further back in the intake, where flow was accelerating. Patterns observed by the acoustic system showed fish being carried with the current, then exhibiting a burst of swimming speed to move back toward the opening. This behavior created “saw tooth” type patterns on the echo sounder (Figure 9). Often fish would leave the beam while they were being entrained; other times they would exit the beam while swimming toward the mouth. For the purposes of entrainment estimation, we assumed that all fish observed by the echo sounder were eventually entrained. We do not have data to test the validity of this assumption. Because fish may have been carried through the sonar beam, swam out at a slightly different depth or location, and then been carried again through the sonar beam, we believe that the entrainment estimates presented in this report represent either maximum values or perhaps overestimates. However, since only the center portion of the flow was sampled, biases operating in the opposite direction could occur if fish were oriented to the sidewalls of the intake structure. The study design was not configured to test these assumptions.

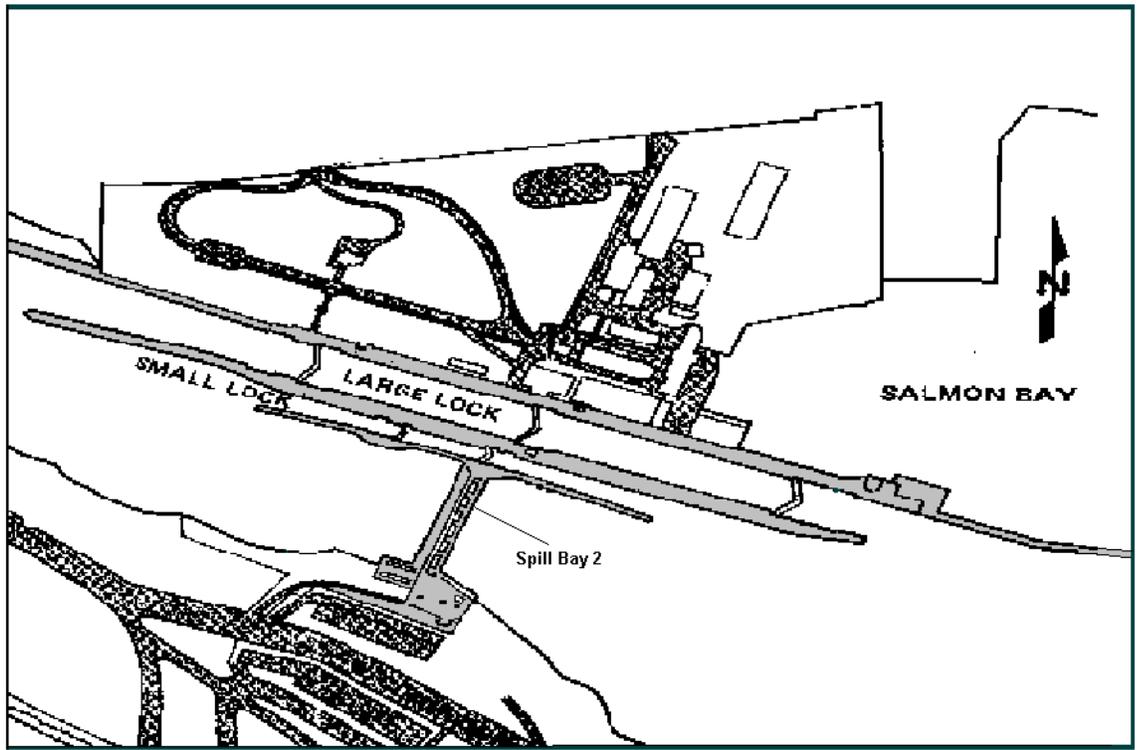
**Figure 10.** Plan view of the Hiram M. Chittenden Locks and surrounding structures.

Six spill bays are located to the south of the small lock (Figure 10,11). The bays are numbered from the north or lock end.

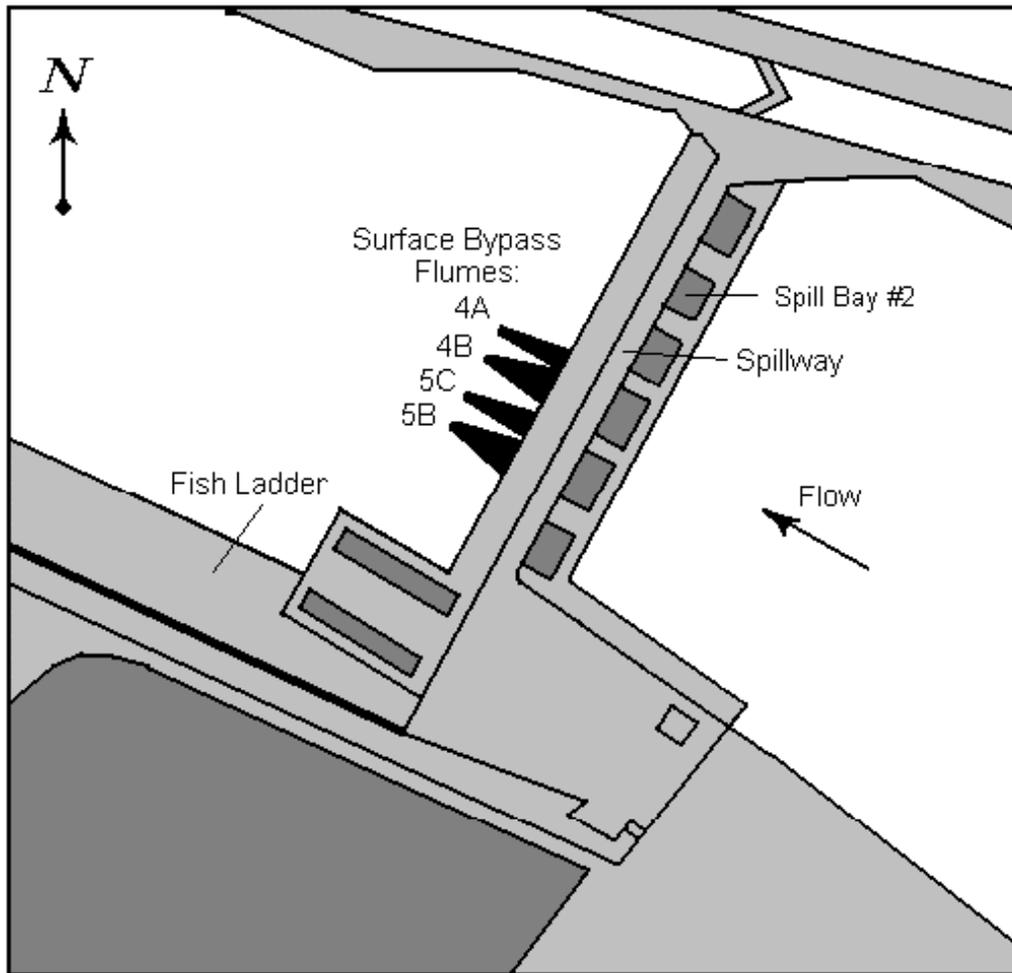
**Figure 11.** Plan view of spillway showing the location of the experimental flumes and spillway bay numbers.

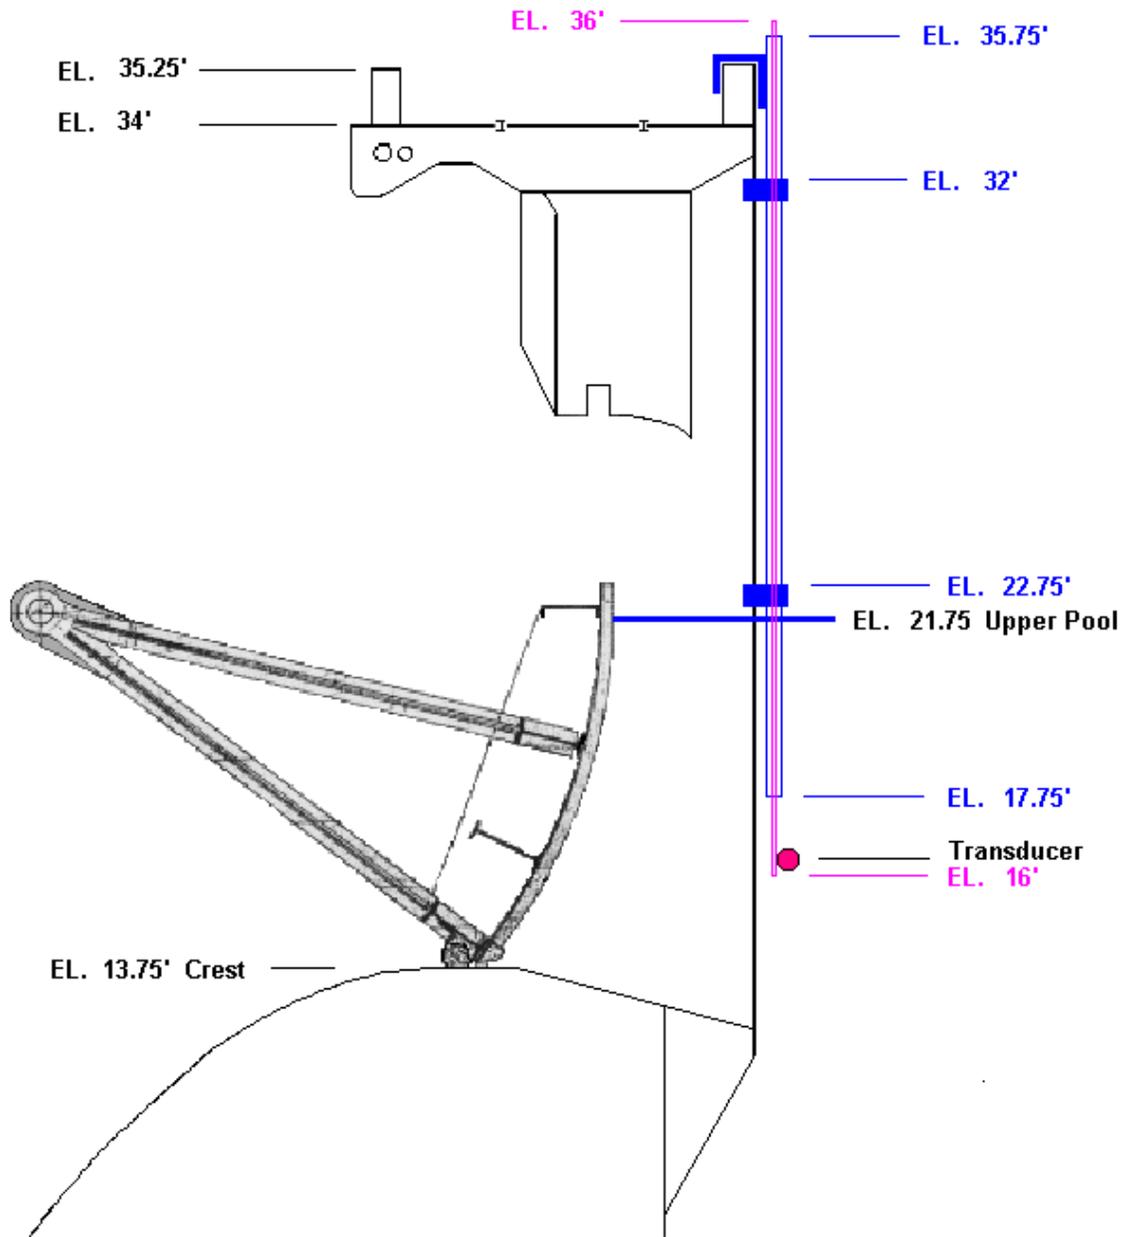
**Figure 12. Spill Bay # 2 showing tainter gate and acoustic transducer deployment.**

Each gate is a tainter gate, which is lifted to pass water. Single-beam 6 degree transducers were installed on each side of Spill Bay 2 at an elevation of 16 feet and aimed horizontally across at the opposite pier nose (Figures 12,13). Gate #2 was selected because it was forecast to have a continuous operating schedule and was physically separated from the installation of the fish flumes at gates 4 and 5. The transducers were initially oriented parallel to the front of the tainter gate, then rotated toward the gate as far as possible before interference from the gate was observed. This aiming procedure placed the sound fields as close to the bottom of the gate as acoustically possible.

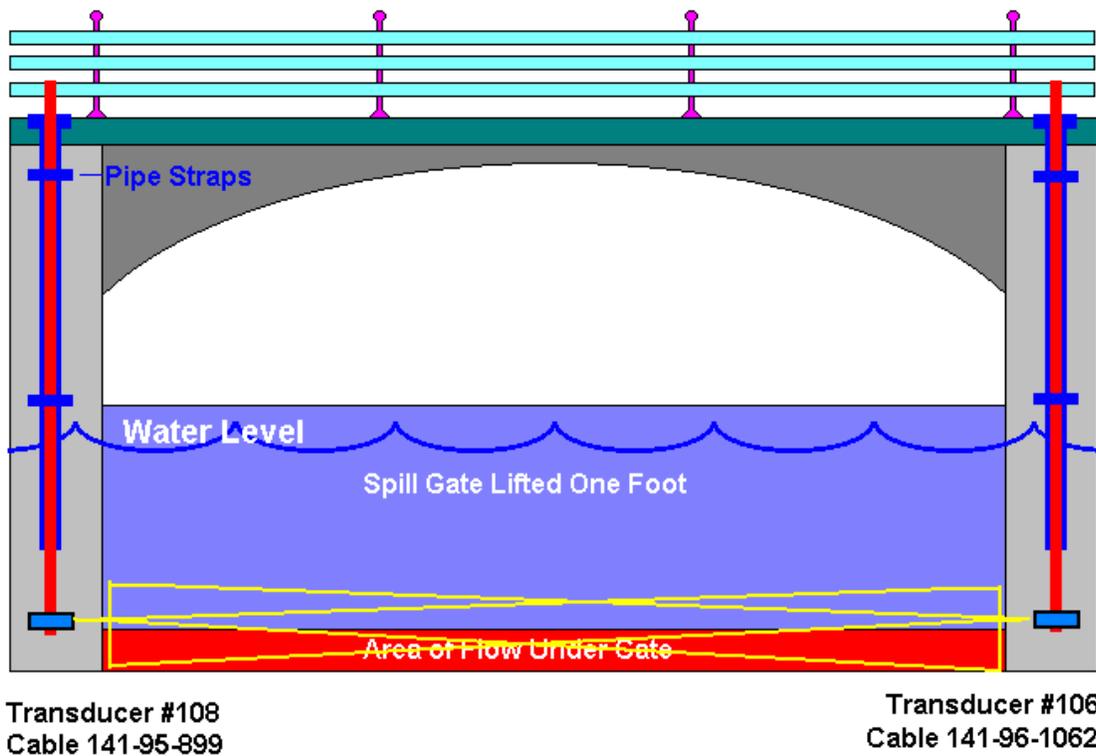
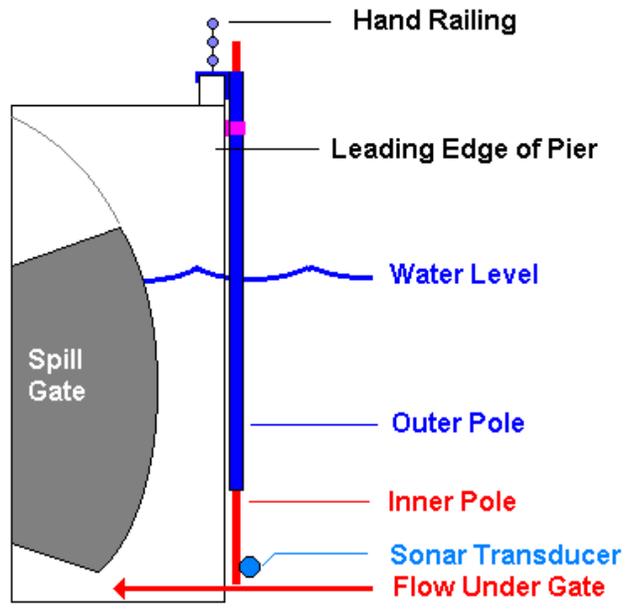
**Figure 13.** View of Spill Bay #2 from upstream showing transducer aiming geometry. Lower panel provides a cross-sectional view.

We incorporated the far half range of acoustic detections from each transducer into the fish passage estimates, that is, 16 to 32 feet in range. The nominal beam dimensions at these ranges were greater in vertical extent than the gate height openings used during all of the block design study. We observed high numbers of echoes in traces that could be identified as coming from a single fish. Due to the high number of detections and the full vertical coverage, we did not attempt to utilize a detectability model to estimate the effective beam width. We assumed full coverage of the opening and did not apply any spatial extrapolation.

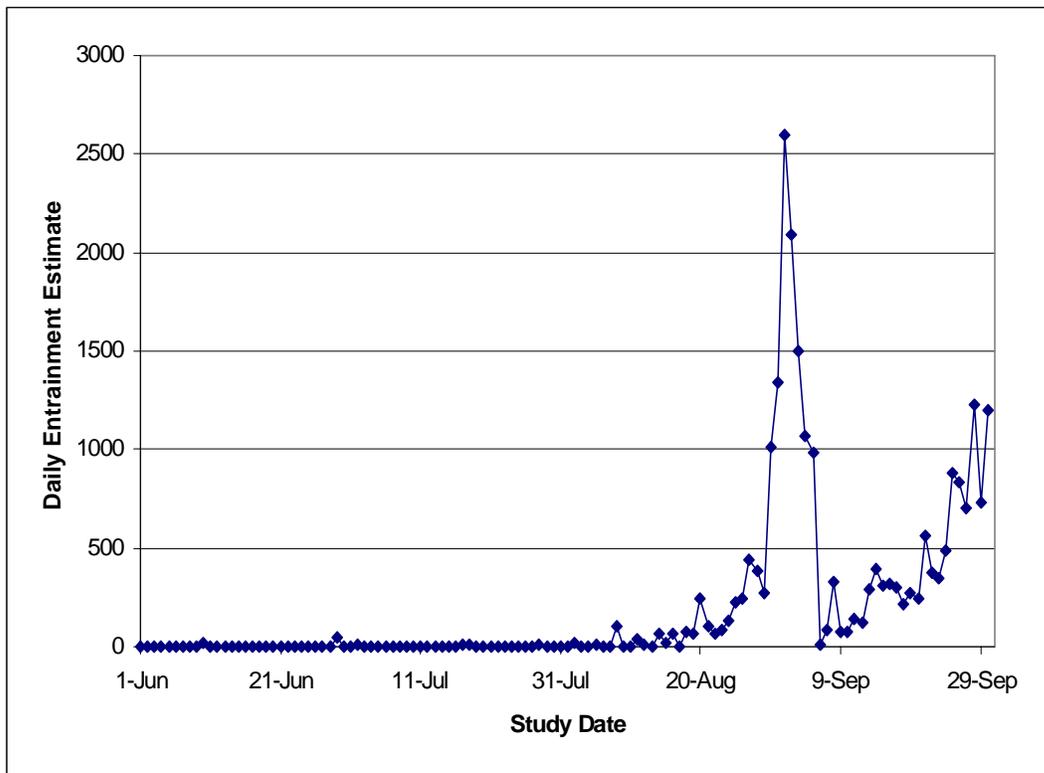
**Figure 14. Seasonal Fish Entrainment Pattern at the Salt Water Drain**

Hourly fish entrainment estimates are presented for June through September 2000, in [Tables 6-9](#) respectively. Horizontal and vertical sums are shown to characterize daily passage and monthly diel periodicity. No fish were observed by the acoustic system prior to the adjustment in the horizontal aiming angle on May 31<sup>st</sup>. Although fish counts were low until mid-August, we believe that the transducer orientation prior to May 31<sup>st</sup> may have had reduced acoustic detectability due to the accelerated flow near the rear of the salt-water drain.

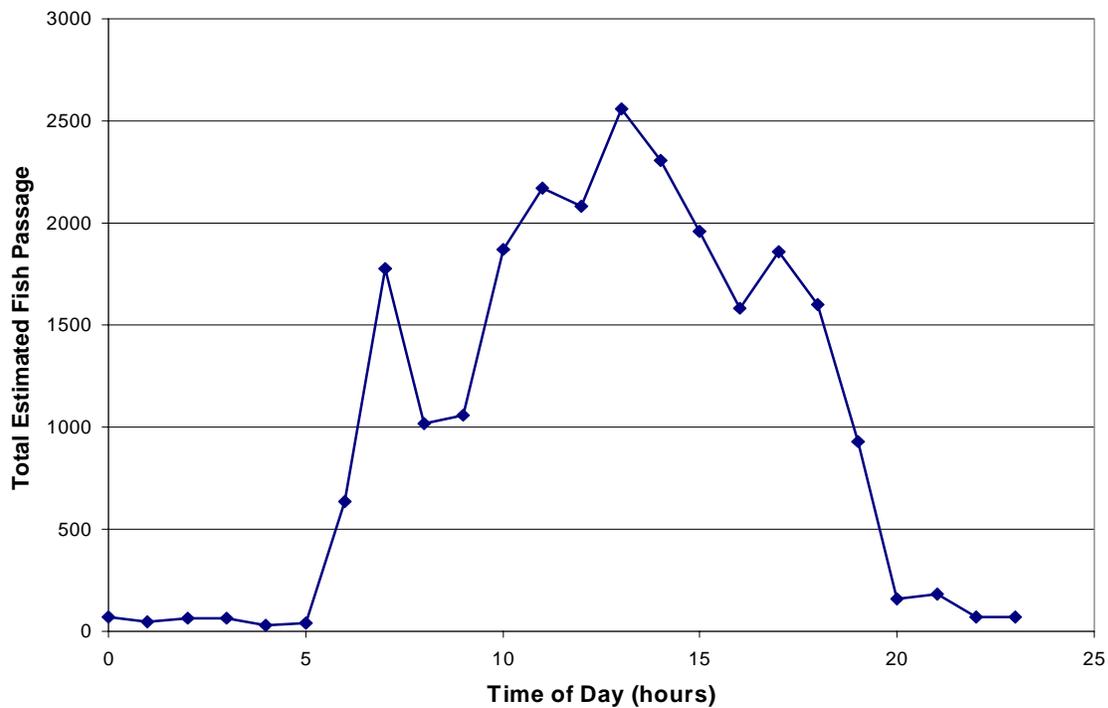
**Figure 15. Diel Fish Passage Pattern, Salt Water Drain Intake, April 24<sup>th</sup> through September 30<sup>th</sup>, 2000**

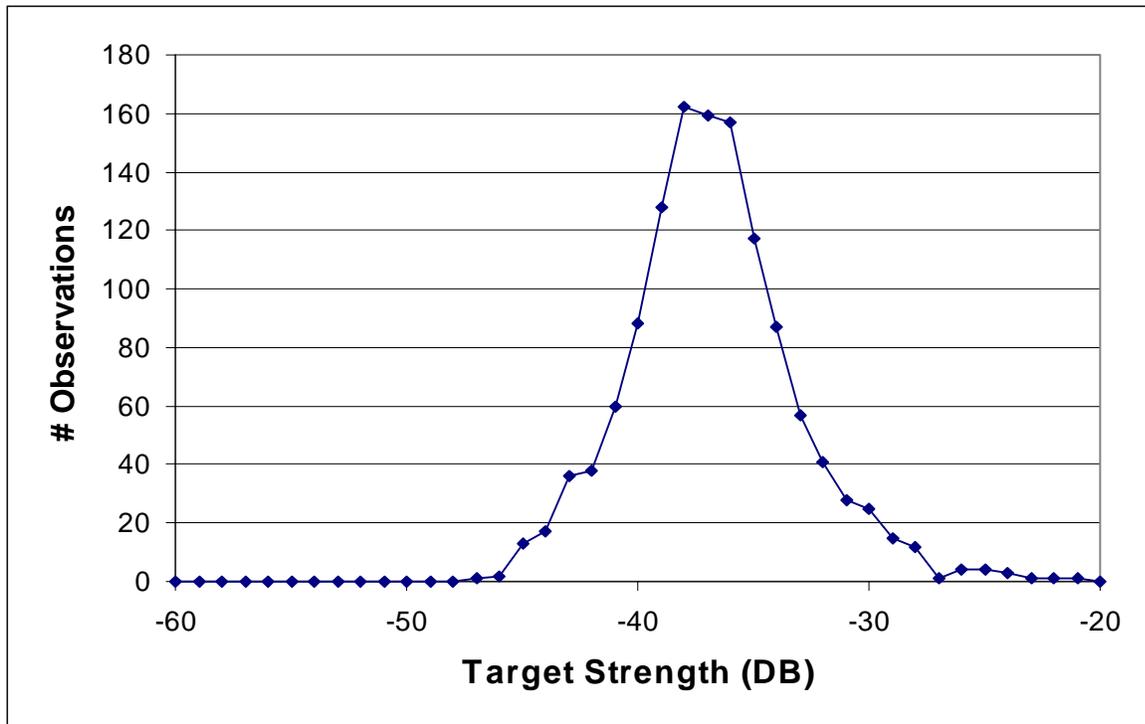
**Figure 20.** Target Strength Distribution of Fish Observed at the Salt Water Drain, August 2000

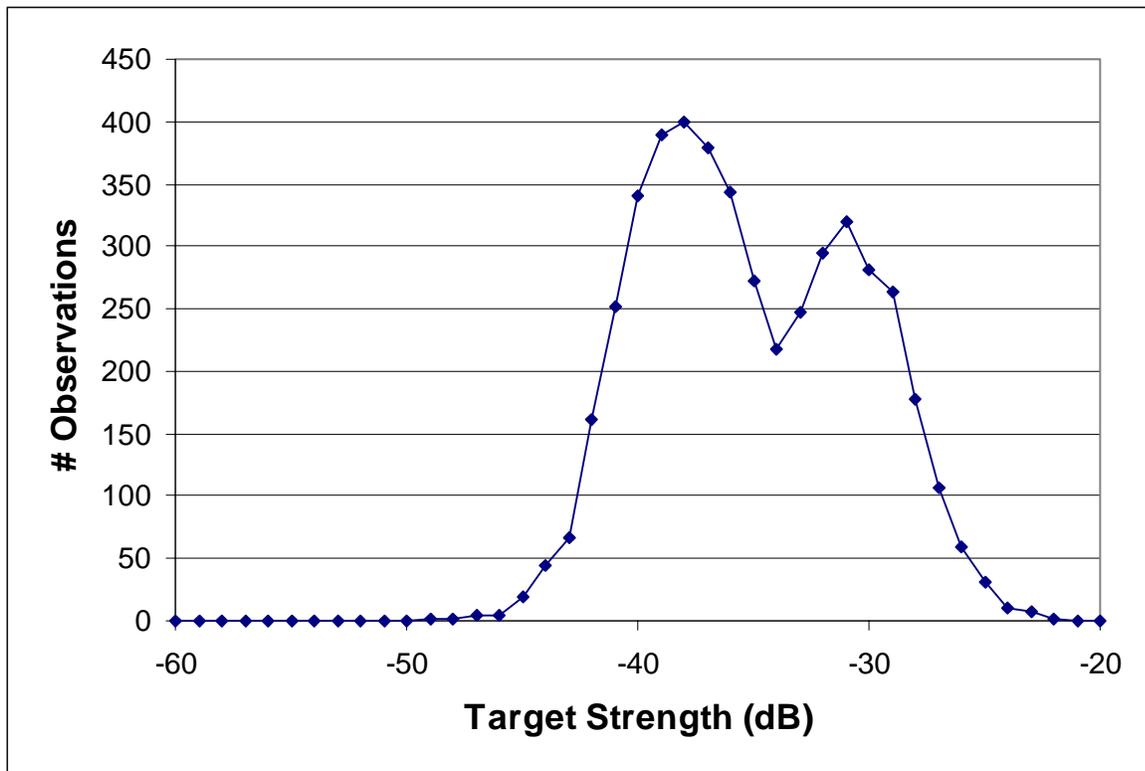
**Figure 21.** Target Strength Distribution of Fish Observed at the Salt Water Drain, September 2000

The arrival of adult salmon at the salt-water drain in September is reflected by the bimodal target strength distribution. We interpret the high number (several hundreds) of observations in the large size mode of **Figure 21** to be caused by adults being carried into the entrance and through the acoustic sensor, then resisting and swimming back upstream. Observations from both the video and acoustic systems suggest that the adult salmon may be more successful at swimming back out of the salt water drain once they are partially entrained than are the smaller marine species. A pattern of movement into and out of the entrance of the salt-water drain was documented by the acoustic system and shown earlier in **Figure 9**. We observed this behavior in most of the large targets entrained. While many of these fish may successfully leave the salt-water drain intake after their battle with the inward flow, many are clearly at risk of entrainment if they are carried too far into the structure to resist the rapidly accelerating flow.

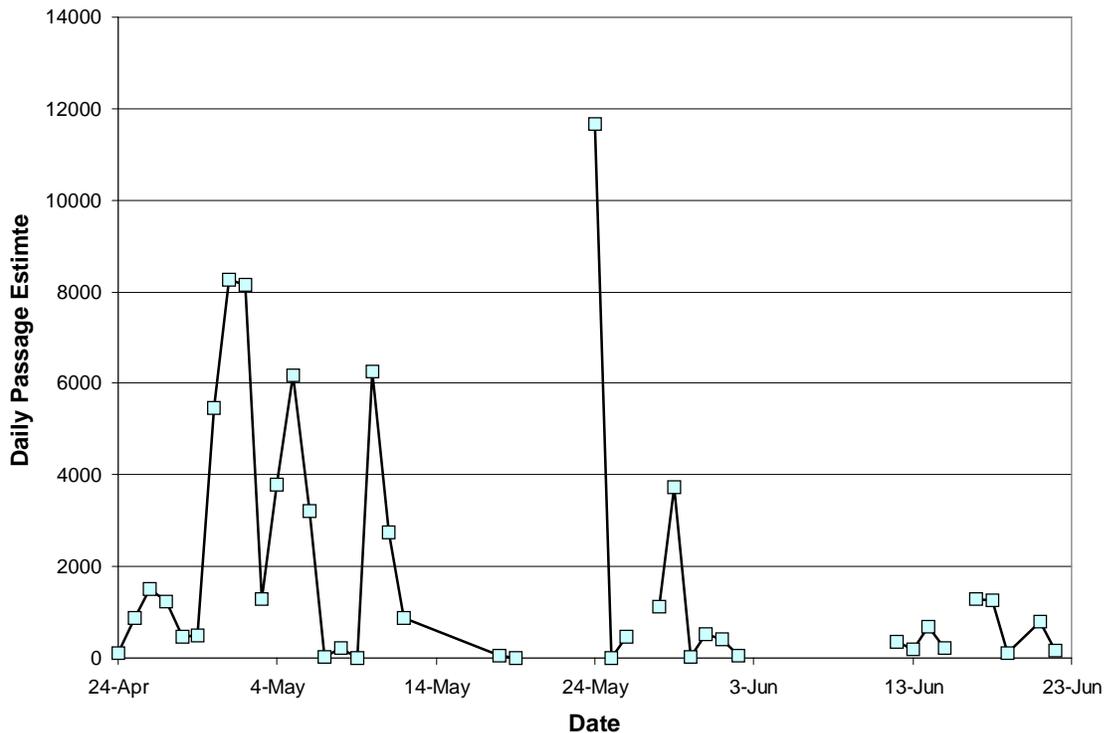
**Figure 22. Fish Passage Numbers Through Spill Bay #2 for the Entire Study Period**

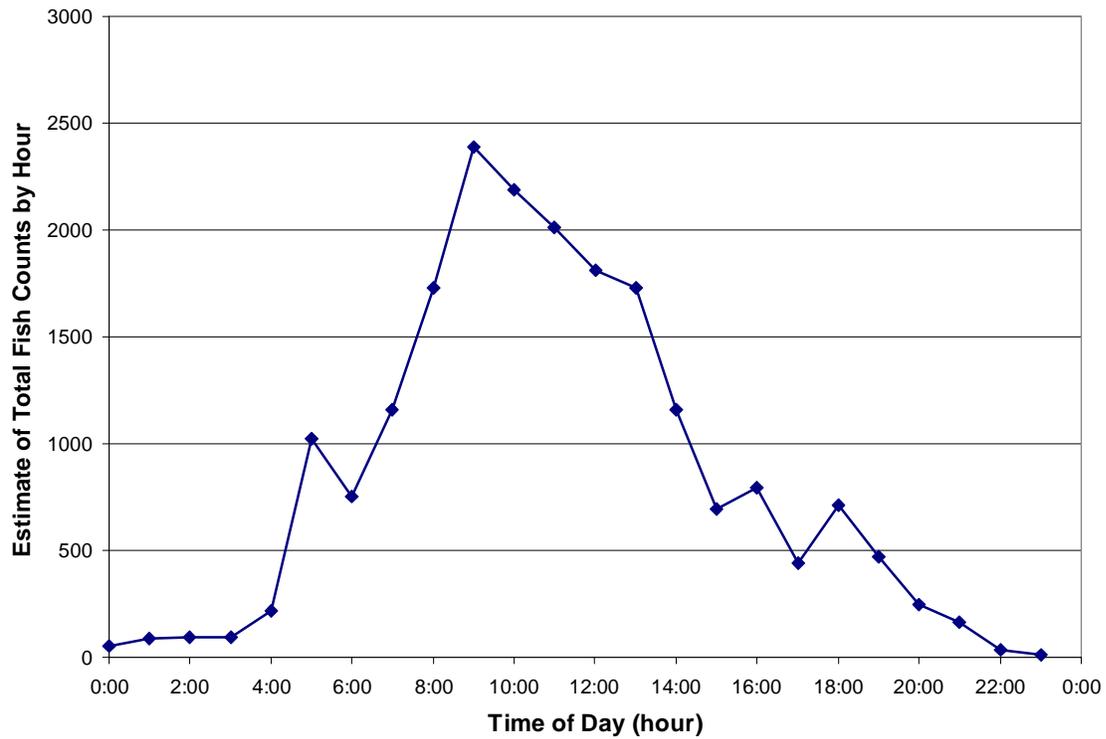
**Figure 23 . Seasonal Diel Passage Pattern Through Spill Bay #2**

The diel pattern of fish passing through Spill Bay #2 for April 24<sup>th</sup> through June 22<sup>nd</sup> is given in Figure 23. Diel passage patterns are presented by week in Figures 24-31. Figure 24 provides

Diel passage patterns were not observed until the last day of April ([Table 11](#)). Starting on April 30<sup>th</sup>, significant increases in passage rate through Spill Bay #2 were observed at dawn. During most of the subsequent sample days, this pattern was observed. For example, a significant diel passage pattern is observed on May 5<sup>th</sup>, where a sharp increase in passage rate corresponds with daybreak. After a drop in passage rates around 0800 hours, rates again are high from 1000 through about 1400 hours. On May 24<sup>th</sup>, the increase in fish passage rates through the spill bay again corresponds with the onset of daylight. Passage rates decrease by 1400 hours but remain quite high through 1900 hours. The remaining figures also show a strong increase in passage rate at daybreak, while passage peaks are seen later in the day during the last half of June. In general, passage is significantly reduced at night through Spill Bay #2.

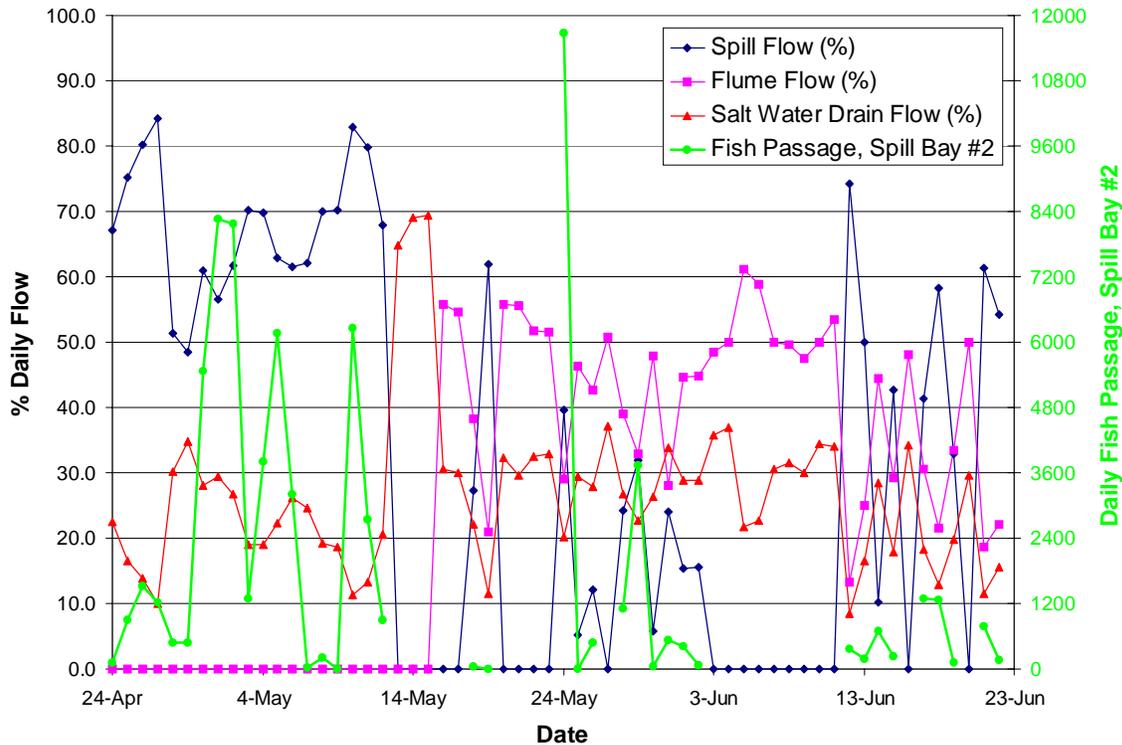
**Figure 32. Fish Passage Through Spill Bay #2 with Daily Flow Through Selected Routes.**

The acoustic fish passage data through Spill Bay #2 have no video or target strength data to indicate species. However, confidence is high that the visual observations of fish passing through fish flumes are salmonids. This observation suggests that salmonid smolts are drawn towards the spill region by flow as they migrate downstream. This flow can be provided either by smolt flumes or by open spill gates. The fish passage data through Spill Bay #2 are re-plotted against selected flow curves in [Figure 32](#).

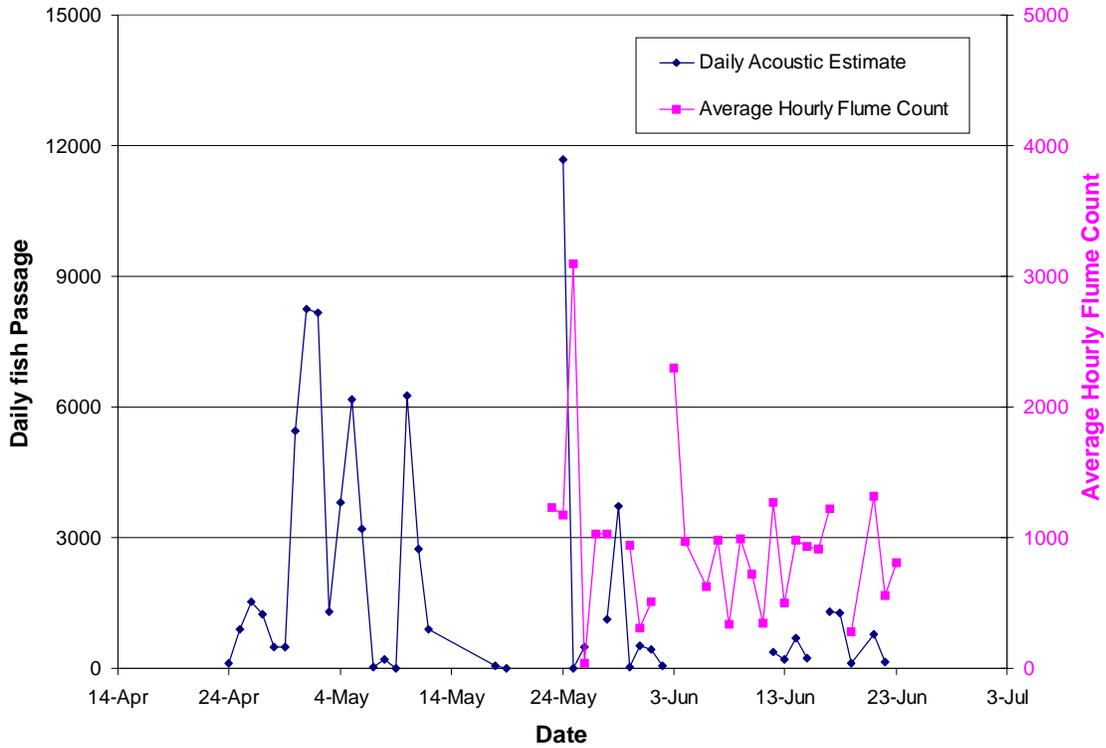
**Figure 33. Total Daily Fish Passage Estimates through Spill Bay #2 from Acoustics with Average Hourly Flume Counts Overlaid**

High fish passage rates were observed through Spill Bay #2 until late May, at which time the smolt flumes were activated (Figure 33). A few remaining passage peaks always corresponded with reduced flume operation. Although the flumes provide surface flow, the spill gate opening is only about 7 feet below surface. It seems reasonable to conclude that either flumes or spill gates can supply attractant flow to draw fish from other regions of the project because the spill forebay is quite shallow. Since no data on species identification of fish passing through spill are available, and since salmonids dominated the visual observations through the flumes, we are assuming that salmonids also dominate the acoustic counts of fish passing through Spill Bay #2.
