Acoustic and Video Measurements of Fish Passage at the Hiram M. Chittenden Locks:

A Year 2000 Focus on the Salt Water Drain and Spill Bay #2

Final Report to:

BioSonics, Inc  
4027 Leary Way Northwest  
Seattle, Washington 98107

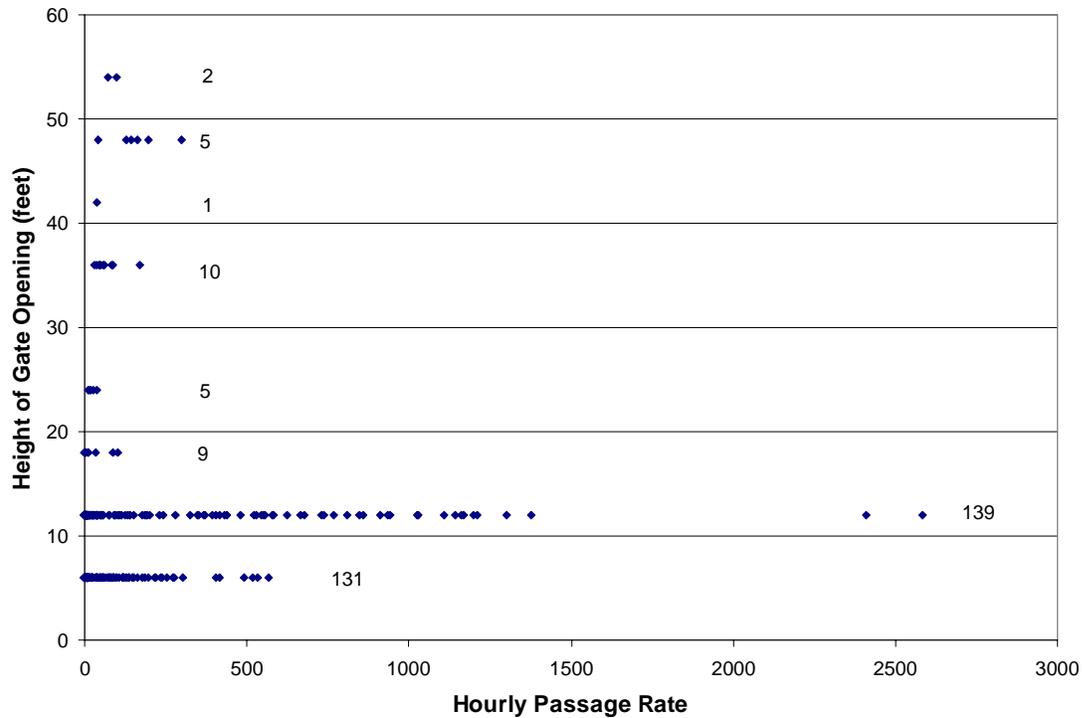
Figure 34. Scatter plot of hourly passage rate samples in the block design as a function of height of gate opening.

After removing hourly points representing gate settings not specified by the block design and points corresponding to down time on the acoustic system, the hourly passage estimates were plotted for the 6 inch and 12 inch gate openings in [Figure 34](#). Sample sizes are provided at each gate setting. Other data points that were not originally in the block design are included in [Figure 35](#).

The estimates of fish passage suggest increased passage at a 12-inch gate height. At the 6-inch height, only 7 points are higher than 300 fish per hour. When the gate is 12 inches high, 42 samples are over 300 fish per hour, and 12 samples are over 1000 fish per hour. The low sample size at any gate height greater than 12 inches precludes any conclusion of beneficial or detrimental effects on passage rate. The high variability at each level is characteristic of the patchy nature of the fish density as schools of various sizes approach and pass through the spill bay. A proposed causal mechanism for the difference in passage effectiveness with gate opening is that a 1-foot gate opening might provide velocities that extend to the surface-and capture surface-oriented fish, while the velocities produced by the 0.5-foot gate opening might not extend far enough.

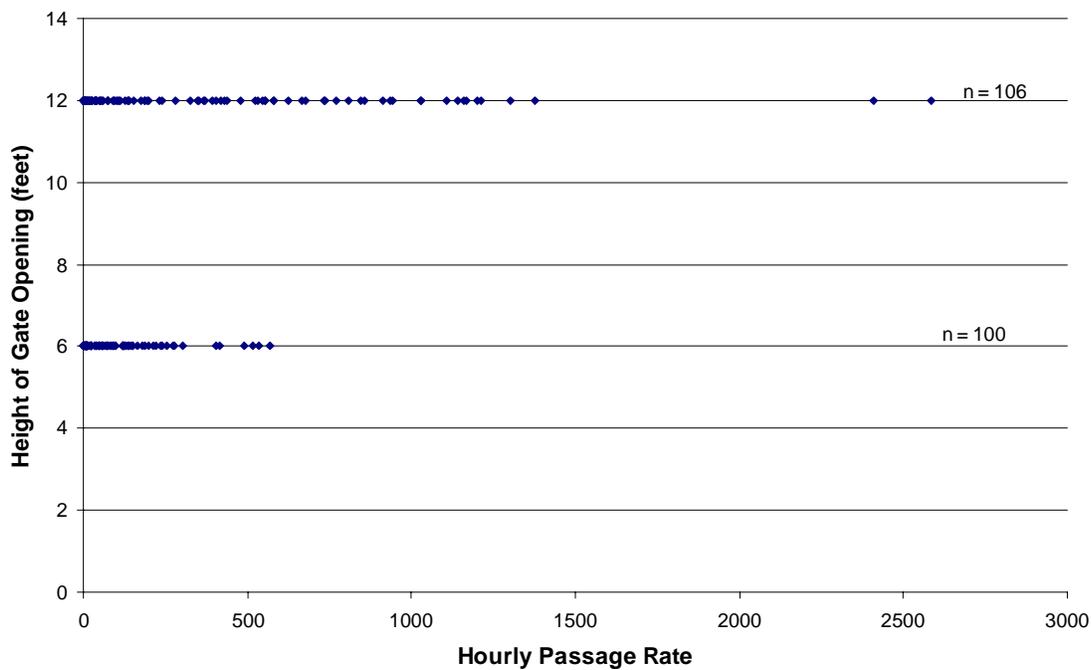
Figure 35. Scatter plot of all hourly passage rate samples as a function of height of gate opening.
