SPENCER ISLAND ECOSYSTEM RESTORATION
PUGET SOUND & ADJACENT WATERS
SNOHOMISH COUNTY, WASHINGTON

Appendix G
Phase 1 Environmental Site Assessment

**Puget Sound and Adjacent Waters Spencer Island Ecosystem
Restoration**

**PHASE I
ENVIRONMENTAL SITE ASSESSMENT**

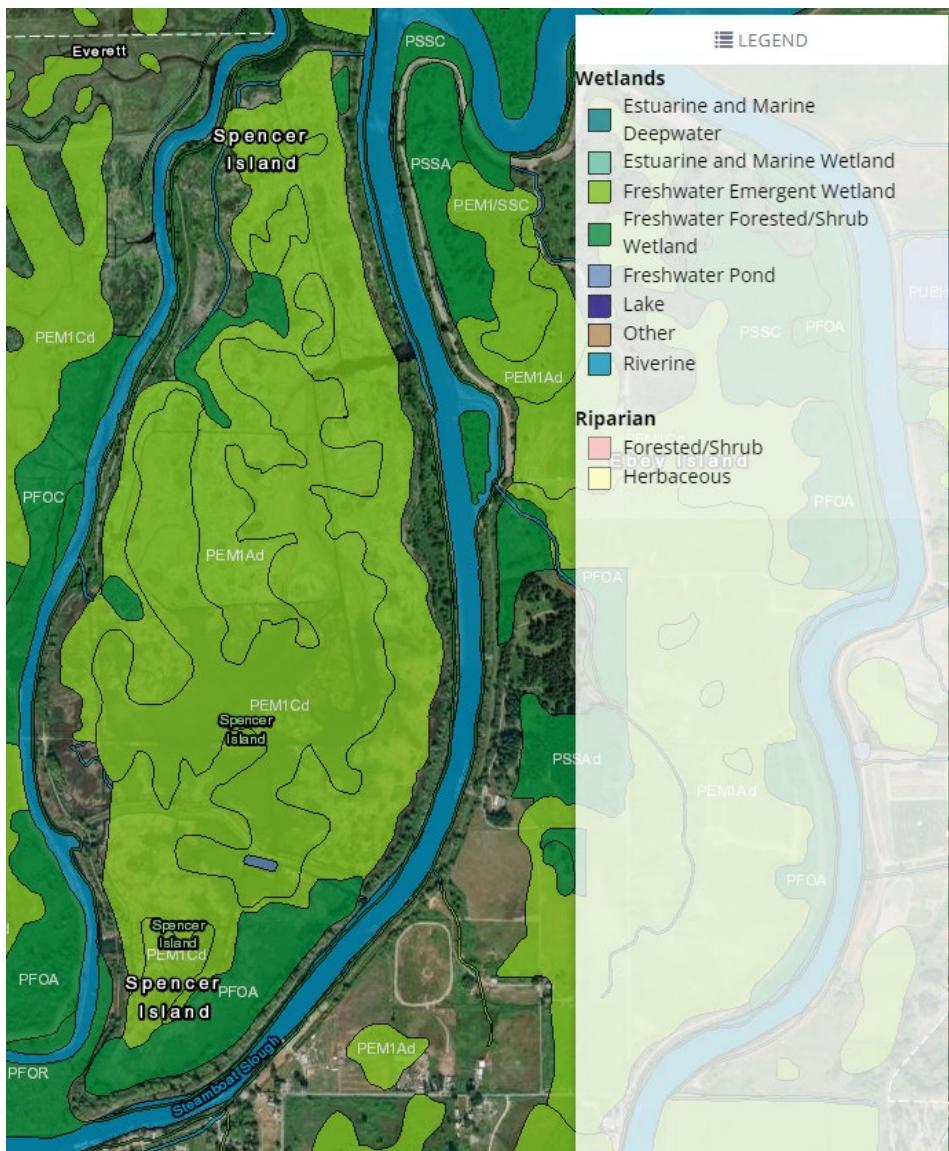
The National Wetland Inventory maps the entire study area as a wetland habitat (Figure 3) and classification codes are described below:

Figure 3. National Wetland Inventory database results for the study area which include classification codes PEM1Cd, PEM1Ad, and PFOA. (Source: National Wetland Inventory Database)

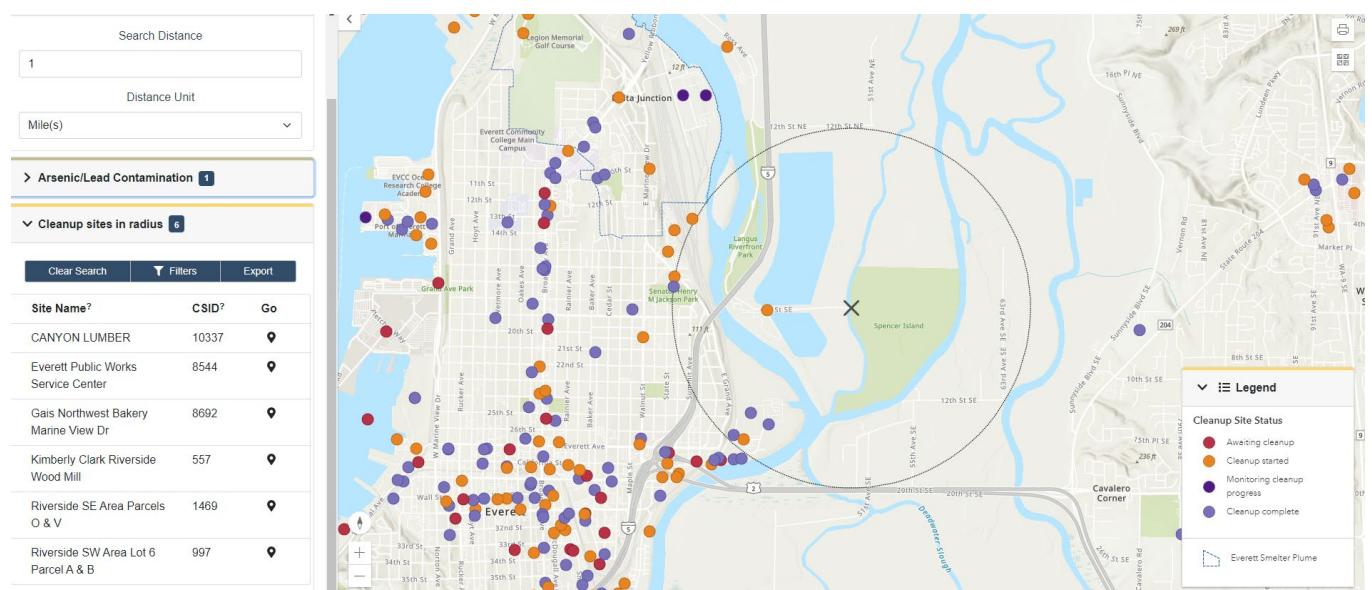
Two state underground storage tanks are registered within 1 mile of the project footprint: Canyon Lumber and Everett Public Works Service Center (Figure 4). Canyon Lumber is an upland site for soil contamination of confirmed mercury, metals, and non-halogenated pesticides. The early notice letter for Canyon Lumber was completed on June 10, 2013. Everett Public Works Service Center is

Figure 4. Cleanup Sites located within 1 mile of Spencer Island. Four Cleanup Sites are listed as 'No Further Action'. The Everett Smelter Plume is outlined in blue. (Source: DOE. 2023a)

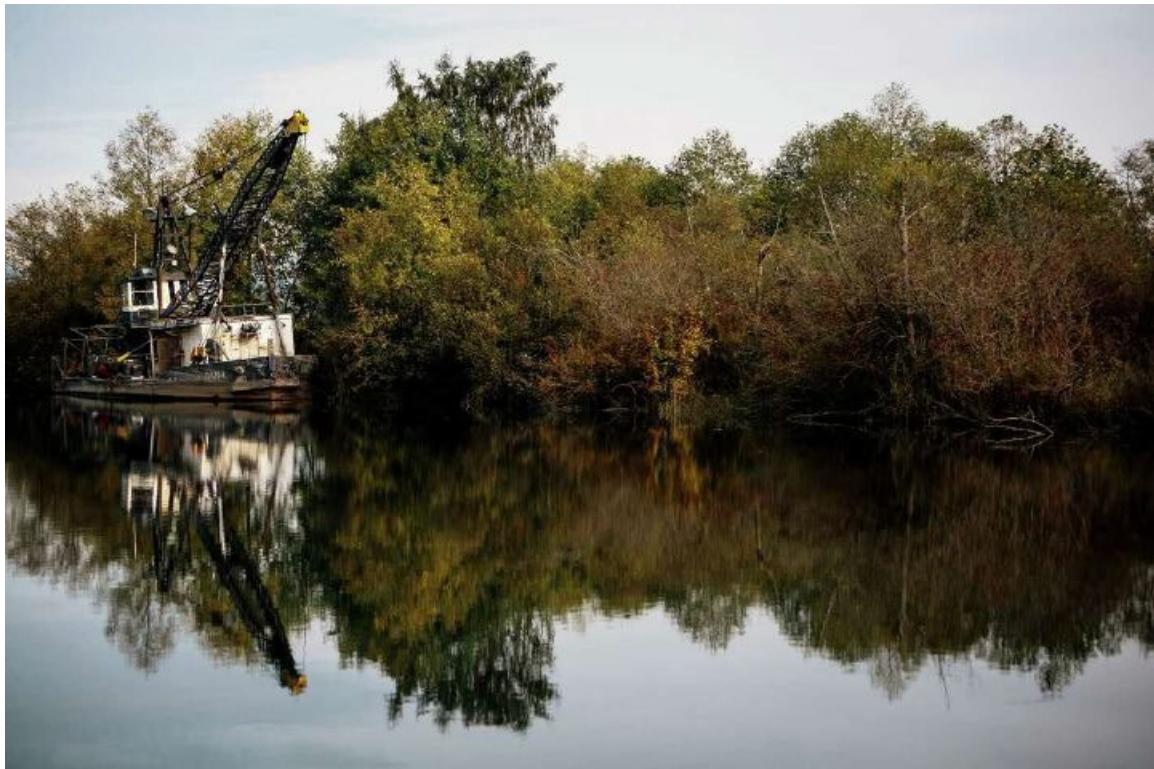
Additional information was gathered after viewing the derelict vessel and barge on Steamboat Slough. The site has become intertidal in the last 18 years and as the slough widens, there has been an increase in debris that has accumulated on site including an unmarked derelict barge and vessel. Although additional information about the derelict vessel and barge could not be obtained, an online newspaper article dated October 3, 2014, titled "*Everett's boat graveyard, Steamboat Slough*" includes a similar photograph of a derelict vessel which may have been dumped by uninterested owners (Figure 12).

Figure 12. Derelict Vessel from October 3, 2014, newspaper article *Everett's boat graveyard, Steamboat Slough*. (Source: Hearts Newspapers, LLC. 2023)

A second derelict vessel and barge are present in Steamboat Slough adjacent to Spencer Island (See Section 6.0). While release of contaminants into Steamboat Slough from the vessel is unknown at this time, any of the alternatives implemented for the ecosystem restoration project are unlikely to alter hydraulic conditions in such a way that results in mobilization of potentially impacted sediments.

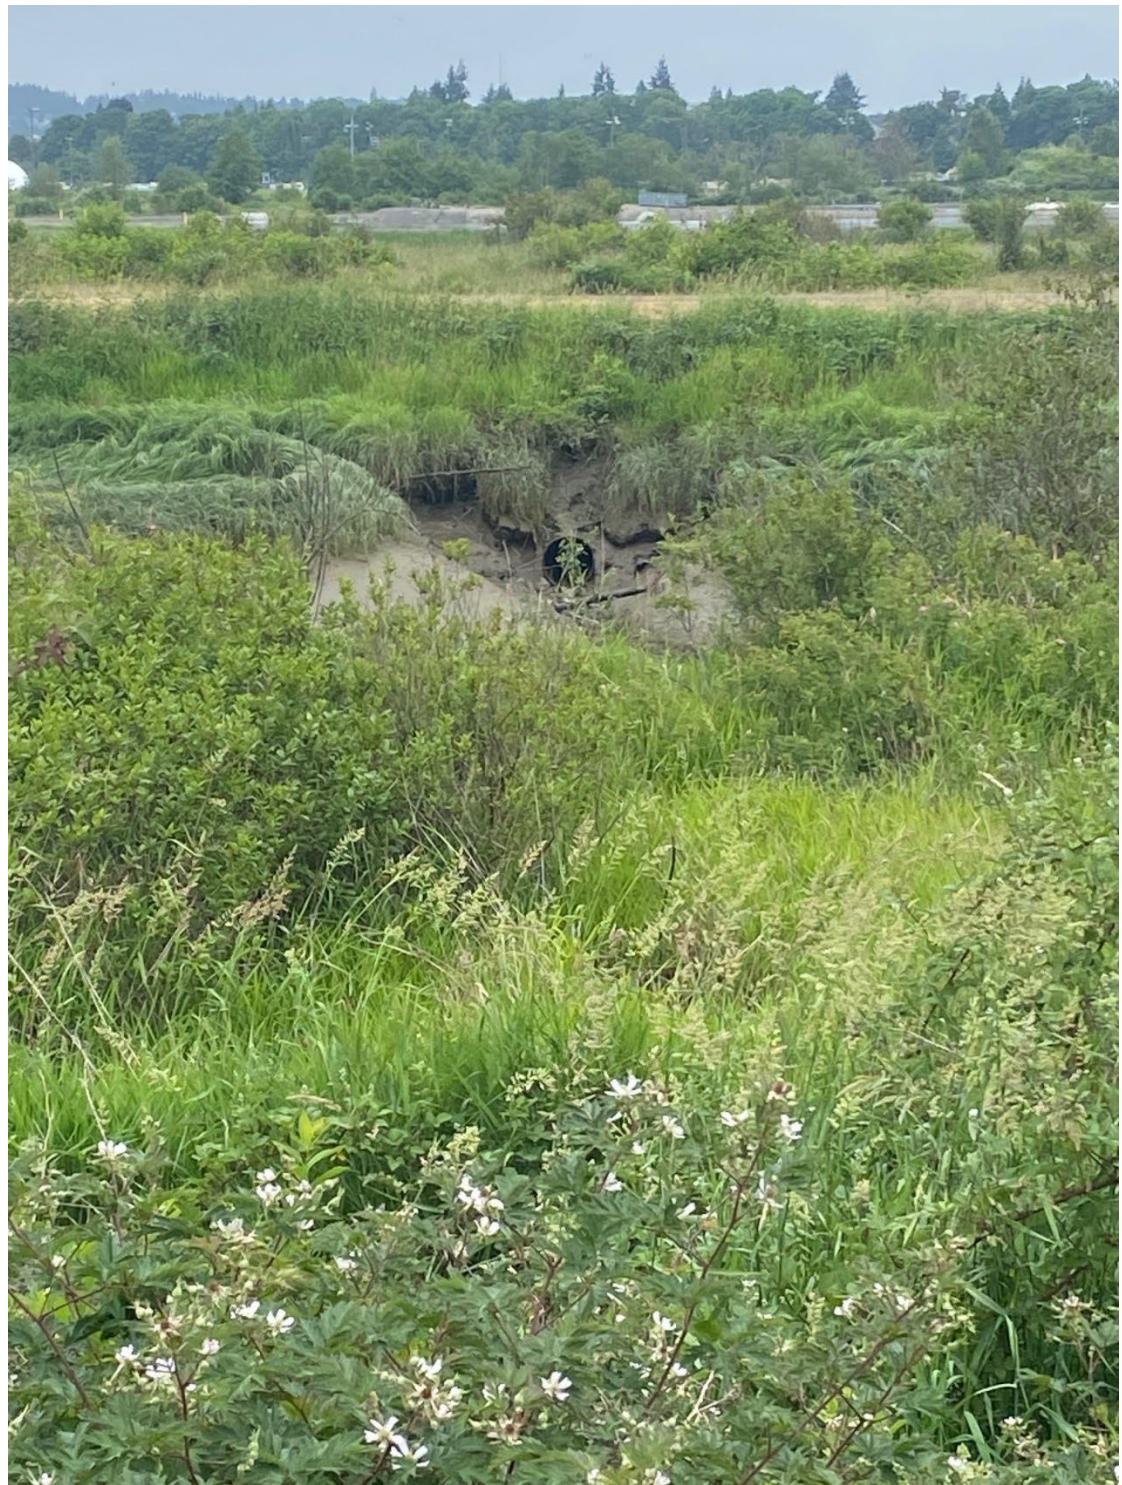
Photo

The Site Inspection Team retraced their steps and noticed one storm outfall in the levee looking west. The team took the cross-through trail towards the eastern side of the island. The team saw one rusted-out metal drum on the northern side of the cross-though trail. The team ended on the eastern side of the island and crossed the second bridge to view the East Channel, which is just south of the project footprint. A derelict barge and vessel are located on the eastern shoreline of the channel.

4. Storm outfall in levee

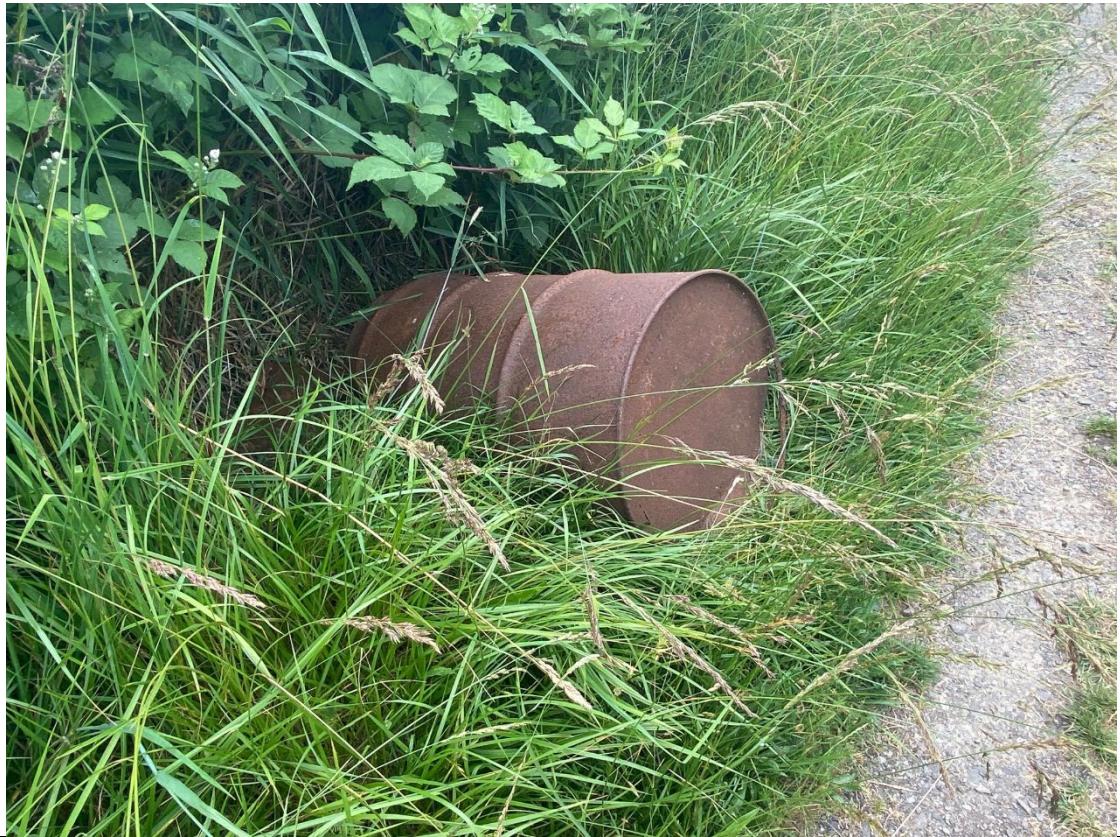
**Photo
7.**
Rusted
Drum

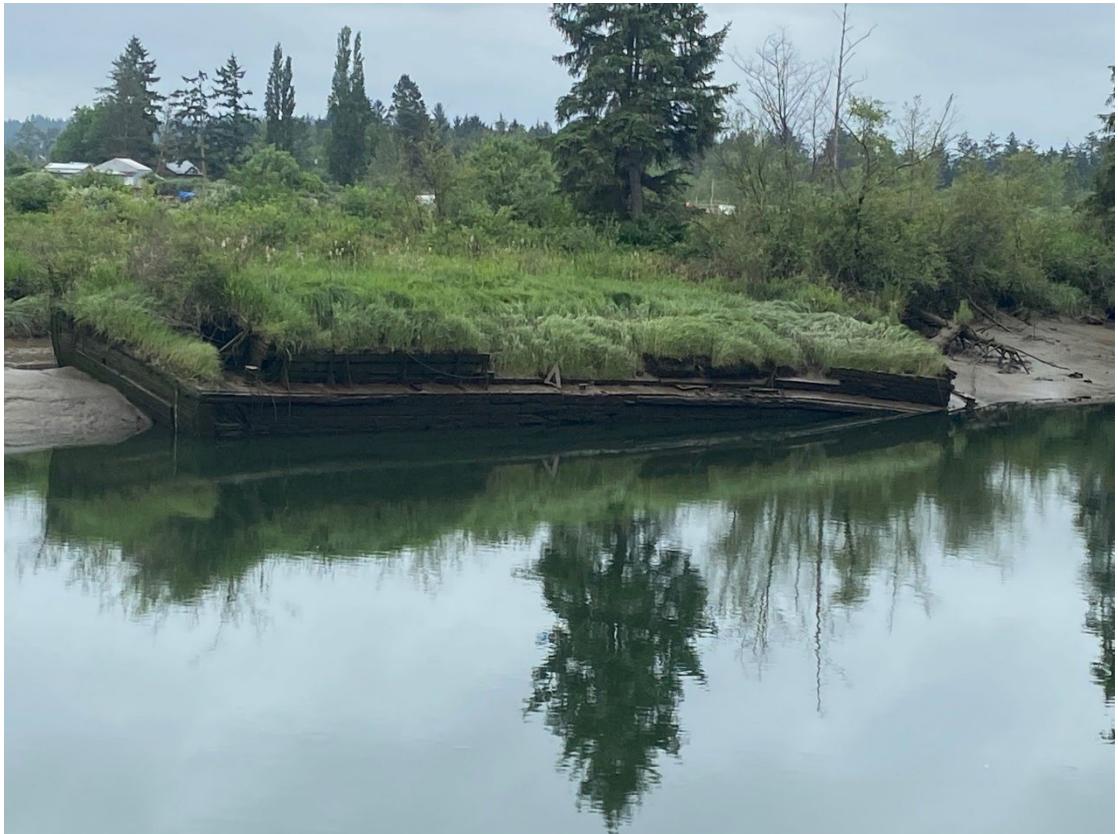
Photo 10.
Derelict Barge on East Channel 1

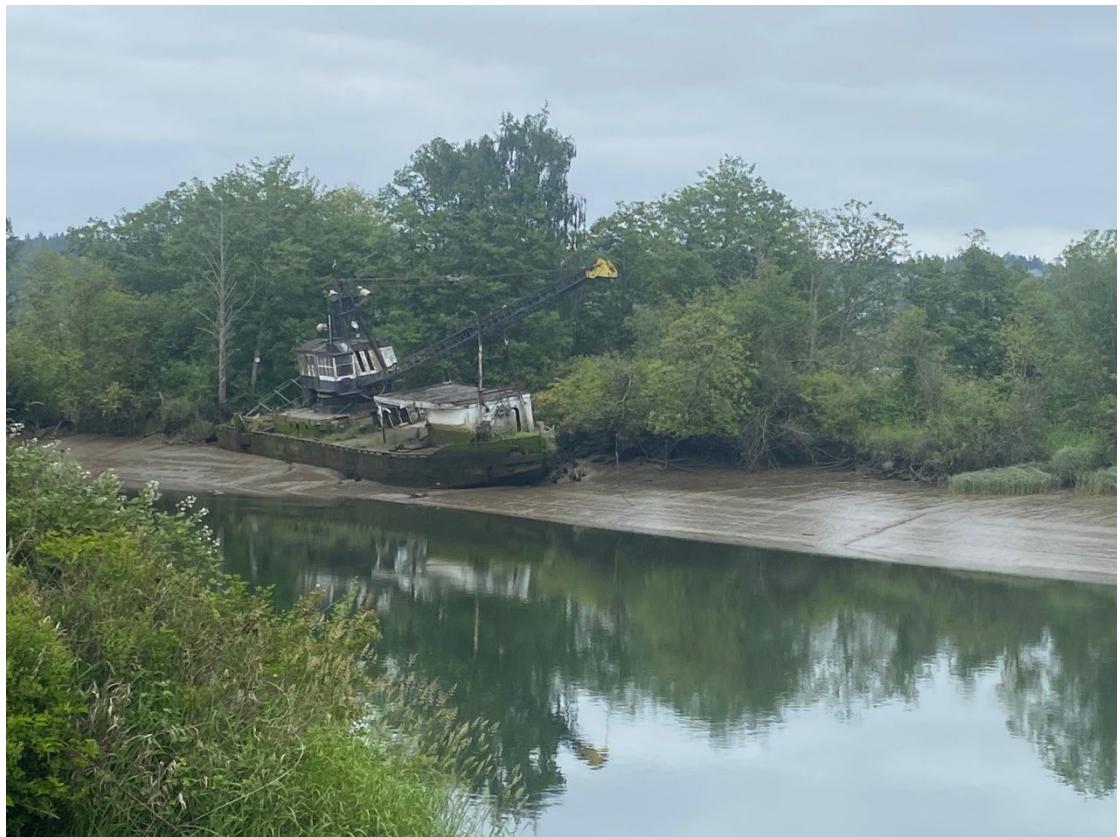
Photo 11.
Derelict Vessel (north of the derelict barge) on East Channel 1
