# Port Gardner Monitoring Pilot Study

# Sediment Profile Imaging & Plan View at Port Gardner

Physical monitoring to evaluate current conditions

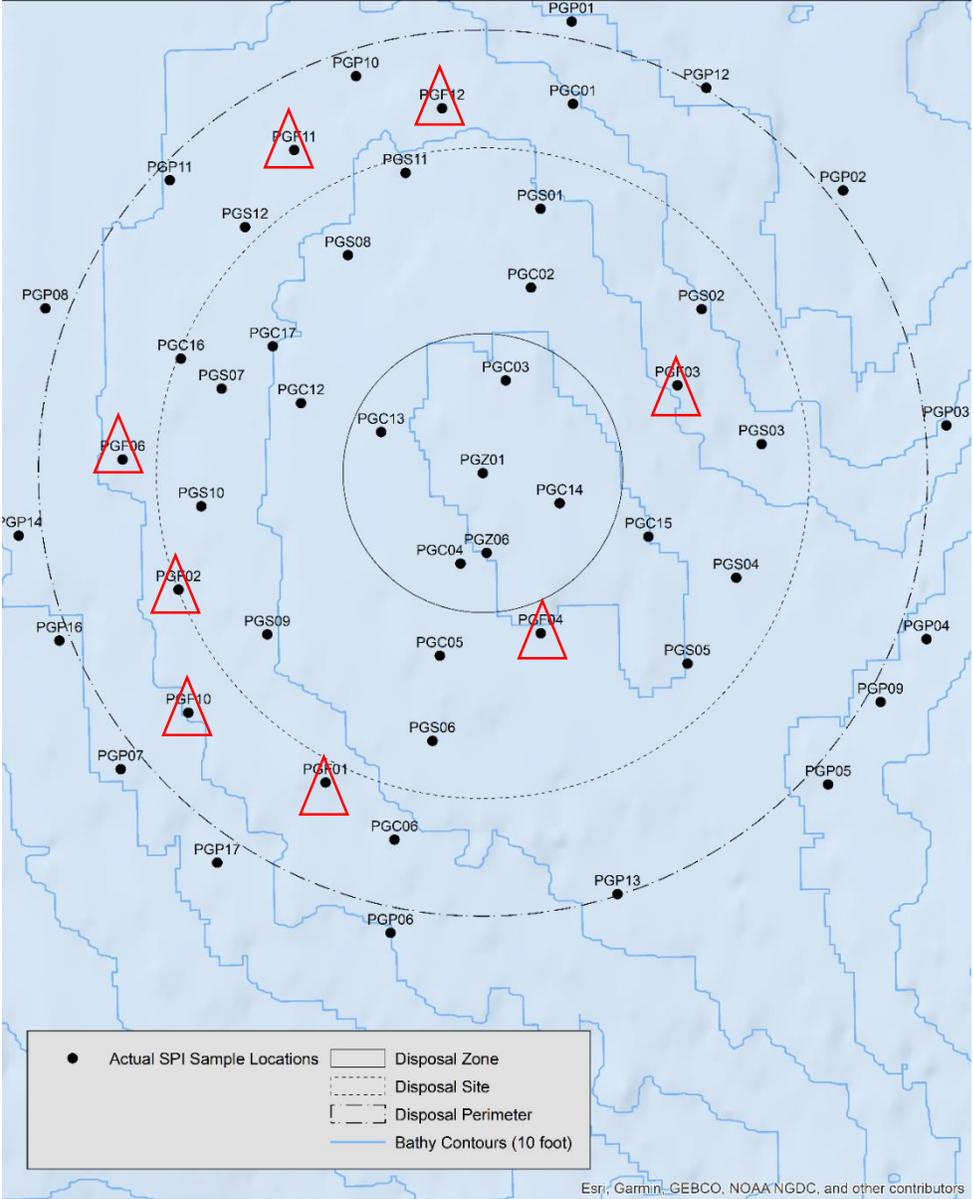
**2020 Port Gardner SPI and PV Sampling Locations**

- Images collected late June 2020 at 50 stations
- 8 Floating stations

added to delineate the 3 cm and 10 cm contours of recently disposed dredged material

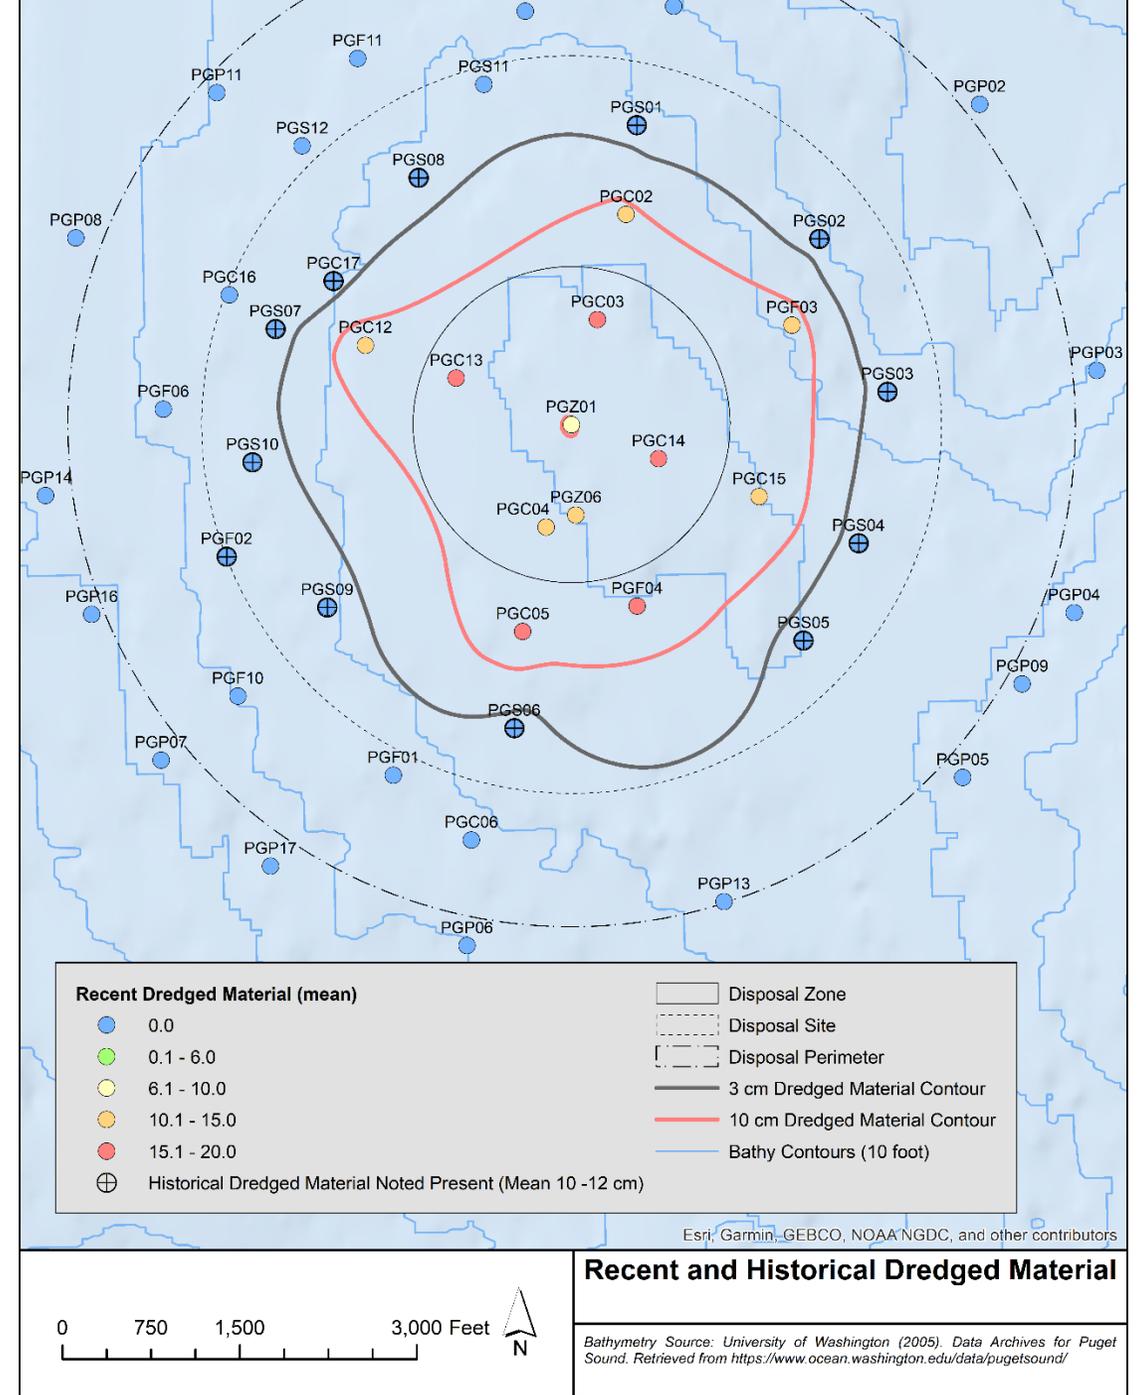
- Recent dredged material observed at 12 stations
- Dredged material footprint confined within disposal site boundary
- Recolonization of high-order successional infauna widespread within the disposal zone, site, and along the perimeter.
- Near surface biogenic mixing levels greater than found in the 2010 survey

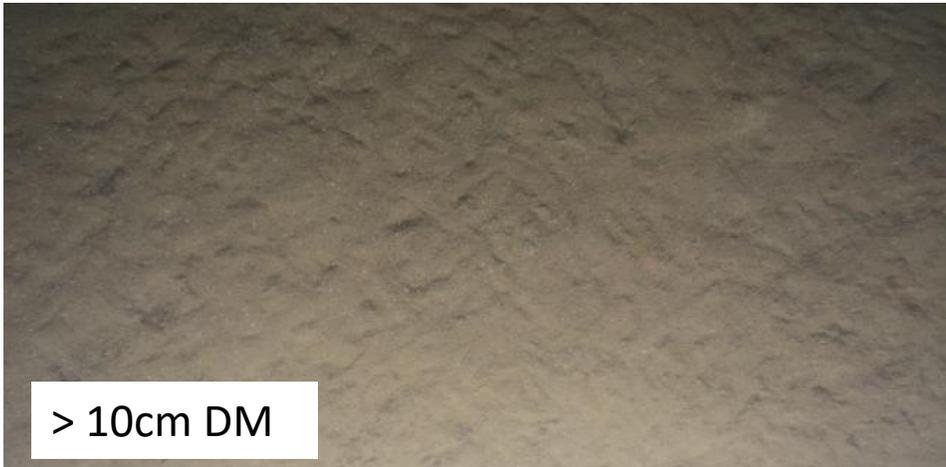
> 10cm DM

Notable difference in the distribution/abundance of large burrowers (e.g., burrowing shrimp, *Molpadia*) on and off the disposal mound

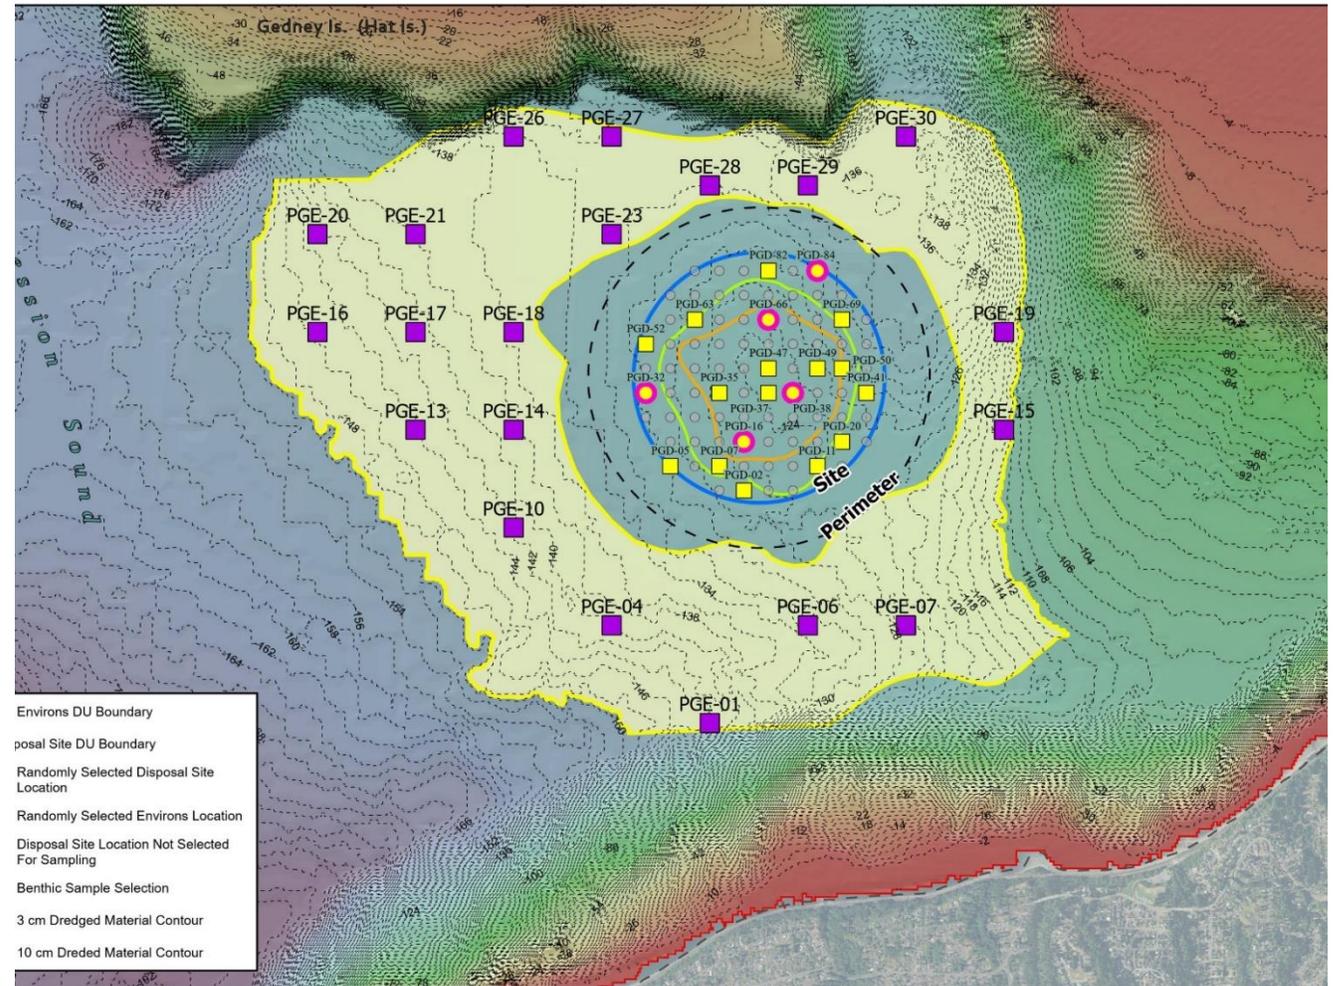
Figure 4. Randomly Selected Sampling Locations in the Disposal Site and Environs DUs

- 20 Disposal site samples (composted)
- 20 Environs samples (composited)
- 5 disposal site samples tested individually

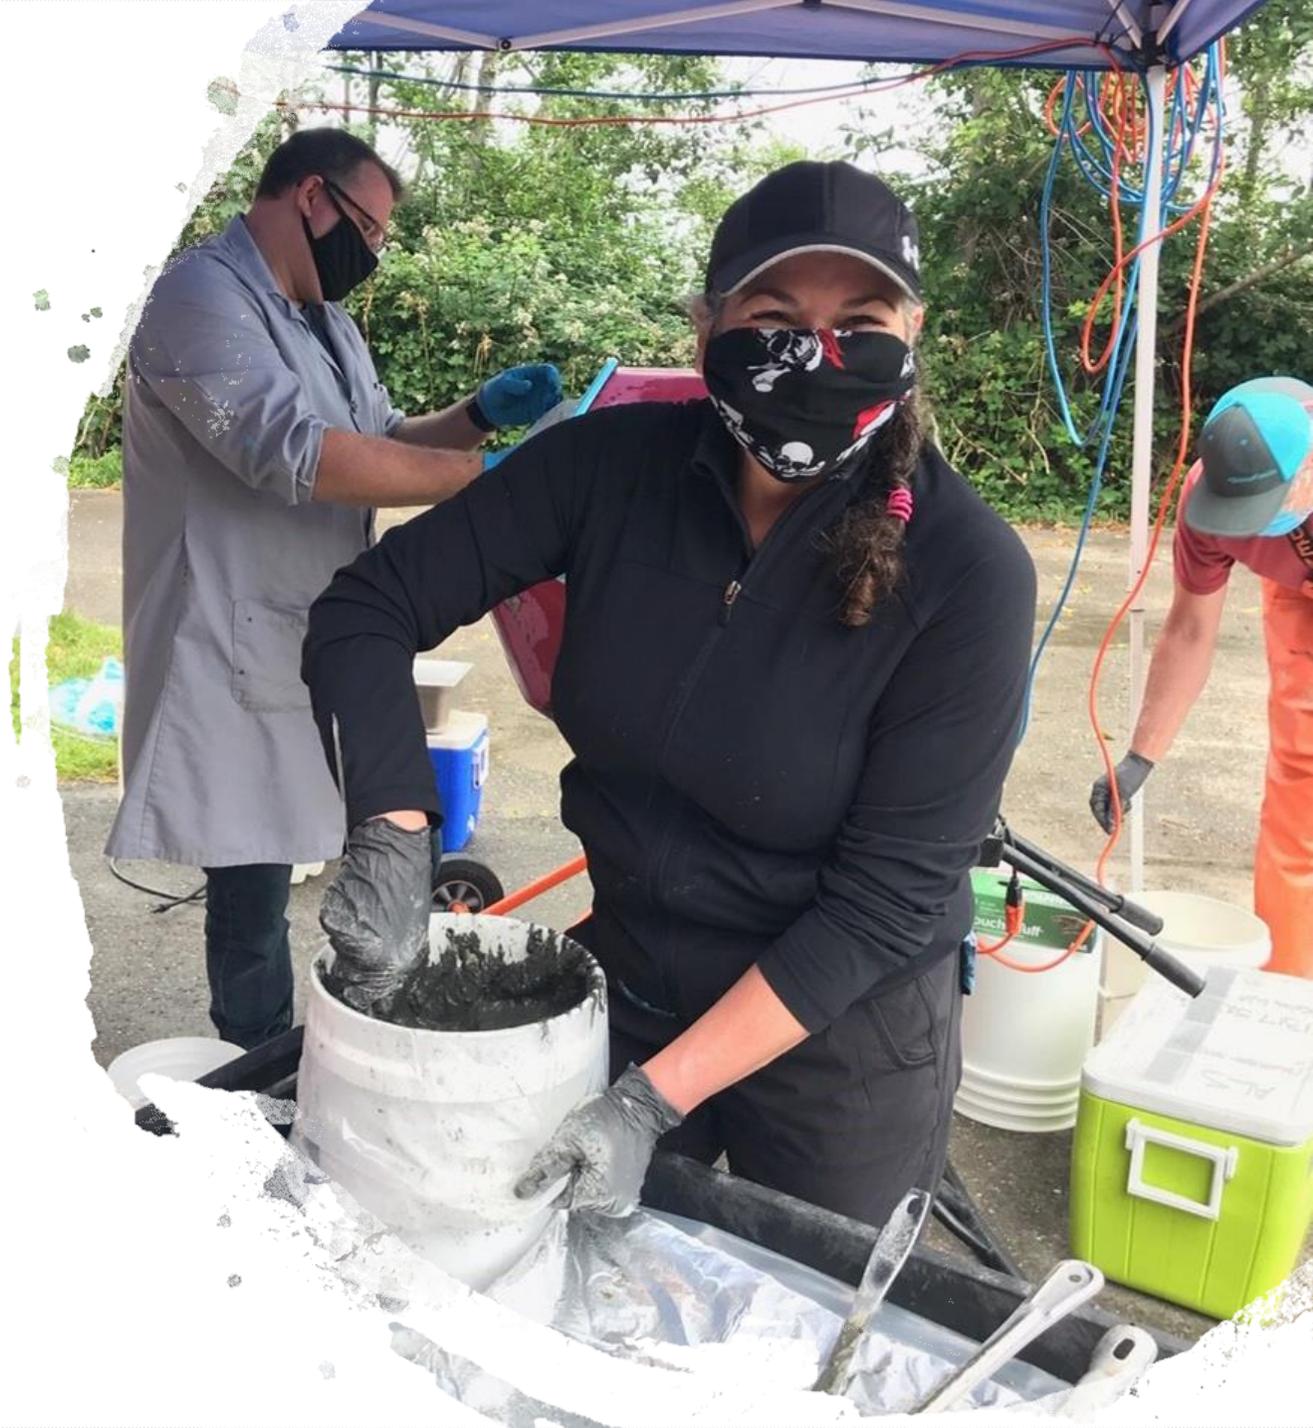
45-day Bioaccumulation  
testing

*Macoma nasuta*  
*Allita virens* (photo)  
separate exposures

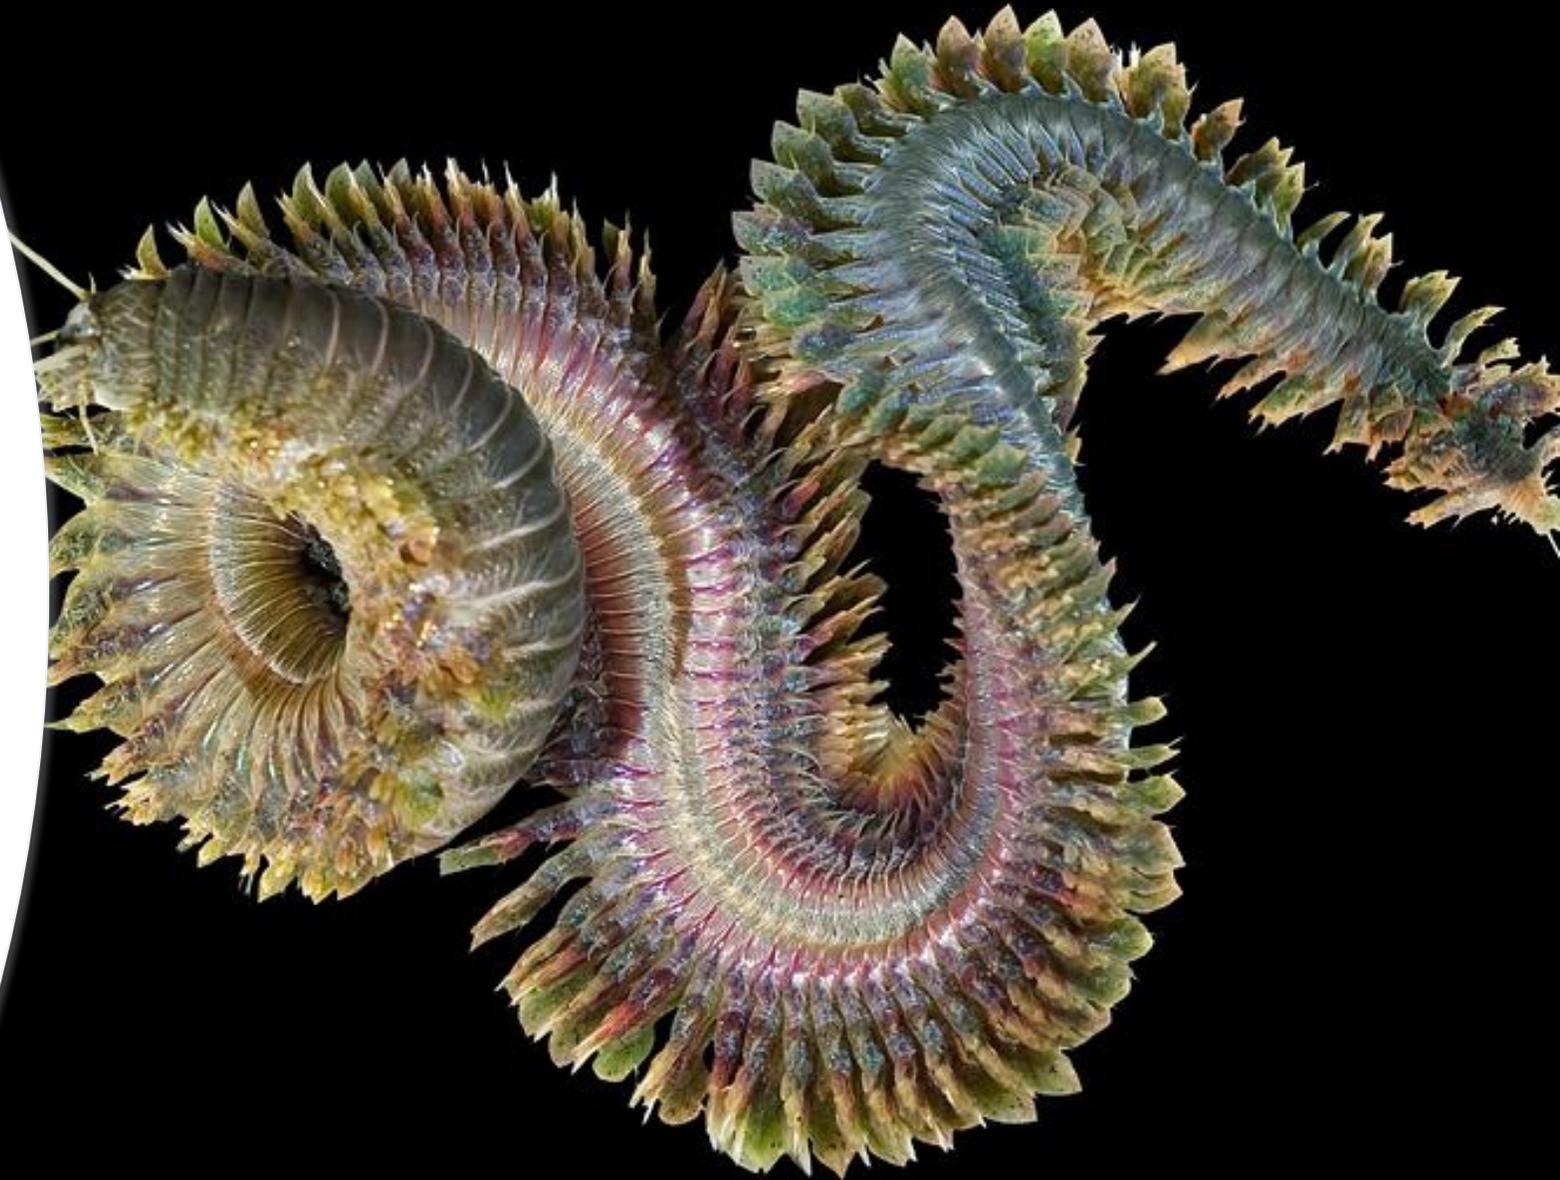
- Bagged SPME fibers in subset of bioaccumulation test chambers
  - 3 from Disposal Site
  - 3 from Environs
- Gain experience with *ex situ* method
- Synoptic exposures to validate SPME results
- Started Sept 2020
