Memorandum for Record

Subject: Tier 1 Antidegradation Evaluation for Lower Granite, Little Goose, and Lower Monumental Dams: Stilling Basin Sediment Removal (USACE Walla Walla District)

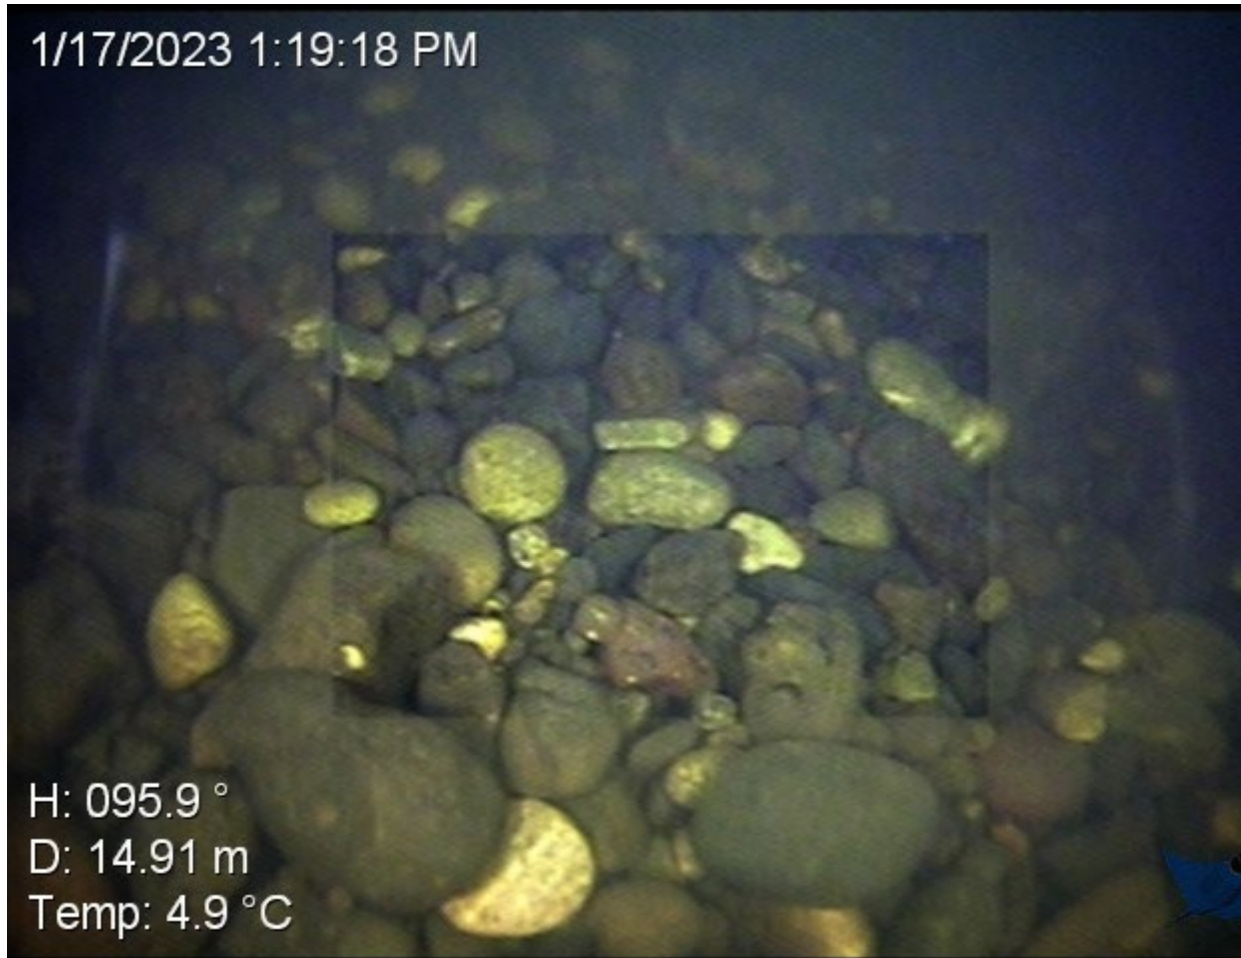
Figure 2: Survey Image of Stilling Basin Accumulation at Little Goose Dam

Sediment materials to be removed at Little Goose.

Sediment accumulates in the stilling basins and is primarily composed of clean, rounded river cobbles with trace amounts of other debris, such as sunken driftwood. Cobbles range in size from 1 to 30 inches in diameter (See Figures 2, 3, and 4). Sediment removal from these basins is necessary for inspection and assessment of potential damage, as their current condition is unknown. Since their last clearance in 2002, significant debris accumulation has hindered necessary surveys to ensure their structural integrity.

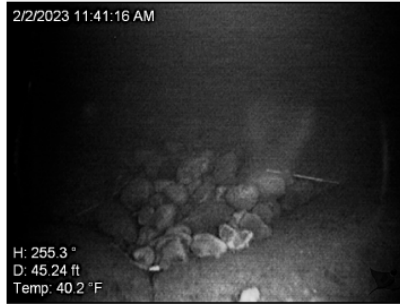
F6 PHOTO: MATERIAL IN ERRODED CONCRETE

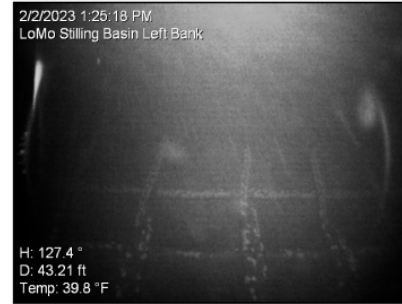
F11 PHOTO: EXPOSED REBAR

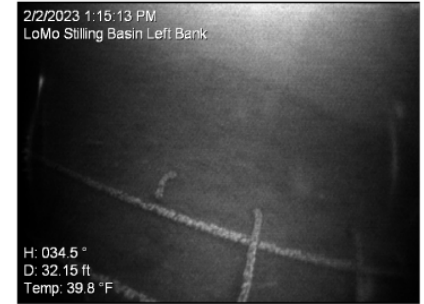
F16 PHOTO: EXPOSED REBAR CAGE AND HOOK

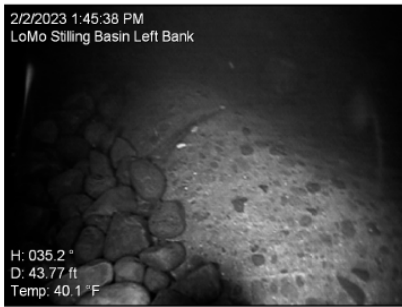
A1 PHOTO: ROCKS AGAINST CONCRETE

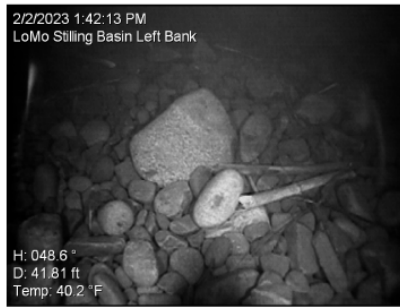
A6 PHOTO: TYPICAL MATERIAL TO REMOVE

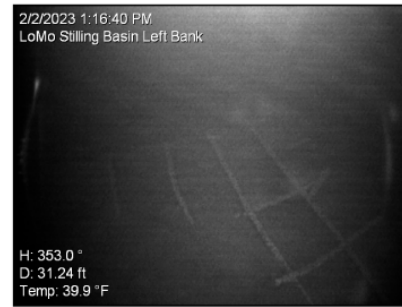
A11 PHOTO: EXPOSED REBAR CAGE

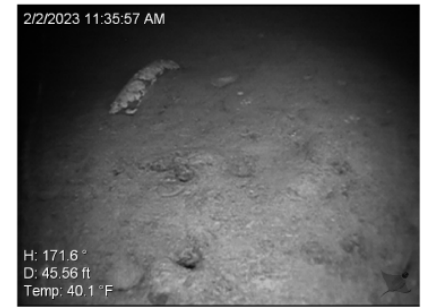
A16 PHOTO: EXPOSED REBAR HOOK

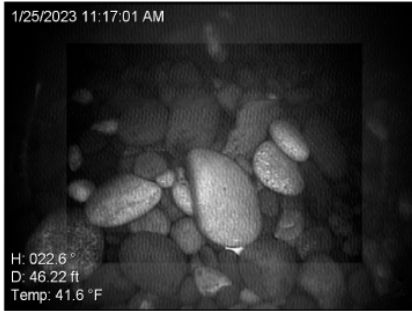
F1 PHOTO: TYPICAL COBBLES
SCALE: 1"=1' FULL SIZE

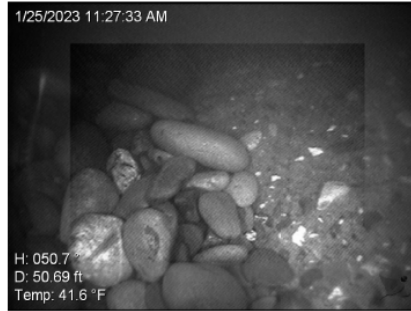
F6 PHOTO: MATERIAL AGAINST CONCRETE
SCALE: 1"=1' FULL SIZE

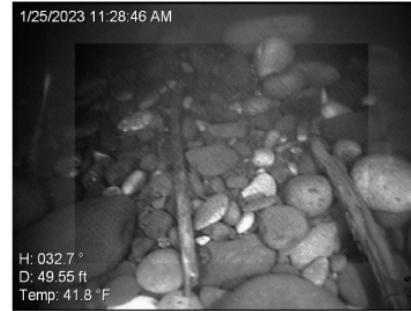
F11 PHOTO: TYPICAL MATERIAL TO REMOVE
SCALE: 1"=1' FULL SIZE

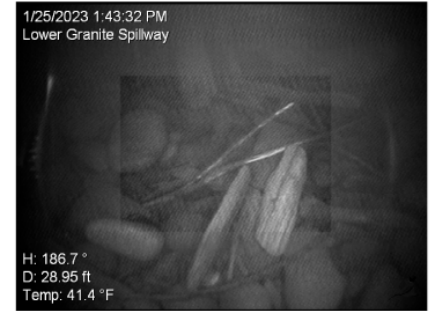
F16 PHOTO: DRIFTWOOD AND COBBLES
SCALE: 1"=1' FULL SIZE

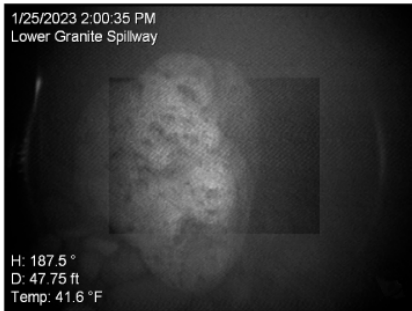
A1 PHOTO: LARGE ROCK
SCALE: 1"=1' FULL SIZE

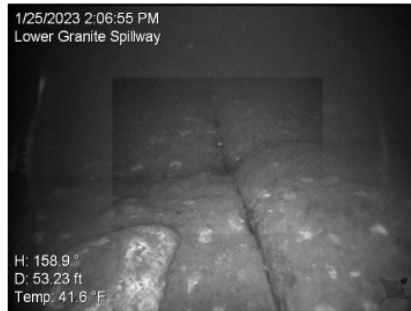
A6 PHOTO: ERODED CONCRETE JOINTS
SCALE: 1"=1' FULL SIZE

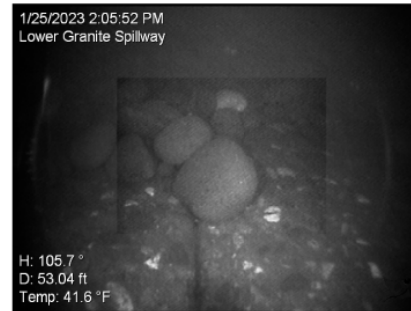
A11 PHOTO: MATERIAL WITHIN CONCRETE JOINT
SCALE: 1"=1' FULL SIZE

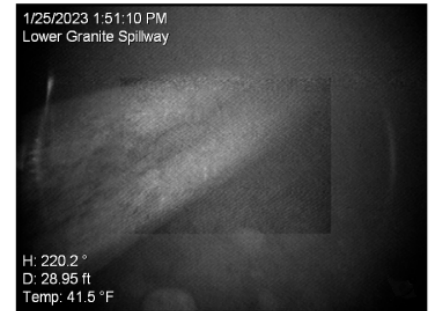
A16 PHOTO: SUBMERGED DRIFTWOOD
SCALE: 1"=1' FULL SIZE
