## Notice of Preparation / Clean Water Act Public Notice

Public Notice Date: 10 April 2019  
Expiration Date: 10 May 2019  
Reference: PMP-18-02

PROJECT NAME: *Elmway Levee Rehabilitation, Okanogan County, Washington*

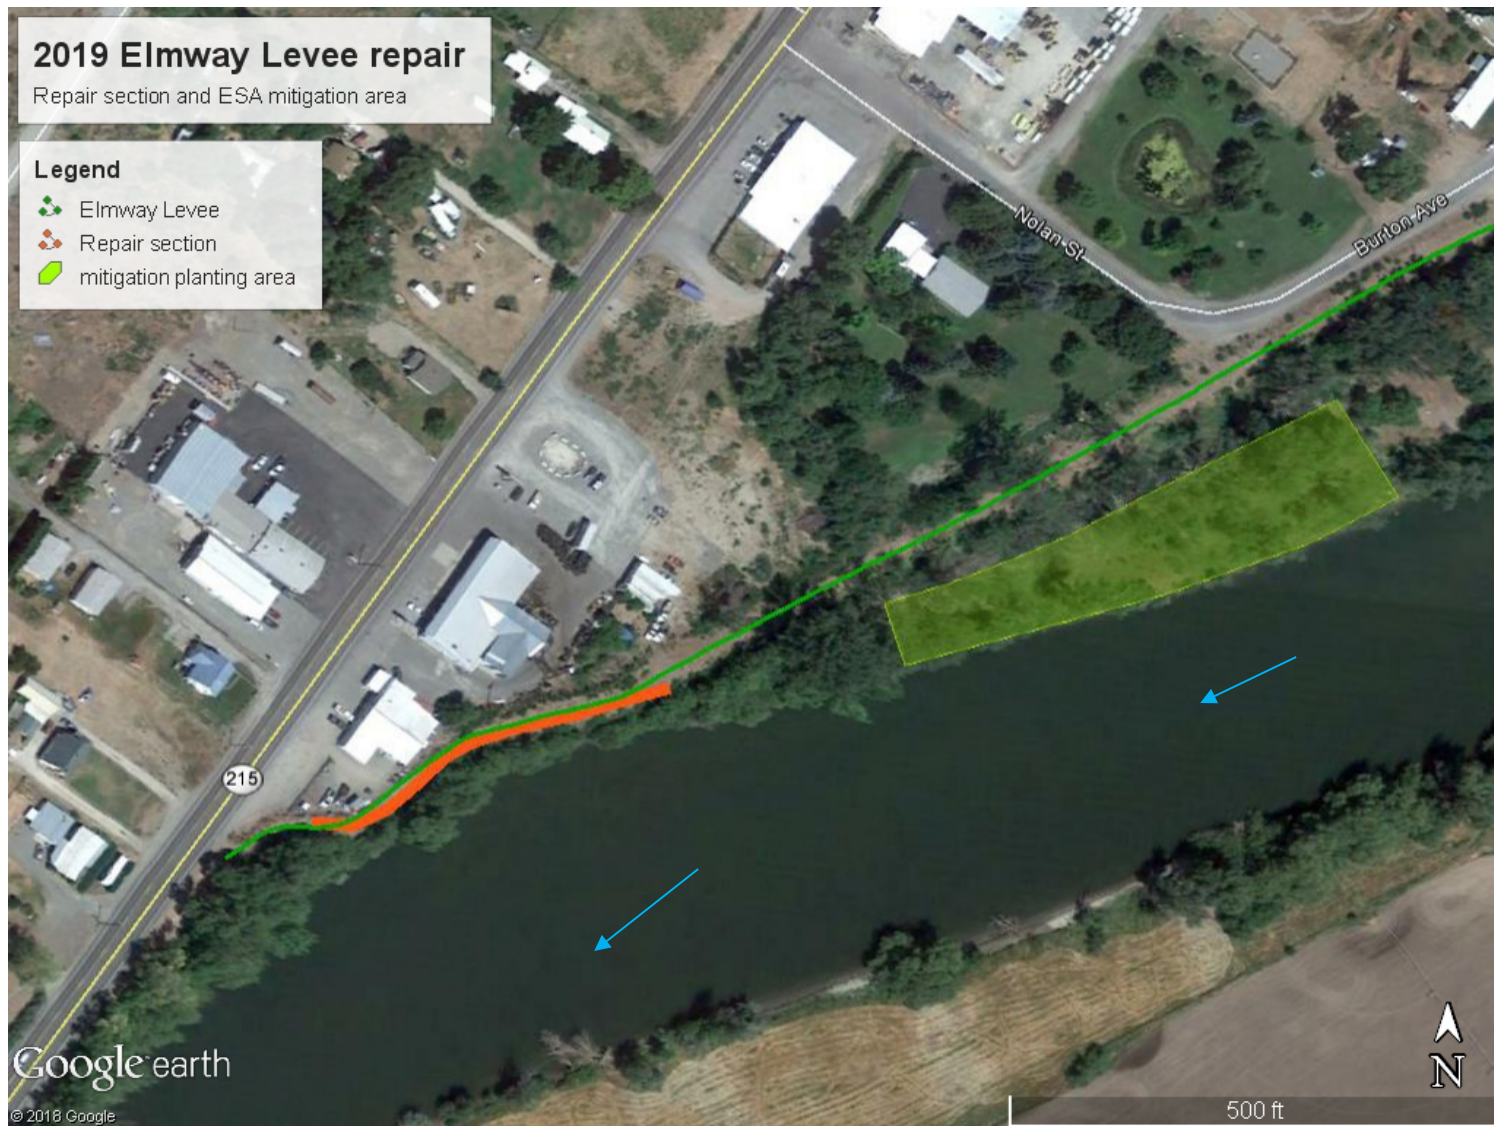
*Figure 2. Damaged section (orange line), levee centerline (green line), off-site mitigation planting area (yellow-green box), and river flow directions (blue arrows).*

The Elmway Levee is comprised of a rock and earthen embankment levee along Okanogan River, approximately river mile 26.6 to 26.0, in the City of Okanogan, Washington (Figures 1 and 2). The levee is 1,880 long; 6 feet tall on the landward side; 12 feet wide at the crown; and has side slopes of 2 Horizontal (H):1 Vertical (V) riverward and landward. As-builts for this levee do not exist. An as-built for a 1972 repair to a levee about a mile downstream (Okanogan Segment 2) exists that shows a 2 ft blanket of Class III riprap placed to the top of the slope with a 10 ft wide by 5 ft high launchable toe. These old as-builts represent the only known available historical designs near the current repair site. Although the 1972 drawing is not specific for this particular levee, it is indicative of what is most likely to have been constructed at this location. Inspection reports from 2002 to 2014 indicate shrubs and small trees were present on the levee in the reach that is the subject of this NOP, prior to the 2018 flood event. The exact nature of the pre-flood condition of this levee is not known. Heavy vegetation obscured much of the slope during past inspections. Observations made during the 2017 site visit during the post-damage assessment indicated remnants of a riprap blanket that was eroded away by high flows.

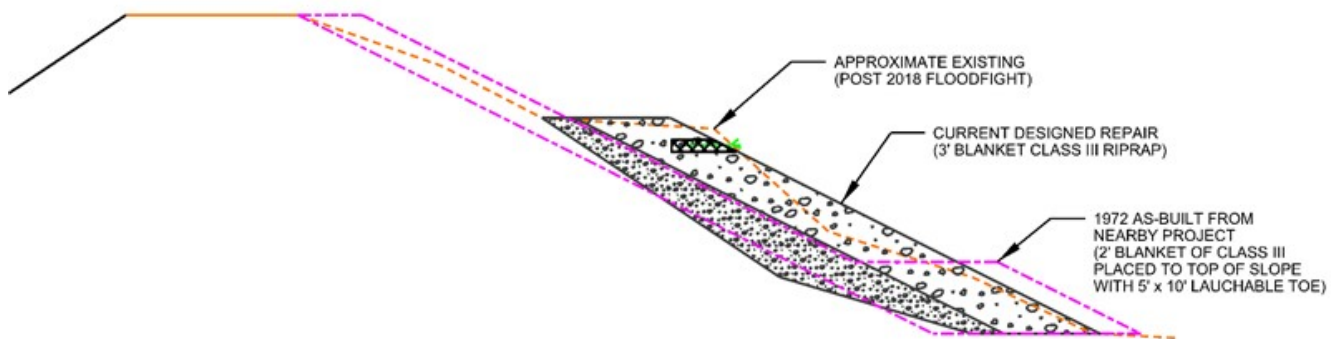
*Figure 3. Typical cross-section of proposed levee repair, with willow bundles at OHW*

Figure 3 illustrates the deviation between the initially designed weighted/launchable toe design profile and the prospective repair profile, which will be engineered to current riverine conditions.

- Repair In Kind. This alternative repairs the levee by returning it to the pre-flood condition with minor change to the character, scope, or size of the levee. This alternative maintains the status quo of the river and levee at the repair location as existed prior to the flood damage. The design uses updated engineering techniques including a thicker armor blanket (Figure 3).

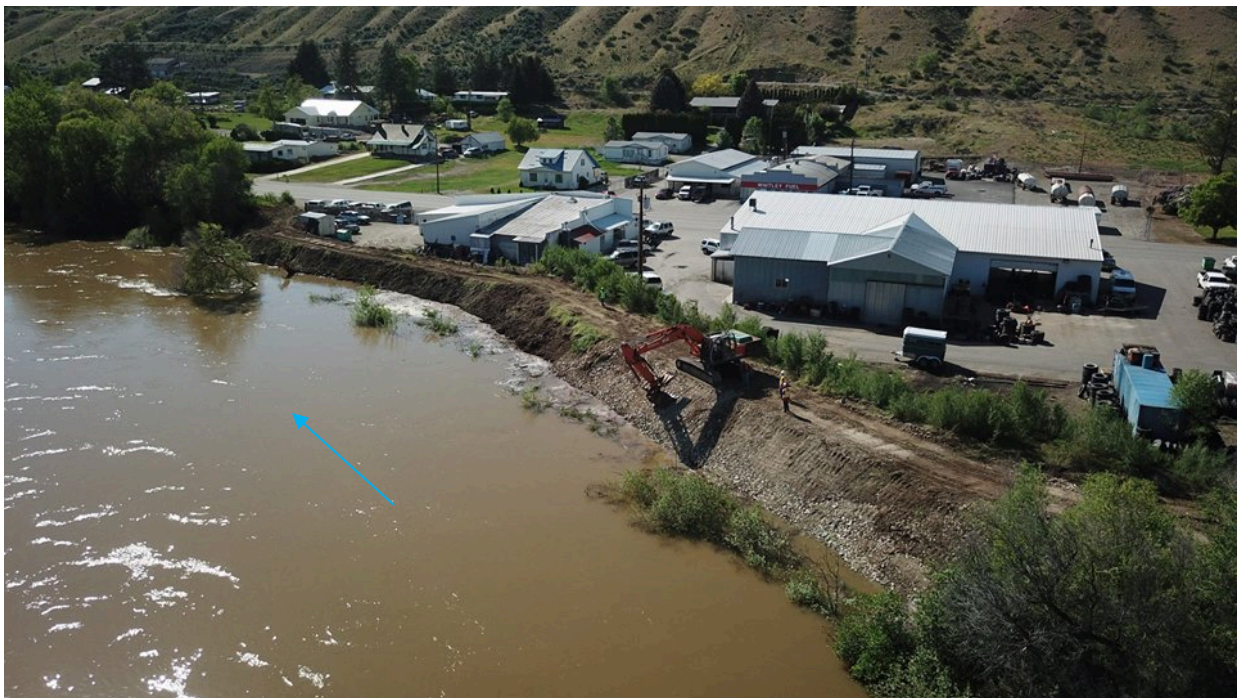
*Figure 4. Emergency repairs during May 2018 flood. Note vegetation covered by floodwaters as well as upstream and downstream vegetation. Photo courtesy of Okanogan County.*

The Corps conducted temporary emergency repairs between May 7 and 11, 2018 to supplement local efforts during the 2018 flood. Shoreline and river impacted by construction activities was restricted to the areas of the damaged levee. The team used an excavator to clear small vegetation from the upper slope of the damaged locations and placed riprap in the active scour pockets of the riverward slope. The temporary measures executed in May 2018 involved work from the top of the levee, placing material by bucket load in a controlled manner to provide a blanket of armor to reduce the impacts from the high-velocity flows and high water levels. The emergency repairs included the removal of remaining vegetation and the placement of approximately 1000 cubic yards (cy) of Class III to Class VI riprap along approximately 400 linear feet of the riverward slope of the levee. The riprap that was placed reduced erosion from the high river velocities and reduced the risk of levee failure from slope instability and seepage. The flood fight emergency response efforts were necessary to prevent catastrophic levee failure. Approximately 90% of the areal coverage of the pre-existing shrubs and smaller vegetation had been lost as a result of the flood flows. The remainder of the smaller vegetation and three trees were removed as a necessary element of the emergency repair.

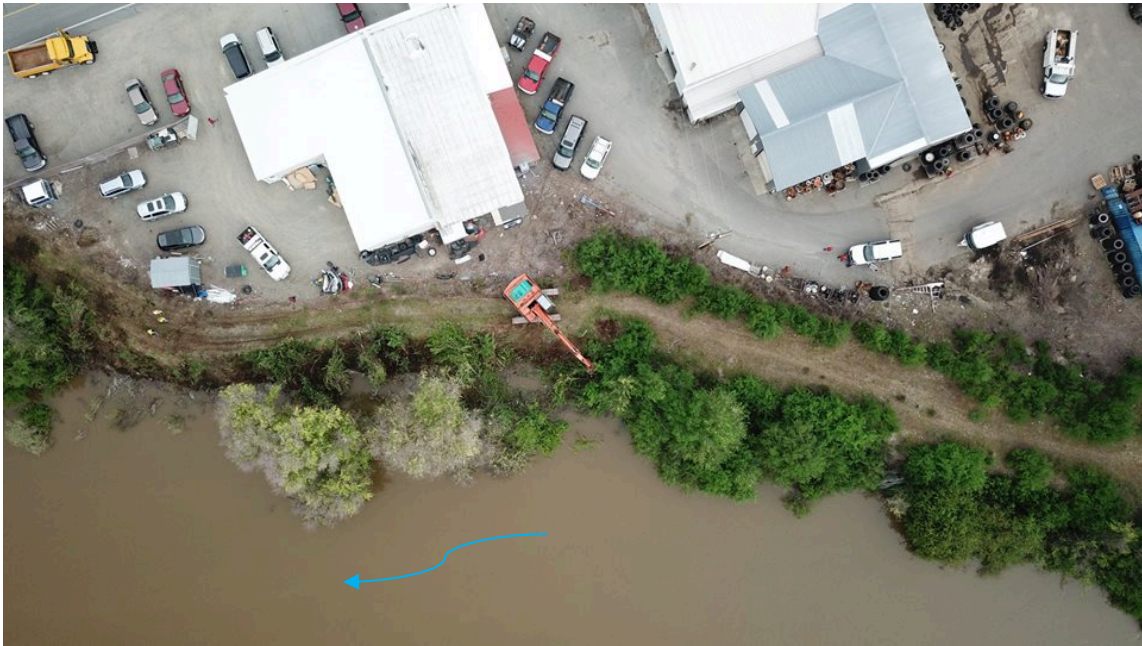
*Figure 5. May 2018 flood fight emergency work. Photo courtesy of Okanogan County.*
