FINDING OF NO SIGNIFICANT IMPACT (FONSI) SKAGIT RIVER DIKE DISTRICTS 17 AND 22 LEVEE REHABILITATION PROJECTS SKAGIT COUNTY, WASHINGTON

FINAL ENVIRONMENTAL ASSESSMENT

SKAGIT LEVEE REHABILITATION (DIKE DISTRICTS 17 AND 22) SKAGIT COUNTY, WASHINGTON

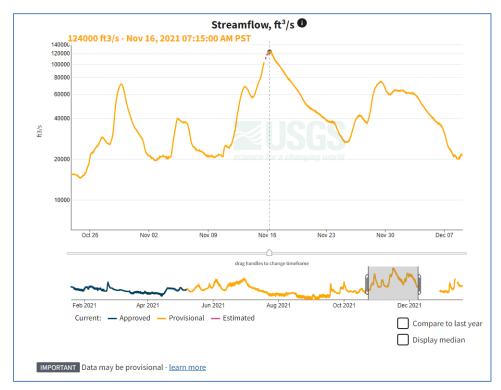
Figure 2. Streamflow in the Skagit near Mount Vernon, WA USGS gate 12200500.

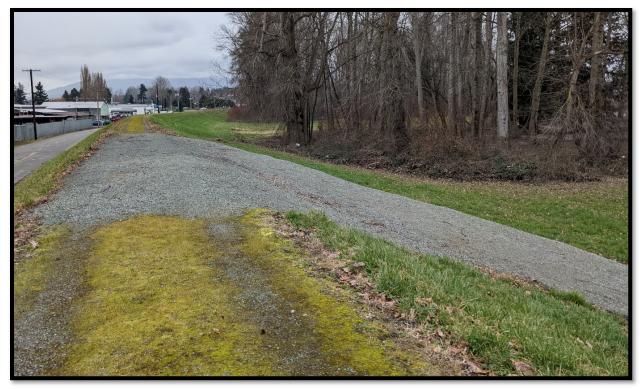
Photograph 1. Typical landward slope of the DD 17 Levee at Site 1, upstream oriented near STA 30+00.

- 1. STA 121+00 (Site 2) Seepage was noted on the centerline of River Bend Road coming up through the pavement. The flow was discolored and resulted in flood fight activities to place a berm on 300 ft of River Bend Road.
- 2. STA 20+00 to 35+00 (Site 1) Seepage noted throughout the reach landward of the roadway.

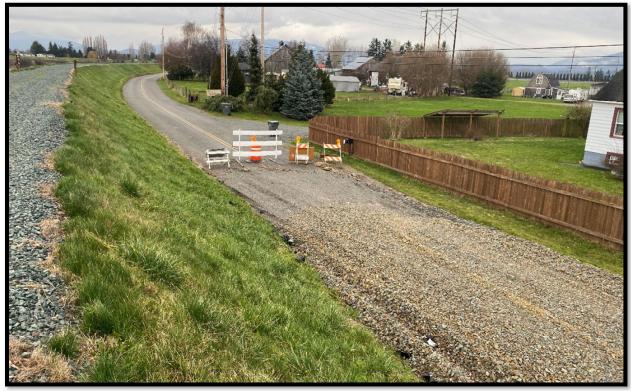
Photograph 2. View of the seepage berm placed at STA 121+00 on the landward side of the DD 17 levee during the November 2021 flood event.

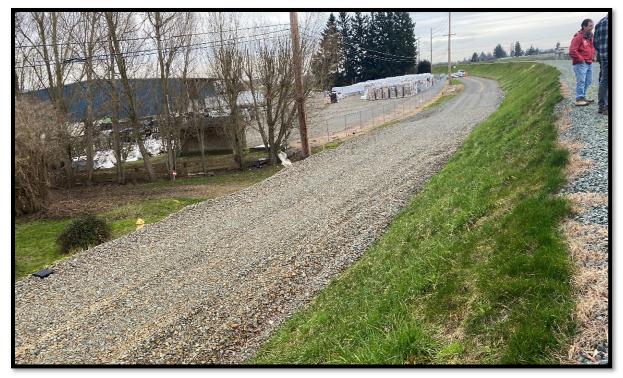
Photograph 3. Typical landward slope of the DD 17 levee, upstream oriented near STA 120+00. The seepage berm was placed on the landward side of the levee during the November 2021 flood event.

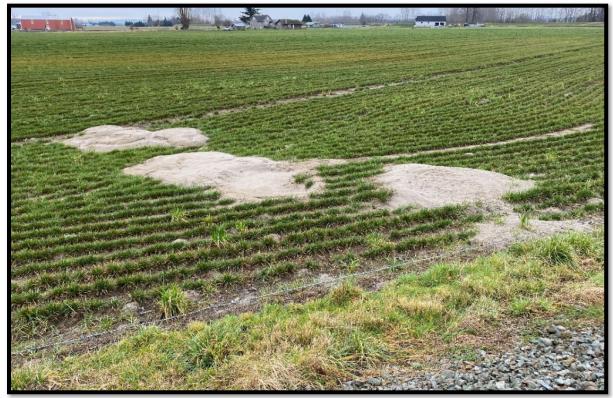
Photograph 4. View of Sand boils near the landward toe of the DD 22 levee at STA 357+00.

During the November 16, 2021 flood event, damages also occurred to the DD 22 levee system from STA 352+00 to STA 360+00. During the high-water event, seepage was noted in the farm field adjacent to the levee. For approximately 800 linear feet (LF), foundation seepage removed a large volume of sand from the levee foundation. Following the event, data was collected from various sources, including local, state, and USACE personnel to assess damages and associated risks. Sources included information from personnel present during the flood event, as well as from a USACE-lead rapid assessment. USACE personnel determined damage from seepage at the two damaged DD 17 sites and the damaged DD 22 site have reduced the LOP of both levee systems from a 2% AEP (50-year) to a 10% AEP (10-year). Photos of the damaged levees are provided in Appendix A.

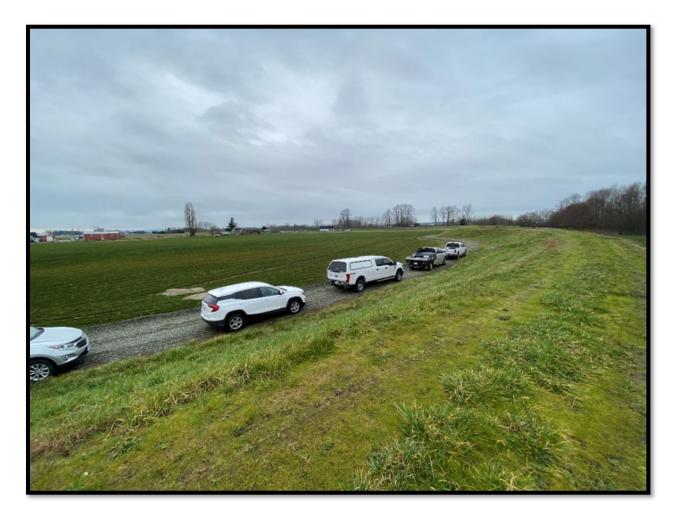
Photograph 5. Typical levee section from the top of the DD 22 levee crest looking towards the landward side, downstream oriented.
