FINDING OF NO SIGNIFICANT IMPACT (FONSI) PILCHUCK AND MARSHLAND LEVEE REPAIR PROJECTS SNOHOMISH COUNTY, WASHINGTON

ENVIRONMENTAL ASSESSMENT

PILCHUCK AND MARSHLAND LEVEE REPAIR PROJECTS SNOHOMISH COUNTY, WASHINGTON

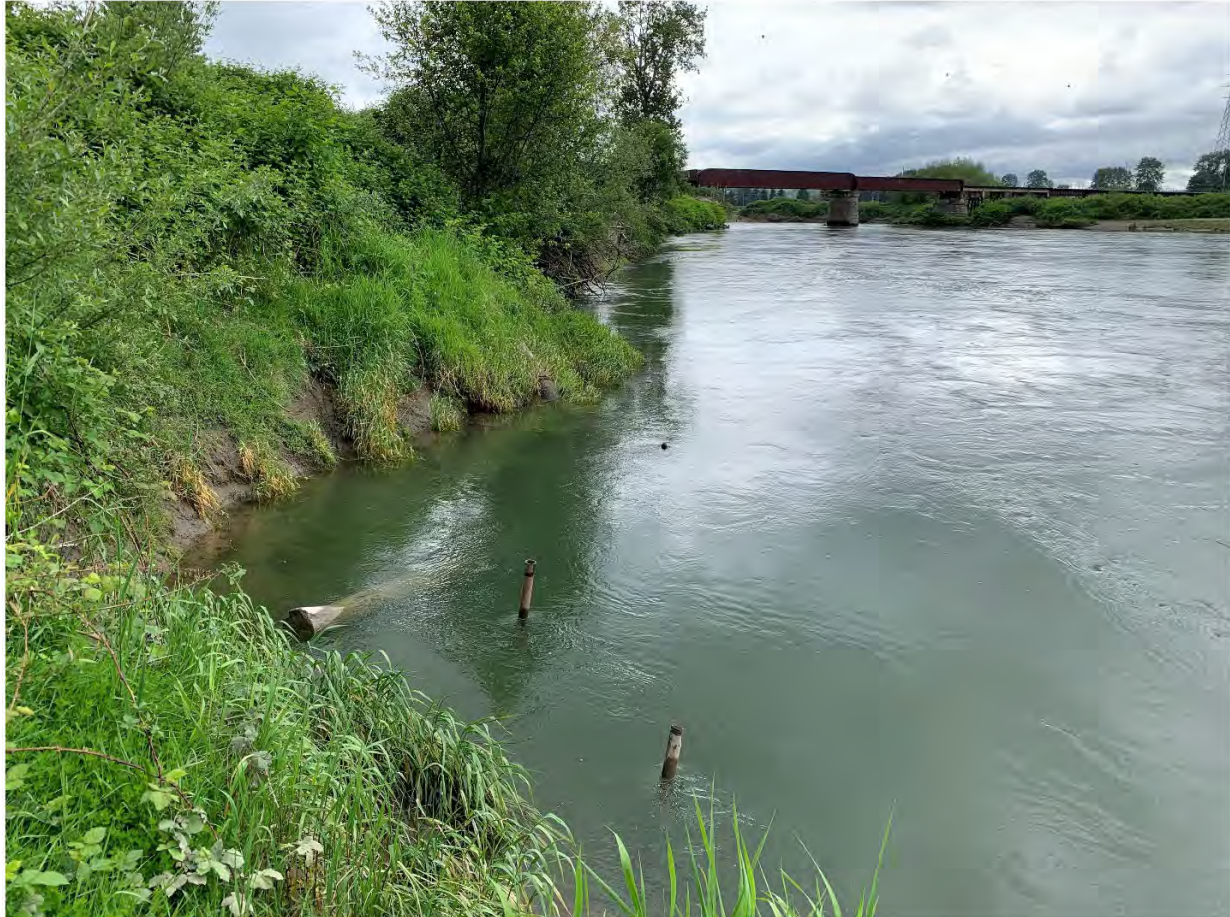
Cover shows the view looking downstream the Snohomish River at the damaged Marshland Levee.

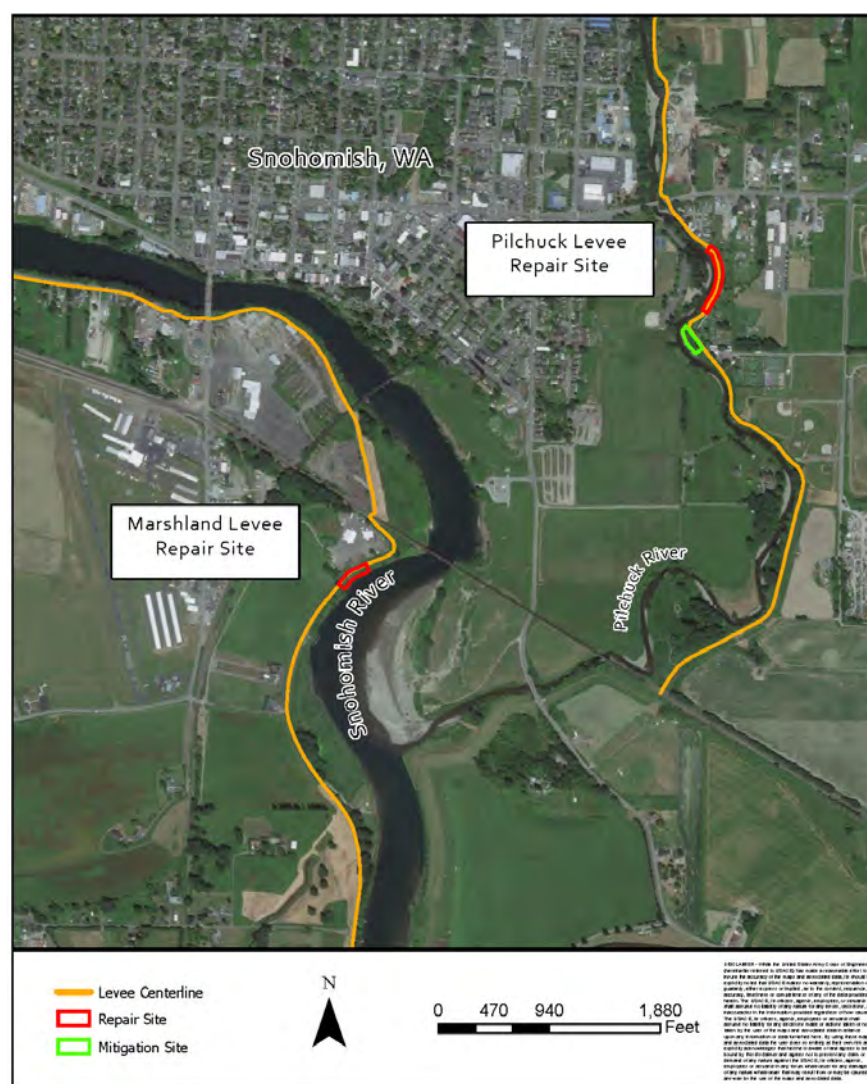
Figure 3. Project Area Map.

The repair sites for the Pilchuck and Marshland Levees are east and south of Snohomish, WA on the Pilchuck and Snohomish Rivers, respectively (Figure 3). The proposed repair to the Pilchuck Levee is approximately 600 feet long (Figure 4). The proposed repair to the Marshland Levee is approximately 300 feet (Figure 5). Mitigation for the proposed repairs is located along the shoreline of the Pilchuck River, approximately 200 feet downstream of the Pilchuck Levee repair (Figure 3). Staging area locations are behind the levee in previously disturbed areas and are shown in the design drawings (Appendix B). Area totals for each part of the two repairs are shown in Table 1.

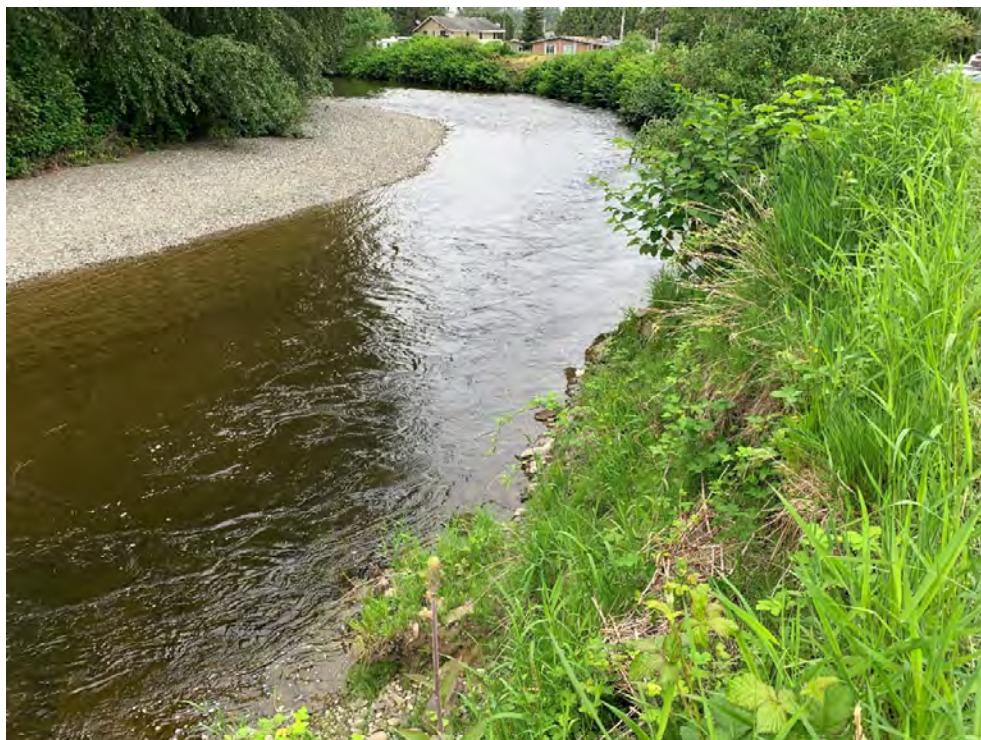
Photo A1. Bank caving and erosion at Pilchuck Levee toe looking upstream.

High water from the two events scoured riprap and levee embankment from the riverward toe and slope along 525 feet of the Pilchuck Levee. Erosion and bank caving removed additional levee material to within 4 feet of the levee crest resulting in an over steepened slope of 1H:1V or steeper. In the damaged state, the level of protection of the Pilchuck Levee is diminished from 10 percent (10-year) to 100 percent (1-year) annual exceedance probability. See Appendix A (Photos A1 to A5) for photos of the damaged Pilchuck Levee.

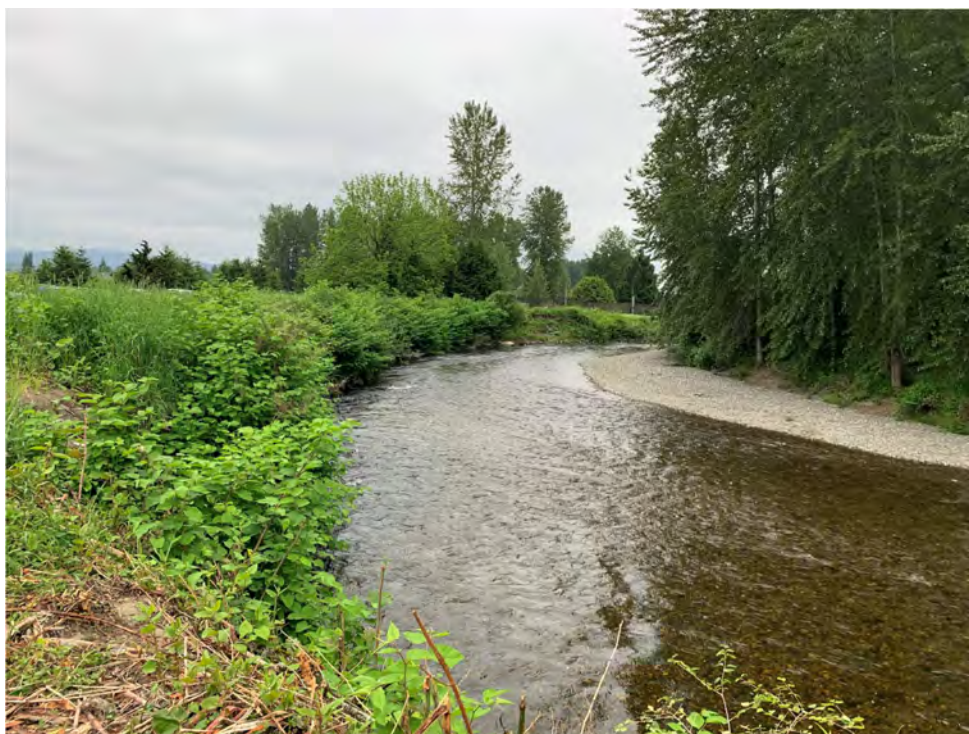
Photo A2. Looking downstream from the upstream extent of the proposed repair at the Pilchuck Levee.

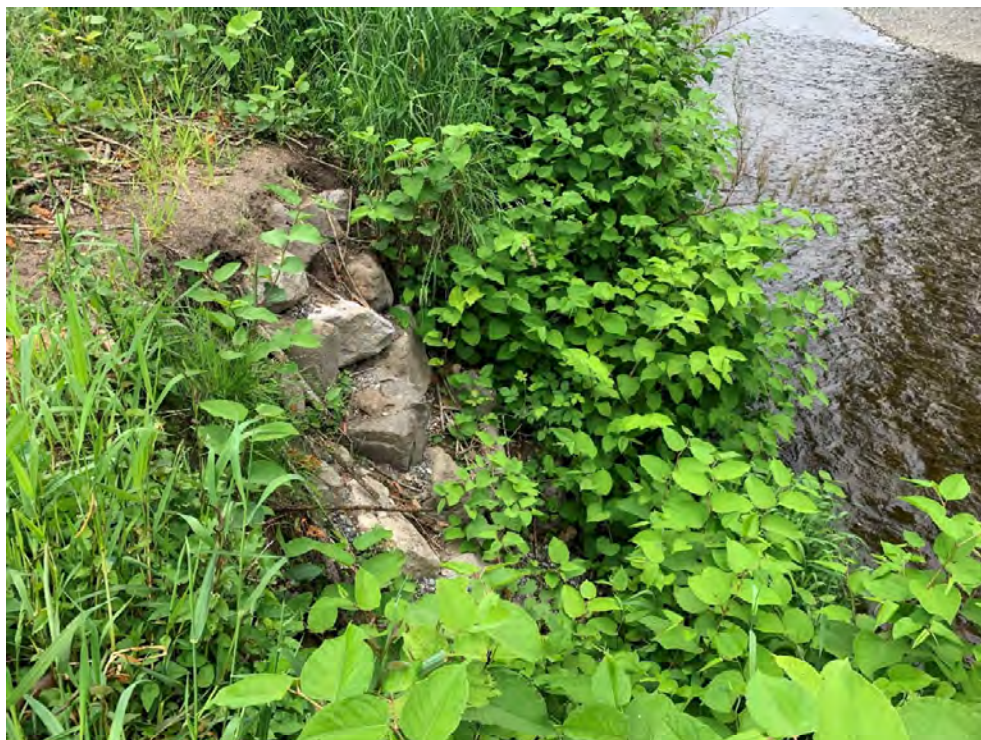
Photo A3. Erosion and temporary repair at the Pilchuck Levee looking downstream.

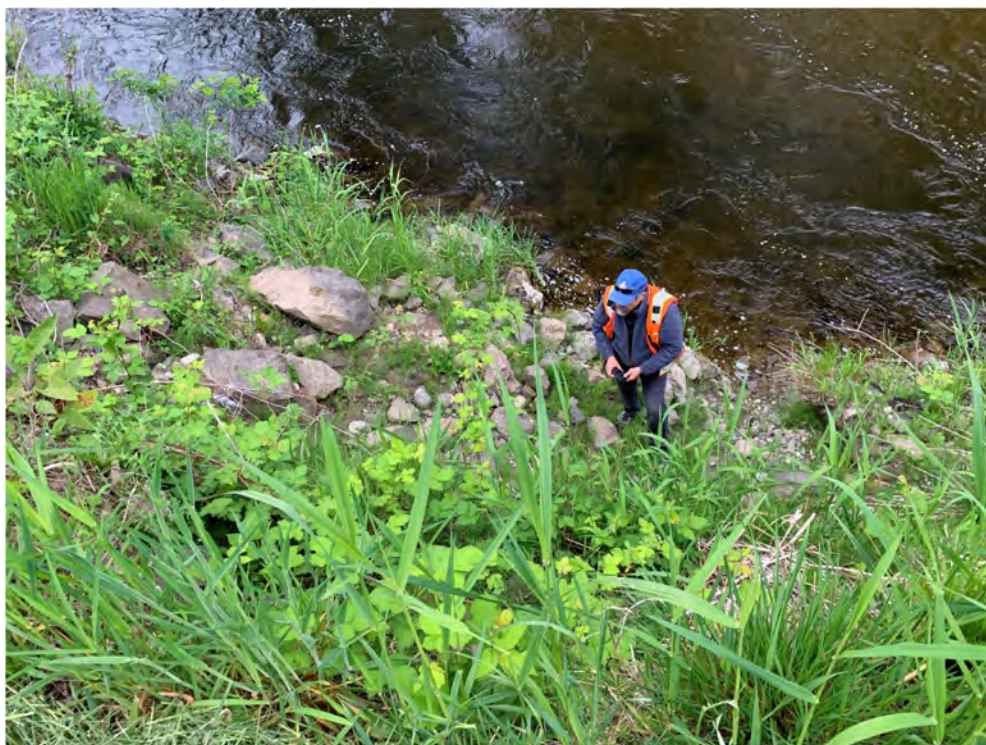
Photo A4. Riprap along the damaged Pilchuck Levee.

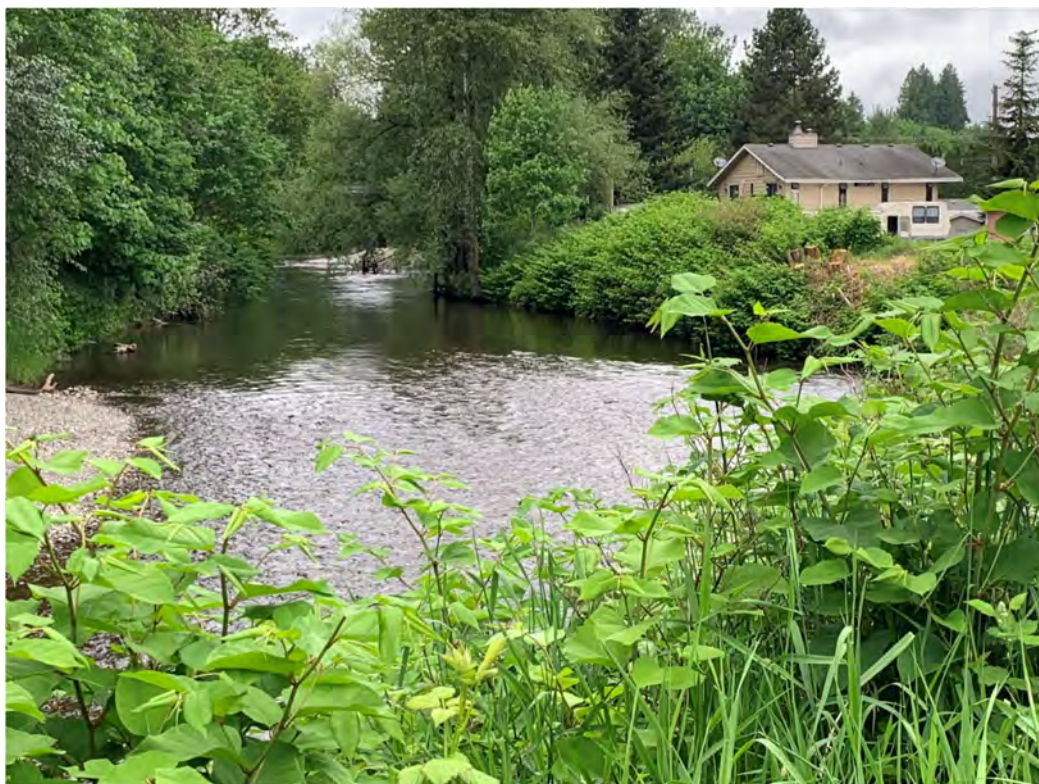
Photo A5. View upstream from near the middle of the damaged Pilchuck Levee. Flow is directed towards the damaged area.

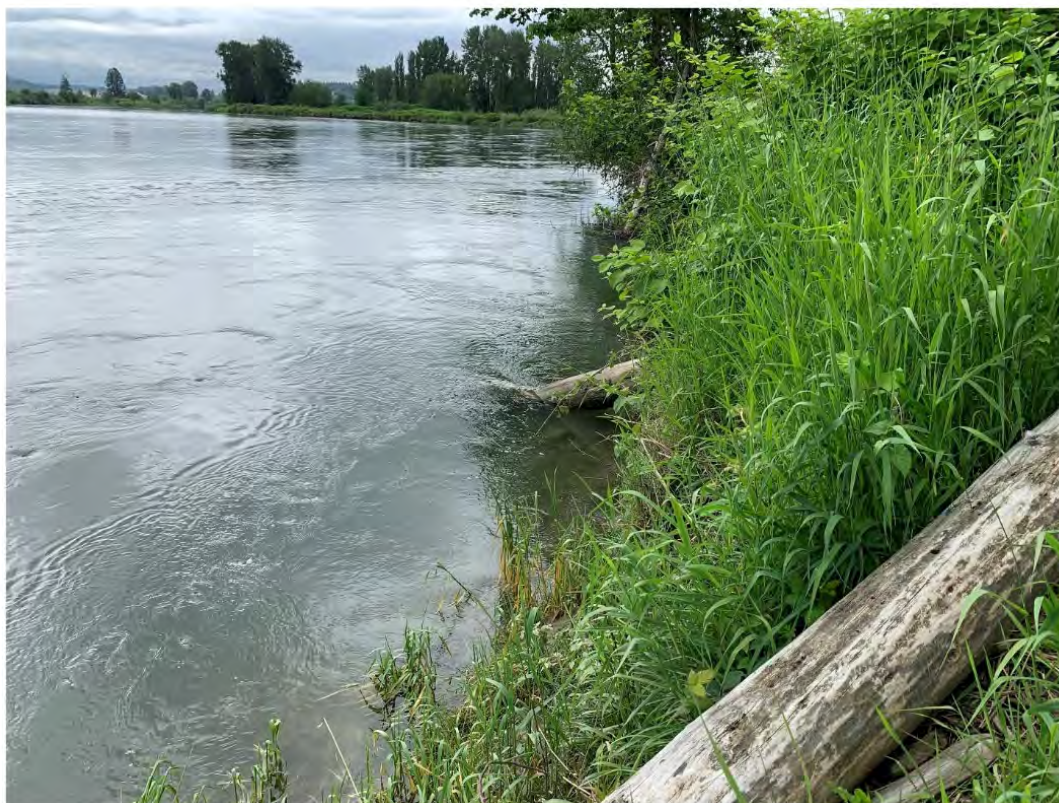
Photo. A6. Toe of the damaged Marshland Levee looking upstream.

The two events caused damage along 280 feet of the Marshland Levee. The damage included scouring of the levee along 200 feet and 80 feet of bank caving resulting in near-vertical slopes up to 9 feet high. In the damaged state, the level of protection of the Marshland Levee is diminished from 10 percent (10-year flood) to 100 percent (1-year flood) annual exceedance probability. See Appendix A (Photos A6 to A9) for photos of the damaged Marshland Levee.

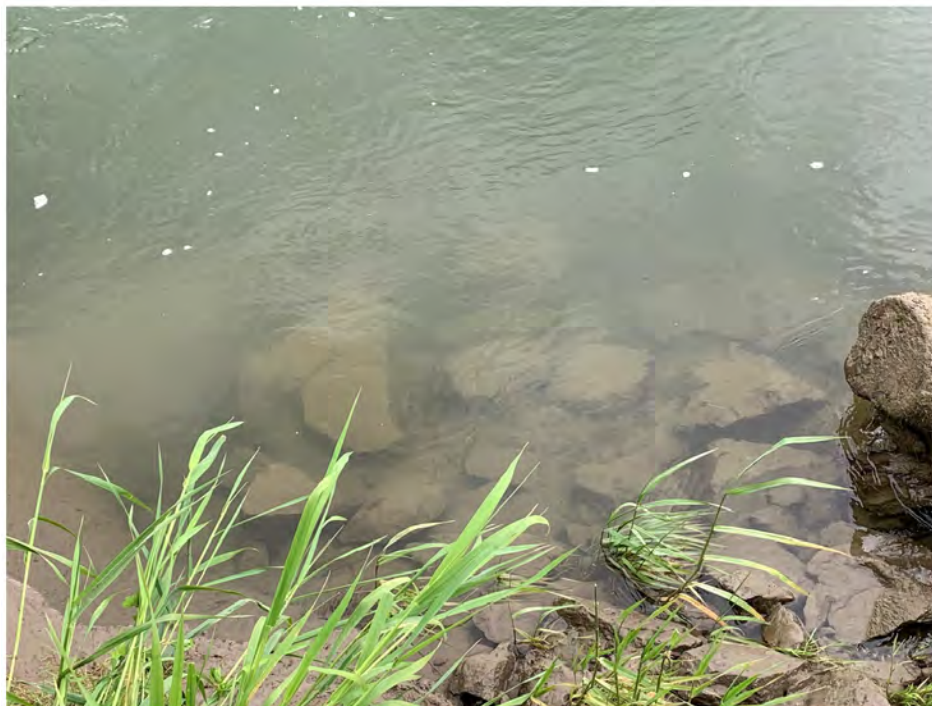
Photo A7. Armor near damaged section of the Marshland Levee.

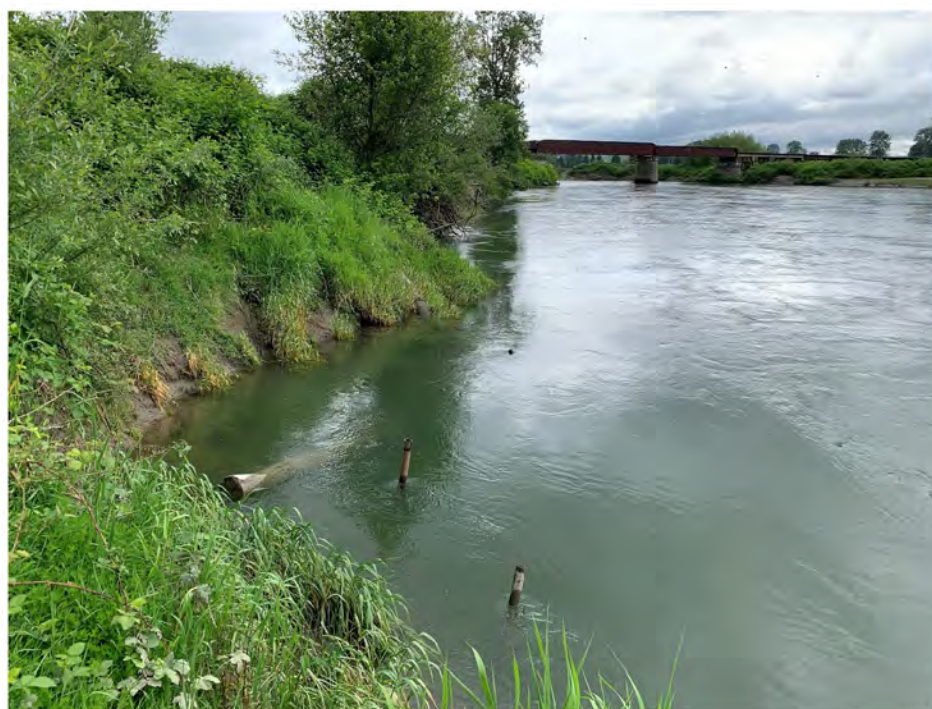
Photo A8. Looking downstream at the damaged Marshland Levee.

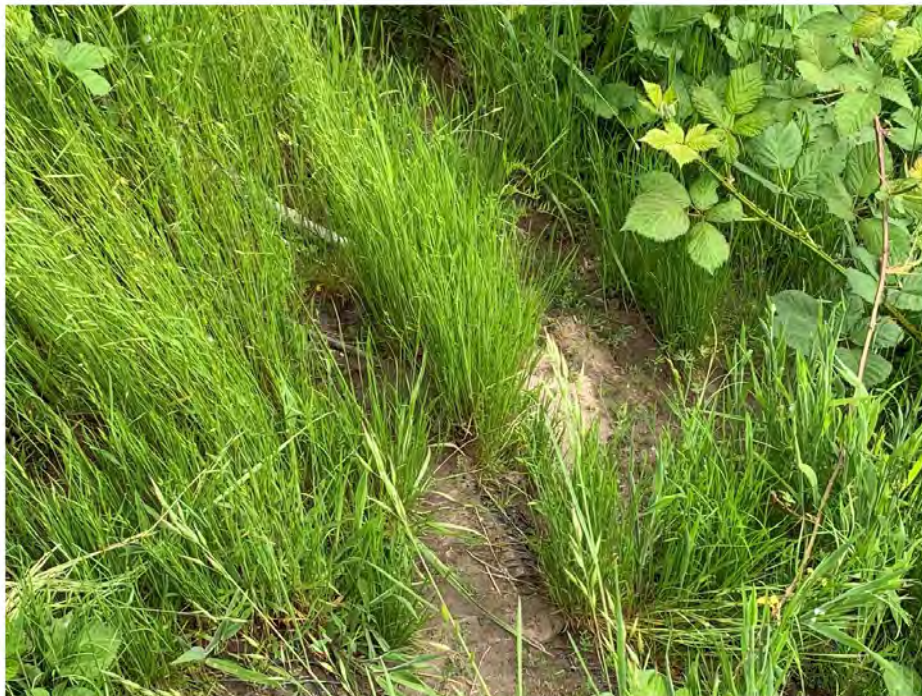
Photo A9. Slope of the damaged Marshland Levee, which was last repaired above the ordinary high-water mark in 2010 using fabric lifts. No armor is present.

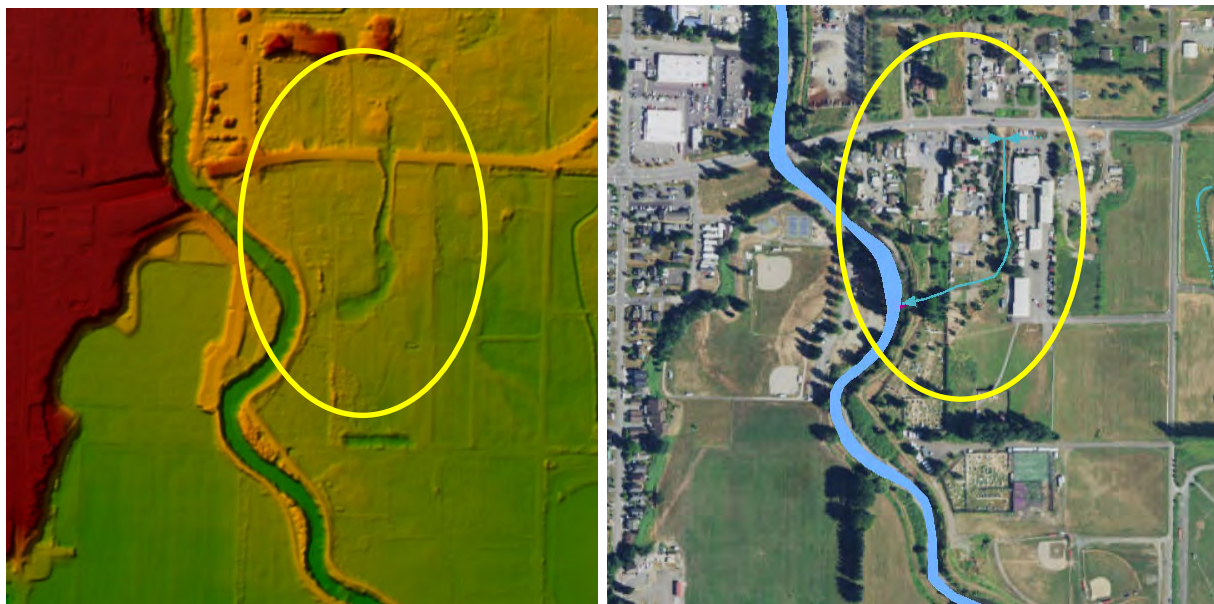
The second is that the model does not account for any influx of water to the Pilchuck River downstream of the gage. The volume of water passing the gage is routed downstream without any additions. An investigation of the bare earth LiDAR and USGS National Hydrography Database reveals the problem with this assumption (Figure 6). There is a small channel visible in the LiDAR that directs flow to the south under 92nd Street Southeast and to the Pilchuck River at the outside of the meander bend and at the site of levee damage. Water flowing toward the Pilchuck levee at this location would have contributed to levee slope instability.

Figure 6. Location of a small channel directing overland flow to the site during flood events. The image on the left is the bare earth LiDAR and the right image is from the USGS National Hydrography Dataset.
