# Appendix A

## Monitoring Equipment Photographs

## Appendix B

## Appendix C

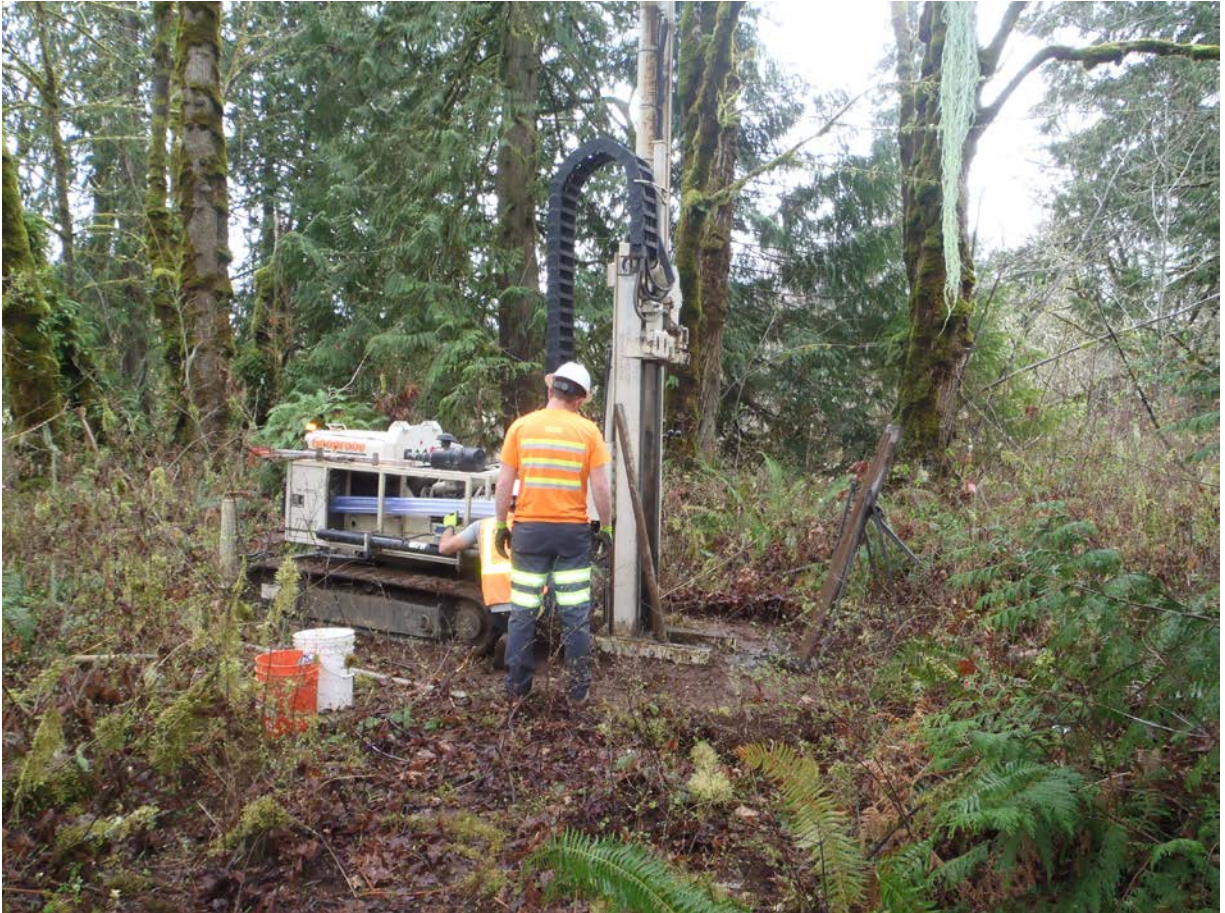
**Photograph A1**

**Groundwater Monitoring Piezometer Installation at a Groundwater Monitoring Location Using Geoprobe Drilling Rig**

Note: New groundwater piezometers were installed at Sites 007, 004, and 086.

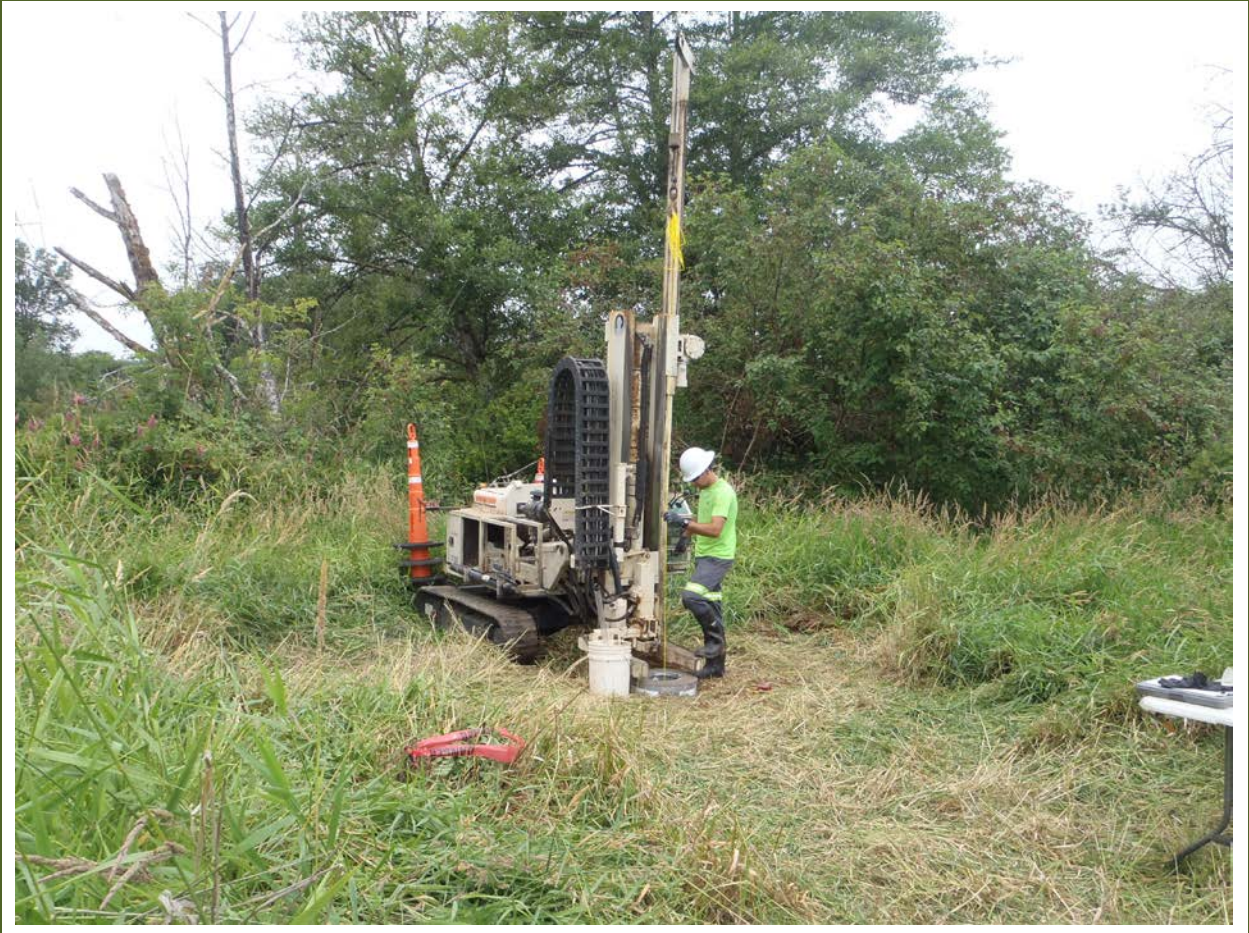
Photograph A2

Groundwater Monitoring Piezometer Well Development Via Surging, Bailing, and/or Pumping

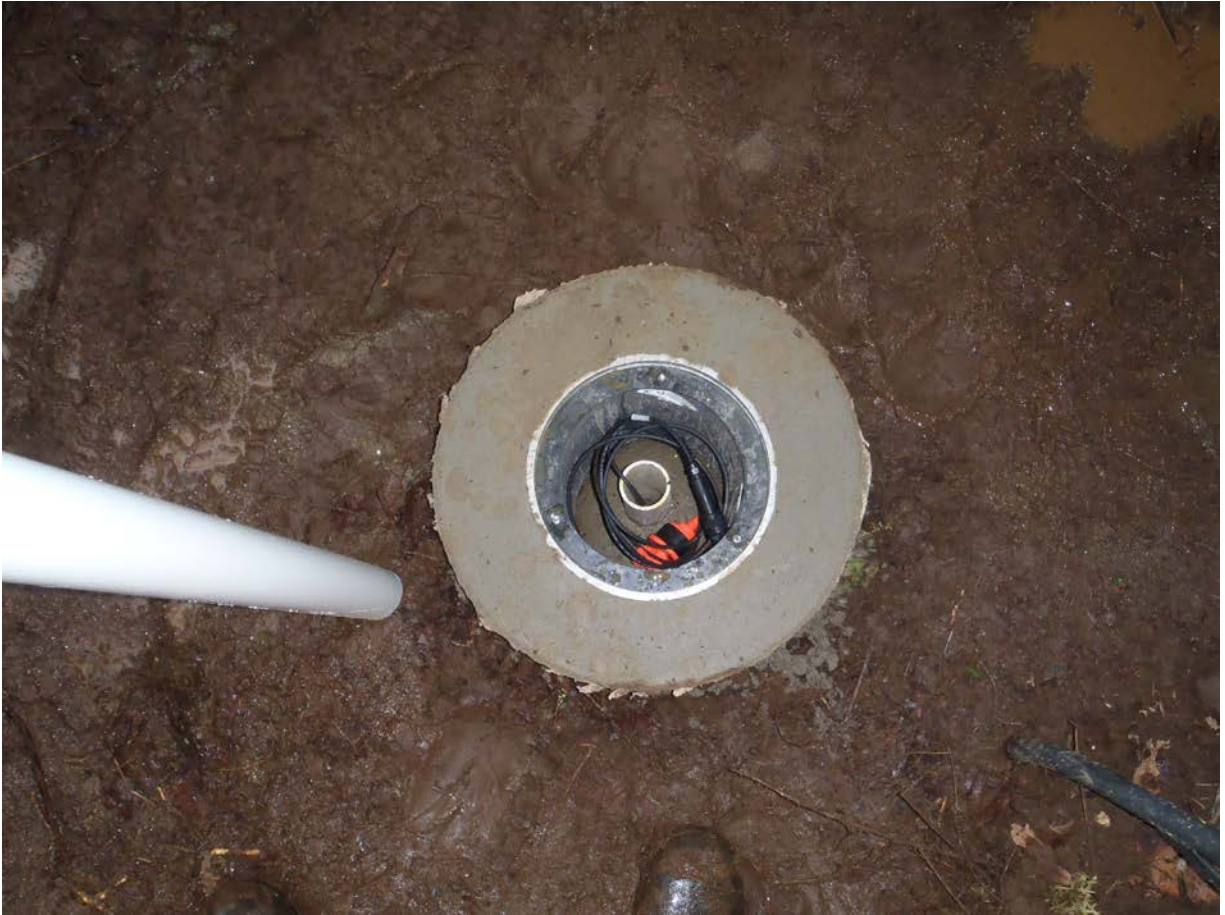
**Photograph A3**

**Completed Groundwater Monitoring Piezometer with Cover Removed Showing In-Situ Rugged Troll 200 Data Logger Cable and Coupler**

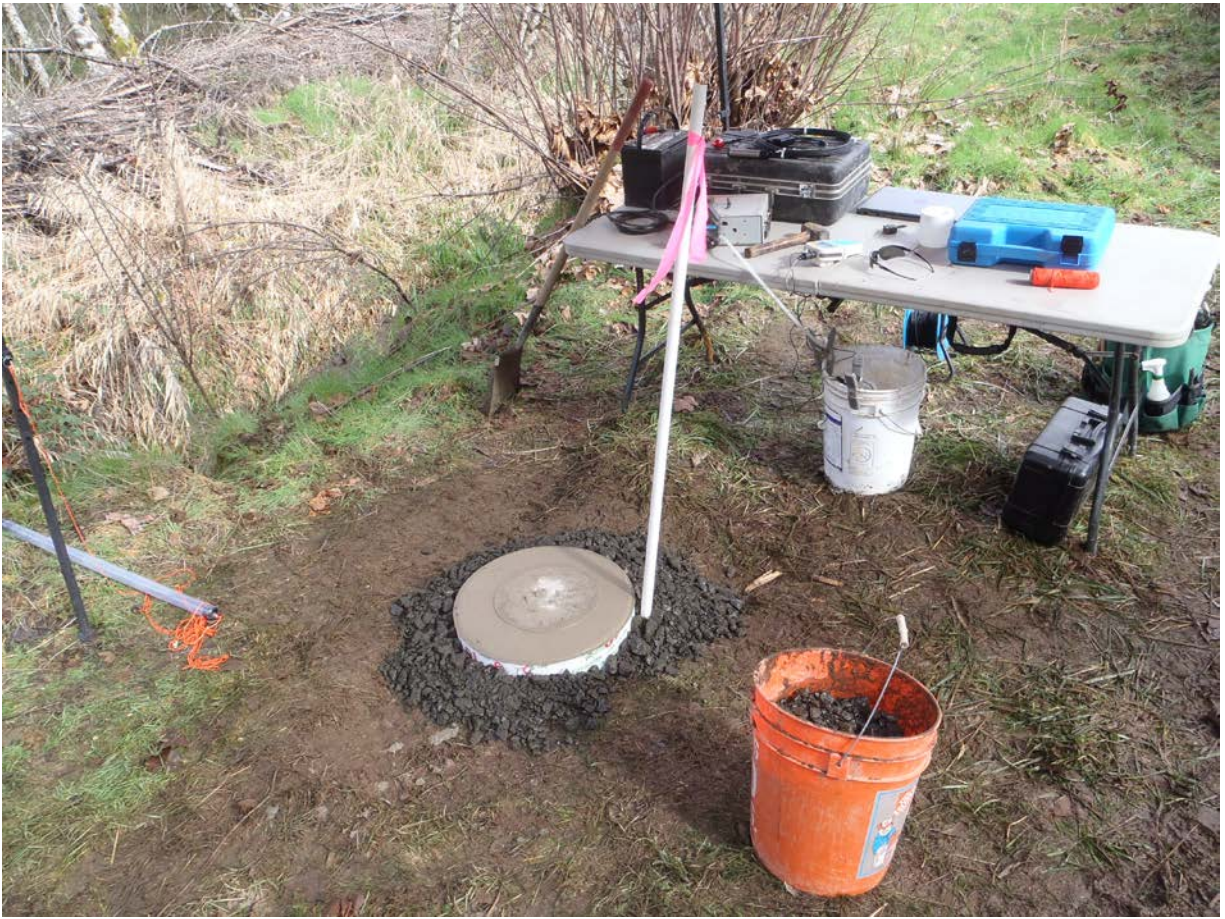
Photograph A4

Completed Groundwater Monitoring Piezometer with Cover Installed

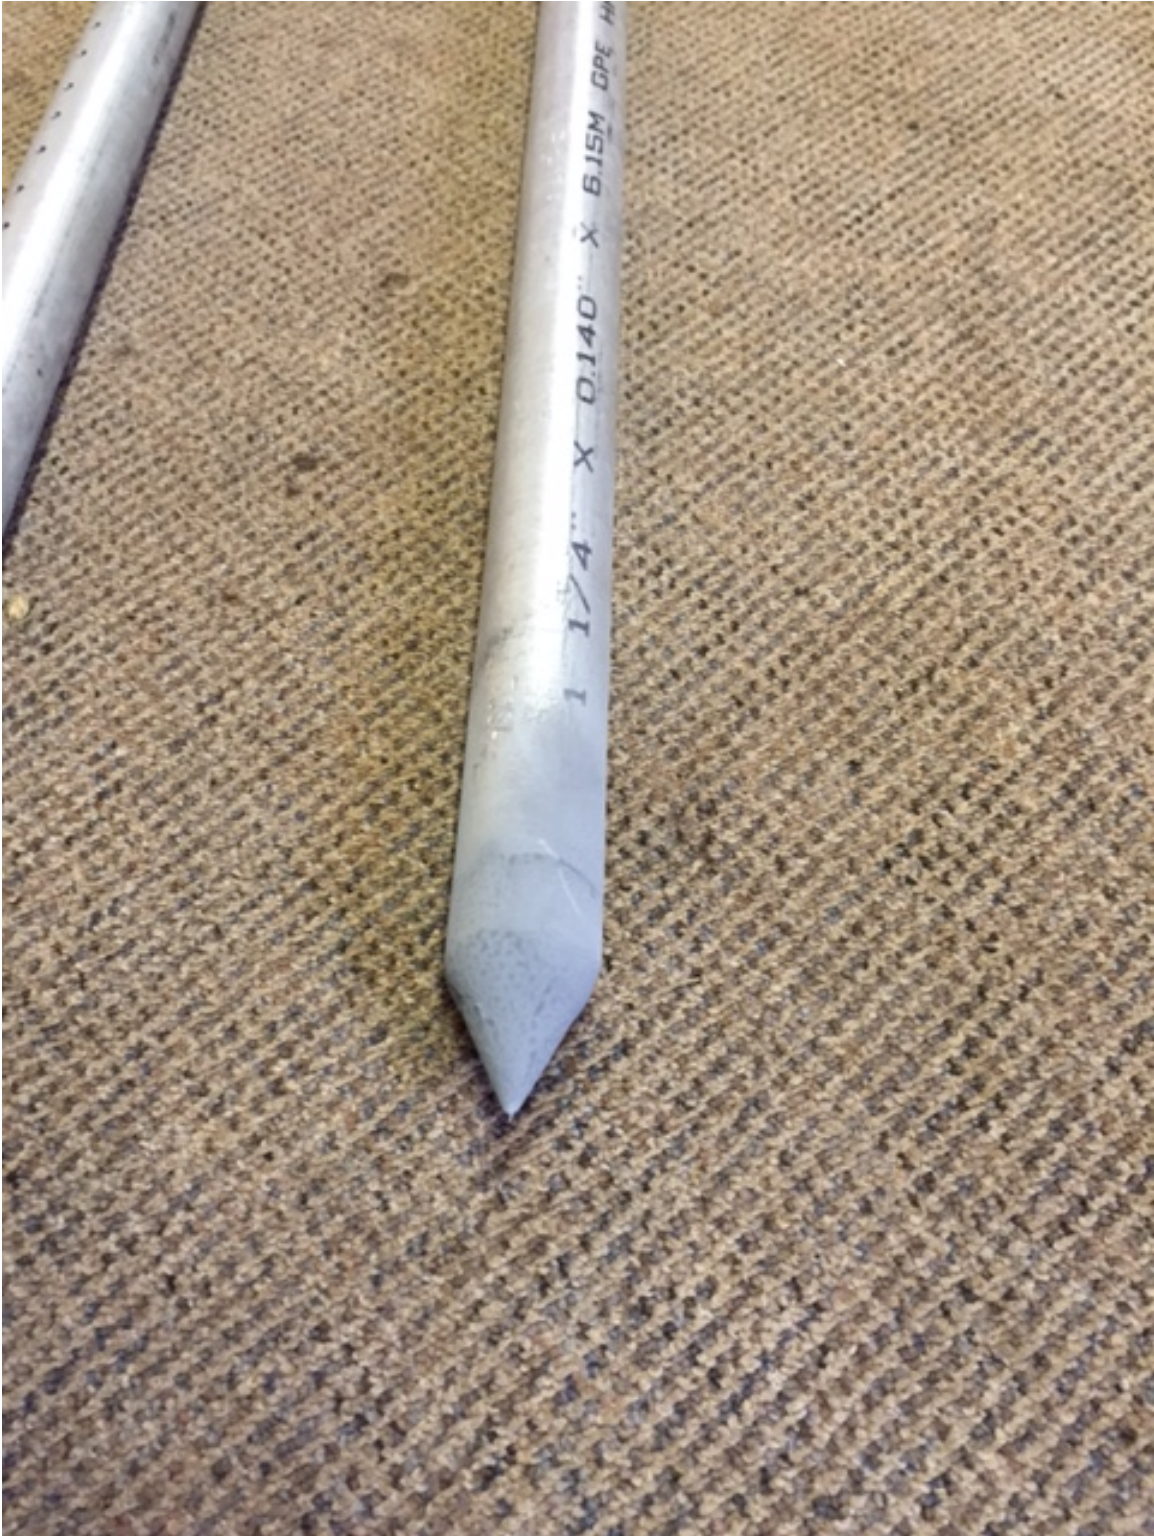
Photograph A5

Perforated Galvanized Steel Pipe and Drive Point Used to Construct the Stilling Wells at the River Monitoring Locations and Oxbow Pond Monitoring Locations

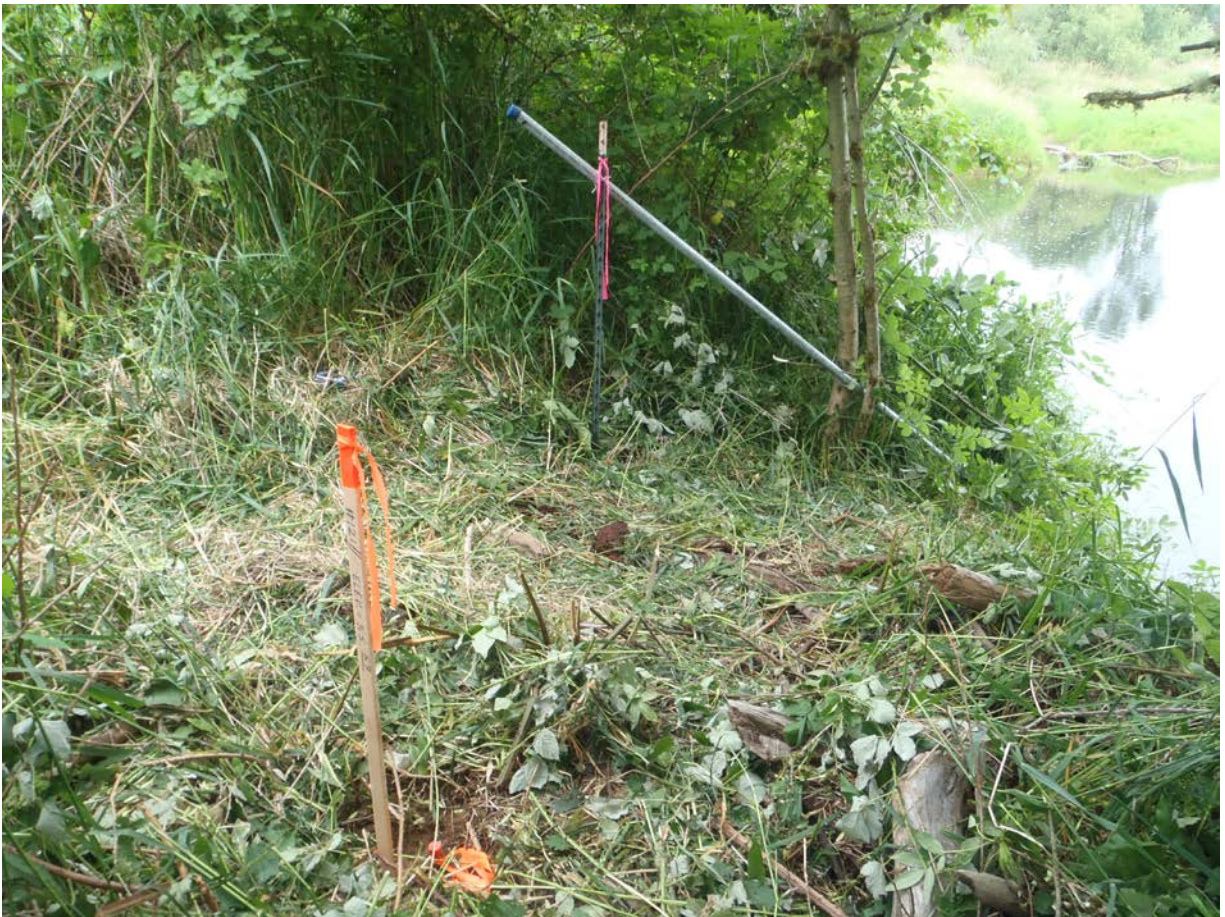
**Photograph A6**

**Typical Stilling Well Installation at a River Monitoring Location Along the Chehalis River**

Note: A monitoring location benchmark is visible in the foreground.

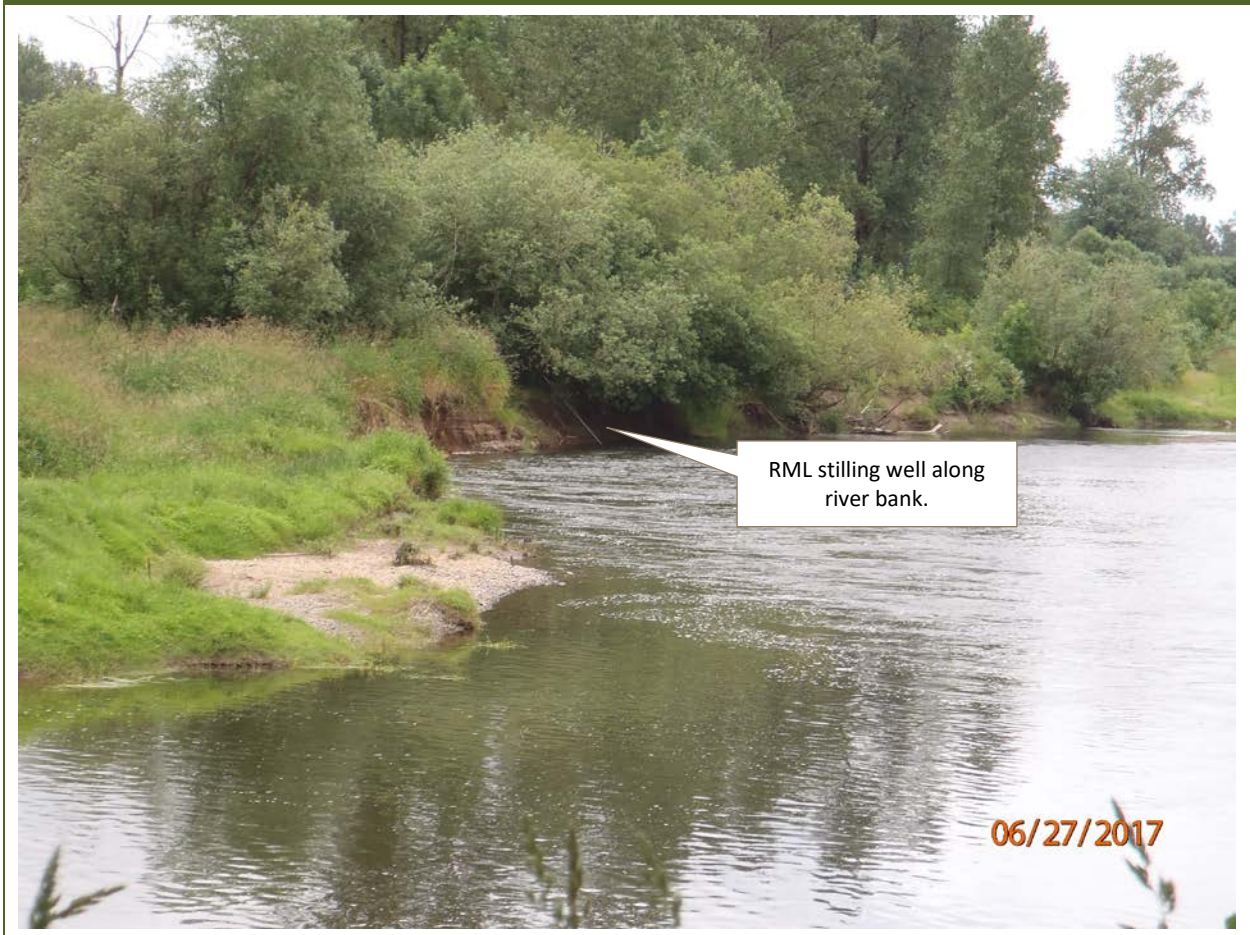
Photograph A7

A River Monitoring Location Stilling Well as Viewed from the Chehalis River

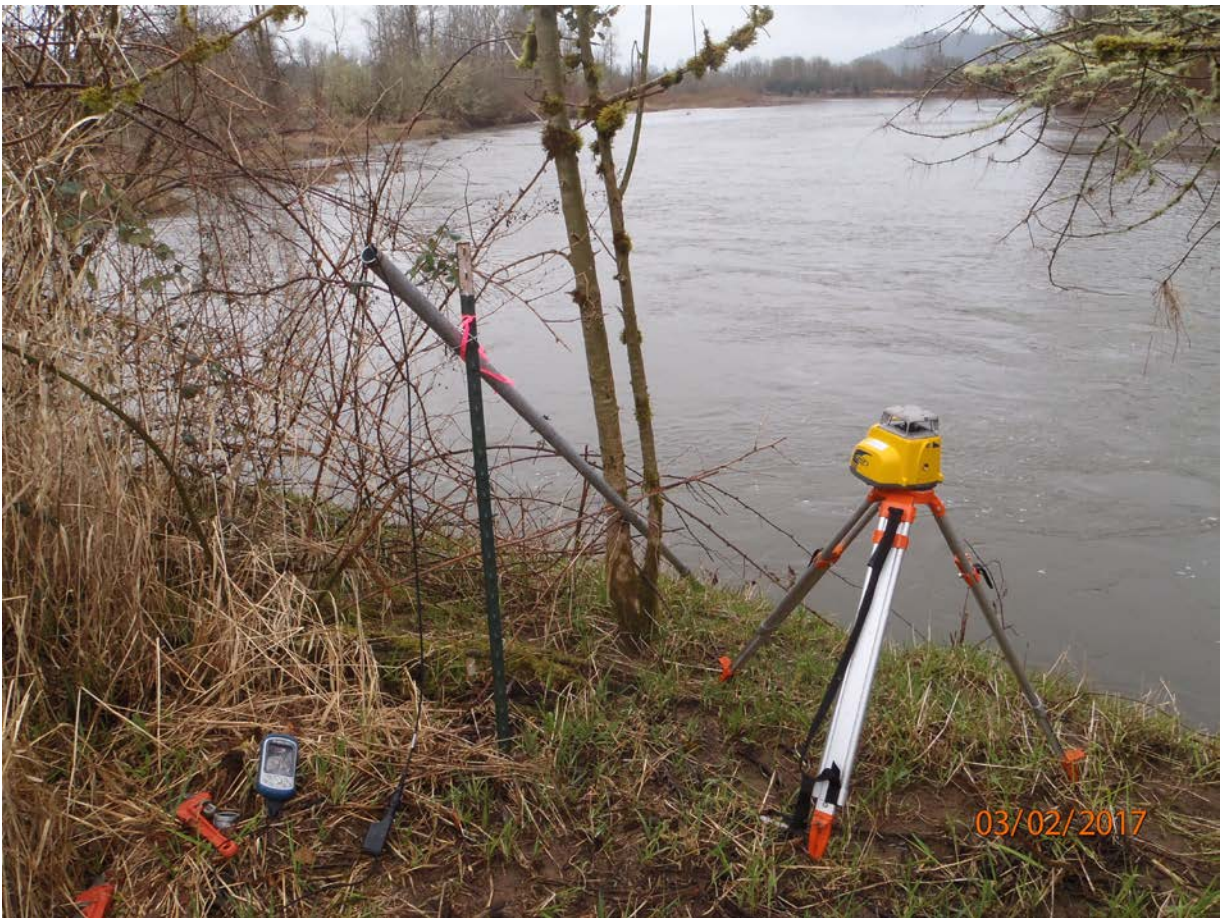
**Photograph A8**

**Data Collection at a River Monitoring Location**

Note: Data logger cable from stilling well is pulled out of well riser and connected to a Rugged Reader portable field computer. Survey equipment for manually measuring water elevation in river is shown at the right.

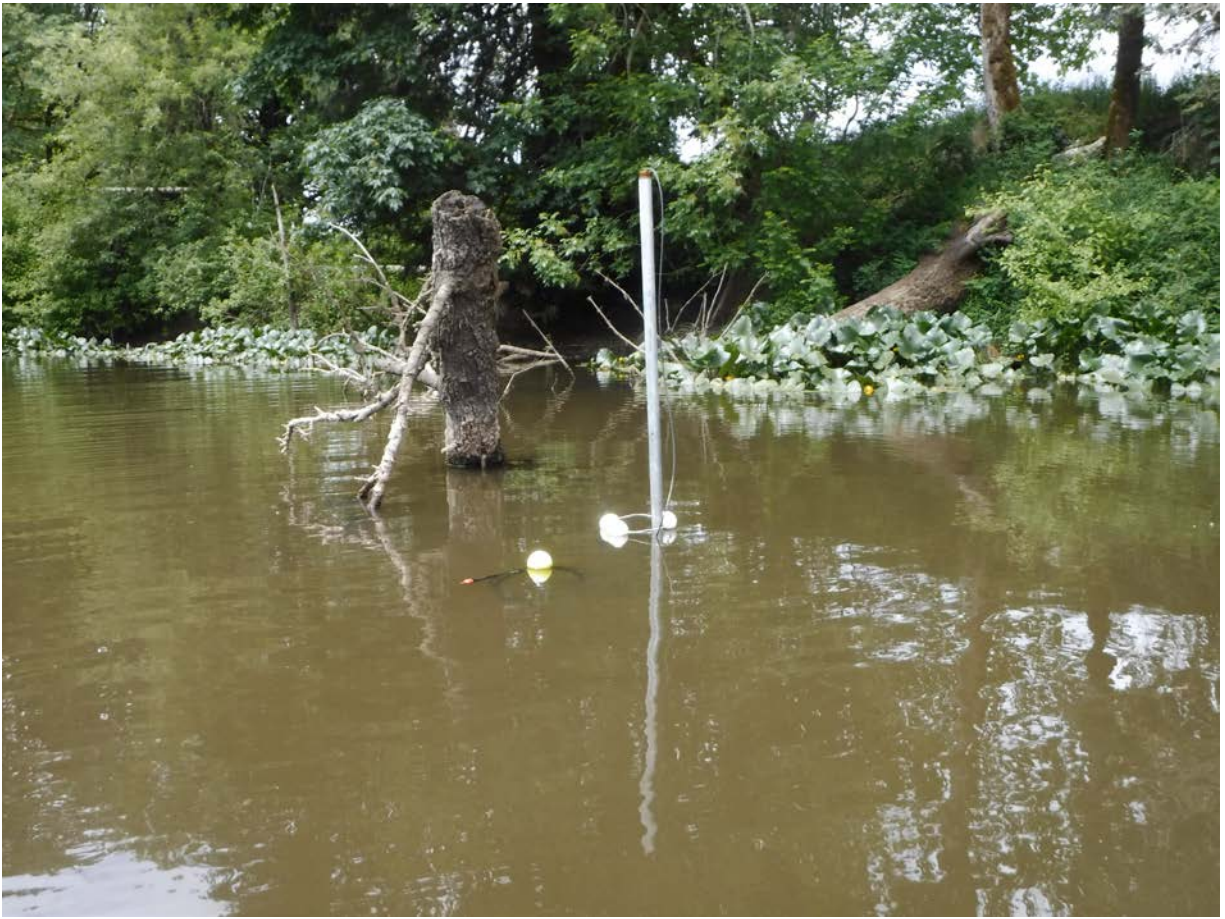
Photograph A10

Typical Oxbow Monitoring Location Configuration When Surface Water Is Present

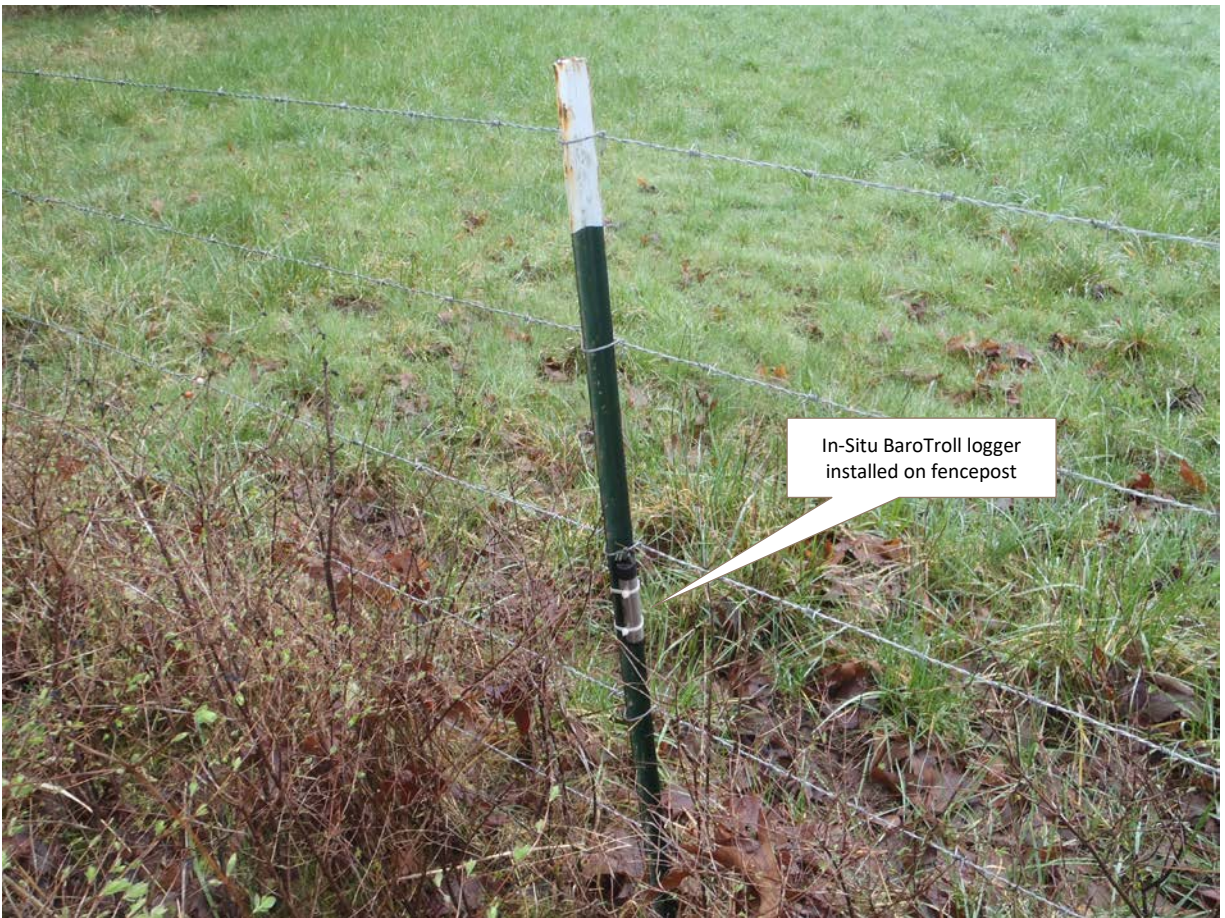
**Photograph A11**

**Typical Installation of an in-Situ BaroTroll Barometric Pressure Data Logger**

Note: These were installed at Sites 007, 004, 068, and 086.

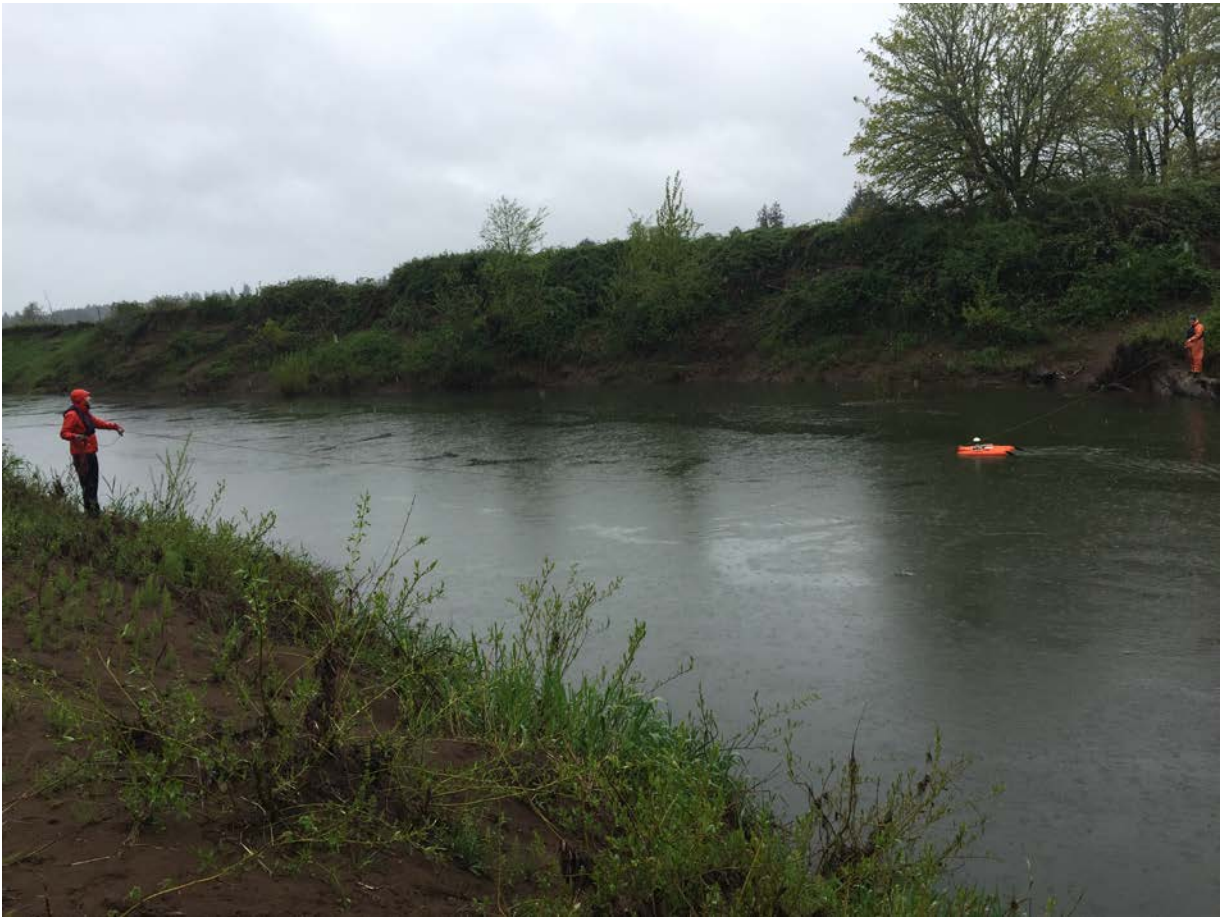
Photograph A12

River Flow Measurement Using an Acoustic Doppler Current Profiler Mounted on a Small Boat
