U.S. ARMY ENGINEER DISTRICT, SEATTLE
CORPS OF ENGINEERS
SEATTLE, WASHINGTON

SQUALICUM WATERWAY

CONDITION 3 MAY 2005
STA. 35+00 to STA. 70+00
BELLINGHAM BAY, WASHINGTON

SURVEYED BY: PJM
PLOTTED BY: CDM
CHECKED BY: LMR
DATE: 11 AUG 2005
FILE NO. E-9-7-068
SCALE: 1" = 200'
PLATE C-2
SHEET 2 OF 2

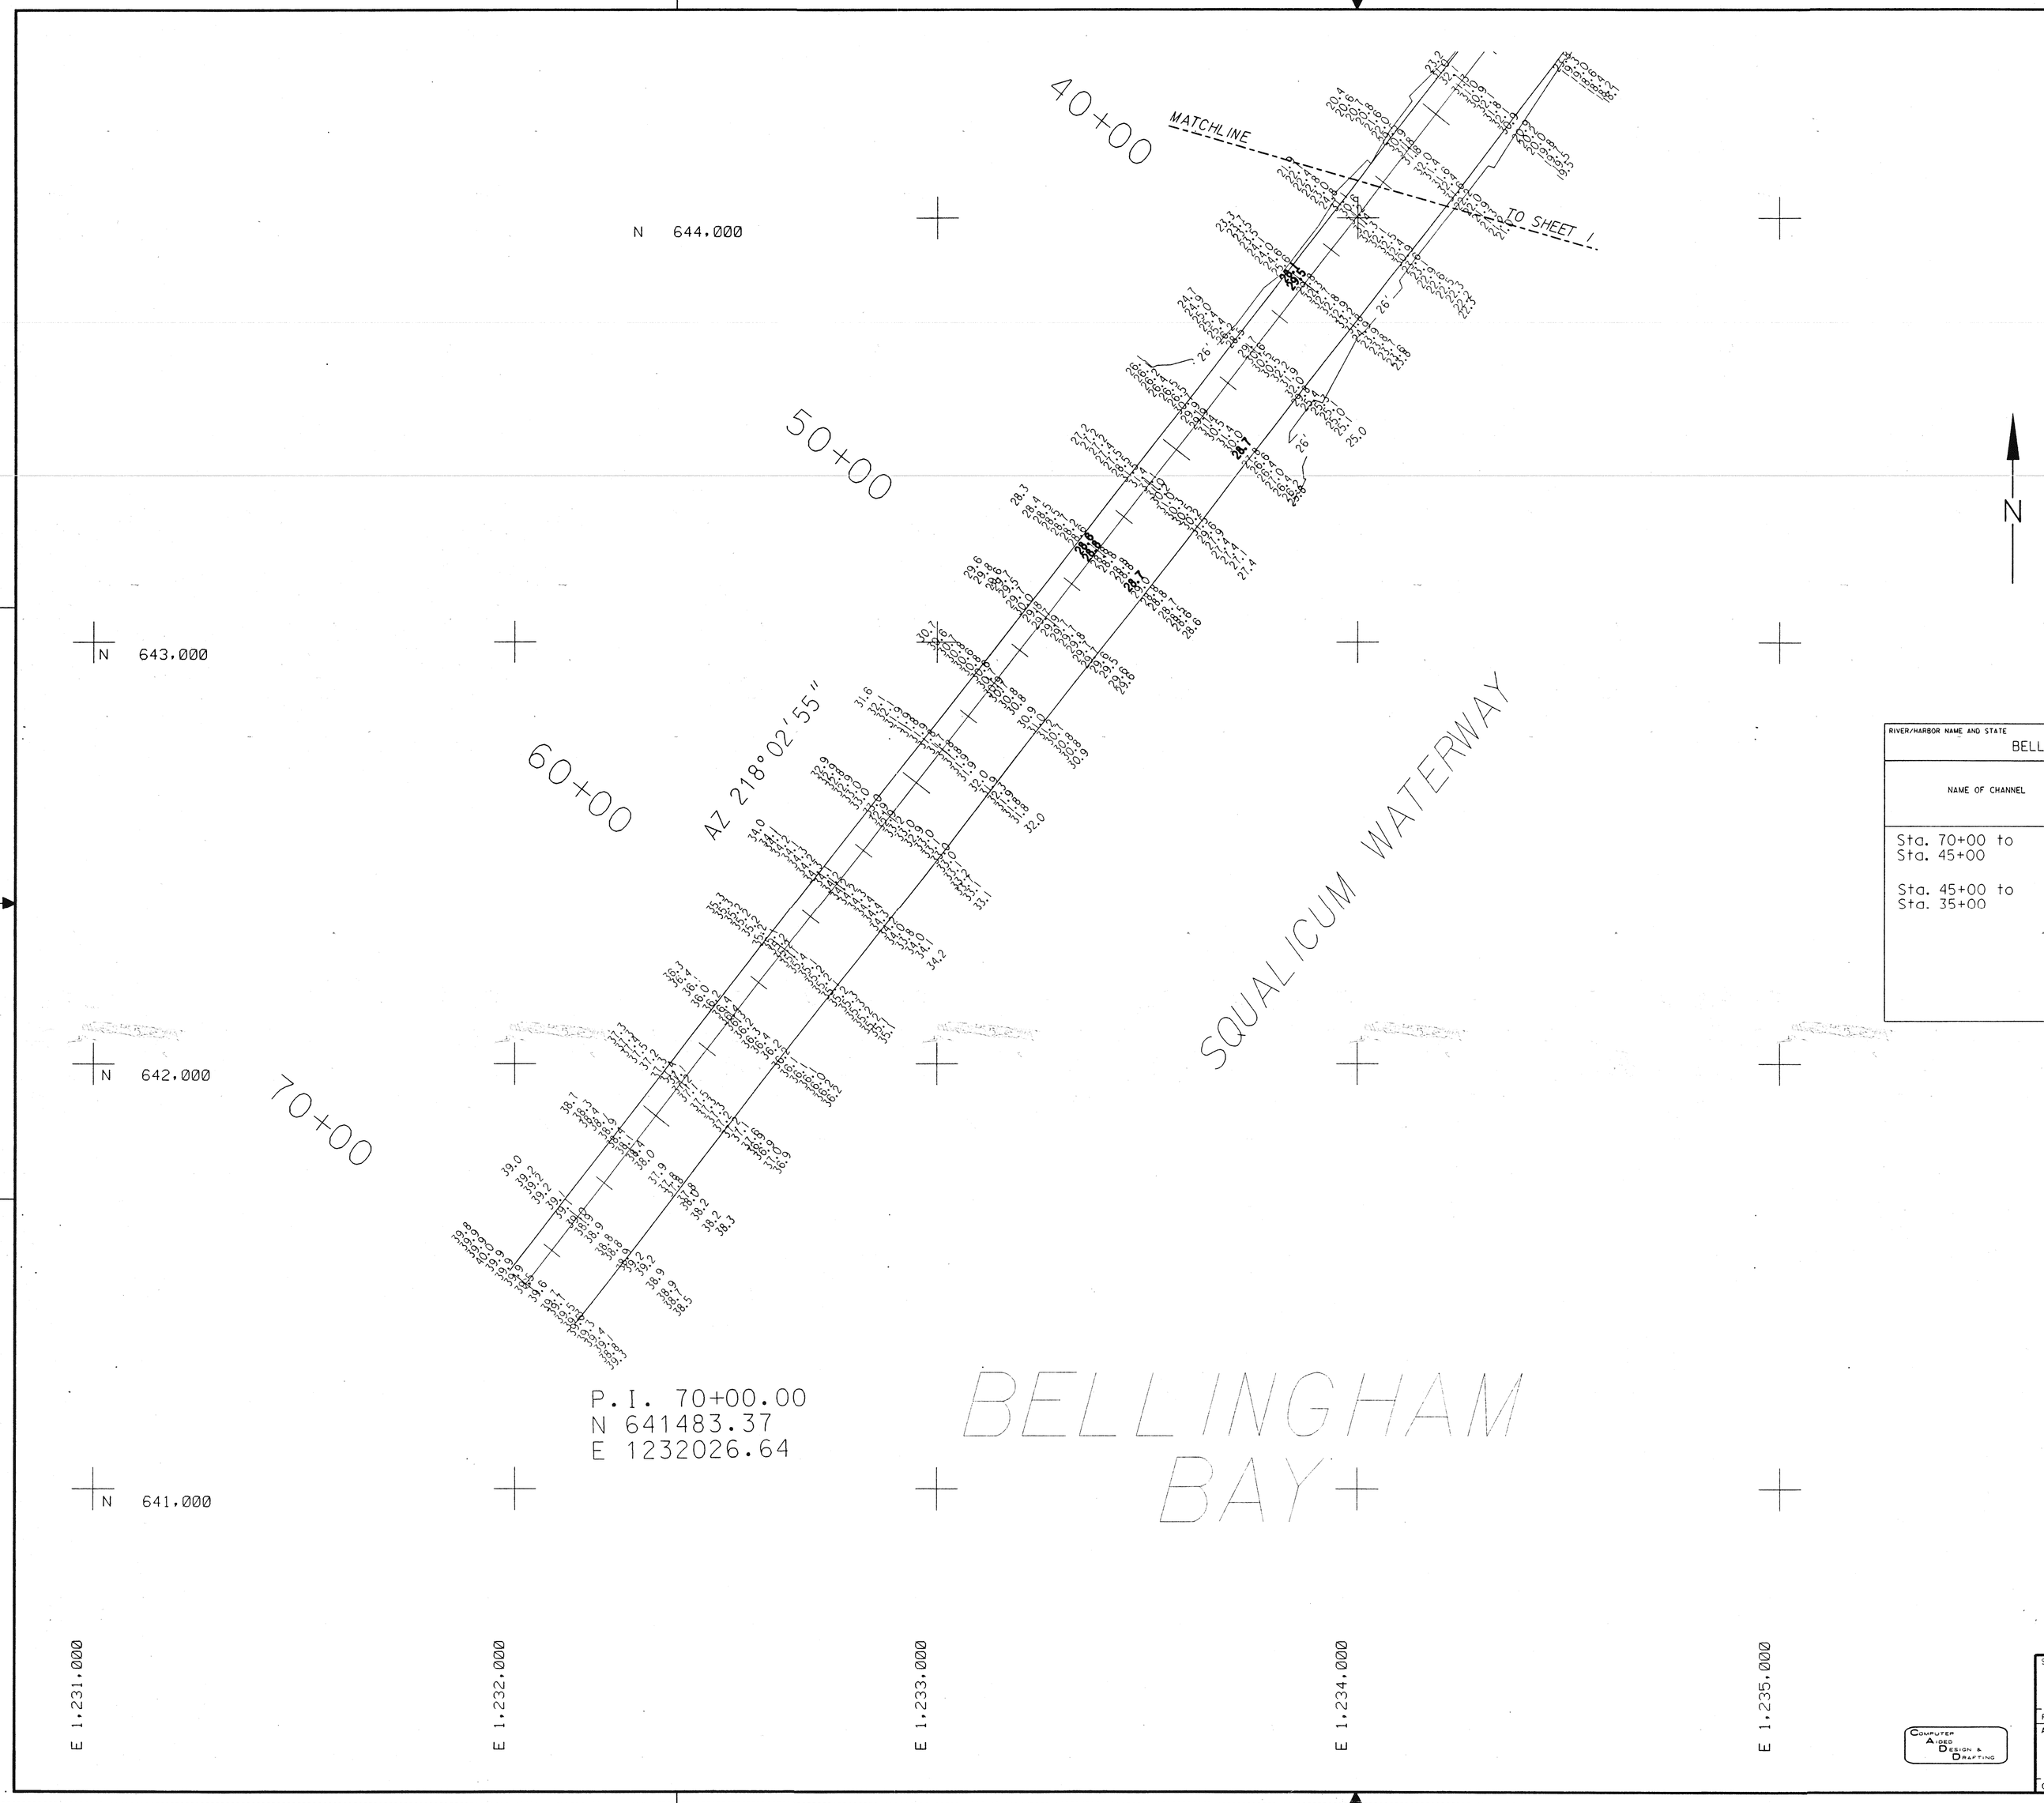
RIVER/HARBOR NAME AND STATE: BELLINGHAM, WASHINGTON					MINIMUM DEPTHS IN CHANNEL ENTERING FROM SEAWARD		
NAME OF CHANNEL	DATE OF SURVEY	AUTHORIZED PROJECT: WIDTH (feet)	LENGTH (miles)	DEPTH (feet)	LEFT OUTSIDE QUARTER (feet)	MIDDLE HALF (feet)	RIGHT OUTSIDE QUARTER (feet)
Sta. 70+00 to Sta. 45+00	3 MAY 2005	200	0.2	26	28.6	28.8	28.7
Sta. 45+00 to Sta. 35+00	3 MAY 2005	200	0.1	26	28.1	29.5	28.7
