**LOWER DUNGENESS RIVER
SECTION 544
ECOSYSTEM RESTORATION**

**APPENDIX F
HAZARDOUS, TOXIC AND RADIOACTIVE
WASTE**

**DUNGENESS RIVER
ECOSYSTEM RESTORATION PROJECT**

**ENVIRONMENTAL SITE ASSESSMENT
PHASE I**

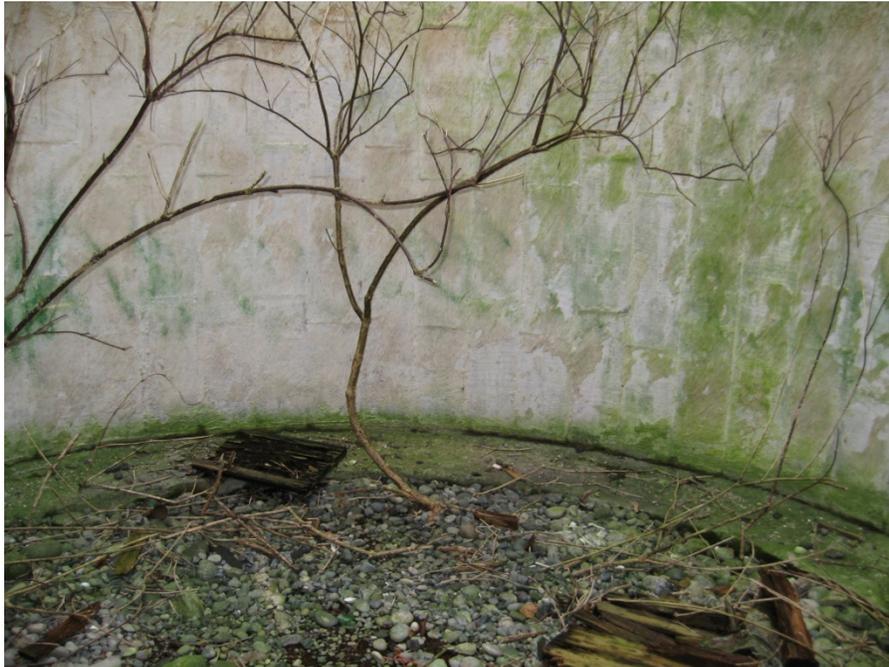
Figure 7 – Photo 5, Inside the grain silo

For the old barn shown in picture 5 and 6 the following observations were made:
