ENVIRONMENTAL ASSESSMENT

SKAGIT RIVER – DIKING DISTRICTS 1, 3, 12, 17, AND 22 LEVEES REHABILITATION OF FLOOD CONTROL WORKS SKAGIT COUNTY, WASHINGTON

May 2011

**US Army Corps
of Engineers®**
Seattle District

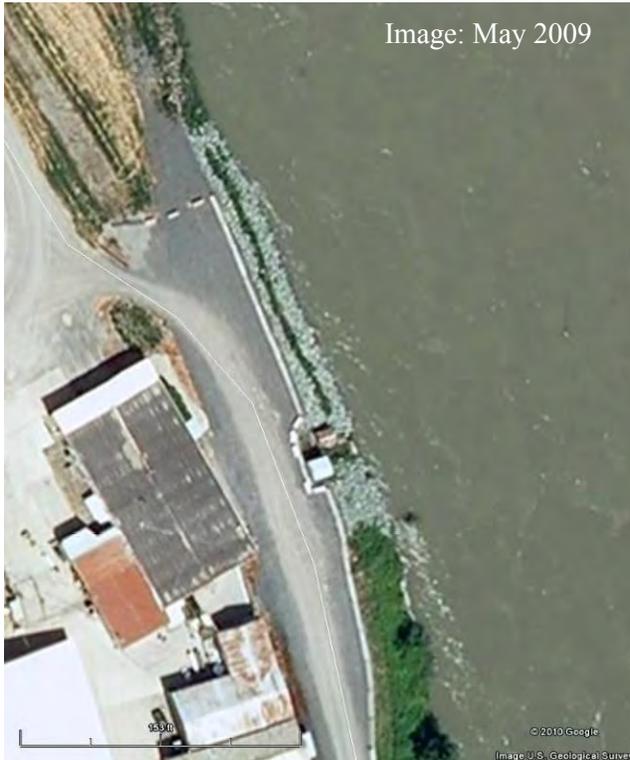
Figure 10: Site 1-7 Before Construction

- Site 1-7: The Corps repaired 257 LF of levee in 2007. The riverward slope of 2H:1V was reshaped and armored with a three-foot blanket of class IV riprap. The piles at the toe were not disturbed. Vegetation removed from the revetment face consisted of one locust tree less than four inches dbh, five small brushy alders, and a dense blackberry understory. The mitigation option installed at this site in 2007 include one willow lift (400 willows) spanning 153 LF was installed 8.6 feet below the levee top, approximately six feet above OHW. In 2011, 100 LF of woody debris will be placed as further mitigation along the toe intertwined in the piles.

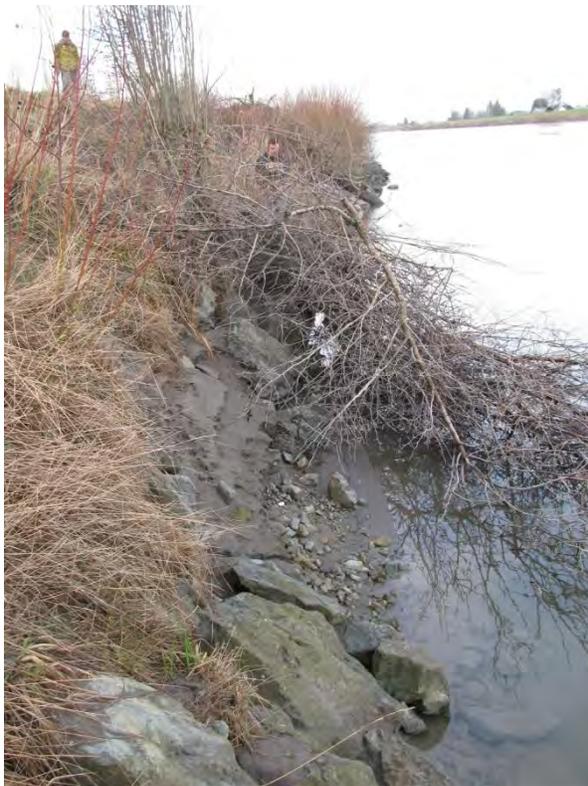
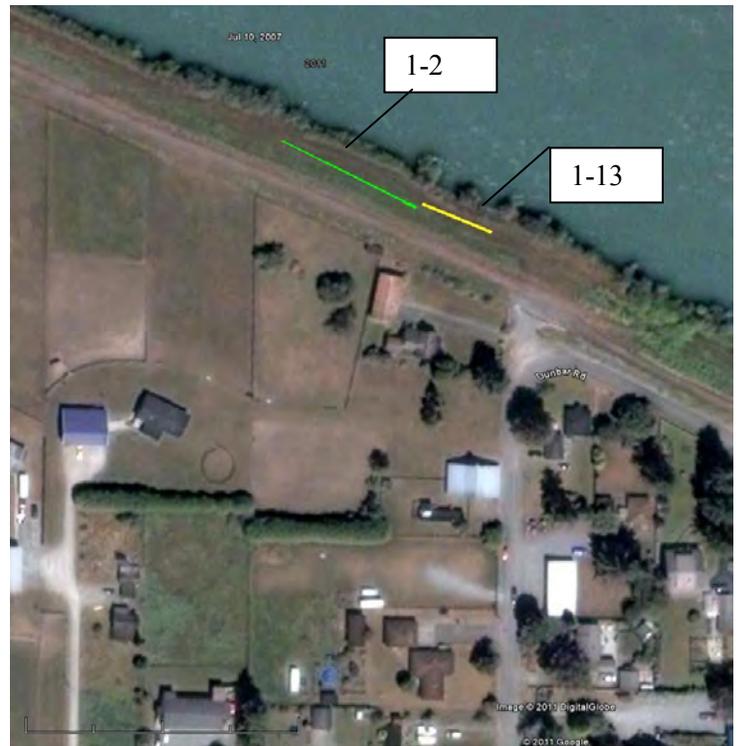
- Site 1-13: This site will be constructed in 2011. The damaged section of levee is 50 LF long and is scheduled to be repaired in 2011. This section of levee is adjacent to and downstream of the 2007 repair site 1-2 and has erosion resulting in displaced riprap due to scour around overgrown willows. A scalloped bank has formed as a result, and continued erosion would lead to further damage of the levee prism. The proposed repair will fill the scour hole and regrade the embankment slope at a 2H:1V slope with a three-foot blanket of class IV riprap. Mitigation options included in the designs for the proposed repair include a single willow lift at OHW and placement of soil and hydroseed over the top of the riverward face and the bench.

Figure 12: Site 1-13. February 2011, Before Construction. Site length : 50ft.

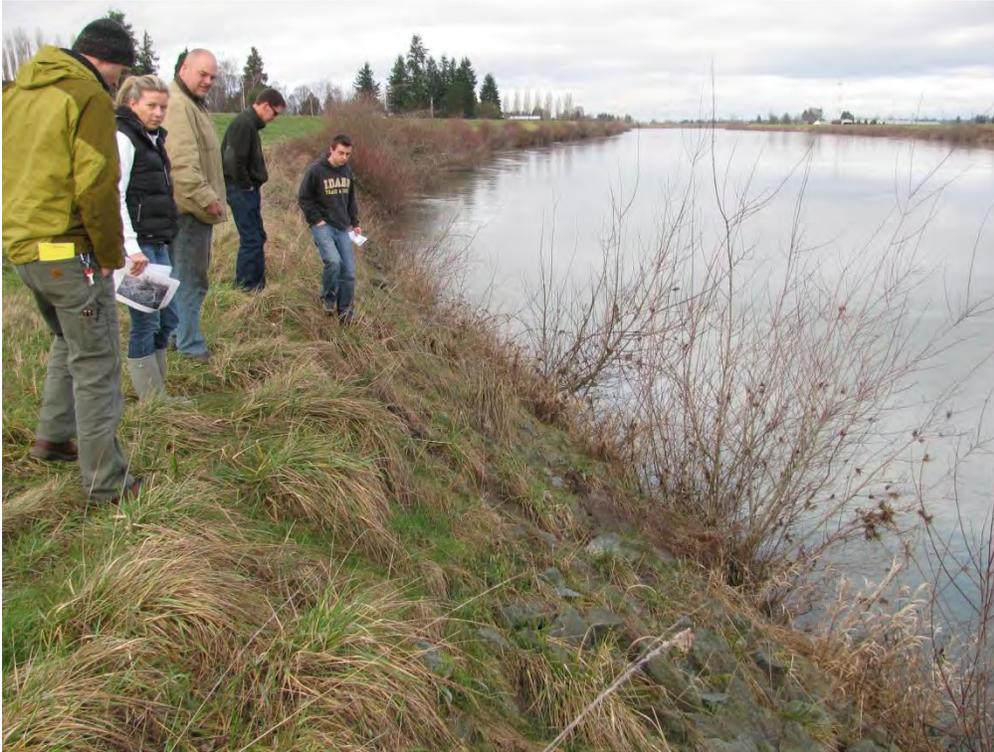
- Site 1-14: This site will be constructed in 2011. The damaged section of the levee is 30 LF long and is within a 2004 repair site. Floodwaters displaced riprap near the top of the embankment slope. Proposed repair will regrade the embankment slope with a three-foot blanket of class IV riprap at a 2H:1V slope and avoid in-water work. The mitigation option included in the designs for the proposed repair is to cover exposed rock above OHW with soil and hydroseed.

Figure 13. Site 1-14. February 2011, Before Construction. Site length: 30 ft.

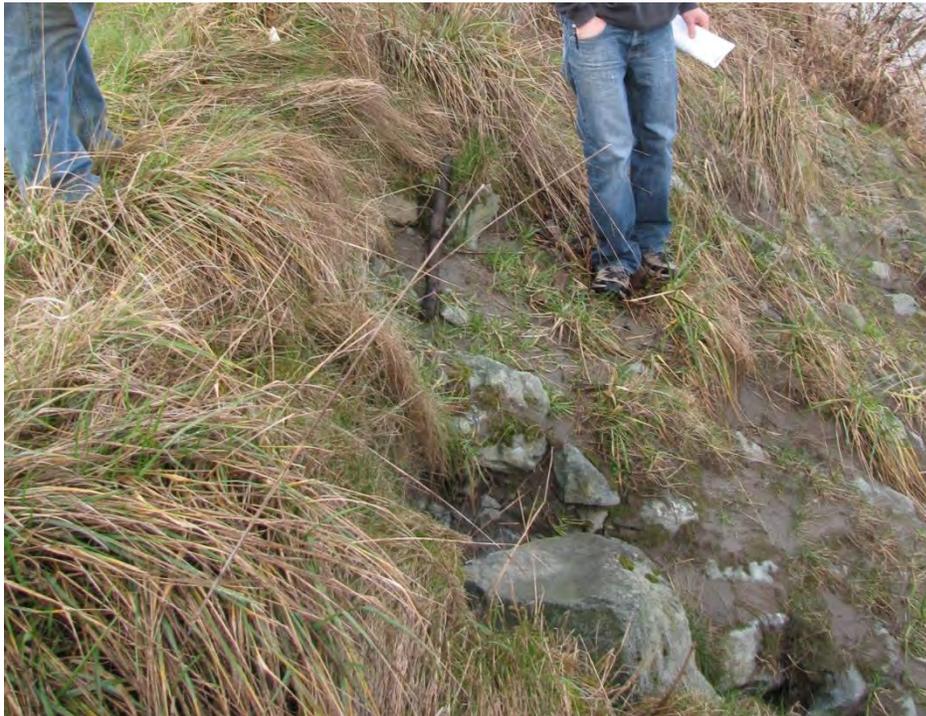
Figure 14. Site 1-14. February 2011, Before Construction.

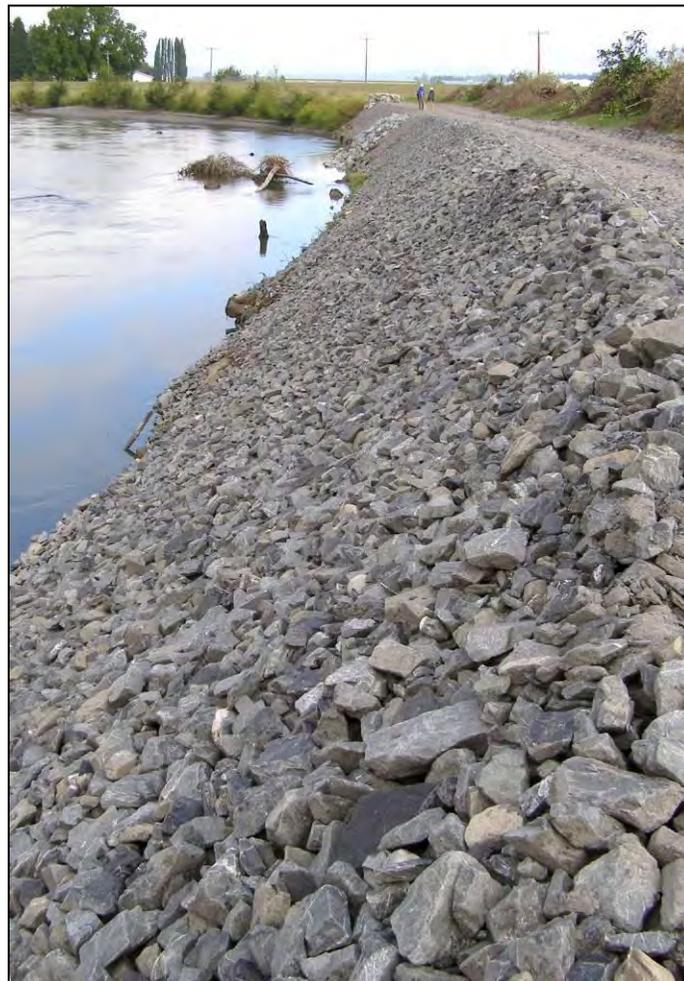
Figure 18: Site 3-2 After Construction

- Site 3-2: The Corps repaired 436 LF of levee in 2007 on the South Fork Skagit River. The riverward slope was reshaped, covered with spall rock, and armored with a three-foot blanket of class IV riprap. The levee crown was topped with crushed gravel, providing a driving surface. Vegetation removed from the site was grass, blackberries, and seven alders smaller than four inches dbh that were growing along the river. Mitigation at this site included one willow lift (~238 willows) installed throughout the project area. The willow lift elevation changes through the repair area with 391 LF at 3.6 feet below the levee crown (3 feet above OHW) and 45 LF at 6.6 feet below the levee crown (at OHW).

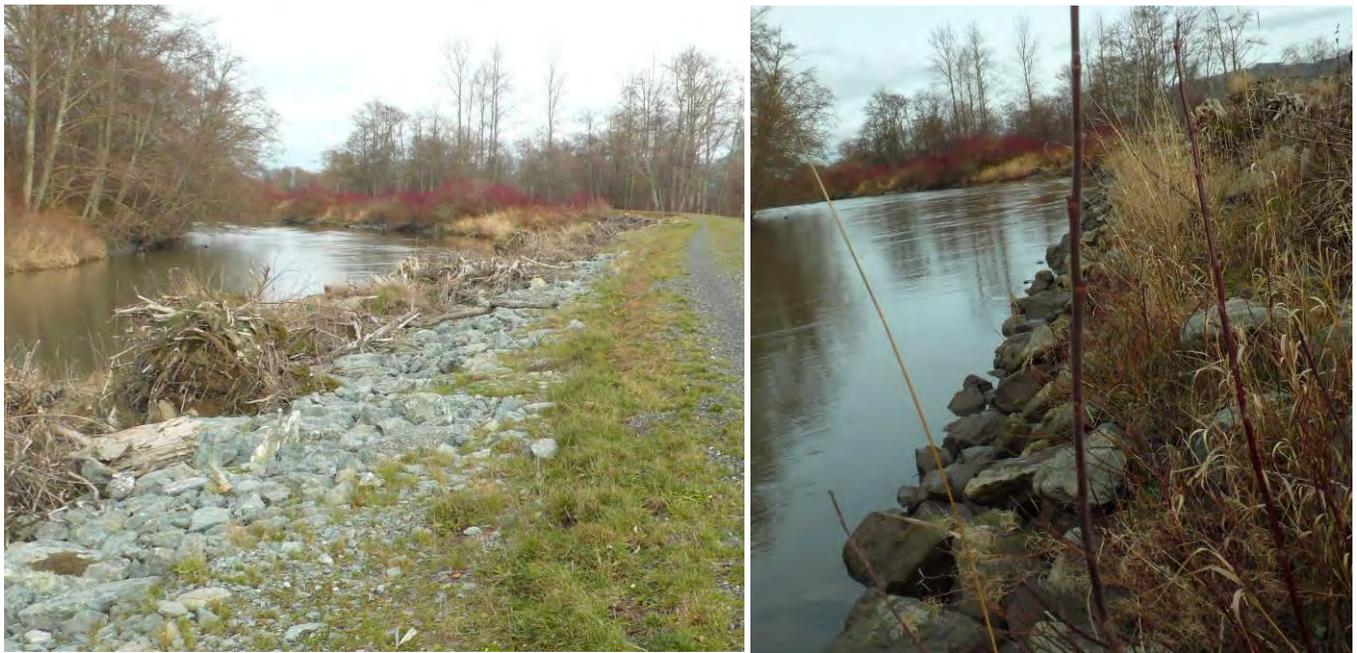
Figure 24: Site 3-6 After Construction, December 2009, showing rootwads placed at top of bank and willow growth at toe.

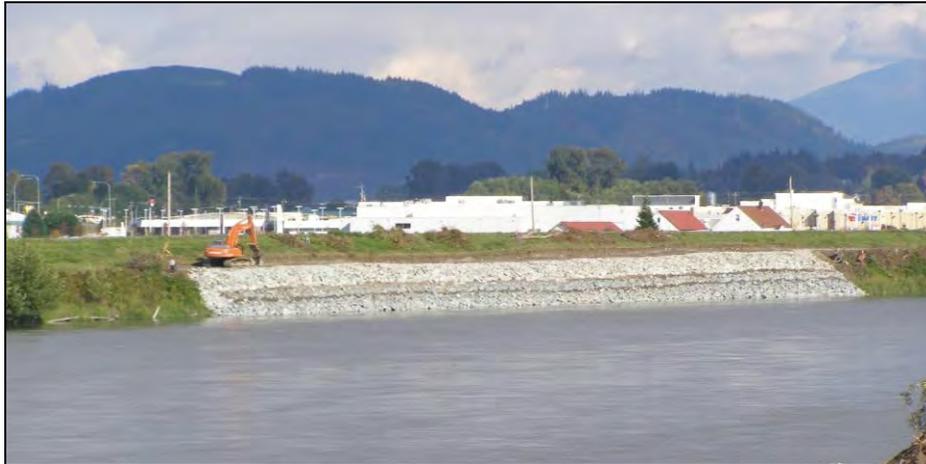
Figure 37: Site 12-6 Immediately After Construction,

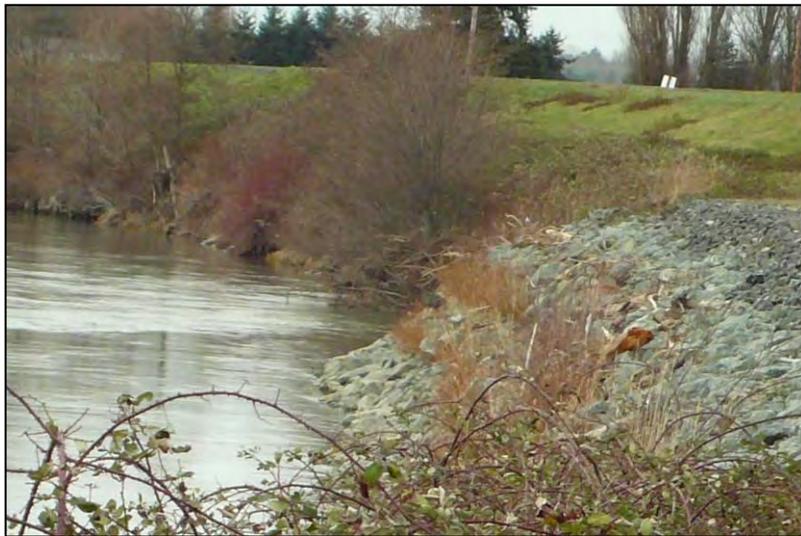
Figure 38: Site 12-6 December 2009, showing willow growth

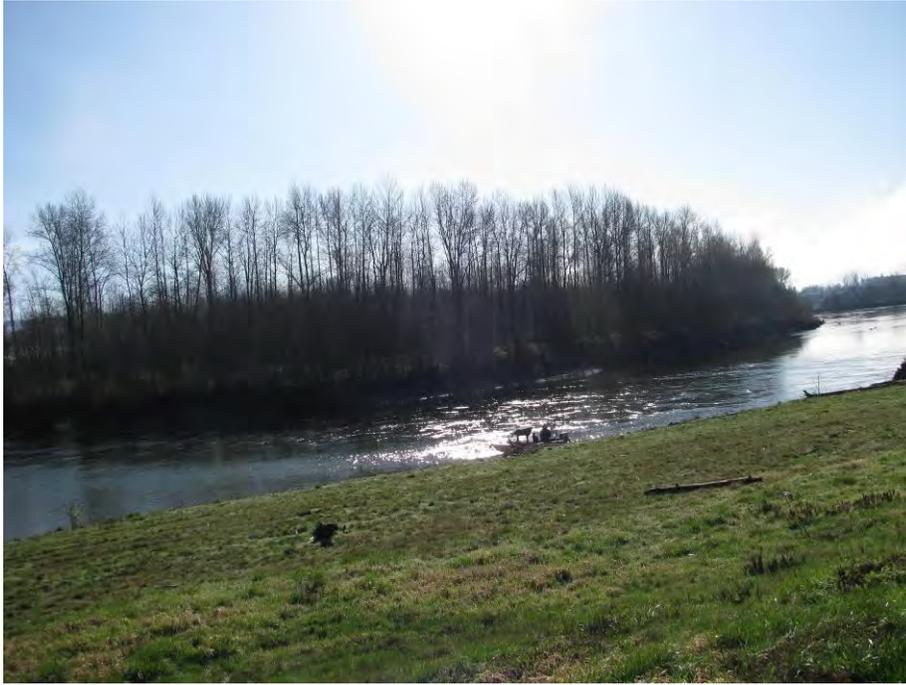
Figure 45: Site 12-14 Length of Repair: 250ft.

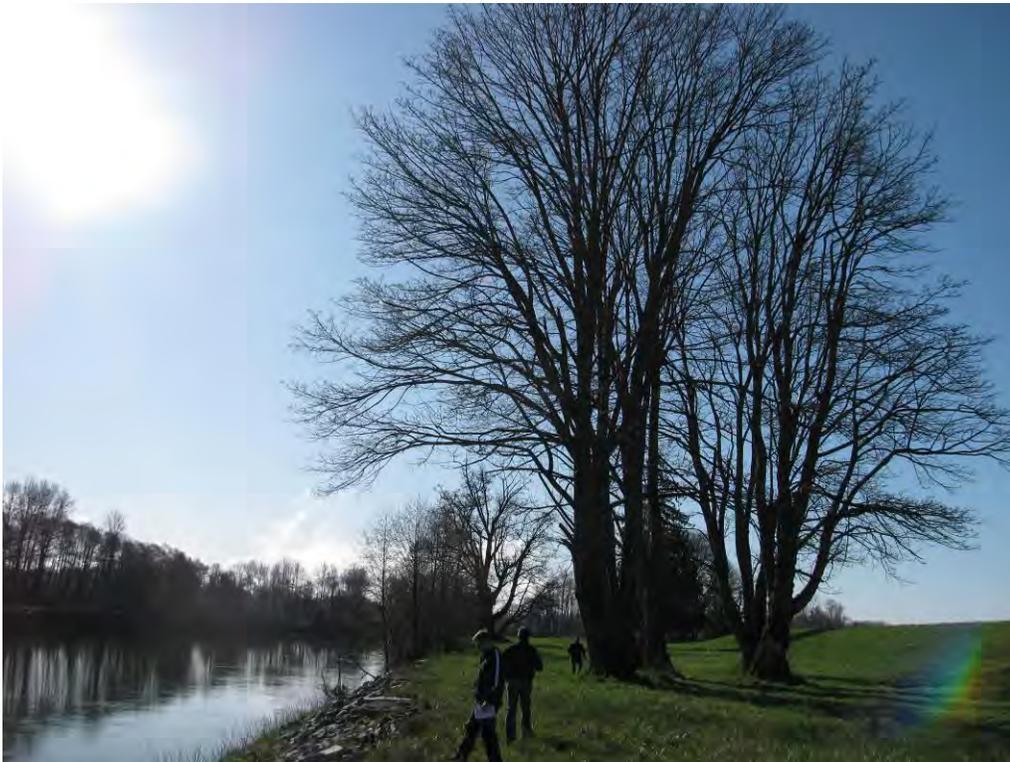
Figure 46: Site 12-15 Length of Repair: 180ft. The large big leaf maples in the foreground will not be impacted by the repair, the trees in the background along the revetment would be removed.

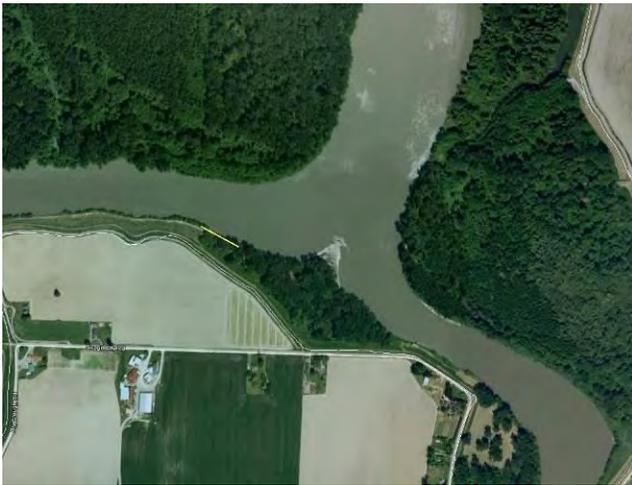
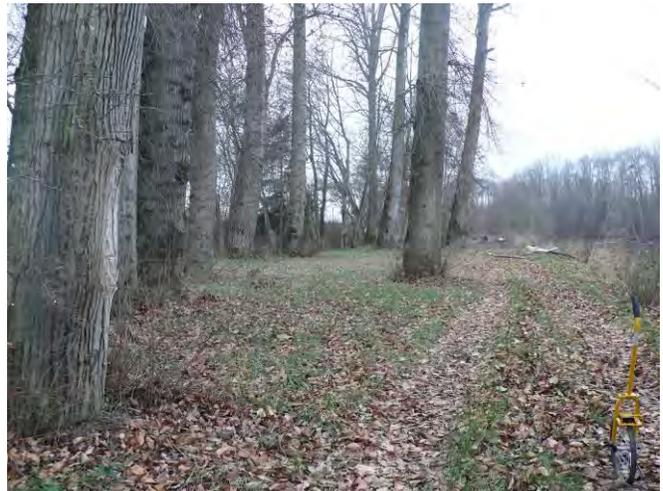
Figure 68: Site 22-7 Length of Repair: 350ft. Some of the large cottonwoods will be lost due to the layback designed for this site. Overstory plantings on the bench will be done for mitigation,

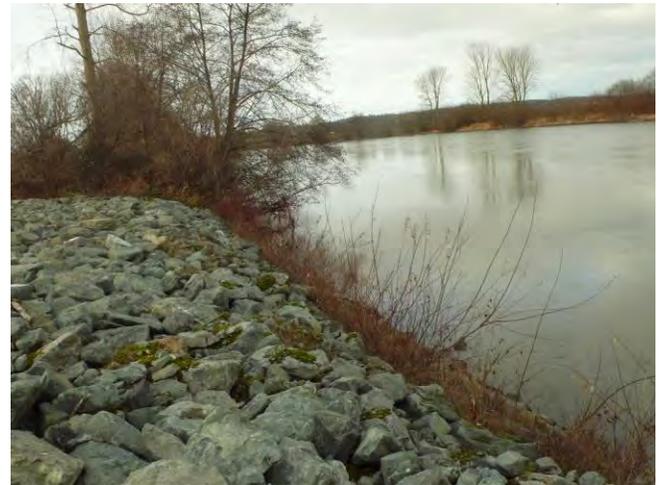
Figure 70: Site 22-8 immediately after construction in 2007 and in December 2009 showing willow growth.
