ENVIRONMENTAL ASSESSMENT

St. Maries Federally Authorized Levee Rehabilitation of Flood Control Works Benewah County, Idaho

September 2012

**US Army Corps
of Engineers®**
Seattle District

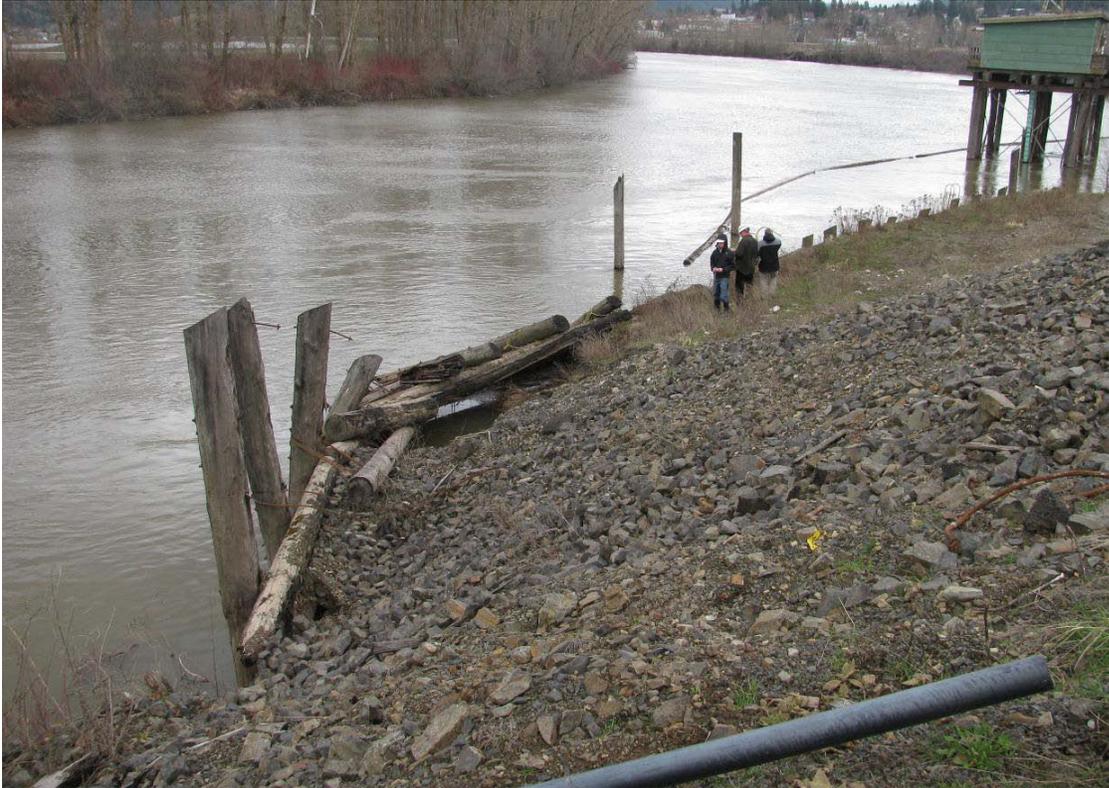
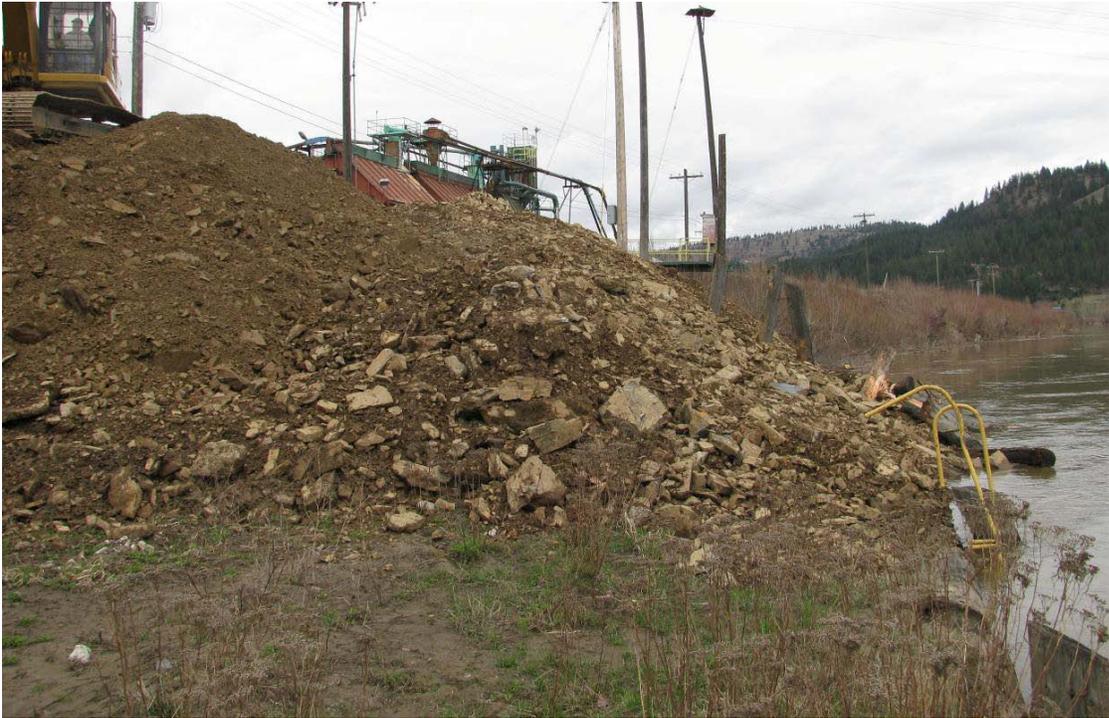
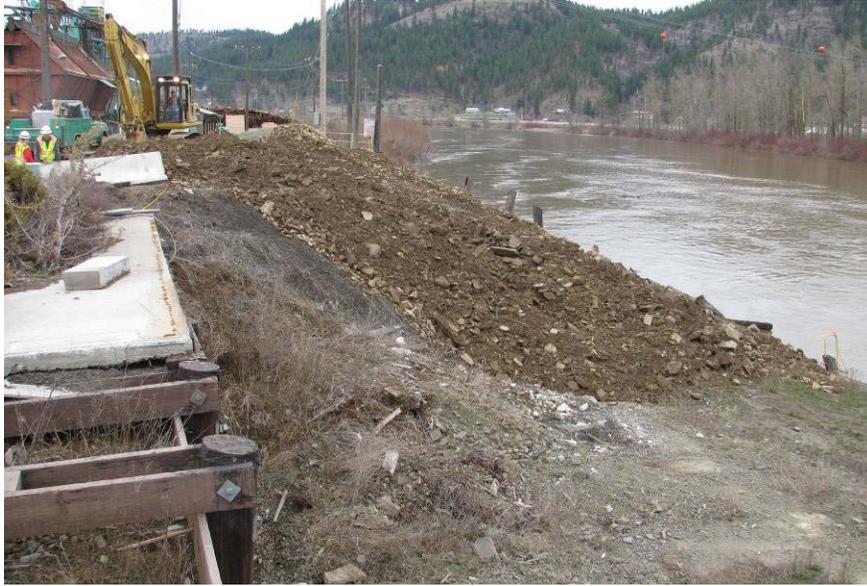
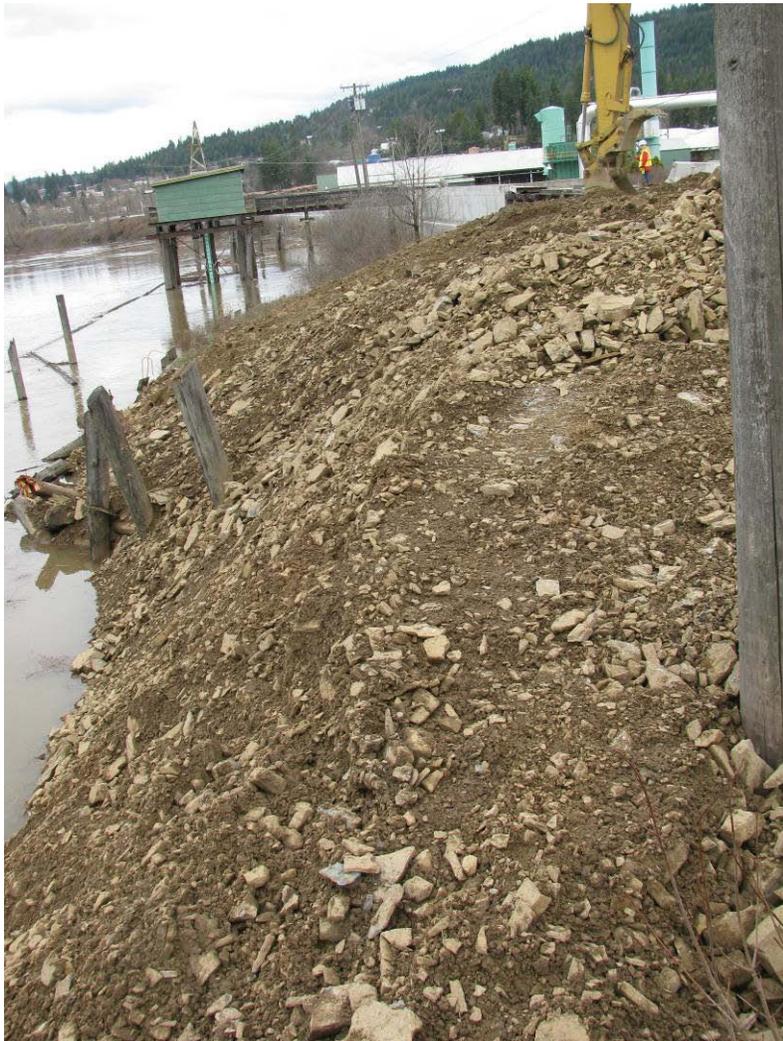
Photos taken during the flood fight work at Site 2:

A third high water event in late March and early April of 2012 resulted in further damage to the St. Maries Federal Levee. Site 2 is located downstream of the floodwall where a 60-foot long tension crack developed in the material that was placed during the 2011 emergency response. In general, this crack is 3 inches wide and 4 inches deep with a vertical displacement, meaning vertical distance from upper edge to lower edge, of 3 inches. At its widest point, the crack was measured at 7.5 inches wide with a vertical displacement of 8 inches. The final damage area, Site 3, is located upstream of the floodwall and sustained a rotational slope failure during the 2012 high water event. The rotational failure is approximately 5 feet in height and approximately 20 feet wide. The depth into the slope is approximately 5 feet. During the site investigation, the project team also noted areas of scour between the rotational failure and the floodwall for a total of 160 feet.

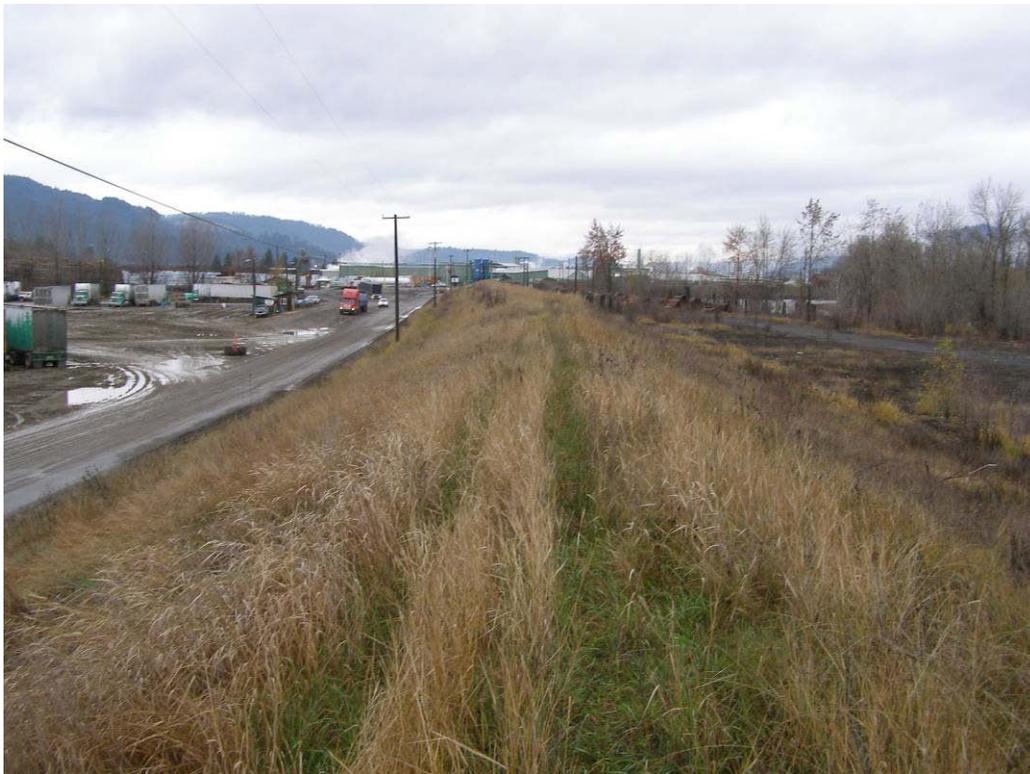
Facing west looking along levee crown, about 250 feet west of the pumphouse

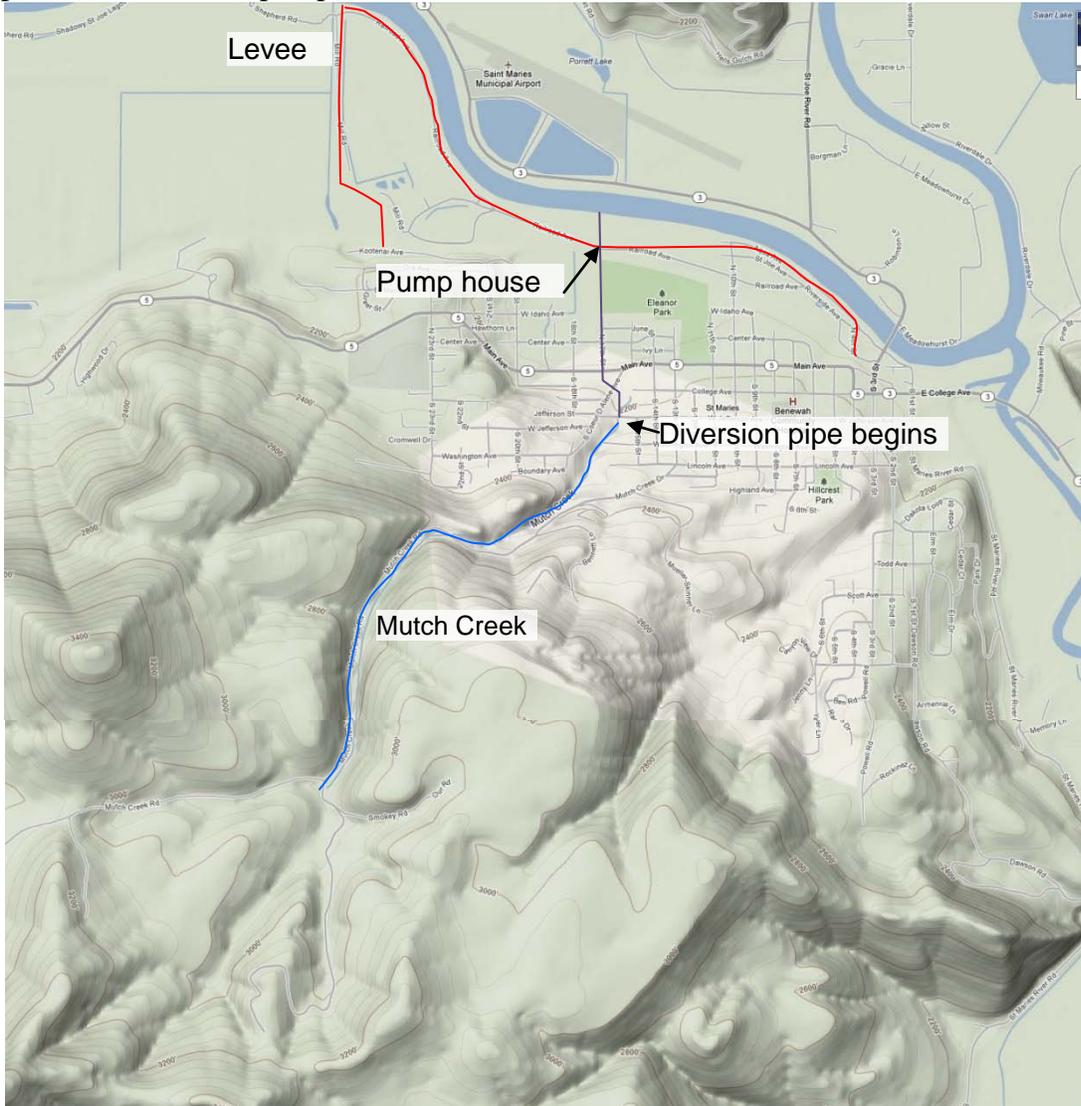
Mutch Creek Watershed. All land within the leveed area below the diversion pipe drains into the pond/wetland at the pump house.

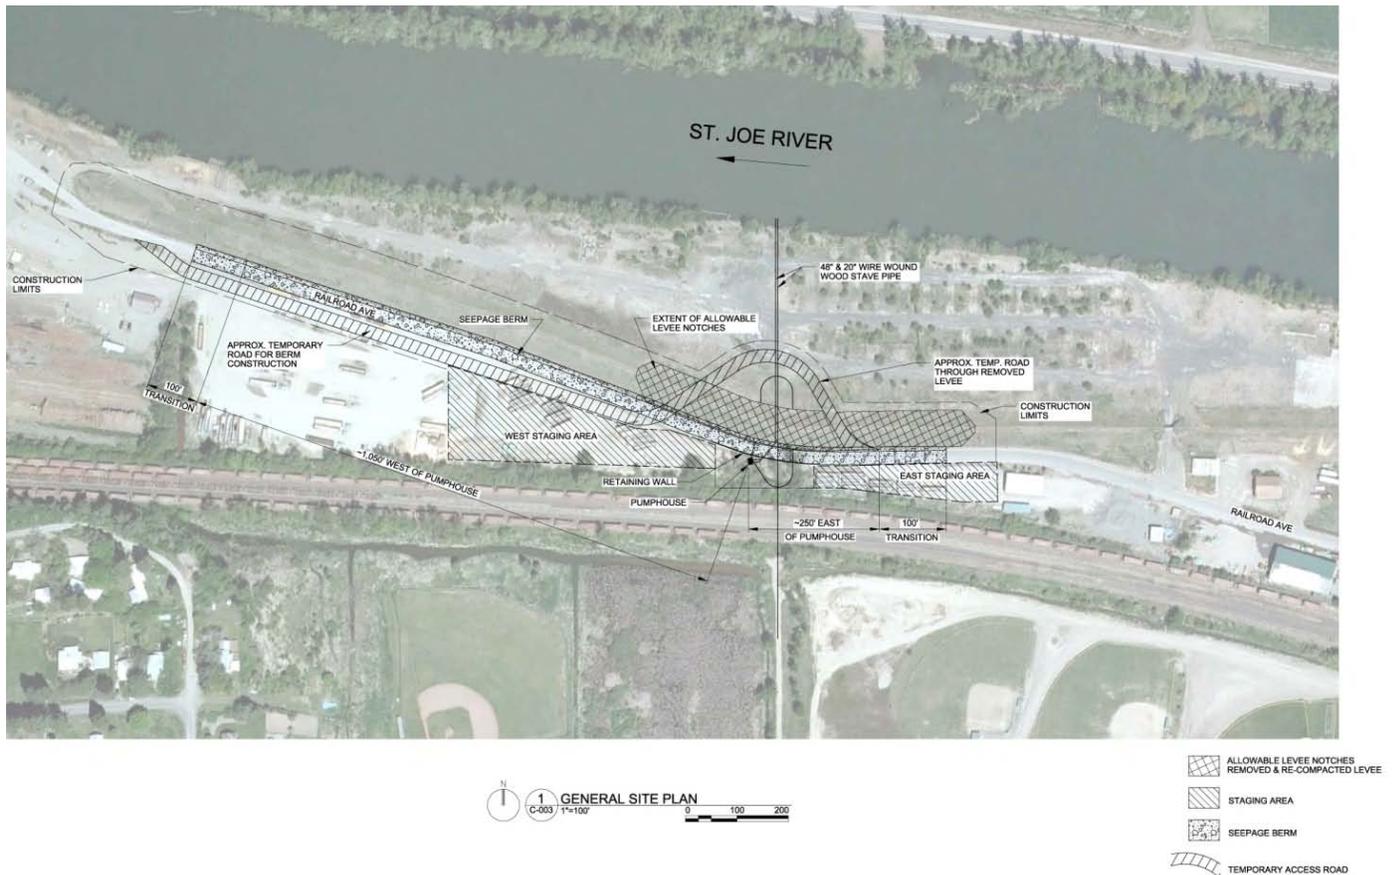
Figure 2. Plan view of Site 1.

During the May and June 2008 flood event, seepage paths developed in the St. Maries Federally Authorized Levee at Site 1 (Figure 1), allowing significant seepage along a 1,300 foot reach. The high river flows likely resulted in the pressurization of the Mutch Creek diversion pipe and the pump house outlet pipe. The pressure is presumed to have led to the pipe's failing. At the same time, seepage occurred along a longer reach of the levee presumably due to a lens of permeable material below the levee or potentially due to seepage along other utility pipes in the landward toe of the levee.

The recommended repair alternative for Site 1 (Figure 2) includes pipe replacements and constructing a 2-foot to 4-foot seepage berm by essentially raising Railroad Avenue. The berm would create an effective seepage control structure. The seepage berm would include a non-woven filter fabric covered by 2 feet minimum depth of ballast rock (≤ 2.5 inch in diameter). The berm would be capped with aggregate base course and finished with 4 inches of asphalt pavement. The landward toe will be located such that the project will not impact the adjacent wetland. The project would be transitioned to the existing roadway height for approximately 100 feet at each end of the seepage berm at a reasonable roadway grade. The total length of the project would be 1500 feet to include these transition areas. Also, the Mutch Creek diversion pipe and the 20-inch pump house outlet pipe would be replaced to correct any postulated deficiencies in the conduits. It is theorized that, when the flap gates are closed on these pipes, pressure develops and any weak points in the pipes leak, creating pressure in the ground water and causing piping damage to the levee. The proposed repair would entail replacing approximately 150 feet of the 48-inch Mutch Creek diversion pipe with 48-inch HDPE butt welded pipe and replacing approximately 120 feet of the 20-inch pump house outlet line with 20-inch HDPE butt welded pipe. Repair of the pipe through the levee, and rerouting of traffic during construction will require a portion of the levee, up to 500 ft, to be removed and rebuilt.
