**INSPECTION REPORT
OF
ASBESTOS AND LEAD-BASED PAINTED
BUILDING MATERIALS**

**CAPEHART FAMILY HOUSING IMPROVEMENTS - PHASE 3
MALMSTROM AIR FORCE BASE
GREAT FALLS, MONTANA**

**MAXIM TECHNOLOGIES, INC.
303 IRENE STREET
HELENA, MONTANA**

October 21, 1999

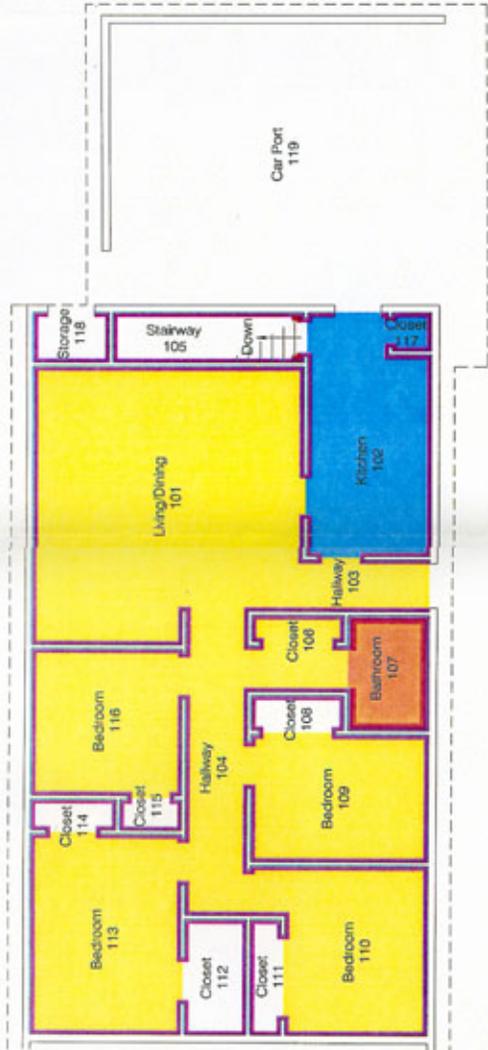
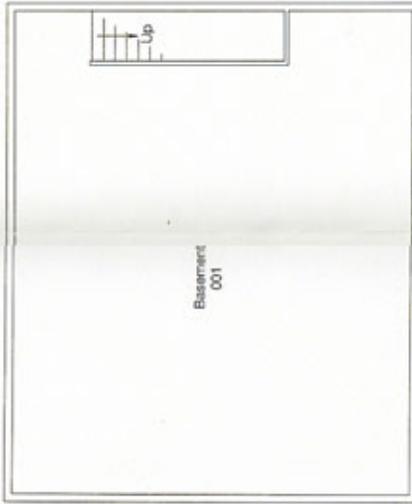
ACBM Homogeneous Area Locations
MAFB - 11 Aspen
Great Falls, Montana
FIGURE 1

- HA-F1.1 Yellow and Tan Linoleum and Mastic (assumed positive)
- HA-F1.2 Tile Pattern Linoleum and Mastic (assumed positive)
- HA-M3.1 Wallboard and Taping Materials
- HA-M12.1 Mastic under 4" Rubber Base (assumed positive)
- HA-S1.1 Surfacing Compound

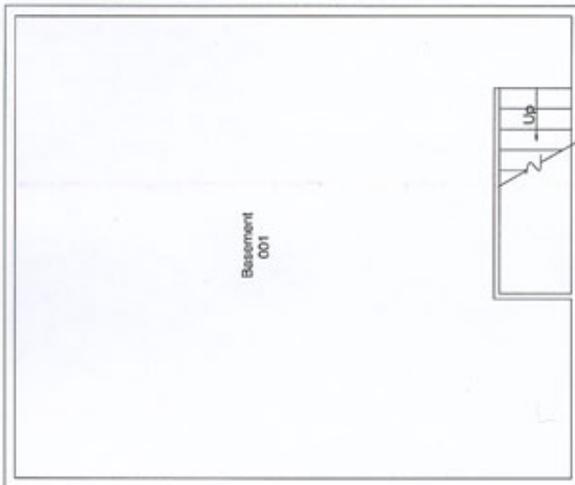
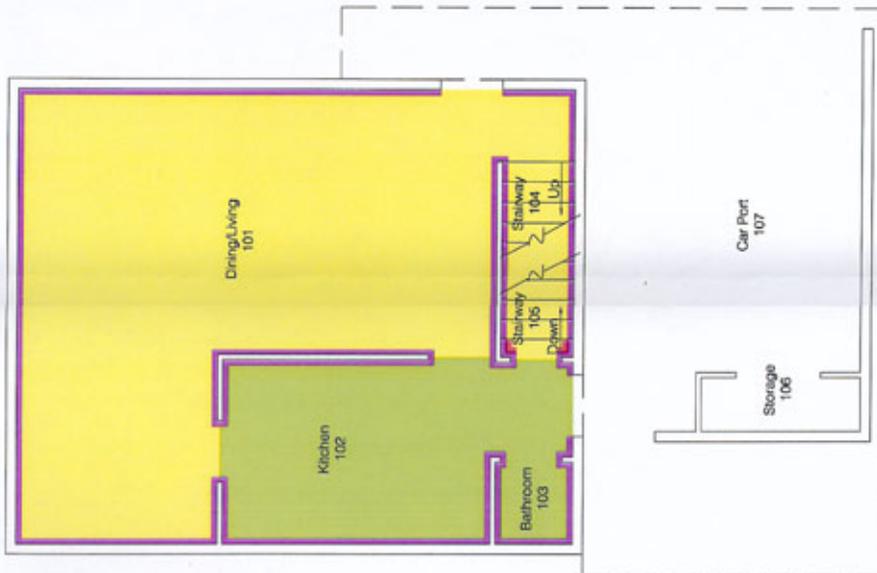
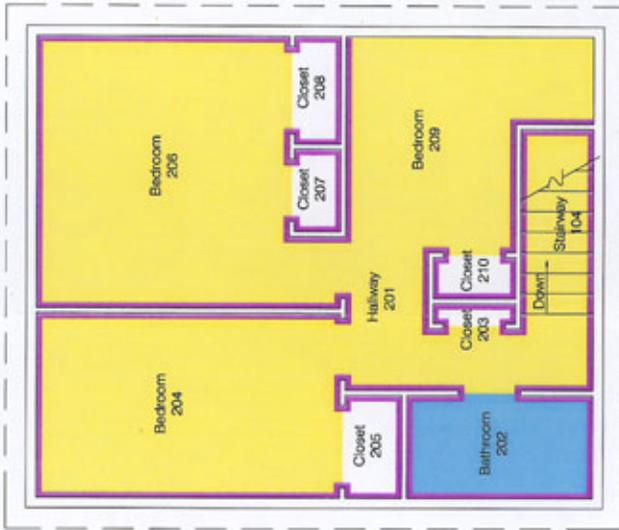
ACBM Homogeneous Area Locations
MAFB - 12 Aspen
Great Falls, Montana
FIGURE 1

- HA-F1.1 Tan and Yellow Linoleum and Mastic (assumed positive)
- HA-F1.2 Orange Linoleum and Mastic (assumed positive)
- HA-S1.1 Surfacing Compound
- HA-M3.1 Wallboard and Taping Materials
- HA-M12.1 Mastic under 4" Rubber Wallbase (assumed positive)

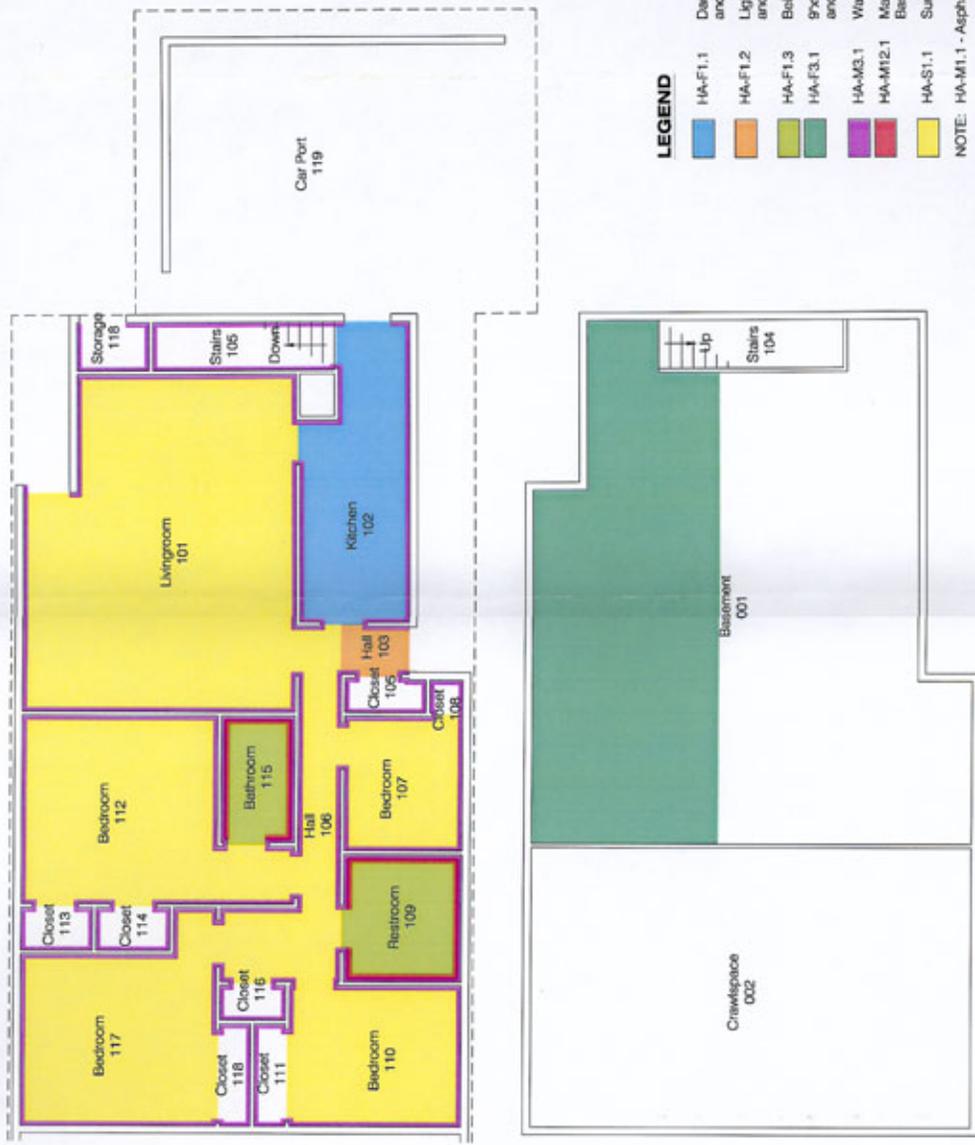
ACBM Homogeneous Area Locations
 MAFB - 2 Cedar
 Great Falls, Montana
 FIGURE 1

- HA-F1.1 Dark Yellow/Beige Pattern Linoleum and Mastic (assumed positive)
- HA-F1.2 Light Yellow/Beige Pattern Linoleum and Mastic (assumed positive)
- HA-F1.3 Beige Linoleum and Mastic (assumed positive)
- HA-F3.1 9x9" Tan and Gray Floor Tile and Mastic (assumed positive)
- HA-M3.1 Wallboard and Taping Materials
- HA-M12.1 Mastic under 4" Rubber Baseboard (assumed positive)
- HA-S1.1 Surfacing Compound

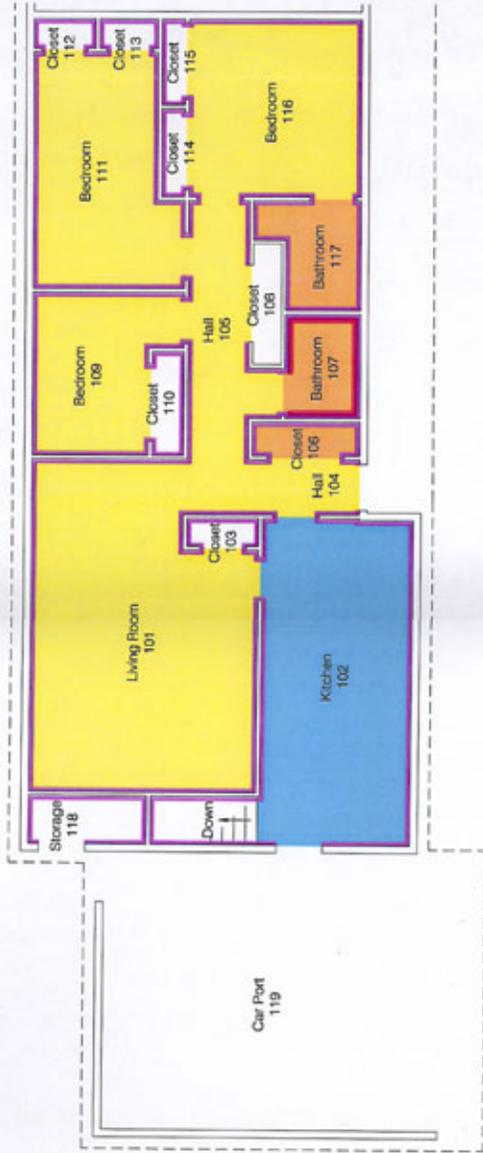
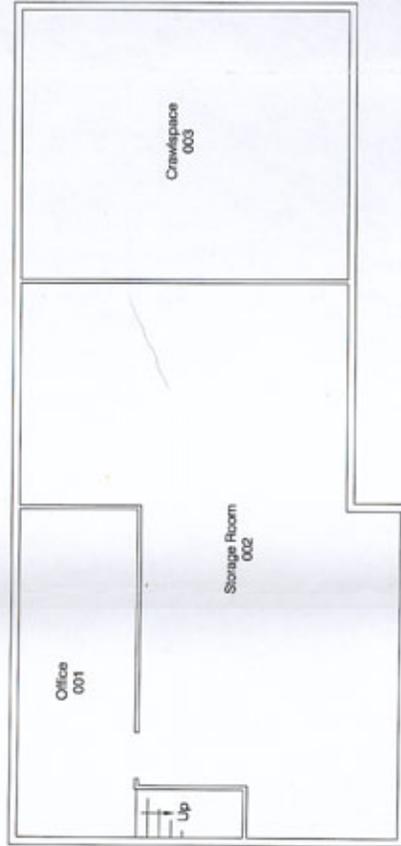
ACBM Homogeneous Area Locations
MAFB - 12 Birch
Great Falls, Montana
FIGURE 1

- HA-F1.1 Beige Linoleum and Mastic (assumed positive) and Surfacing Compound
- HA-F1.2 Beige/Grey Linoleum and Mastic (assumed positive)
- HA-M3.1 Wallboard and Taping Materials
- HA-M12.1 Mastic under 4" Black Rubber Vitrabase (assumed positive)
- HA-S1.1 Surfacing Compound

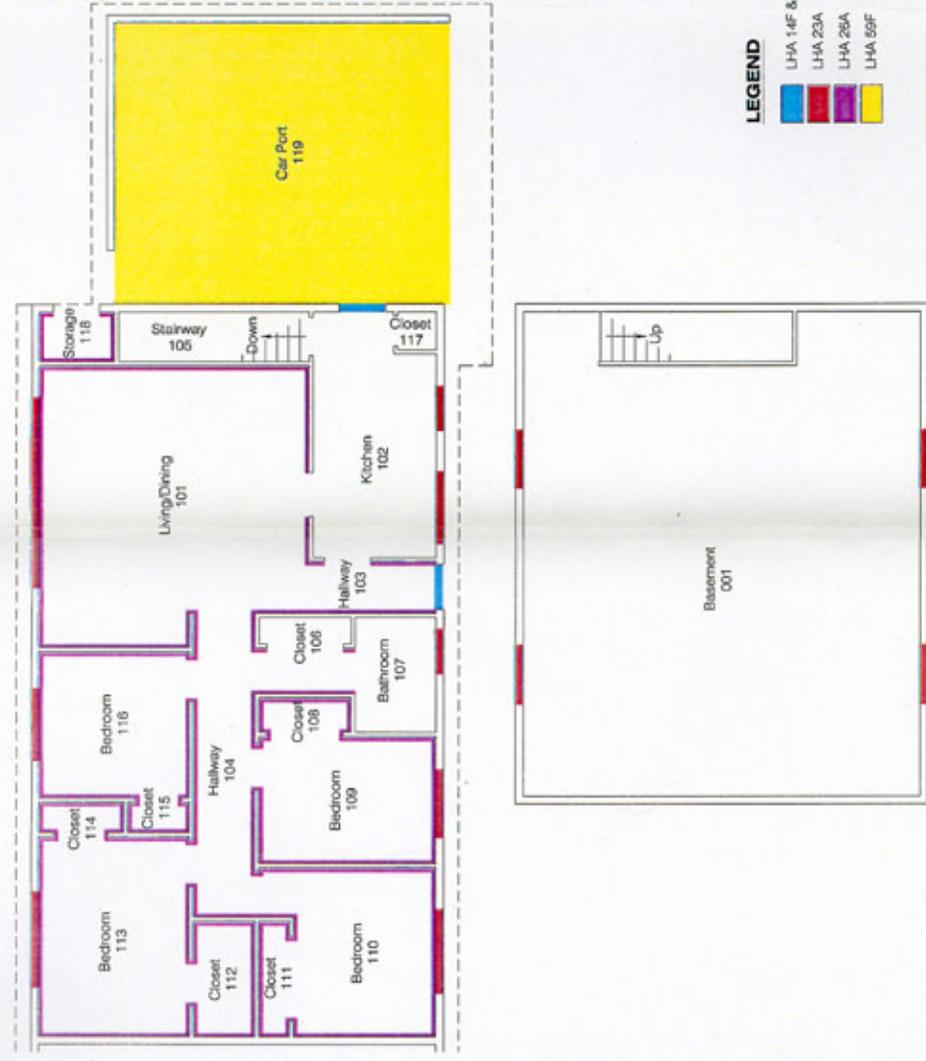
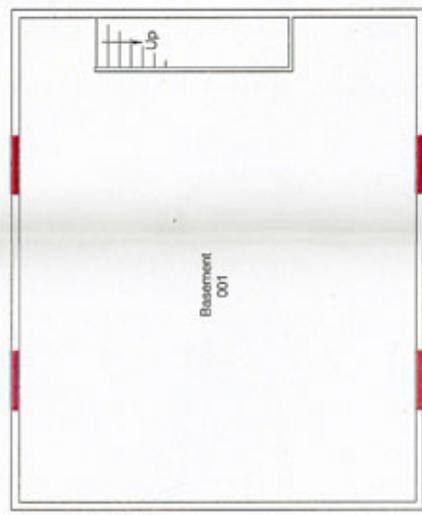
- LHA 14F & 17F
- LHA 23A
- LHA 26A
- LHA 59F
- White Wood Door and Door Jamb
- White Wood Window
- White Wood Baseboard
- Green Wood Soffit and Beams

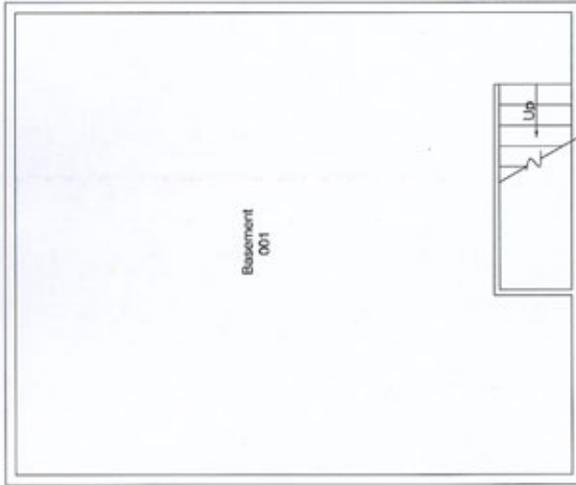
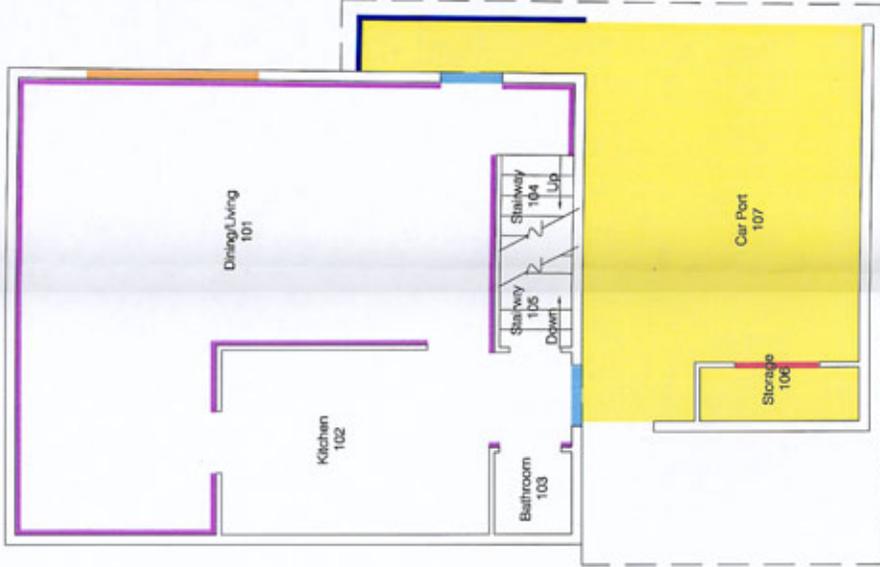
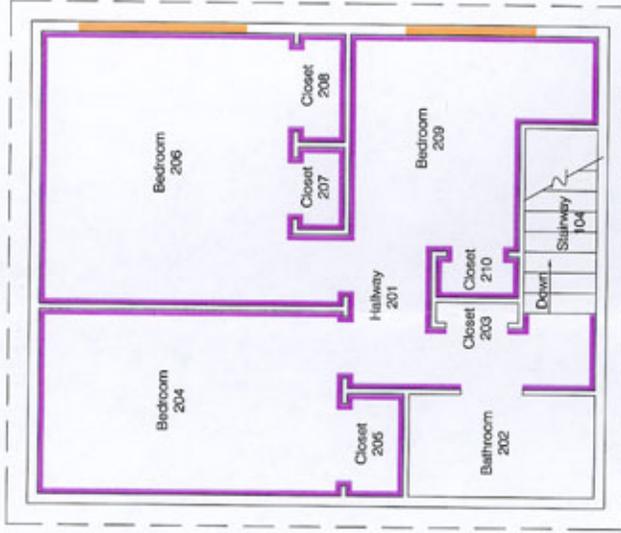
LBP Homogeneous Area Locations
 MAFB - 12 Aspen
 Great Falls, Montana
FIGURE 2

- LHA 14B & 17A Cream Wood Door and White Wood Jamb
- LHA 14A & 17A White Wood Door and Door Jamb
- LHA 23A White Wood Window
- LHA 26A White Wood Baseboard
- LHA 331 Black Metal Handrail
- LHA 46A White Wood Soffit and Beams

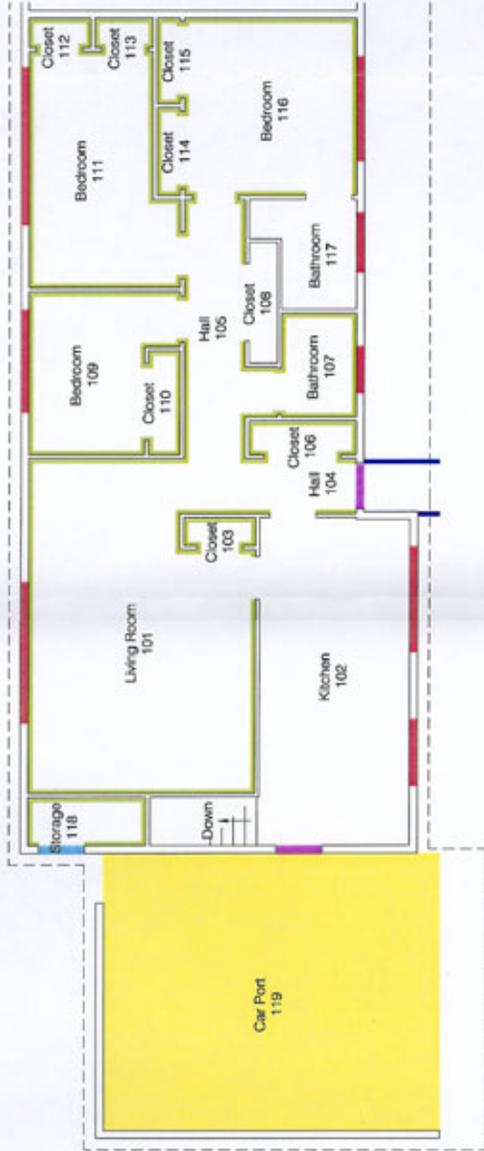
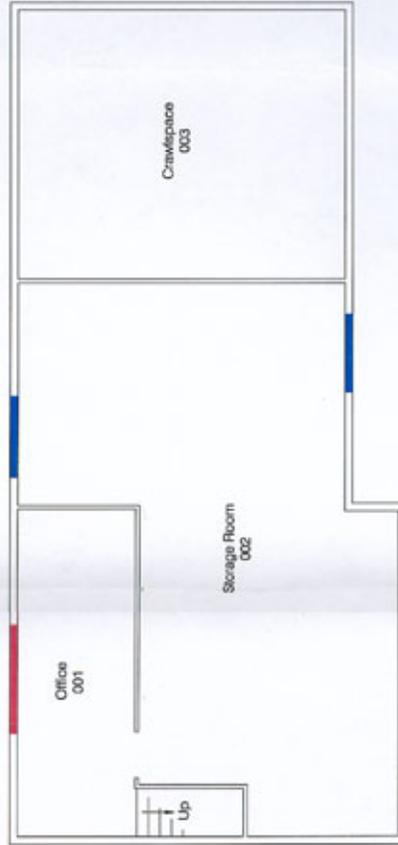
LBP Homogeneous Area Locations
MAFB - 12 Birch
Great Falls, Montana
FIGURE 2

- LHA 14A & 17A White Wood Door and Jamb
- LHA 17D Brown Wood Door Jamb
- LHA 23A White Wood Window
- LHA 23D Brown Wood Window
- LHA 23F Green Wood Window
- LHA 26A White Wood Baseboard
- LHA 33I Black Metal Handrail
- LHA 37C & 55C Tan Wood Soffit and Beams
