**PROJECT EXECUTIVE SUMMARY
REHABILITATION OF FLOOD CONTROL WORKS
DUN-2-04**

**PROJECT INFORMATION REPORT
REHABILITATION OF FLOOD CONTROL WORKS
DUN-2-04**

SUBJECT: Hydrology and Hydraulics Report PL 84-99 Dungeness River

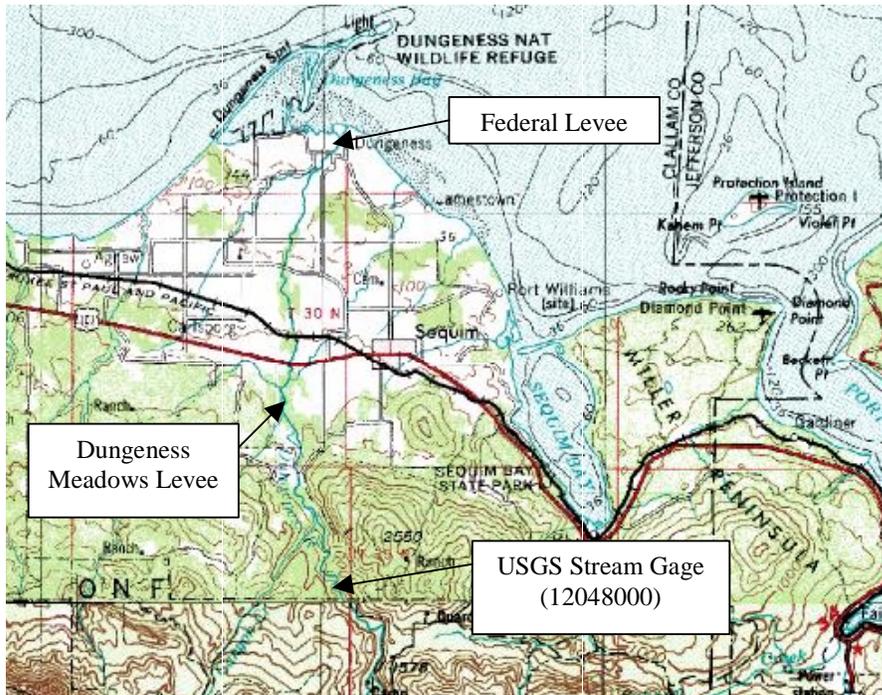
Figure A – Location of USGS Stream Gage and Investigated Levees.

4. **Original Construction / Repairs:** Two levees on the Dungeness River (shown in *Figure A*) were investigated. Details are as follows:
 - A) Dungeness Meadows Levee – The Dungeness Meadows levee spans from River Mile 8.6 (Levee Station 0+00) to River Mile 7.98 (Levee Station 32+70) and is maintained by the Dungeness Meadows Homeowners Association (DMHA). The levee failed in the late 1970's and was rebuilt in 1980 and rehabilitated in 1981 and 1986. Using survey data from 1990, and modeling in HEC-RAS version 3.1, the levee was found to provide protection against the 100-yr flood with three feet of freeboard. The performance of the 1990 levee is shown in *Figure C*. The most recent levee inspection prior to 2003 occurred on 22 March 2002, a few months after the flood of record. The levee appeared to have held up against the flood, but the DMHA was recommended to closely monitor the levee at station 7+00, where the river makes a sharp bend (*Figure D*).
