NEAH BAY SECTION 107  
NAVIGATION IMPROVEMENT PROJECT  
NEAH BAY, WASHINGTON

APPENDIX C  
MARINE VEGETATION SURVEY

May 2018

**Neah Bay Channel Navigation Improvement Project: Marine vegetation in the area of proposed sediment disposal**

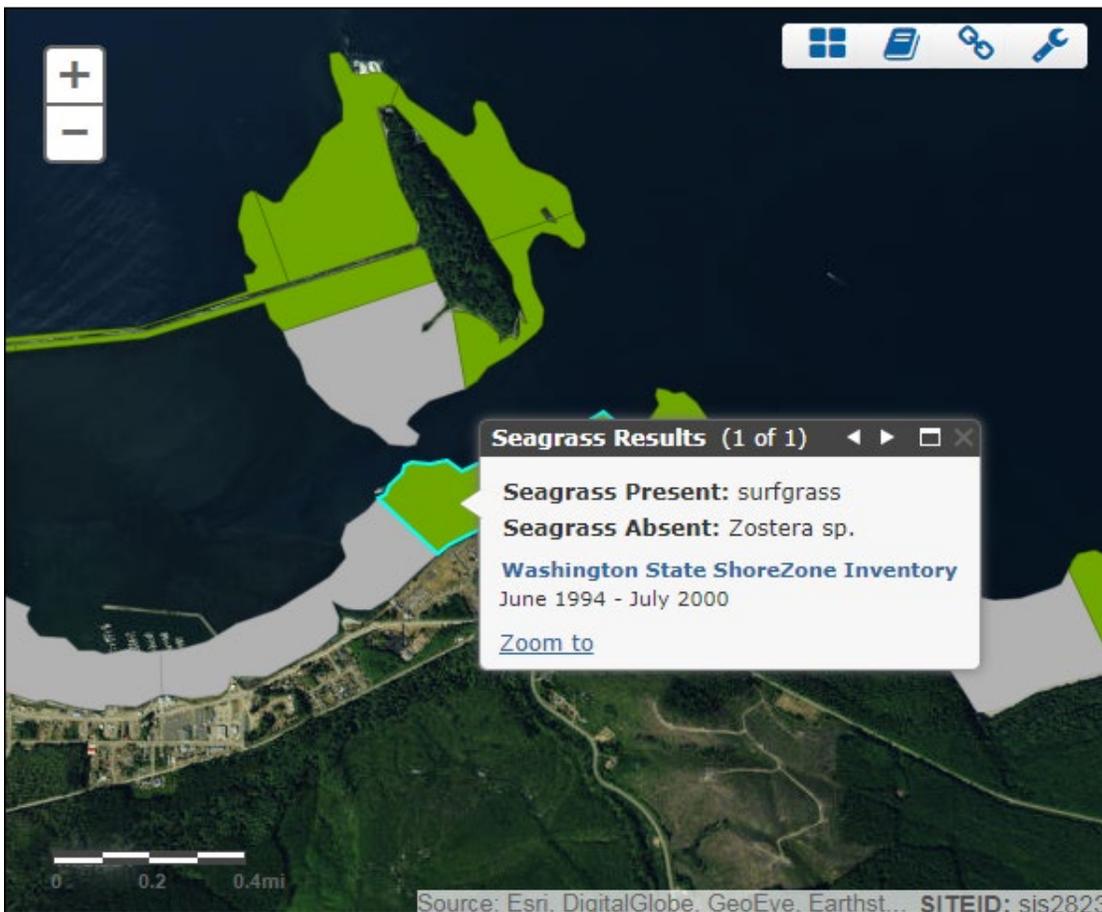
Figure 3. Presence of absence of sea grasses from WDNR Marine Vegetation Atlas (<http://mva.apphb.com/index.html>)

Washington Department of Natural Resources Marine Vegetation Atlas (<http://www.dnr.wa.gov/programs-and-services/aquatics/aquatic-science/washington-marine-vegetation-atlas>) has two polygons that cover the portion of the shoreline where the dredged sediment will be placed; the atlas notes the presence of surfgrass but the absence of *Zostera* species in the section just to the west of Baada point and notes both groups as absent in the next section to the west (Figure 3). The western polygon of interest extends roughly from the midpoint between Baada Point and the marina; the eastern portion of that polygon is in the area of proposed beach nourishment. The atlas says that California kelp (*Macrocystis integrifolia*) is present in both sections while bladder kelp (*Nereosystis leutkeana*) is present in the Baada point area. Other results from the atlas include the presence of red algae and *Ulva* sp. and absence of *Gracilaria* sp., *Sargassum muticum* in both polygons.
