CENPS-OP-DMMO

MEMORANDUM FOR RECORD 13 February 1994

SUBJECT: DETERMINATION ON THE SUITABILITY OF DREDGED MATERIAL RETESTED FOR THE U.S. NAVY'S PIER D DREDGING PROJECT , BREMERTON, WASHINGTON (OYB-2-012791) FOR DISPOSAL AT A PSDDA UNCONFINED OPEN-WATER DISPOSAL SITE.

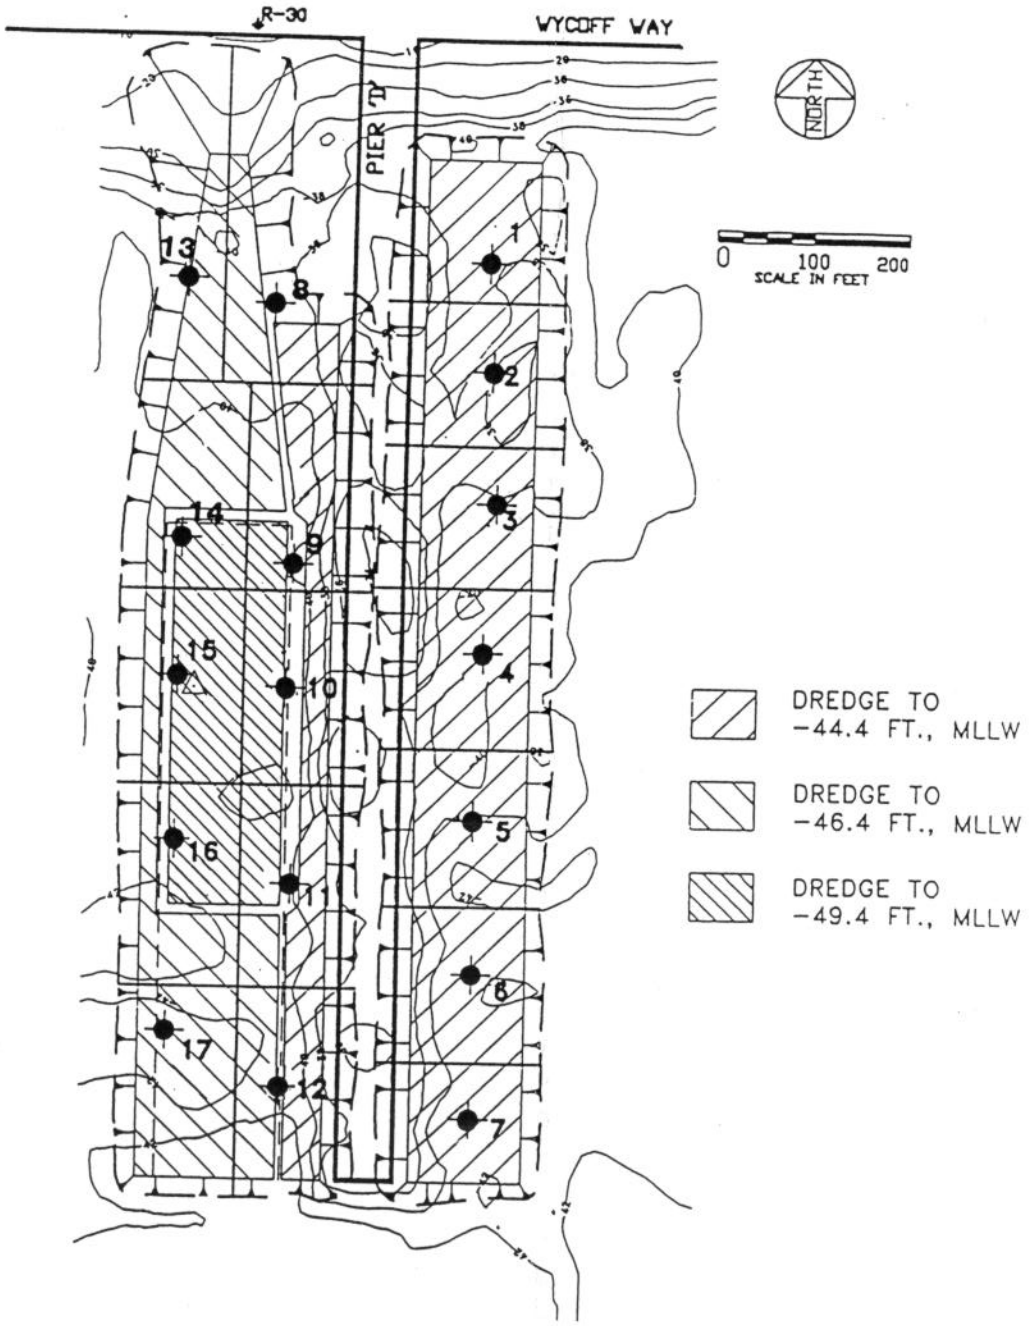
FIGURE 3

SURFACE DMMUs AND
SAMPLING LOCATIONS

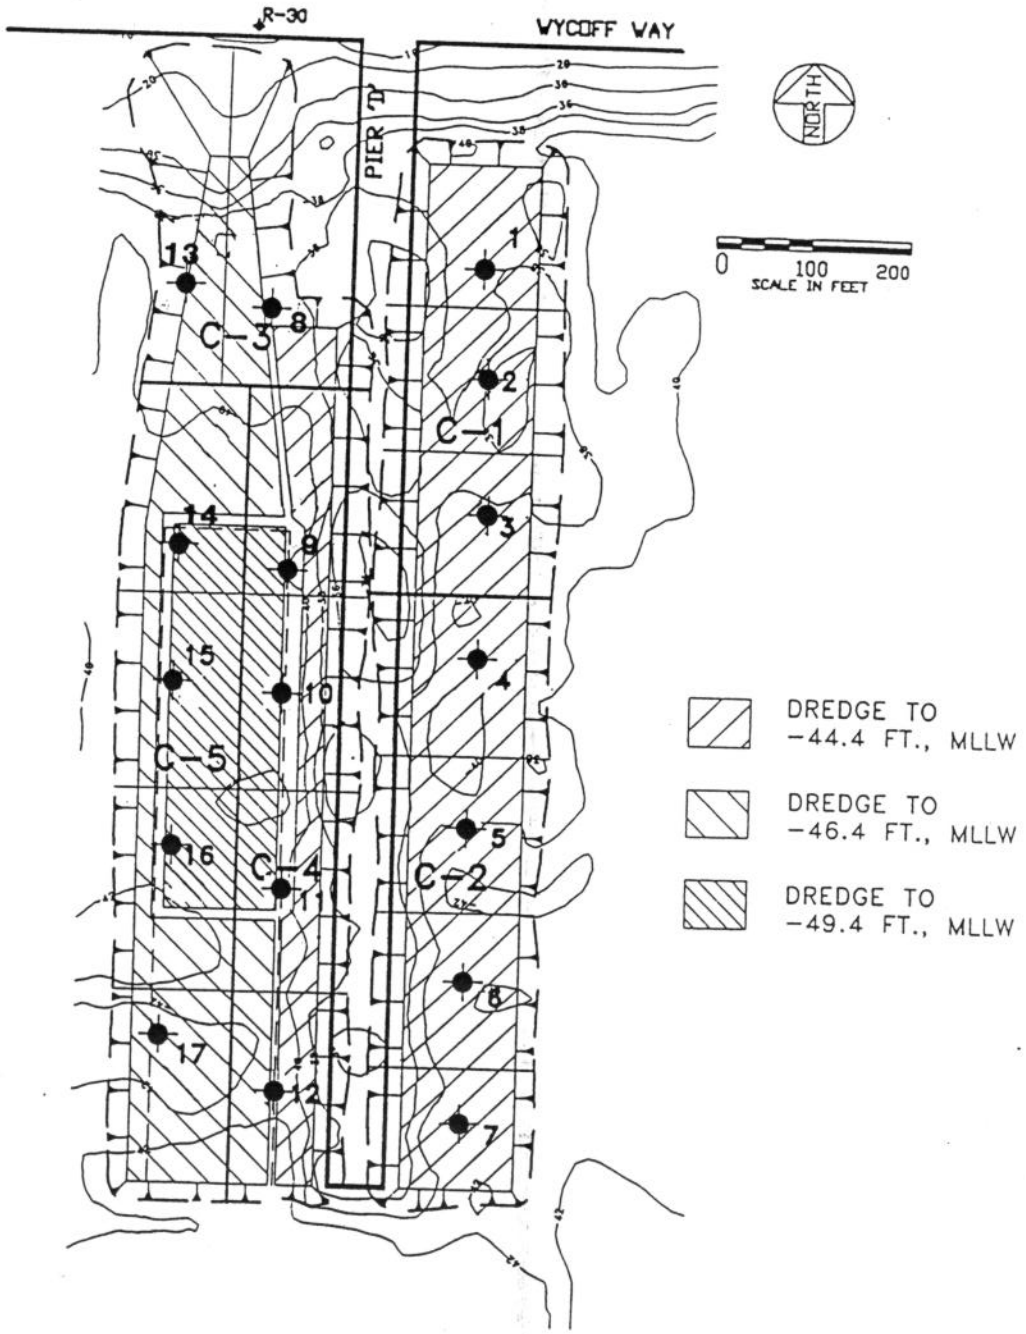
FIGURE 4

SUBSURFACE DMMUs , SAMPLING LOCATIONS AND COMPOSITING SCHEME
