US Army Corps
of Engineers®
Seattle District

Notice of Preparation

Project Name: St. Maries Levee Rehabilitation Project, St. Maries, Idaho

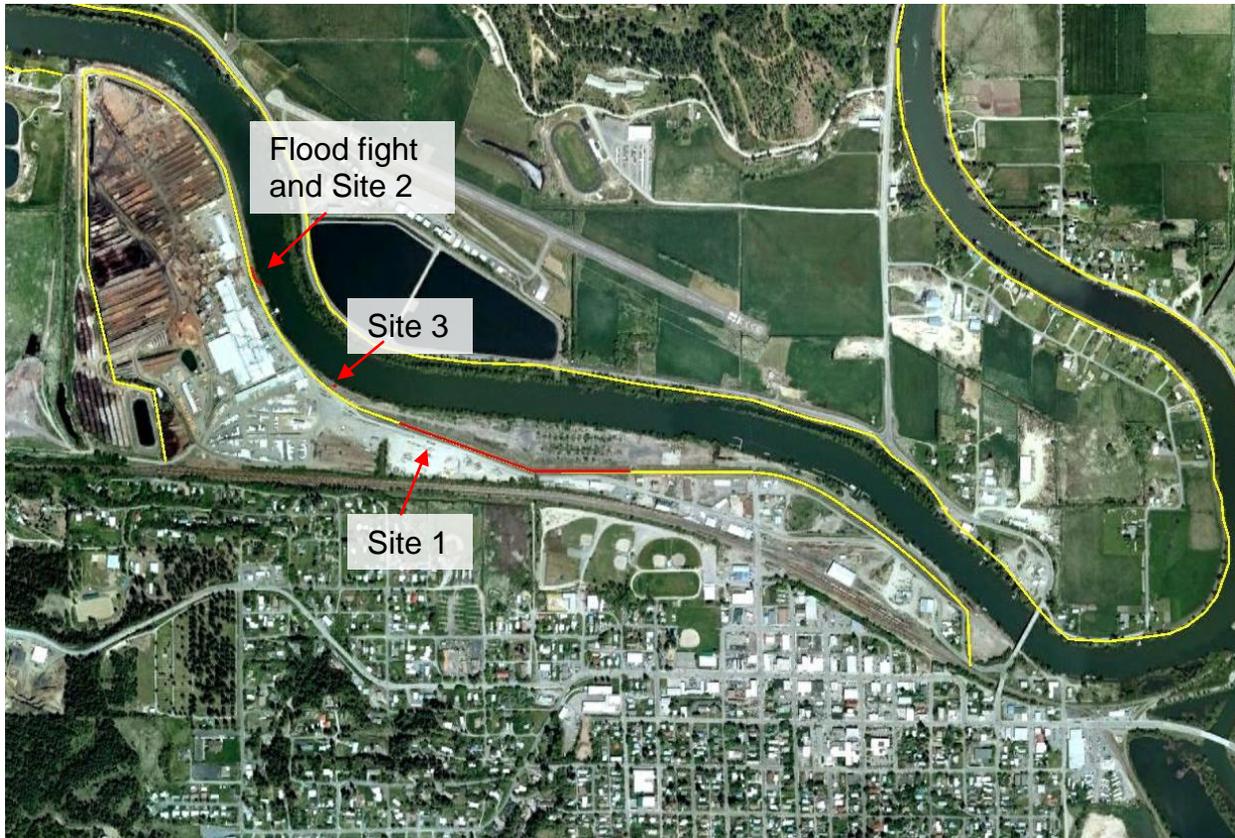
Figure 1. Overview of Project area. Levees shown in yellow, damage areas in red.

Three damage areas have reduced the level of protection of the St Maries levee. During the May and June 2008 flood event, seepage paths developed at Site 1 through the levee, allowing significant seepage along a 1,300 feet reach. The high river flows likely resulted in the pressurization of the Mutch Creek diversion pipe and the pump house outlet pipe. The pressure is presumed to have led to the pipe's failing. At the same time, seepage occurred along a longer reach of the levee presumably due to a lens of permeable material below the levee or potentially due to seepage along other utility pipes in the landward toe of the levee.

susceptible to instability. The rotational failure is approximately 5 feet in height and approximately 20 feet wide. The depth into the slope is approximately 5 feet. During the site investigation, the PDT cited three downstream areas of undercut bank. Allowing to tie-in to strategic points, the full repair would be 160 LF.

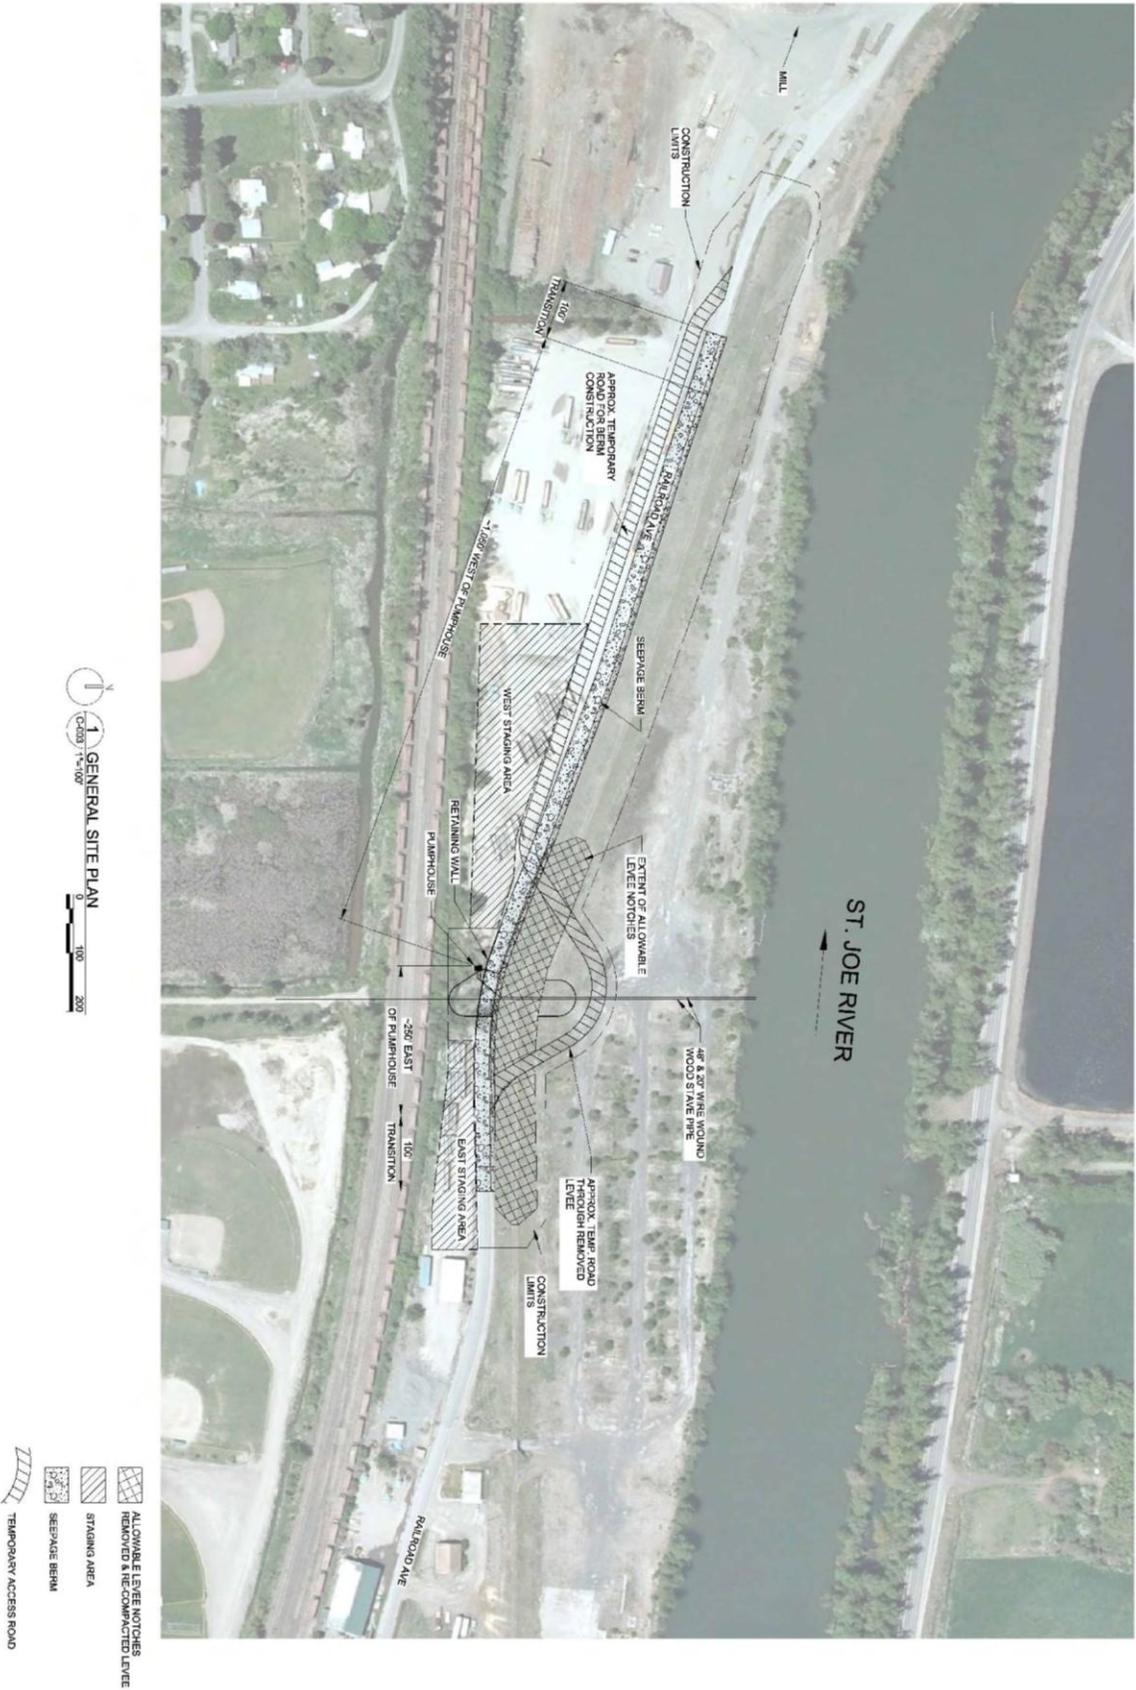
Draft Designs:
Site 1 plan view

GENERAL SITE PLAN
 Scale: 1" = 100'
 0 100 200

The recommended repair alternative for Site 1 includes pipe replacements and constructing a 2-foot to 4-foot seepage berm. The berm would create an effective seepage control structure and allow for increased road width. The City of St Maries would like to increase the road width in this confined area to improve traffic flow. The seepage berm would include a non-woven filter fabric and 2 feet minimum of 2 ½-inch minus ballast. The berm would be capped with aggregate base course and finished with 4 inches of asphalt pavement. A retaining wall, approximately 100 feet in length, would be included along the southerly length of the roadway near the pump station constriction point. The project would be transitioned to the existing roadway height for approximately 100 feet at each end of the seepage berm at a reasonable roadway grade. The total length of the project would be 1500 feet to include these transition areas. Finally, the Mutch Creek culvert and the 20" pump house outlet would be replaced to correct any postulated deficiencies in the conduits. It is theorized that, when the flap gates are closed on these pipes, pressure is developed and any weak points in the pipes leak, creating pressure in the ground water and causing piping damage to the levee. The proposed repair would entail replacing approximately 150 feet of the 48-inch Mutch Creek diversion pipe with 48-inch HDPE butt welded pipe and replacing approximately 120 feet of the 20-inch pump house outlet line with 20-inch HDPE butt welded pipe. Repair of the pipe through the levee, and rerouting of traffic during construction will require a portion of the levee, up to 500 ft, to be removed and rebuilt.

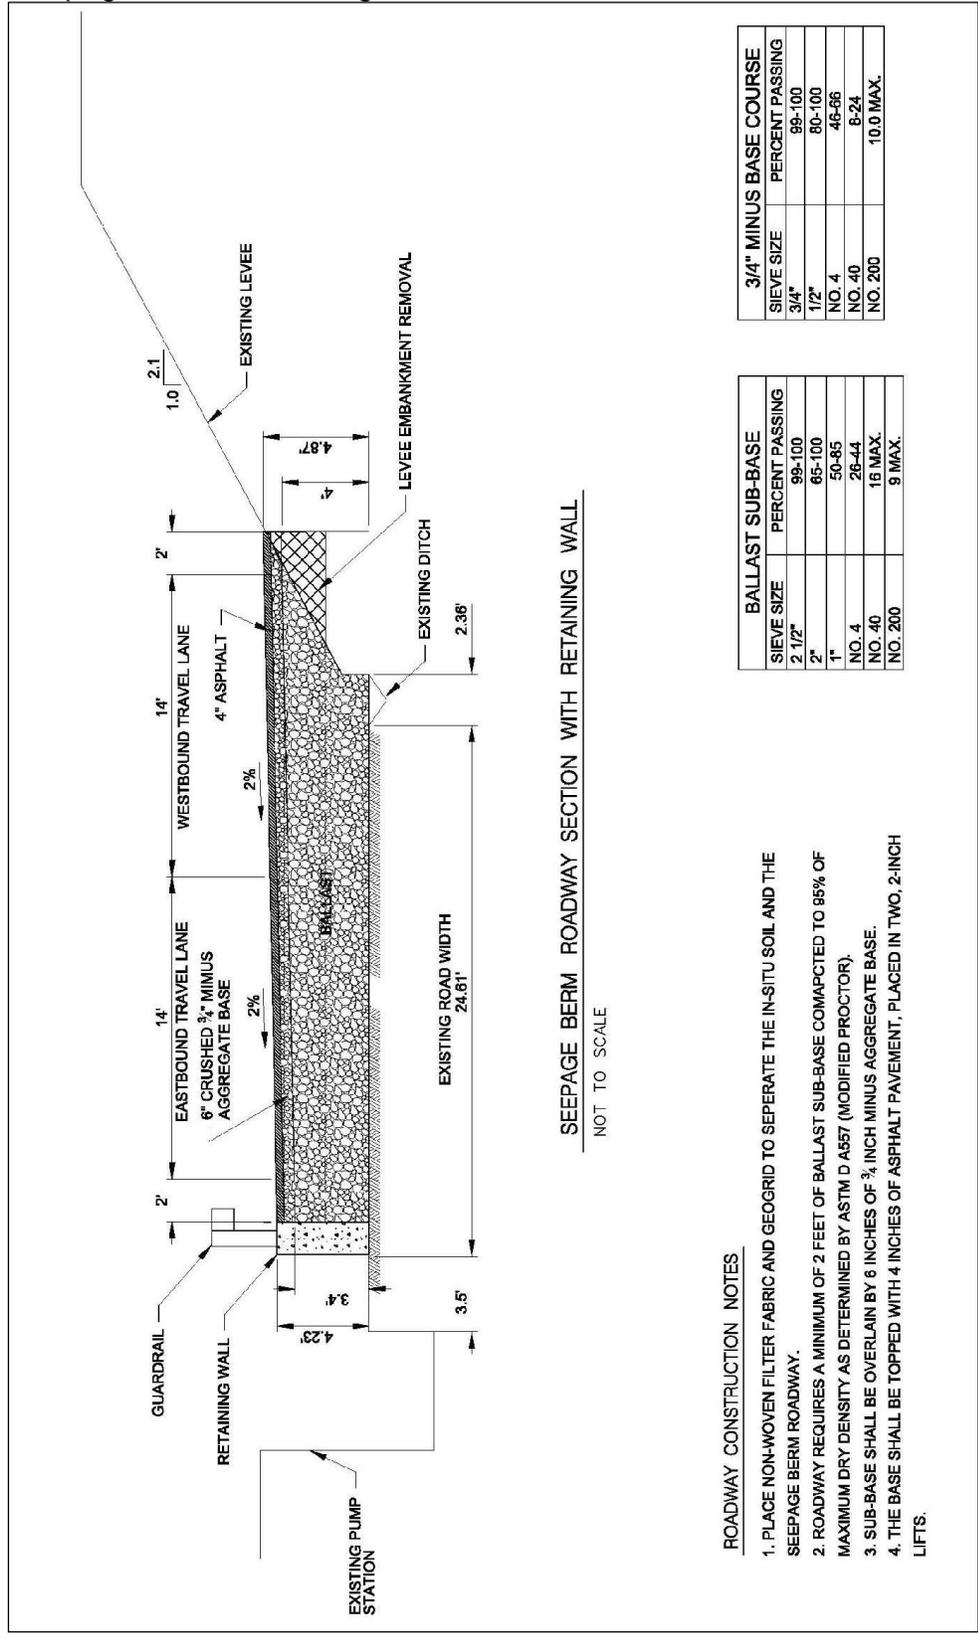
Seepage berm draft design

SEEPAGE BERM ROADWAY SECTION WITH RETAINING WALL
NOT TO SCALE

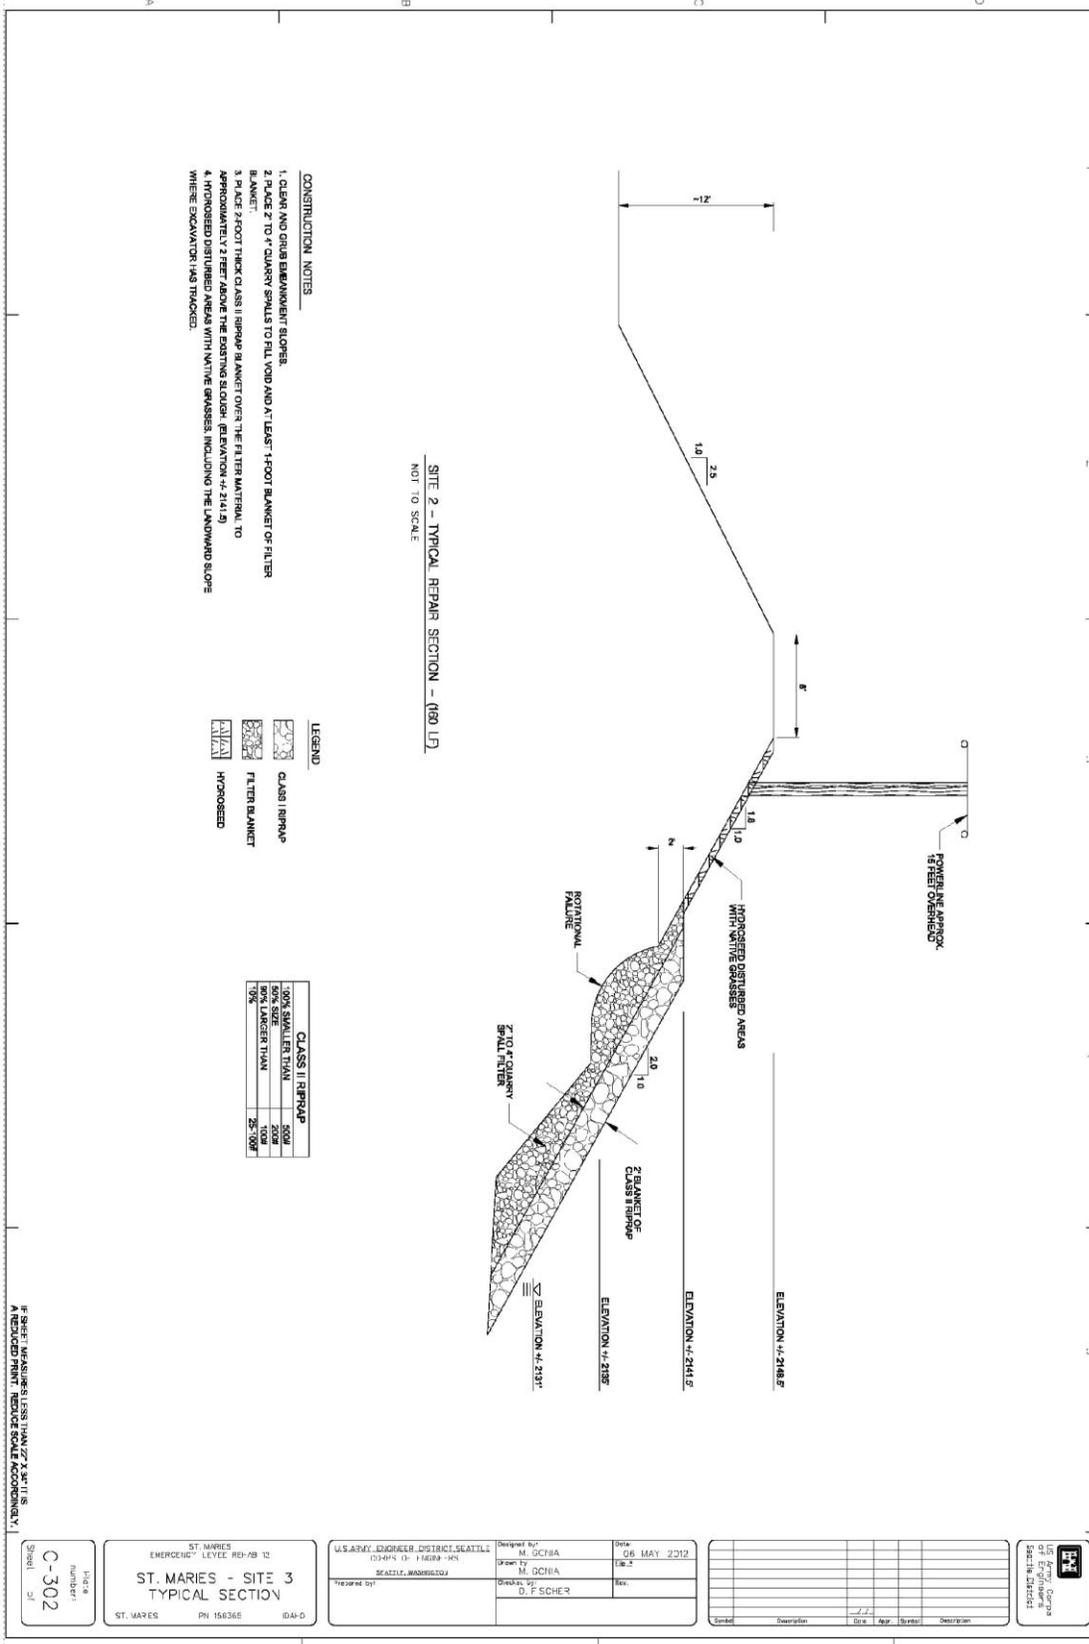
Site 3 draft design (continued)

- CONSTRUCTION NOTES**
1. CLEAR AND GRAB EXISTING SLOPE.
 2. PLACE 2 TO 4 QUARTER INCH SMALL FILTER TO FILL VOID AND AT LEAST 1 FOOT BLANKET OF FILTER ABOVE.
 3. PLACE 2 FOOT THICK CLASS II REPAIR BAND OVER THE FILTER MATERIAL TO APPROXIMATELY 2 FEET ABOVE THE EXISTING SLOPE. (ELEVATION +2141.0)
 4. NON-REPAIR DISTURBED AREAS WITH NATIVE GRASSES, INCLUDING THE LANDWARD SLOPE WHERE EXCAVATION HAS TRACKED.

The recommended repair alternative for Site 3 includes armoring the slope with a Class II riprap. The armor would include a 1 foot filter blanket that should also improve drainage from the slope. The weight and strength of this rock armoring is intended to buttress the slope, while nullifying any potential for erosion and bank undercutting. The full repair would be 160 feet. This repair will constitute a change in substrate at this location, placing rock on what had been an earthen bank, but will maintain the pre-damaged slope and footprint. The repair will tie into existing rock at the downstream end, extending the existing armored bank through the 160 ft repair.
