2. MAINTENANCE OF PROJECT FEATURES

2.1 Introduction

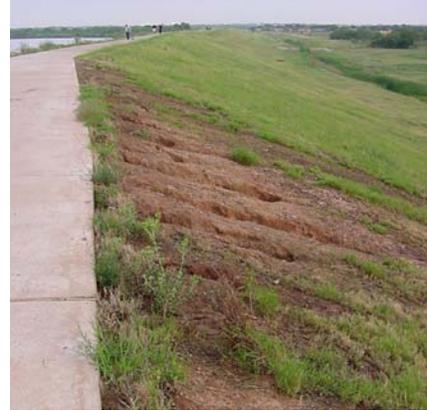
Figure 2.1 UNACCEPTABLE erosion of levee slope. (TX)

There are several types of erosion that effect FCWs. For example, the slopes of any embankment can become eroded from rain runoff, as shown in Figure 2.1 or by embankment overtopping, as in Figure 2.2. Depending on the extent of the erosion, the level of protection provided by the FCW can be significantly reduced. In cases of embankment overtopping during a flood, there may be a total failure of the structure.

All erosion gullies like those pictured in 2.1 need to be repaired to prevent further erosion and more significant damage during high water.

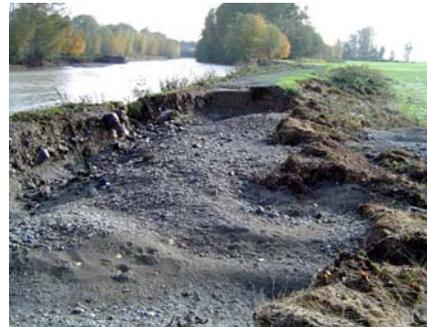
Figure 2.2 Flood damage. (WA)

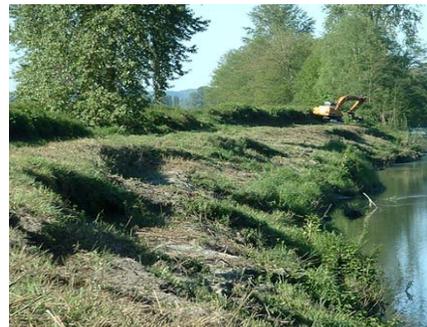
Figure 2.3 Slope failure on bank protection project. (WA)

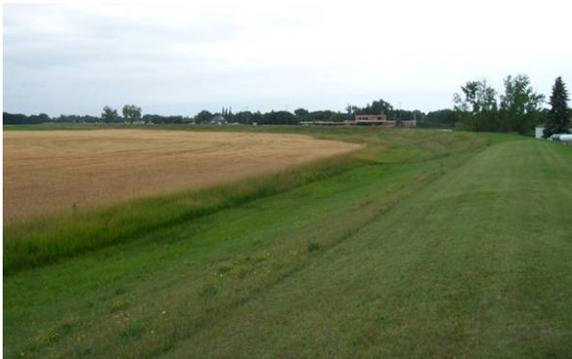
Figure 2.4 ACCEPTABLE. Landowner has not encroached on levee easement area and has stayed back 10 - 15 feet. (MN)

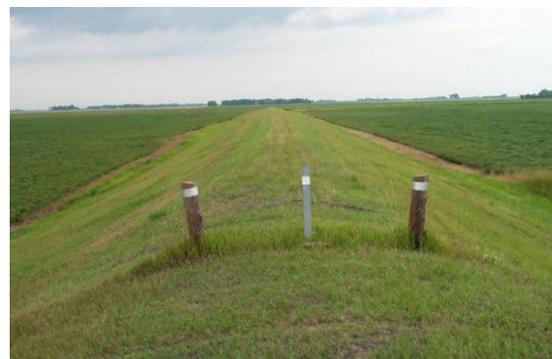
Figure 2.5 MINIMALLY ACCEPTABLE. Field encroaches on levee easement. The landowner has tilled the soil right to toe of the levee, and was requested to stay back at least 10 feet. (ND)

Excavations, structures, or other obstructions present within the project easement area are generally prohibited. Fencing that prohibits access along the crown of the levee is prohibited. Where access control is needed, the public sponsor should install gates that will allow continued access along the crown of the levee for surveillance and flood fight activities. The Corps may make certain exceptions to this rule, provided the encroachment does not impact the operation, maintenance, or structural integrity of the project. Figures 2.5 through 2.14 are examples of common encroachments that should not be permitted.

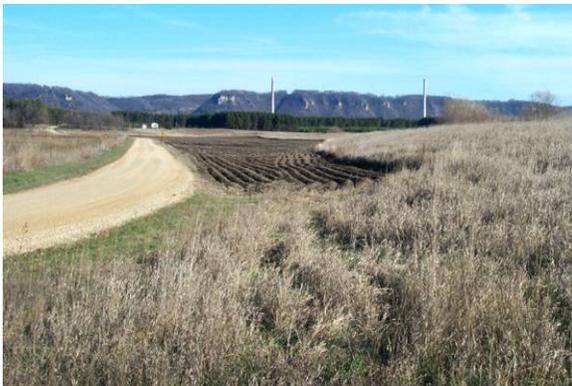
Figure 2.6 UNACCEPTABLE levee encroachments. This landowner tilled near one third of the way up the landward levee slope. (MN)

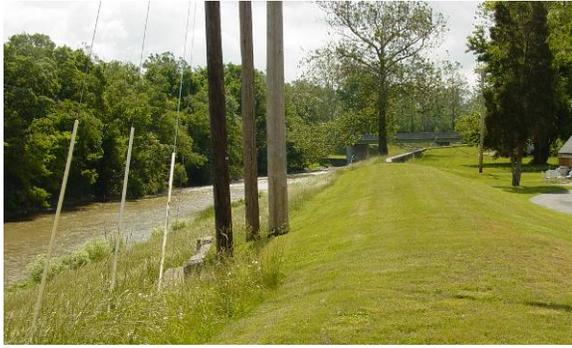
Figure 2.7 UNACCEPTABLE levee encroachments. Utility poles in levee embankment. (IN)

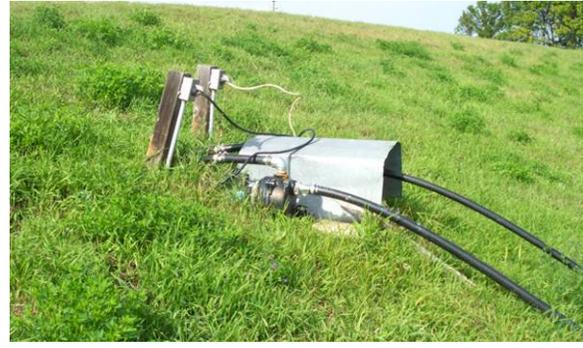
Figure 2.8 UNACCEPTABLE encroachment. Piping for lawn irrigation system drilled through levee without approval. (ND)

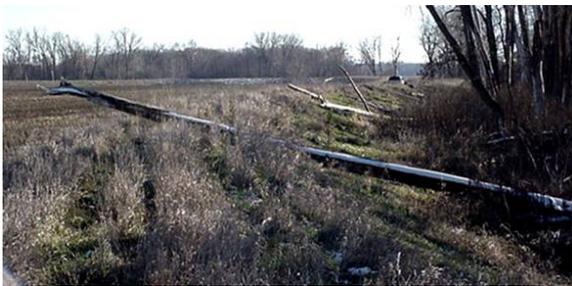
Figure 2.9 UNACCEPTABLE encroachments on earthen levee. Fallen woody debris requires removal. (KS)

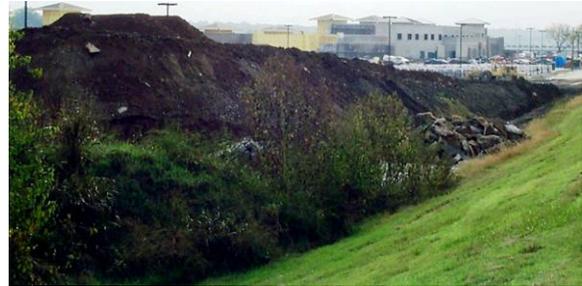
Figure 2.10 UNACCEPTABLE, unapproved encroachment. Material stockpiled against the levee. (OK)

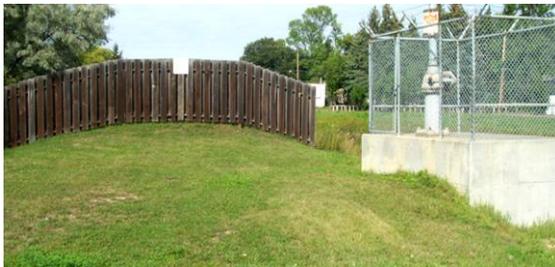
Figure 2.11 UNACCEPTABLE encroachment. Residential and rural fences crossing the levee. (ND)

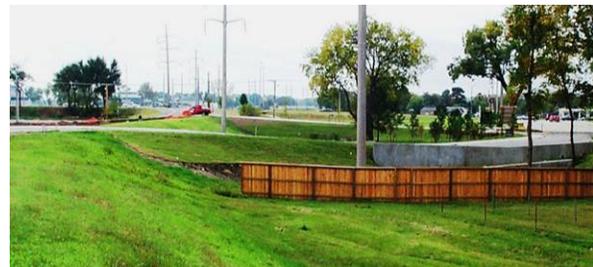
Figure 2.12 UNACCEPTABLE, unapproved encroachment on levee easement (fencing). (OK)

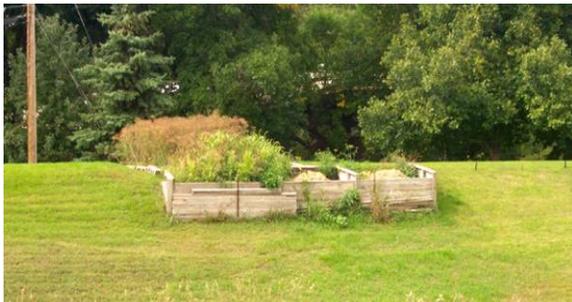
Figure 2.13 UNACCEPTABLE encroachment. Gardens and compost bins located on levee crest and riverward slope. (ND)

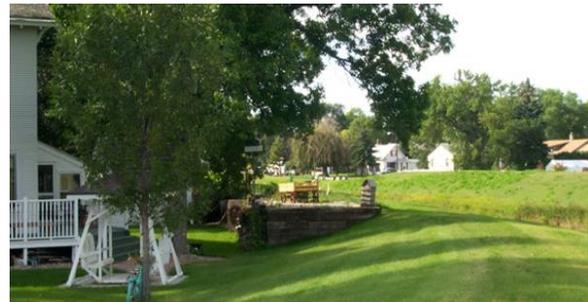
Figure 2.14 UNACCEPTABLE encroachment. Patio construction using railway timbers and fill without approval. (ND)

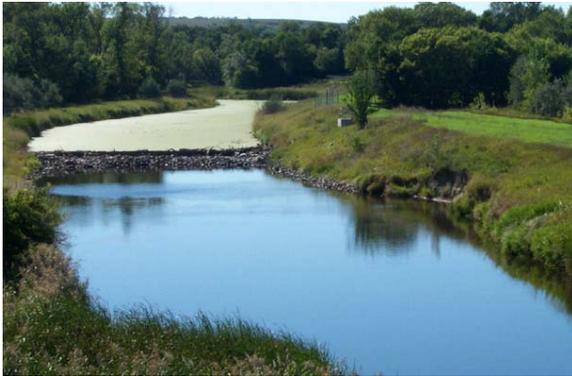
Figure 2.15 UNACCEPTABLE. Slope failure and erosion caused by inadequate channel bottom and side slope protection. This was a direct result of bottom scouring that undercut the levee slope and erosion caused by turbulent flow at the end of the bank protection. (ND)

Some earthen materials tend to become saturated with water very easily. When this happens, they lose stability and can't support their own weight. If a stream or river embankment is composed of these materials, the embankment will slump off and move down the slope into the river, causing a bulge at the base of the slope. When river banks break down like this, they are said to have slope stability problems and need to be repaired. Slope failures can lead to serious problems, especially if the failure occurs near a levee or floodwall. Figures 2.15 through 2.17 show examples of slope stability problems.

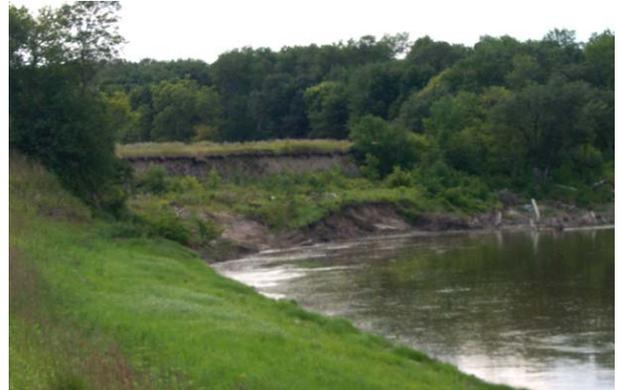
Figure 2.16 UNACCEPTABLE. Slope failure and erosion on a channel improvement project. (MN)

- a. Wide deep cracks that parallel the riverbank or levee crest. In the case of levees, these cracks may also extend down the slope of the levee.
- b. Vertical movement of the material along the crack. Remember that this movement may be very obvious like in Figures 2.16 or 2.17, or very subtle if the stability problem is just starting to develop.
- c. If the slope has slumped or is starting to slump, examine the area along the toe of the embankment. In many cases there will be a noticeable bulge in the slope or riverbank.

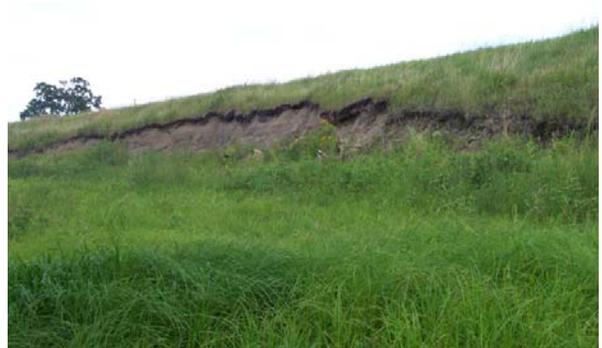
Figure 2.17 UNACCEPTABLE earthen embankment failure. (MN)

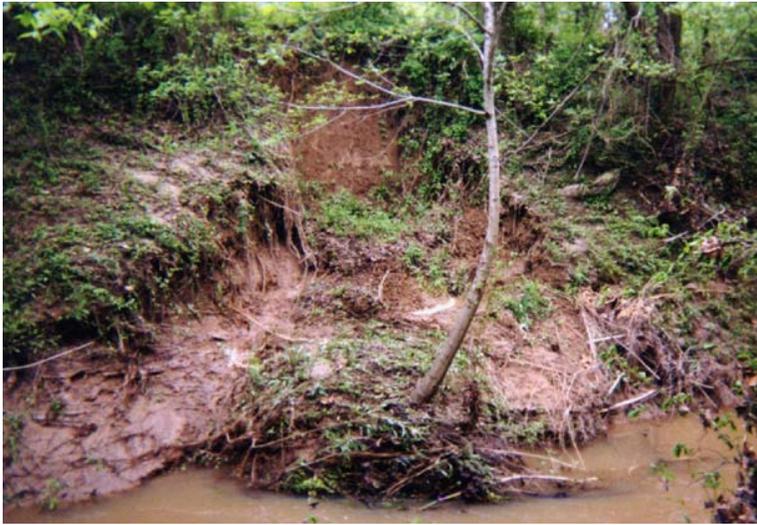
Figure 2.18 *Classic picture of a tree causing slope failure. (WA)*

A related slope failure/stability problem involves trees growing on or near the channel or levee slopes. It's very important to prevent tree growth near levee or channel embankments, because when the roots of these trees decay they leave voids in the soil, which allow water to quickly saturate the slope and cause a slope failure. Trees can also be uprooted and deflect flood flows into the embankment, accelerating the erosion of the bank.

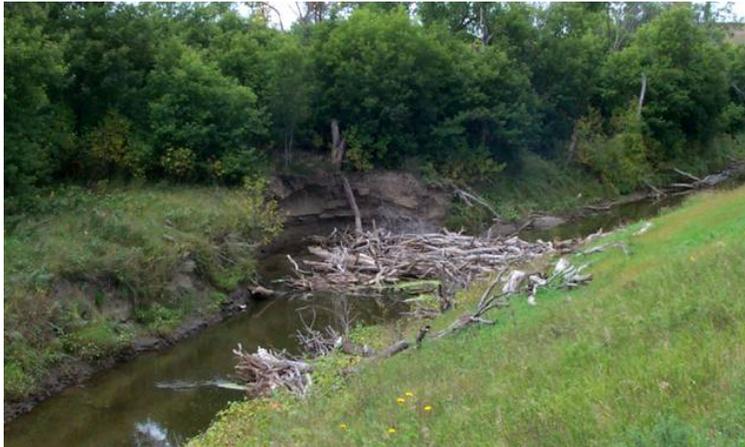
Figure 2.19 UNACCEPTABLE erosion of river channel, caused by a log jam. (ND)

significant damage to the FCW. Figure 2.19 shows the result of what started out as a beaver dam that was not removed, which expanded into a log jam. Before this log jam was removed, both the inside river bank and the levee experienced severe bank erosion. Log jams have endangered bridges and railway crossings, and they lead to higher flood crest elevations upstream of the obstruction.

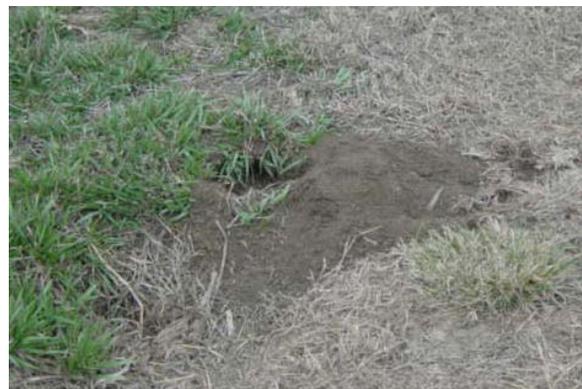
Figure 2.20 Animal burrow in a levee. (IA)

Inspections to detect the presence of burrowing animal activity are generally most effective immediately after the levee has been mowed. Animal burrows that are identified should be thoroughly excavated and inspected, backfilled with compacted soil that is similar to material of the levee, and reseeded. This will avoid the possibility of water piping through unfilled portions of the burrows during a flood.

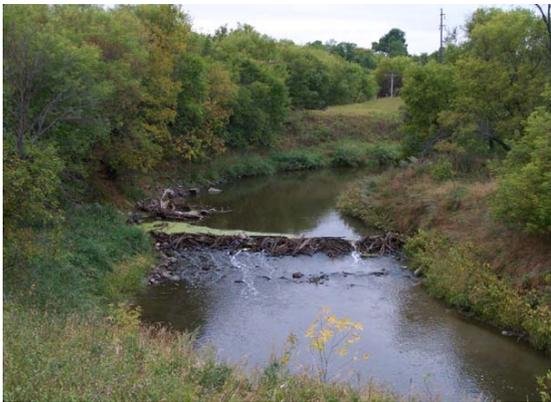
Figure 2.21 Beaver dam. Such dams can stop flow within the channel and cause erosion to the channel banks. Sponsors are encouraged to remove beaver dams ASAP. (ND)

Beavers pose an additional concern in streams and channel improvement projects. They have been known to cause problems by building dams, blocking culverts, and by burrowing into the stream bank to create a den. When beaver activity is noted, the beaver should be removed and the dam and blockages removed. Failure to correct the problem may result in increased bank erosion and slope stability problems in the area of the beaver den during periods of high water.

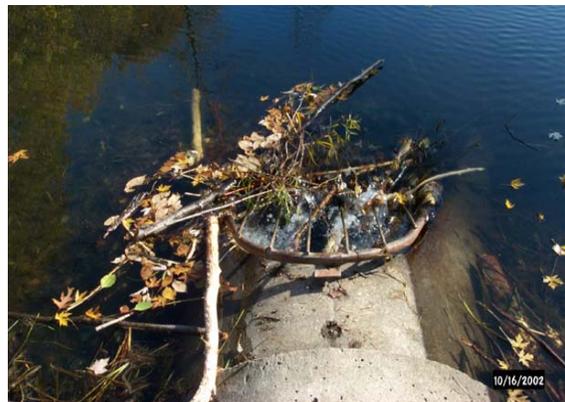
Figure 2.22 Beavers attempting to block the culvert passing through a gated embankment. (MN)

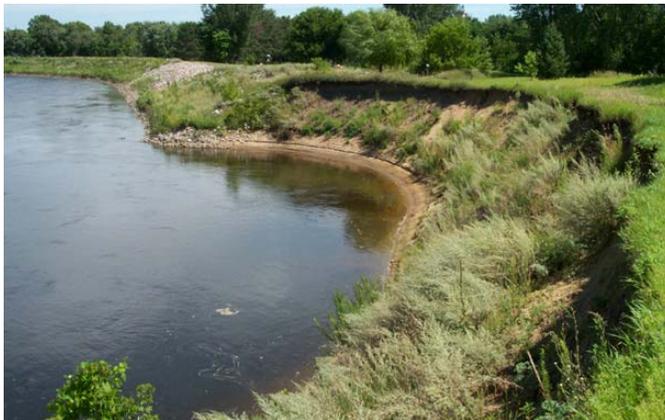
Figure 2.24 Channel erosion located at the upstream end of a flood control levee protected by riprap. Erosion caused by riprap protection and eddy currents. (MN)

As shown in Figure 2.23, riprap can be a very effective method for protecting a riverbank or flood control feature from erosion. However, if the riprap protection is not placed correctly, it can cause eddy currents to erode unprotected areas of the bank upstream or downstream of the project, as shown in figure 2.24.

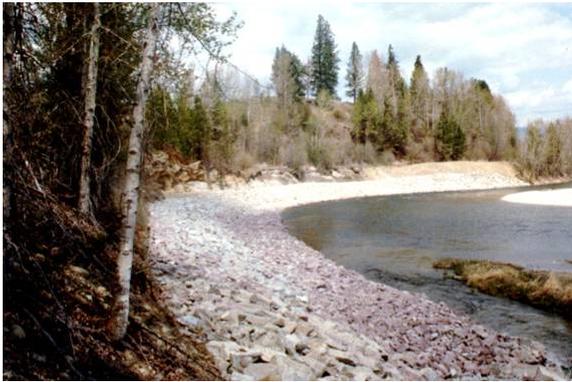
Figure 2.25 ACCEPTABLE riprap for erosion control. (MT)

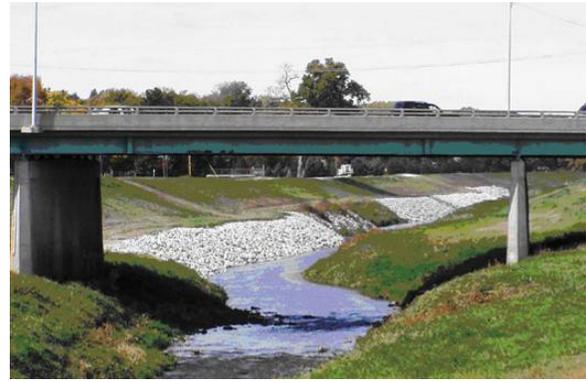
Figure 2.26 ACCEPTABLE riprap for erosion control. (NE)

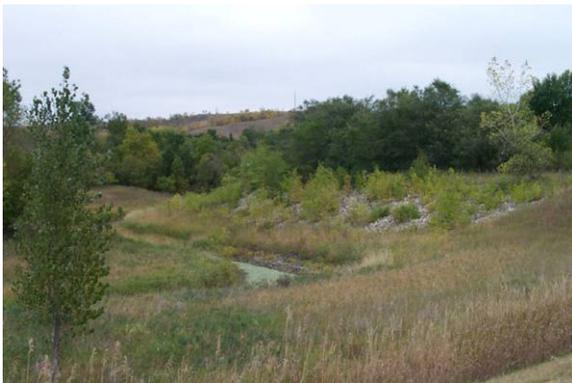
Figure 2.27 MINIMALLY ACCEPTABLE. Trees and saplings are becoming established within riprap-protected areas and along the lower portions of the river channel, and must be removed. (ND)

The protected area needs to be kept free of unwanted brush, saplings, and trees. Unwanted vegetation should be sprayed with an appropriate herbicide to kill the plant, and the root system should be removed. Failure to control the sapling and tree growth can result in the trees being uprooted during a flood, displacing the riprap and increasing the rate of erosion.

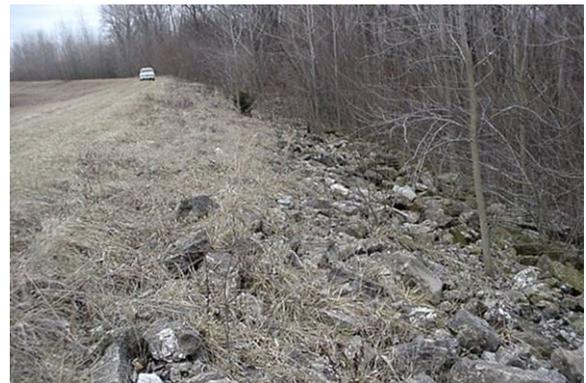
Figure 2.28 UNACCEPTABLE. Tree and sapling growth is well established within the riprap protection on an earthen levee. This overgrowth must be removed. (MO)

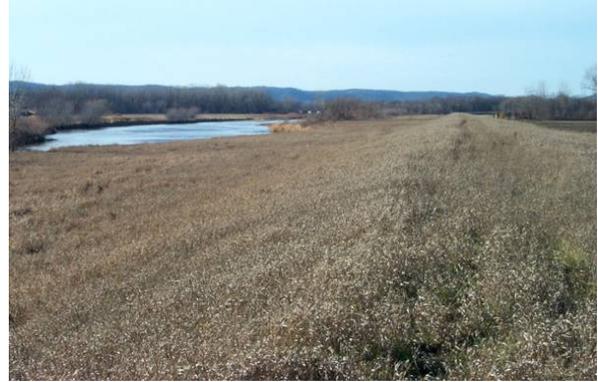
Figure 2.30 UNACCEPTABLE levee with knee-high grass, making visual inspection nearly impossible. (MN)

make a visual inspection nearly impossible and can hide serious concerns such as rodent activity, levee slides, and cracking; all of which can lead to the failure of the levee. For these reasons, the grass should be mowed to a minimum height of 3 inches. The last mowing of the season should be accomplished under conditions that will allow the grass to grow to approximately 8 to 10 inches by the winter season. It's important to ensure that the entire levee profile has been mowed, including zones extending 15 feet beyond the toes of the embankment, which should be free of all woody growth and should be clear of other obstructions so that a truck could drive beside the levee if needed.

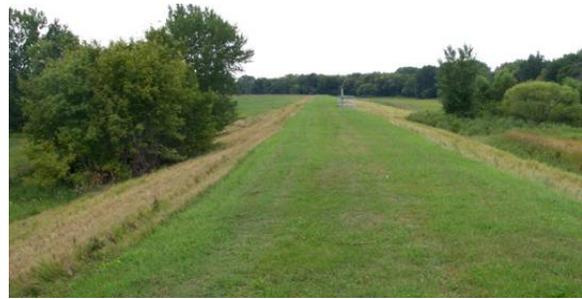
Figure 2.31 UNACCEPTABLE. Levee is mowed but trees and longer grasses within levee easement area. Trees are greater than 2" in diameter. (MN)

and local laws and regulations. Any trees that reach 2 inches in diameter or greater, and are located on the levee, riprapped areas, drainage channels, or within 15 feet of the toe of the levee must be cut down, the root ball removed, the voids filled with impervious material, and the fill material firmly compacted and reseeded.

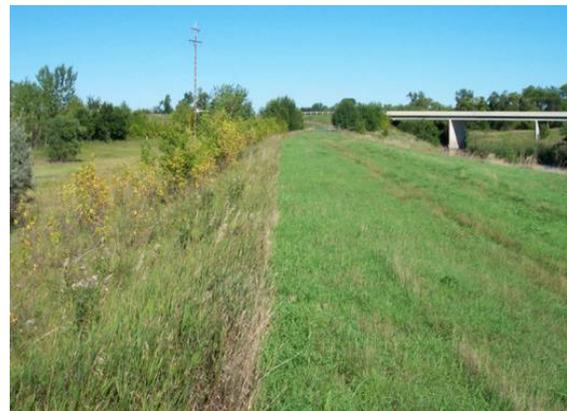
Figure 2.32 UNACCEPTABLE long grasses and trees on levee side slopes. (ND)

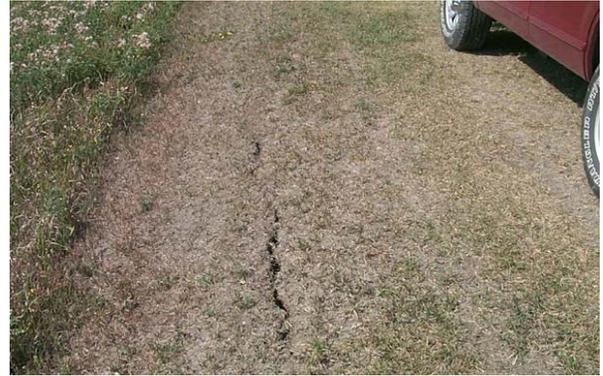
Figure 2.33 ACCEPTABLE cracking in clay levee with shrinkage cracking caused by dry conditions. (MN)

It's important to closely monitor and evaluate all visible areas of cracking on a levee or riverbank, to ensure they don't develop slope stability problems as shown in Figure 2.35 and discussed in section 2.4. Cracks in a levee develop when the levee material is saturated with water and when it is overly dry. Clay, like most impervious materials, will shrink as it dries and re-expand when wet. Clay levee surfaces tend to shrink and expand slightly, and some cracks in the surface of the FCW are to be expected. Shrinkage cracks are generally narrow and shallow, not extending more than a few inches into the levee, but during long periods of drought they may extend as much as two feet into the levee. These cracks can run longitudinally or transverse to the levee, as in Figure 2.33, or may appear as blocks as shown in Figure 2.34. If the cracking becomes excessive, it needs to be corrected even if the levee appears to be stable. It's important that you contact your local Corps district office for guidance on how to repair cracks observed in your levee.

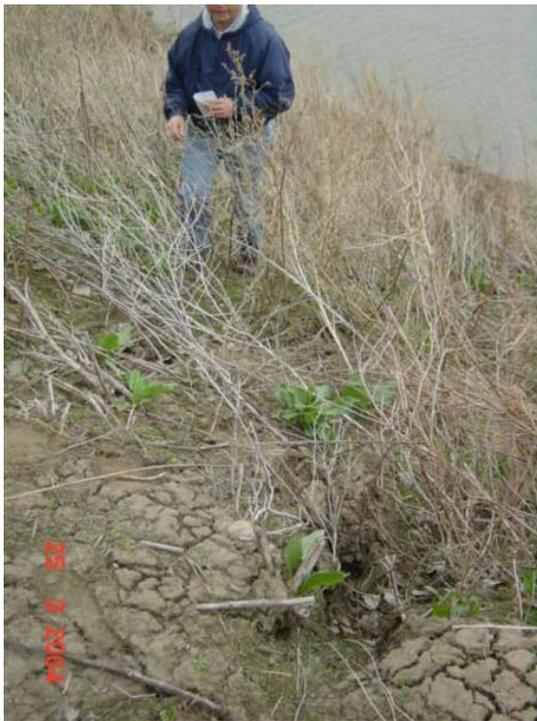
Figure 2.34 UNACCEPTABLE cracking with landside pooling, Whitehead Levee Project, (IA)

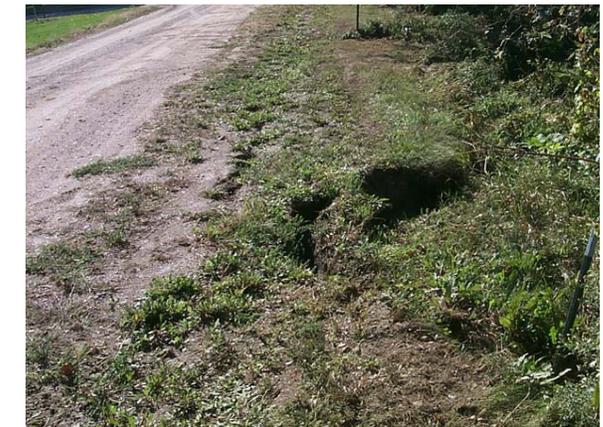
Figure 2.35 UNACCEPTABLE embankment cracking and slope failure. This photo shows what started out as cracking along the crest of the embankment and quickly developed into a slope failure. All cracking located on a levee or riverbank must be closely monitored. (MN)

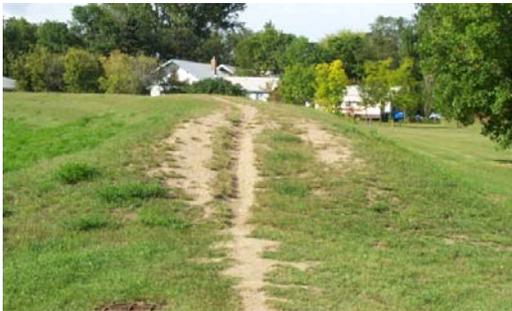
Figure 2.36 *MINIMALLY ACCEPTABLE* levee rutting caused by pedestrian and bicycle traffic. (ND)

Figures 2.36 through 2.39 show common ruts which can hold water on access roads and levees.

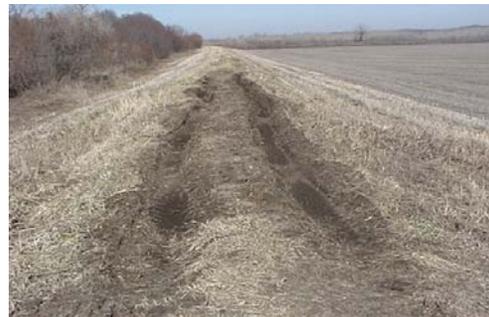
Figure 2.37 *UNACCEPTABLE* ruts in levee crown require fill. (MO)

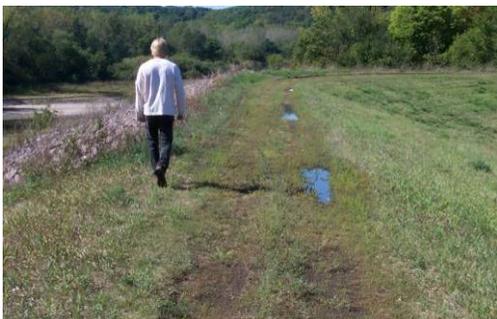
Figure 2.38 *MINIMALLY ACCEPTABLE* ponded water along a levee crest. (MN)

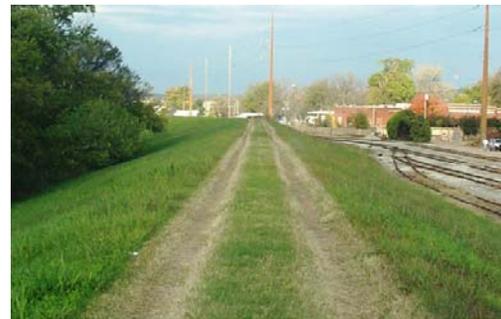
Figure 2.39 *UNACCEPTABLE* rutting in levee. (OK)

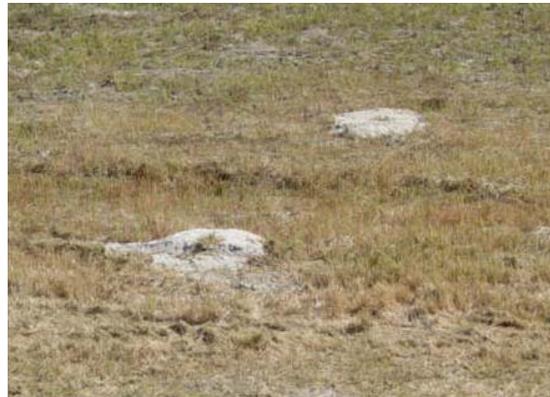
Figure 2.41 Evidence of sandboils. (IN)

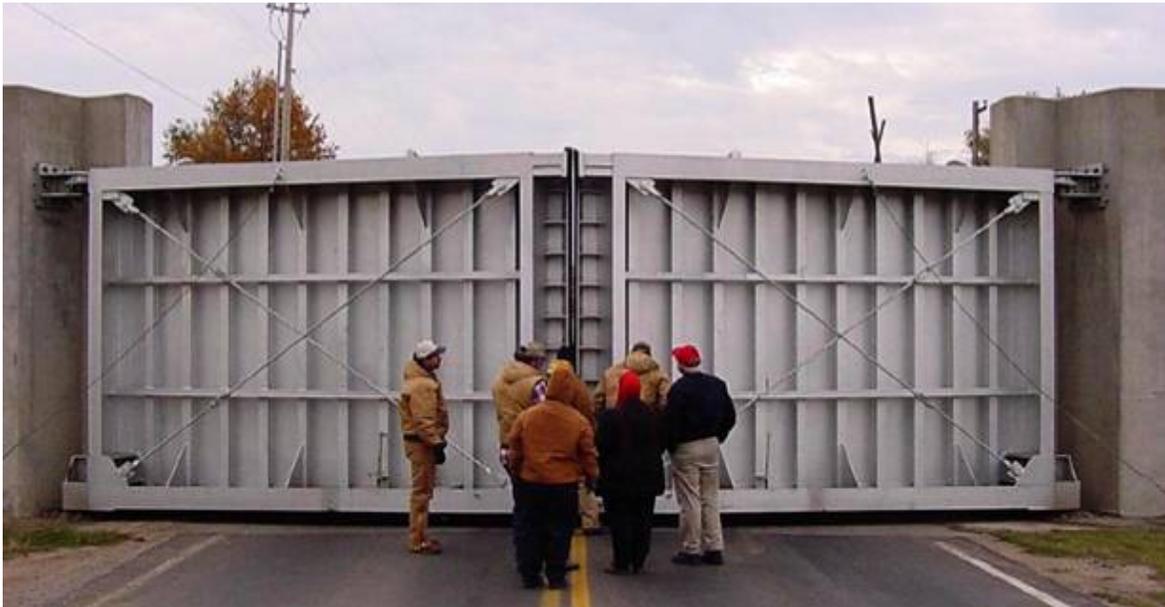
Figure 2.42 *ACCEPTABLE* floodgate in a levee. (KS)

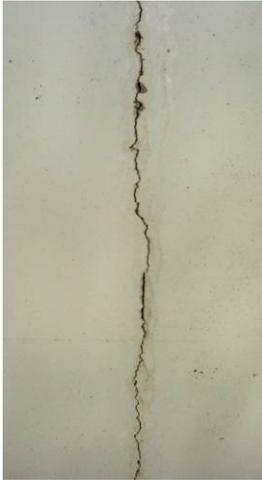
Figure 2.43 *MINIMALLY ACCEPTABLE* 1/8th inch crack extends through concrete floodwall and needs to be sealed to prevent further damage. (MN)

Visible cracking, scaling, or spalling are signs of concrete movement and stresses within the concrete. Cracks in concrete walls that aren't repaired are subject to freeze / thaw damage, which widens the gap and leads to additional spalling of the concrete. When examining any concrete flood control structures, spalling, scaling, or cracking should be very minimal. Figures 2.43 through 2.47 show various degrees of cracking, spalling, and scaling.

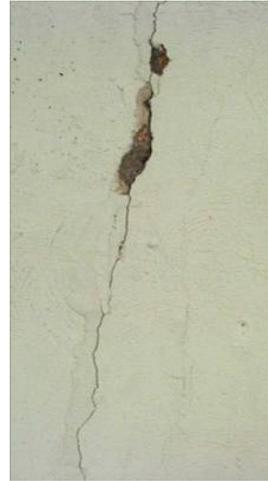
Figure 2.44 *MINIMALLY ACCEPTABLE* Vertical floodwall crack with spalling. The rating for this particular crack is Minimally Acceptable because the crack is still tight but there is some spalling occurring as well. (MN)

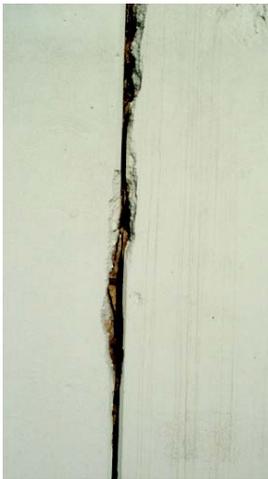
Figure 2.45 *UNACCEPTABLE* exposed rebar. Monolith joint separation with exterior spalling along the joint and interior spalling in the area of the rebar. (MN)

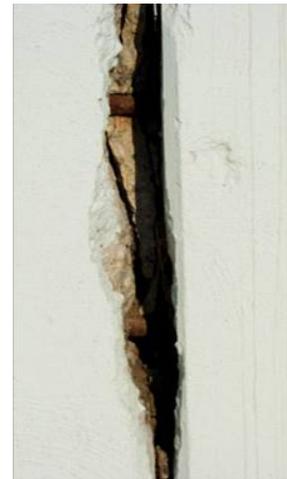
Figure 2.46 Detail of the crack in Figure 2.45, showing the exposed rebar that tied the two monoliths together. (MN)

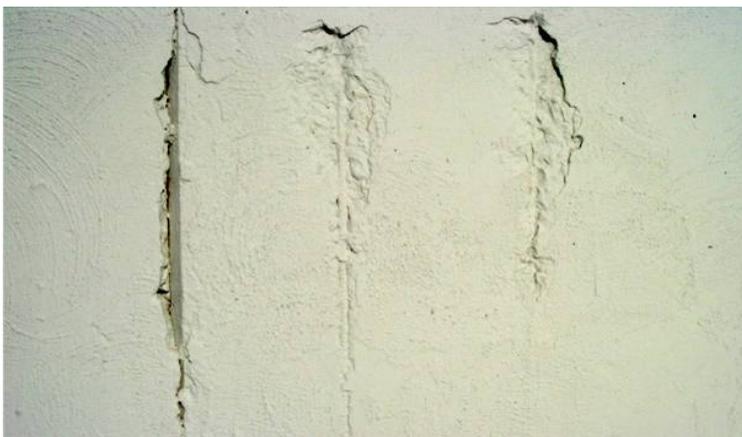
Figure 2.47 *MINIMALLY ACCEPTABLE* floodwall. Exposed surface rebar resulting from poor construction practices. The public sponsor has painted over the rebar in an attempt to keep it from rusting. (MN)

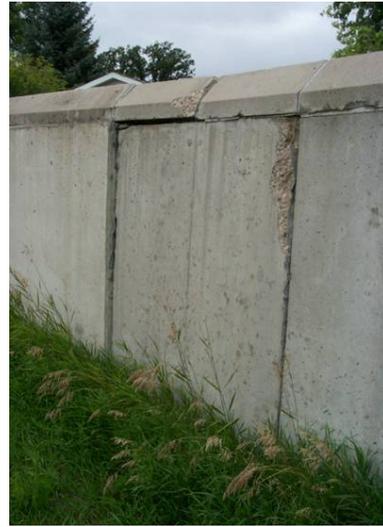
Figure 2.49 UNACCEPTABLE monolith movement in floodwall. The monolith shown in the photo has tilted about 6 inches riverward as well a vertically. Note the movement when compared to the adjoining monolith and the top cap. As the monolith moved considerable spalling has occurred along the joint. This project is monitored very closely during flood events. (ND)

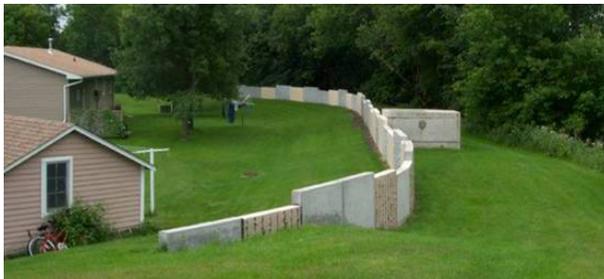
Figure 2.50 ACCEPTABLE. Decorative floodwall is in straight alignment, with no tilting or spalling, and all joints are tight together. (MN)

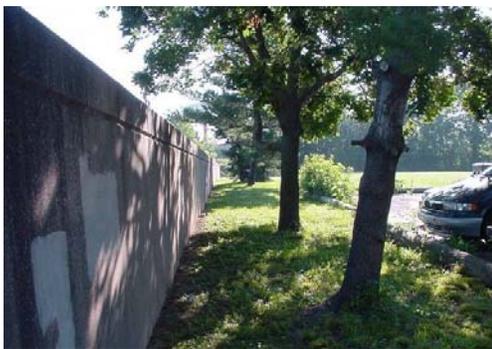
Figure 2.51 UNACCEPTABLE. Trees growing too close to floodwall. (KY)

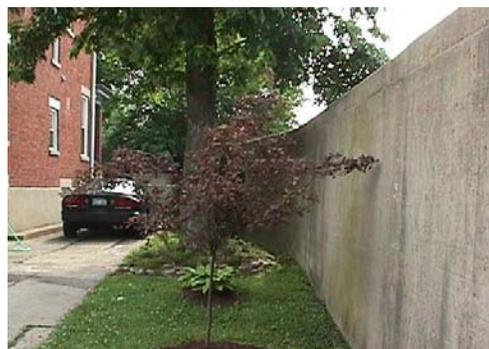
Figure 2.52 UNACCEPTABLE. Trees growing too close to floodwall. (KY)

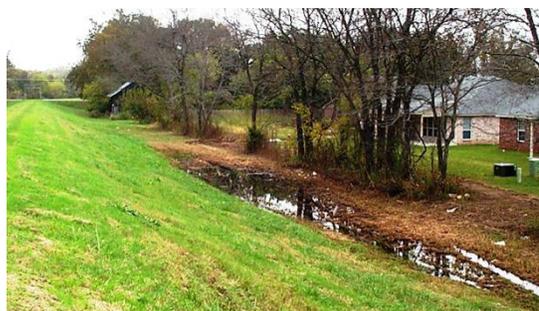
Figure 2.53 UNACCEPTABLE interior drainage at the toe of an earthen levee. (OK)

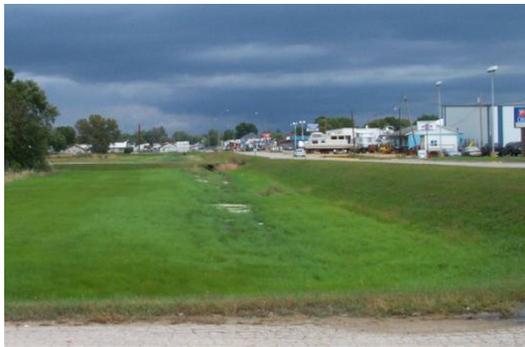
Figure 2.54 ACCEPTABLE interior drainage channel. (IA)

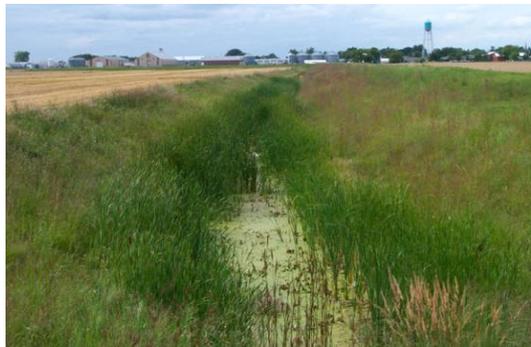
Figure 2.55 MINIMALLY ACCEPTABLE vegetation (cat tails and bull rushes) in interior drainage ditch. (MN)

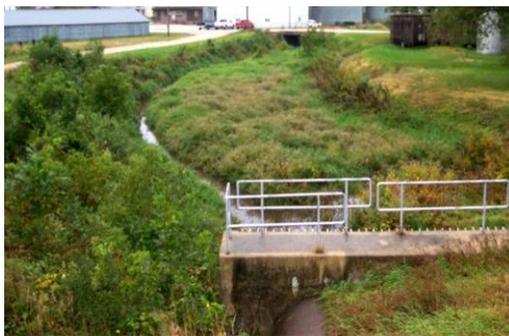
Figure 2.56 UNACCEPTABLE vegetation and sediment in interior drainage channel. (IA)

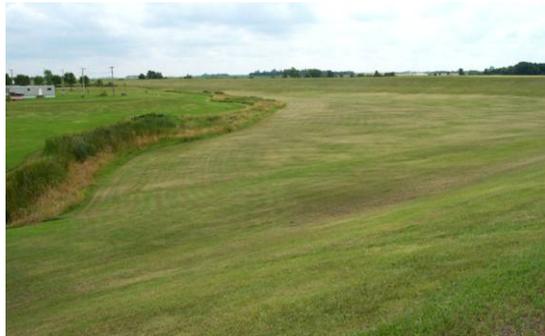
Figure 2.57 ACCEPTABLE interior ponding area and drainage ditch. (MN)

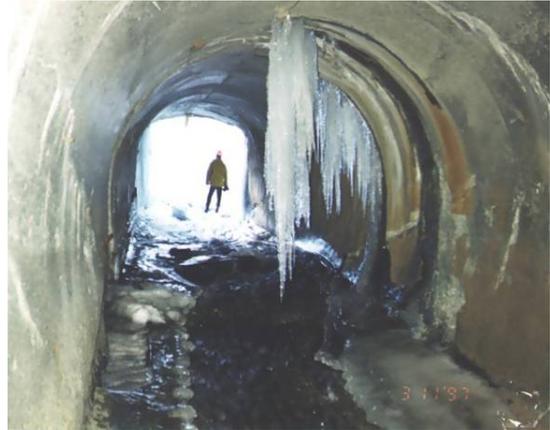
Figure 2.58 Concrete drainage tunnel. (AK)

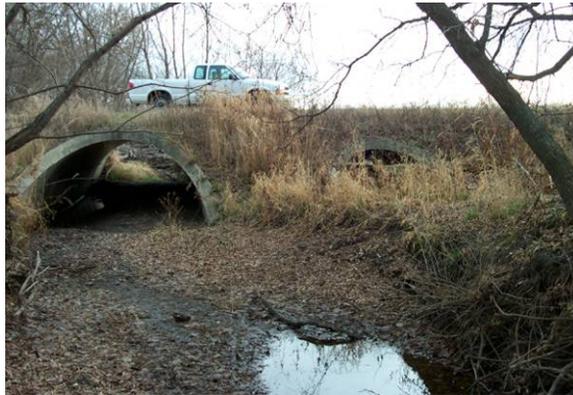
Figure 2.59 The culvert on the left is Minimally Acceptable with sediment accumulation within the culvert. The culvert on the right is totally unacceptable with 2/3 of its flow capacity reduced by sediment and debris. This project was rated as UNACCEPTABLE because of the reduced flow capacity of the culverts. (MN)

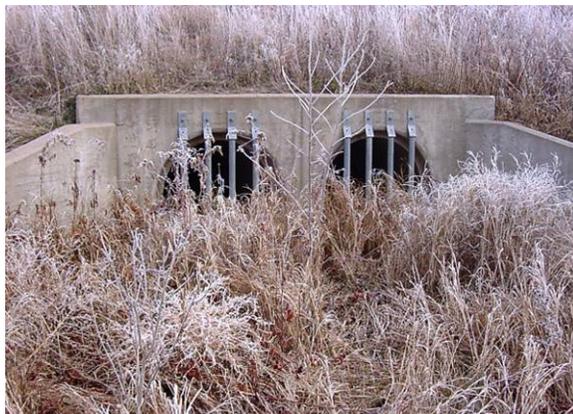
Figure 2.60 MINIMALLY ACCEPTABLE, vegetation blocking the concrete culvert must be removed. (KS)

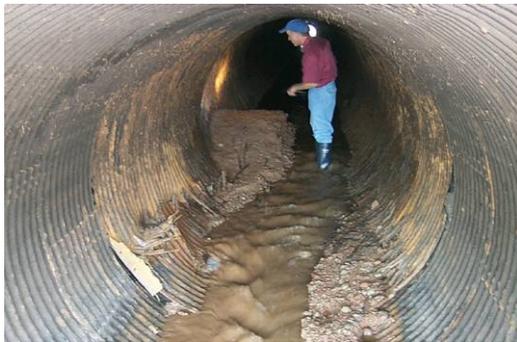
Figure 2.61 UNACCEPTABLE, Failing corrugated metal pipe. DO NOT WALK INTO A FAILING CULVERT LIKE THIS. This section has actually separated, allowing the surrounding soil to enter the pipe and the overburden to collapse. This sponsor was denied rehabilitation assistance due to this maintenance deficiency.

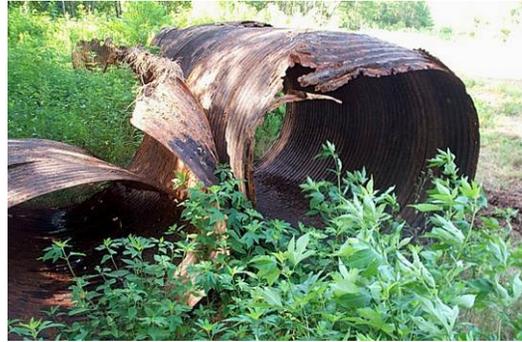
Figure 2.62 Pieces of the same pipe, once removed from the levee. Note that while much of the pipe may have appeared to be in good condition from the inside, the outside was extremely corroded. The public sponsor attempted to patch the pipe the first year, but when it failed again, the entire CMP was replaced.

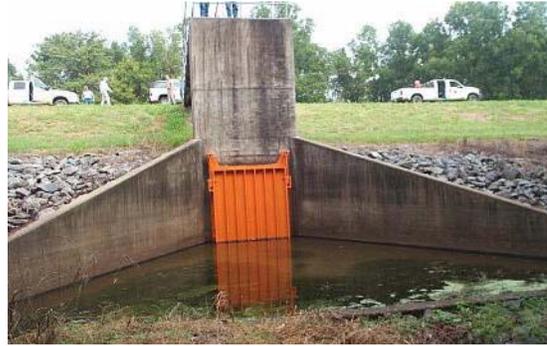
Figure 2.63 ACCEPTABLE culvert gate. (LA)

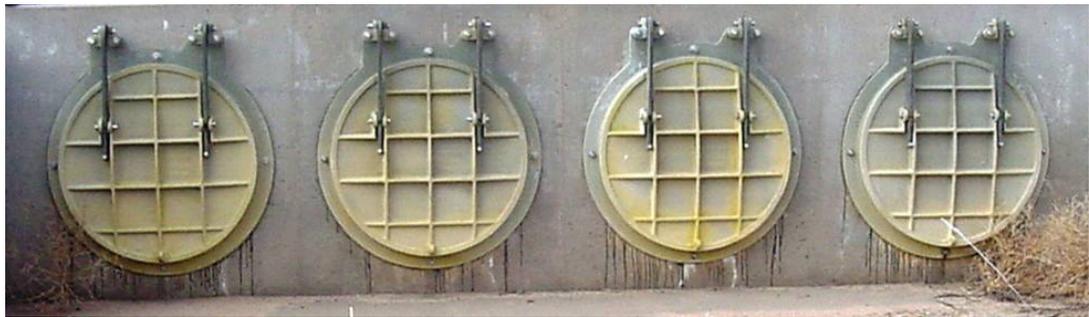
Figure 2.64 ACCEPTABLE flap gates in earthen levee. (KS)

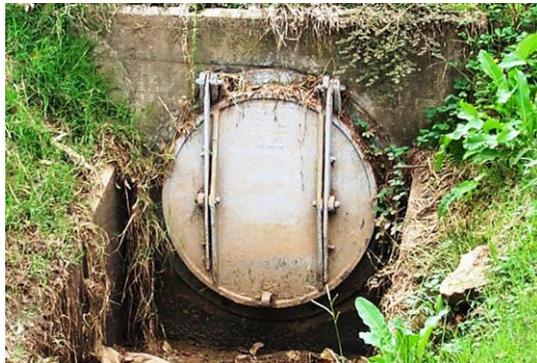
Figure 2.65 UNACCEPTABLE vegetation around flap gates in earthen levee. (OK)

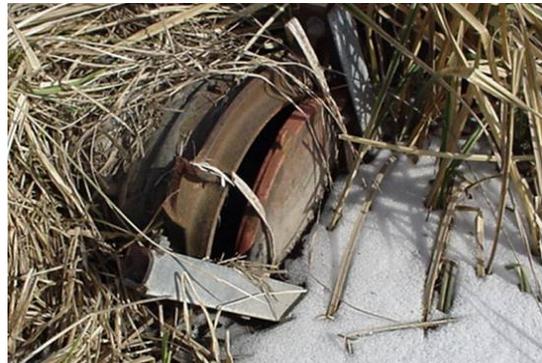
Figure 2.66 UNACCEPTABLE flap gate in earthen levee. (Broken hinge and vegetation growth.) (MO)

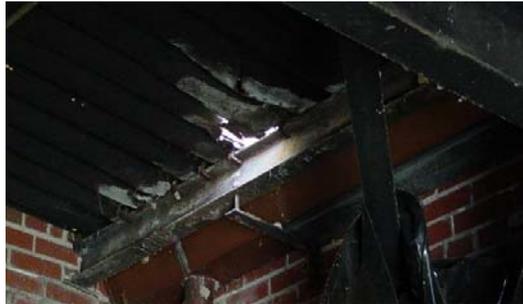
Figure 2.67 Hole in roof of pumping station. (IL)

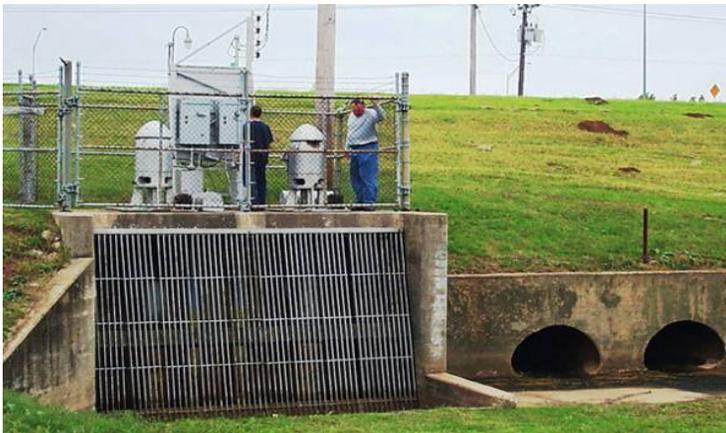
Figure 2.68 Pump station beside earthen levee. (OK)

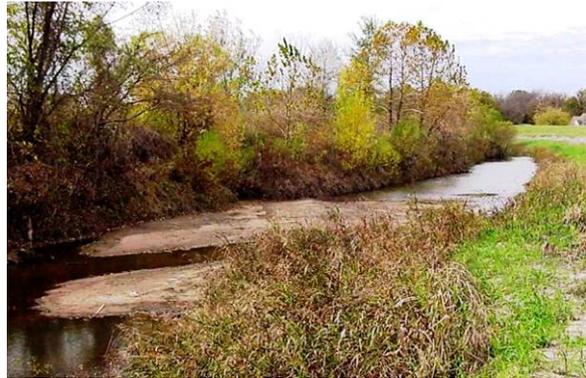
Figure 2.69 UNACCEPTABLE vegetation in channel and sediment shoaling. (OK)

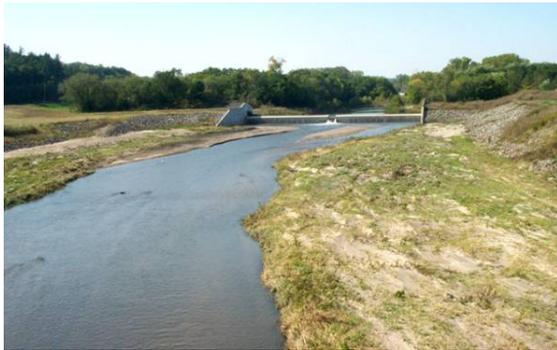
Figure 2.70 UNACCEPTABLE channel shoaling below a control structure. The original channel bottom extended all the way to the riprapped banks. There is an estimated 2-3 feet of sediment in the channel, mostly from upstream field erosion and highway construction. (MN)

Sedimentation, silt, vegetation, downed trees, and other debris in the channel must be removed to maintain channel capacity. These materials should be disposed of in a manner that does not adversely affect the project or the floodway/floodplain. This improves water quality as well as helping prevent further flooding and maintenance problems. Before removing any sediment, trees, vegetation, or placing rock bank protections, you should contact the Corps' Regulatory Office and your local Department of Natural Resources to determine if any environmental permits are required.

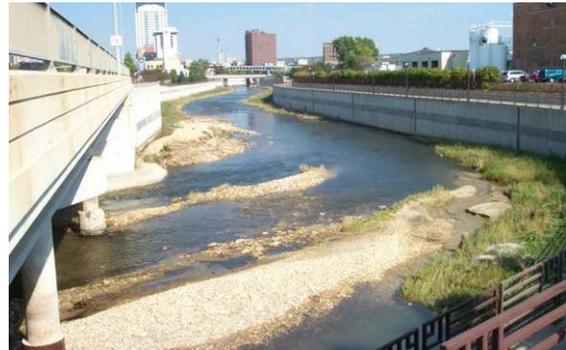
Figure 2.71 MINIMALLY ACCEPTABLE shoaling within a concrete lined channel. (MN)

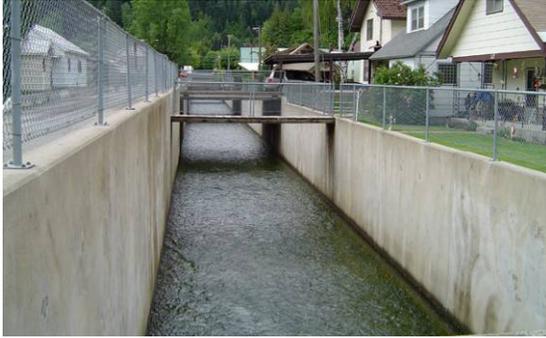
Figure 2.72 ACCEPTABLE concrete lined flood control channel. (ID)

Concrete lined channels should be kept clear of debris, sediment, and vegetation. The concrete, flap gates, and other structures must be inspected annually and maintained as described in previous sections of this chapter. Sample maintenance and inspection activities may include (but are not limited to) clearing the sediment, vegetation, and debris; replacing joint seals as needed, and repairing damage to the concrete.

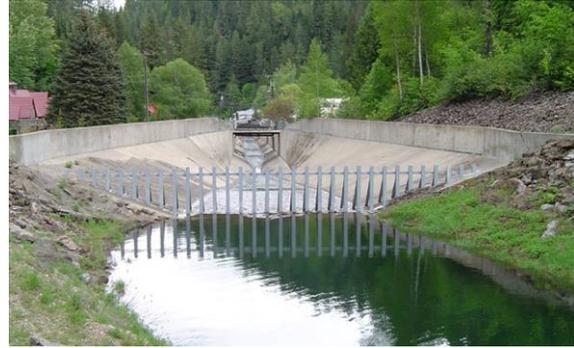
Figure 2.73 ACCEPTABLE intake structure upstream of the concrete channel. (ID)

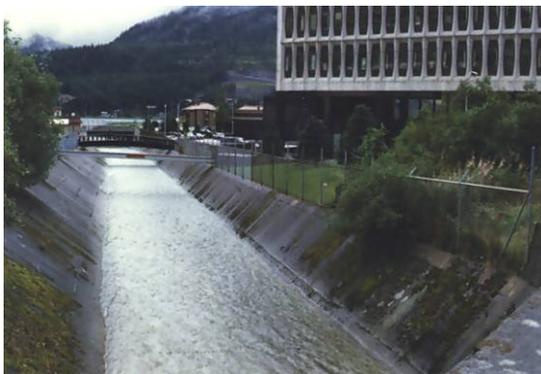
Figure 2.74 ACCEPTABLE concrete lined channel. (AK)

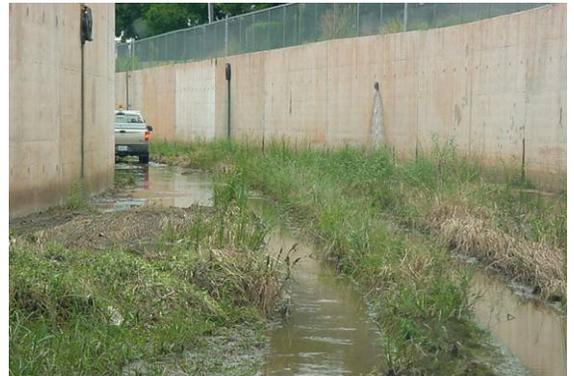
Figure 2.75 UNACCEPTABLE vegetation and extensive sediment in channel. (TX)
