APPENDIX E

GEOTECHNICAL CONSIDERATIONS

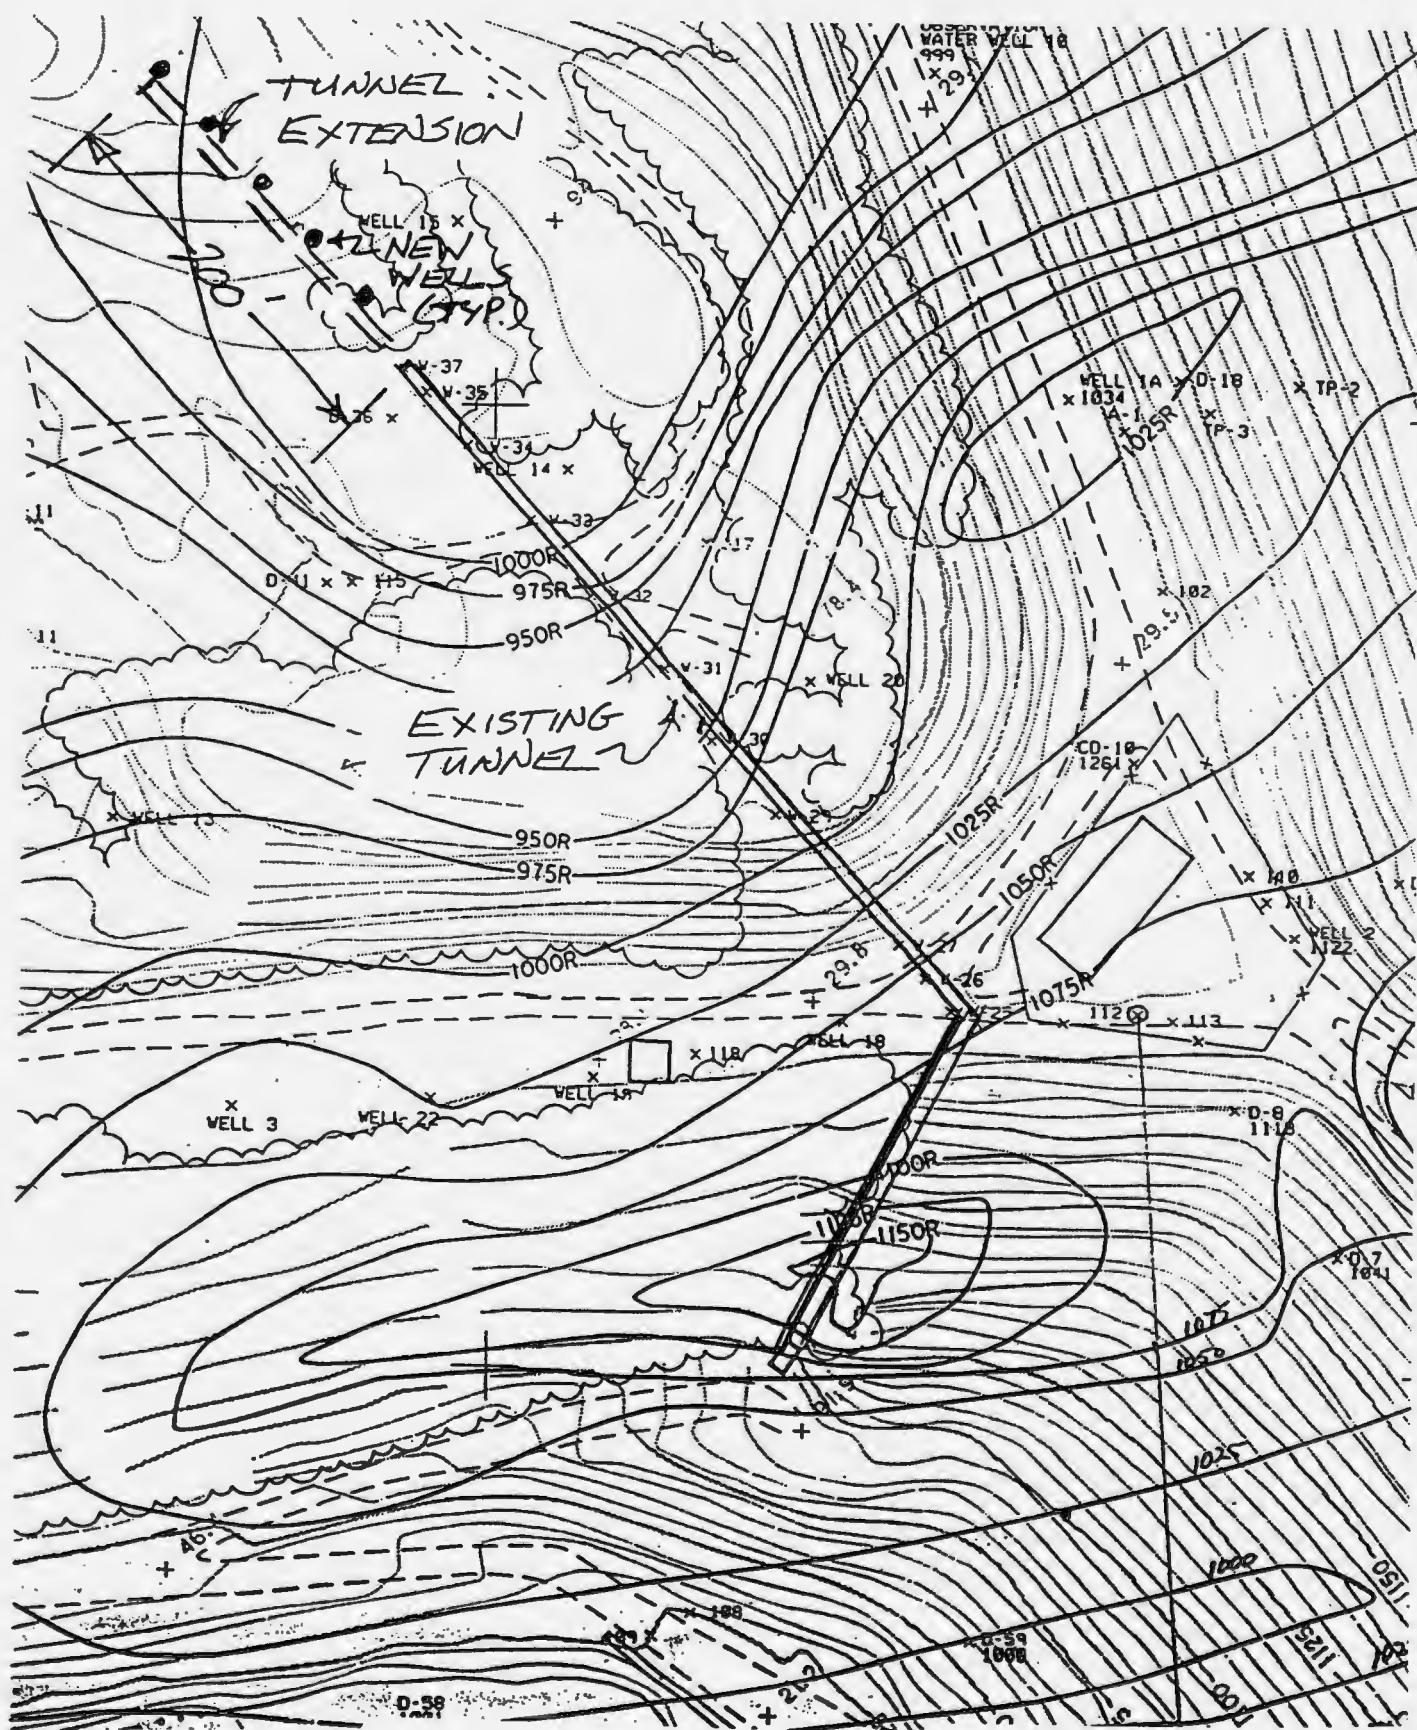
FIGURE E-3

TUNNEL EXTENSION

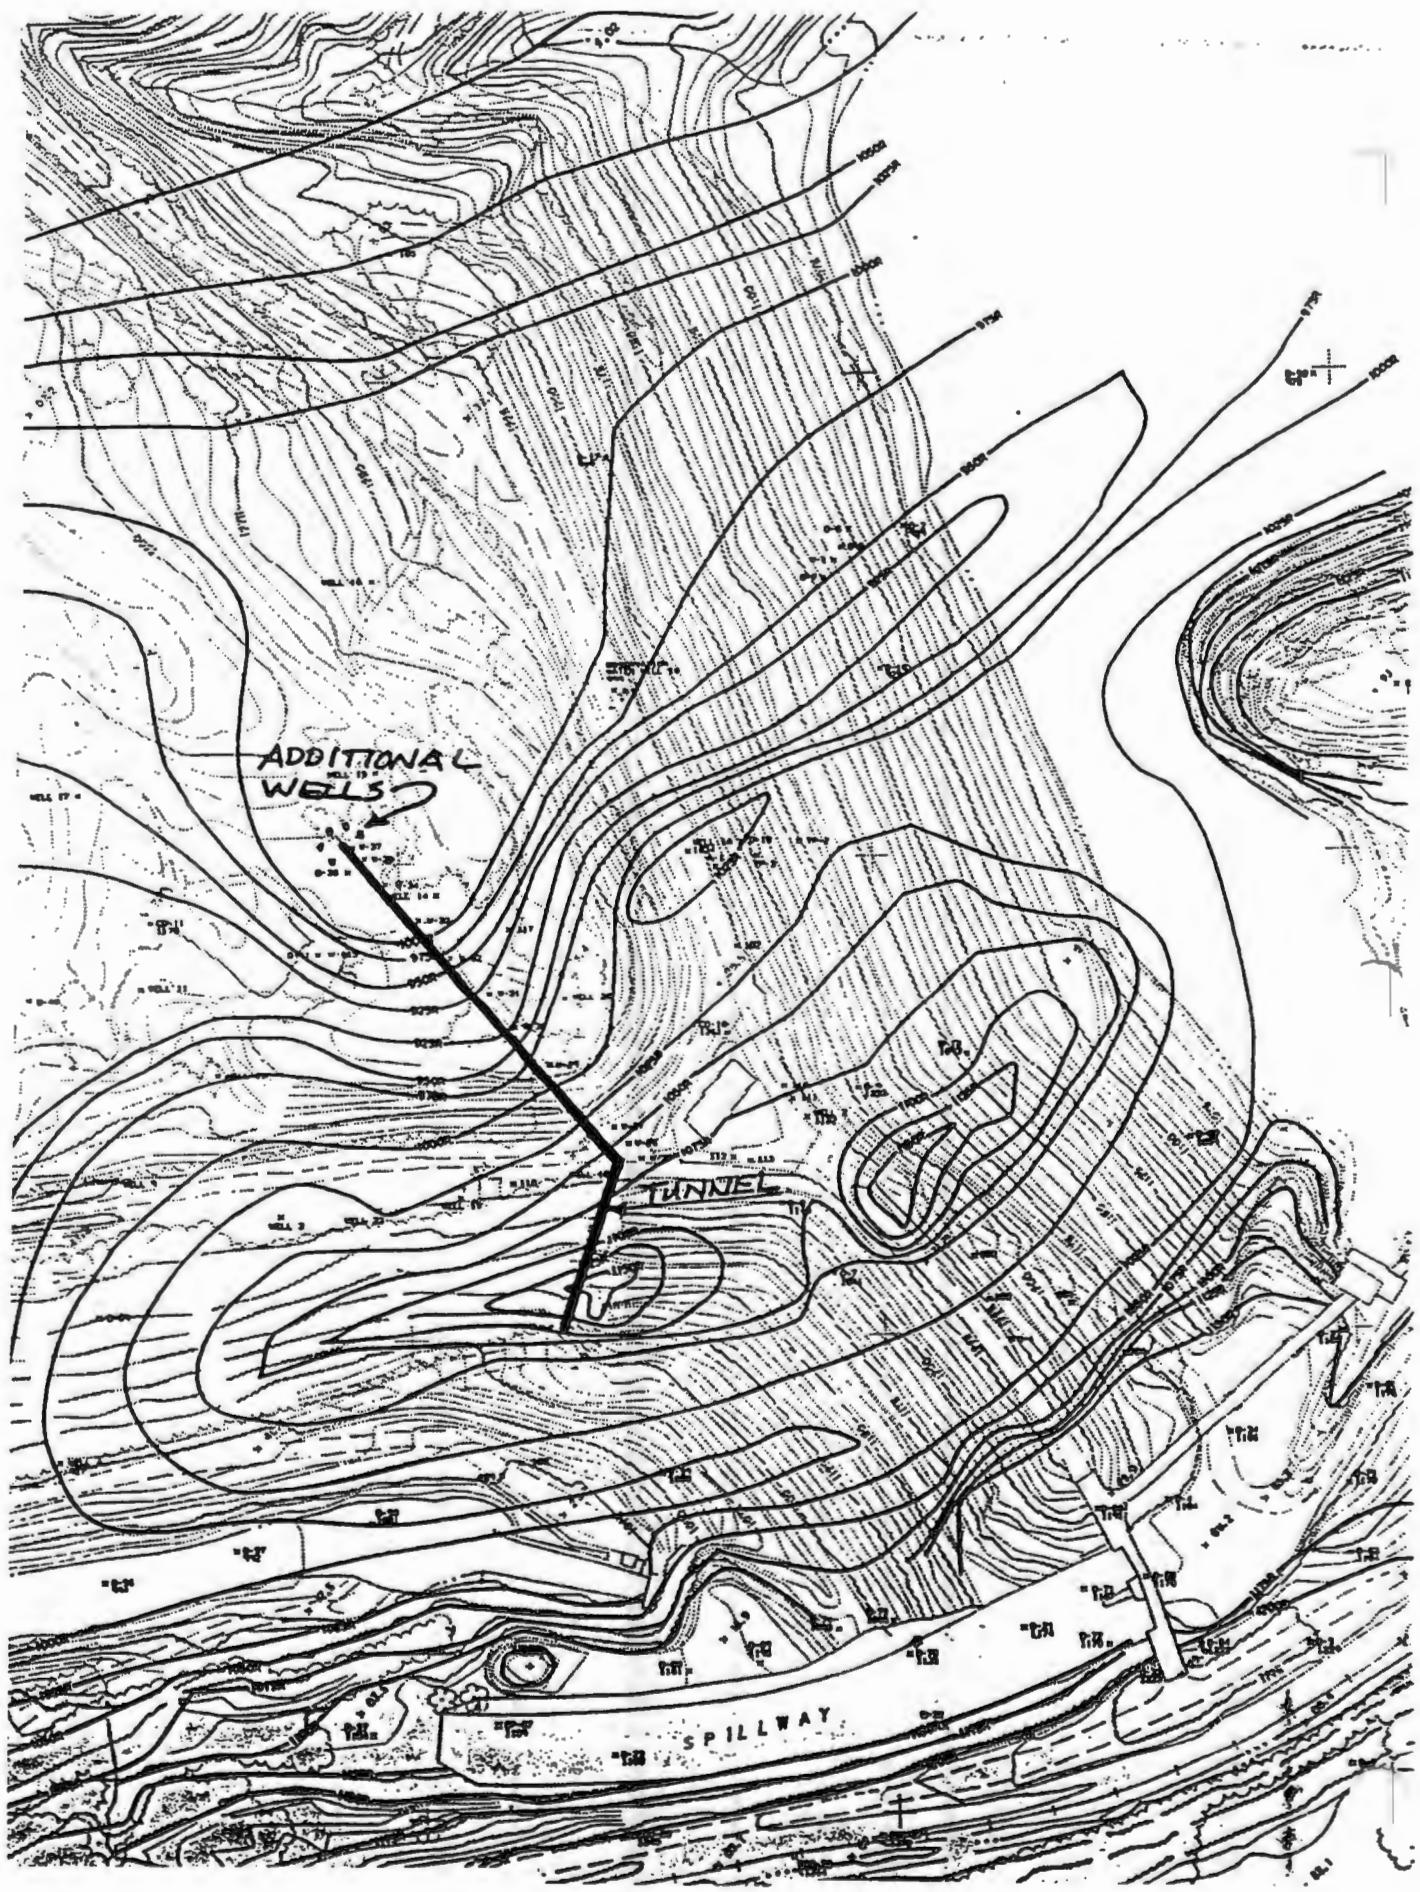
FIGURE E-4

ADDITIONAL WELLS

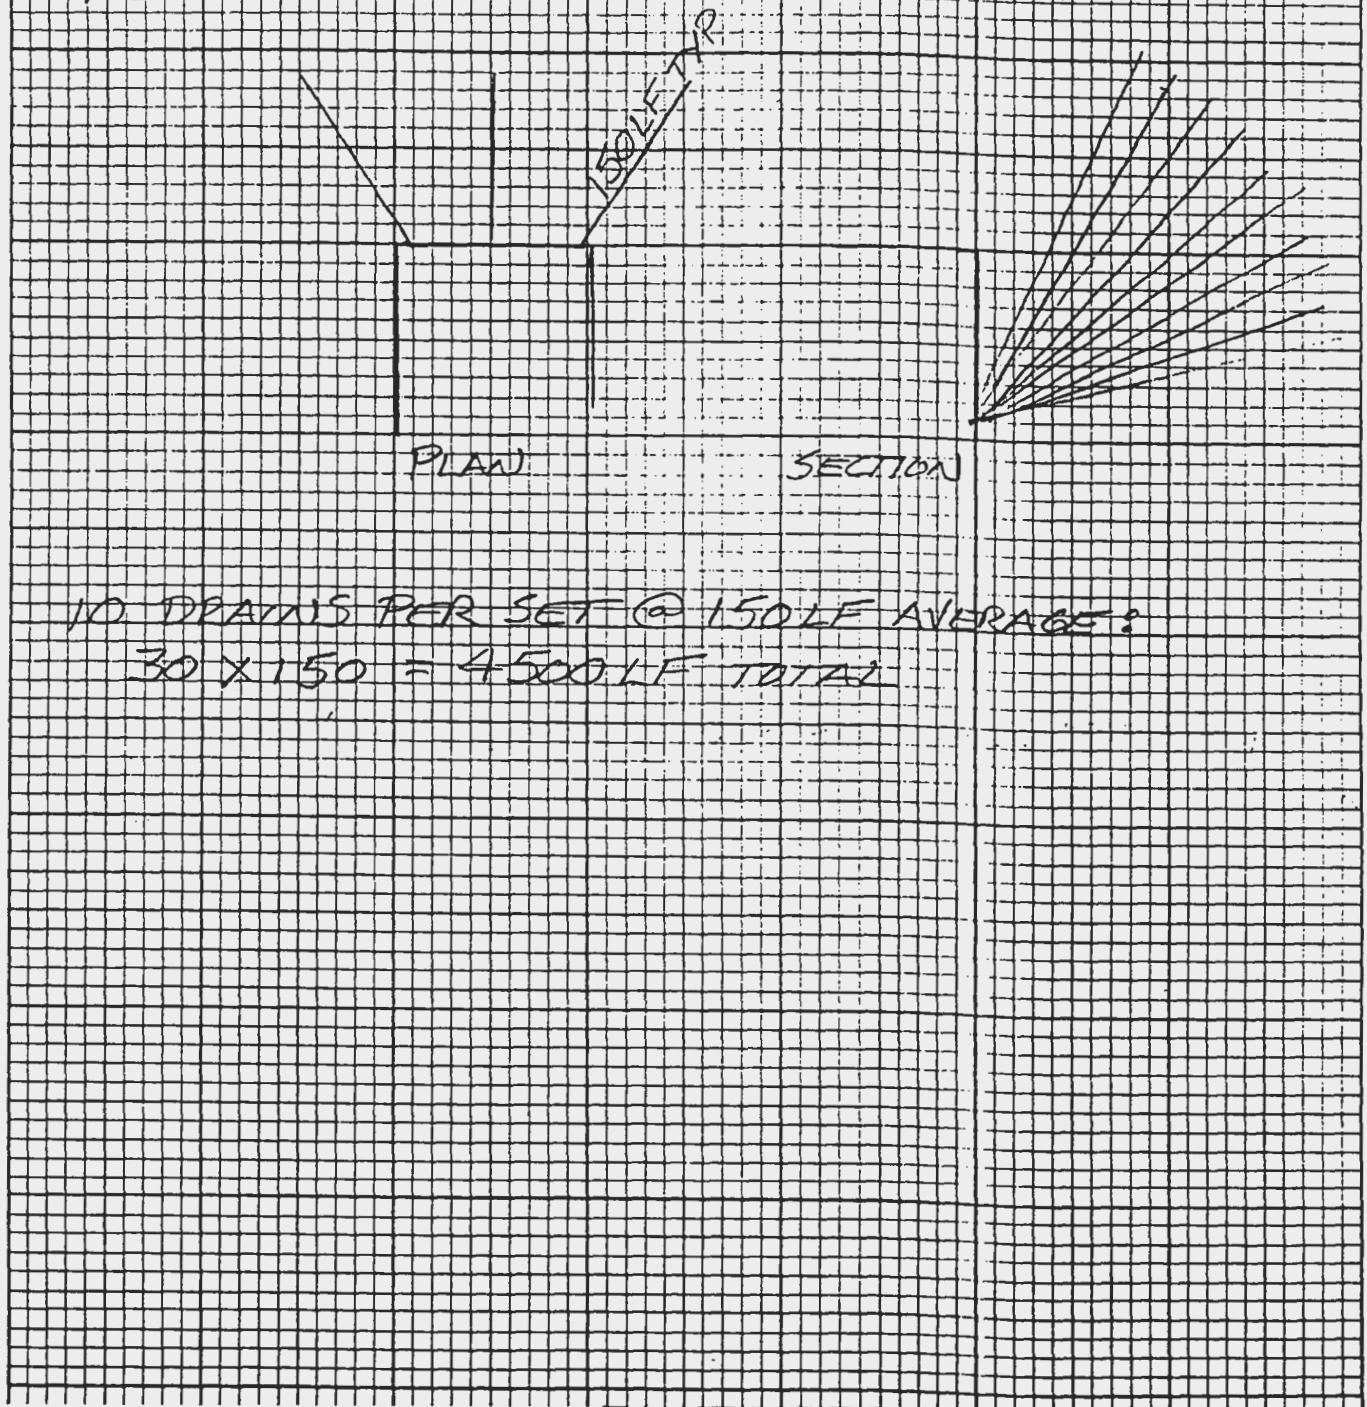
FIGURE E-5

HORIZONTAL DRAINS DRILLED THROUGH
BACK OF EXISTING TUNNEL.

ASSUME THREE SETS:

10 DRAINS PER SET @ 150 LF AVERAGE?

$$30 \times 150 = 4500 \text{ LF TOTAL}$$

PROPOSED HORIZONTAL WELLS AT
BACK OF EXISTING TUNNEL

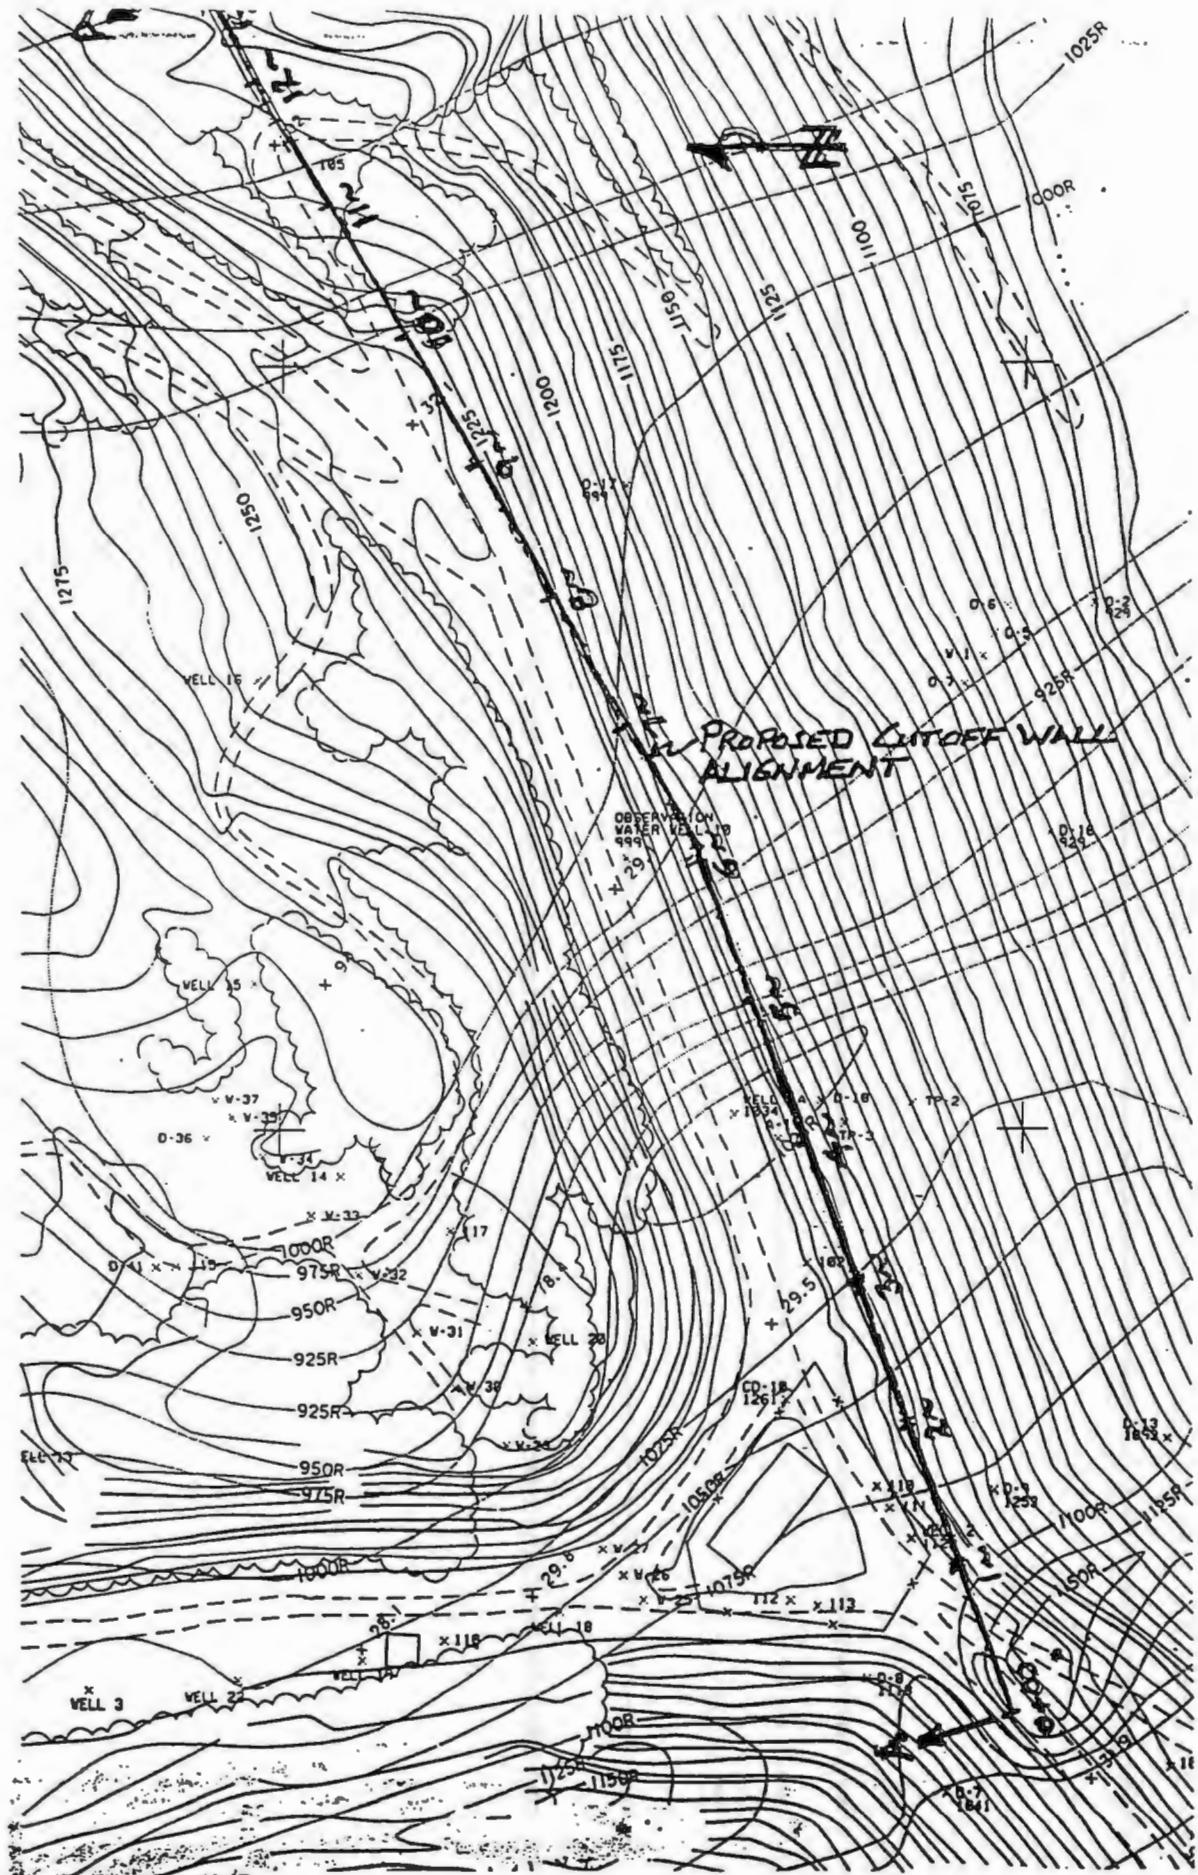
FIGURE 2 C

PROPOSED CUTOFF WALL ALIGNMENT

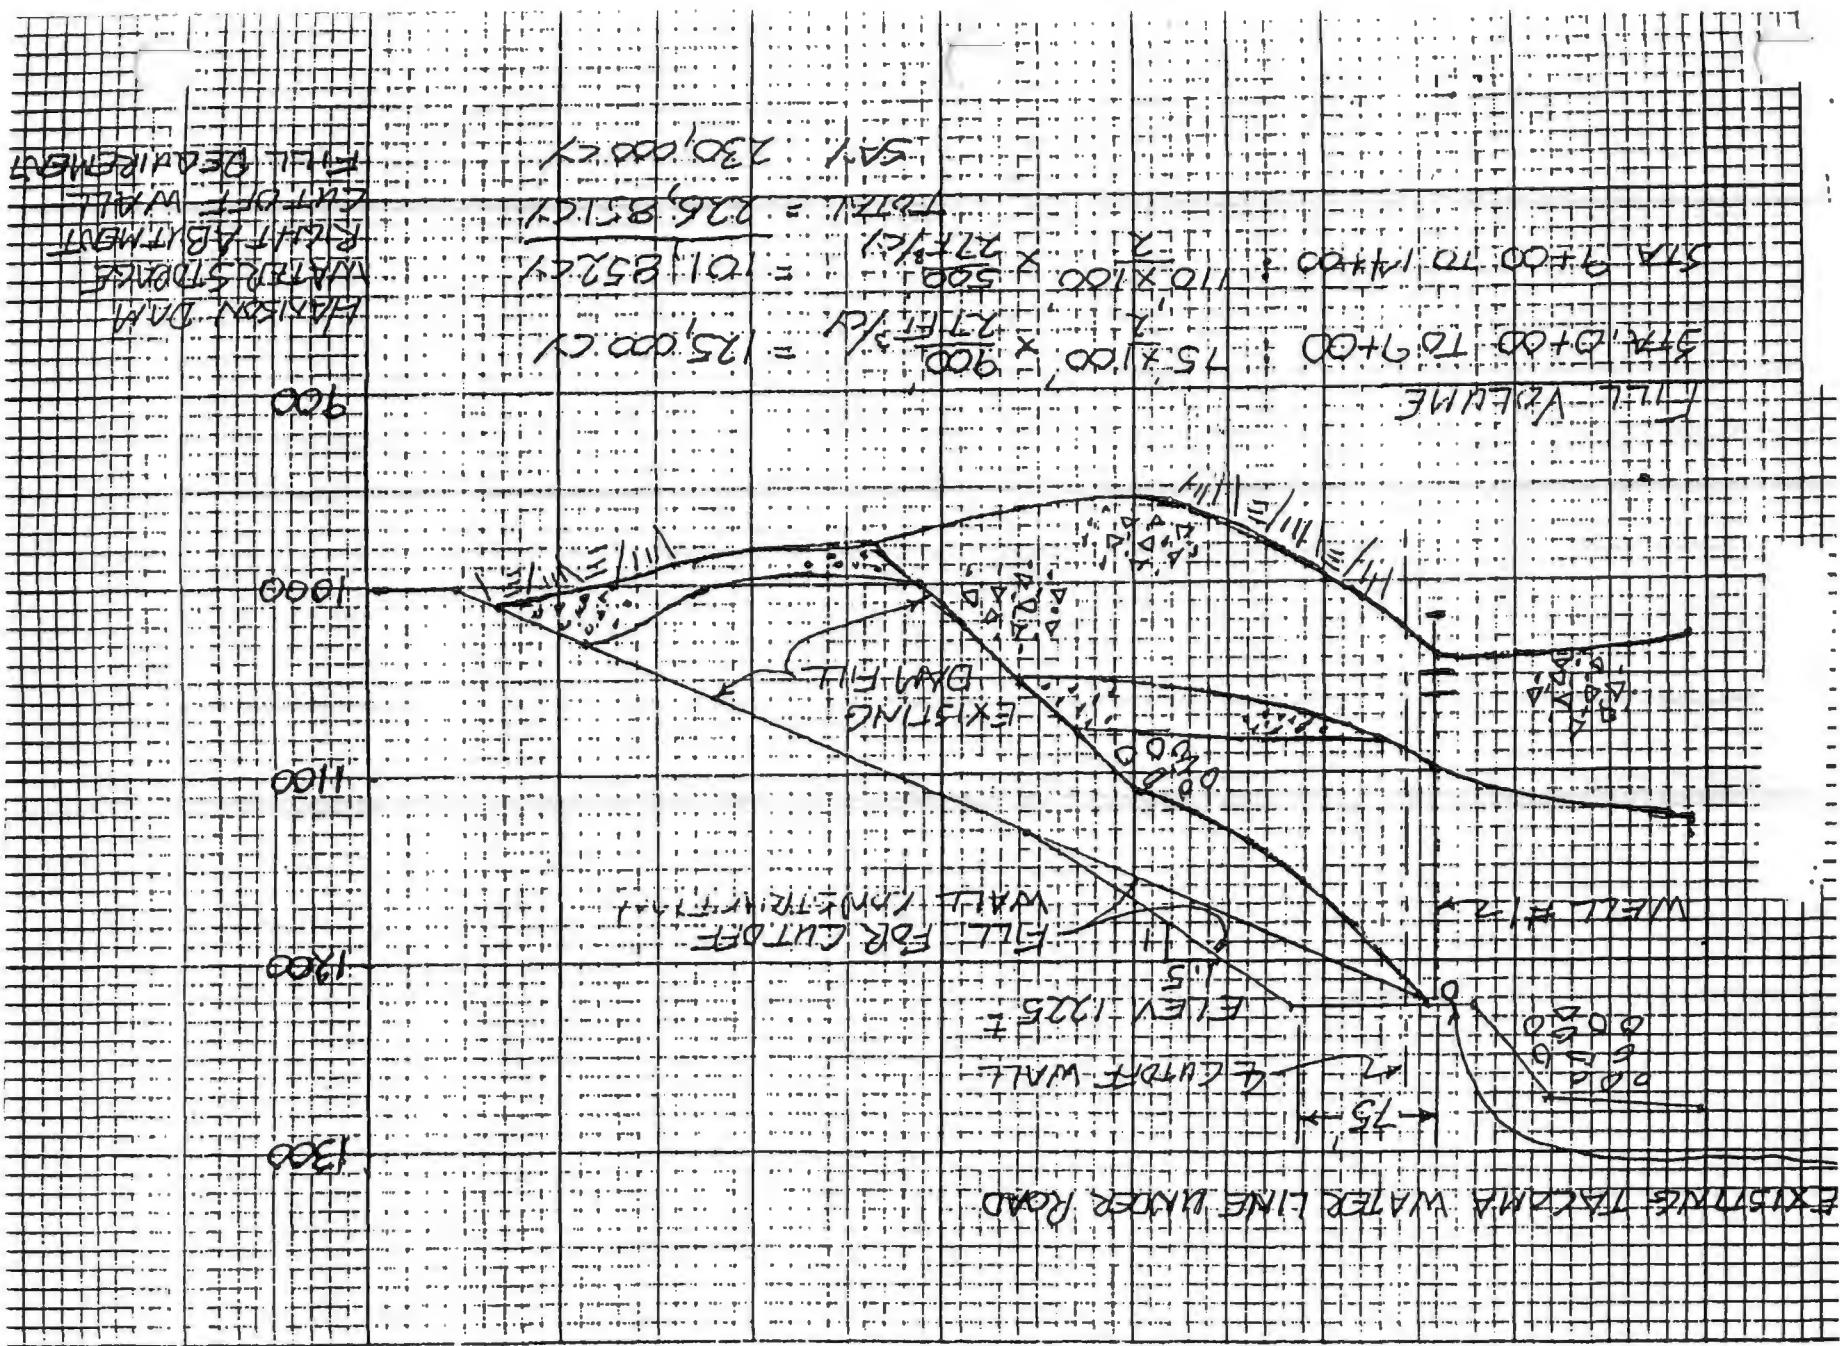
PAD FOR CUTOFF WALL CONSTRUCTION FIGURE E-8

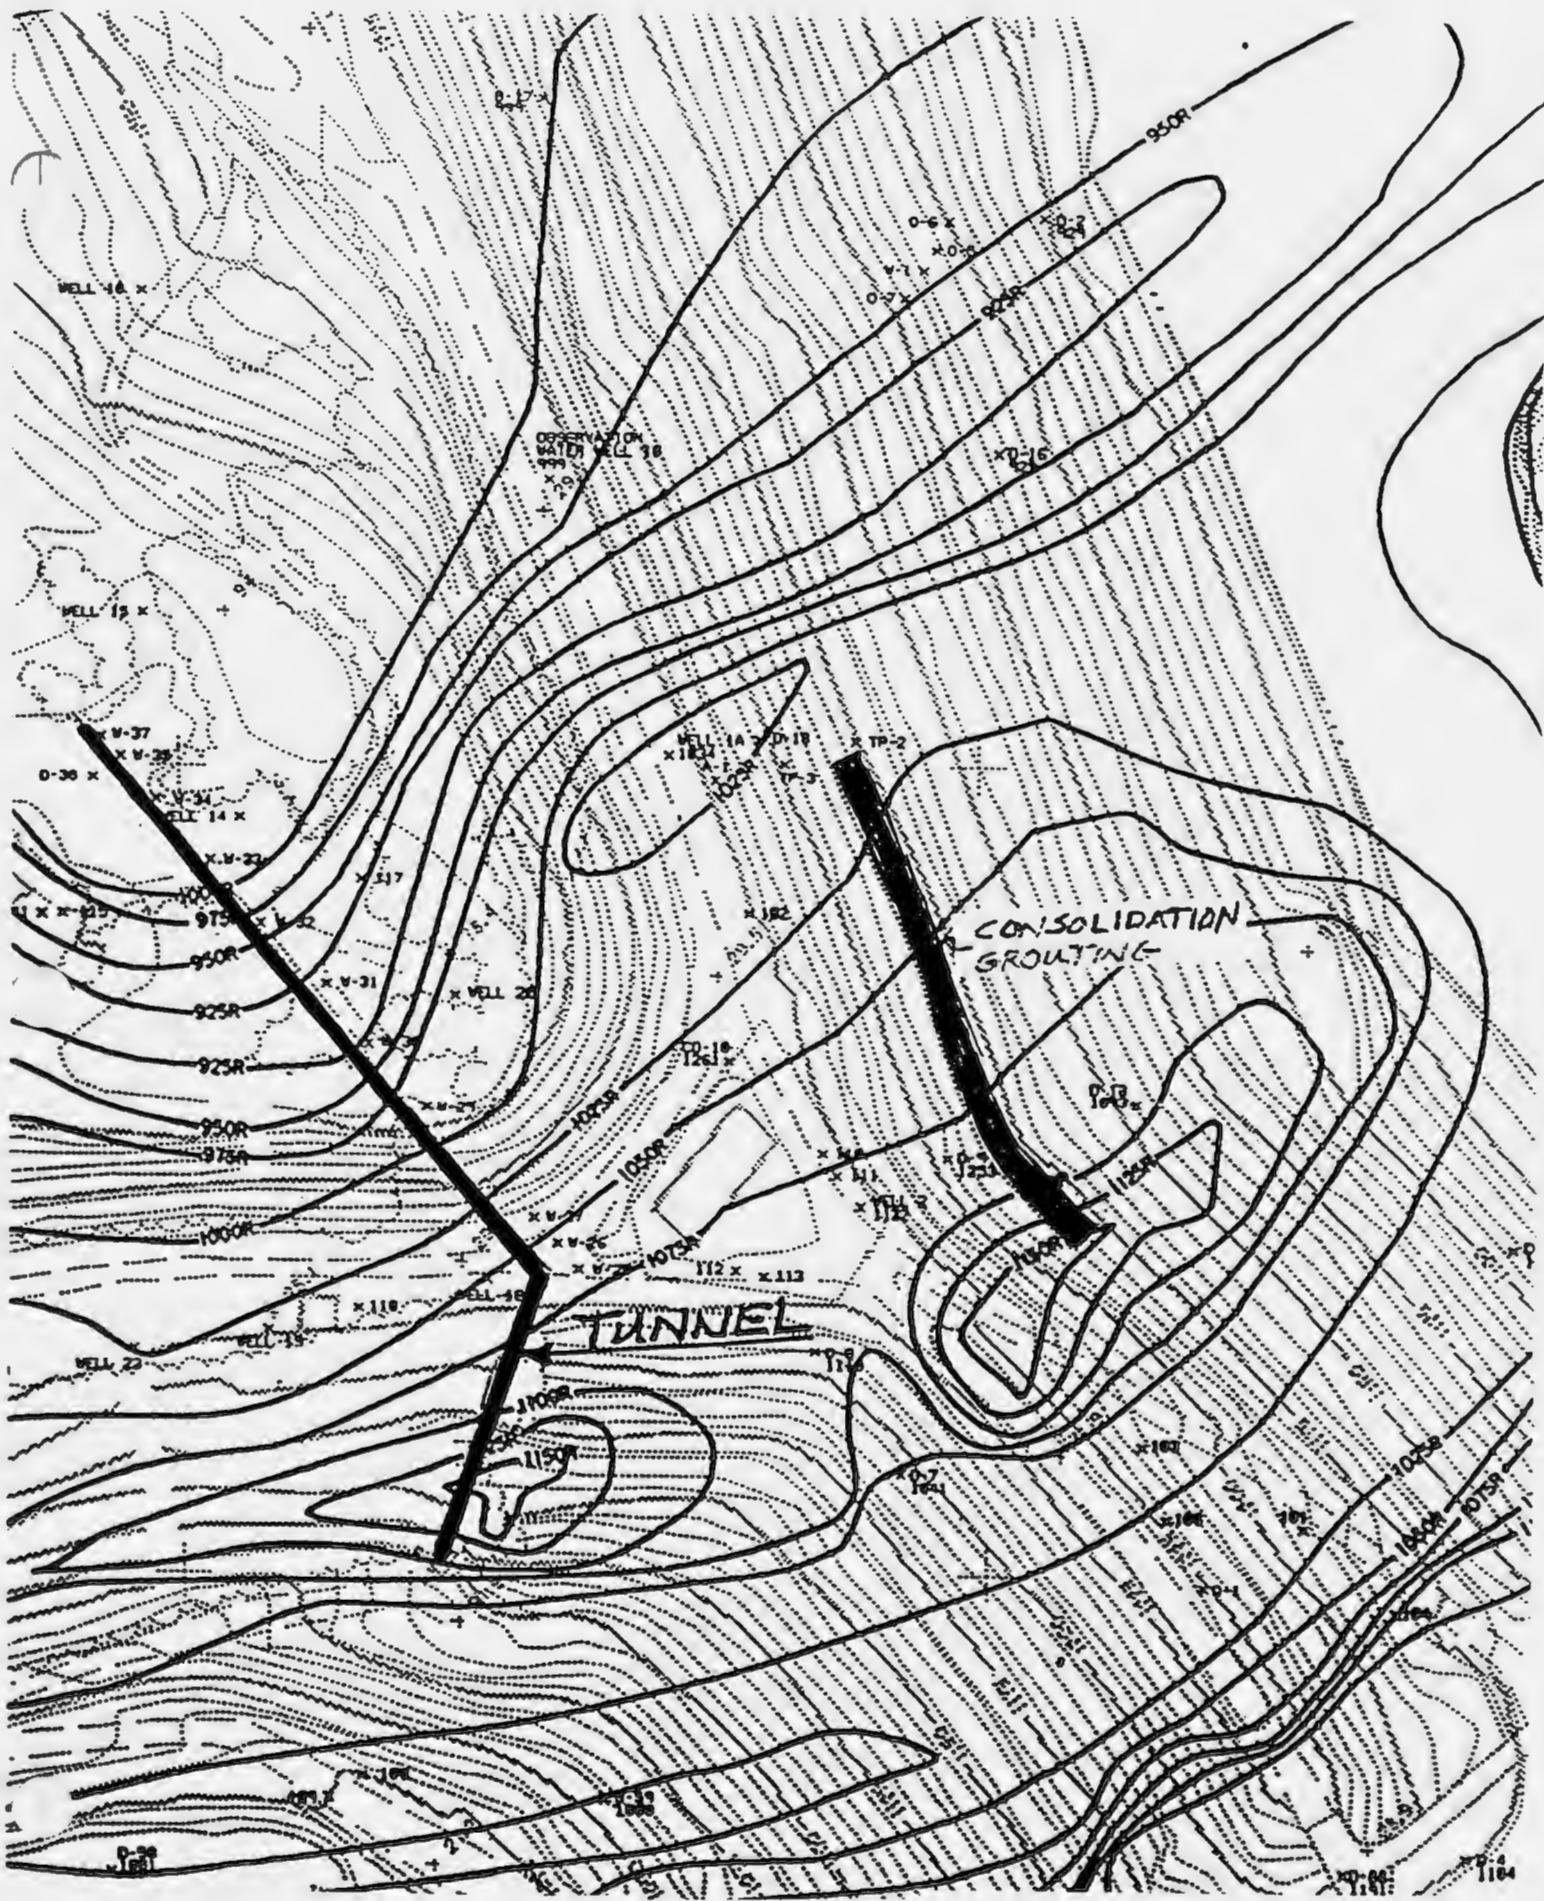
FIGURE E-9

CONSOLIDATION (INJECTION) GROUTING PLAN

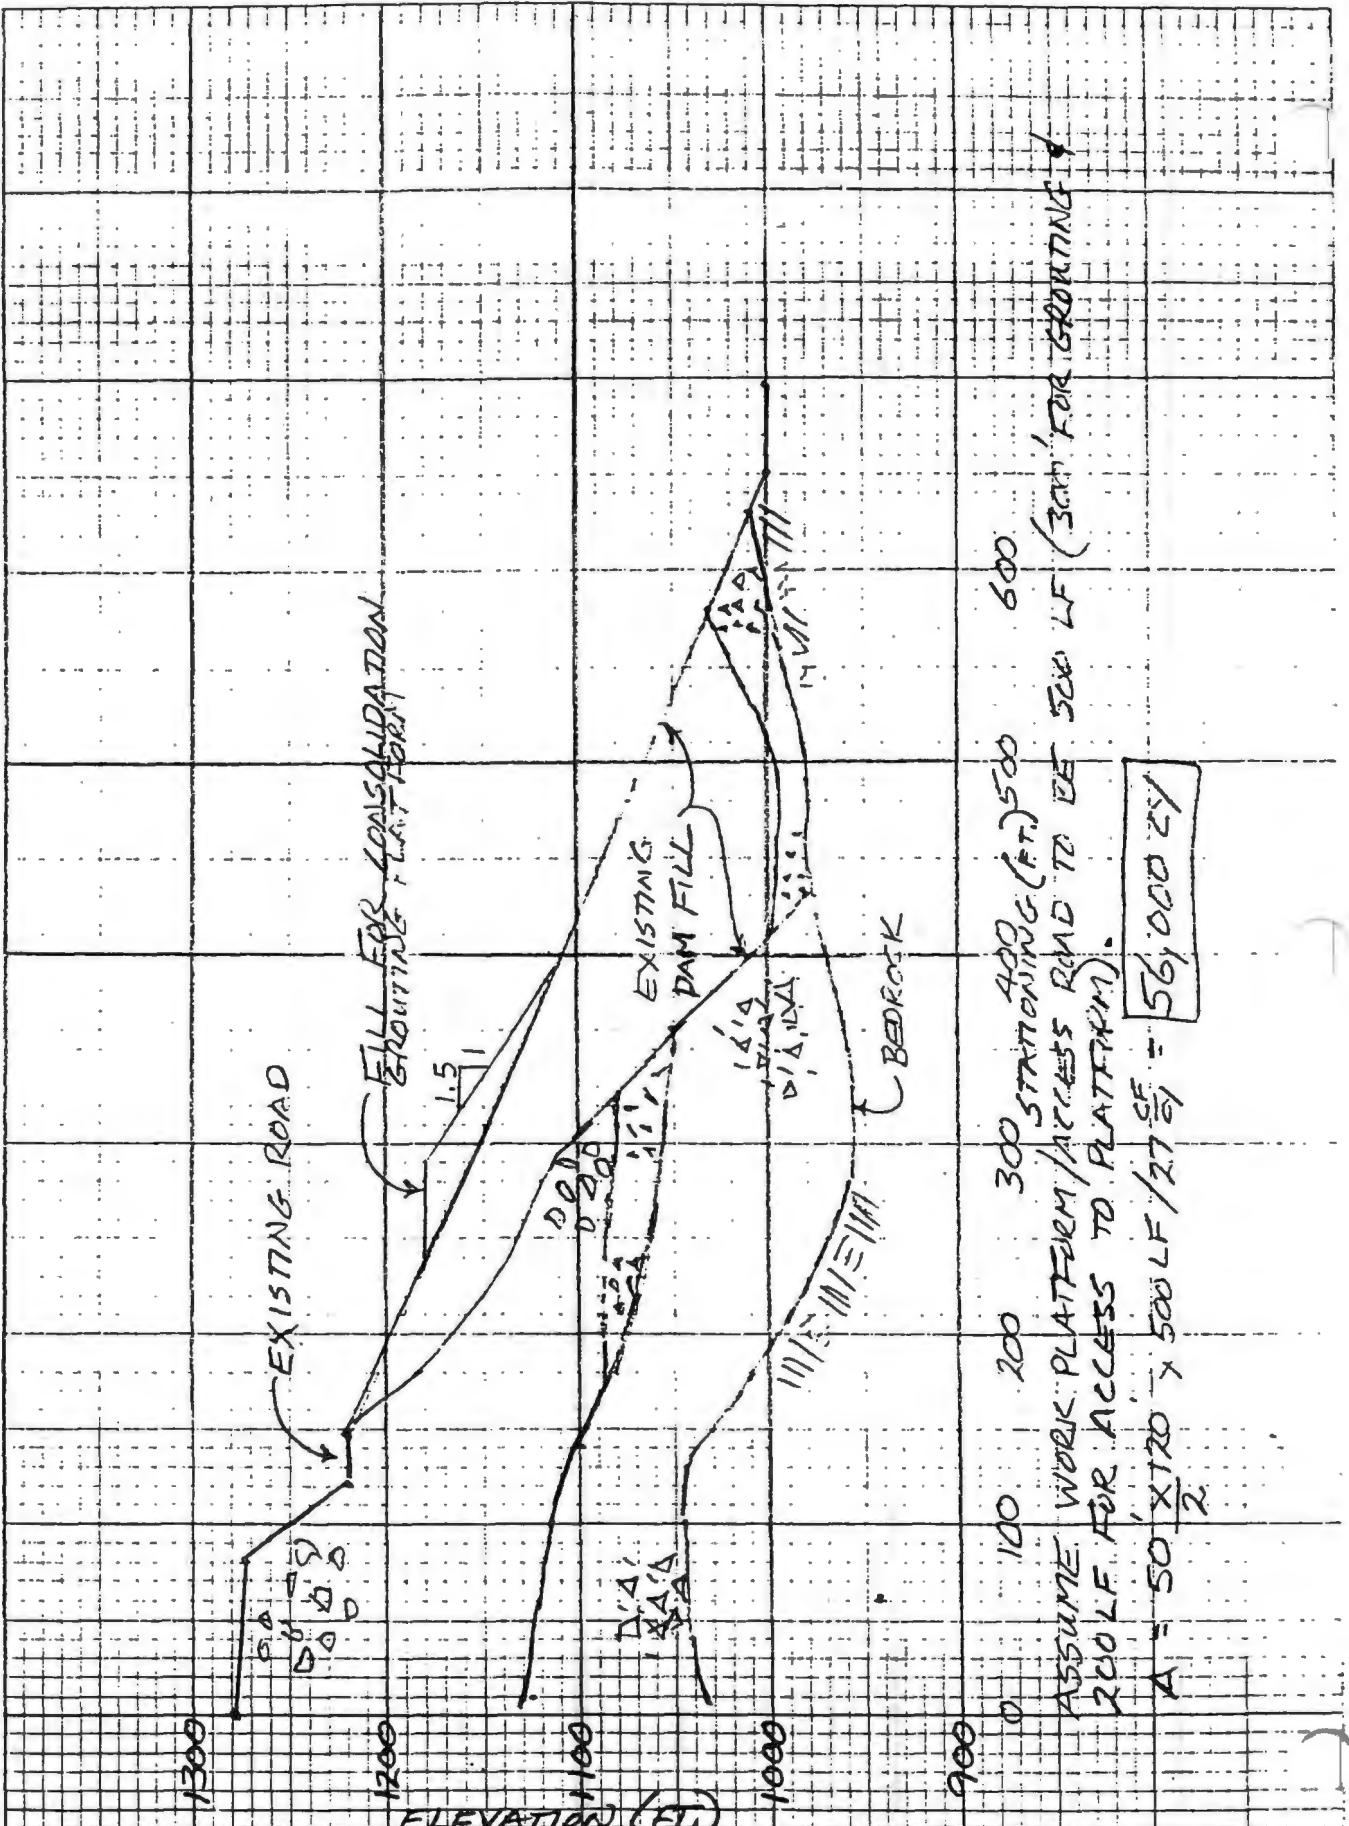
FIGURE E-12

WORK PLATFORM

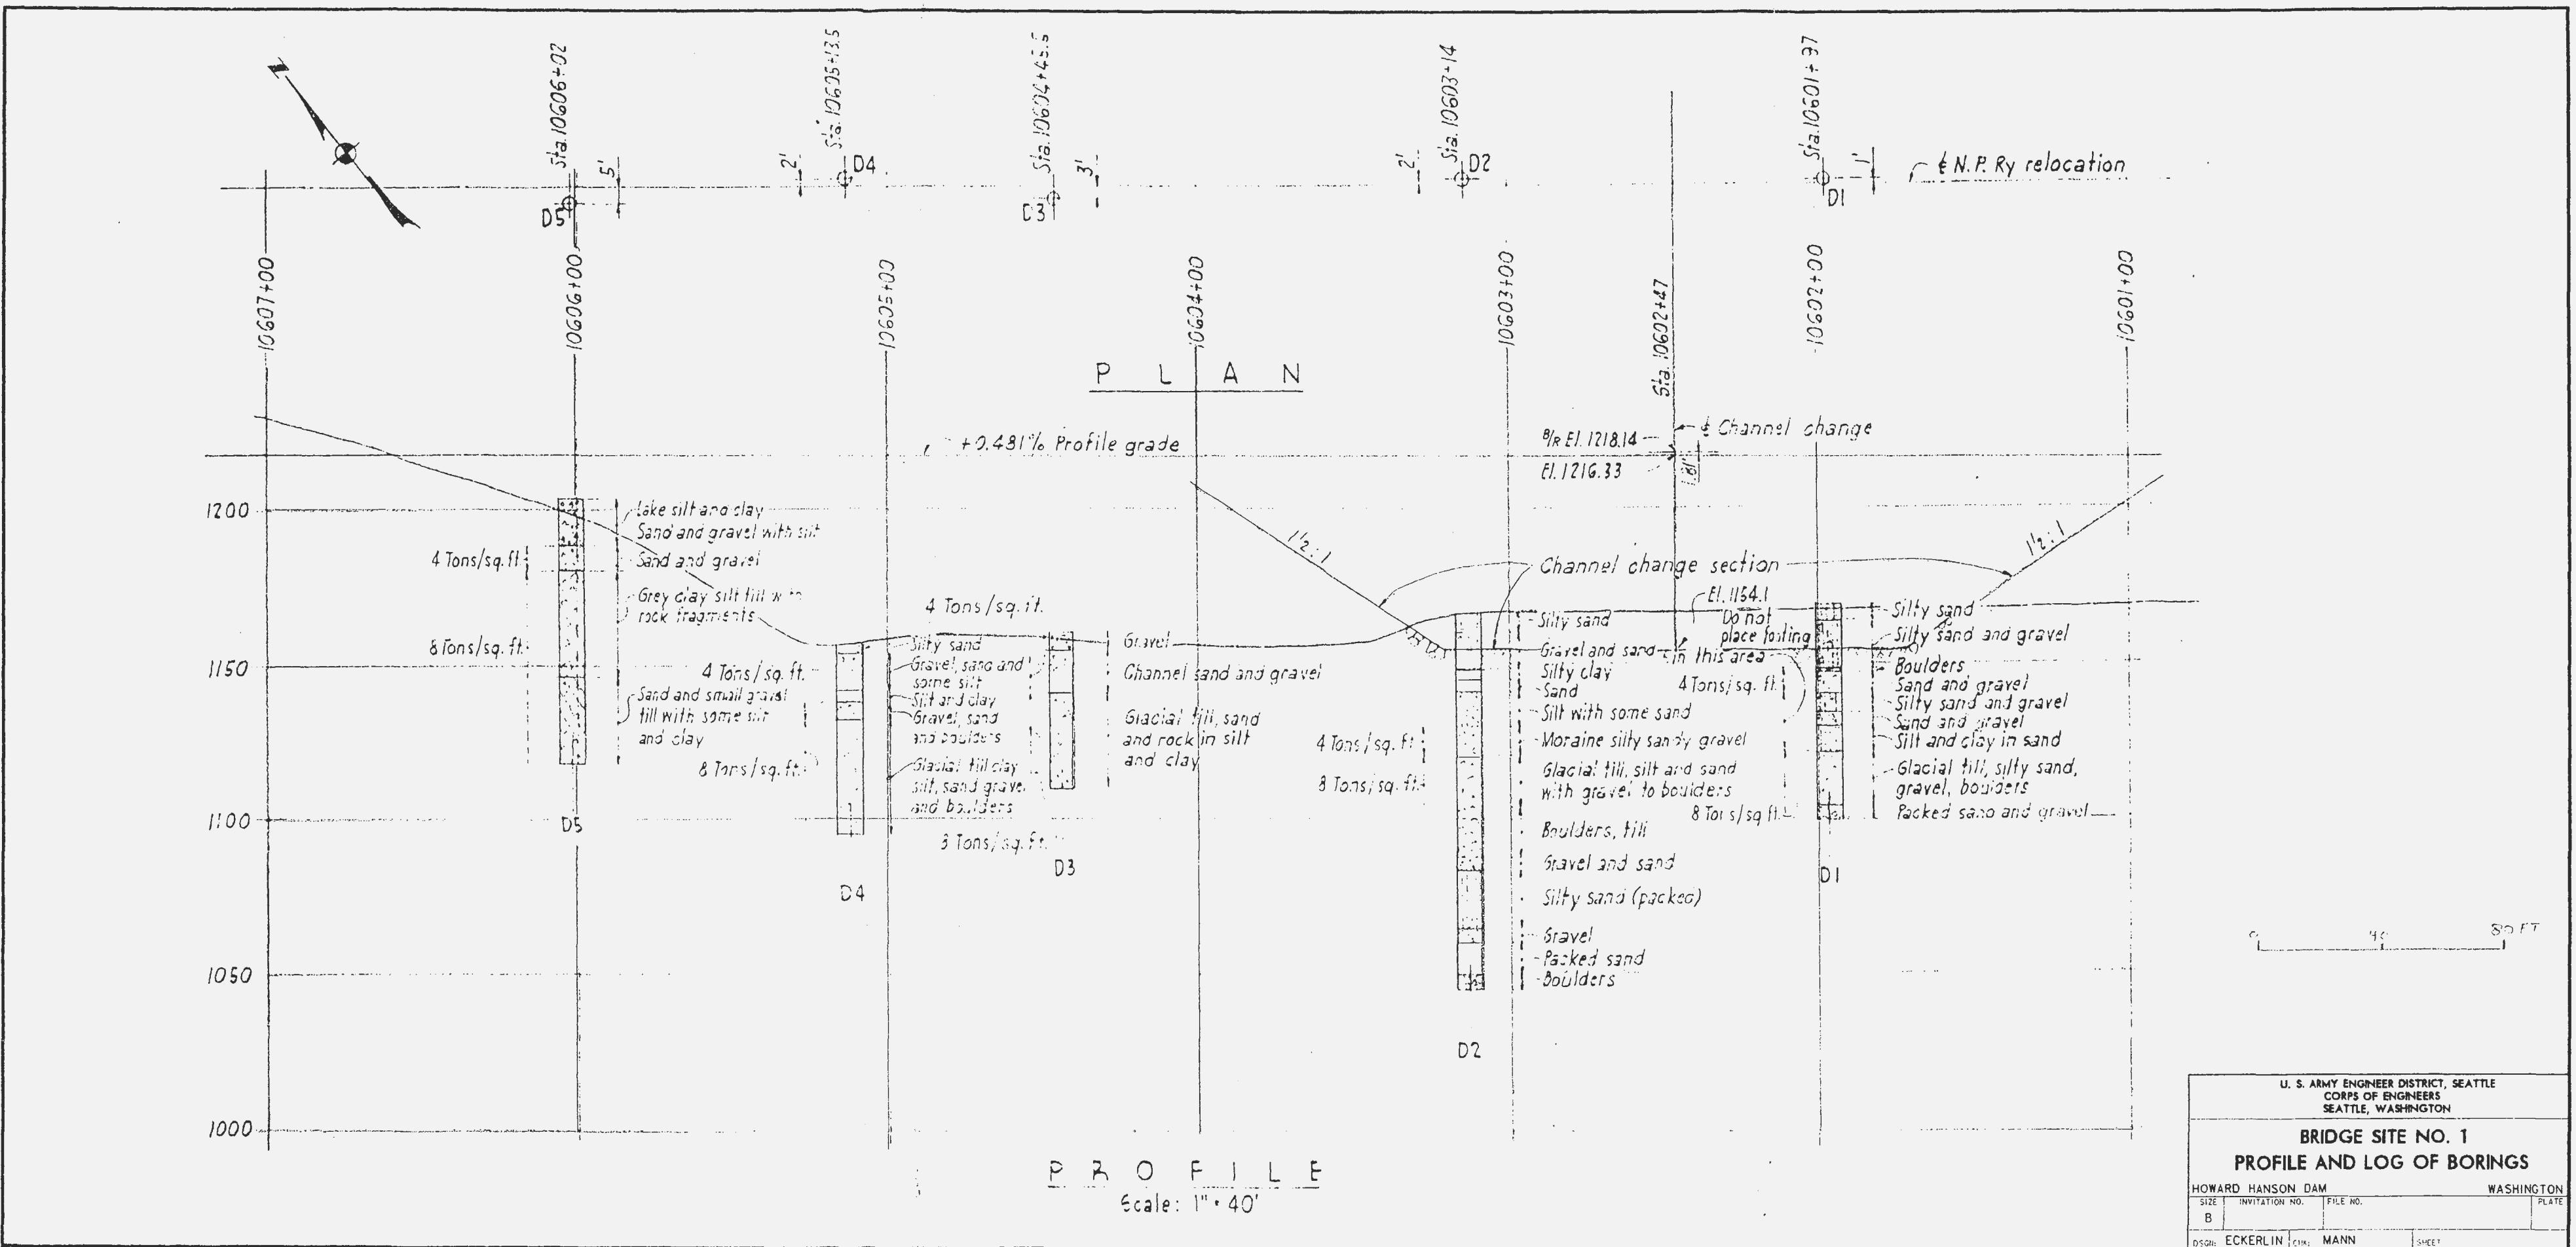
PLATE E-5

BRIDGE SITE NO. 1
PROFILE AND LOG OF BORINGS

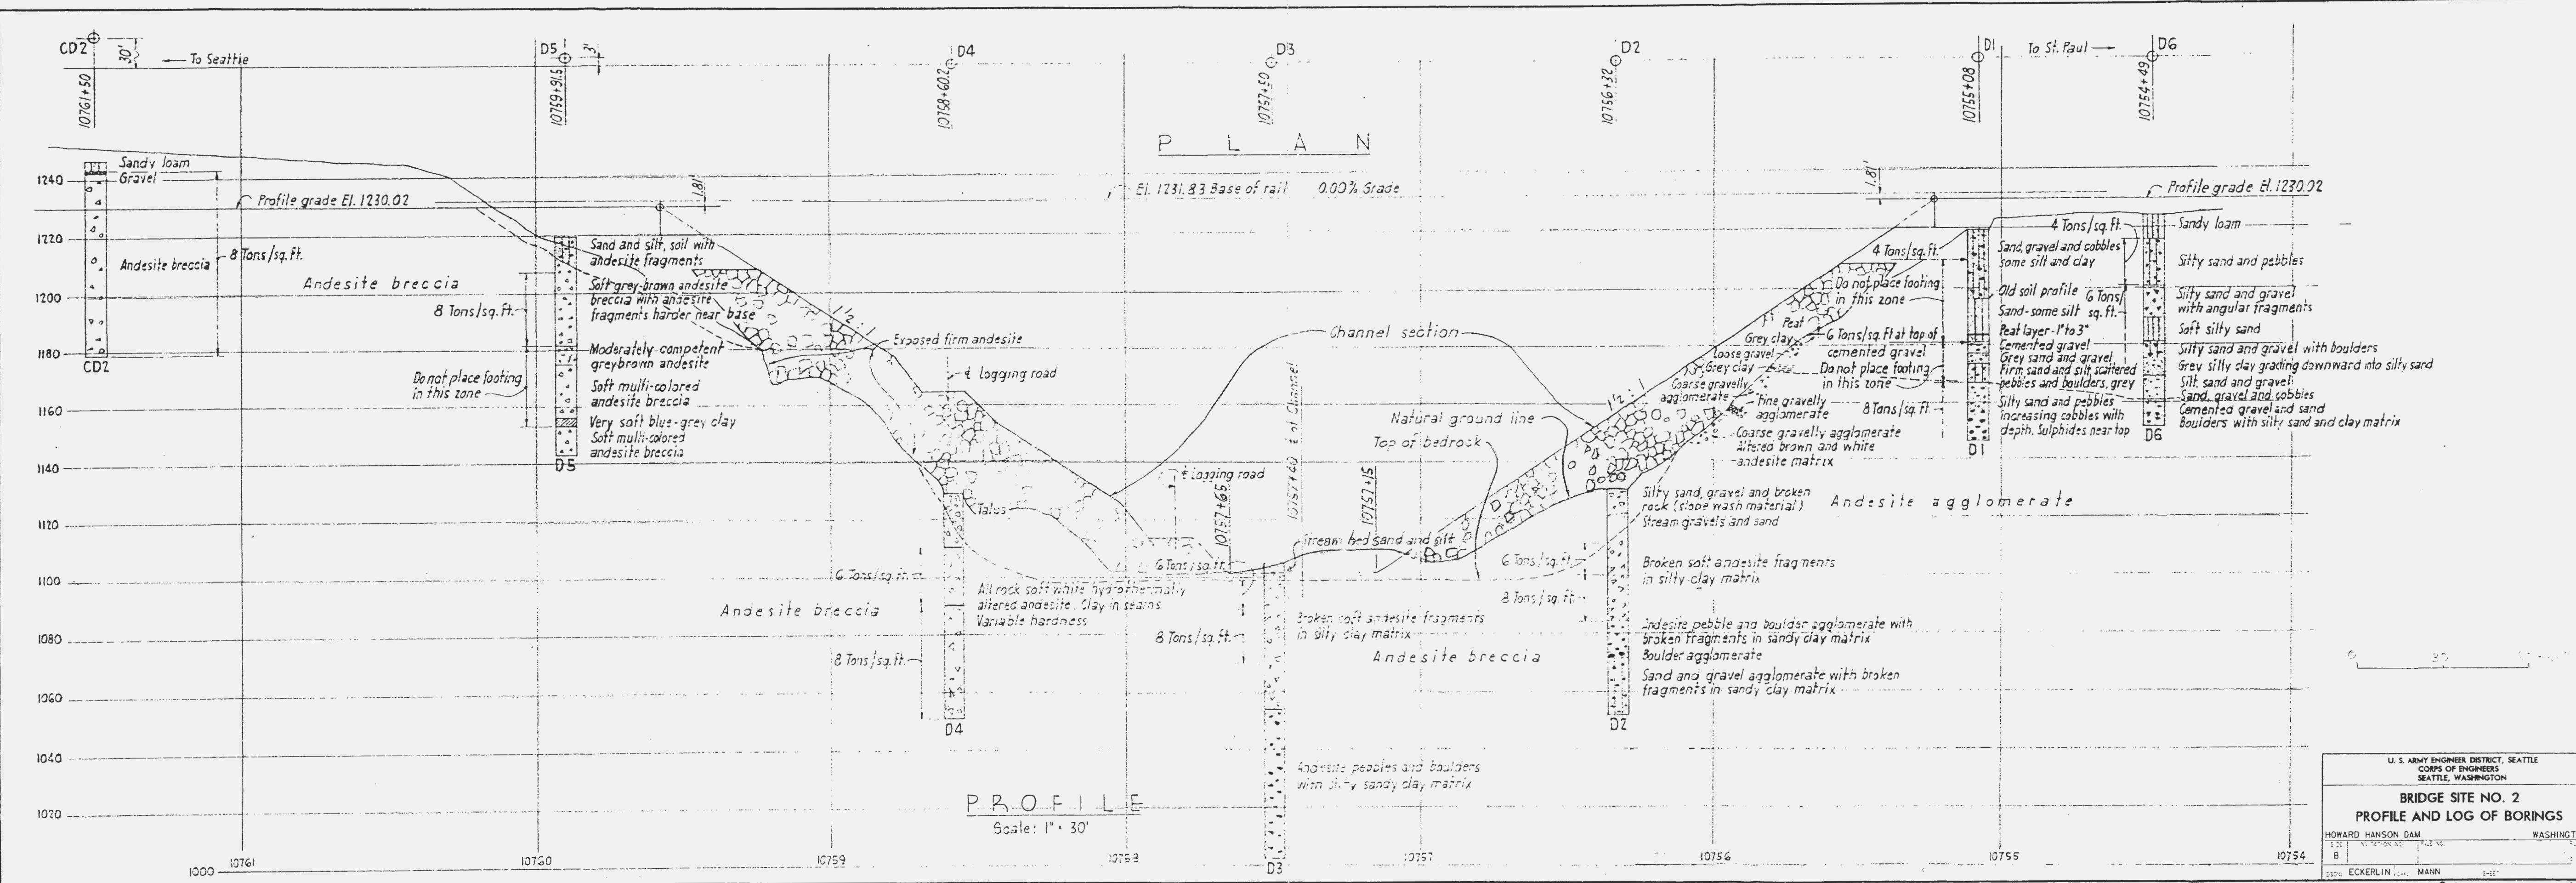
PLATE - E-6

BRIDGE SITE NO. 2
PROFILE AND LOG OF BORINGS
